Annual Monitoring Report:

## Mahogany Creek Culvert Replacement Project

Contract No: 27255  
BPA Project No: 1992-026-01

February 21, 2008

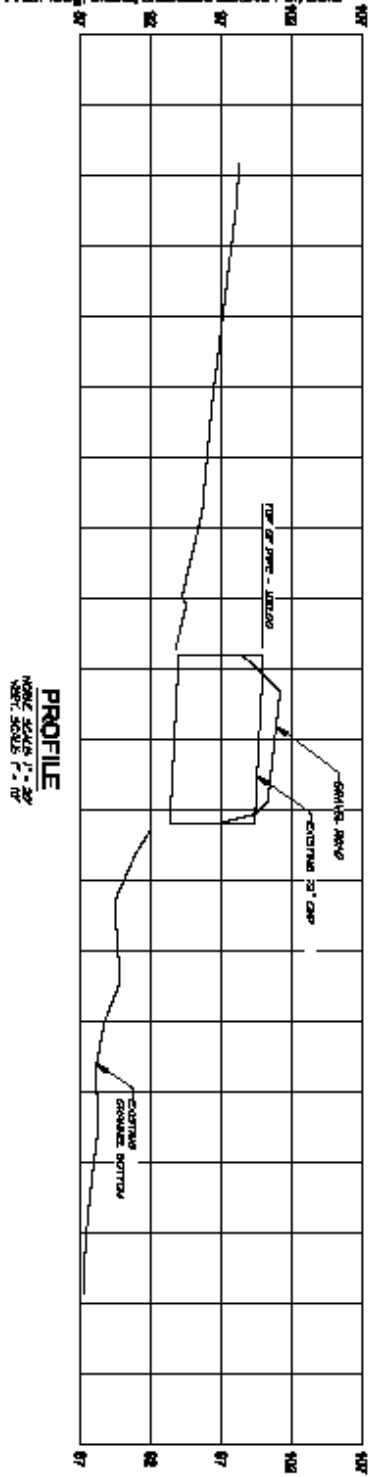
Figure 1. Pre-implementation longitudinal profile for Mahogany Creek (2004).

The longitudinal profiles obtained post-construction (Fig 2) show that the new channel constructed was at the same gradient as the natural channel above, throughout and below the project area. The 20-ft section of scour downstream of the culvert outlet depicted in the 2004 profile (Fig 1) was removed with the construction of the new channel, as was the 13-ft section of aggradation downstream of the scour. Comparing the 2006 and 2007 profiles, it appears as though the channel has settled on average five inches through the construction area from station 70 to station 220. This is close to the average settling of about 6 inches for this type of project (Anne Connor, Pers. Comm., 2008). It also looks as though the channel has reached a consistent gradient and appears to be stable. The profile clearly demonstrates that no headcuts have formed along its entire length and that a natural step-pool sequence has formed.

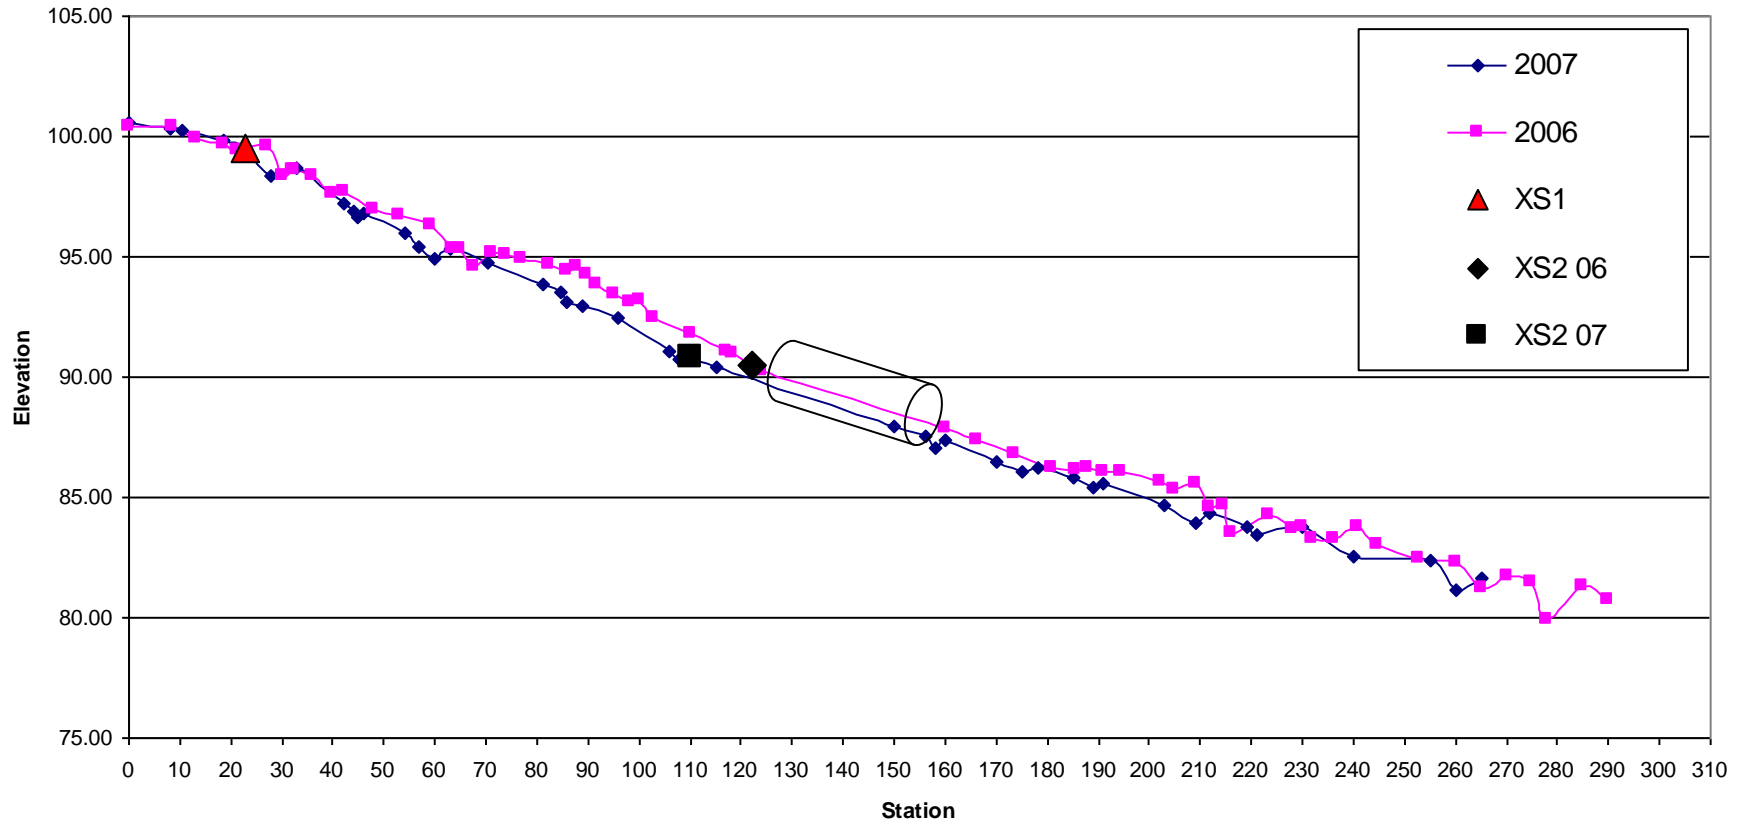
**Figure 2.** Post-implementation longitudinal profiles for Mahogany Creek (2006 and 2007).

The pre-implementation longitudinal profile is shown in Figure 1 (below), while the longitudinal profiles conducted post-construction are shown in Figure 2. The profile immediately following construction is drawn in pink, while the same survey conducted one year later is shown in dark blue. The newly installed open-bottom arch is depicted by the cylinder. It is important to note that the stations shown in Figure 2 are unique for each year, i.e. the cloth measuring tape will not lay in exactly the same place from year to year due to physical changes in streambed structure, so XS2 may appear to be in 2 different locations when it is actually a fixed point. Other fixed points that are monumented on the ground are the starting point, XS1, the culvert inlet and the culvert outlet.

is also consistent with that which is depicted in the longitudinal surveys from 2006 to 2007 (Fig 2) when actual elevations are compared.

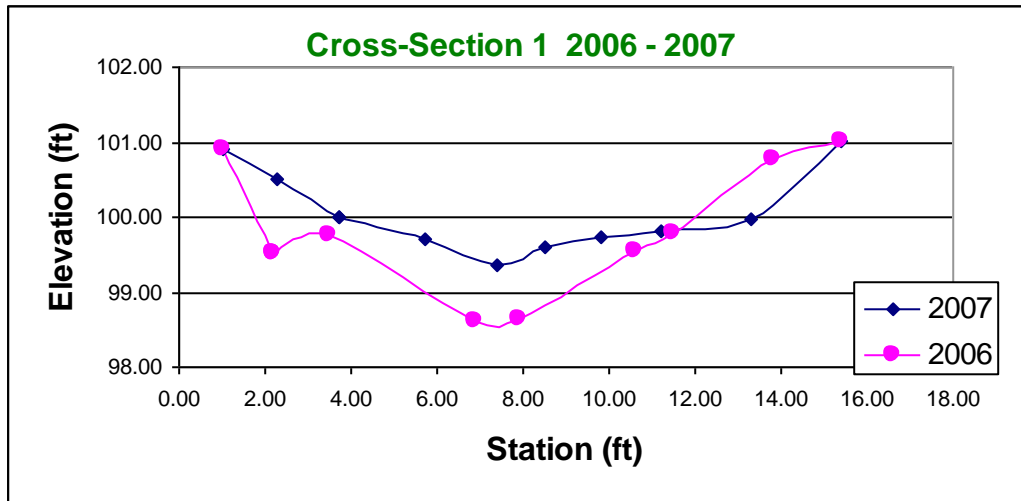
Figure 3. XS1 elevations in 2006 and 2007.

The cross-sectional surveys indicate that the channel upstream of the work zone aggraded approximately one foot in the year post-implementation (Fig 3). This was most likely the result of increased woody debris immediately downstream of the cross-sectional area, although woody debris counts were not conducted. The cross-section contained within the work zone appears relatively stable both vertically and horizontally (Fig 4). This data

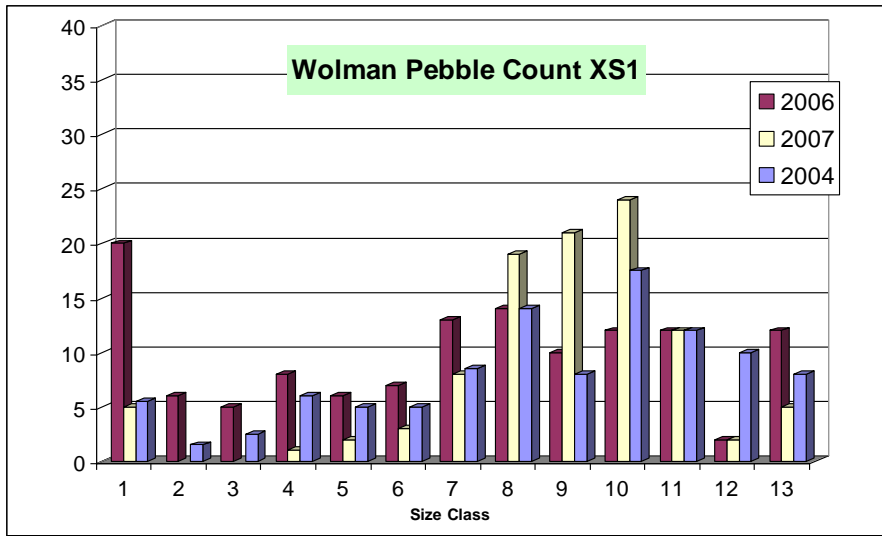
**Figure 5.** XS1 Wolman pebble count results in 2004, 2006 and 2007.

Second, it appears that immediately after construction the particle size distribution shifted to the left, or became finer, in cross-sections both outside and inside the construction zone (Figs 5 & 6). That is to be expected for XS2, but is unexpected in XS1, which is outside the construction zone. One conclusion may be that this reflects the natural movement of wood or large substrate within this system. One year post-implementation, the particle size distribution shifted back to the right for both cross-sections and appears to be moving toward the pre-implementation distribution in XS1. The data obtained from the construction zone (Fig 6) show the size classes represented fairly evenly, with less material in the 65-90 mm and 91-128 mm size classes than the prior sampling event. It is expected that more of the fine sediment (<5.6 mm), located within the work zone, will be redistributed downstream each spring during high flow events, similar to what has already happened between 2006 and 2007, and that more substrate will move into the cross-sectional area in those size classes that are deficient (65-128 mm). However, no definite conclusions can be drawn from the data at this time. It will take a number of years and repeated surveys to draw meaningful conclusions regarding the particle size distributions. When the size class distributions are consistent across years at the same location, the stream has achieved relative stability.

Third, when comparing Figure 5 to Figure 6, it appears that the particle size distributions outside and within the work zone were fairly different in 2006 relative to 2007. As mentioned above, they are expected to move closer together over time.

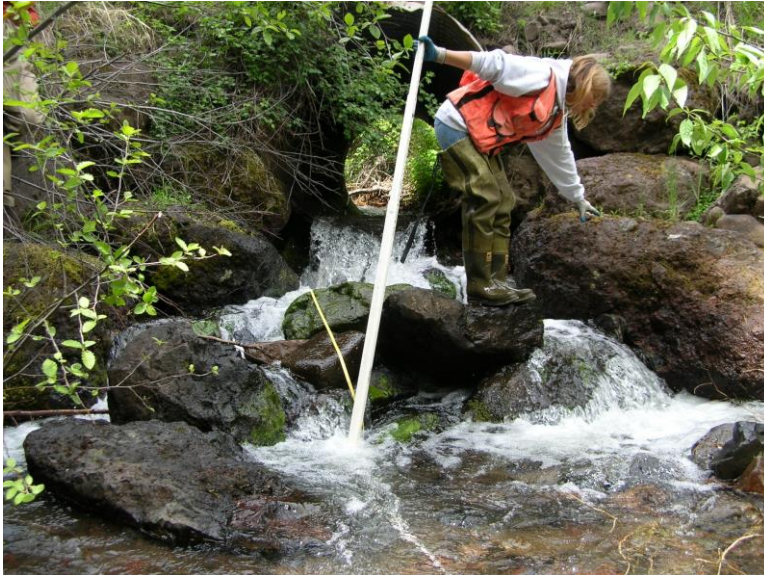
This photograph depicts the culvert outlet in 2005 before implementation. This is taken close to the location for Photo Point 4.

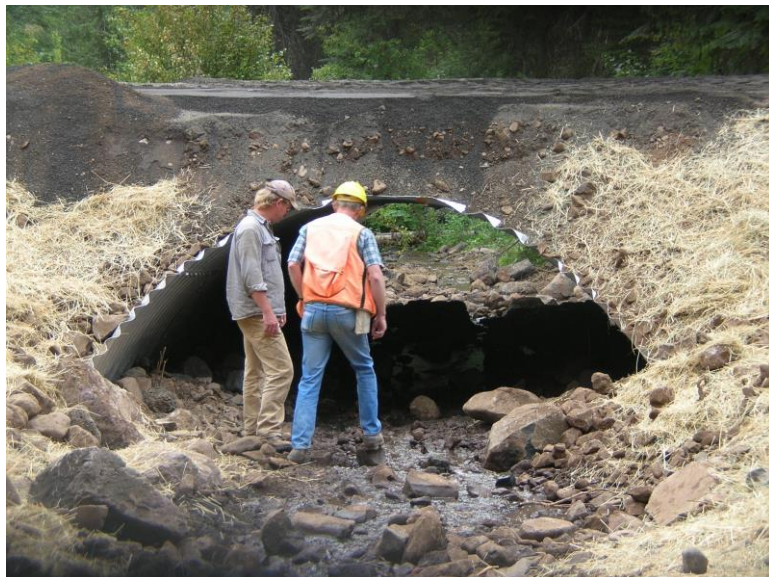
This picture was taken immediately after construction in 2006 and prior to any planting. This is taken from the same location as Photo Point 4. The difference is that it was taken with a telephoto lens, unlike previous photographs from this location.

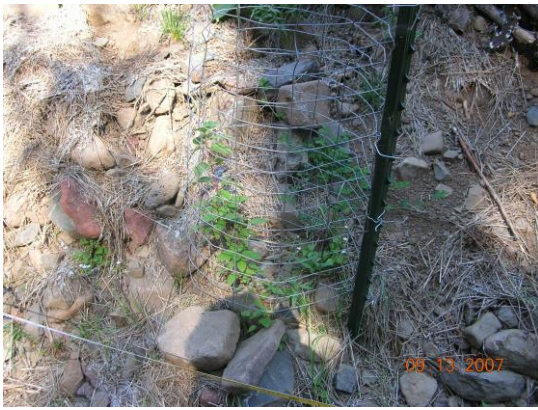
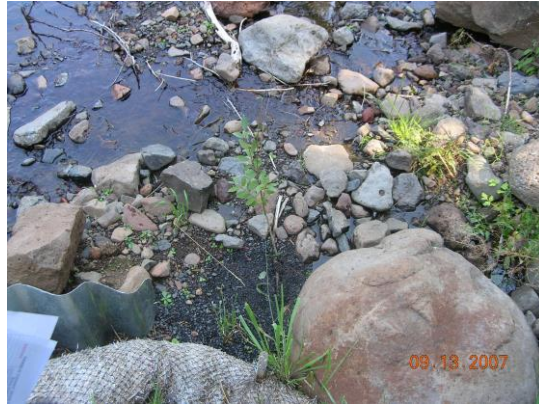
above also contains an example of the cages used for plant protection.

The two photographs here depict examples of plant survival and vigor. The photograph
