## APPENDIX J.1

### TIER 1: TREATED PROJECT AREAS

## Project Area 1.1 Description

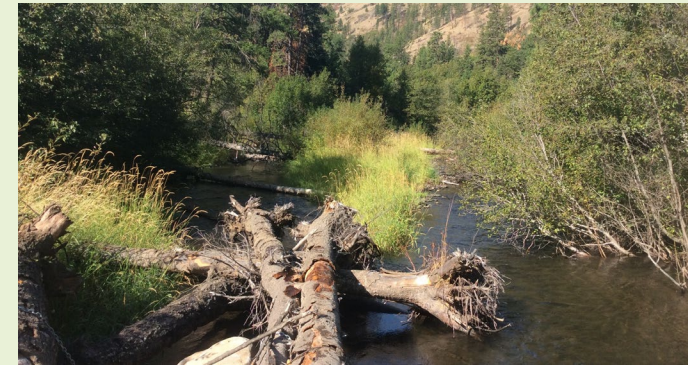
**Project Area 6**  
**Engineered log jam placed by helicopter 2 years**  
**following construction in 2017.**

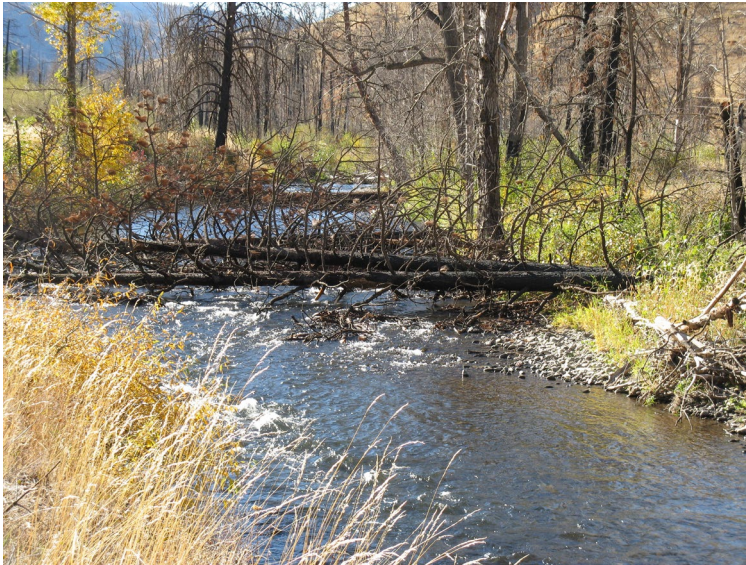
Culling fire killed trees in 2008, dropping them into the river channel in box 2.
