# Walla Walla River Basin Fish Habitat Enhancement Project

**Annual Report**  
**2001 - 2002**

**WALLA WALLA RIVER BASIN  
FISH HABITAT ENHANCEMENT PROJECT**

**ANNUAL REPORT OF PROGRESS 2001  
(February 1, 2001 to January 31, 2002)**

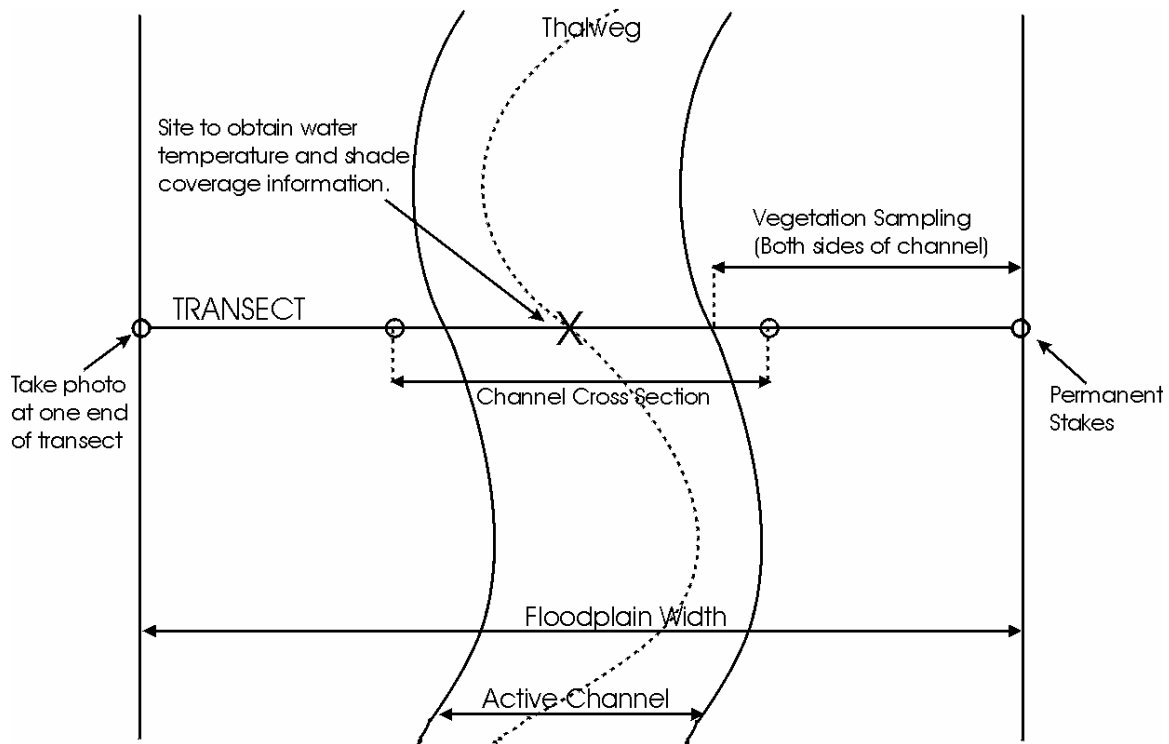
Figure 4: Transect setup for monitoring surveys.

During the cross-sectional survey, 2-10 permanent transects are established within the project area (depending on project length), ensuring that transects are representative of the different vegetation coverage within the project area. At each cross section, the transect is marked with permanent stakes perpendicular to the stream's thalweg (see Figure 3). The transect will run the entire width of the project area (from fence line to fence line) unless it is more feasible to sample just the floodplain width. Cross sections will be numbered from "1" starting from the downstream end of the project site.

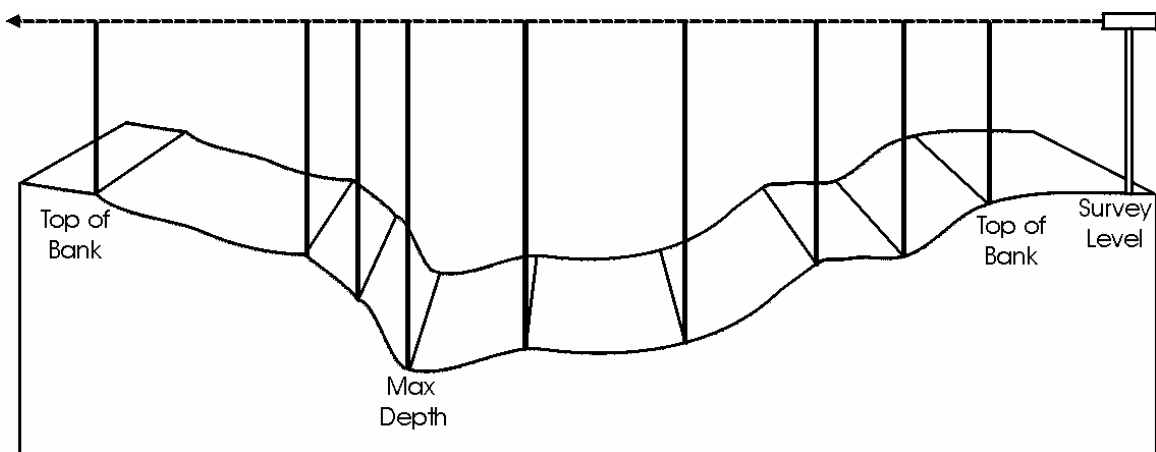
Figure 5: Survey all major slope changes across the active channel.

A measuring tape is staked across the width of the stream channel along the transect, and the cross-section is surveyed using a rod and hand level. The elevations are recorded at any major slope breaks within the active channel (see Figure 4). Elevations are also taken at the top of the bank, bankfull, water's edge, bank toe and thalweg. Right and left banks (looking upstream) should be clearly identified in the notes. While collecting cross-sectional information, the wetted width and bankfull width should be measured. Permanent transects should be easily locatable so that they can be repeated over time.

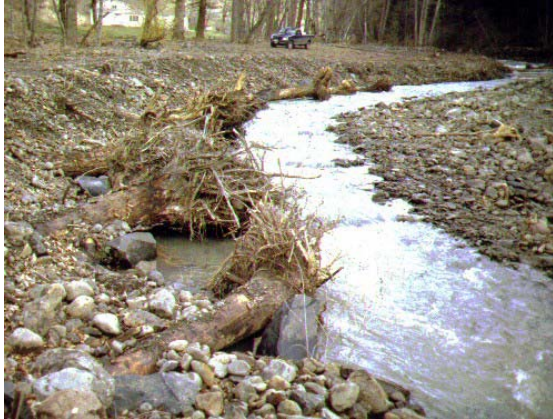
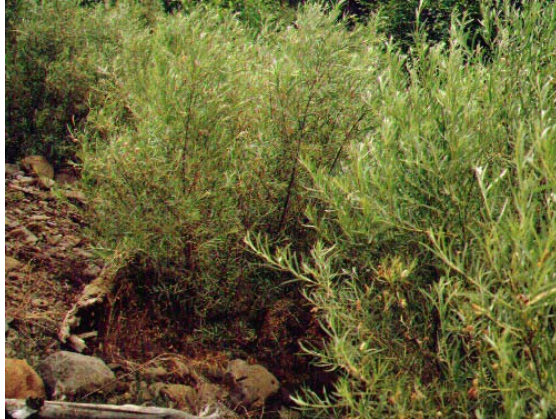
The following photo points portray the significant vegetative recovery that has occurred at this project site.

Native plant restoration efforts have been very effective. Nearly all of the willow cuttings placed during excavation and subsequent planting efforts of rooted stock plants have survived. It's worth noting that the riparian corridor of this project area is almost exclusively river rock (please see 1998 photos below) and virtually no soil can be observed whatsoever. The project did hand-water the rooted stock plants the first two years following reintroduction.
