**WALLA WALLA RIVER BASIN
FISH HABITAT ENHANCEMENT PROJECT
ANNUAL REPORT OF PROGRESS
2005 and 2006**

Project No. 96-046-01
Contract Number: 32726

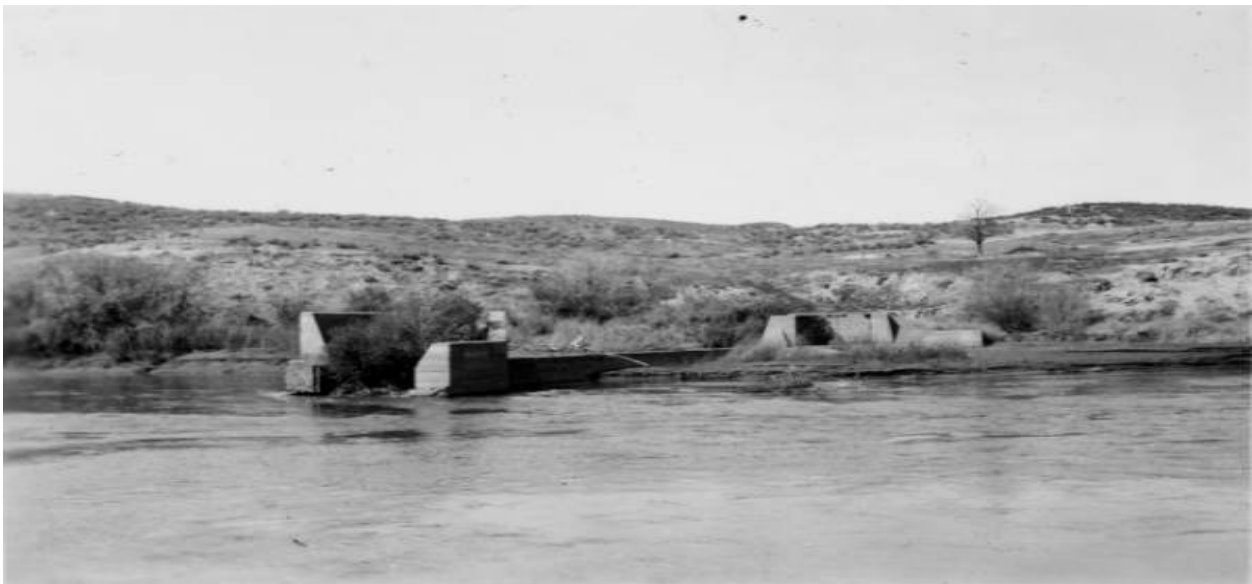
Figure 2: A portion of Nine Mile Dam near Reese Washington can be seen in this undated photo on the mainstem Walla Walla River. This dam was reportedly built in 1905 and eventually removed.

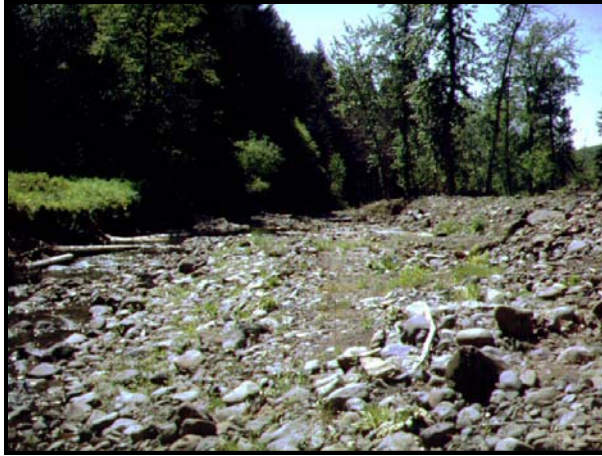
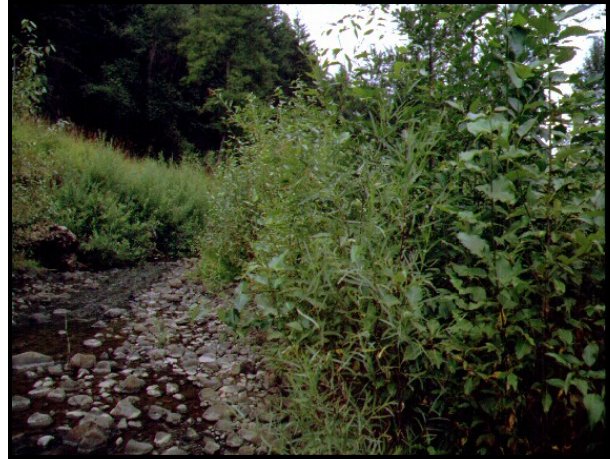
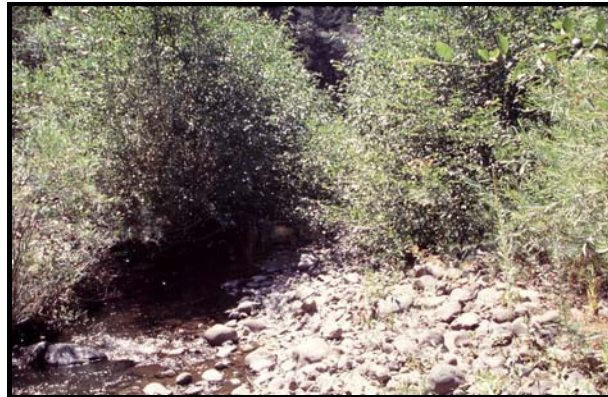
Recovery of riparian vegetation at this site has been excellent. Riparian areas completely devoid of vegetation in 1996 now contain strong stands of various native trees and shrubs. Stream canopy shade has improved throughout the entire project corridor and active erosion has essentially been eliminated. The stream channel remains incised because of a push-up dike on the right bank and natural sloping topography along left side of the stream. This situation prevents access to the floodplain and formation of high-water channels and off-channel habitat. Further results and discussion regarding the Blue Creek Project Area is included in the monitoring section of this report.

Figure 5: Project photo-points on Blue Creek within the project area collected at the same location in 1998, 2001, and 2004. All of the willows shown above the log structures along the left bank and right riparian corridor were placed with the aid of an excavator and stinger in 1998.

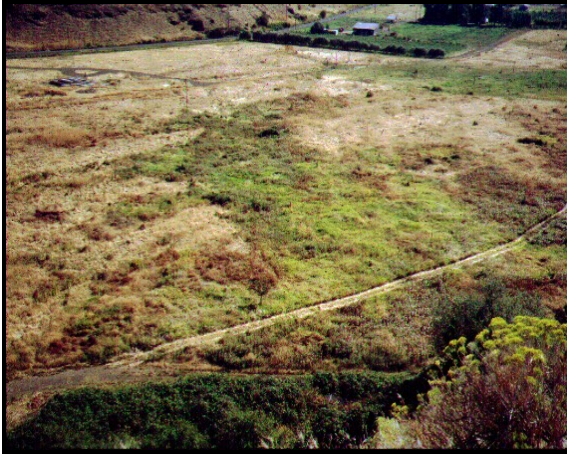
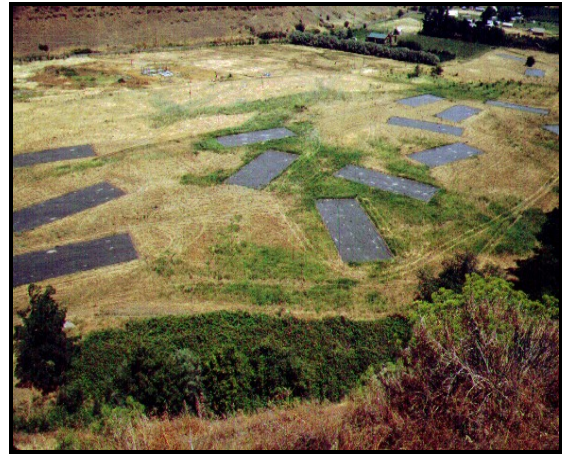
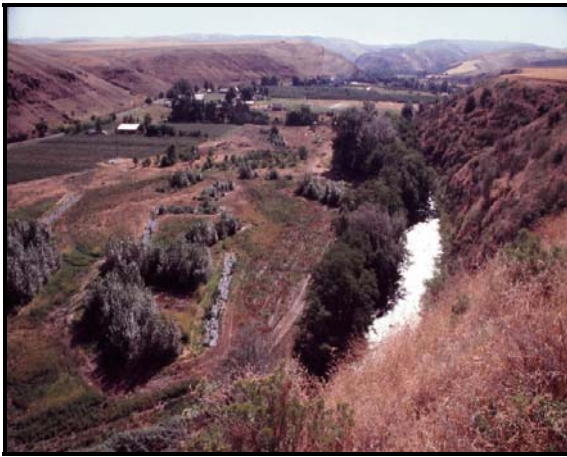
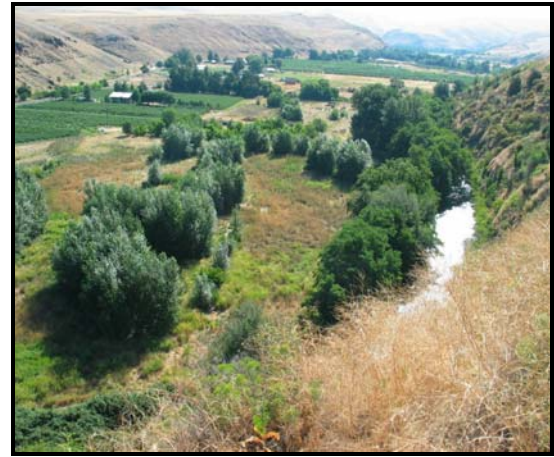
In the spring of 2001, the project installed 36 large (41' x 100') black plastic weed barrier tarps purchased from Layfield Plastics Incorporated of Bellevue, Washington. The tarps are designed to eliminate competitive weeds and aid in the maintenance of soil moisture. Each tarp was secured in place by burying the perimeter with topsoil. Small rocks were also arbitrarily positioned on the tarps as additional protection against high winds. The tarps were placed in a random pattern throughout the 20-acre restoration area in an attempt to mimic the natural succession of a shrub, tree, and grass ecosystem. Each tarp was planted with a compliment of approximately 200 native plants appropriate for the site. Plants were maintained throughout the first and second years with summer watering and hand weeding. Thus far, survival of the plants in the tarps has varied from 60 to 90 percent and growth has been outstanding.

Figure 6: Photo points taken from a ridge over-looking the mainstem Walla Walla River (Lampson) project area in 1998, 2001, 2004 and 2006.

In March of 2004, some maintenance planting was done on the tarps, which included 20 ponderosa pine, 1200 willows, 400 mock orange, 360 ninebark, and 680 snowberry. A contractor was hired to chemically treat cheat grass (*Bromus Tectorum*) in February of 2006. Project technicians periodically treated new infestations of noxious weeds with backpack sprayers throughout each growing season. Technicians also cleared the tarps of any weeds by hand pulling them and mowed around the perimeter of the tarps to help control weeds in June and December of each year.

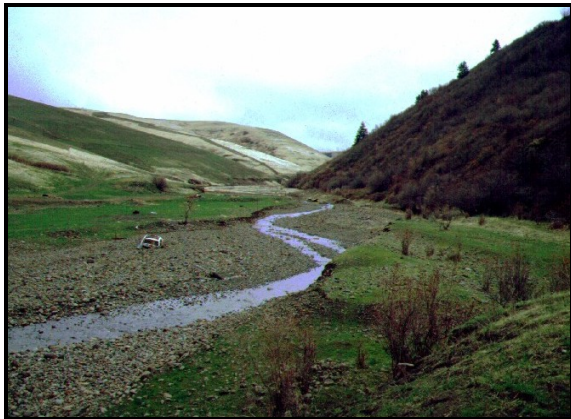
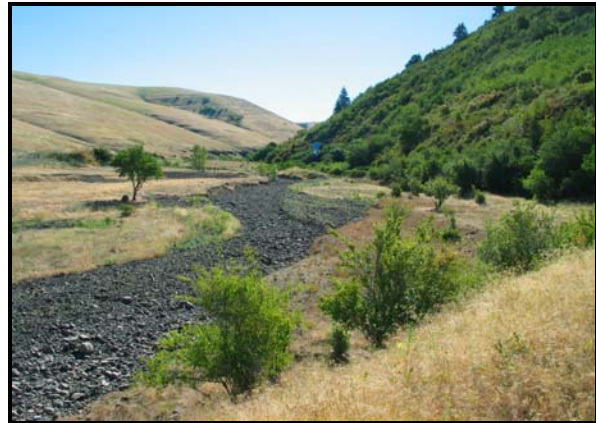
Figure 7: Photo-points taken within the project area on Couse Creek (Hasso) in 1999 and 2006. A century of over-grazing, shallow soils, and summer drought make this restoration site particularly slow to recover. The stream is narrowing, however, and vegetative is slowly recovering.

Restoring riparian vegetation to this site is particularly challenging because of the extended summer drought, ephemeral flows, and poor soils. As a result, the project has chosen to focus on “passive restoration approaches” including livestock exclusion and self-watering willow cuttings. Several thousand native willow cuttings were collected nearby on the North Fork of the Walla Walla River and trenched in adjacent to the stream with an excavator during the fall of 2000. Survival of the cuttings was higher than 80 percent the following spring but as summer progressed and stream flows eventually stopped many of the plants began to die. By the summer of 2005, approximately 40 percent of the willows are remaining and dozens of young cottonwood trees, hawthorn, rose, and various other species are beginning to reestablish themselves also. We expect that with continued livestock exclusion and time, perhaps decades, the entire riparian corridor will again support a healthy riparian plant community and properly functioning stream channel and floodplain.

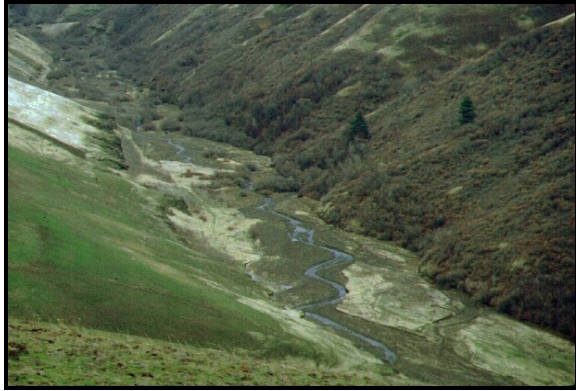
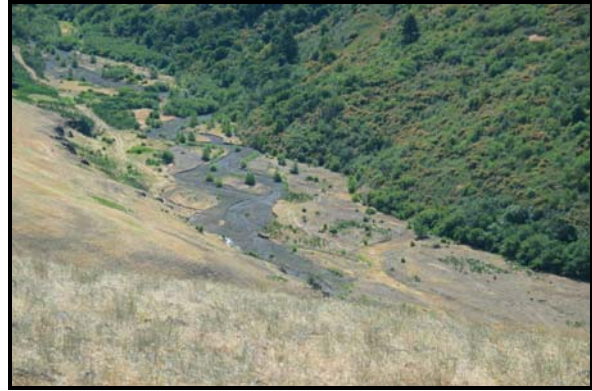
Figure 8: Photo-points taken in 1999 and again in 2006 over-looking the project area on Couse Creek (Hasso).

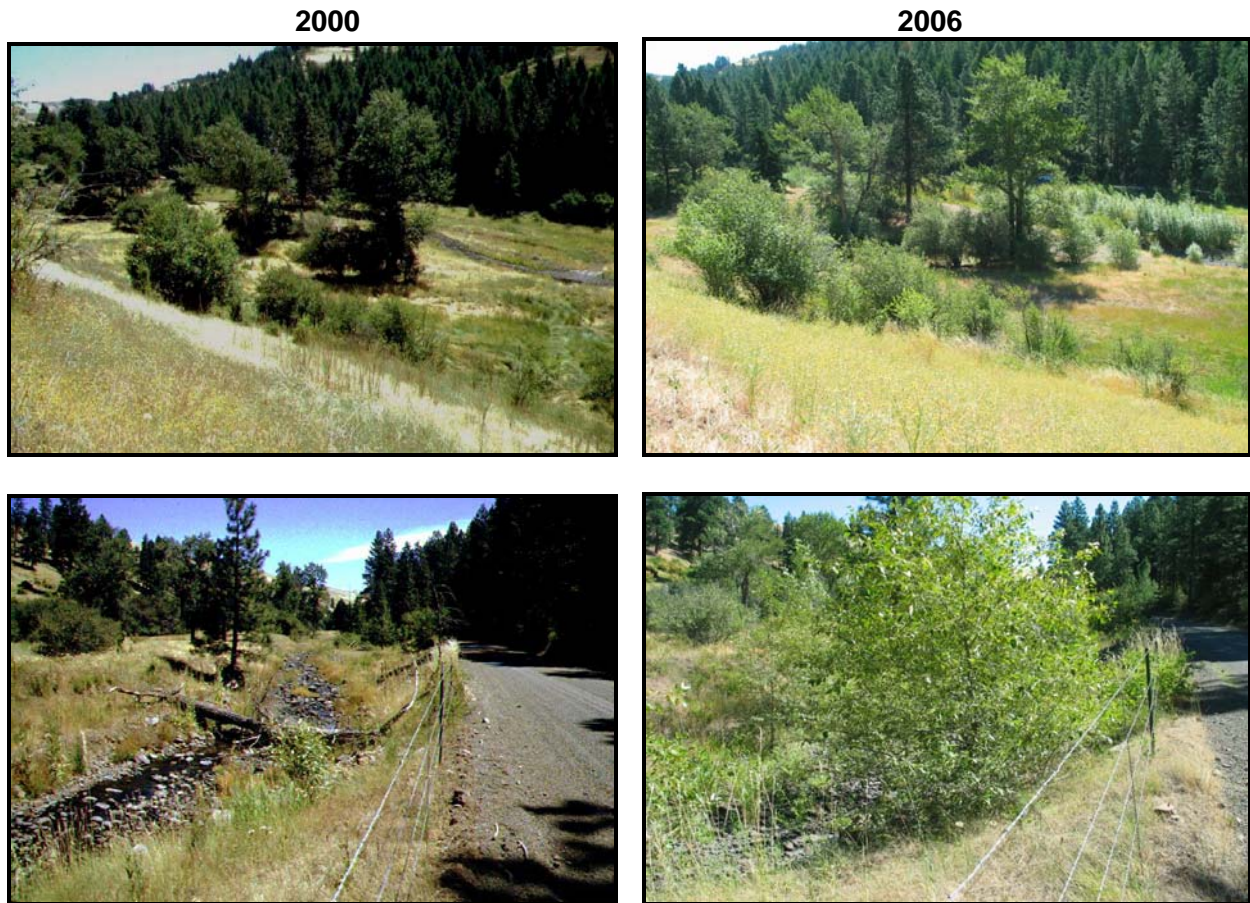
Figure 9: Patit Creek photo points taken in 2000 and repeated in 2006. The willows along the shoreline in the top right photo were planted by the project during instream enhancement activities conducted in 2000.

A total of 220 pine, 400 willow, 300 mock orange, and 140 ninebark were planted as tublings in the project area in the reporting period. Survival of these plants has not been as successful as hoped because of drought conditions and competition by non-native plant species. Noxious

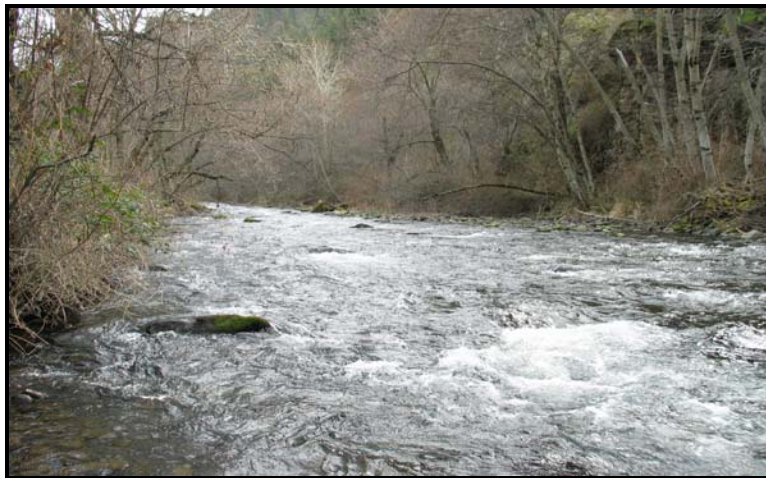
Figure 10: Photo looking upstream on the mainstem Walla Walla River within the property owned by the CTUIR.

With assistance from the Trust for Public Lands, the CTUIR purchased a 46-acre property on the South Fork of the Walla Walla in December of 2003. A combination of Pacific Coastal Salmon Funding and Wildhorse Gaming Resort dollars were used to fund the acquisition. The 46-acre property is located in the foothills approximately 13 miles east of Milton Freewater, Oregon on the mainstem Walla Walla River. Included in the property is 0.5 miles of the river, an older 900 square foot family dwelling in need of much repair (currently vacant) and several outbuildings. Also attached with the property is a water right for approximately 13 acres of pasture. Water quality at this point of the river is excellent throughout the year and provides refuge for strong populations of summer steelhead, red-band trout, spring chinook salmon, and bull trout. The river channel is confined by a dike along the right bank and an abrupt hillside with conifer trees and basalt out-cropping to the south. Limiting factors the project will address include riparian and upland vegetation, floodplain function, and instream habitat quality. No restoration work was done on this property during the reporting period.

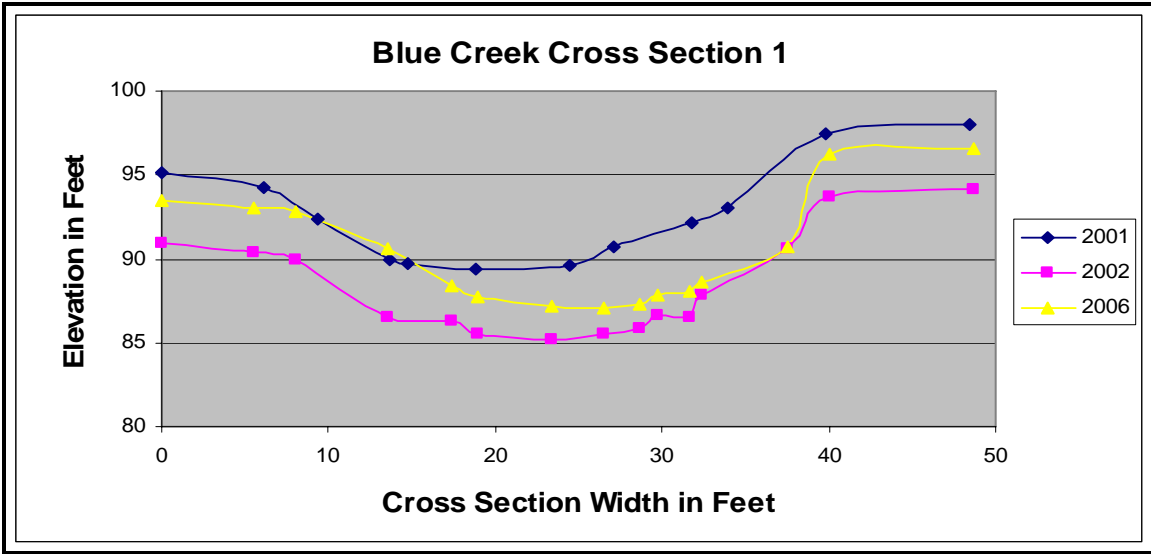
Figure 11: Stream Cross-section data for Blue Creek RM 2.4 collected at cross-section “1” for the period of 1997, 2002, and 2006.

Physical and biological monitoring data collected over the last decade on Blue Creek is documenting a dramatic improvement in habitat conditions. The channel is narrowing and deepening as a result of a now recovering riparian corridor. Shoreline erosion has virtually been eliminated which indicates that riparian vegetation is improving and that sediment transfer and channel form is closer to a proper functioning condition.

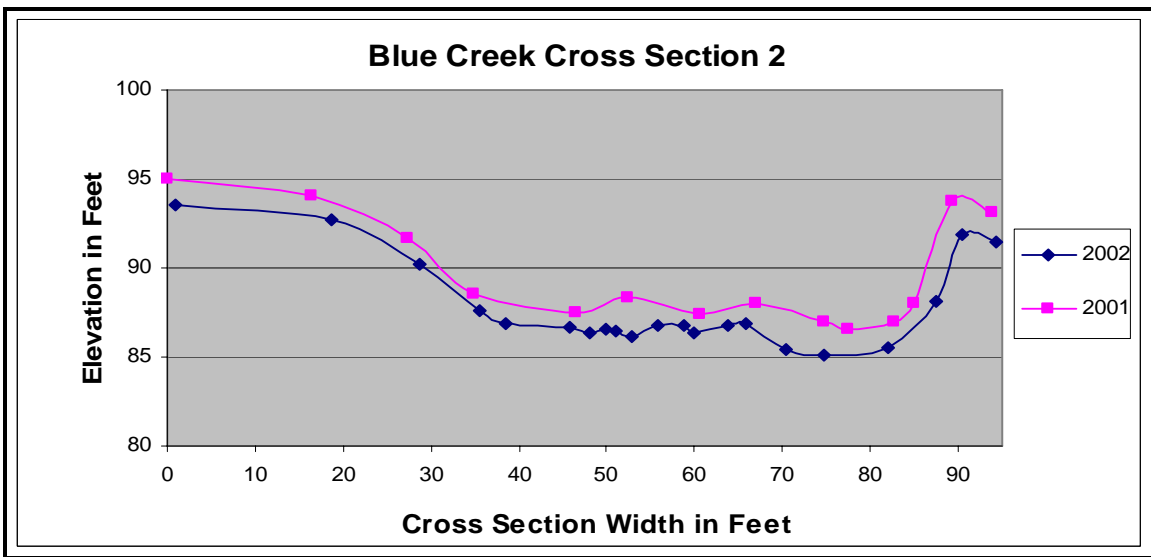
Figure 12: Stream Cross-section data for Blue Creek RM 2.4 collected at cross-section “2” for the period of 1997 and 2002.

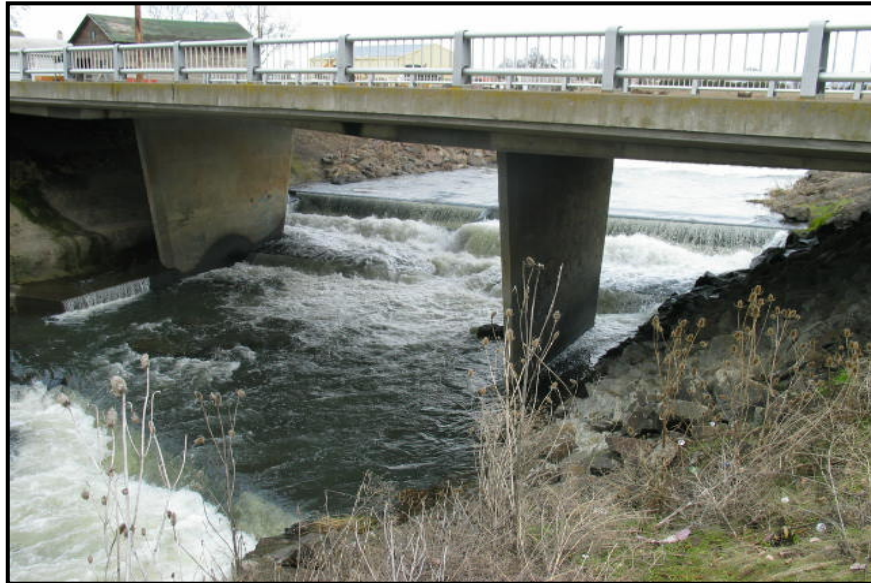
Figure 13: This pre-project photo was taken in 2004. In this condition, migrating salmonid fish were unable to negotiate the series of structures under most flow conditions.

In 2005, the Confederated Tribes of the Umatilla Indian Reservation (CTUIR) in coordination with the Walla Walla Conservation District began the process of securing funding to repair a series of passage barriers at Gose Street on Mill Creek. By the summer of 2006, grants totaling approximately 450,000 dollars were secured through a combination of sources that include the Snake River Salmon Recovery Board, the Walla Walla Watershed Alliance, the Pacific Coastal Salmon Recovery Board, the US Fish and Wildlife Service, and Bonneville Power Administration.

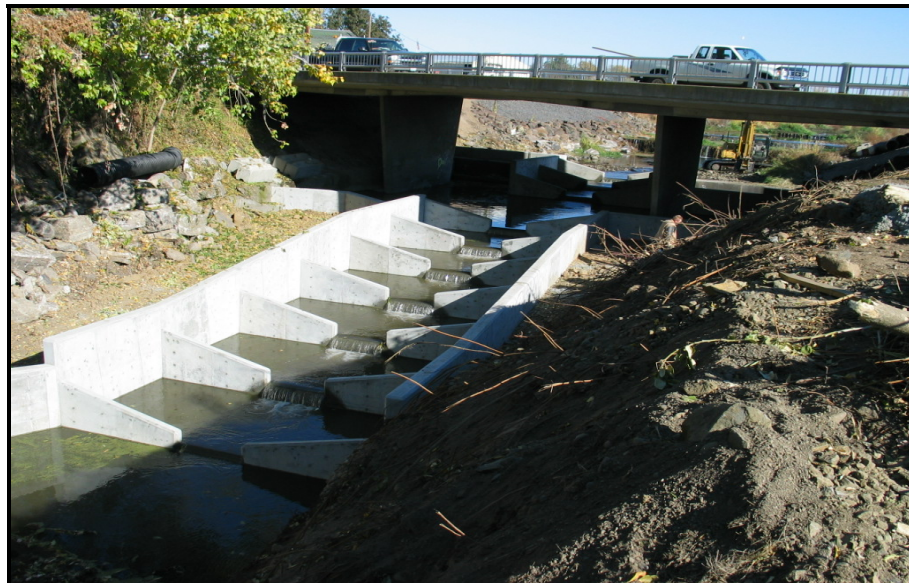
Figure 14: The photo was taken in late October of 2006 shortly after both new fish ladders were

completed. The new ladder meets state and federal passage criteria for both juvenile and adult migrating fish in Mill Creek.

Construction of the new fish ladder began in mid-September and was completed by October 30, 2006. The fish ladder is operating as designed and no juvenile or adult passage concerns have been identified since its completion. There are some minor concerns with stranding in the cement box near the top of the first fish ladder on the left bank and various options for correcting this problem are being discussed. Two additional cement weirs designed to improve passage at the first sheet-pile weir above the bridge are scheduled for construction in 2007. Out monitoring and evaluation for the project site will be conducted by the CTUIR Monitoring and Evaluation Project.

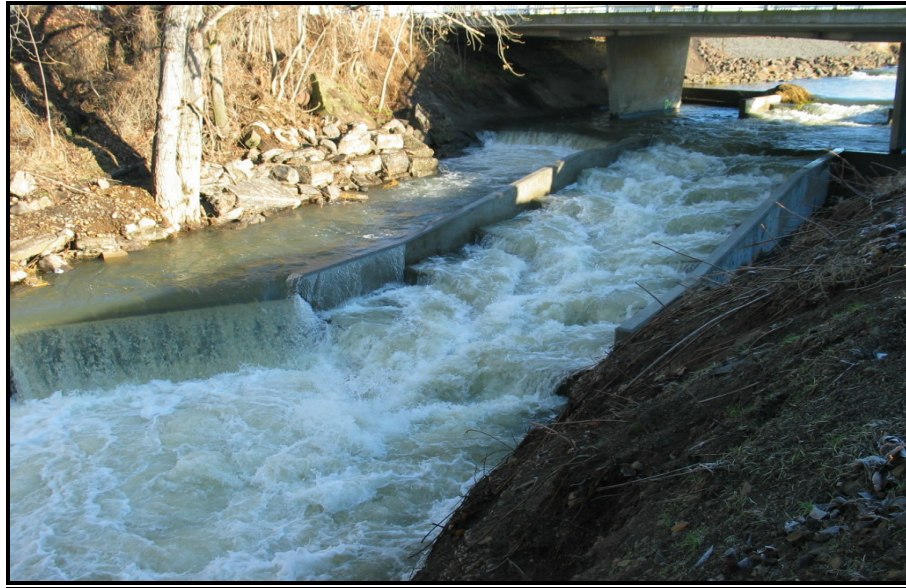
Figure 15: Photo of completed fish ladder at Gose Street during high flows.
