WALLA WALLA RIVER BASIN FISH HABITAT ENHANCEMENT PROJECT ANNUAL REPORT

January 1, 2007 – December 31, 2008

Project No. 1996-046-01
Contract Number: 00032726

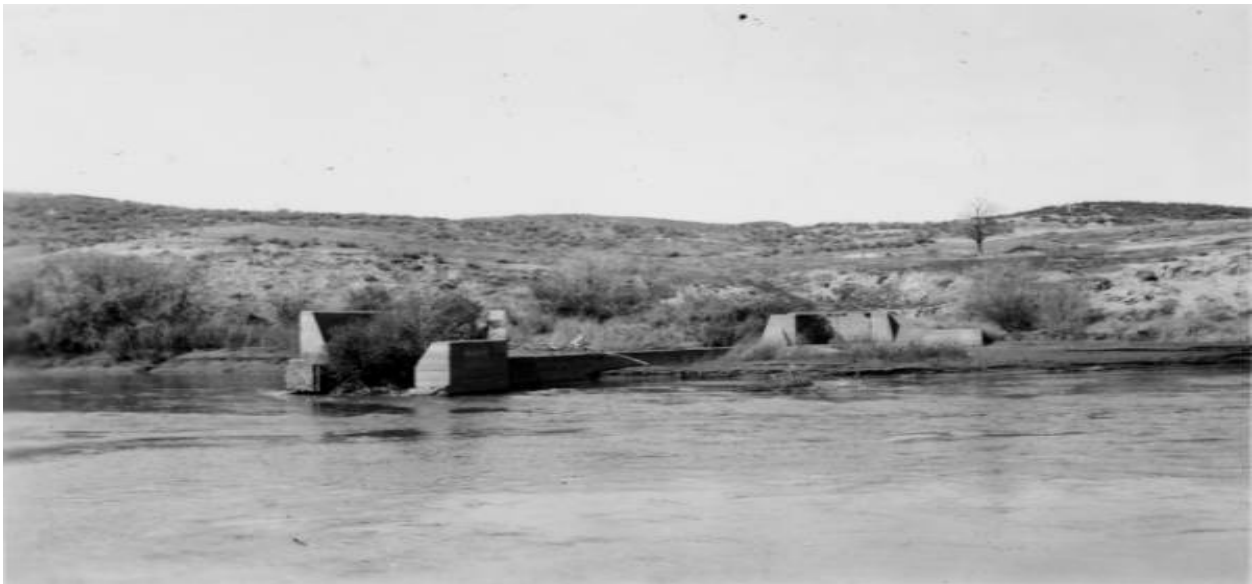
Figure 2: A portion of Nine Mile Dam near Reese Washington can be seen in this undated photo on the mainstem Walla Walla River. This dam was reportedly built in 1905 and eventually removed.

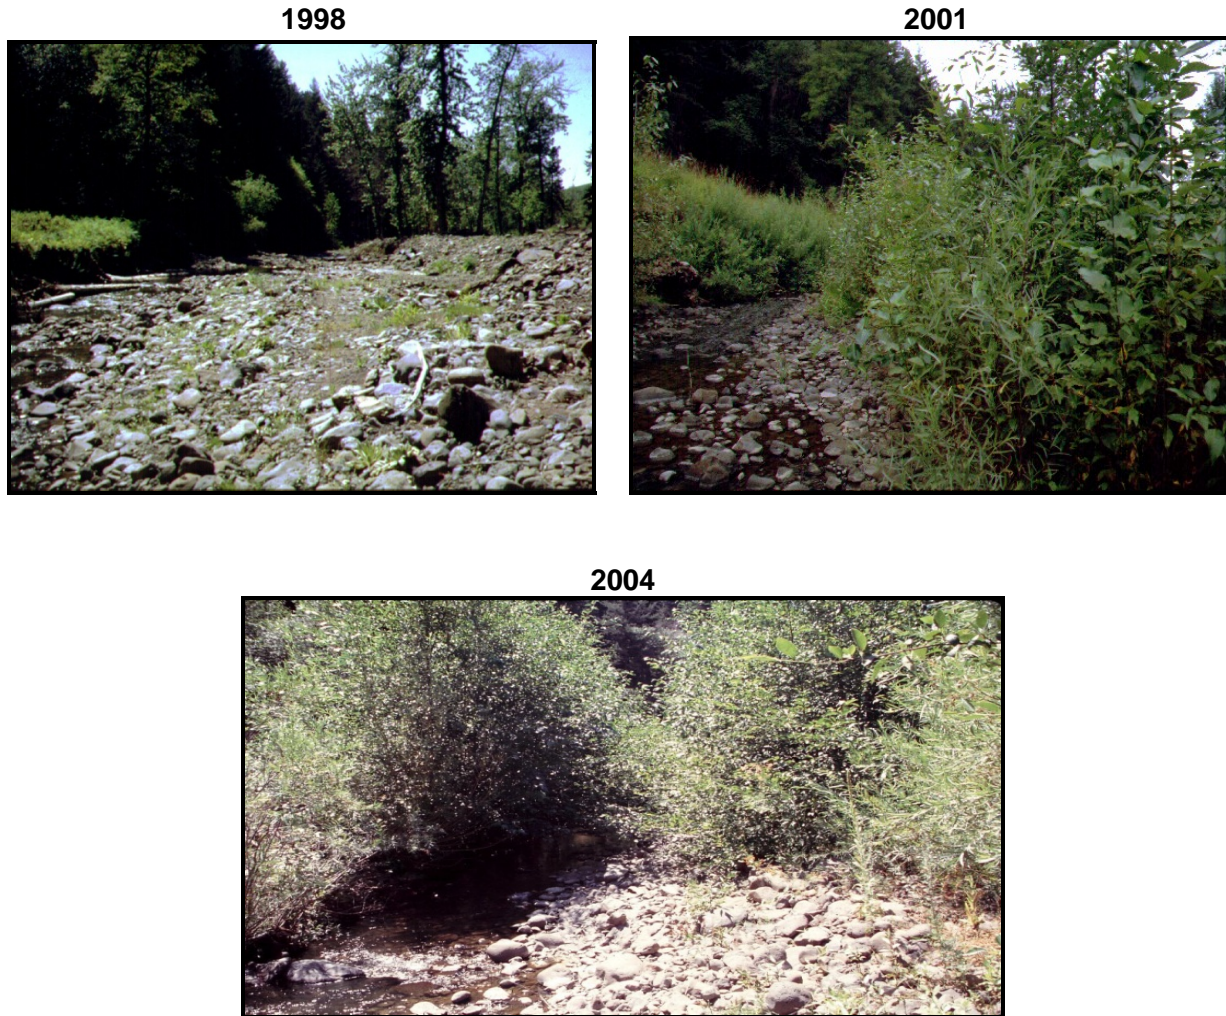
Figure 5: Project photo-points on Blue Creek within the project area collected at the same location in 1998, 2001, and 2004. All of the willows shown above the log structures and within the riparian corridor were placed with the aid of an excavator and stinger in 1998.

In 1997, a 15-year conservation easement was signed with two separate but adjacent landowners. In the fall of 1997, the project installed three log weirs and several rock grade-control structures in an attempt to improve instream habitat conditions, stabilize the stream channel grade and reduce bank erosion. Two of the log weirs ultimately failed because of further changes in the channel grade. The remaining log structure and rock structures are still in place and functioning as designed.

Recovery of riparian vegetation at this site has been excellent. Riparian areas completely devoid of vegetation following the flood of 1996 now contain strong stands of various native trees and shrubs. Stream canopy shade has improved throughout the entire project corridor and active bank erosion has been mostly eliminated. The stream channel remains incised as a result of stream channel work done in 1996 below the project area and a push-up dike on the right bank. This situation prevents access to the floodplain and formation of high-water channels and off-channel habitat. Further results and discussion regarding the Blue Creek Project Area is included in the monitoring section of this report.

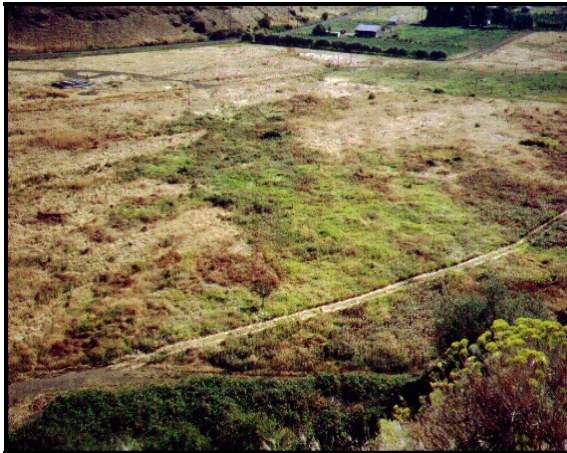
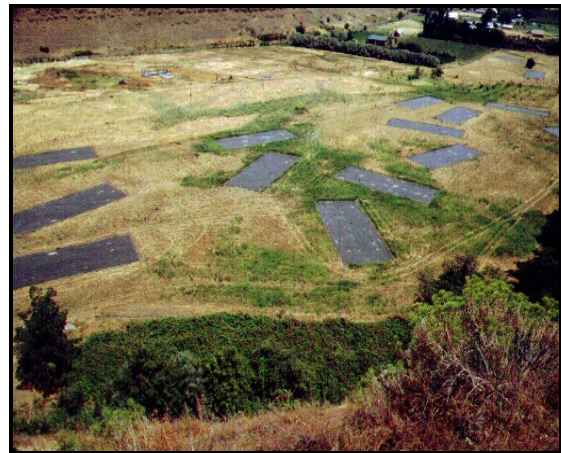
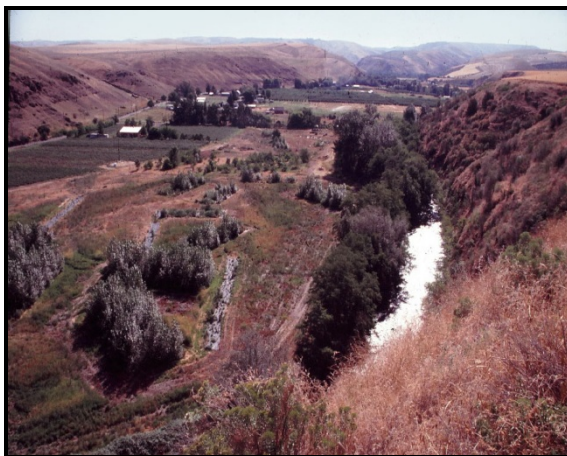
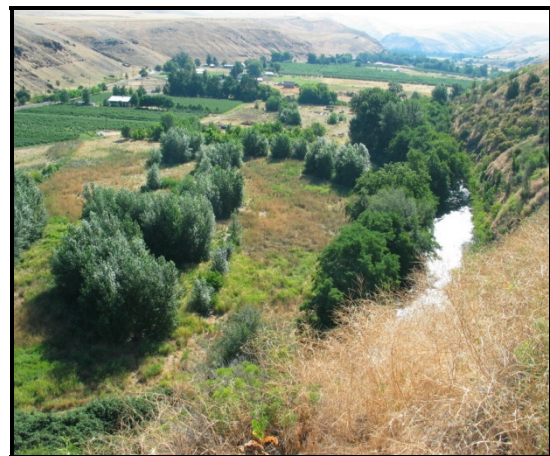
Figure 6: Photo points taken from a ridge over-looking the mainstem Walla Walla River (Lampson) project area in 1998, 2001, 2004 and 2006.

In the spring of 2001, the project installed 36 large (41' x 100') black plastic weed barrier tarps purchased from Layfield Plastics Incorporated of Bellevue, Washington. The tarps are designed to eliminate competitive weeds and aid in the maintenance of soil moisture. Each tarp was secured in place by burying the perimeter with topsoil. Small rocks were also arbitrarily positioned on the tarps as additional protection against high winds. The tarps were placed in a random pattern throughout the 20-acre restoration area in an attempt to mimic the natural succession of a shrub, tree, and grass ecosystem (Figure 6). Each tarp was planted with a compliment of approximately 200 native plants appropriate for the site. Plants were maintained throughout the first and second years with summer watering during the months of June through September. Growth of the trees and shrubs has been outstanding with many of the cottonwood trees exceeding 50 feet in height and 15 inches in diameter at the base. The weed barrier tarps

although designed to decay over a period of five years are still in good condition after seven years of use. We are hoping that with time and the addition of naturally falling plant litter (leaves, branches, etc.) that the tarps will eventually decompose.

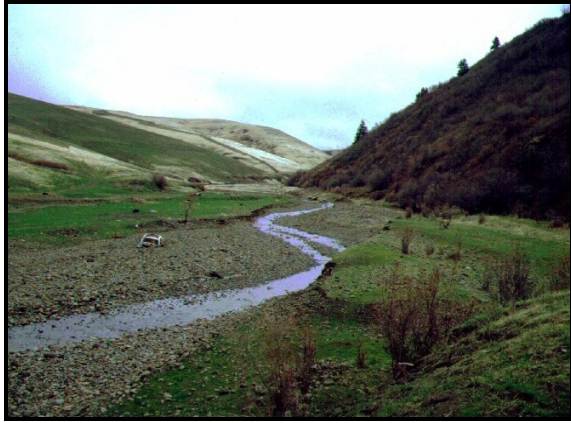
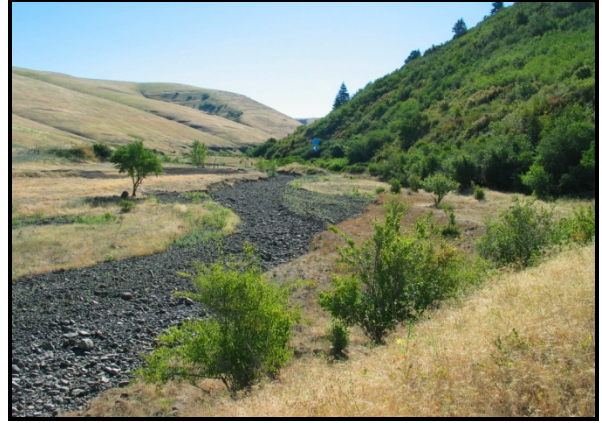
Figure 7: Photo-points taken within the project area on Couse Creek (Hasso) in 1999 and 2006. A century of over-grazing, shallow soils, and summer drought make this restoration site particularly slow to recover. The stream is narrowing, however, and vegetative is slowly recovering.

This area of Couse Creek has been severely over-grazed by livestock for more than 75 years. The upland slopes that were historically dominated by perennial grasses are now mostly comprised of non-native yellow-star thistle (*Centaurea solstitialis*). The riparian and floodplain areas are comprised of sparse stands of annual grasses and a few drought tolerant shrubs. Soils are typically shallow and most of the riparian corridor is comprised of river rock. In recent years, the stream channel has been dry from late June through November. The site is further complicated by prodigious amounts of streambed material following each high water event because of a dramatic change in valley width within the upper reaches of the project area. The floodplain contains a myriad of high flow and abandoned stream channels indicating that the stream has changed its course many times over the last several decades. Summer steelhead spawn within reaches of the project area and juvenile redband trout/steelhead are found when water is present.

Restoring riparian vegetation to this site is particularly challenging because of the extended summer drought, ephemeral flows, and poor soils. As a result, the project has chosen to focus on “passive restoration approaches” including livestock exclusion and self-watering willow cuttings. Several thousand native willow cuttings were collected nearby on the North Fork of the Walla Walla River and trenched in adjacent to the stream with an excavator during the fall of 2000. Survival of the cuttings was higher than 80 percent the following spring but as summer progressed and stream flows eventually ceased many of the plants began to die. By the summer of 2008, approximately 40 percent of the original willows are remaining and we are confident that the plants will begin to multiply. Other plant species including cottonwood trees, hawthorn, rose, and various other species are beginning to reestablish themselves also. We expect that with continued livestock exclusion and time, perhaps decades, the entire riparian corridor will again support a healthy riparian plant community and properly functioning stream channel and floodplain.

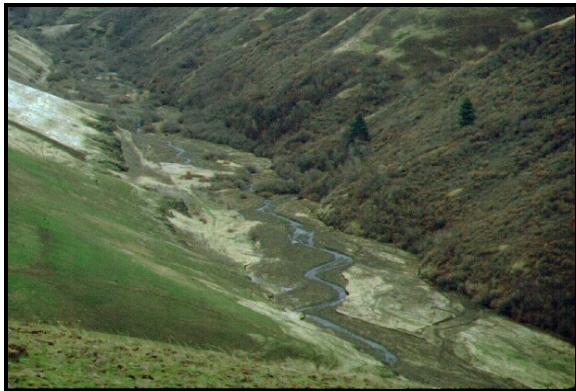
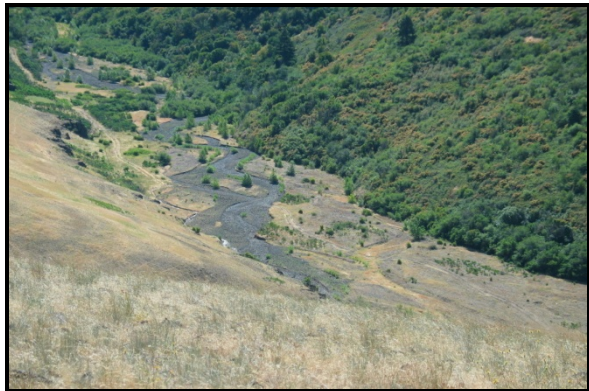
Figure 8: Photo-points taken in 1999 and again in 2006 over-looking the project area on Couse Creek (Hasso).

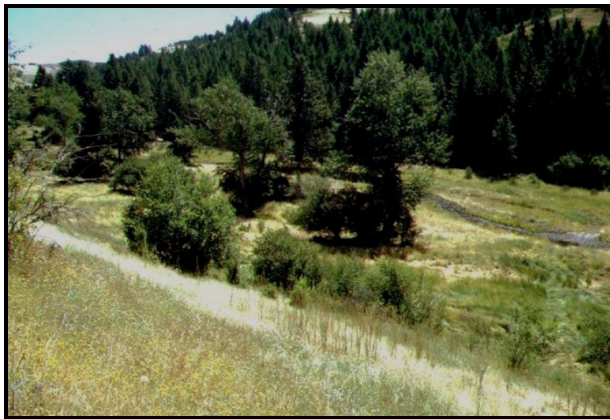
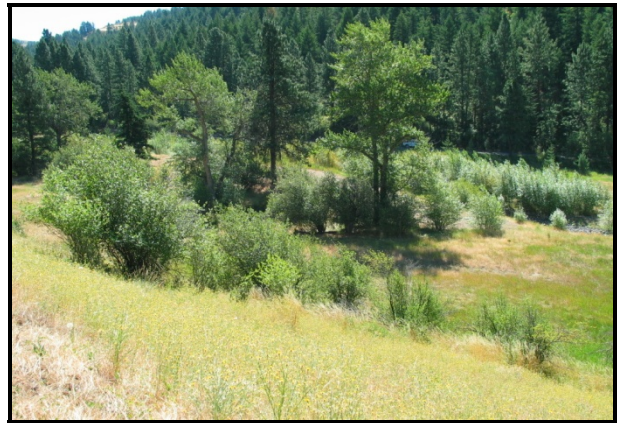
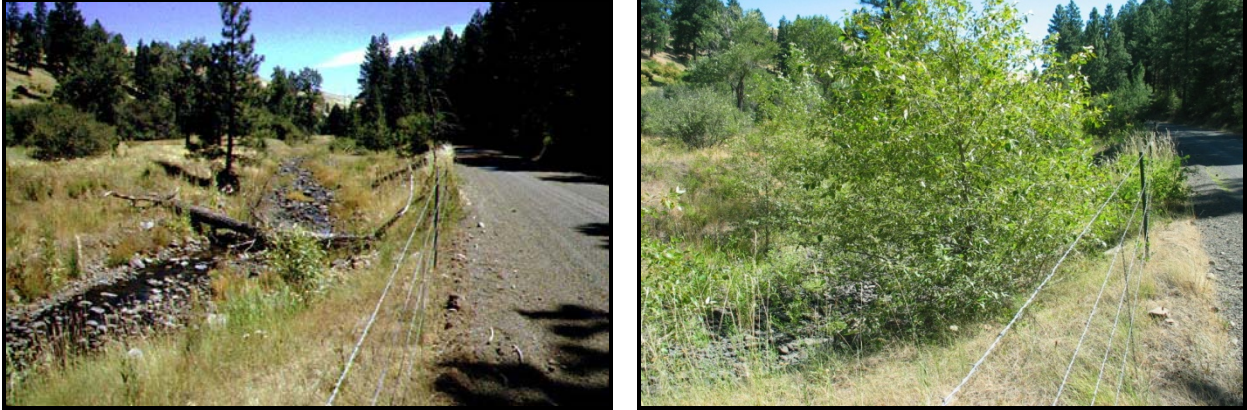
Figure 9: Patit Creek photo points taken in 2000 and repeated in 2006. The willows along the shoreline in the top right photo were planted by the project during instream enhancement activities conducted in 2000.

Noxious weed infestations, particularly yellow star thistle originating on the eastern slopes above the project continue to be a management challenge. Native grasses are being used in an attempt to out-compete unwanted weeds with some success. The project has also hired a contractor to treat the project reach with herbicides in the spring and again in the fall of each year.

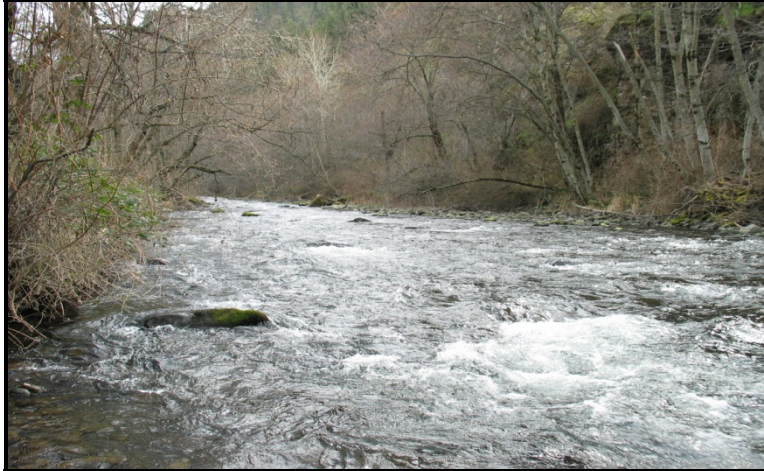
Figure 10: Photo looking upstream on the mainstem Walla Walla River within the property owned by the CTUIR.

In February of 2007, a contract was developed with an area contractor to have approximately 15 acres of former pastureland prepared for seeding. Several large clumps of blackberry were removed and the soil was tilled and seeded with native grasses. The field was treated with broadleaf herbicides in May and November of 2007. In March of 2008, portions of the field were broadcast seeded with native grasses in an attempt to strengthen the grass stand. Broadleaf herbicides were applied in the spring and fall of 2008. The upland field now has a good stand of native grasses but it will take several more years of weed control measures before the grass becomes fully established.

Similar to the Lampson project site, the project will be requesting proposals (RFP) in 2009 for an assessment of site conditions and restoration recommendations from qualified consultants. The products from this effort will increase our understanding of current conditions, provide a better understanding of site potential, assist in the development of strategies for achieving desired future conditions, and direct out-year stream restoration activities. A summary of the assessment and design will be provided in the 2009 annual report of progress.
