WALLA WALLA RIVER BASIN
FISH HABITAT ENHANCEMENT PROJECT
ANNUAL REPORT OF PROGRESS
February 1, 2012-January 31, 2014

Jed Volkman and Jonathan Thompson
Department of Natural Resources, Fisheries Program
Confederated Tribes of the Umatilla Indian Reservation
Pendleton, OR 97801

Project No. 1996-046-01
Contract Numbers: 46692, 53046

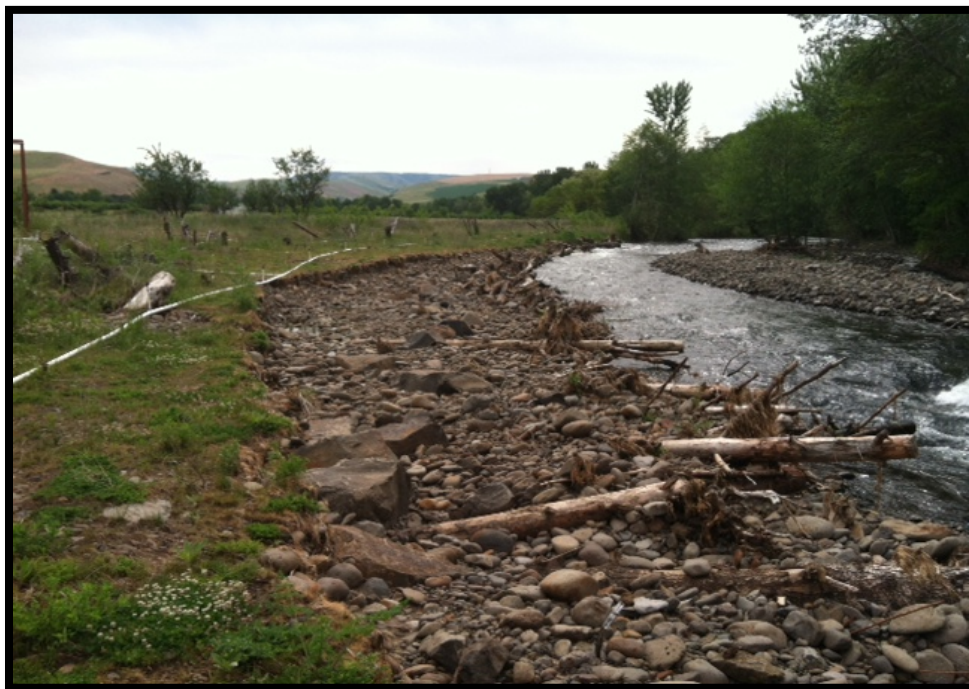
In 2012, the site experienced some unanticipated gravel accumulations at the side channel entrance. Some minor erosion also occurred along the right bank on the upper reach of the project (Figure 4). GeoEngineers was contracted in early 2013 to develop a design for the repairs. Partney Construction of La Grande, Oregon was contracted to provide all construction materials and complete the installation in September of 2013. The eroded section of stream bank was filled with 15 conifer trees with attached root wads, 200 yards of rounded river cobble, 16 large boulders, and 20 yards of topsoil. The trees were pinned to the existing large woody debris with #10 rebar and further secured with large boulders as ballast. River cobbles and topsoil were then spread over the entire surface. Finally, the entire area was seeded with native grass and planted with several hundred native willow cuttings and rooted stock plants obtained from the CTUIR Native Plant Nursery.

Figure 3: Photo looking upstream at eroded section of stream bank within the Lampson Project Area, mainstem Walla Walla River, 2013.

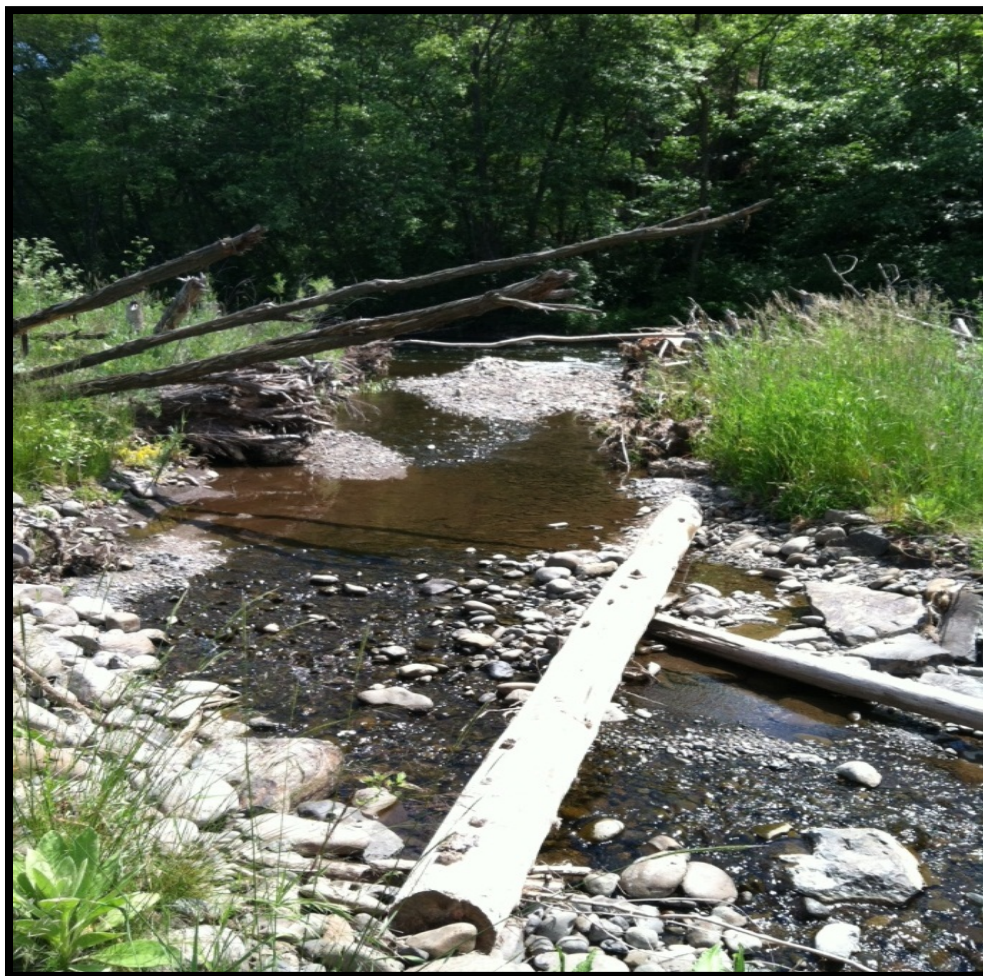
Figure 4: Photo looking upstream toward the side channel entrance, summer 2013. The gravels in the center of the channel were removed to improve surface flows.

At the side channel entrance and extending 20 feet downstream, approximately six yards of river gravels were removed and deposited on the floodplain. Several large boulders were placed at the entrance in an attempt to both narrow and increase flows into the channel. The project intends to continue maintenance of the side channel entrance so long as the repairs are minor. If at some point large accumulations of river gravels obstruct the channel then it may become necessary to reconsider this strategy.

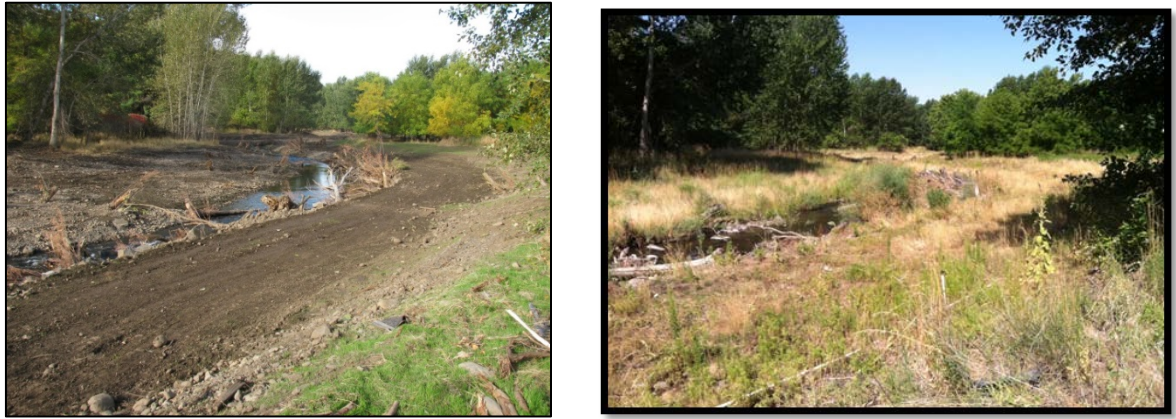
Despite irrigation and weed management, less than 25% of the rooted stock plants survived through 2013. Most of the small native rooted stock plants were out-competed by non-native weeds for space and water. Survival of the willow cuttings, however, has been excellent because of their ability to consistently access ground water.

Figure 5: Looking downstream at the side channel following construction in 2011 left and same location two years later in June of 2013 on the right.

Following construction in 2011, Botanical Developments of Bend, Oregon installed approximately 3000 native rooted stock plants. The plants varied in size but most were less than 20 inches in height. The project also installed several hundred-willow cuttings, which were trenched several feet below the soil surface and into available ground water with an excavator. An irrigation system operated by the landowner provided the new plants with water during the summer months of 2012 and 2013. Casey Farms, LLC, of Walla Walla, Washington, was contracted to chemically treat competing noxious weeds in each of the same years.

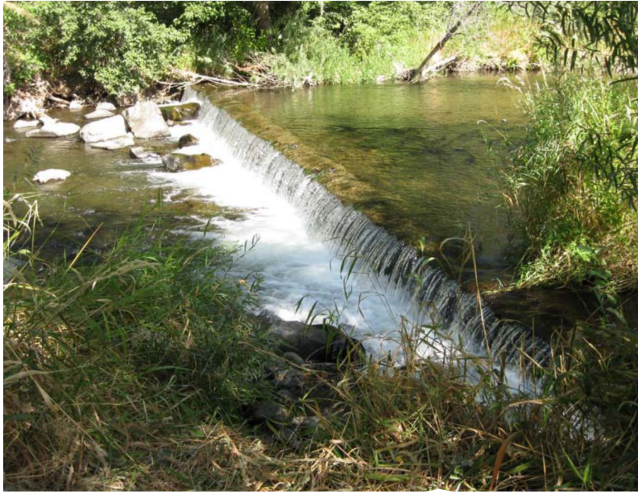
The Walla Walla Basin Watershed Council completed construction of the Smith Diversion Dam Fish Passage project in September 2012. The Smith dam, a grade control sill, is located at river mile 44.9 on the Walla Walla River along the edge of Milton-Freewater. The US Army Corps of Engineers originally built the structure in the 1940s as part of the Milton-Freewater Levee flood protection project. Over the last few years, a three-foot head cut in the riverbed migrated up to the structure, creating a fish passage barrier for redband trout, bull trout, juvenile steelhead, and juvenile Chinook salmon during low flows. There was also concern that if the concrete sill collapsed or was undermined, the toe of the flood protection levee could be exposed and vulnerable to erosion.

This pre construction photo shows the fish passage barrier. The structure was originally built in the 1940s

The project involved temporarily dewatering the work area, cutting an eleven foot wide, one foot deep v- notch into the channel spanning concrete grade control structure and installing a 45 foot long, 110 foot wide "u-shaped", and downward sloping roughened riffle of boulders immediately below the structure to ensure fish passage up to and through the notch. A small rock semi-circular rock structure was installed immediately upstream of the notch to reduce upstream headcutting. A secondary passage route was also improved in a smaller side channel that runs along the base of the levee.

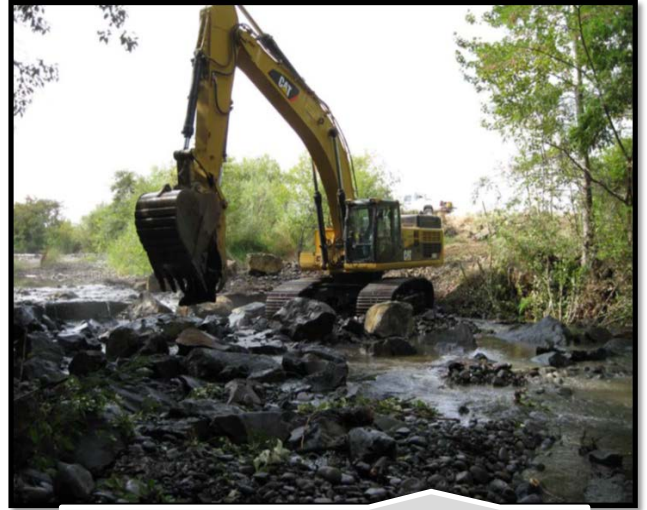
Photo looking upstream during the construction of the roughened channel

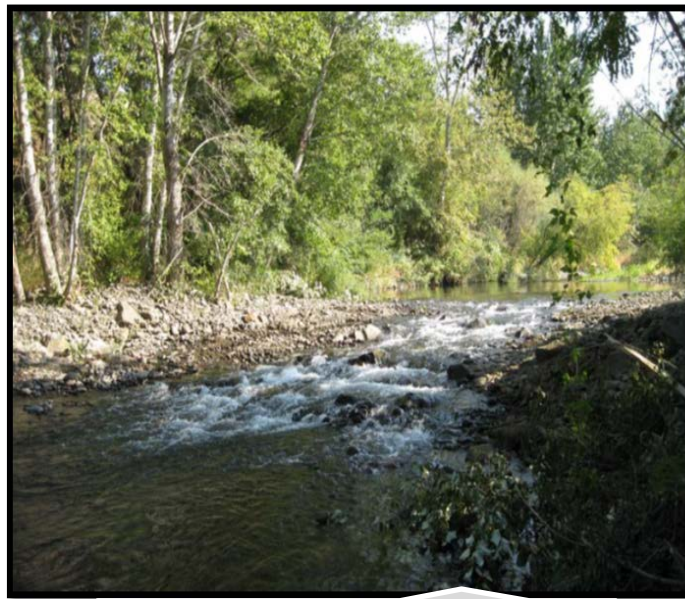
Photo looking upstream at the completed project site. The roughened channel was constructed to maintain a slope that fish can negotiate

Figure 11: Series of photos taken at the Smith Sill Project, mainstem Walla Walla River, 2013.

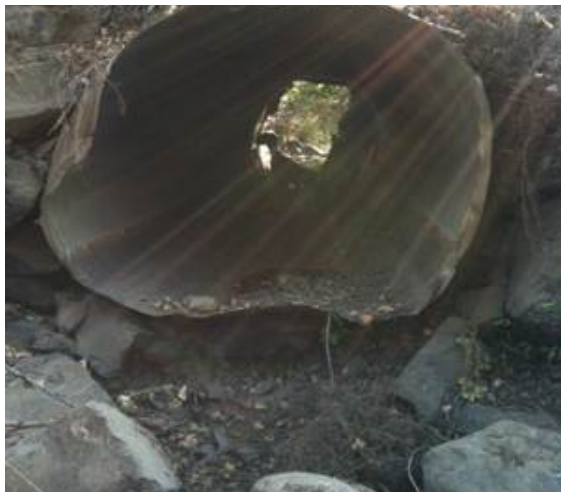
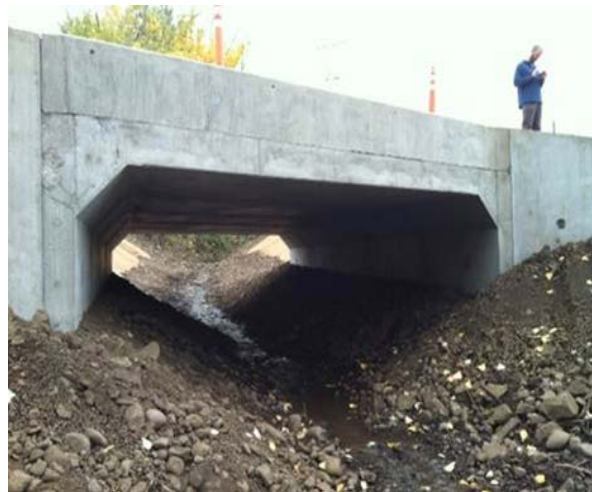
Couse Creek is a tributary to the Walla Walla River just east of Milton Freewater, Oregon. This small stream contains healthy populations of resident native trout and summer steelhead that ascend the stream each spring to spawn. Near RM 3 on Couse Creek is a large rock quarry and at the entrance of the quarry is a bridge crossing Couse Creek. The bridge was constructed over the top of a six-foot culvert that was 32 feet in length and 6 feet in diameter. The culvert was undersized for the stream flow, too steep, failing structurally, and perched approximately 2 feet above the water surface at the downstream end creating a fish passage barrier.

Figure 12: Looking upstream at the pre-project perched culvert on the left and finished project bridge on the right.

In 2011, the project hired Anderson Perry of Walla Walla, Washington to develop a fish friendly design improvement for the bridge crossing. Because the bridge is located at the entrance of a working rock quarry, it was designed to withstand a gross vehicle weight of 120,000 pounds, the heaviest anticipated rock crusher; the project implementation also had to maintain full access to the quarry during the entire construction period. In 2012, the project secured all necessary environmental permits and retained Royse Hydroseeding and Excavating of Walla Walla, Washington to complete the construction work. All construction work was done in a dry stream channel during the months of August-October, 2012. Post project, disturbed areas of the stream were planted with several hundred willow cuttings to reduce future bank erosion.
