WALLA WALLA RIVER BASIN
FISH HABITAT ENHANCEMENT PROJECT

Project No. 1996-046-01
Contract Numbers: 46692, 53046

ANNUAL REPORT OF PROGRESS
February 1, 2014-January 31, 2015

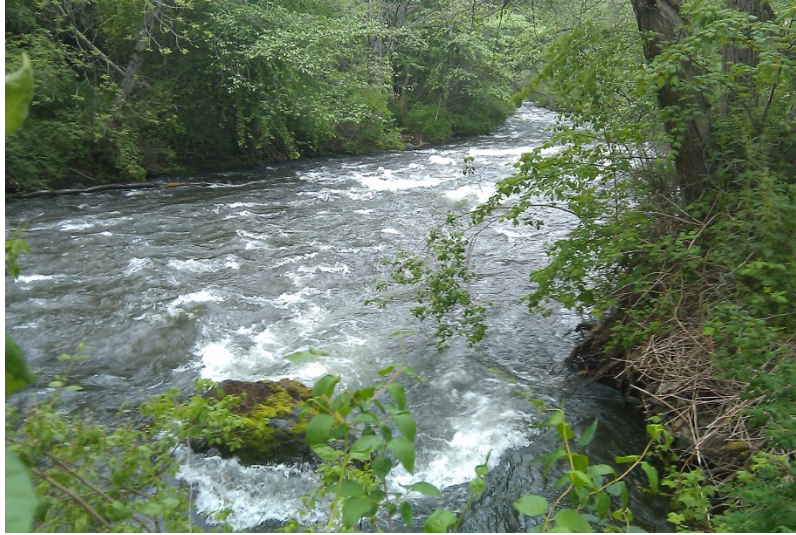
Figure 3: Looking downstream within the Kentch Project reach in June of 2011.

Within the Kentch property boundary, the South Fork Walla Walla River is a single thread, straightened channel with very low sinuosity. Over the entire project reach, the channel flows remain along the left side of the valley floor, which is fortified by a low elevation levee along the right bank. The channel is entirely disconnected from the floodplain and exhibits a narrow riparian corridor adjacent to the active channel. Pre-project habitat surveys determined that the channel has an average bankfull width of 67 feet. Nearly 87% of the stream channel is riffle habitat, 12% run habitat, and less than 1% pool habitat. Only two primary pools were found in 0.75 stream miles. Approximately 36% of the channel was determined to be either “good or fair” for spring chinook spawning but this is compromised by the lack of pool habitat and cover. At all flows, more than 99% of the stream channel is considered “poor” habitat for juveniles primarily because of high velocities and lack of channel complexity. What little juvenile habitat is present can only be found in the pool areas and along the stream margins during low flows.

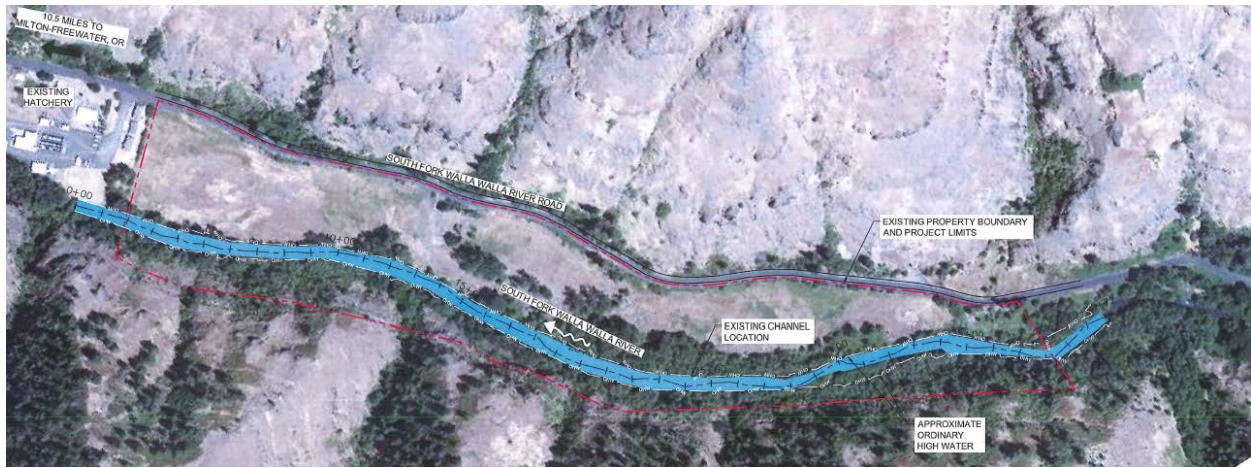
Figure 4: Existing site condition shown in the top photo and proposed condition shown below.

Parameter	Existing Condition	Proposed Condition
Side Channel Length (ft)	156	3,500
Sinuosity	1.07	1.36
Bankfull Width (ft)	67.7	44.6
Mean Riffle Depth (ft)	2.2	2.2
Cross Sectional Area (ft ²)	155	91
Width/Depth Ratio	32.8	20.0
Radius of Curvature* (ft)	2,200	155
Flood Prone Width (exclusive of berm sections) (ft)	150	180
Entrenchment Ratio	2.4 (Avg.)	3.3
Meander Belt Width (ft)	0	300
Meander Width Ratio	0	6
Meander Length (ft)	0	429
No. of Pools	2	11
Riffle Bed Material D ₈₄ (mm)	201	195

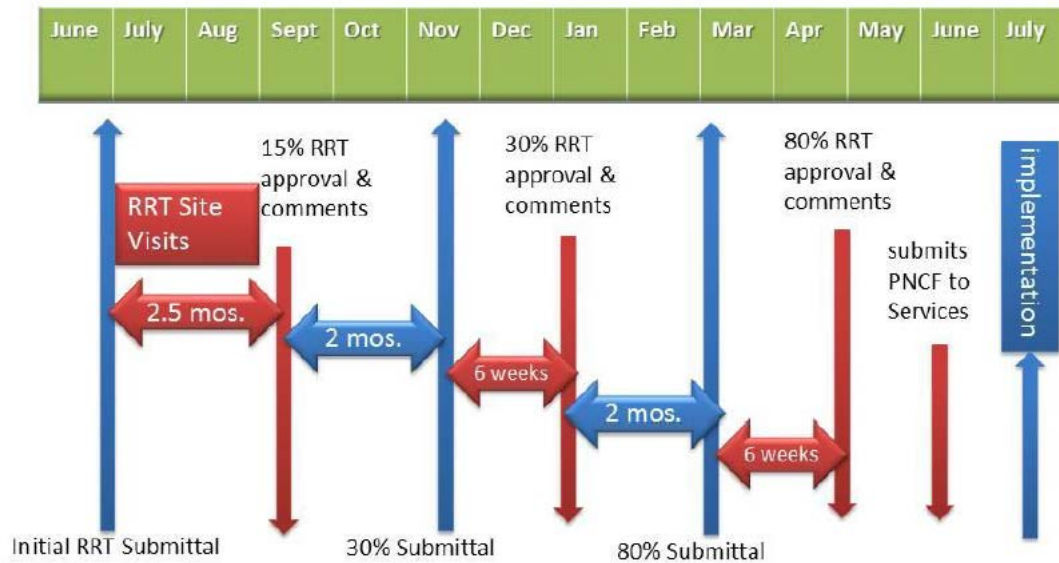
RRT Process Timeline for High Risk Projects

*Blue indicates project sponsor action, red indicates BPA RRT action.

The overall timeline was close to the diagram below from the HIP3 review handbook for the stepwise review of high risk projects, though final approval of the updated Monitoring and Adaptive Management Plan is still pending as of the time of this writing. As described below under the construction section, design alterations during Phase One construction were routed to the RRT for review and feedback was immediate, providing both helpful and timely input during construction.

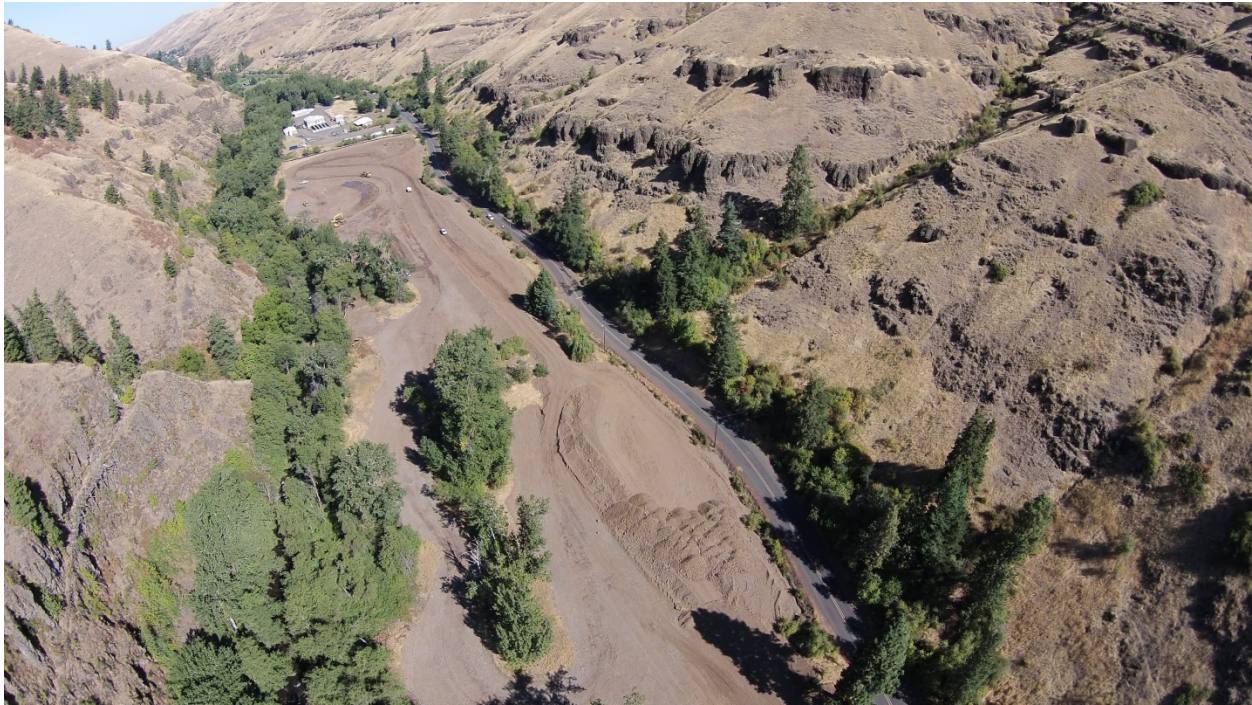
Figure 8: Aerial image of Kentch construction.

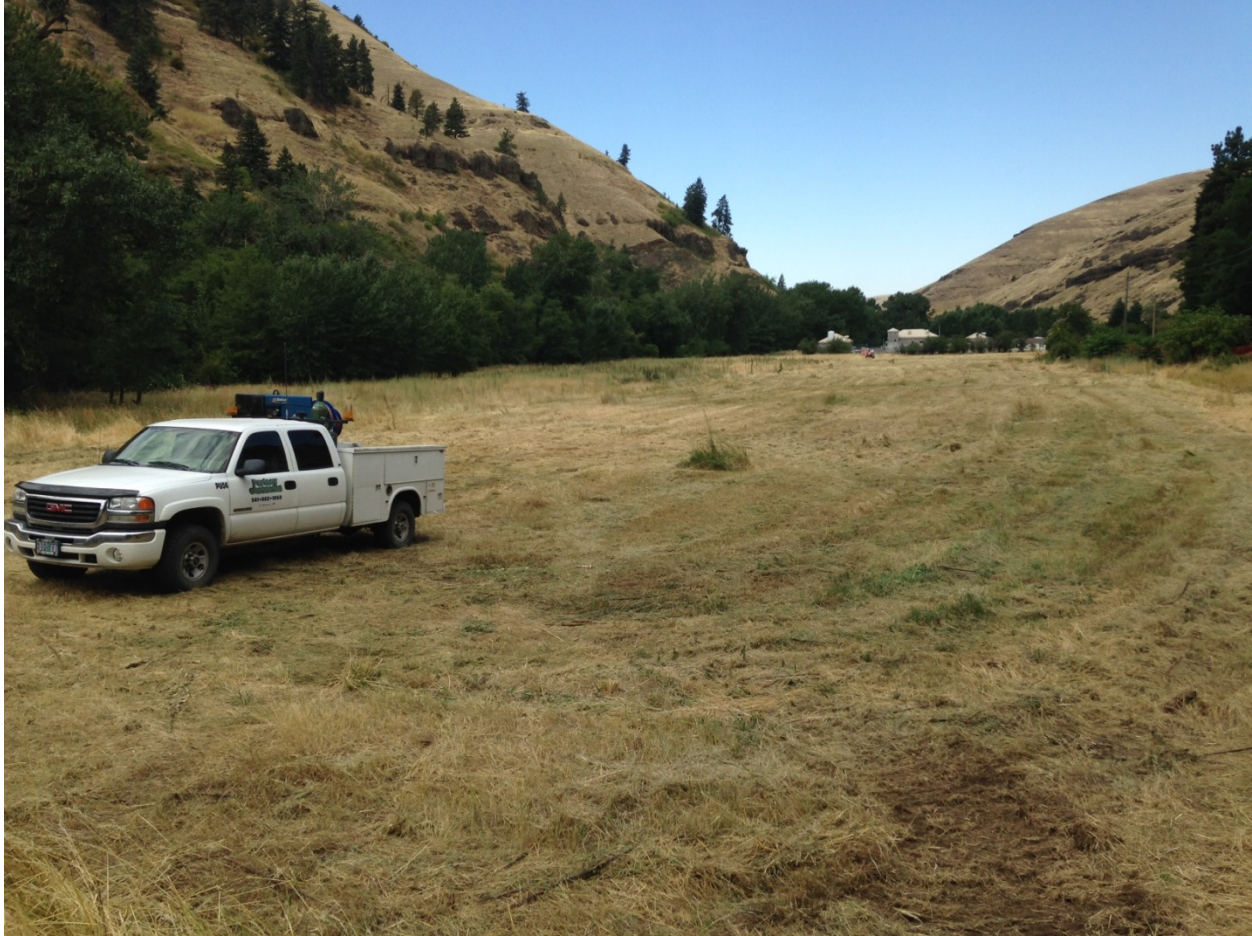
Figure 9: Kentch site on first day of construction, looking towards the hatchery.

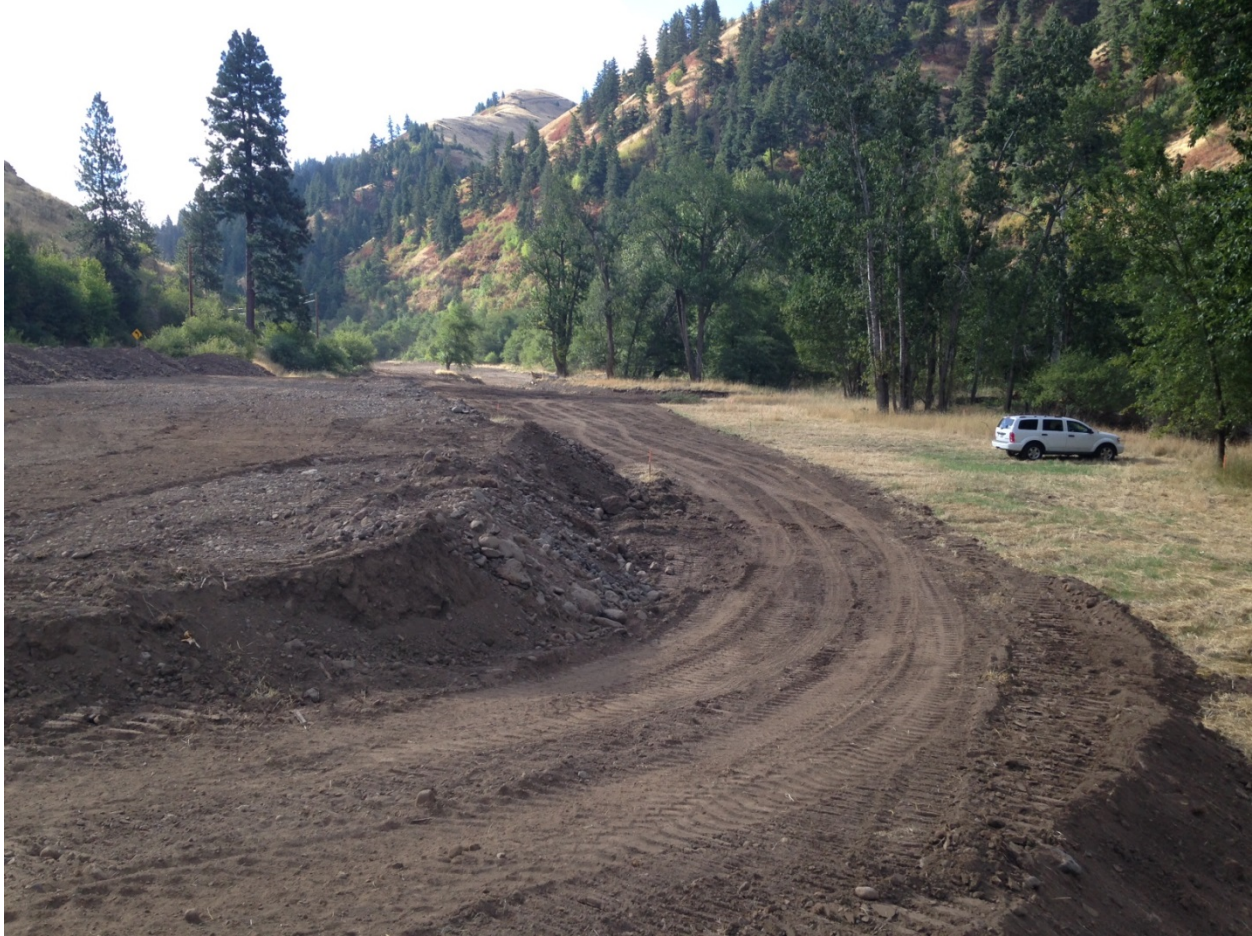
Figure 9: Kentch construction looking upstream

Construction proceeded smoothly according to plan and without significant incident. No change orders were generated nor were changed or unanticipated conditions encountered. Work predominantly proceeded from the downstream end of the project in an upstream direction, though because of necessary coordination with Cultural Resources it was necessary to leapfrog past the monitored area and then return when cultural monitoring staff were available. Mass excavation of the floodplain and channels occurred first, followed by installation of rock and wood structures. After final excavation work completed and the weather was cold enough for plant dormancy, approximately 35,000 willows were trenched and stung across all exposed floodplain and bank areas. The final action was the seeding of approximately 16 acres of exposed area using an NRCS-suggested mix of native grass seed.

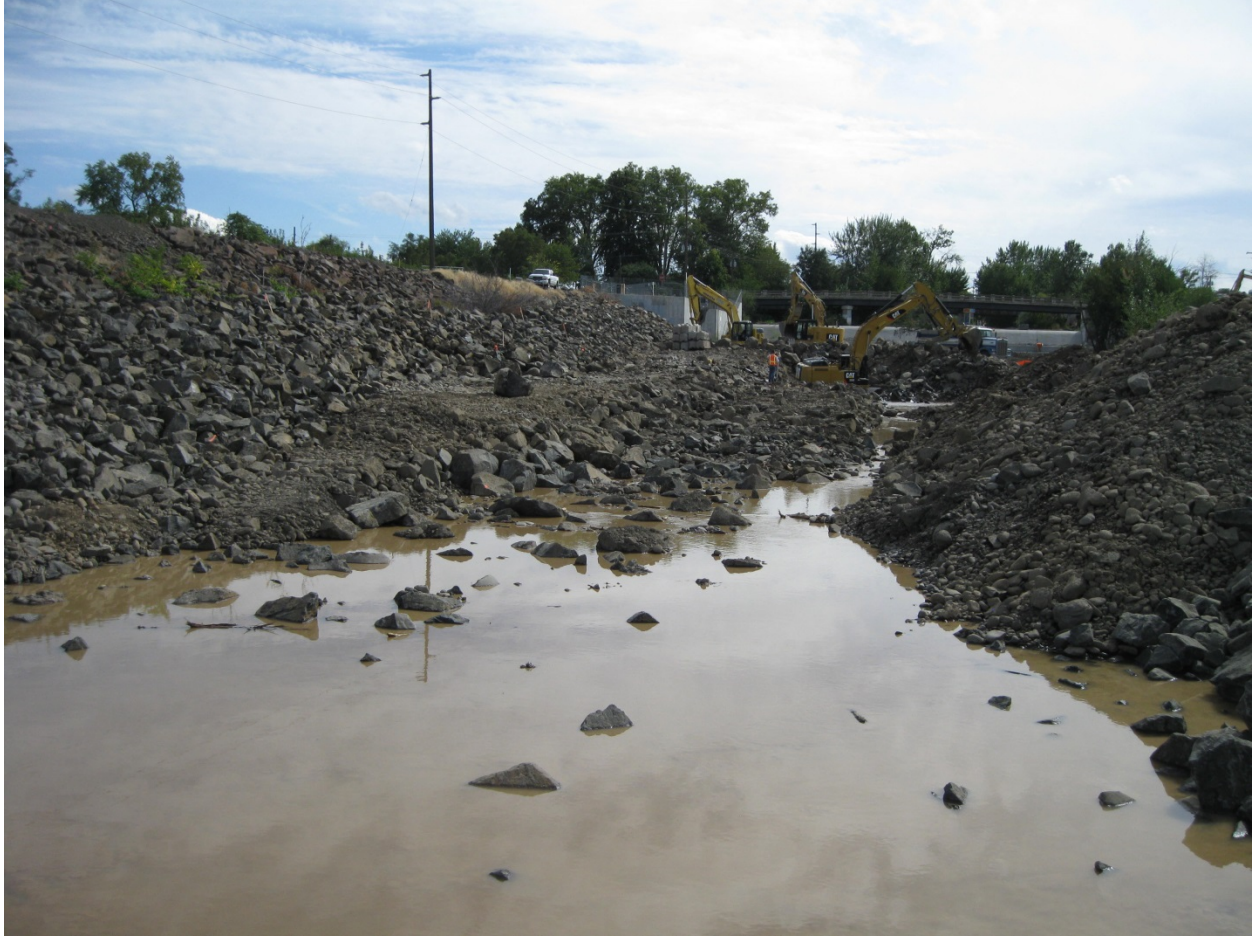
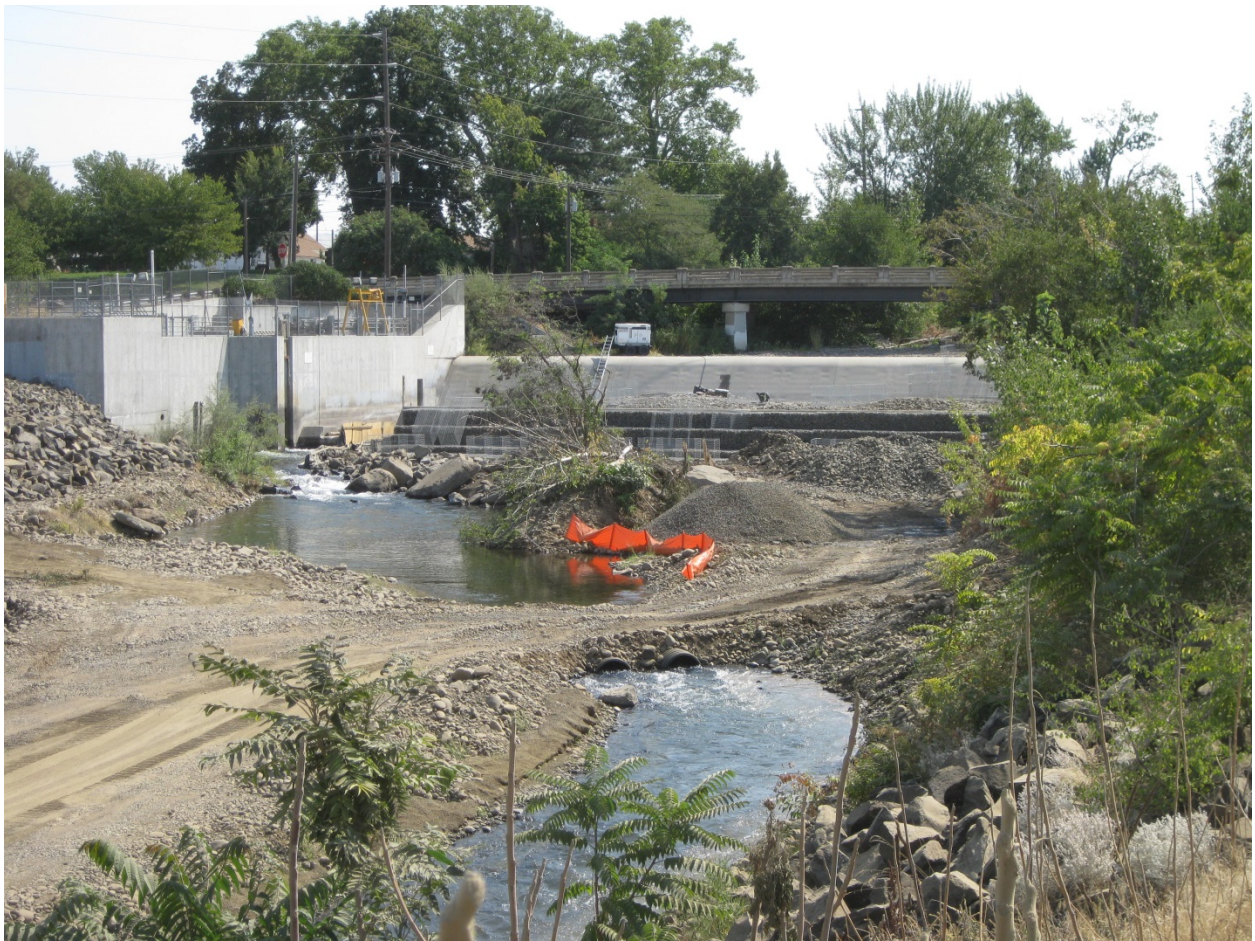
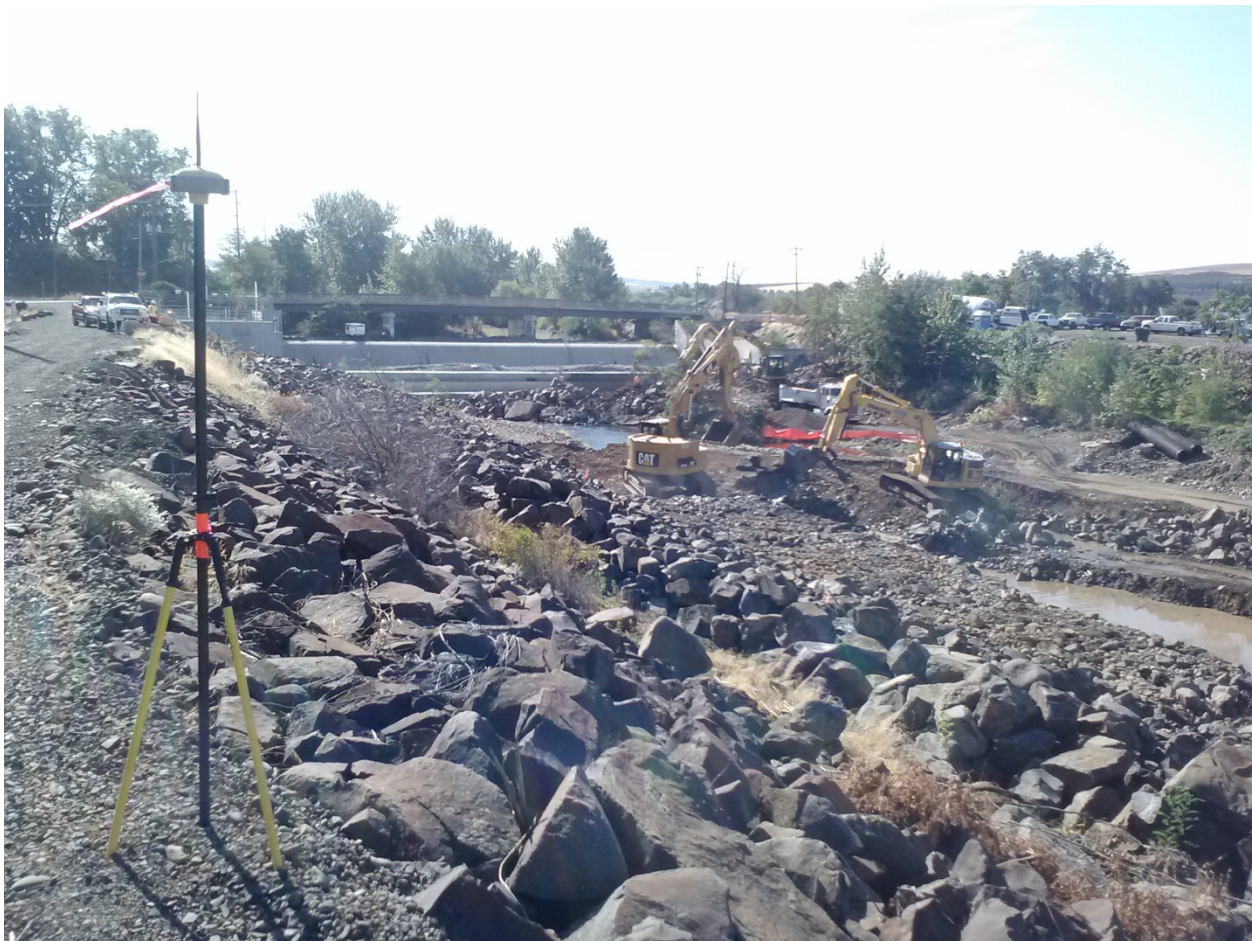
Figures 20-22: Nursery Bridge construction

Following a competitive bidding process, Partney Construction was selected as the highest qualified contractor. Work commenced on September 22, 2014, and was completed ahead of schedule. One change order was required to address conditions different from the designed state, due in part to the two other projects proceeding in the same reach that summer. Fish salvage and handling was provided by CTUIR and ODFW, with assistance from WWBWC. The full construction report will be provided by the Walla Walla Basin Watershed Council, but example construction photos are below:
