Couse Creek Watershed

Assessment and Action Plan

2020

Walla Walla Basin Watershed Council

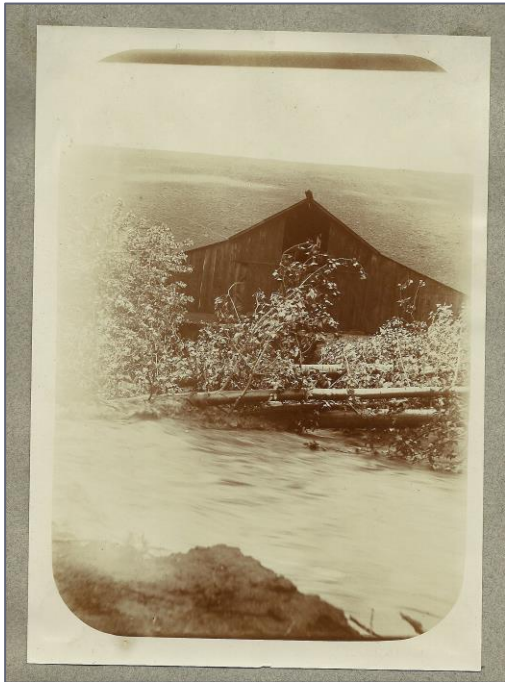
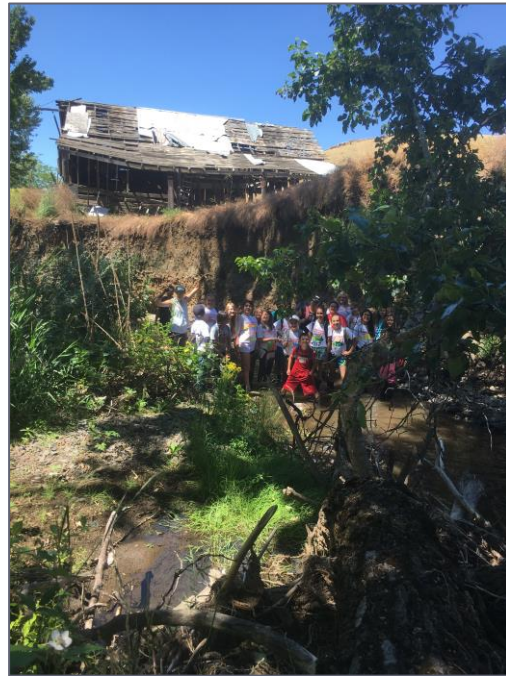
Figure 8. Barn next to Couse Creek in the early 1900s (left). Same barn in June 2017; Couse Creek located behind children. Cut bank just past Couse Creek indicates amount of channel incision (right).

Portions of the channel are incised (Figure 8). A few banks have been artificially armored to prevent erosion and subsequent damage to structures or working lands. In some locations, flows are ephemeral during summer months with pocket water sections providing habitat in some reaches.

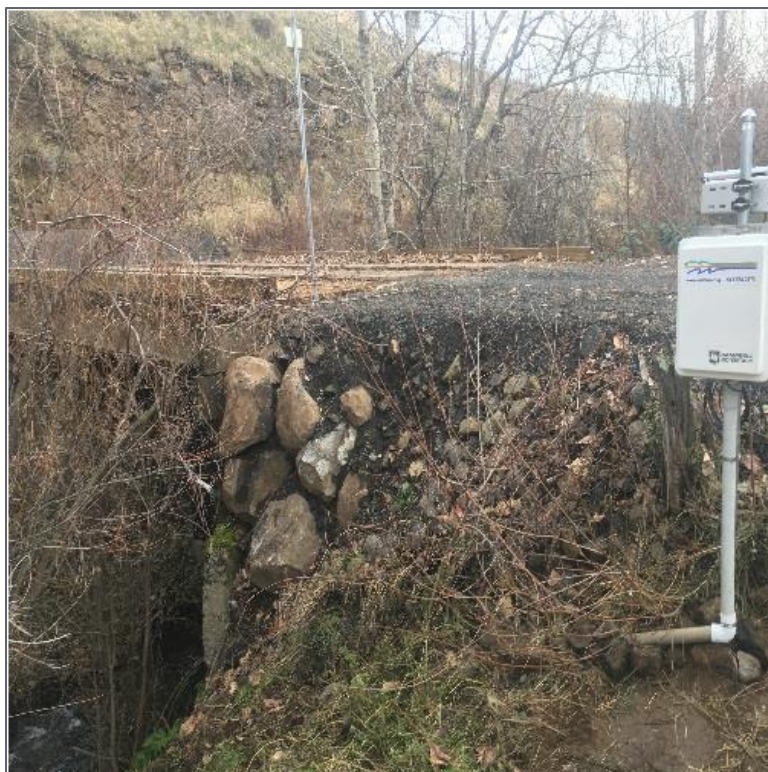
Figure 14. Map below showing Couse Creek flow monitoring locations at RM 1.1 and Blue Mountain Station Road (RM 3.2). Photo (right) showing water level monitoring equipment (equipment box, conduit, pressure transducer (circled)) installed at RM 3.2.

- Landowners at two locations agreed to the installation of streamflow monitoring equipment on their property, like the setup shown below at RM 1.1.
- Landowners at seven additional locations granted permission for summertime water temperature monitoring on their property.

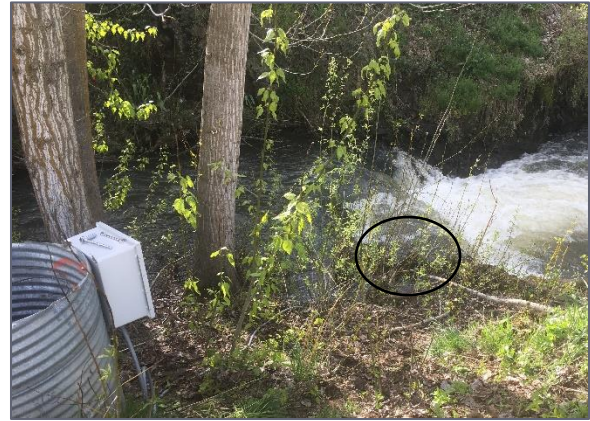
Flows in Couse Creek are dominated by prolonged periods of high flow pulses and low flows, suggesting a mixed rain and snow driven hydrology supplemented by groundwater inputs during the summer and fall. Flow data obtained during the 2018-2019 assessment project were collected at RM1.1 and RM 3.2 (Figure 14).

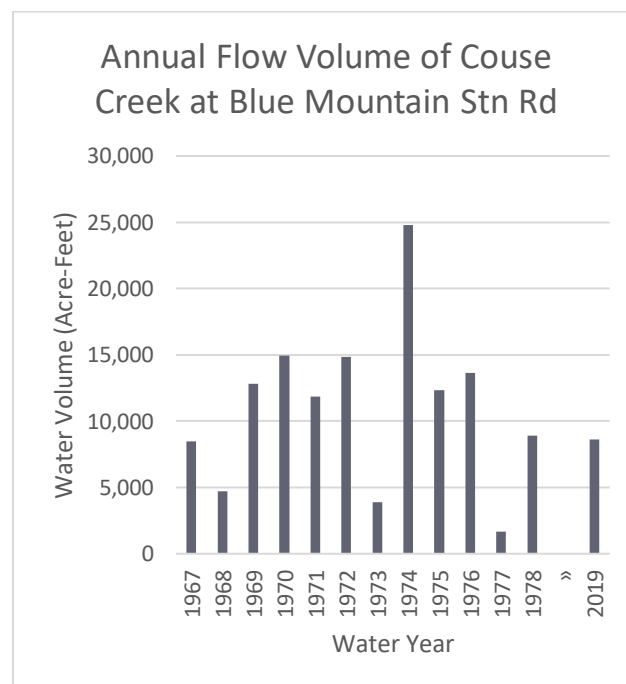
Figure 18. Annual flow volume at Blue Mountain Station Rd gage from 1966-1977 and during the recent watershed assessment. The 2019 value represents a composite dataset calculated from median of daily mean flow values produced during 2018-2020.

To obtain yearly total volume, each day's average flow in cfs is multiplied by 1.983 to convert to acre-feet per day. Within the historical dataset, the mean annual flow was 14.7 cfs. The total flow volume varied widely with a low of 1,662 AF in WY 1977 and a high of 24,767 AF in WY 1974. From the composite data set collected at Blue Mountain Station Road from 2018-2020, we calculated an annual flow volume of 8,620 AF (Figure 18). Although the current flow volume falls within the range of historic volumes, it is less than the 1967-78 average annual flow volume of 11,270 AF/year. Annual precipitation during the recent period was notably lower than the annual historical average.

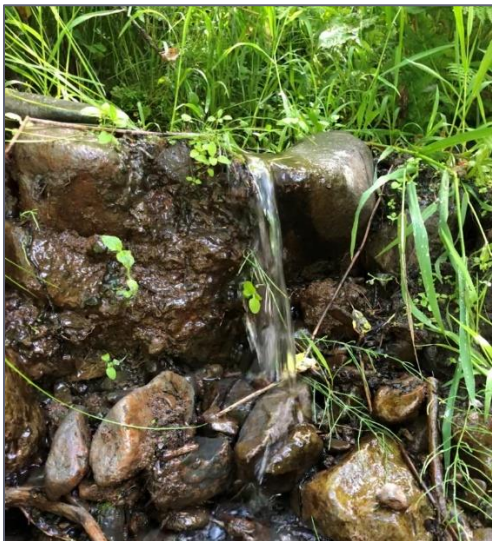
Figure 20. Groundwater flowing into Couse Creek in Reach 5; taken July 16, 2019 at the “elbow”.

Water temperature monitoring data, manual flow measurements, conductivity measurements, and observations during the instream fish habitat survey suggest that groundwater inputs play a significant role in Couse Creek hydrology, particularly during the low flow season (Figure 20).

Year-round flow was documented in reaches 3-6, and several springs were observed during the stream survey in June and July (Figure 20 shows one example). Several manual flow measurements were conducted during the summers of 2018 and 2019 to evaluate longitudinal trends. Table 5 shows a summary of results.

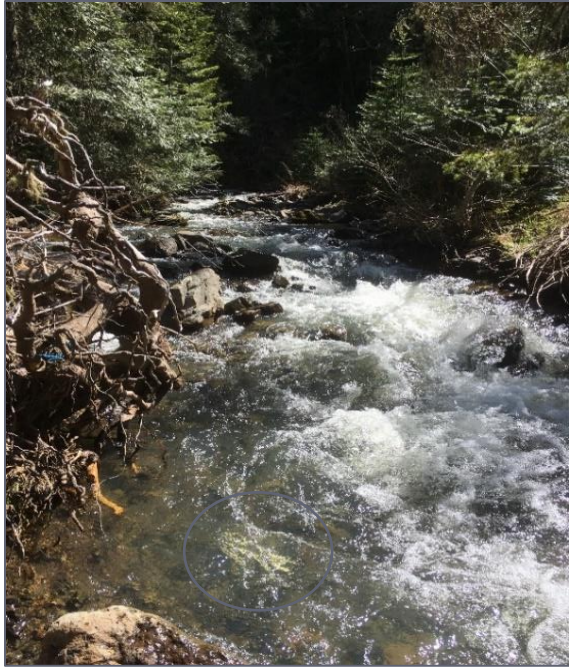
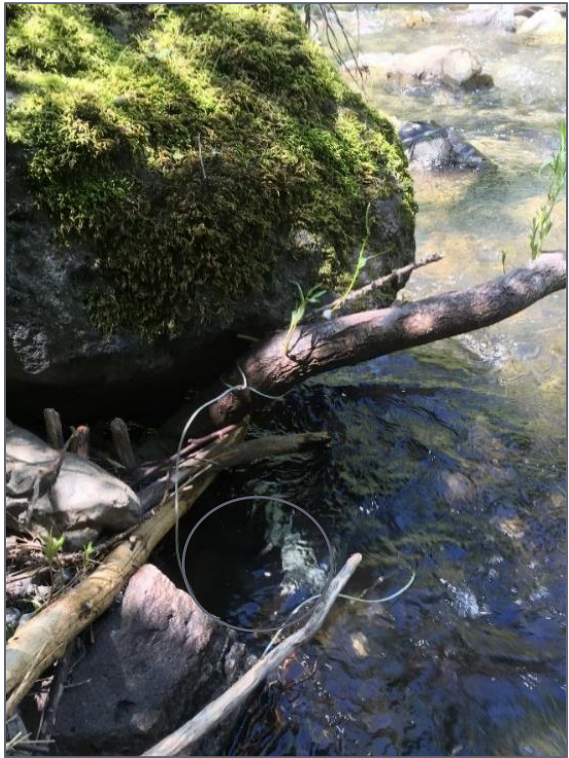
Figure 23. Water temperature sensors deployed at RM 13.8 (top) and RM 12.4 (bottom). White circles indicate sensor location. Sensors were anchored to nearby roots or branches with cable and housed in pvc tubes for protection and to block solar radiation.

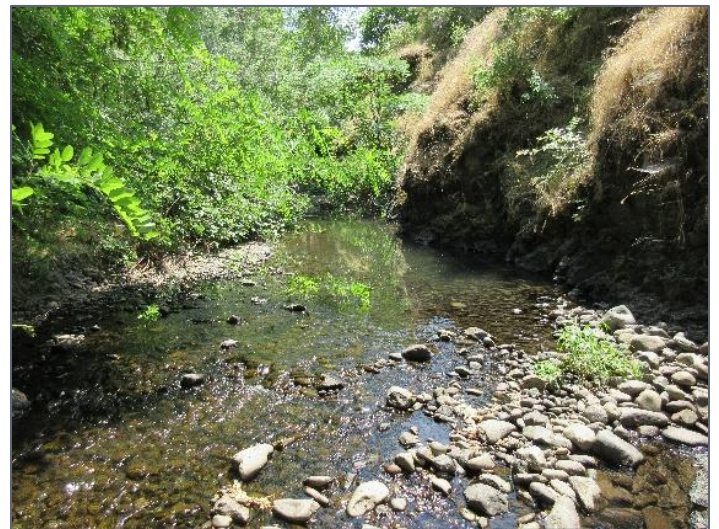
Reach 1 conditions

Reach 1 began at the confluence with the Walla Walla River and continued upstream for 3.1 miles (4982 m). Typical conditions in Reach 1 include a single channel bordered by a wall of vegetation or a steep hillslope (sometimes exposed basalt), giving the surveyors the impression of walking through a long narrow tunnel with occasional glimpse of open sky. The channel was constrained by terraces within a wide valley. Land use is primarily rural residential and farm land yet few homes or barns were visible from the stream corridor due to dense vegetation and steep hillslopes.

Many debris jams were observed, and most instream woody debris was too small to qualify according to the survey methods. The numerous cut banks were usually vertical, not undercut. Near the end of the reach, at unit 105, the canopy disappeared. A large spring or tributary inflow entered the stream from the right bank at the end of the reach. Out of 28 recorded debris jams, 22 occurred in Reach 1. Very few benthic invertebrates were initially observed when picking up rocks for the substrate characterization but numbers increased farther up the reach.

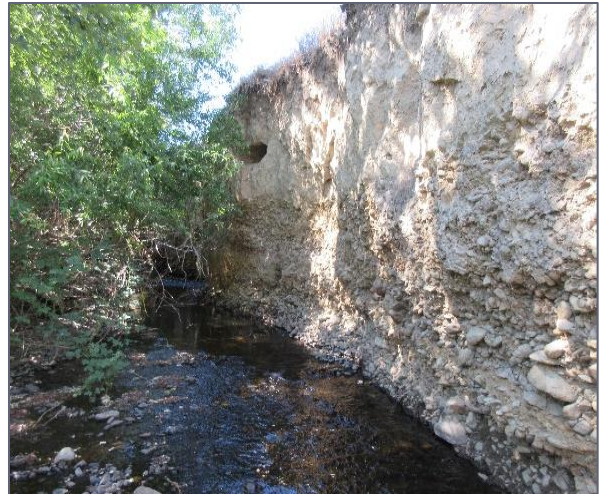
Photos Top: Cut bank example

Middle: Unit 2 looking upstream at the logjam (left) and looking downstream from above the jam (right)

Bottom: Unit 57 looking upstream at the jam (left) and sediment accumulated upstream of the jam (right)

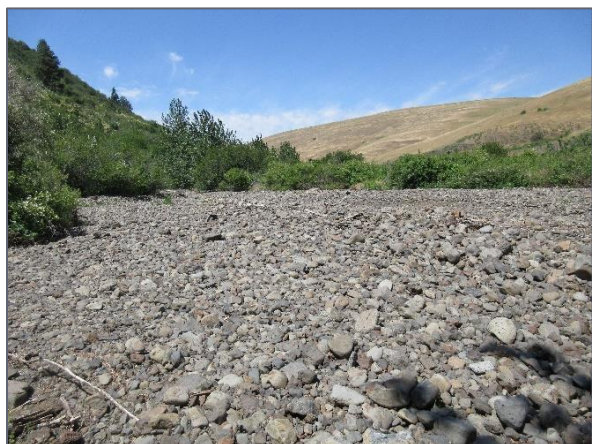
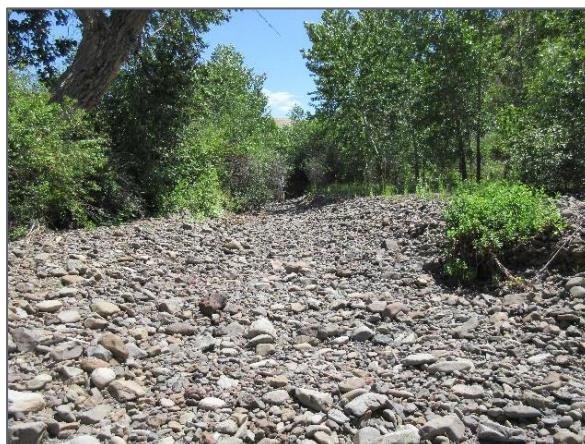
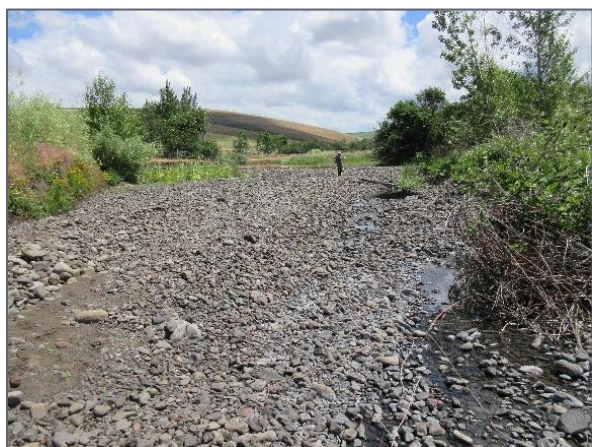
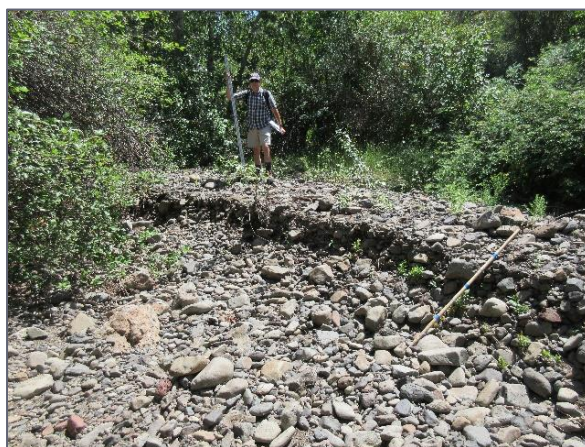
Landowners remember the area being dramatically changed during the high flow events of 1964 and 1996. One account includes the scouring of “all the black soil in the meadows” and deposition of “much rock” during the 1964 event.

The four images above illustrate the extensive gravel and cobble deposits in the middle portion of Reach 2.

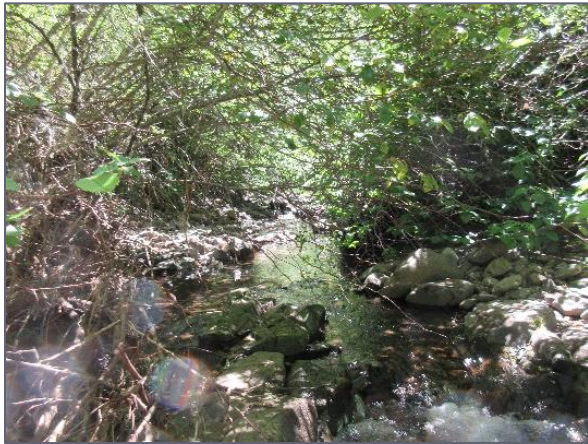
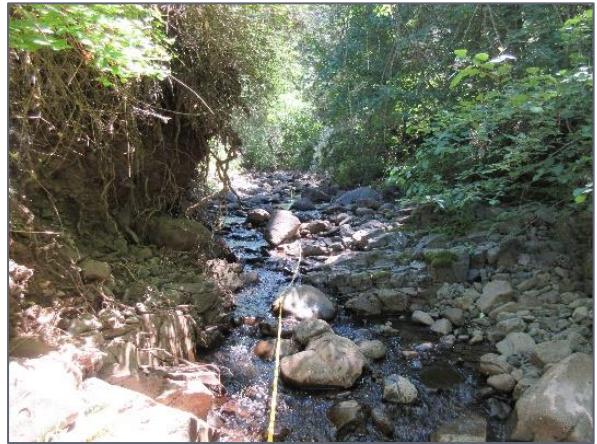
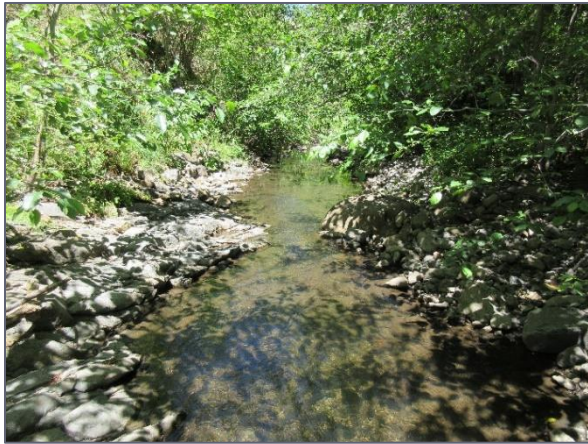
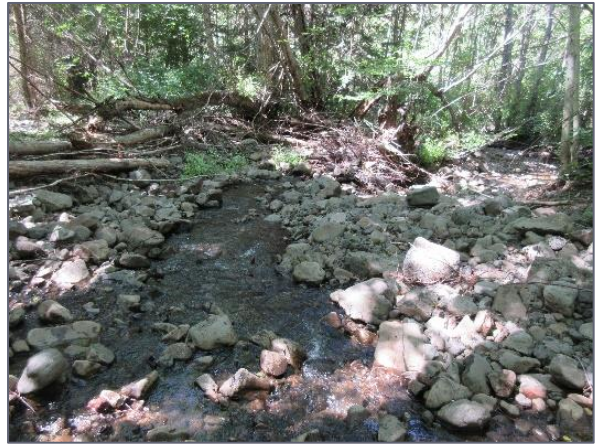
Only 15% of this reach was surveyed, so conditions are mostly unknown. In the surveyed portion, however, canopy cover increased, the channel narrowed and had shallow sloping banks. The stream was mostly shaded due to dense riparian vegetation. Substrate contained an increasing proportion of larger sized

material and was somewhat embedded, in contrast to the highly disordered substrate in Reach 2. The gradient increased and several pool-like units were observed that were not classified as pools due to the velocity of water moving through them. Several juveniles and one 8" fish were observed in these pool-like habitats.

The four images above were taken in Reach 3.

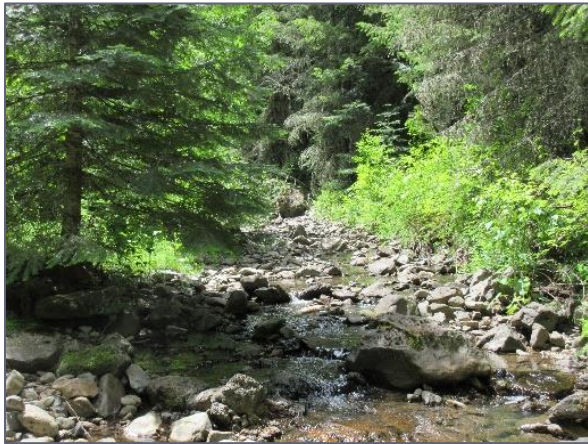
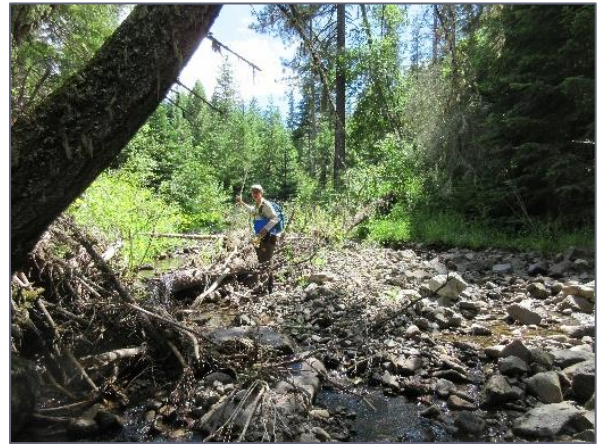
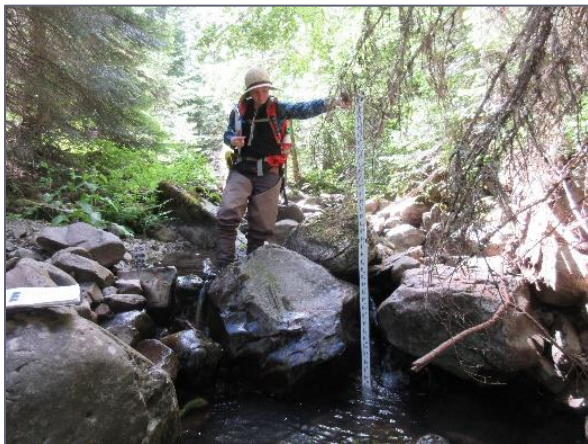
The lower 25% of Reach 4 was surveyed and observations suggest a transition to a montane environment. Couse Creek flows through a narrow valley with steep hillslopes, a steeper channel gradient, larger substrate, and varying canopy closure but often only a narrow opening was present. The riparian area was

dominated by fir trees instead of deciduous. A crayfish was observed but not as many juvenile fish were apparent compared to Reach 3. Water temperature monitoring data from this reach indicated the continuous presence of water during the summer of 2018 and intermittent dry periods during summer 2019.

These images show the conditions present in Reach 4.

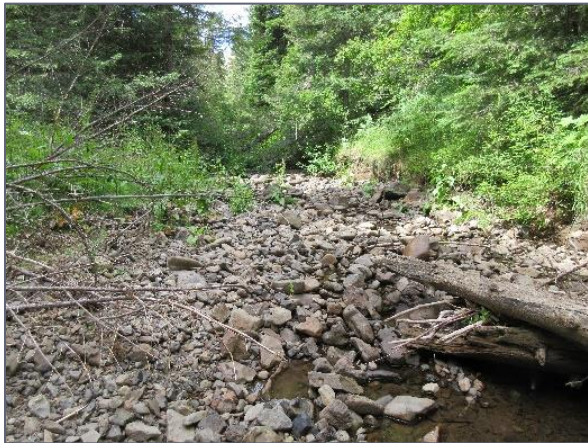
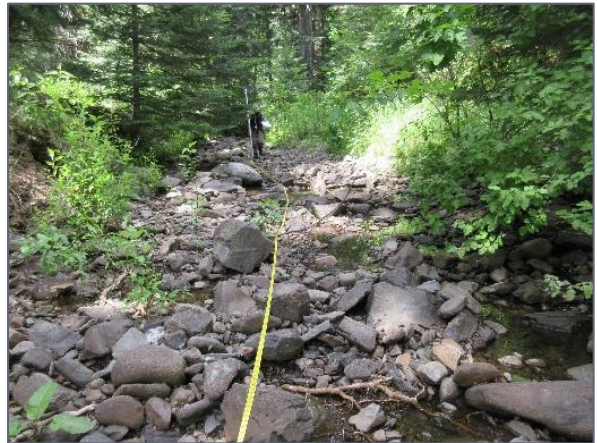
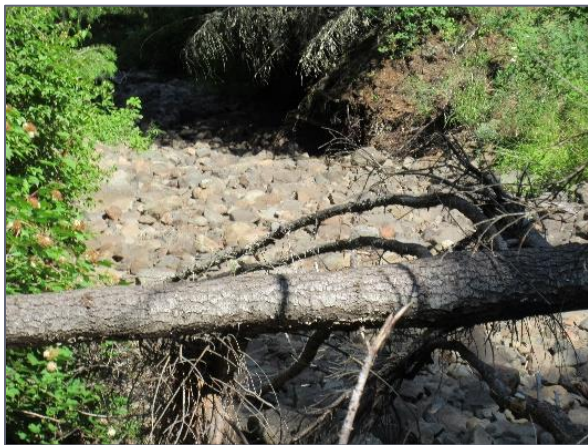
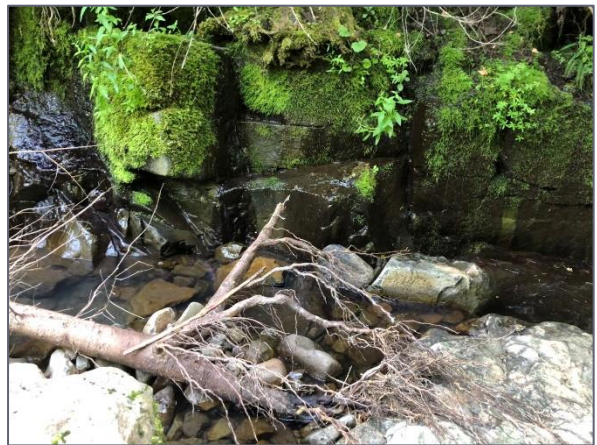
We surveyed about 30% of the lower portion of Reach 5, which is largely owned by a timber company. Observations include decreased flow, increased substrate size compared to Reach 4, narrow opening of canopy, and generally the floodprone width equaled the valley width. Flow in Reach 5 included both dry and flowing units. The change in flow was dramatic near the lower end of the reach, where a proportionally large quantity of water entered the channel from spring water emerging from a basalt cliff near the middle of the “elbow.” Upstream of the

basalt cliff the stream flow decreased and the stream was dry for a section before flowing again on the surface in a series of riffles and pools. Maximum pool depth varied from 0.2-0.5 meters. Three 5 inch fish were observed. Water temperature data collected by a sensor deployed at the “elbow” showed continuous presence of water throughout the summers of 2018 and 2019. Throughout the monitoring period, temperatures at this location met the Core Cold Water Habitat and Spawning Use criteria for salmon and steelhead.

These photos illustrate Reach 5 conditions: Low flows, dry units, and a basalt wall with flowing springwater inputs to Couse Creek.

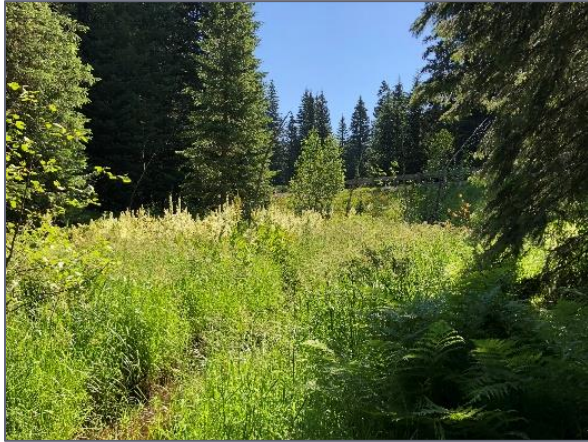
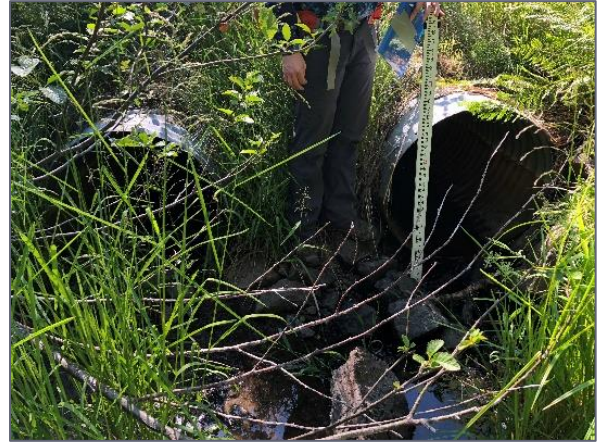
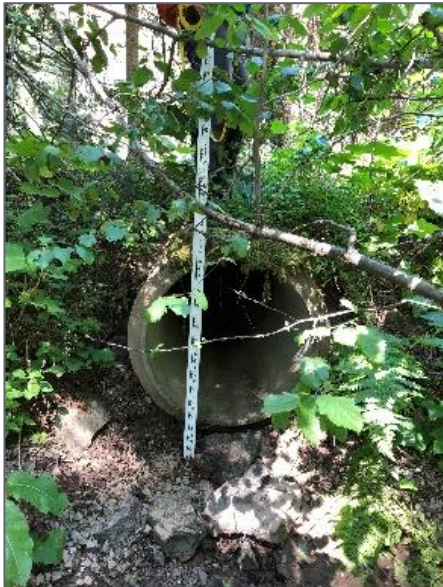
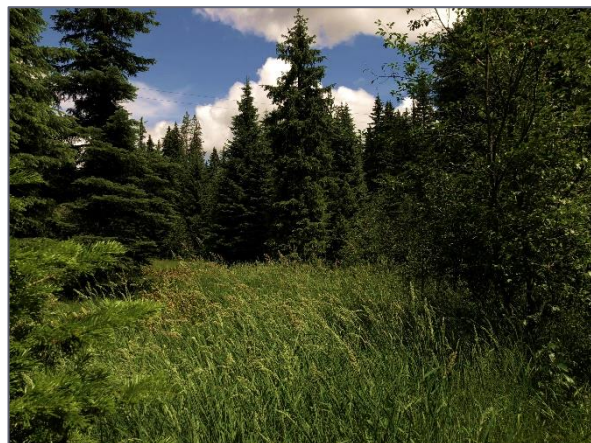
Reach 6 is a low-gradient headwater reach east of the Hwy 204 crossing. Distinctly different than Reaches 4 and 5, Reach 6 has a poorly defined channel in a broad valley, mostly herbaceous and brushy deciduous riparian vegetation, and substrate of almost exclusively fine sediment. Land use is primarily recreational with seasonal cabins. The survey documented invertebrates observed but no fish in this reach. The survey ended at a dry unit with a small amount of puddled water upstream of the end point. Couse Creek headwaters likely emerge from multiple diffuse groundwater inputs. Water temperature data from Reach 6 indicate the presence of water throughout the summer of 2018 and intermittent dry spells during summer 2019.

These photos show Reach 6 conditions: Low-gradient meadows, multiple culvert crossings, intermittently dry

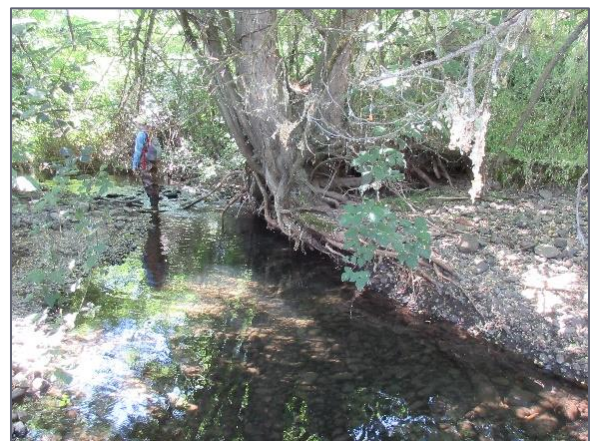
Figure 28. Example of undercut bank.

Undercut banks provide cover and low-velocity areas for fish and are an indication of stream banks effectively stabilized by vegetation because it is likely that without vegetation, the bank would erode away. Undercut banks were present throughout the surveyed units but were most frequent in Reach 1 (Figure 28). Out of 253 units, 36 units (14%) contained undercut banks meeting the survey criteria. Out of the 36 units with undercut banks, 47% were in Reach 1.

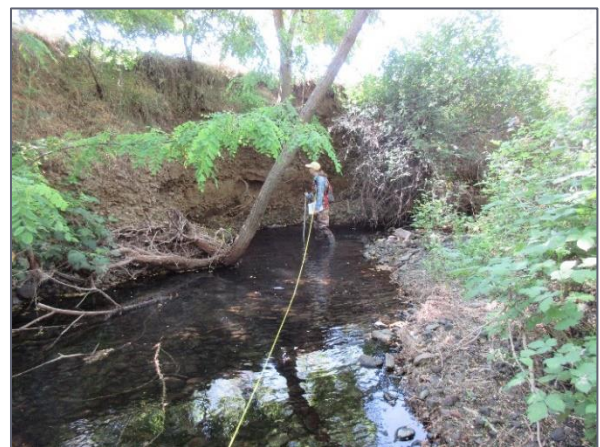
Figure 29. Reach 1 incised channel with tall cut bank.

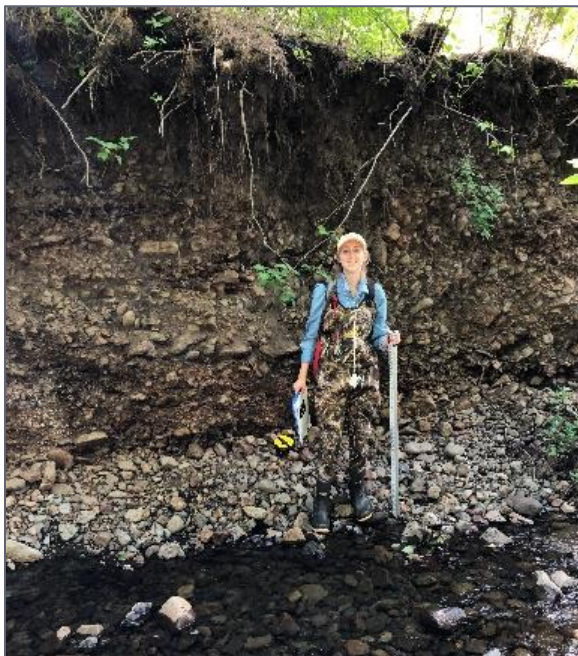
Figure 30. Active erosion of a cut bank in Reach 2.

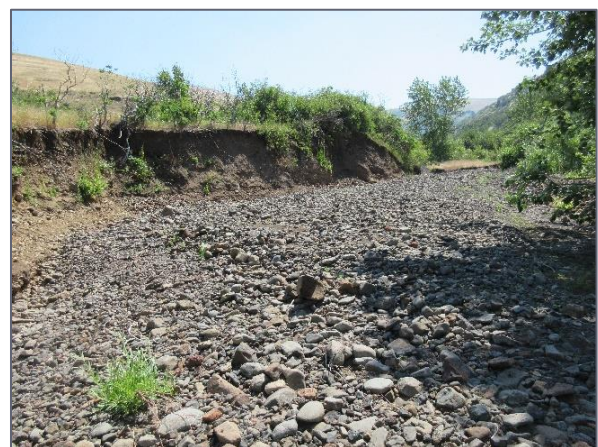
Figure 31. Example of a dry unit in Reach 2.

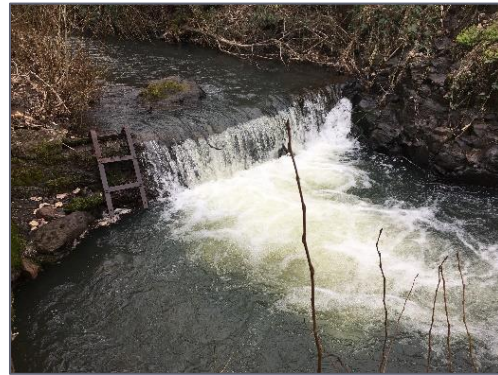
Figure 32. Unit 96, Step over Structure

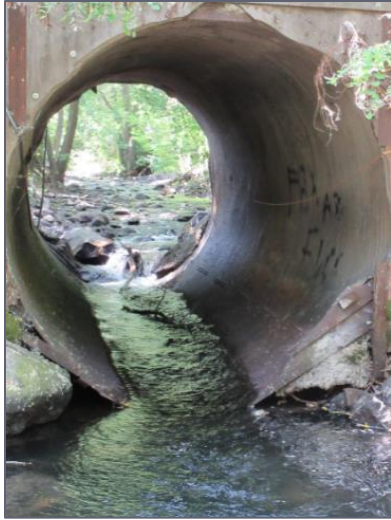
Figure 33. Culvert with no step, Unit 15, under a private road crossing.

None of the four culvert crossings were considered as barriers or steps (Figure 33, for example). ODFW's 1997 survey identified a possible barrier of a boulder step in the "elbow" and, although the 2018 survey did document two boulder steps in the same area, neither were identified as potential barriers (Figure 34).

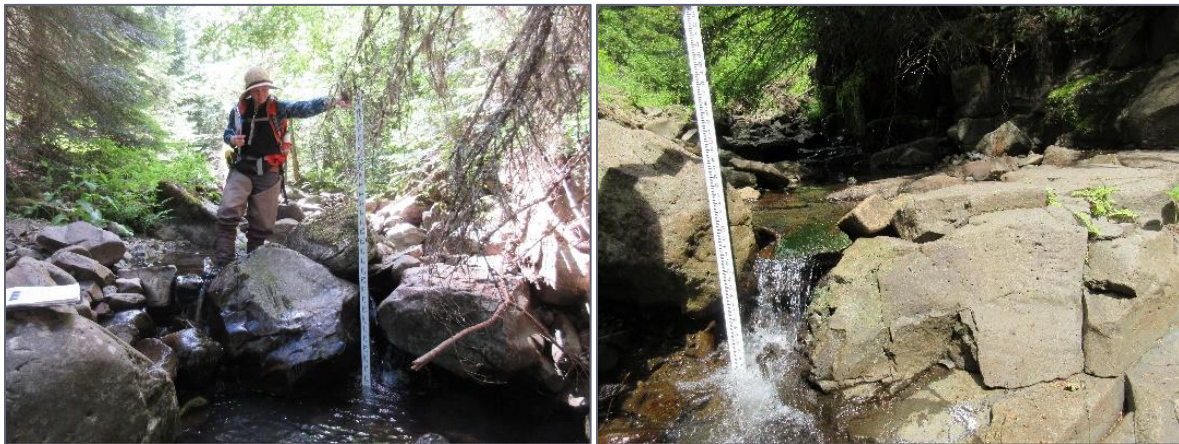
Figure 34. Steps near the possible barrier documented in the 1997 ODFW survey. Unit 220, Step over boulders (top). Unit 224, Step over boulders and bedrock (bottom).
