Lower Walla Walla River

Geomorphic Assessment and Action Plan

December 2014

Tetra Tech. 2014. Lower Walla Walla River Geomorphic Assessment and Action Plan. Submitted to The Confederated Tribes of the Umatilla Indian Reservation. December.

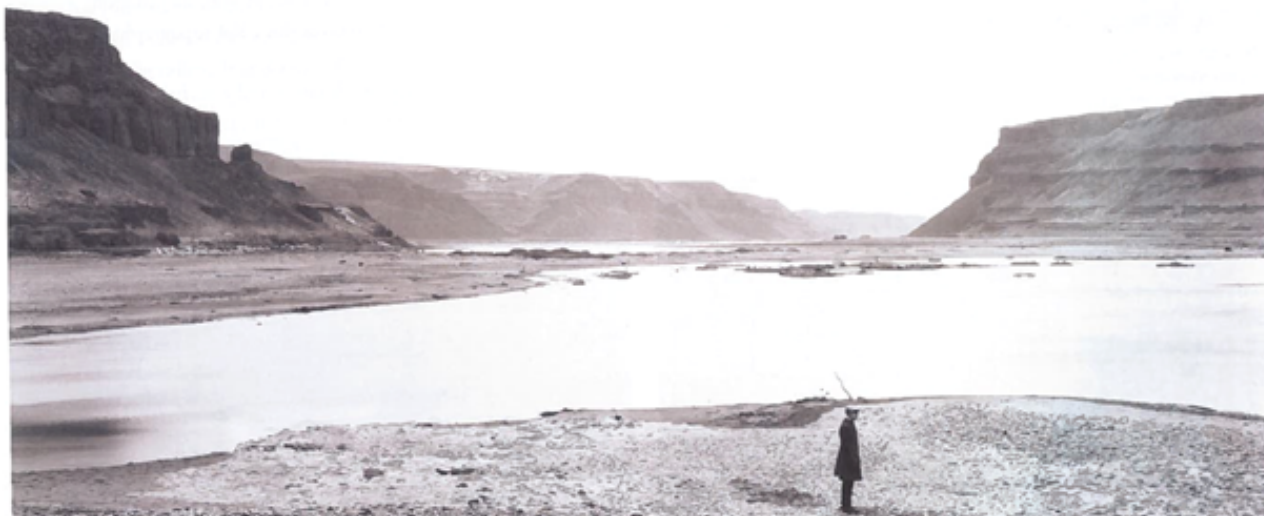
Figure 2-5. The Confluence of the Walla Walla River and the Columbia River in the 1920s, before inundation from the McNary Dam. The Walla Walla River enters the frame from the left.

transported sediment eventually filled in the valley confines and created a river delta at the mouth of the Walla Walla River (Carson 2008). Figure 2-5 shows a man standing on a gravel bar at the mouth of the Walla Walla River around March 1922, prior to the creation of Lake Wallula (Carson 2008, p.23).

Reaches 1, 4, and 5 have very low current geomorphic function. Reach 1 has been highly modified from its historic pattern and process (see Figure 2-5). The in-channel complexity and habitat conditions are very low, but there are multiple surface water connections that are likely providing off-channel habitat. Reaches 4 and 5 are not laterally active and have relatively low sinuosity compared to a high historic meander belt width and sinuosity, suggesting that they are in a stage of arrested degradation.

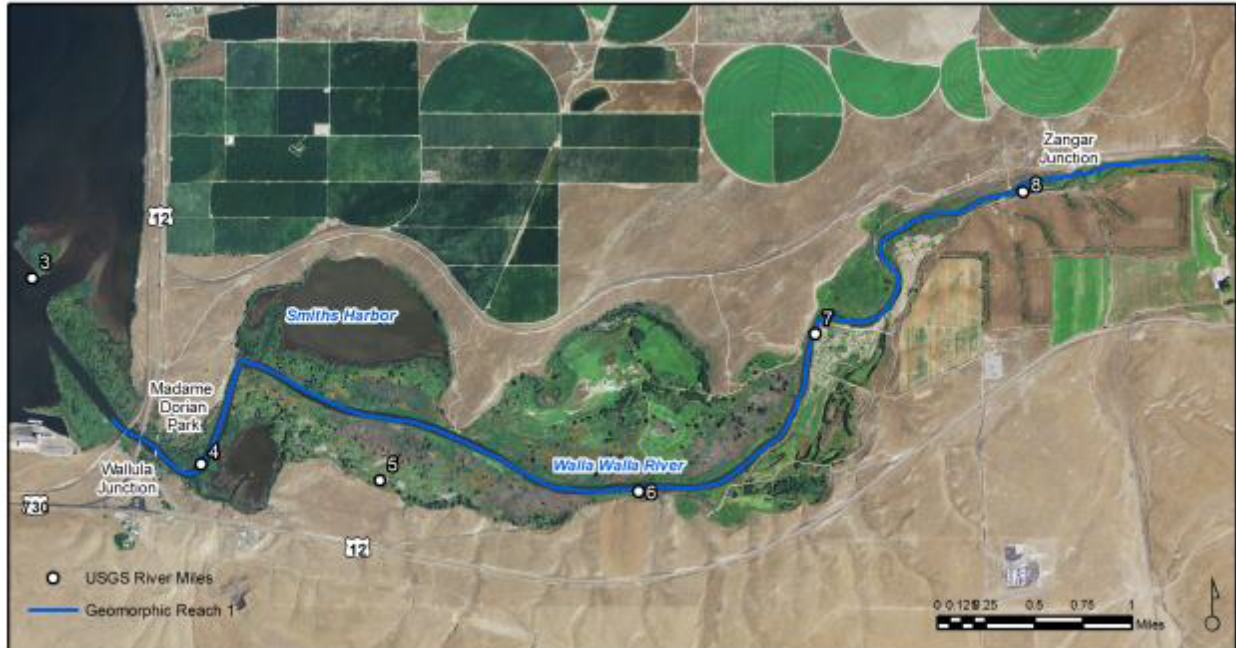
Figure 3-1. Aerial View of Geomorphic Reach 1

The Lower Walla Walla River in this reach is a very low gradient (0.0004 foot/foot), single-thread, and relatively straight channel for most of its length (Figure 3-1). The historic floodplain in the lower half of the reach is broad (average of over 2,000 feet) and flat, and contains several connected waterbodies and wetlands including Smiths Harbor. The majority of Reach 1 is contained within the McNary National Wildlife Refuge and is managed for conservation. The riparian zone covers a wide area that is primarily tall grasses and sparse in understory, canopy cover, and diversity. The vegetation on the banks is dominated by tall grasses and the occasional willow shrub. There are no significant tributary junctions in Reach 1.

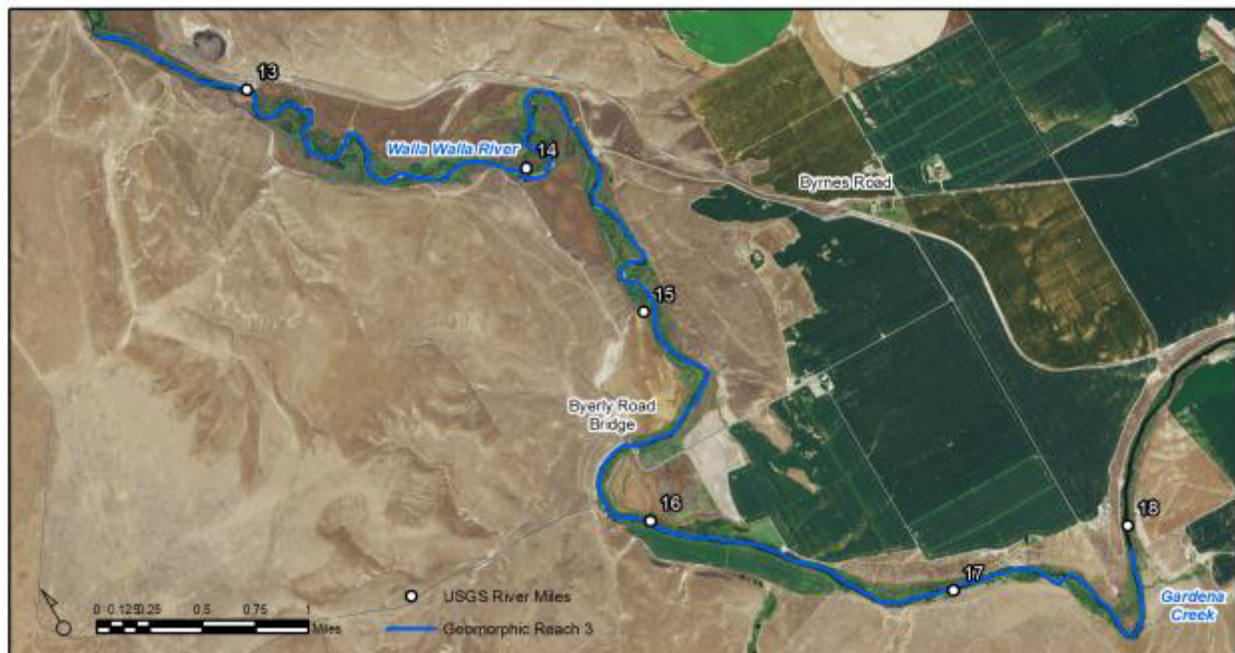
Figure 3-3. Aerial View of Geomorphic Reach 3

Geomorphic Reach 3 extends from RM 12.5 to RM 17.9 upstream of the Gardena Creek confluence (Figure 3-3). The defining characteristic of Reach 3 is the bedrock controls on the channel pattern and form. Near RM 13 the river is confined as it flows through a bedrock (Wanapum basalt) notch. Periodic bedrock grade controls are also visible on the channel bed throughout the downstream half of the reach.

From RM 13 to RM 14.5, the historic floodplain is wider (average 1,100 feet) allowing for increased sinuosity. Upstream of RM 14.5 the channel is largely confined by bedrock controlled hillslopes or high terraces comprising primarily Touchet bed deposits.

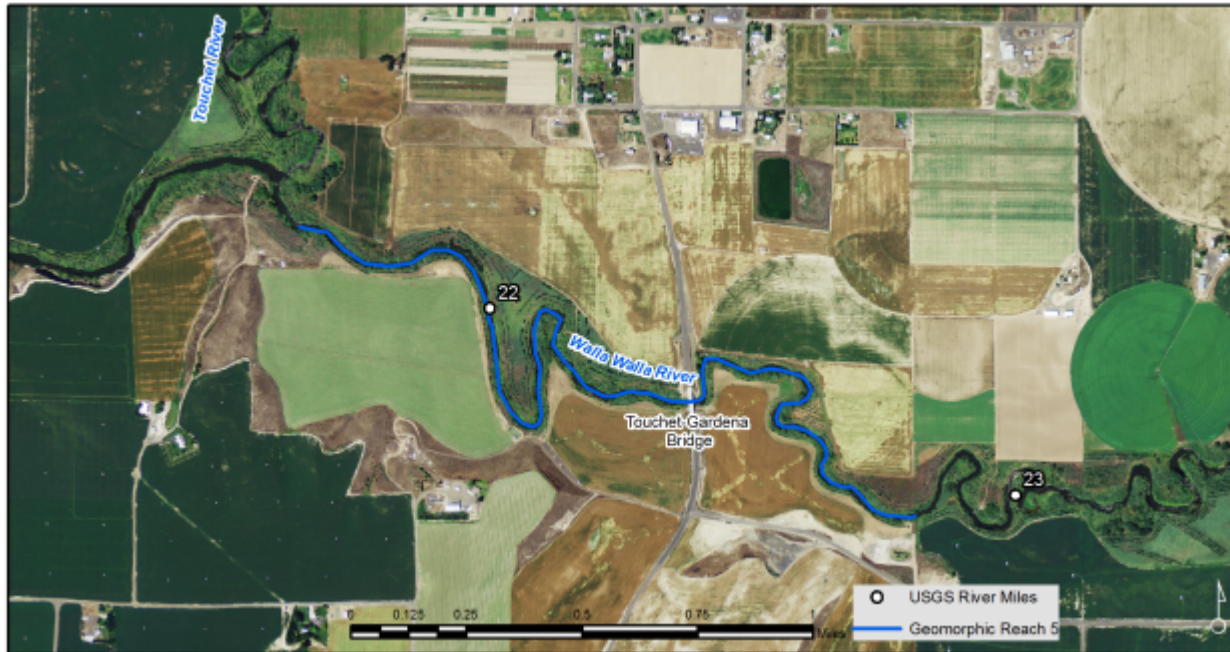
Figure 3-5. Aerial View of Geomorphologic Reach 5

Geomorphic Reach 5 extends from RM 21.6 to RM 22.8, which is about 0.5 mile upstream of the Touchet-Gardena Bridge (Figure 3-5). The primary defining characteristic of Reach 5 is that it is narrow and deep with relatively few bedforms and little channel complexity. In contrast to downstream reaches, Reach 5 has a broad historic floodplain (average 1,700 feet)

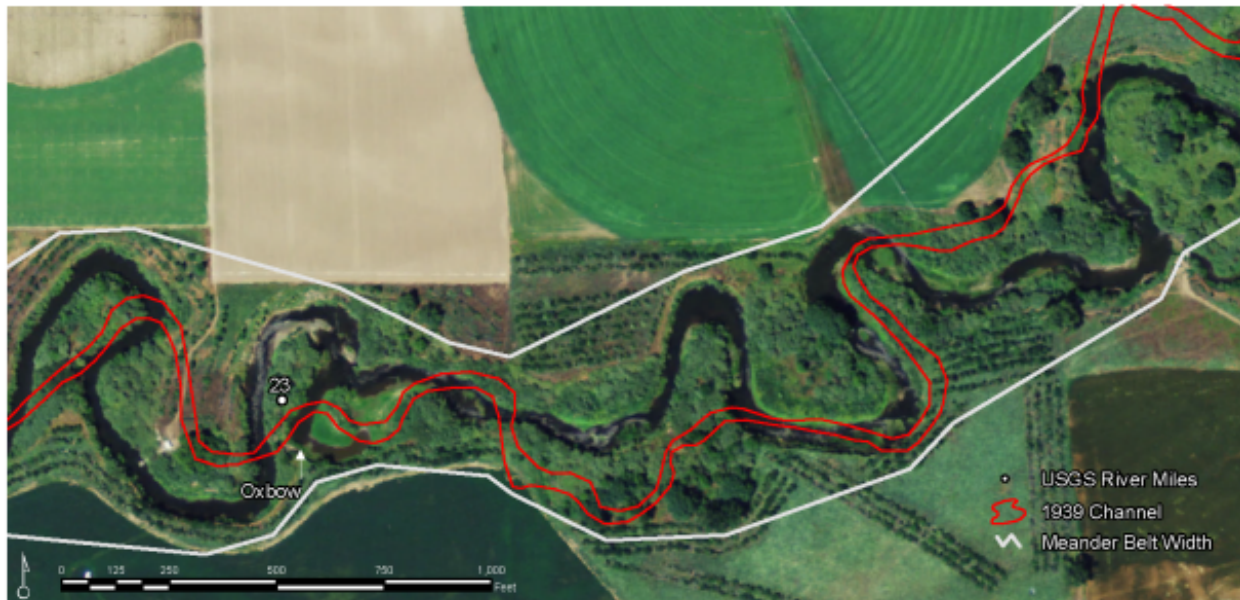
Figure 3-11. Example 2013 Aerial Photograph and 1939 Mapped Channel Location within Geomorphic Reach 6 Showing Channel Meander Pattern and Progression and Approximate Belt Width (the photograph shows an example cutoff and oxbow)

The meander belt width and channel migration rate were measured at each of the cross sections and averaged for each geomorphic (see Table 3-6). The belt width included the minimum width that encompassed both the 1939-40 and the 2013 channel location. An example of the extent of the meander belt width is included in Figure 3-11. Reach average meander belt widths ranged from 423 feet in Reach 2 to 1,318 feet in Reach 7 feet as shown in Table 3-6. Reach 7 had the highest meander belt width, but the lowest confinement width and sinuosity due to channel straightening and the presence of bank armoring structures.

only one in which meander progression included cutoffs and the formation of oxbows as shown in the example in Figure 3-11. Reach 7 had no measured channel migration at the measured cross sections, but had a channel migration rate of 9 feet per year in an isolated area directly downstream of the Lowden Bridge. Reaches 3 through 5 had relatively low average and maximum channel migration rates.

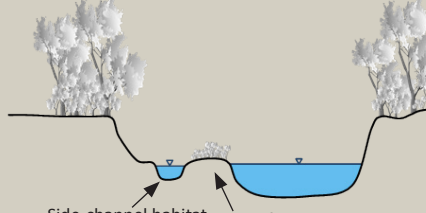
<ul style="list-style-type: none"> Placed LWD increases channel complexity and provides cover from predators Improved riparian vegetation and floodplain connectivity Alcoves and off-channel areas provide high-velocity refugia and rearing habitat Improved habitat diversity

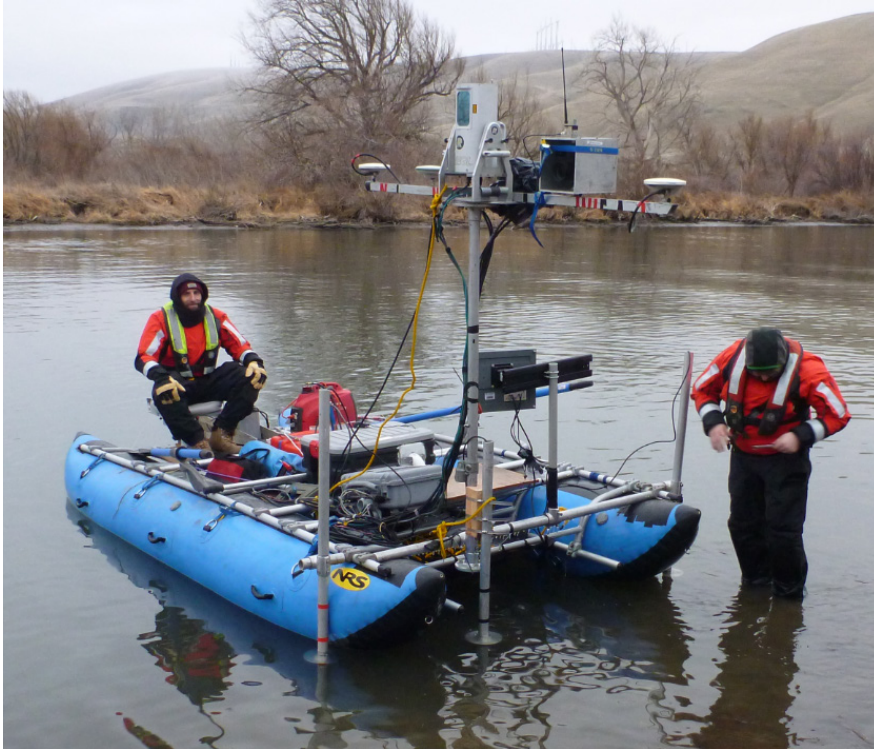
Figure 2-1. Tetra Tech Survey Vessel (R/V *Screaming Seagull*) with vessel-mounted LiDAR and sweep system in deployed position

The survey system was installed on Tetra Tech research vessel (R/V) *Screaming Seagull*, a 14-foot inflatable Cataraft boat configured for shallow water surveying (Figure 2-1). The equipment used for the survey is shown in Table 2-1. Manufacturers' product data sheets that describe the system characteristics and specifications of the primary survey hardware are provided in Attachment A.

movement and ensure repeatable placement. Figure 2-1 shows the mount and various sensors in its down, or deployed, position.

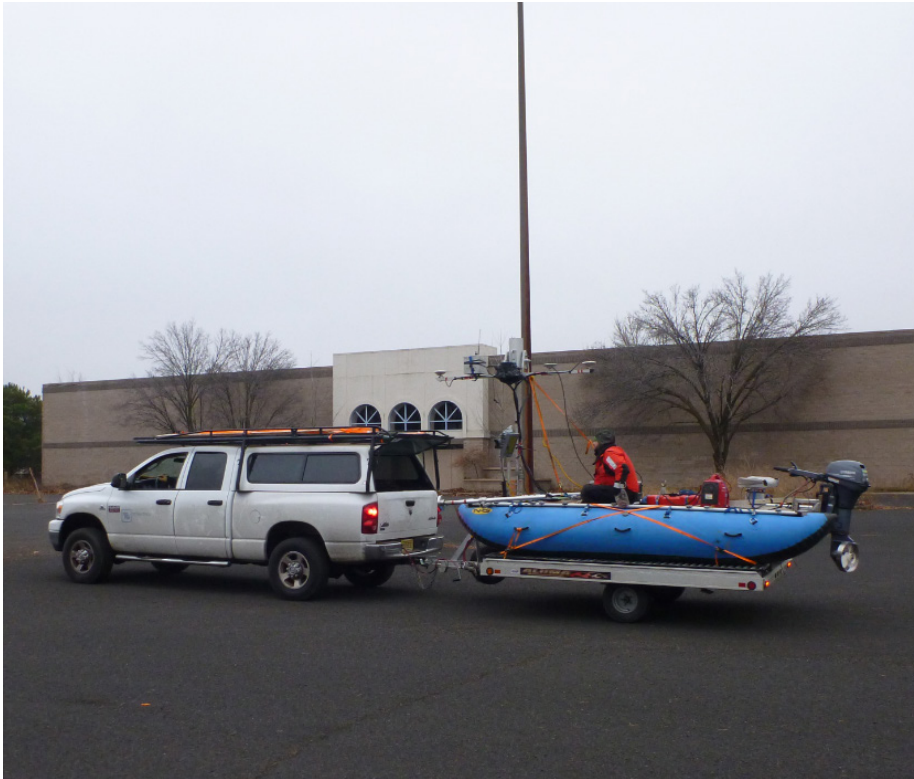
Figure 3-1. Performing the LiDAR Installation Calibration

The data collection software and hardware were time-synchronized to GPS-coordinated universal time (UTC), and the time stamp from the GPS position messages was used for the position data, which typically provides a latency value of zero; this was confirmed with the LiDAR patch test. Figure 3-1 shows the system as configured for the VML patch test.

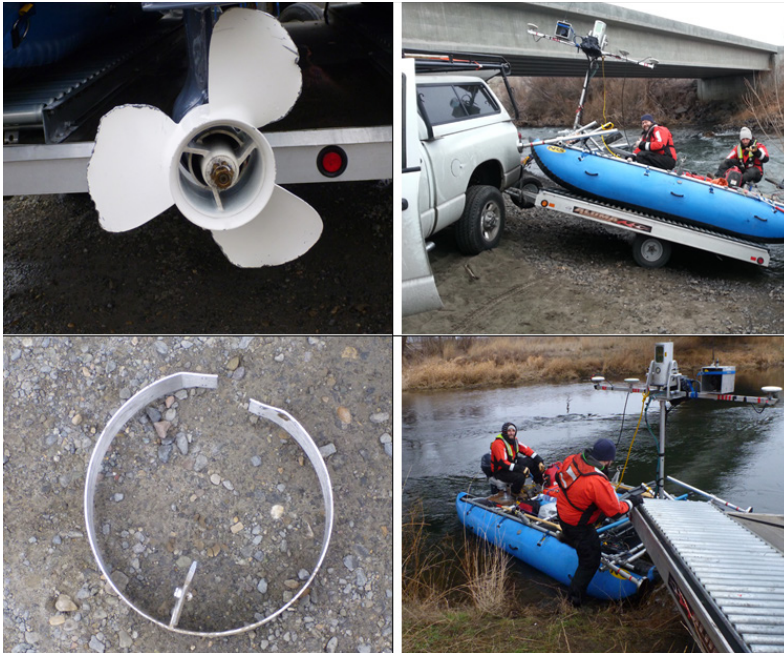
Figure 3-2. Photographs Showing Survey Field Work

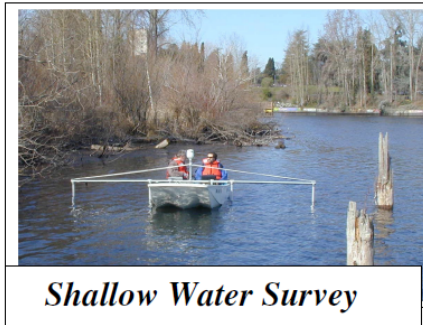
- Four to six channel data collection
- Shallow water operation (1.5ft to 100 ft)
- Lightweight portable boom system
Stores in transportable shipping case
- Desk top or suitcase enclosures
- 20GB HD Internal Storage Capacity
- 200kHz, narrow beam transducers
- Bright color LCD display
- Portable, Ruggedized & Splashtight
- 12v DC operation, serial depth output

Four transducers on a lightweight 18 foot portable boom, easily mounted on small skiffs or john boats.

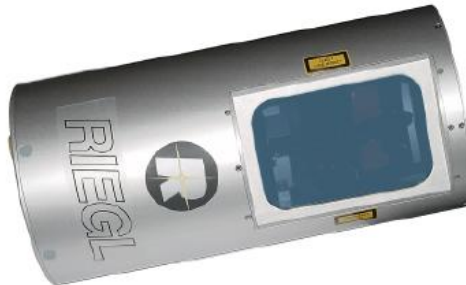
The rugged overall system design makes the *RIEGL* LMS-Q120 exceptionally well suited for installations in harsh industrial environment, and the compactness of the housing allows an installation under narrow space conditions (e.g. in a robotic vehicle). The instrument needs only a single supply voltage and provides line scan data via its integrated TCP/IP Ethernet interface. The binary data stream can easily be post-processed by any user-designed software using the available software library.

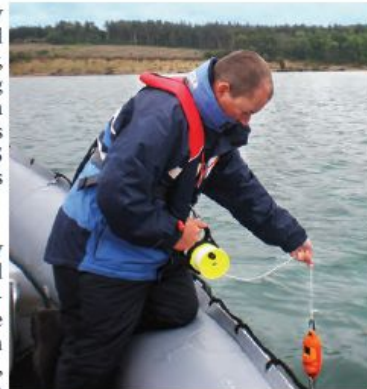
The CastAway is a multi-functional tool that incorporates the most modern technology available - yet is simple to use. It is designed for CTD profiling down to 100 m and is easy to deploy.

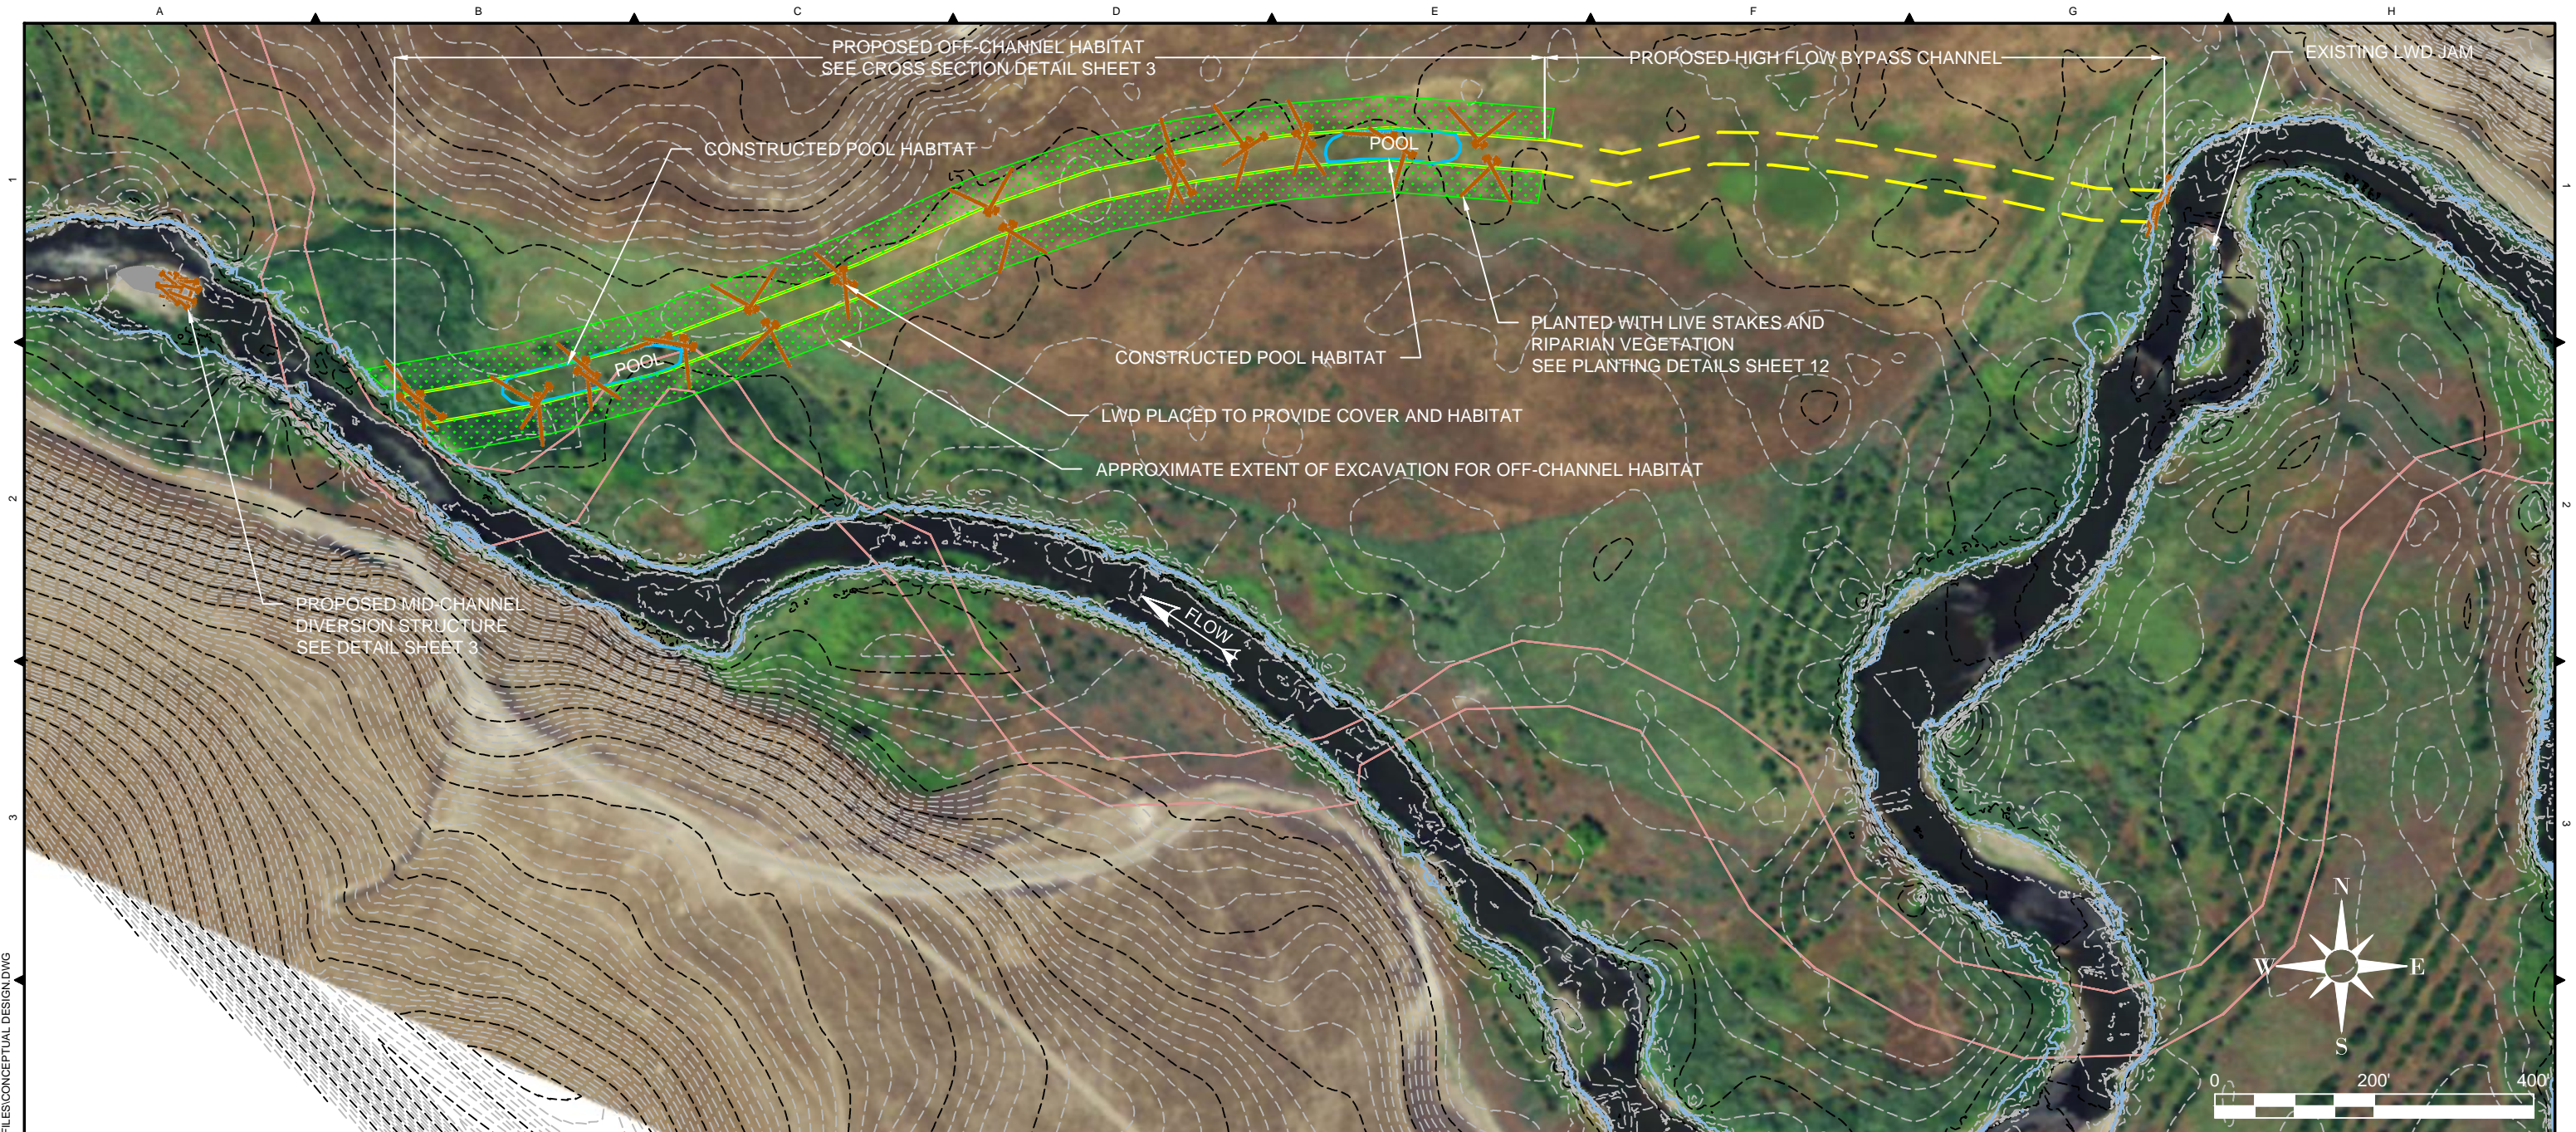
LOWER WALLA WALLA
GEOMORPHIC ASSESSMENT AND
ACTION PLAN
**CONCEPTUAL DESIGN
OVERVIEW**

1. NO FLOWS EXPECTED IN OFF-CHANNEL HABITAT WHEN HIGH FLOW BYPASS IS NOT CONSTRUCTED AS PART OF DESIGN.
2. WOOD INCLUDED IN DESIGN OFF-CHANNEL HABITAT TO PROVIDE COVER FOR FISH.

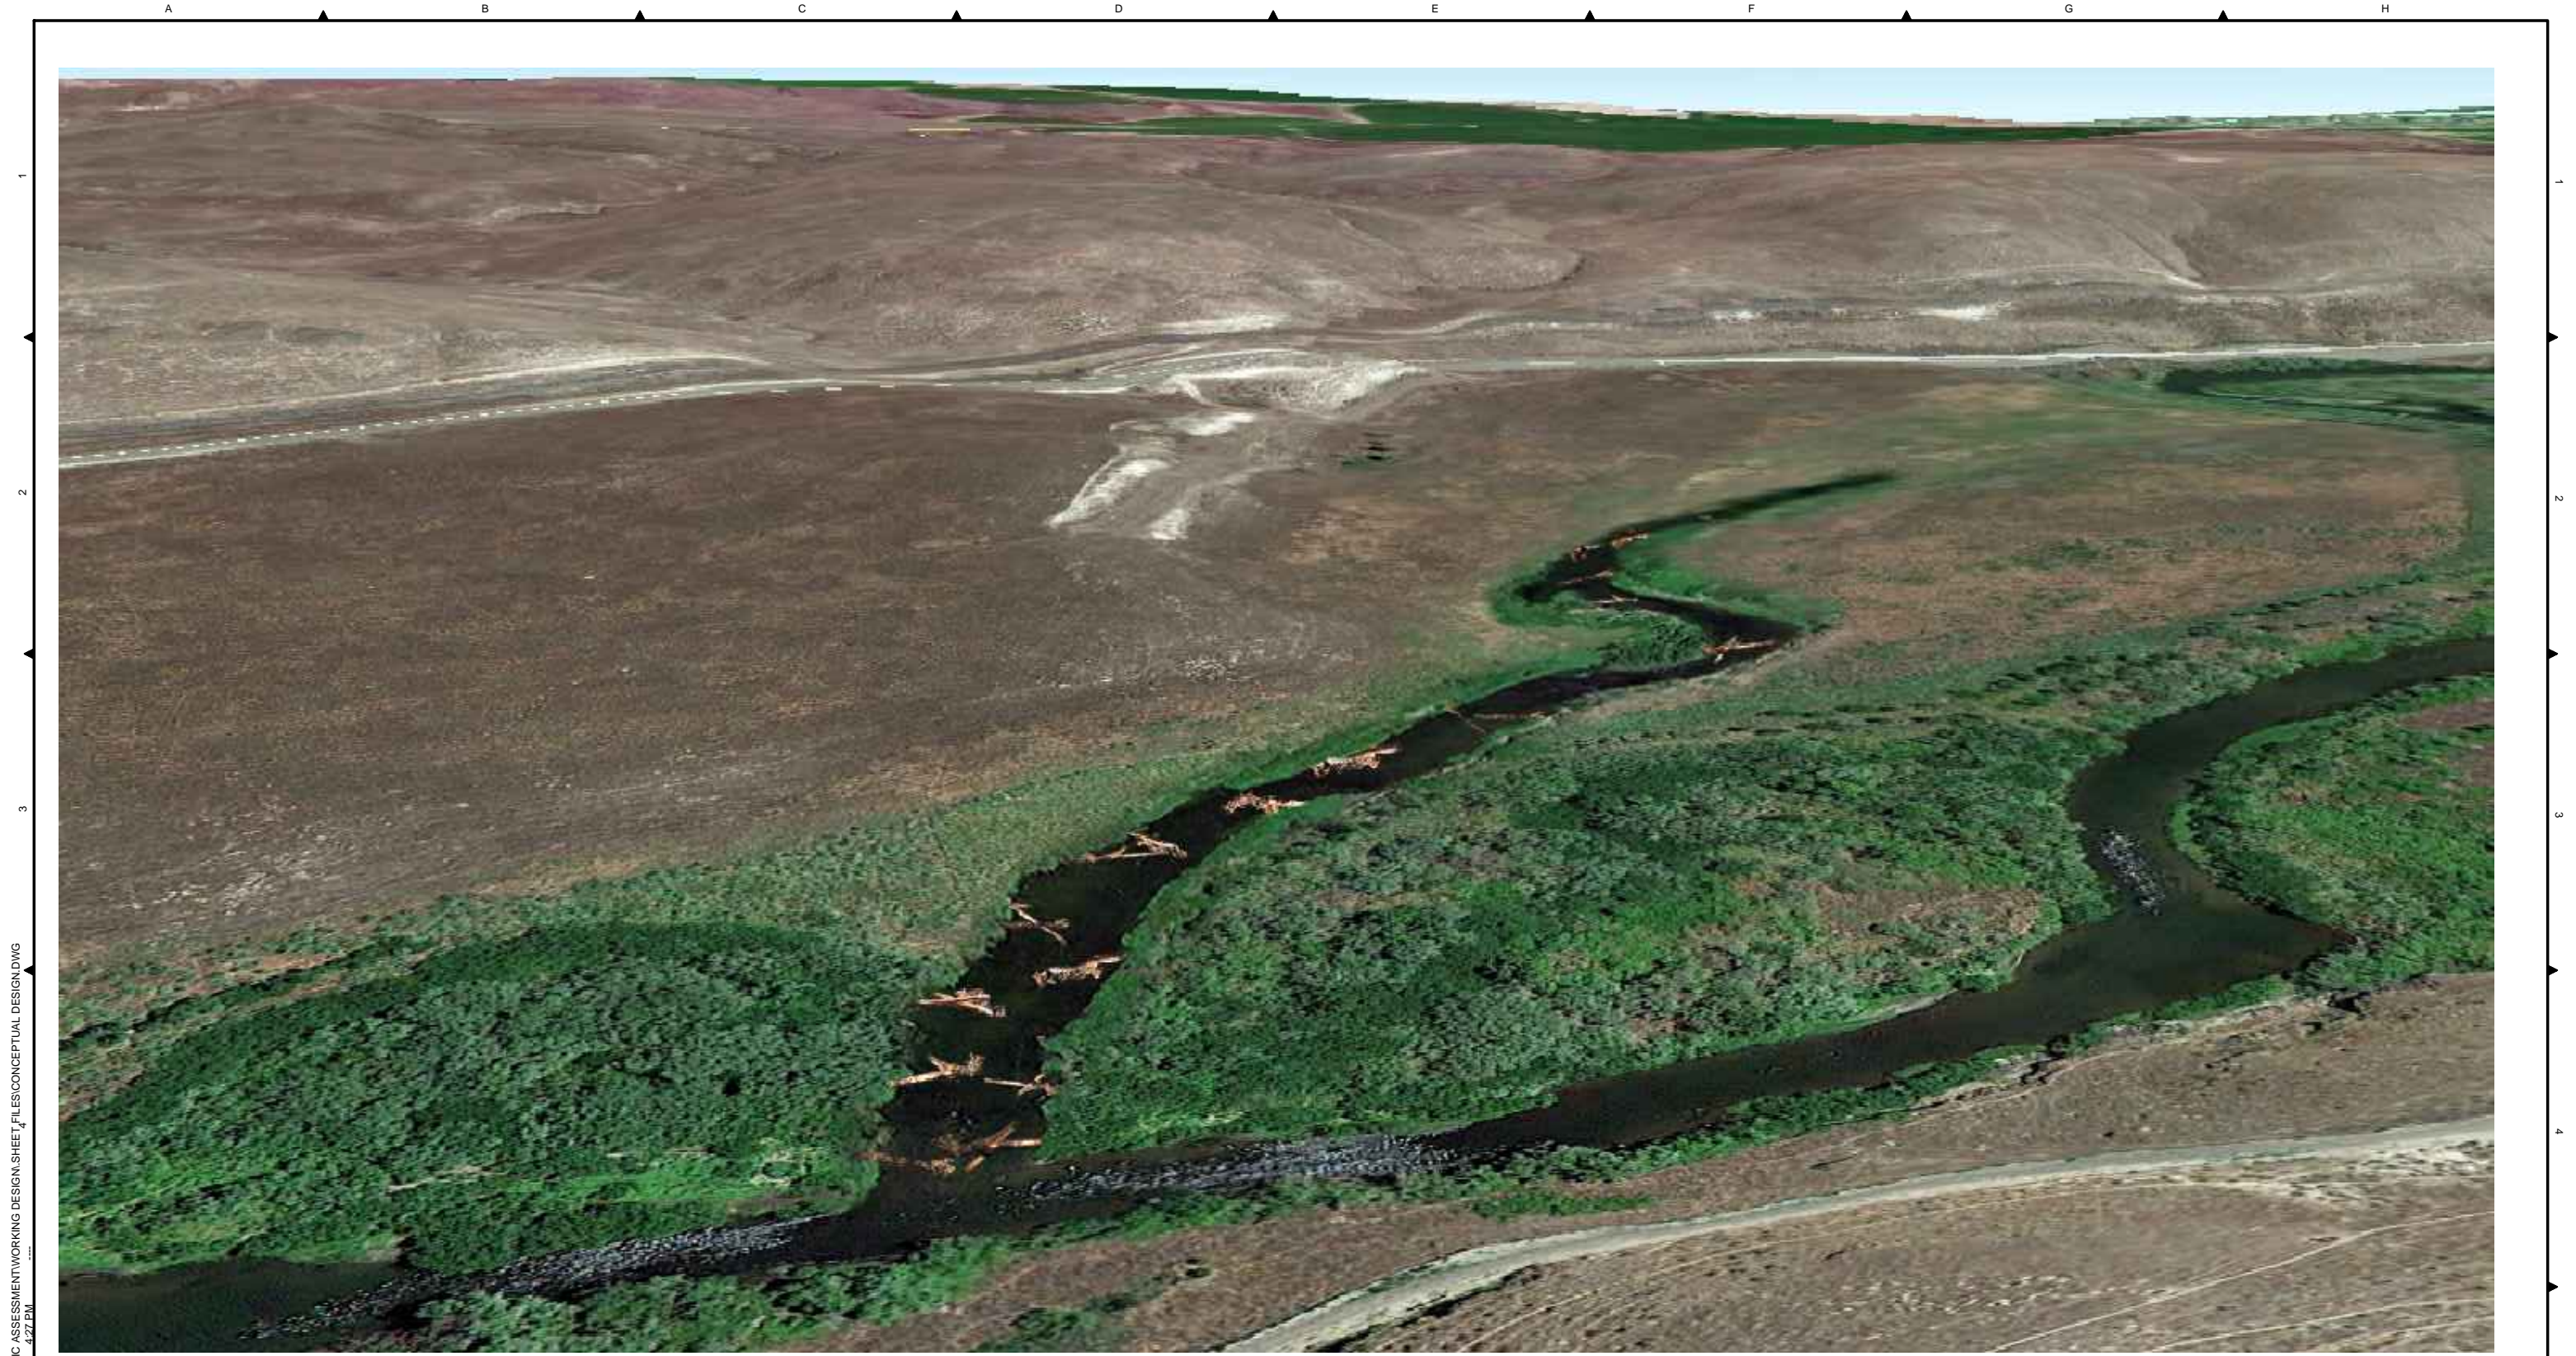
OFF-CHANNEL HABITAT - VISUALIZATION

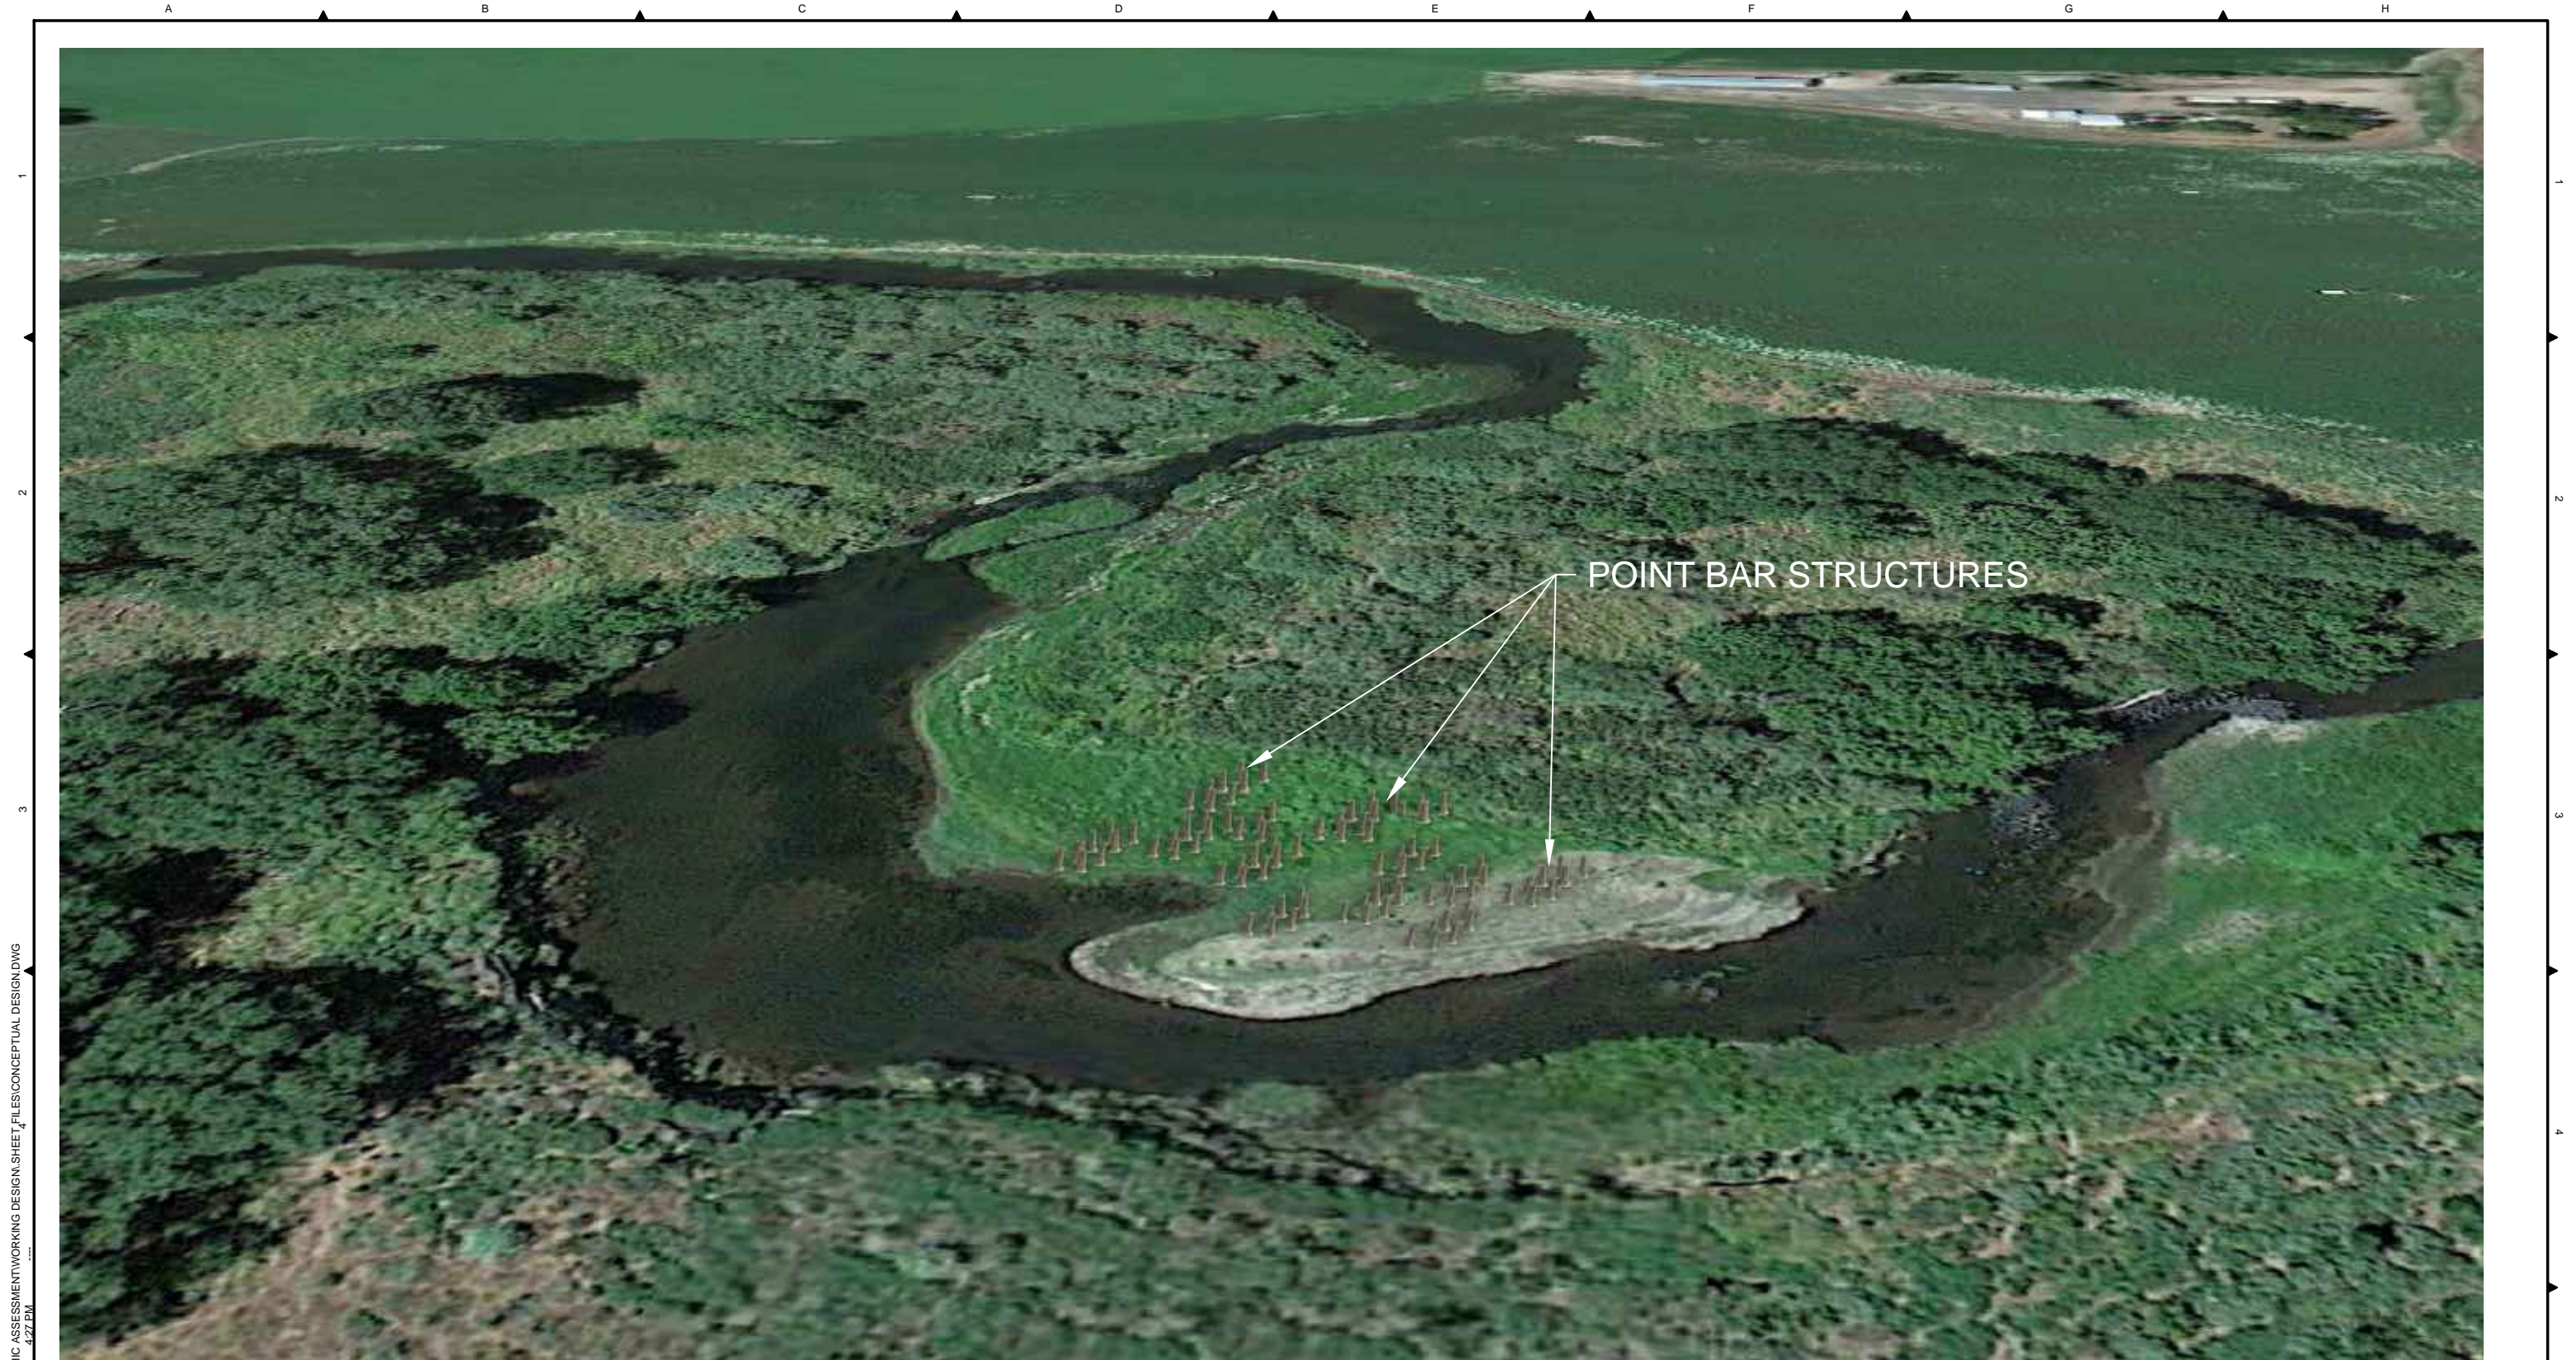
POINT BAR STRUCTURES
