Túuši Wána Design Project
Touchet River - Mile 14 – 17

Final Basis of Design Report

May 2024

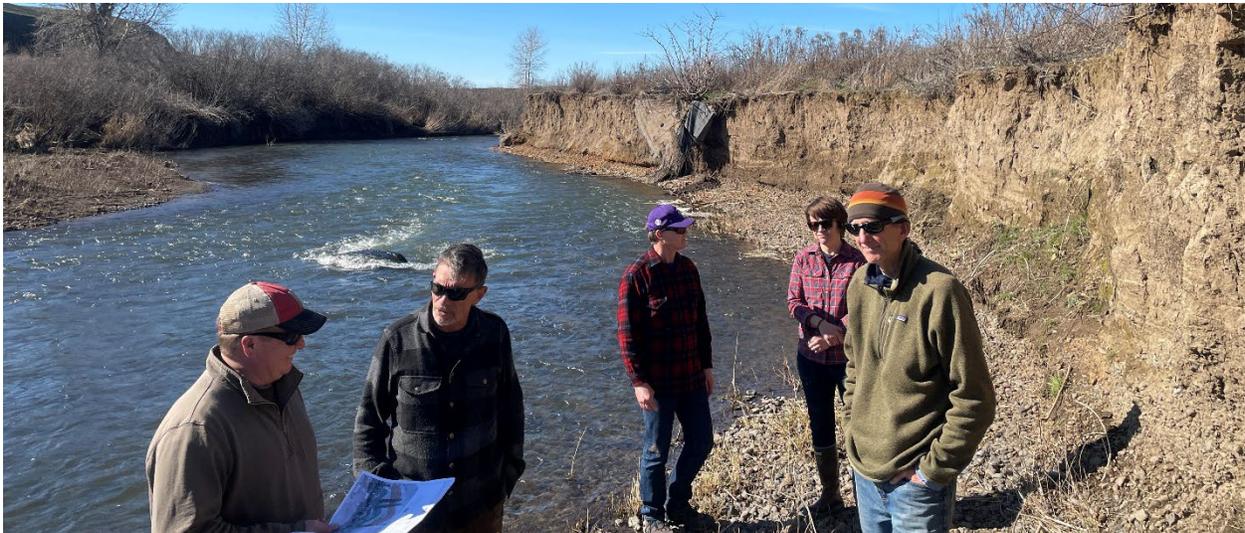
Figure 2: Photo looking down river near RM 16.1. | February 2024

Photo shows the tall right bank composed of fine sediments over a consistent layer of gravels.

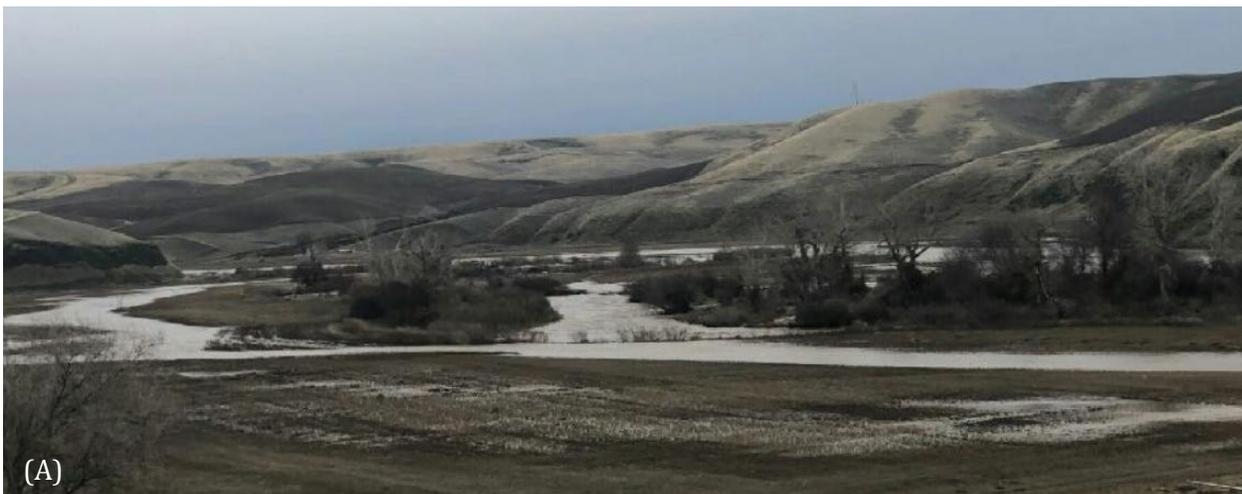
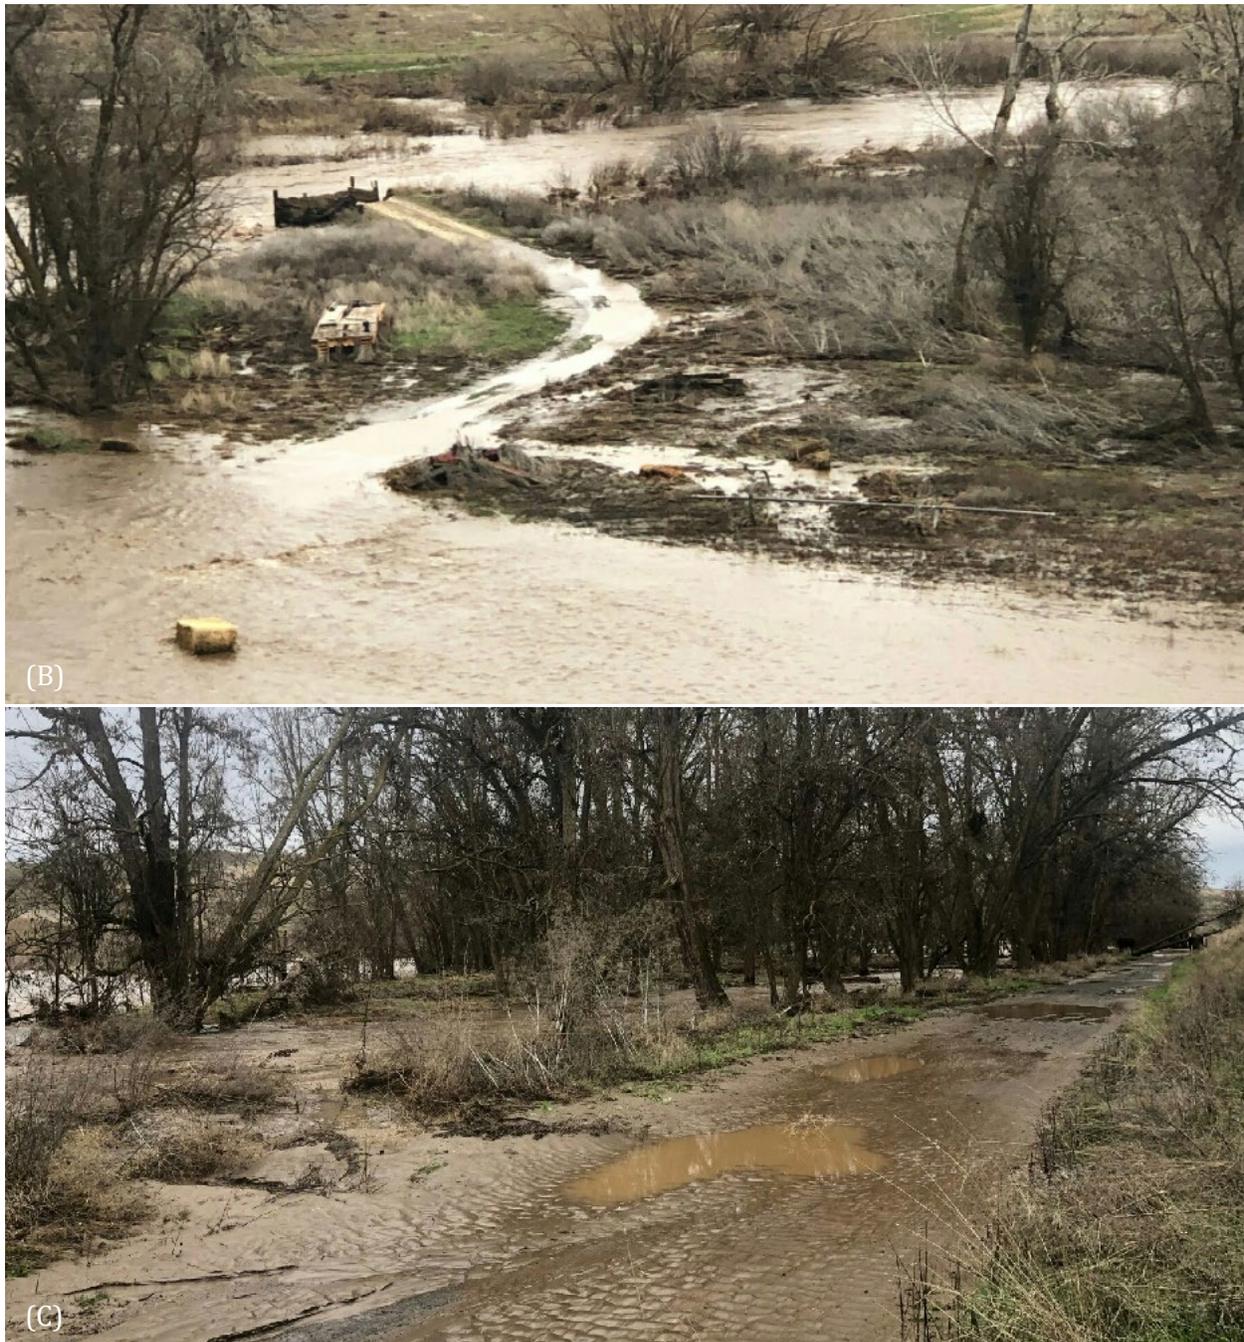
Figure 3: Photos of 2020 Flooding

Note inundation of large areas of the valley bottom (A), appearance of sediment laden water (B), and fine sediment deposition on the order of inches (C) visible as the flood water receded.

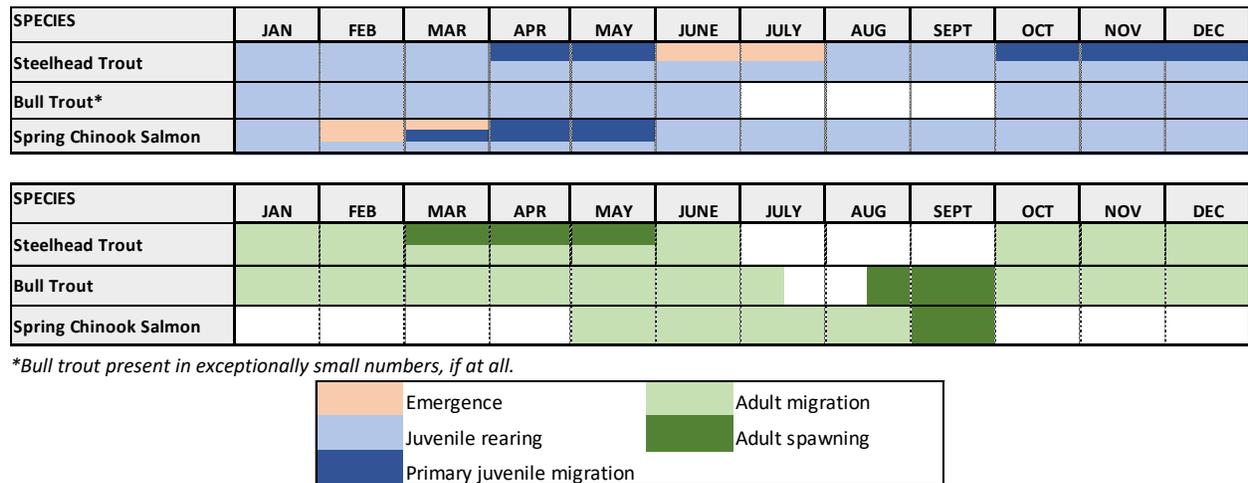
Figure 4: ESA listed fish use timing in the project area. From CTUIR 2014 and Steve Martin, personal communication.

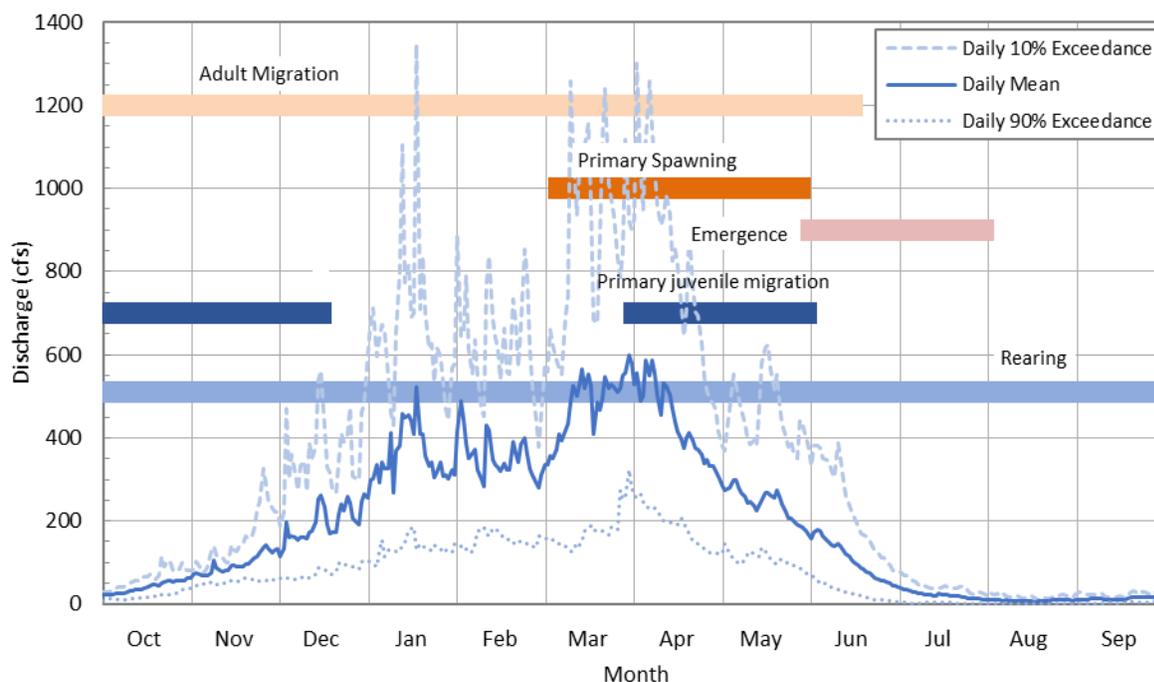
Figure 5: Steelhead (*Oncorhynchus mykiss*) life history timing in the Touchet River and Walla Walla River watersheds overlaid on discharge in the Túuši Wána project area.

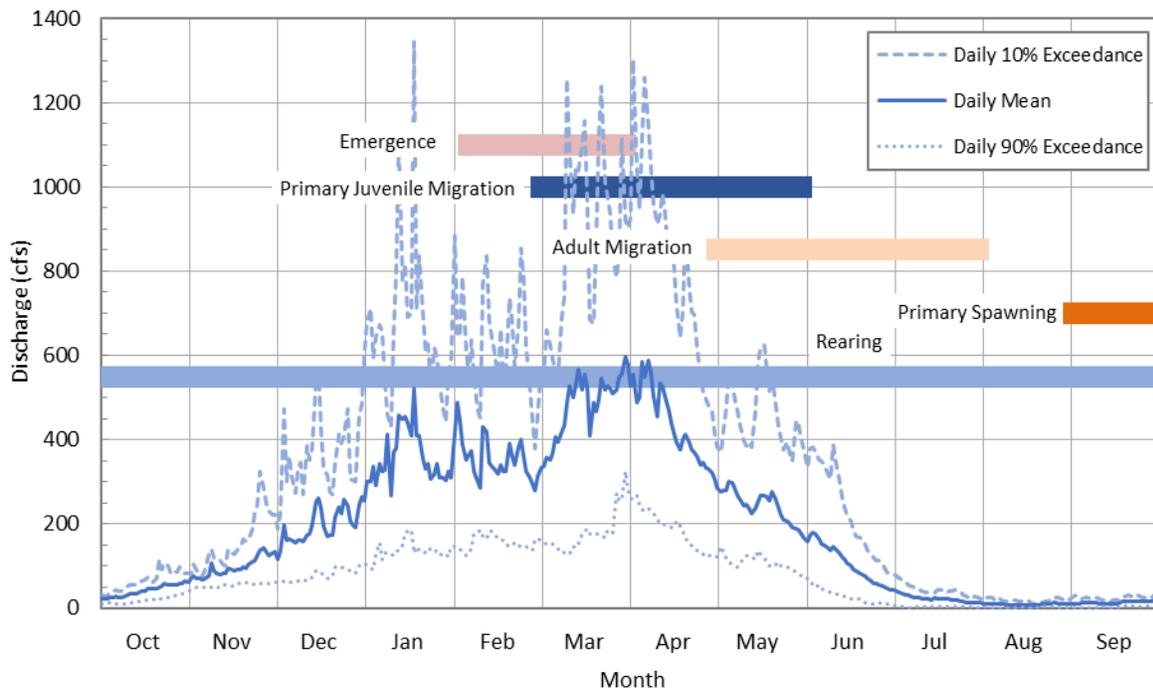
Figure 6: Chinook (*Oncorhynchus tshawytscha*) life history timing in the Touchet River and Walla Walla River watersheds overlaid on discharge in the Túuši Wána project area.

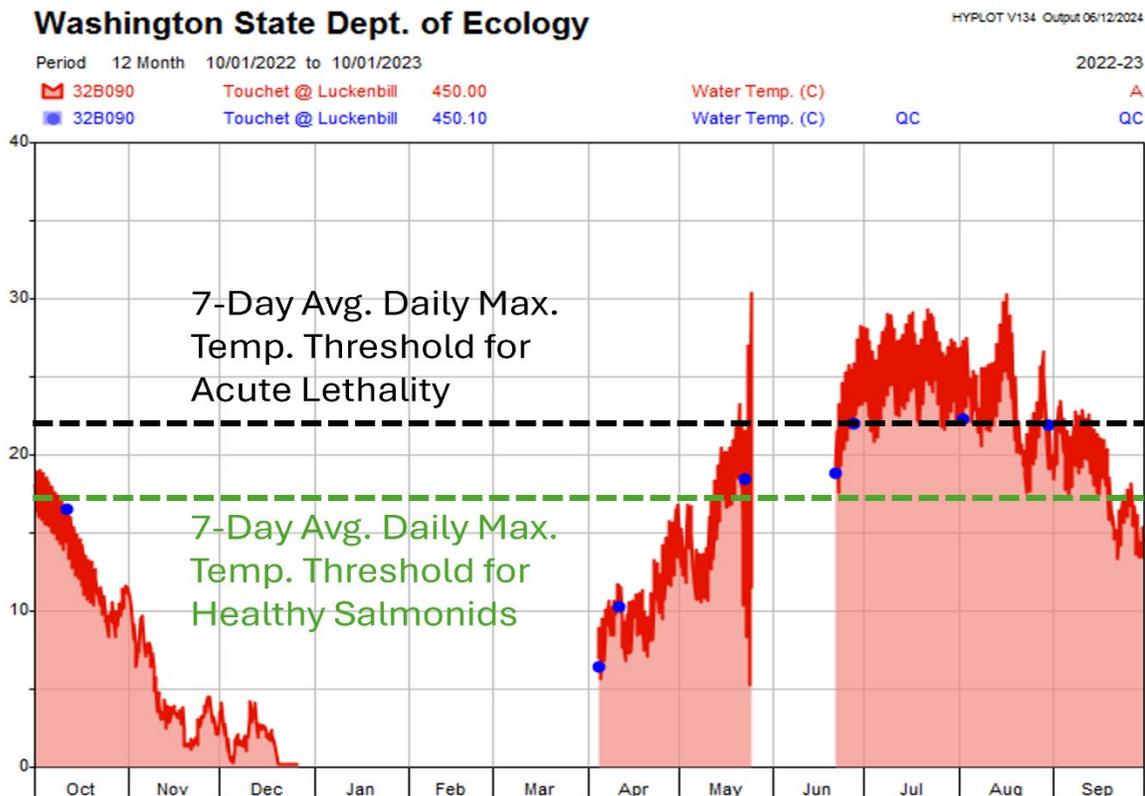
Figure 7: Plot of water temperatures recorded immediately upstream of the project area with salmonid water temperature threshold overlay.

Temperature values are in degrees Celsius from the WADOE gage 32B090.

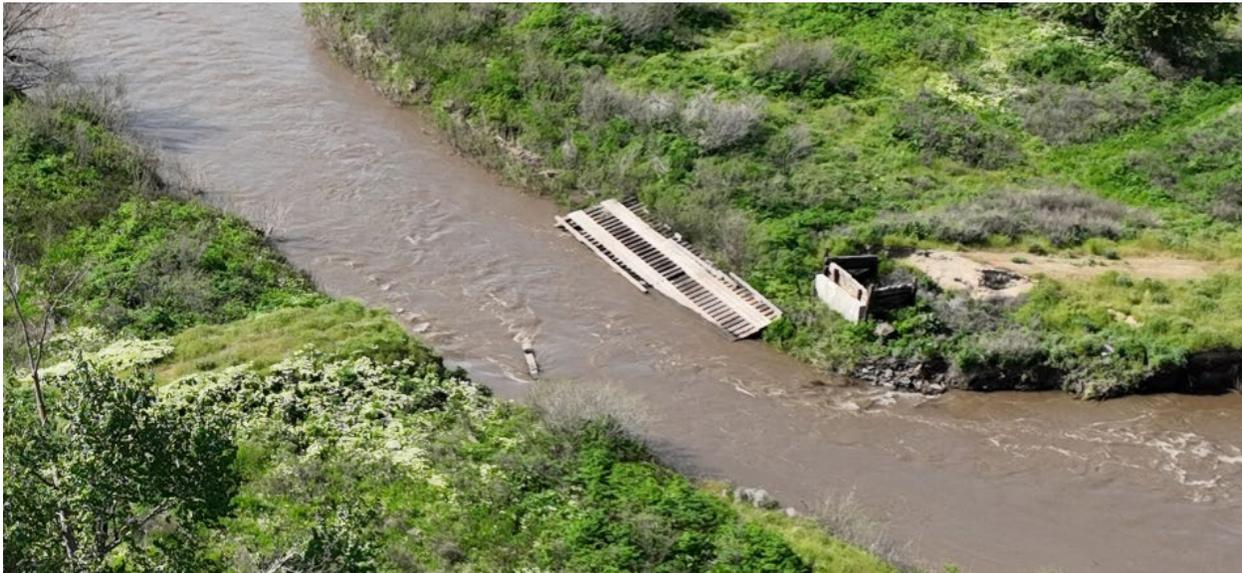
Figure 8: Photo of derelict bridge and abutments to be removed near River Mile 16.5.

Removal of riprap and derelict items. Existing riprap, other types of bank armoring, a farm bridge deck and abutments (Figure 8), and other derelict agricultural items (pipes, fences, poles, equipment, etc.) will be removed throughout the project area. Removal of the riprap and bank armoring will allow for natural bank erosion rates and remobilization of floodplain sediments with the project reach. The overhead electric powerlines serving the irrigation pumps with the project area will remain in-place until they are no longer needed to provide irrigation water to help establish the riparian plantings. This plant establishment period is expected to take around five years. The larger power transmission lines that cross the valley near River Mile 16.5 will remain, including the two sets of poles in the valley bottom. There will be a 300-foot buffer on each side of the transmission lines with no excavation, fills, or LWS within it.

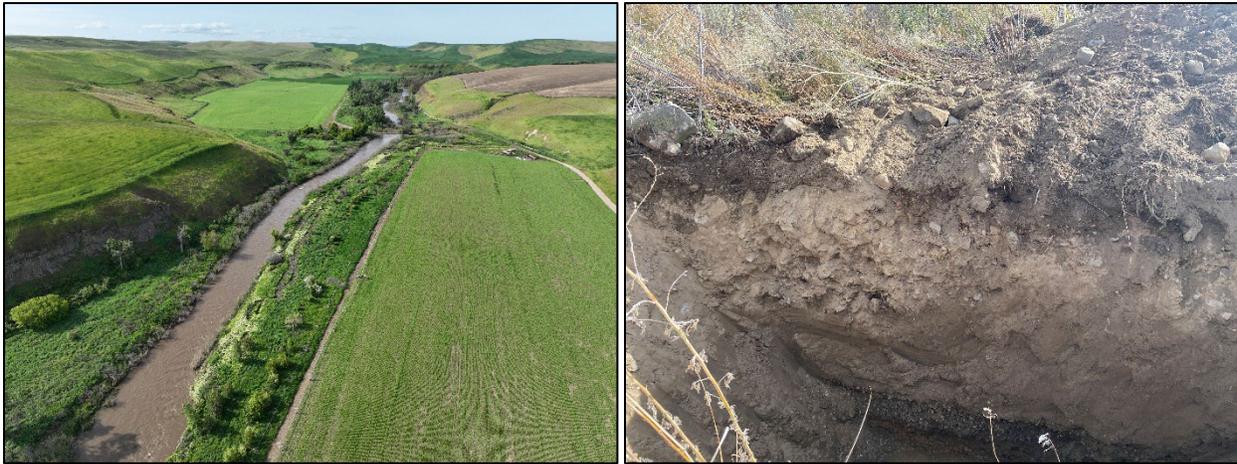
Figure 9: Photo of straightened channel segment at the project site (left). Photo of test pit excavated along the right bank of the photo at left showing substantial coarse, angular non-alluvial material likely placed during the channelization process.

- *Channelization and bank stabilization.* Observations of aerial imagery and LiDAR suggest the current channel has been straightened in several locations throughout the project site, and the channel may have been forced to the valley margins in places (Figure 9). Several straightened channel segments bounded by pushup berms and/or bank armoring are present at the site, and a test pit excavated along these straightened reaches (Figure 28) revealed coarse non-alluvial material in the subsurface, which was likely placed during the channelization process (Figure 9). Riprap was found in multiple locations throughout the project site, both related to discrete infrastructure protection (pumps, road crossings, etc.) and in continuous placements along sections of the bank.

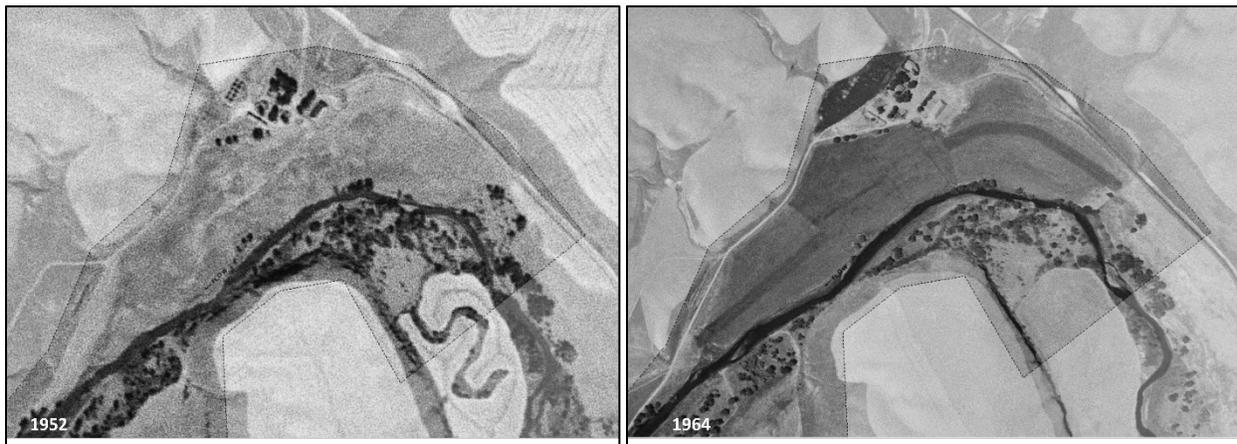
Figure 10: Aerial photos from 1952 (left) and 1964 (right) focusing on the uppermost portion of the project area where a well-defined floodplain channel visible in the 1952 image (valley left upstream end) was filled and incorporated into an agricultural field by 1964.

- *Floodplain grading.* At several locations in the project site, the floodplain was graded to remove floodplain channels and/or swales to expand the area of agricultural fields in the valley and/or to improve access to fields (Figure 10). The commencement of valley bottom agriculture predates the aerial photo record of the site (1952-present), but several instances of floodplain grading are recorded in the photo series, and substantial floodplain grading is likely to have occurred prior to 1952.

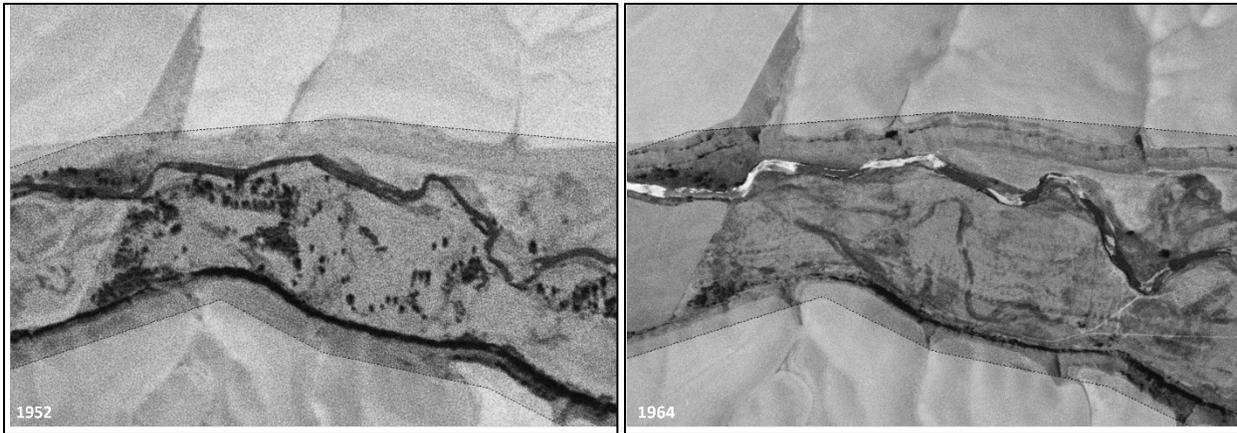
Figure 11: Aerial photos from 1952 (left) and 1964 (right) focusing on the lower portion of the project area where floodplain vegetation (likely cottonwoods) in the 1952 image were removed by the 1964 image.

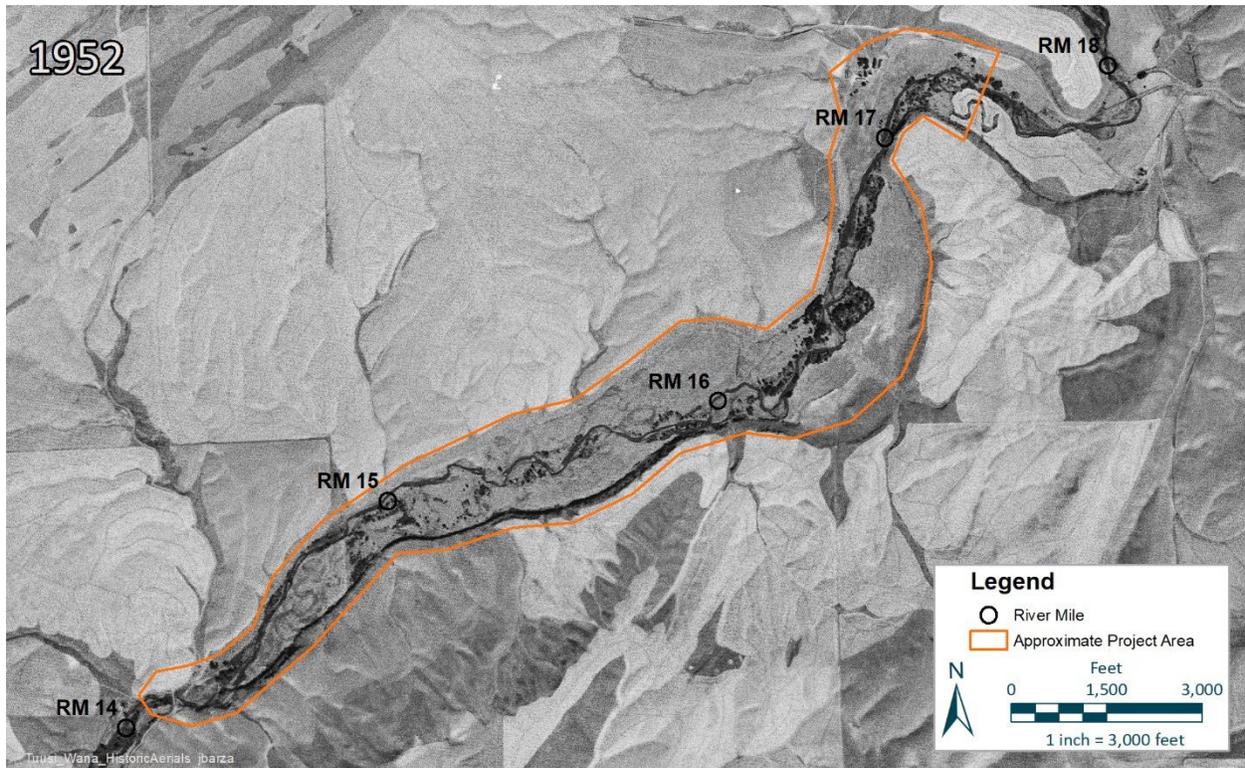
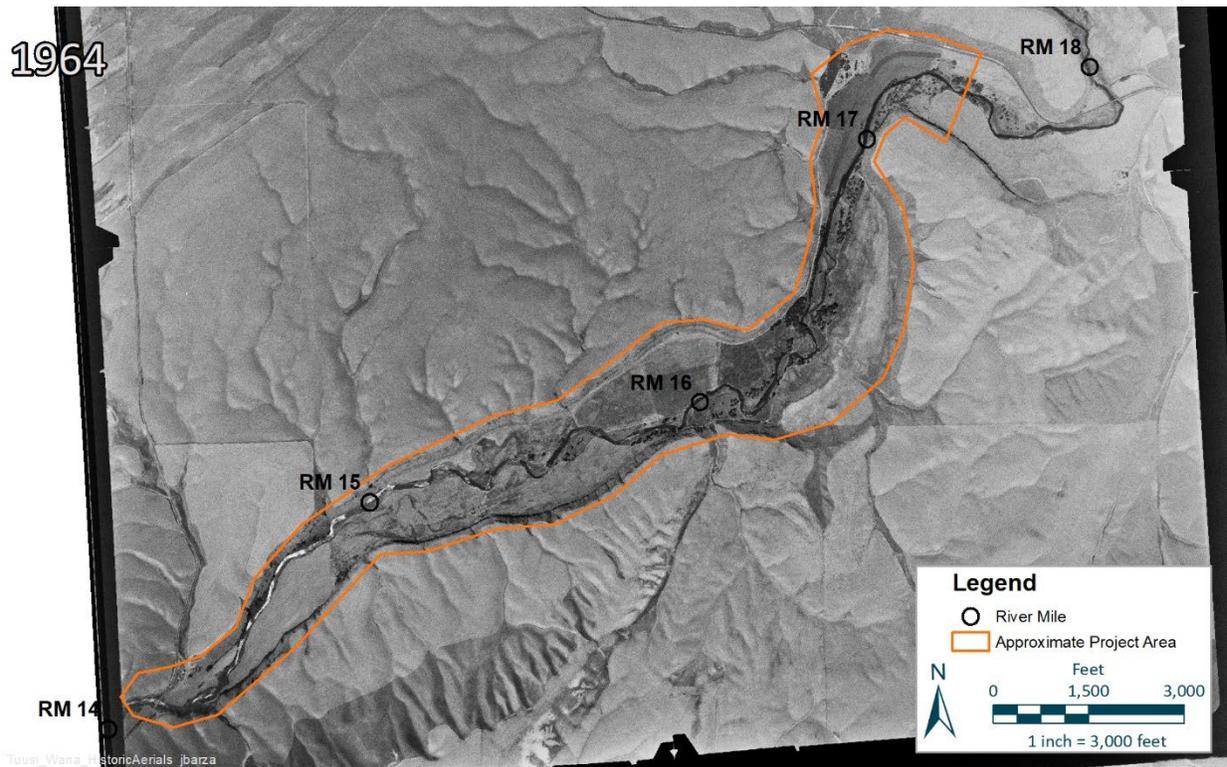
Figure 12: Aerial imagery from 1952 and 1964. Note, a nearly 100-year event occurred in 1949, approximate 5-year events occurred in 1952, 1953, a near 25-year event occurred in 1959, and a near 50-year event occurred in December 1964.

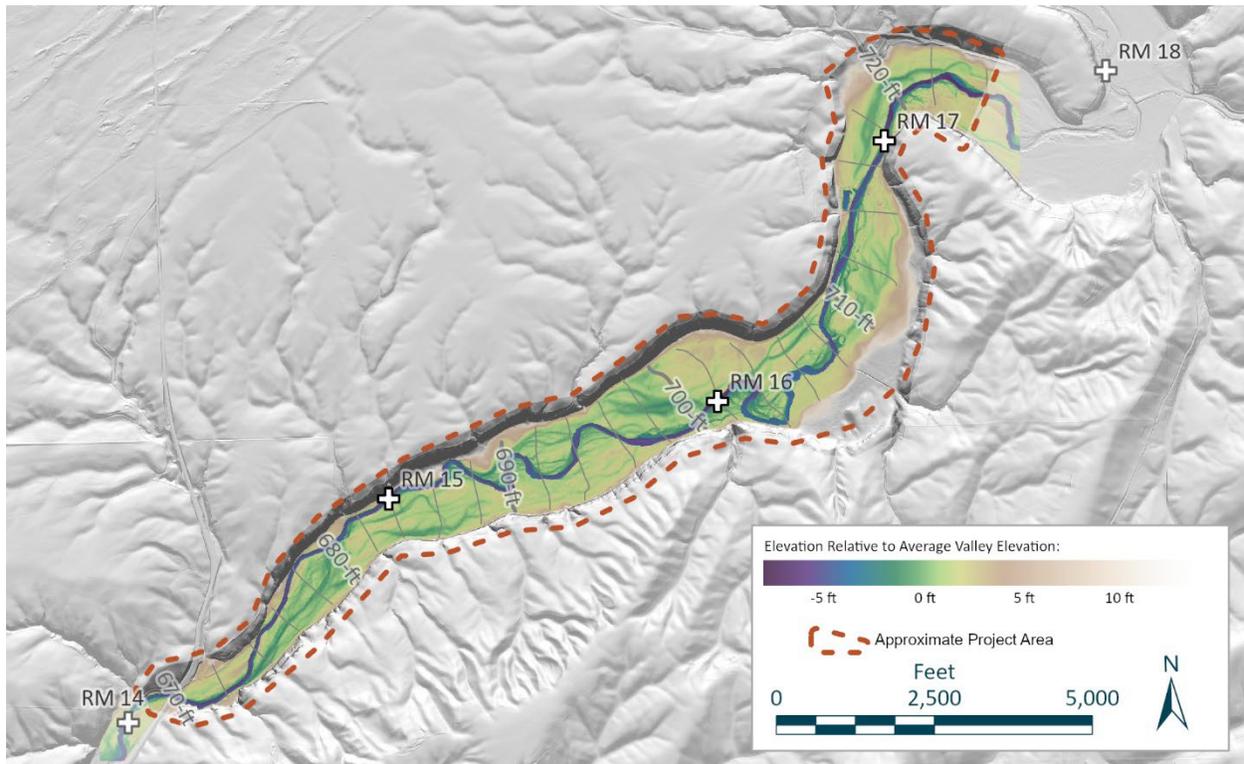
Figure 16: LiDAR elevation data of the project area, showing hillslopes, and historical floodplain areas.

The project area occupies the entire Touchet River valley bottom from roughly RM 14 – 17. At the site, the Touchet River has a channel slope of 0.2% and drains a watershed of 700 mi² which receives roughly 25 inches of annual precipitation, when averaged across the basin. The Touchet River valley bottom at the project site lies roughly 100-200 feet in elevation below the neighboring hills, and the valley bottom is bounded by steep, often near-vertical, valley sides composed of exposed outcrops of basalt bedrock or basalt mantled by shallow colluvium. The channel is laterally unconfined as the valley bottom width at the project area ranges from roughly 700-2000 feet. An overview of the morphology of the Touchet River valley at the project site is shown in Figure 16.

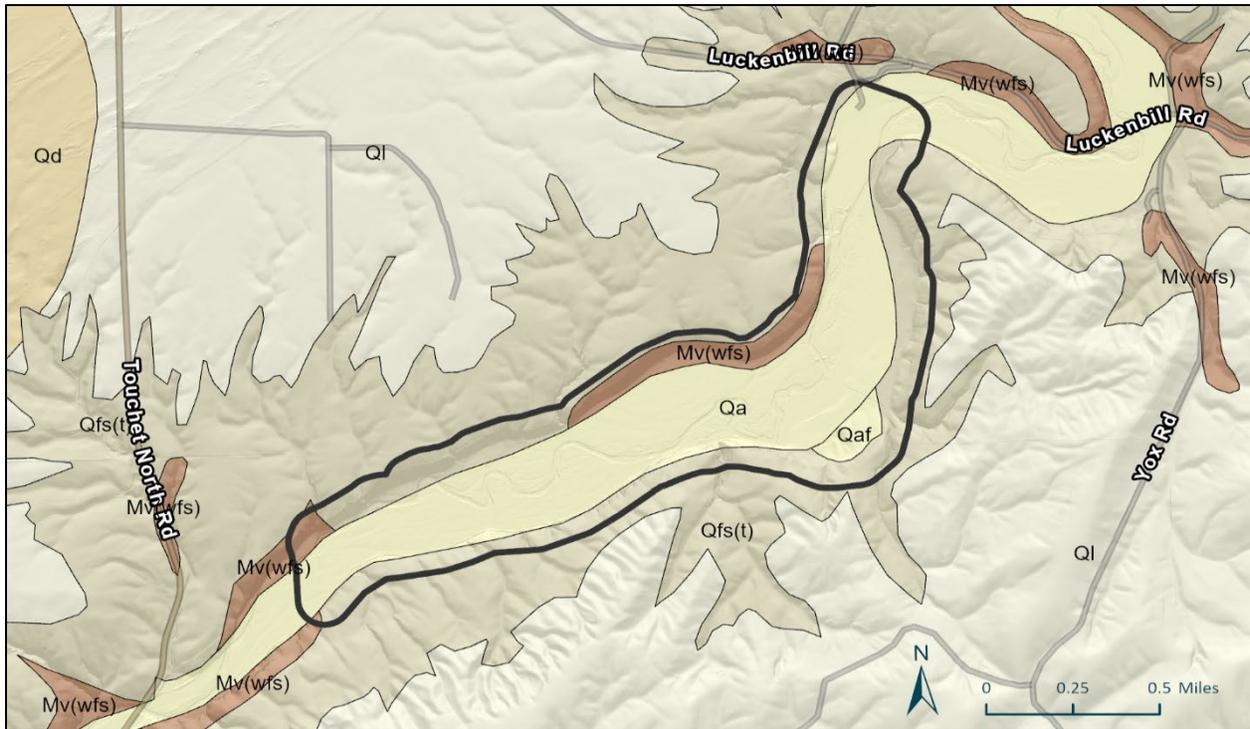
Figure 17: Geologic map of the project area. Geologic data are from Washington Division of Geology and Earth Resources (2016).

Geologic mapping of the site was performed at 1:100,000 scale, so the location of some geologic contacts may not match the exact location of outcrops at the site, and several small landforms/outcrops that were observed in the field are not noted by the Washington Division of Geology and Earth Resources (2016) mapping, but field observations from site visits for this project agree with the general geologic framework shown for the site. In general, the valley is bound by basalt bedrock hillslopes, which were covered by fine grained Pleistocene outburst flood backwater deposits (Touchet Beds) during the Missoula Floods, occurring from roughly 12 - 15 kiloannum (k.a.) ago (Spencer and Knapp 2009). Missoula Flood deposits in the project area vicinity are present due to backwatering of the flood waters upstream of Wallula Gap, and these deposits consist of graded silt and sand deposited in a series of rhythmic beds (Bjornstad 1980) associated with over 40 mega flood events (Waitt 1980; 1985). Sediment deposits associated with later phases of the Missoula Floods were placed contemporaneously with the Mt. St. Helens S tephra (roughly 13 k.a. ago) which provide age control and telltale marker for late-stage Missoula Flood sediments (Bjornstad 1980; Clague et al. 2003).

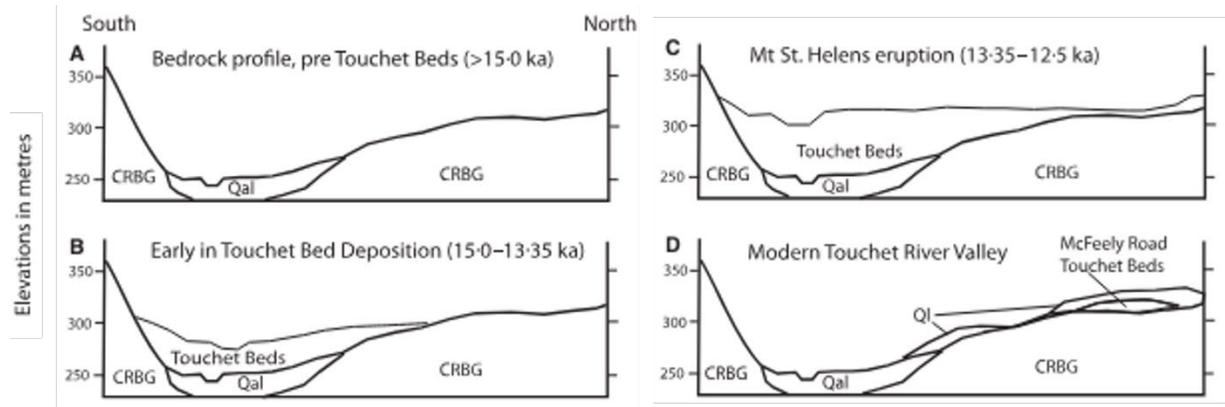
Figure 18: Generalized Late-Quaternary evolution of the Touchet River Valley (modified from Spencer and Knapp (2009)).

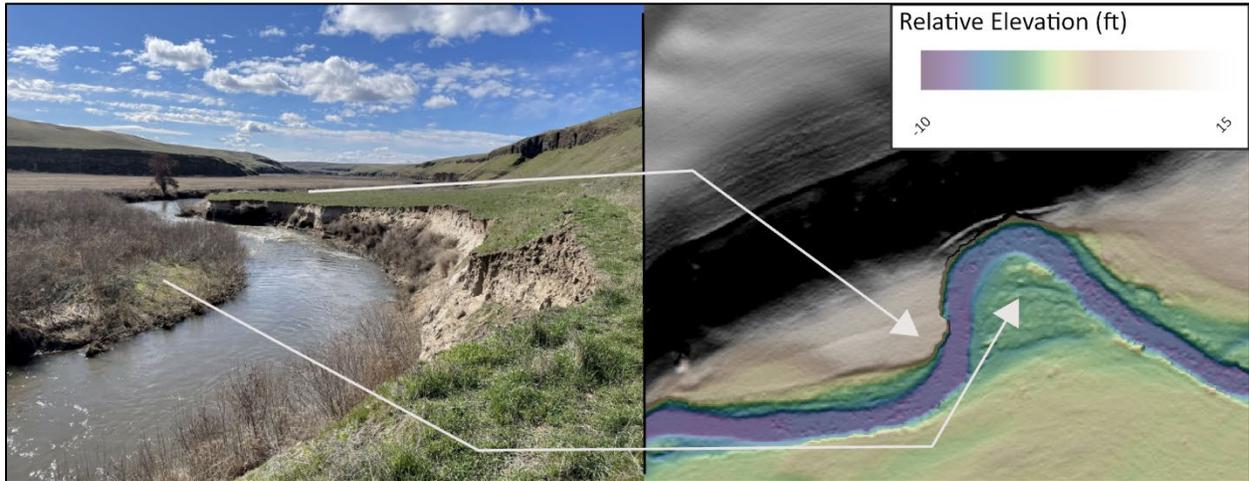
Figure 19: Photo of a high, valley-margin terrace which displays distinct bedding of fine sediments (left) and a relative elevation map of the same landform (right).

Field and desktop observations suggest that Touchet Beds may be preserved in limited locations through the project area as valley-margin terraces where the channel has not migrated and removed the sediments, though these locations have not been thoroughly analyzed to confirm the presence of Touchet Bed deposits in the valley bottom of the project area. At least one of these older landforms which may be composed of Touchet Bed material is actively eroding, pointing to the limits on residence times by fine sediments in valley bottoms (Figure 19).

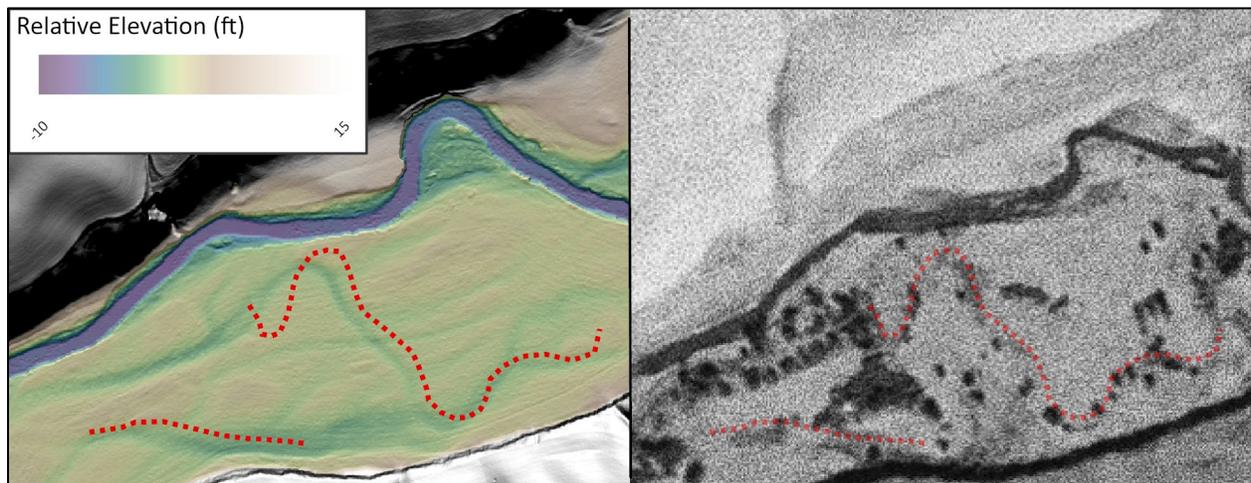
Figure 20: Relative elevation mapping (left) and 1952 aerial imagery (right) of the abandoned floodplain surface which comprises much of the project site.

Red lines highlight former channel scars or swales visible on both maps.

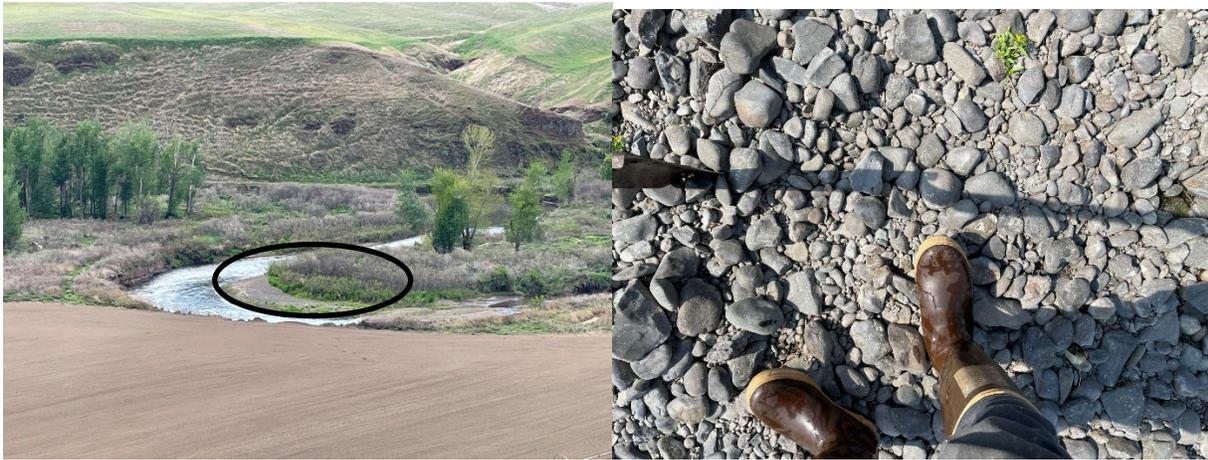
Figure 21 : Active contemporary (modern) alluvial surface (left) and material on active point bar (right).
 This surface correlates with channel traces and signatures visible on LiDAR (Figure 21).

The most recently formed alluvial surface (Figure 21) at the project site is a connected floodplain inset to elevated valley bottom surface. This contemporary floodplain has formed in response to lateral channel changes and active fluvial reworking of sediments in the channel bed and banks. This surface is approximately 2-4 feet above the modern channel bed, displays substantial local topographic variability, shows evidence of fluvial reworking, and is mostly found in areas where the channel has occupied since approximately 1950 and since migrated away from that location (Figure 22). This surface is connected to the channel at semi-regularly occurring flows (~2-year return period), and woody riparian species densely cover this surface along the channel margins in most locations.

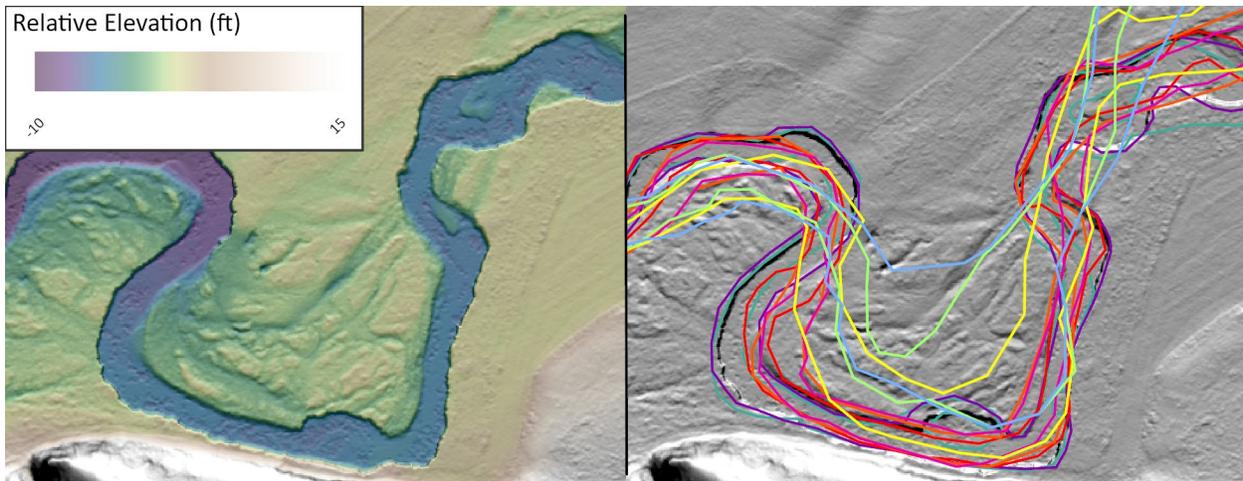
Figure 22: Relative elevation mapping (left) and a LiDAR hillshade overlain with channel traces (right) delineated from historical images (1952-2021) highlighting areas of modern, inset floodplain at the site.
 The modern floodplain is located in areas where the channel has recently been located and reworked the valley bottom.

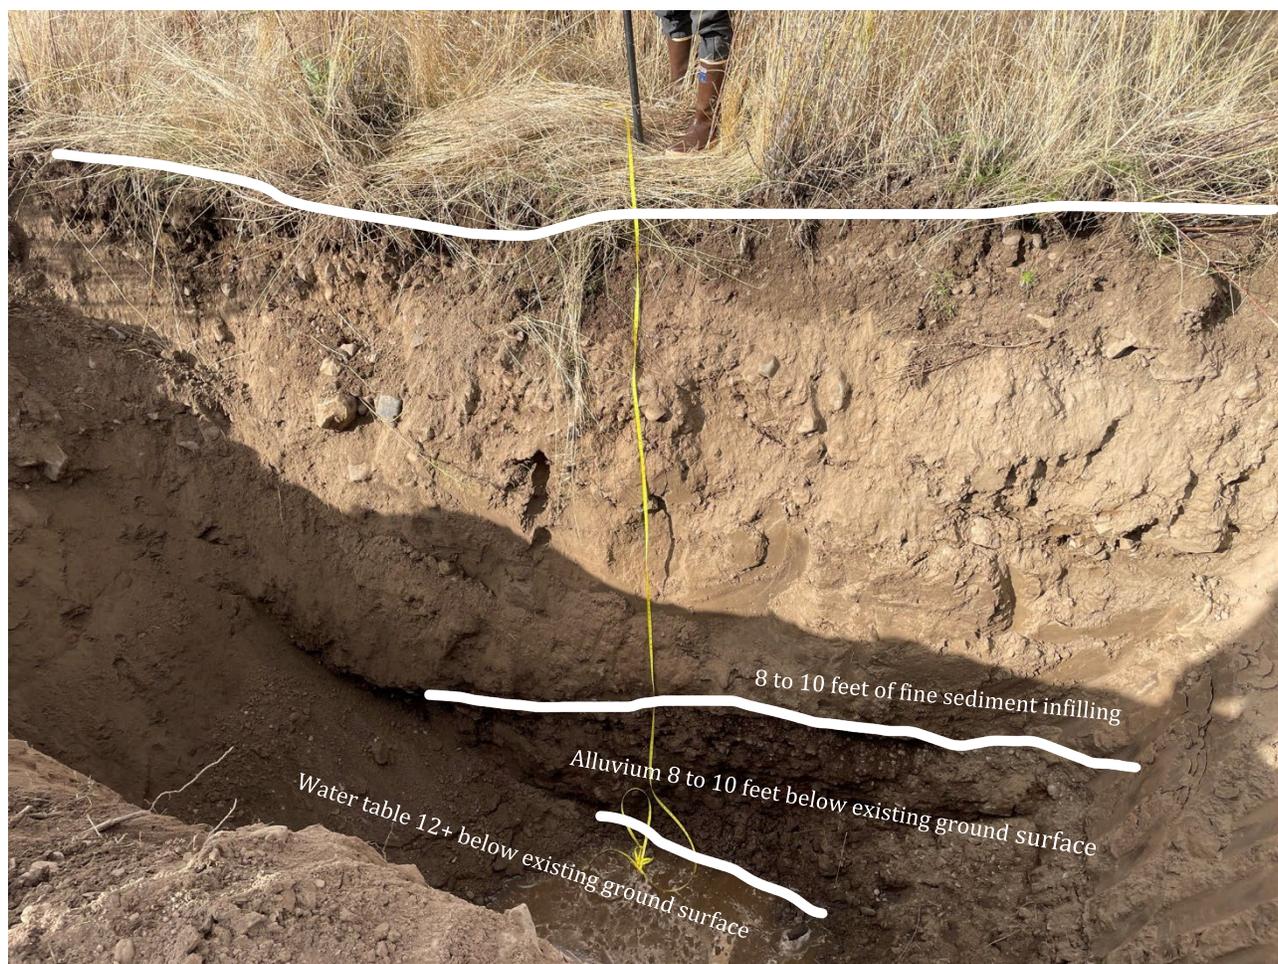
Figure 23: Annotated example of a test pit dug at Túuši Wána project area.

Lack of discernable stratification along channel banks and within test pits (Figure 23) suggests the surface comprising the majority of the valley bottom was formed by large scale floodplain aggradation during one or multiple large floods. This is primarily evidenced by an unstratified layer of sandy silt eight to ten feet above gravel alluvium observed along channel banks and within test pits as well as an absence of discernable alluvial stratigraphy and/or substates associated with in-channel or channel margin deposition and a lack of buried soil horizons in the valley bottom stratigraphy. It is acknowledged that there is uncertainty regarding this hypothesis and that test pits were limited to the river right side of the project area due to channel crossing limitations. Of note, planned additional test pits for the Spring of 2024 requested by the SRFB were unable to occur due to equipment challenges. A ground penetrating radar (GPR) evaluation of valley bottom sediment and groundwater characteristics was attempted in summer 2024 to inform design efforts, but these investigations were not successful due to an equipment malfunction which limited the depth of radar imaging to roughly 1-2 feet. The data collected as a part of this investigation is not suitable to evaluate the sedimentological and stratigraphic properties of valley bottom sediments to the degree required to satisfy review comments and substantively change the design approach at this time. Further investigation by test pits and trenches was attempted, but access constraints and technical issues provided only limited data insufficient to fill the data gap.

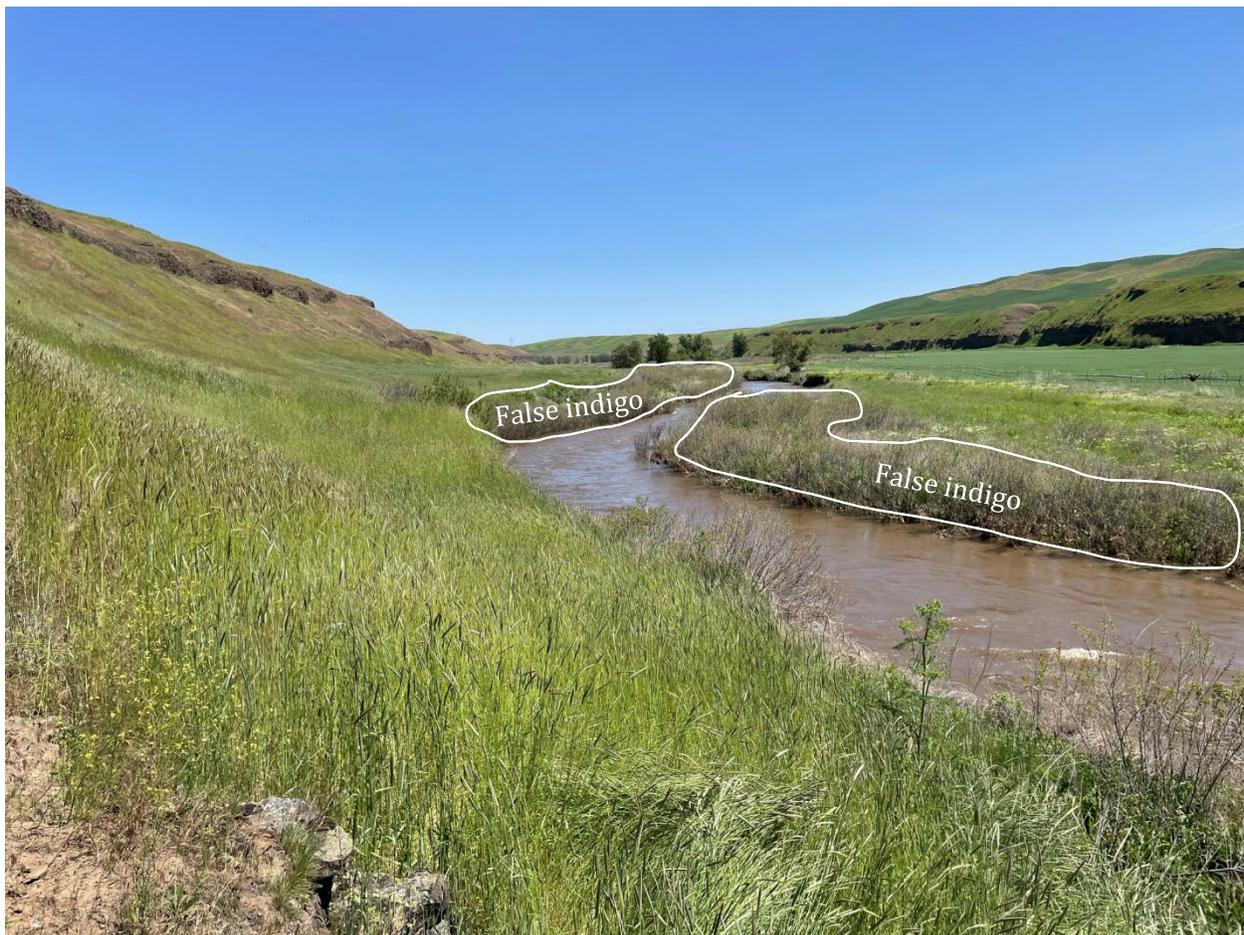
Figure 24: Representative image of False indigo likely occupying the historical niche of shrub willow (e.g., *Salix exigua*)

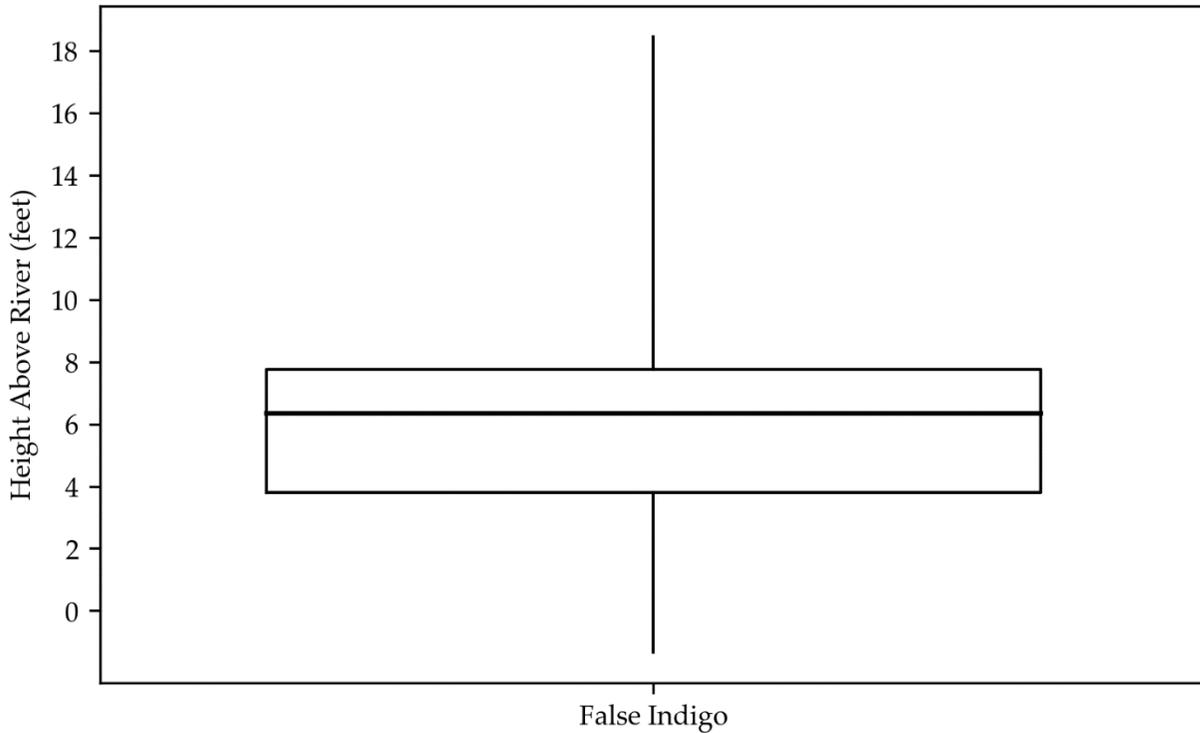
Figure 25. Box plot showing False Indigo Height Above River (HAR) estimated using NAIP aerial imagery.
 The box represents the first and third quartiles, and the horizontal bar represents the median. The vertical lines extend to the minimum and maximum False Indigo HAR estimated within the project area.

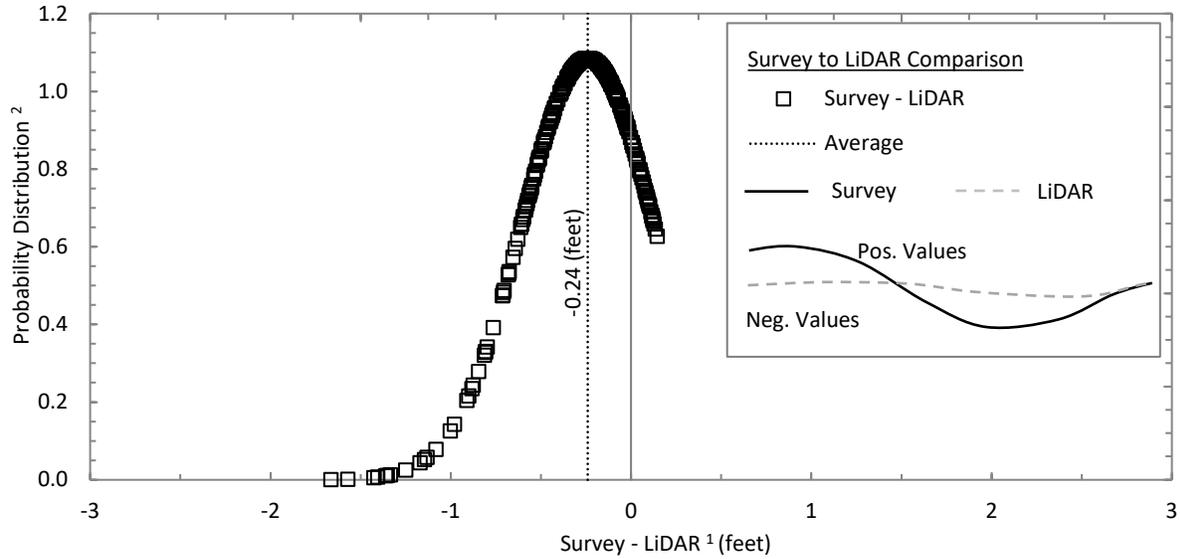
Figure 26: Survey comparison to LiDAR ground elevations.
