Túuši Wána Design Project
Touchet River - Mile 14 – 17

Final Basis of Design Report

May 2024

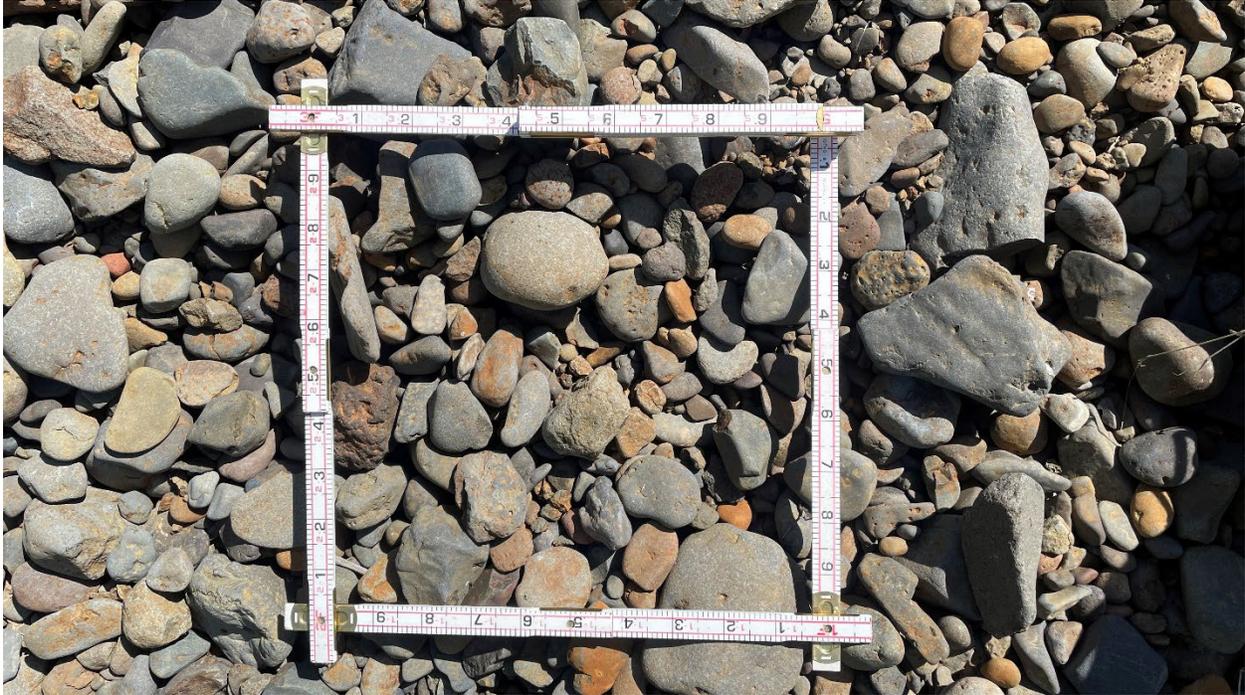
Figure 27: Representative photo of gravel bar substrate in the project area.

The Touchet River is a gravel bed river system (e.g., Church 2010) in the vicinity of the project site. The channel readily transports gravel-sized sediment as bedload at regularly occurring flows (annual peak flows, or less, based on field observations), and the deposition of gravel-sized sediment creates bed and bar forms which drive the morphology of the river channel. Much of the gravel which is transported to the site likely is generated in the headwaters, but local, secondary sources of gravel include colluvial inputs and gravel eroded from channel banks. Figure 27 provides a representative example of bar substrate at the site.

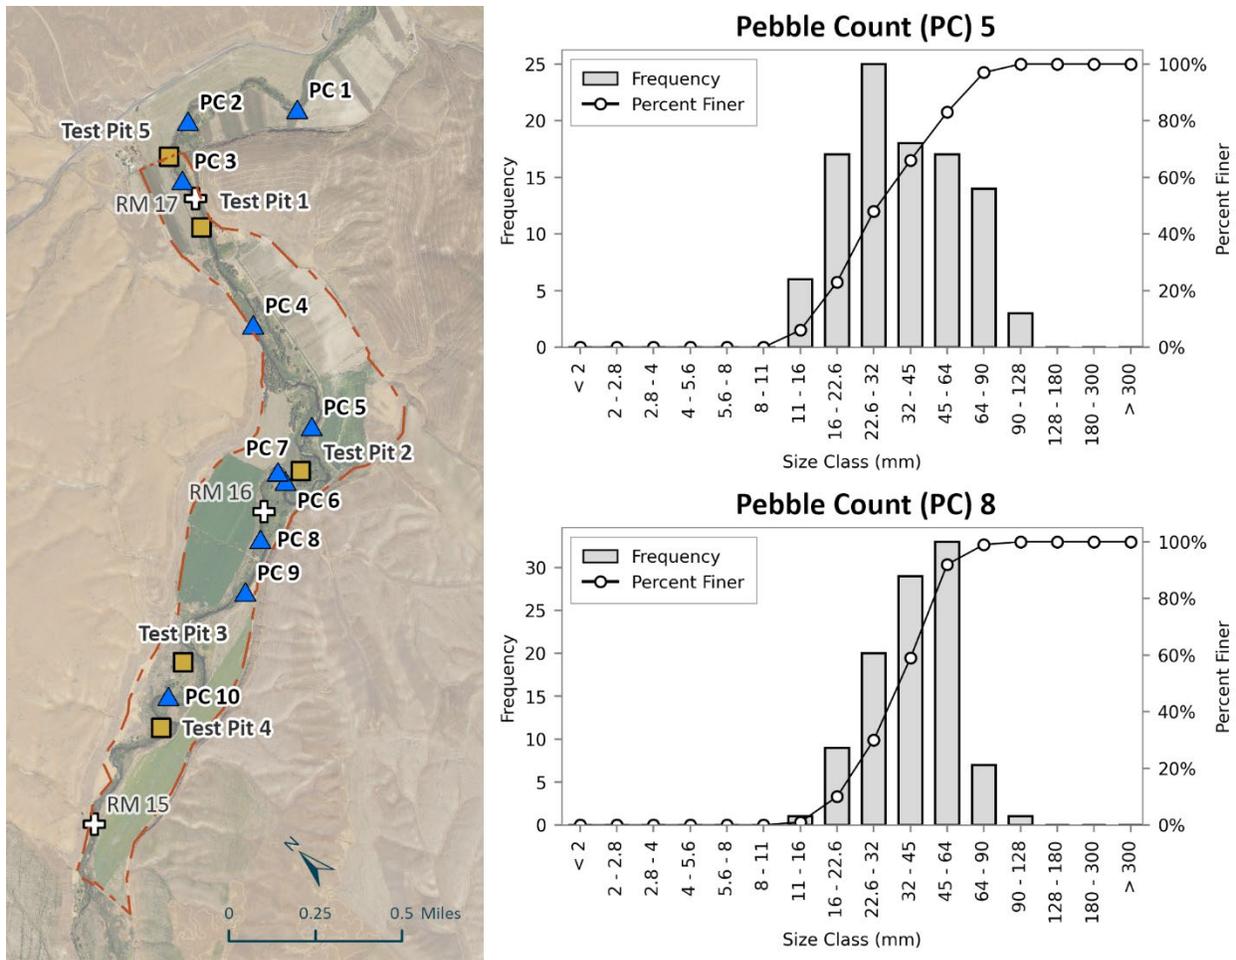
Figure 28: Map of pebble count and test pit locations. Data from two representative pebble counts is shown at right.

Figure 28 shows the locations where channel bed grain size data were collected and representative grain size distribution data from two sites within the bankfull channel, it also shows the test pit locations. Grain size data were collected by performing Wolman Pebble Counts (Wolman 1954) consisting of 100 or more clasts sampled using a step-toe random-walk approach across selected bars and islands which were exposed and/or shallowly inundated and safe to access at the time of the site visit. Alluvial bed material is relatively well sorted, and the average size of sediment forming bars and islands in the channel is roughly 0.1–0.25 ft in diameter. Bed material at riffles was roughly 0.25–0.5 ft in diameter, but no pebble counts were conducted at riffles as those sites were not accessible at the time of the field visit. Coarse cobble and boulder sized material was observed sporadically in the channel in areas which had been anthropogenically modified and where the channel flows against bedrock outcrops along the valley margins. These grain size data support previous qualitative observations regarding the sedimentary characteristics of coarse alluvium found at the site. Appendix 7.7 includes summary plots of all pebble count data collected at the site.

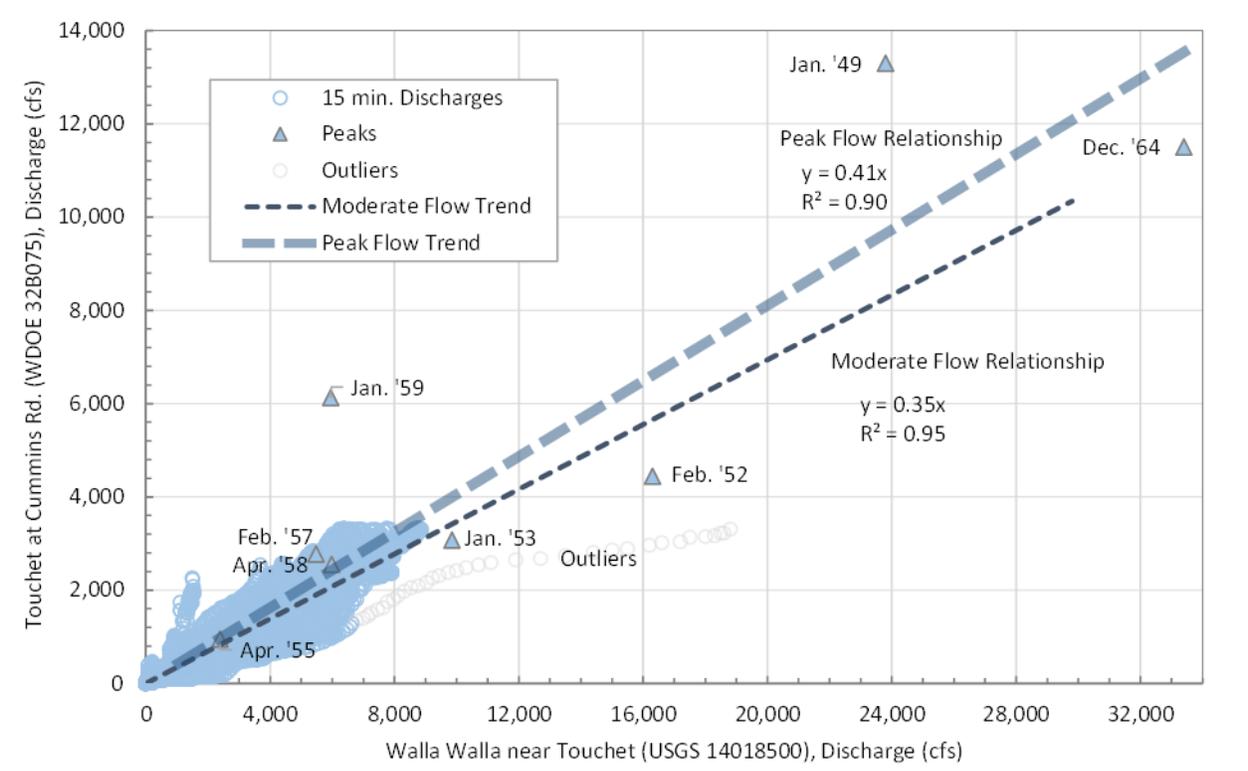
Figure 29: Flow relationship between the Walla Walla River near Touchet and the Touchet River at Cummins Road.

Stream flow data from these gages were used for annual and monthly hydrologic analyses (Table 5 and Figure 29). To compensate for the more limited and periodic period of record on the Touchet River a discharge relationship analysis was completed relative to the much longer period of record on the Walla Walla River. This relationship was used to transfer peak flow statistics for the 2- through 25-year recurrence interval events from the Walla Walla gage to the Touchet River gage at Cummins Road. Data from the recently installed gage WADOE gage located immediately upstream of the project area was used to verify the efficacy of the previously performed gage transfer.

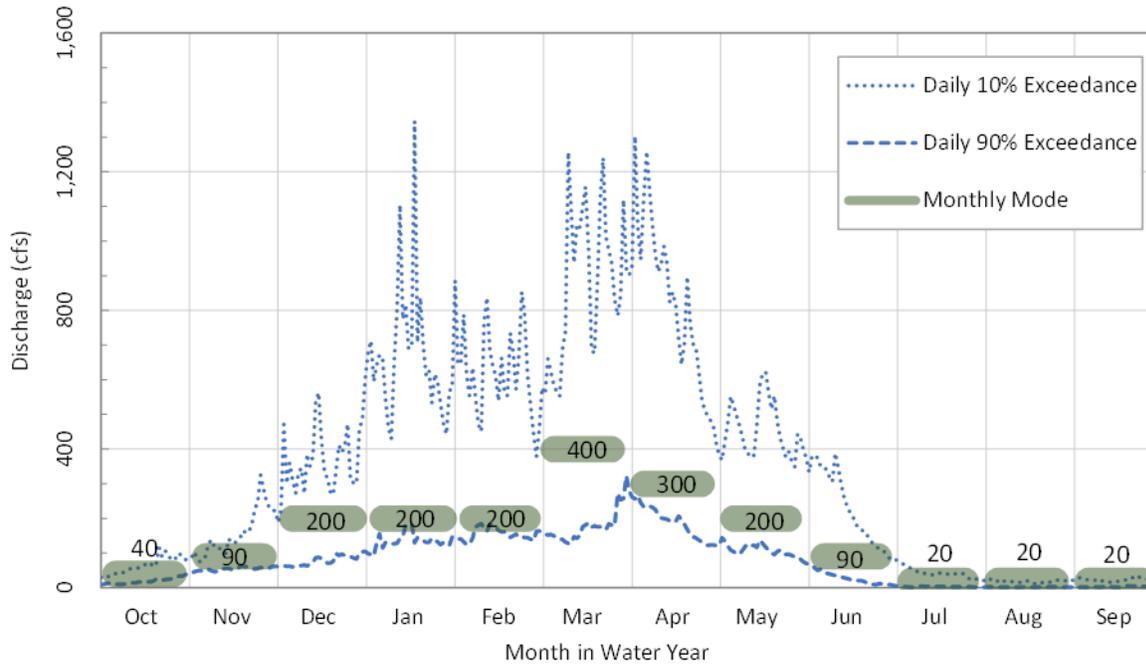
Figure 30: Annual Hydrology Statistics | Touchet River at RM 14 | Water Years 2003 to 2021.

The project reach seasonal flow estimates are presented in Figure 30 and Table 6.

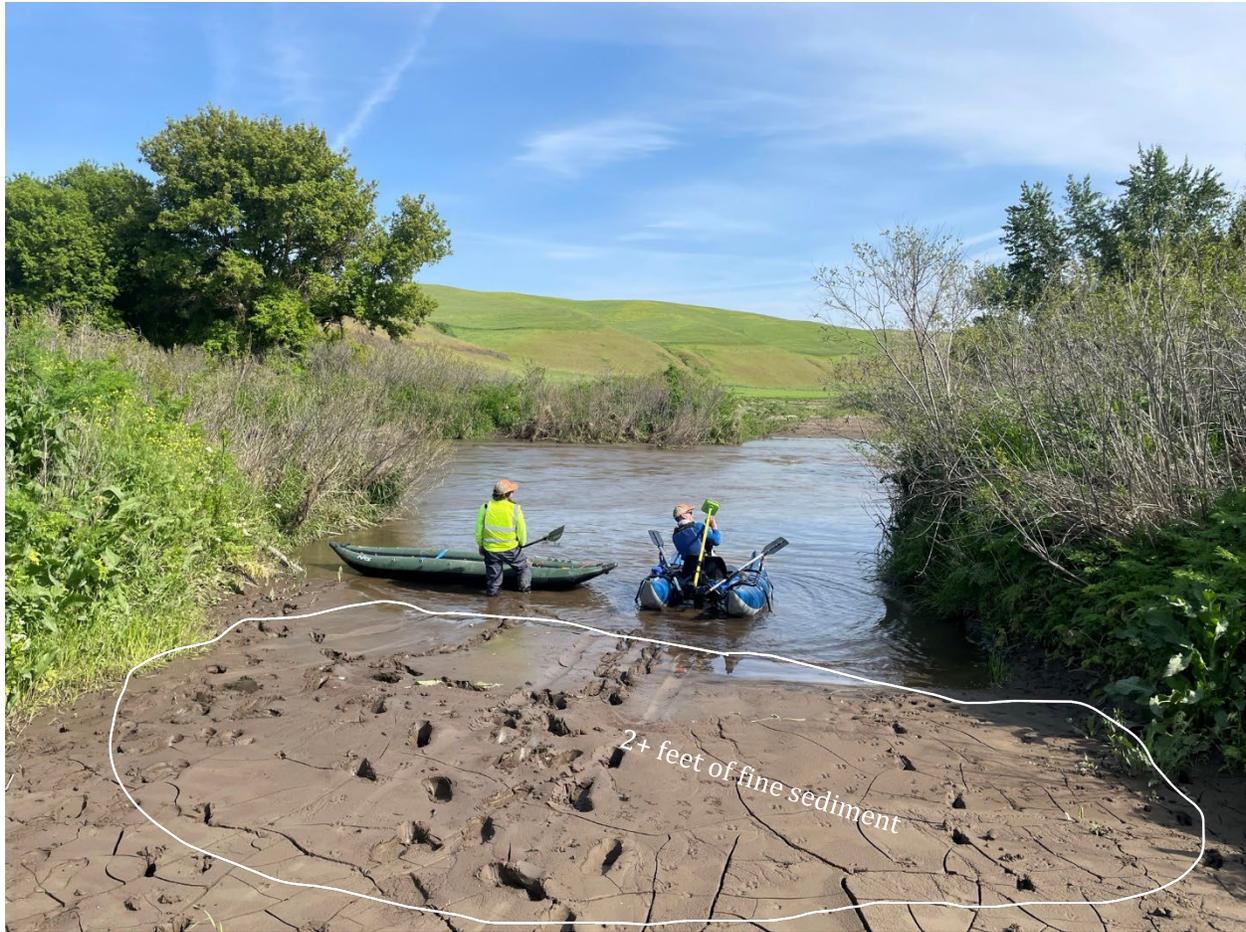
Figure 31: Fine sediment along the banks near RM 15.7. Deposit was from a single year of spring runoff flows.

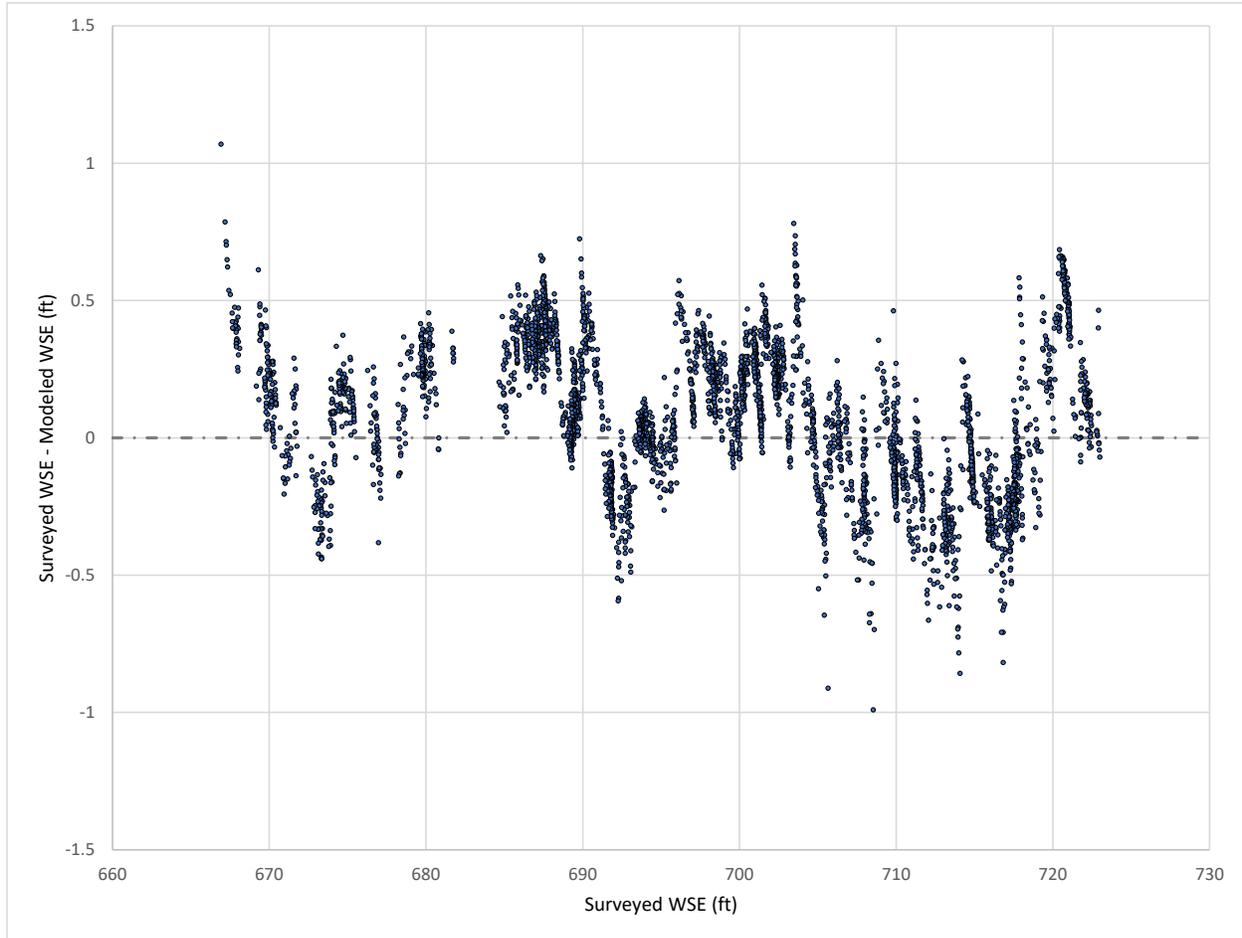
Figure 32: Touchet River Model Validation at 1,000 cfs.

The model was validated by comparing the model water surface elevations (WSE) at 1,000cfs to elevations that were surveyed during the May 2022 topo/bathy survey, which occurred when the Touchet river was 1,000 cfs on the DOE 32B090 gage. 3740 points were used for the comparison. The difference between the surveyed WSE and Modeled WSE are shown in Figure 32. The root mean square average of the difference in WSE was 0.27 ft, suggesting a good agreement between the model and surveyed conditions.
