CTUIR UMATILLA ANADROMOUS FISHERIES HABITAT PROJECT

Annual Report

February 1, 2008 to January 31, 2009
Fiscal Year 2008

CONTRACT # 36848
Northwest Power Planning Council Project # 1987-100-01

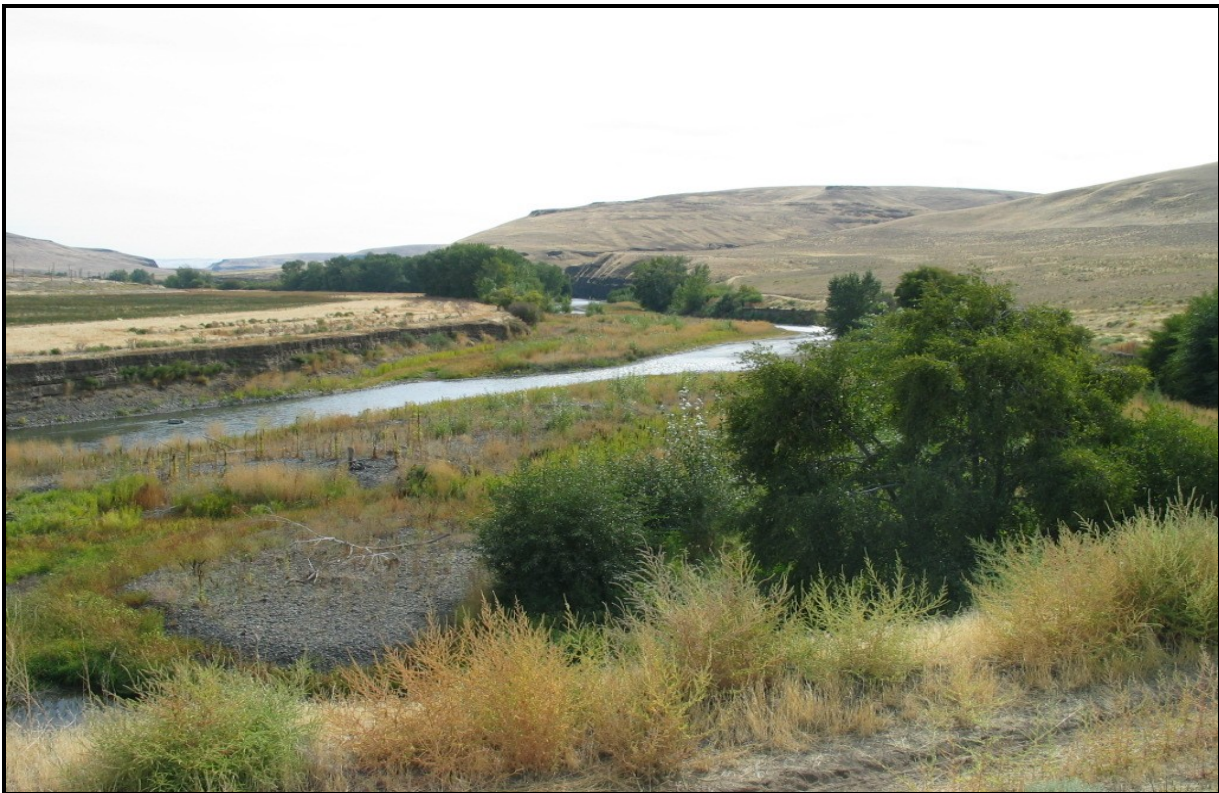
Figure 5. Typical Reach of the Mid-Umatilla River Basin

Figure 5 shows the valley form and degraded fisheries habitat conditions in the mid-Umatilla River Basin, including the disconnected floodplain, poor width-to-depth ratios, streambank erosion, channel incision, noxious weeds, and lack of adequate stream shading due to the narrow riparian belt width comprised of secondary growth and located a significant distance from the wetted channel. Three-quarters of the Umatilla River has been constrained by levees, and consequently, approximately 70% of 422 miles of inventoried river and streams are in need of improvement (Umatilla/Willow Subbasin Planning Team 2004).

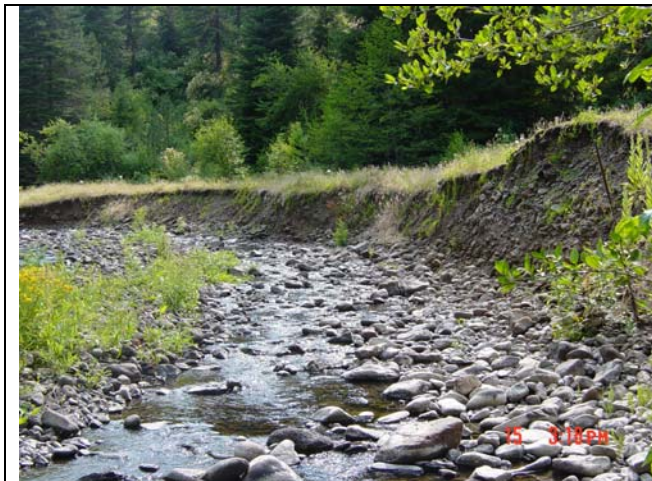
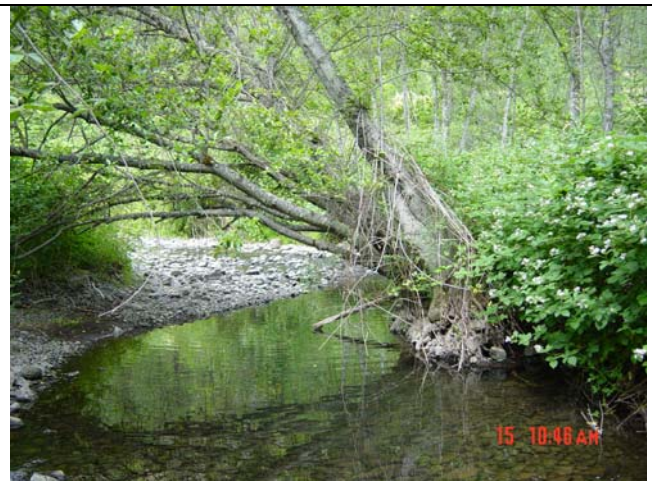
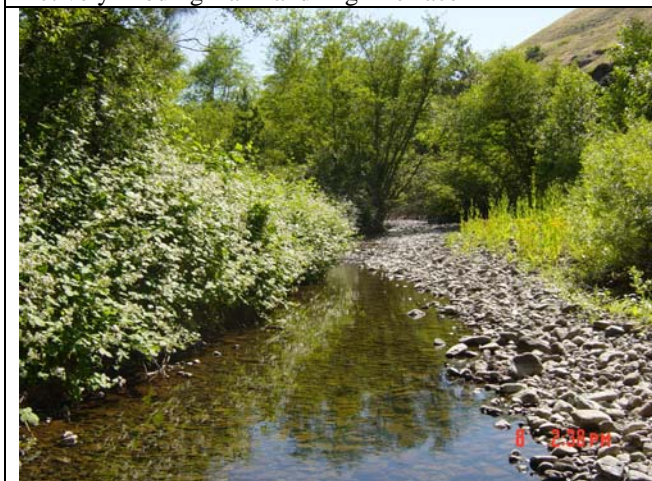
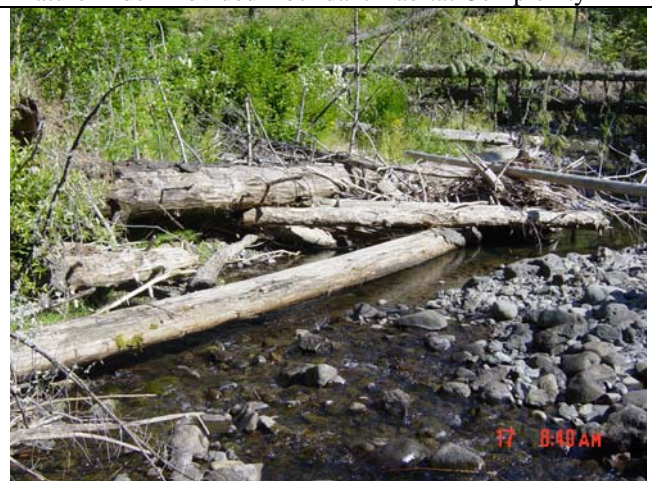
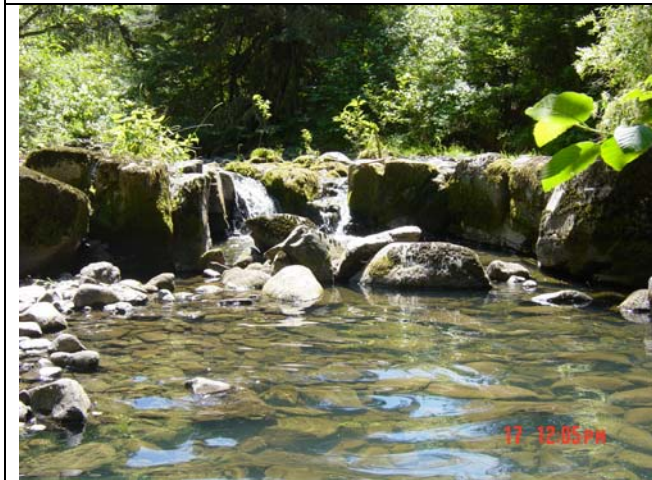
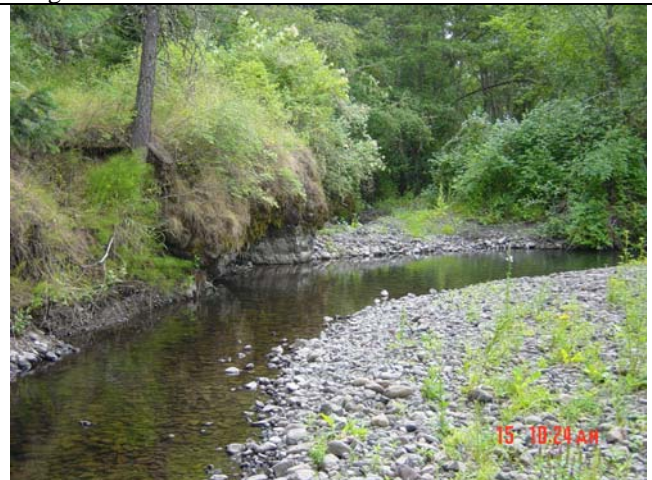
Figure 14. Isquiltpe Creek Channel and Riparian Features

Actively Eroding Bank and High Terrace

Mature Alder Provided Abundant Habitat Complexity

Blackberries Provided Substantial Undercut

Large Wood Debris Accumulation

Natural Falls Classified as a Partial Fish Passage Barrier

Pool and Encroaching Hillslope and Formation of Lateral Pool

Figure 14 shows various habitat types inventoried in Isquultpe Creek, RM 0-8.

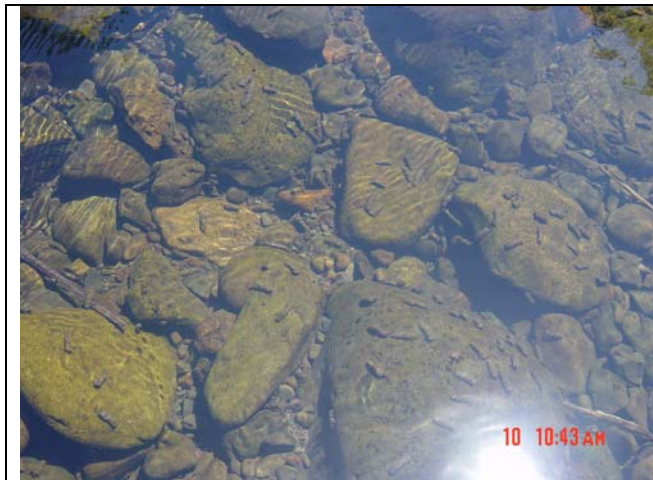
Caddisfly Larvae on Substrate

- Caddisfly larvae are very abundant (Figure 14)
- Some light cattle grazing due to cattle trespass issues
- An old gravel logging road runs parallel to the creek

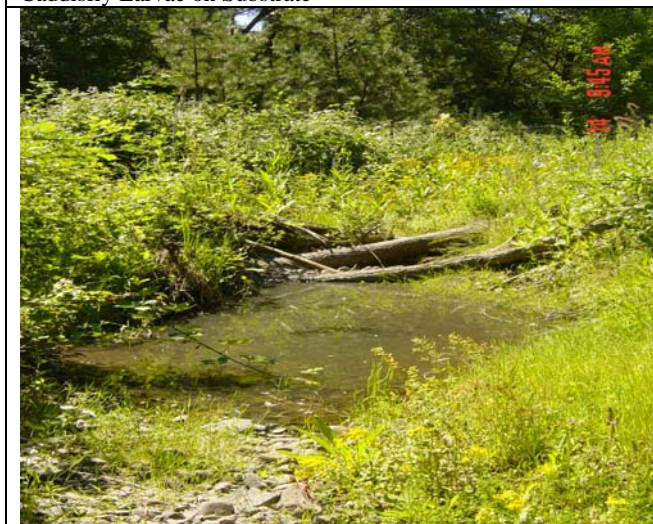
Juvenile Salmonids Were Observed Trapped In Isolated Pools

- Evidence of old timber harvesting (tree stumps)
- Juvenile salmonids were observed trapped within isolated pools due to summer low flows (figure 14)
- Recent beaver activity

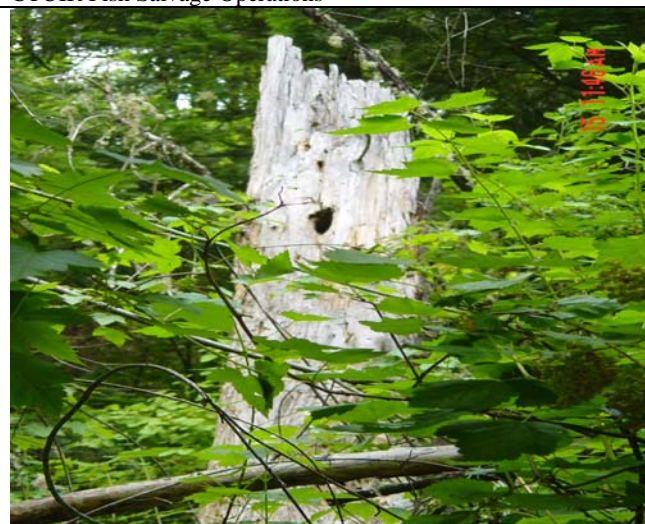
Snag Used By Wildlife, e.g., Pileated Woodpeckers

- Biota documented included: butterflies, hummingbirds, crayfish, owls, frogs, grouse, and bears
- Riparian habitat available for wildlife, e.g., snags for pileated woodpeckers (Figure 14)

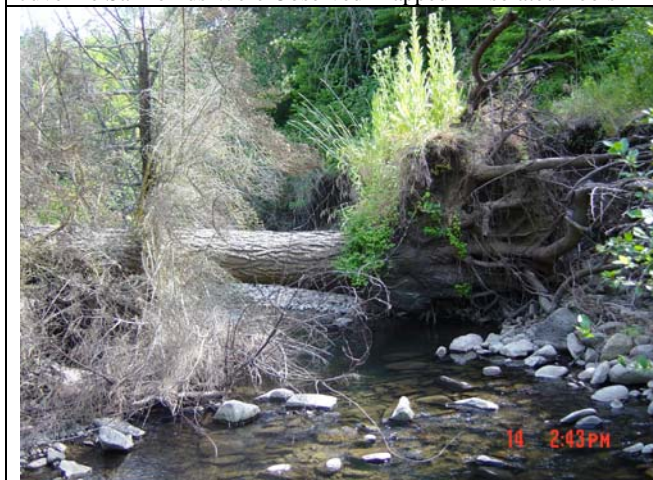
Mature Conifer Recently Felled by 90 mph Windstorm

- A recent event, a 90-mph windstorm, knocked down conifers and cottonwoods (Figure 14)
- Filamentous algae covered much of the substrate in one section of the upper reaches (Figure 14)

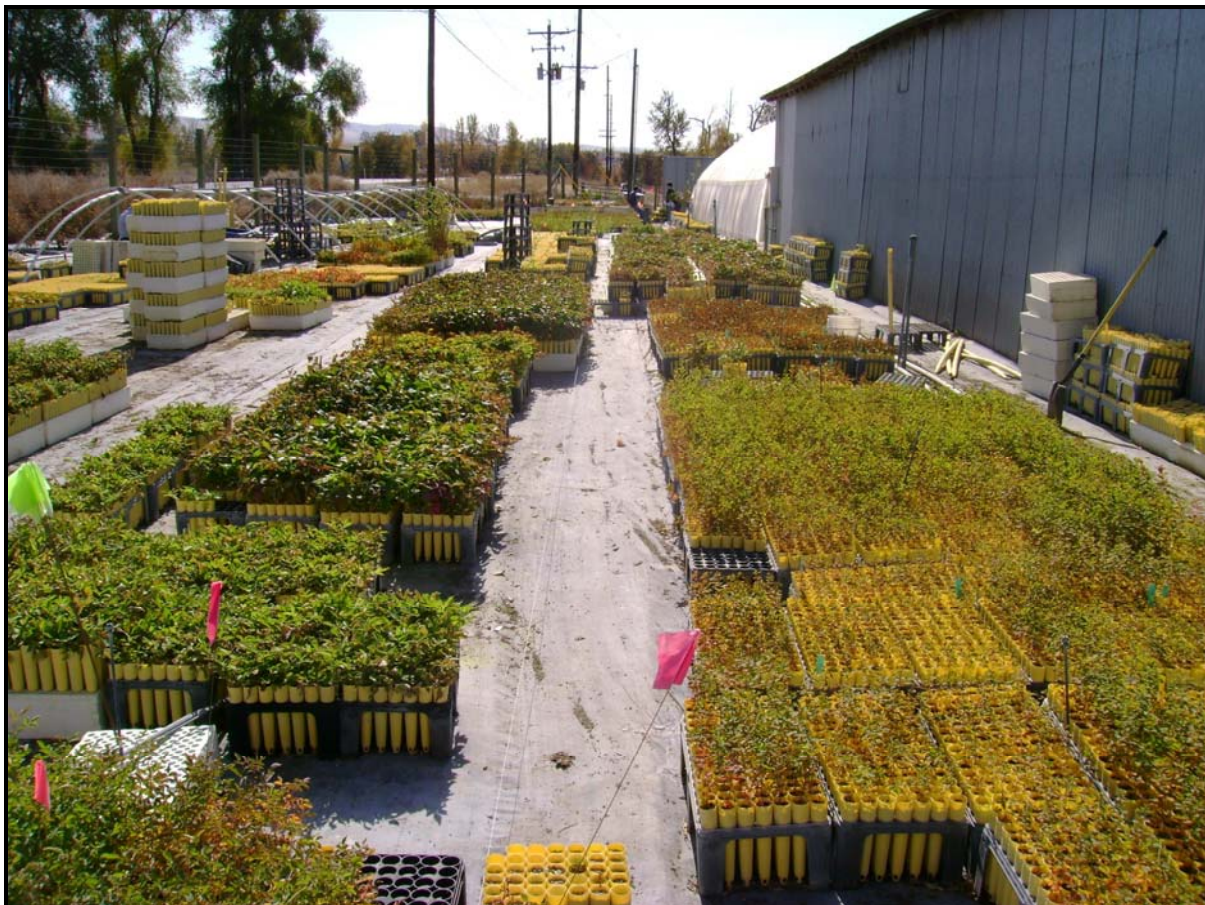
Figure 18. CTUIR Native Plant Nursery Containerized Plant Stock

Planting tasks include site planning and development of planting strategies, collection and preparation of materials (pruning and conditioning of live whip material), pre-order coordination with the CTUIR native plant nursery (Figure 18), and installation. Planting techniques are

The CTUIR UAFHP relies heavily on the nursery to provide plants for use on restoration projects. Features of the ever expanding nursery include a greenhouse, refrigerated cooler, irrigated stool beds, and containerized plant stock and its capabilities are growing steadily. The availability and quantity of plants is increasing on a daily basis due to demand, increased funding, and professional staffing.

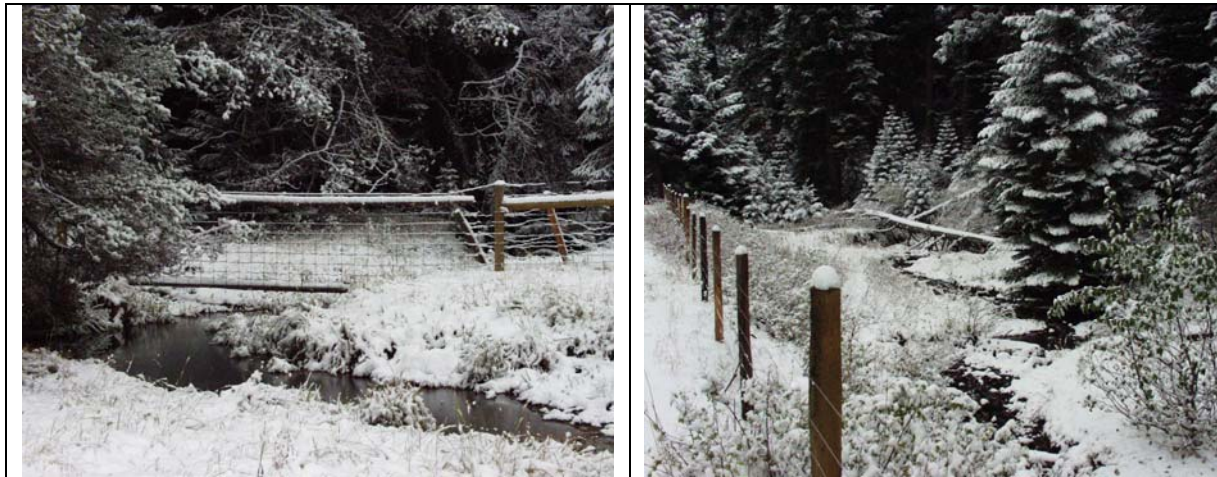
Figure 22. Fencing Installed at RM 34, Meacham Creek

Three and a quarter miles of livestock exclusion fencing were installed in the riparian area adjacent to Meacham Creek at RM 34 (Figure 22) in accordance with ODFW specifications.

Fencing consisted of several strands of high tensile smooth wire, treated wooden posts and fencing across the creek to allow livestock access to drink at selected sites and to manage livestock intensity and access at specific points.

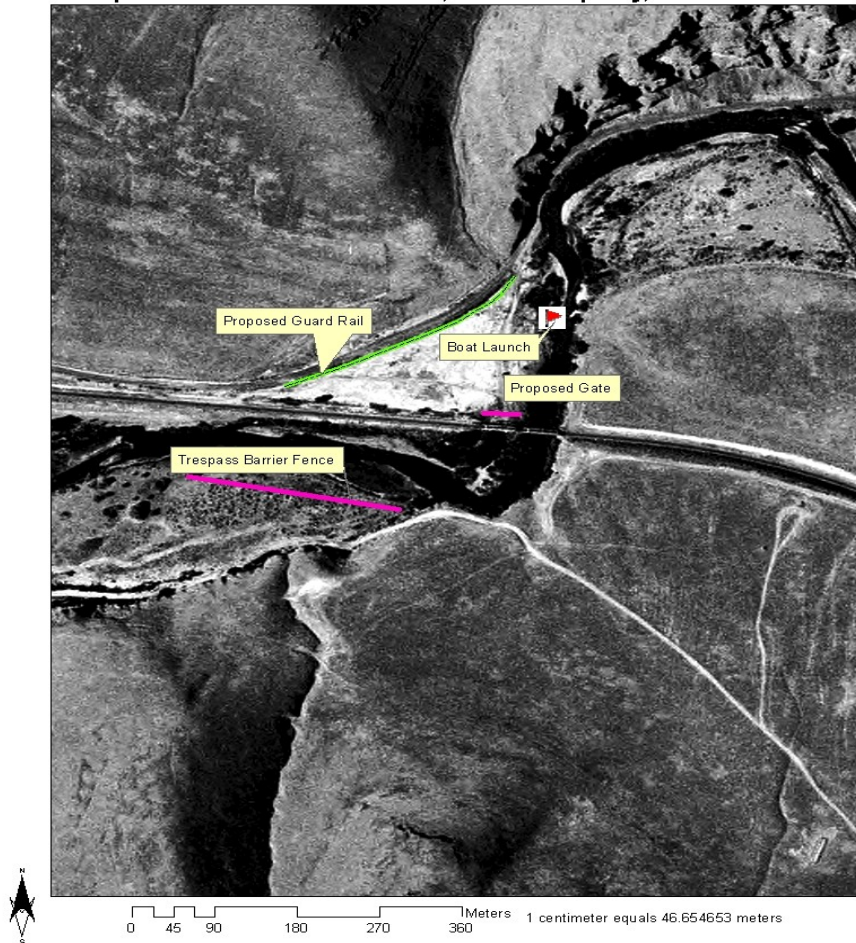
Figure 37. CTUIR/ODFW Access Restriction Project, June 2008

Proposed Access Restriction, Forth Property, Umatilla RM 43

Figure 36 shows soil preparation activities (black tarps and mowing) at the CREP project sites. Figure 37 shows the location and design of the access restriction fence and gate through the Forth property access easement that were installed to protect the B&G and Becker property easement to reduce impacts from human disturbances. Drivers of recreational off-road vehicles had been trespassing on the property and across the CREP planting areas. The access restriction project was a cooperative effort between CTUIR, ODFW, and the three adjacent landowners. CTUIR facilitated the implementation of this project by proposing the design for the gate and fence and worked with the landowners to move this projected forward. ODFW installed the fencing, gate and sign. This has resulted in improved landowner relations and has preserved the standing of this easement with the landowners for the duration of the agreement. It has protected the plantings and improved the overall aesthetics of the project area.
