# Birch Creek Watershed Action Plan

Confederated Tribes of the Umatilla Indian Reservation

Confederated Tribes of the Umatilla Indian Reservation (CTUIR). 2016. Birch Creek Watershed Action Plan. Oregon.

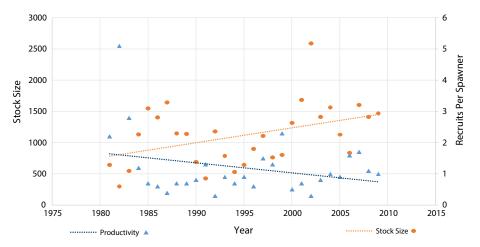
Figure 19. Birch Creek summer steelhead approximate stock size and recruitment per spawner ratios (estimates based on returns to Three Mile Falls Dam on the Umatilla River)

Current conditions throughout the Birch Creek Watershed limit returns and stock sizes in the area of the current equilibrium abundance owing largely to relatively widespread degradation of habitat. Relatively high steelhead productivity areas, that support the remaining population, are generally located in the upper reaches of the watershed (Figure 21).

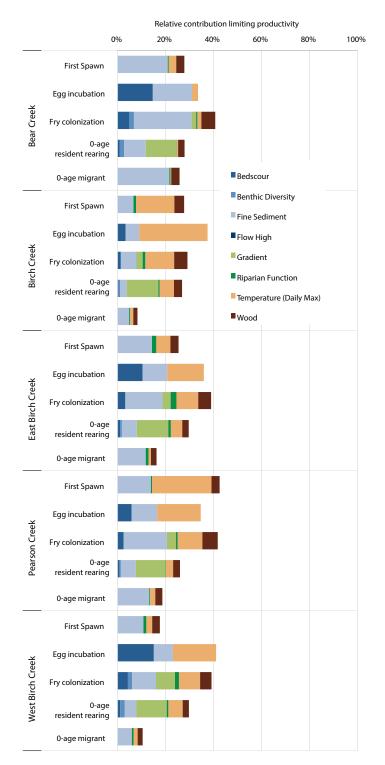
Figure 24. Limiting factors for each Tier 1 stream from first spawn through 0 age migrant

Gradient is limiting to the productivity of fry and rearing fish in all tributaries (Figure 24). Gradient increases the work requirements needed to secure food, and indirectly reduce survival through decreased growth and survival. Gradient cannot be improved in all cases, and may be related to natural limitations and natural processes. However, the loss of Beaver Ponds and natural log jams reduces the effective gradient of Birch Creek and limits productivity and capacity for summer steelhead.

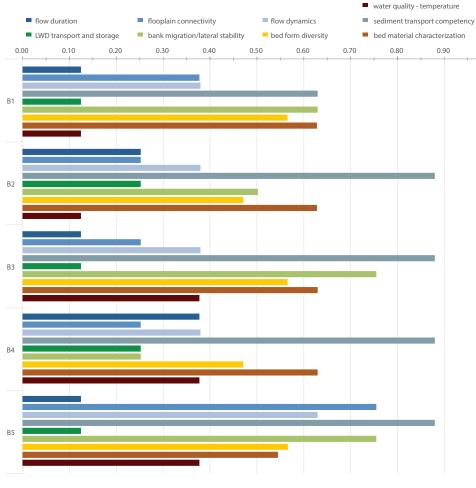
Figure 28. Functional parameter scores by reach in Birch Creek

The highest performing categories are hydraulic and geomorphology, largely due to the streambed material composition and sediment transport characteristics.

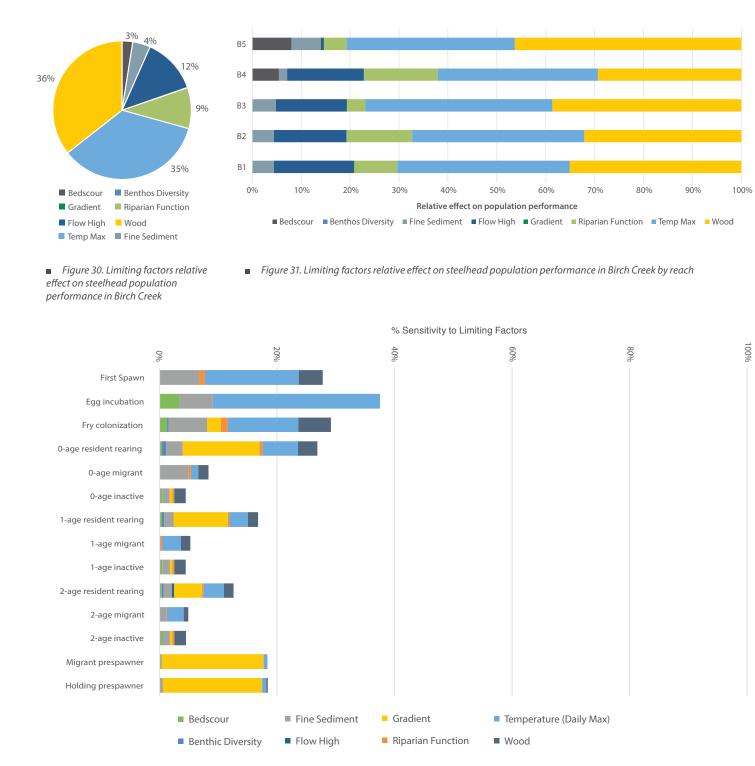
Figure 32. Steelhead sensitivity (%) to limiting factors by life stage in Birch Creek

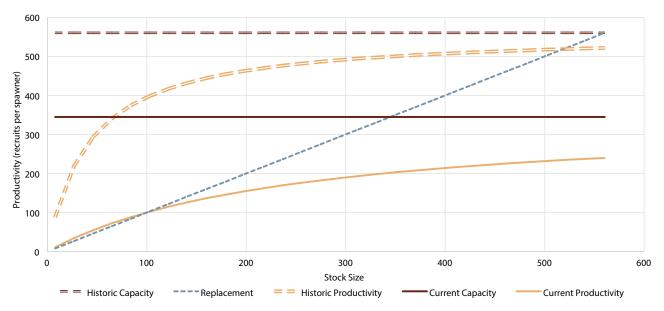
Figure 33. Stock recruitment relationships for the current and historic scenarios based on habitat productivity
and capacity in Birch Creek

Independent of the temperature impacts, the current physical adult habitat capacity in Birch Creek is approximately 62% of historic conditions (Figure 33). However, due to multiple sources of degradation, productivity in Birch Creek is less than 10% of historic (Figure 33). Collectively, the reduction in productivity and capacity, in Birch Creek reaches, has resulted in an equilibrium abundance that is less than 20% of historic, and a population with substantial restoration potential and need.

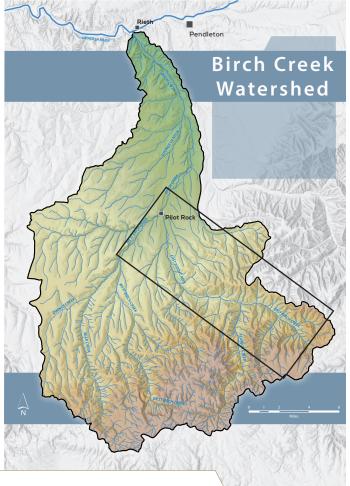
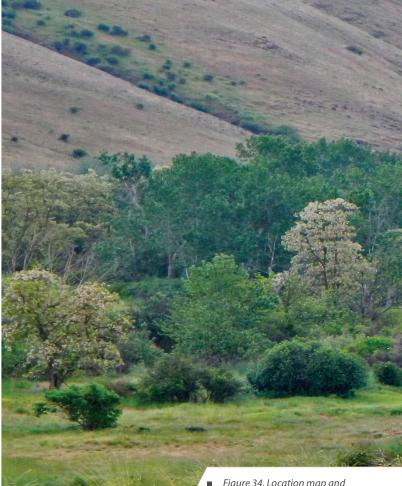
Figure 34. Location map and photograph of East Birch Creek

Despite being situated within unconfined or partiallyconfined valley bottom, East Birch Creek reaches EB1 through EB3 have been disconnected from the floodplain. As an indicator of channel straightening, all of the reaches are much less sinuous than expected, with sinuosity ranging from 1.10 (EB3) to 1.15 (EB1). In response to channel straightening, reaches EB1 through EB3 have become incised vertically into the valley bottom, with entrenchment ratios ranging from 1.74 to 2.62. Reaches EB4 and EB5 are less incised and better connected to the floodplain, with a larger entrenchment ratio of 2.84 and 2.61, respectively. At the larger 100-year flood discharge, the percentage of the valley bottom inundated ranges from 40% (EB3) to 55% (EB2), indicating significant floodplain disconnection.

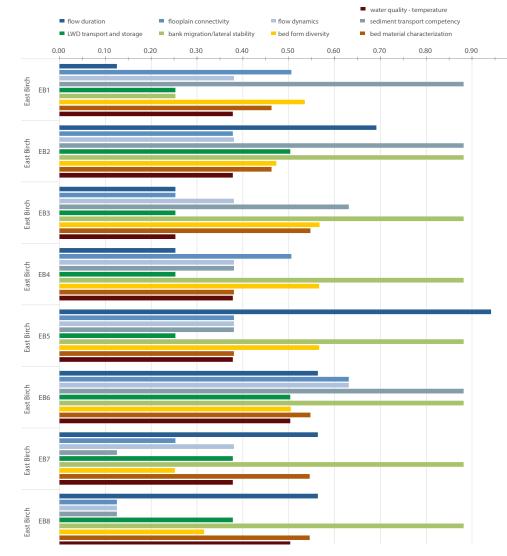
Figure 36. Functional parameter scores by reach in East Birch Creek

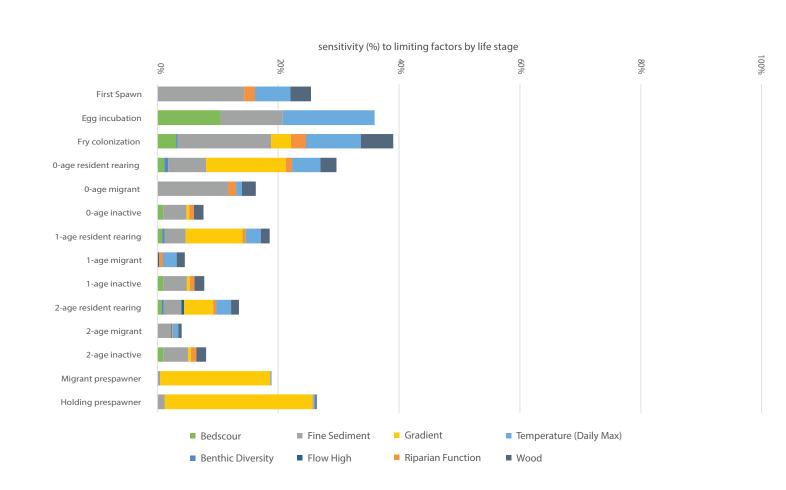
Figure 39. Steelhead sensitivity (%) to limiting factors by life stage in East Birch Creek

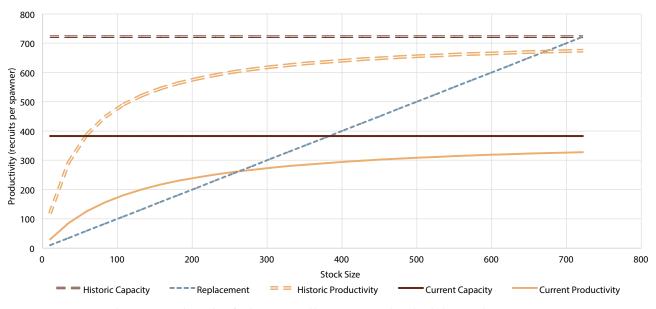
Figure 41. Stock recruitment relationships for the current and historic scenarios based on habitat productivity and capacity in East Birch Creek

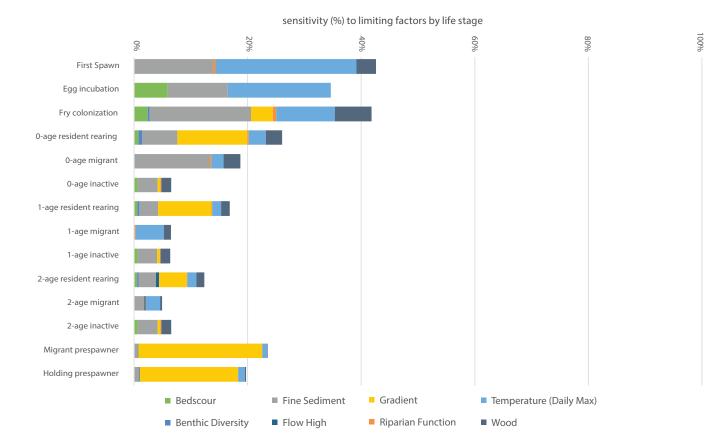
Figure 48. Steelhead sensitivity (%) to limiting factors by life stage in Pearson Creek

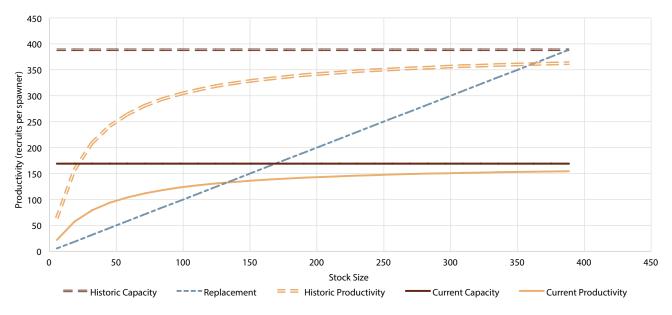
Figure 51. Stock recruitment relationships for the current and historic scenarios based on habitat productivity and capacity in Pearson Creek

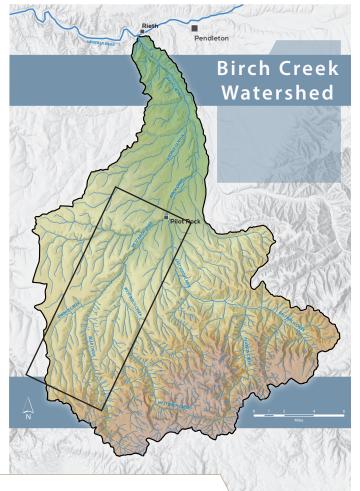
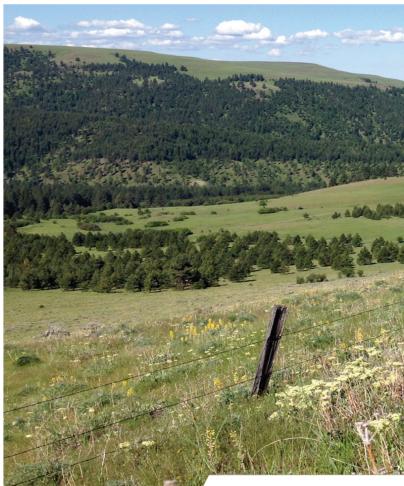
Figure 54. Location map and photograph of West Birch Creek

Despite being situated within unconfined or partiallyconfined valley bottom, West Birch Creek reaches WB1, WB2, and WB4 have been disconnected from the floodplain. As an indicator of channel straightening, all three reaches are much less sinuous than expected, with sinuosity ranging from 1.08 (WB2) to 1.16 (WB4). In response to channel straightening, reaches WB1, WB2, and WB4 have become incised vertically into the valley bottom, with entrenchment ratios ranging from 2.11 to 3.15. Reach WB3 is less incised and better connected to the floodplain, with a larger entrenchment ratio of 3.73. At the larger 100-year flood discharge, the percentage of the valley bottom inundated ranges from 41% (WB3) to 61% (WB2), indicating significant floodplain disconnection. The valley narrows and steepens upstream of WB4, and West Birch reaches WB5 – WB8 alternate between

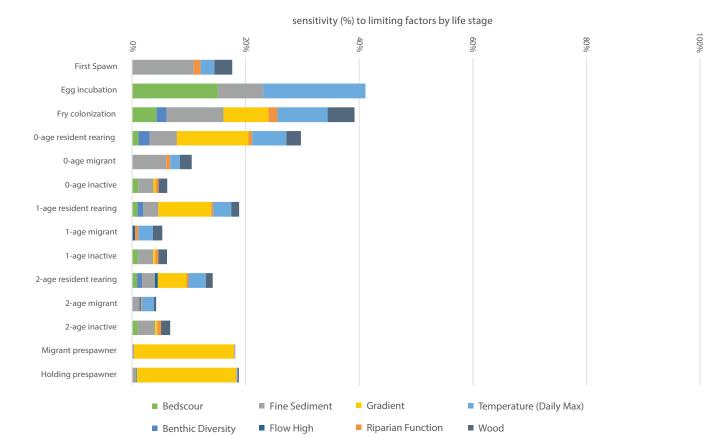
Figure 58. Steelhead sensitivity (%) to limiting factors by life stage in West Birch Creek

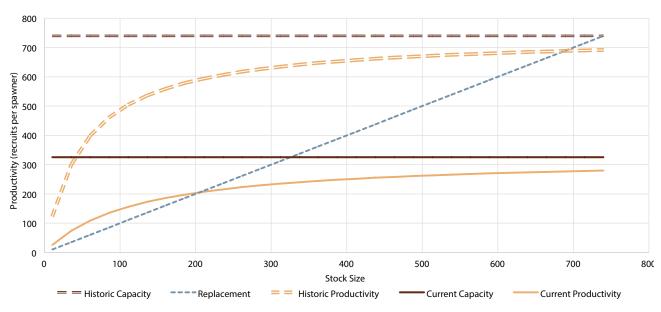
Figure 61. Stock recruitment relationships for the current and historic scenarios based on habitat productivity
and capacity in West Birch Creek

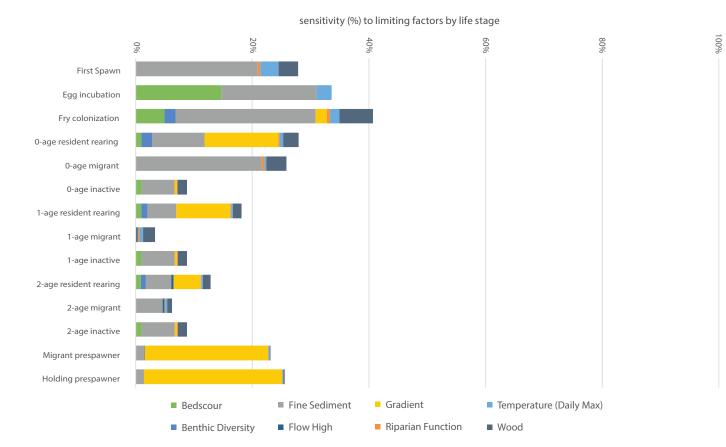
Figure 68. Steelhead sensitivity (%) to limiting factors by life stage in Bear Creek

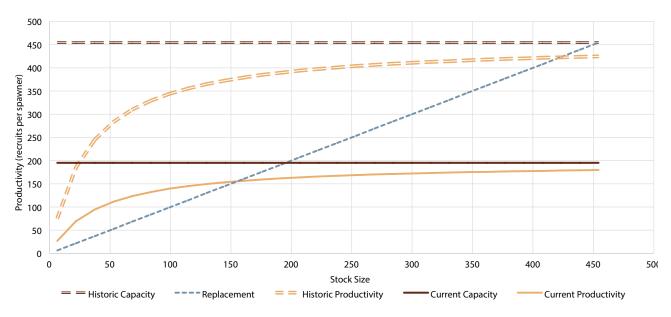
• Figure 71. Stock recruitment relationships for the current and historic scenarios based on habitat productivity and capacity in Bear Creek

The apparent availability of cool water conditions in Bear Creek is a likely explanation for its comparatively high productivity throughout the watershed.

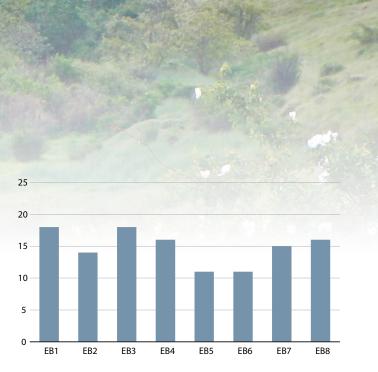
■ Figure 77. Summary of reach restoration priority for East Birch Creek

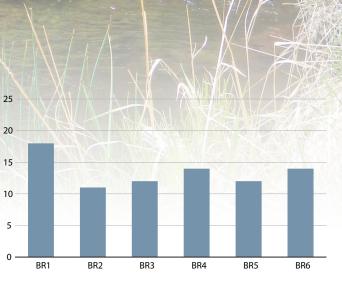
Figure 80. Summary of reach restoration priority for Bear Creek
