Meacham Creek Watershed Analysis and Action Plan

Final Report

April 16, 2003

Prepared for the Confederated Tribes of the
Umatilla Indian Reservation

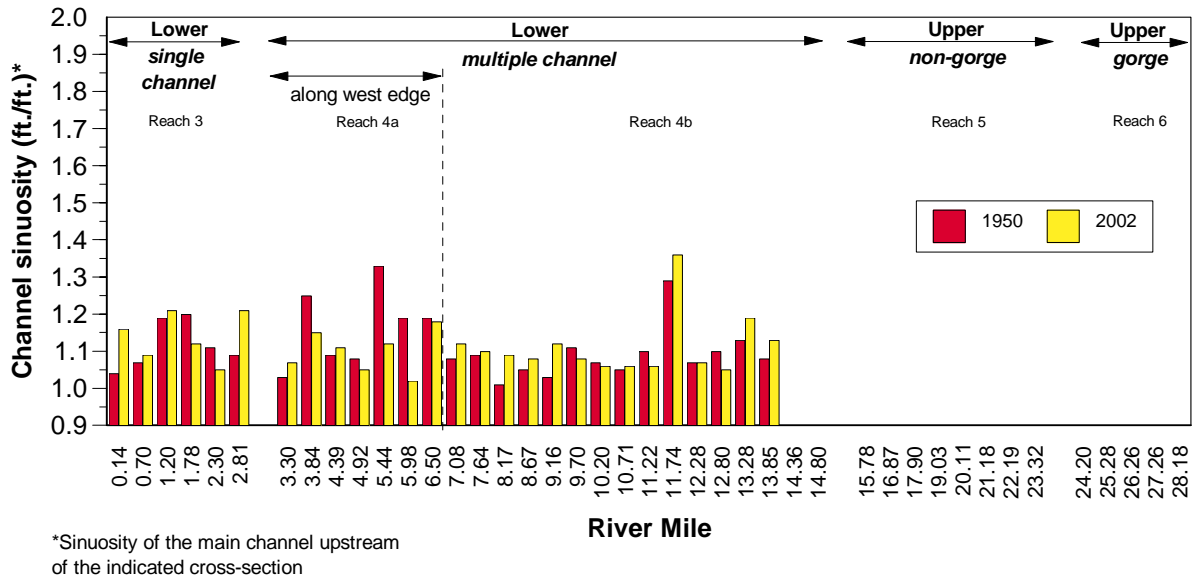
Figure 2. Comparison of Meacham Creek sinuosity for 1956 and 2002.

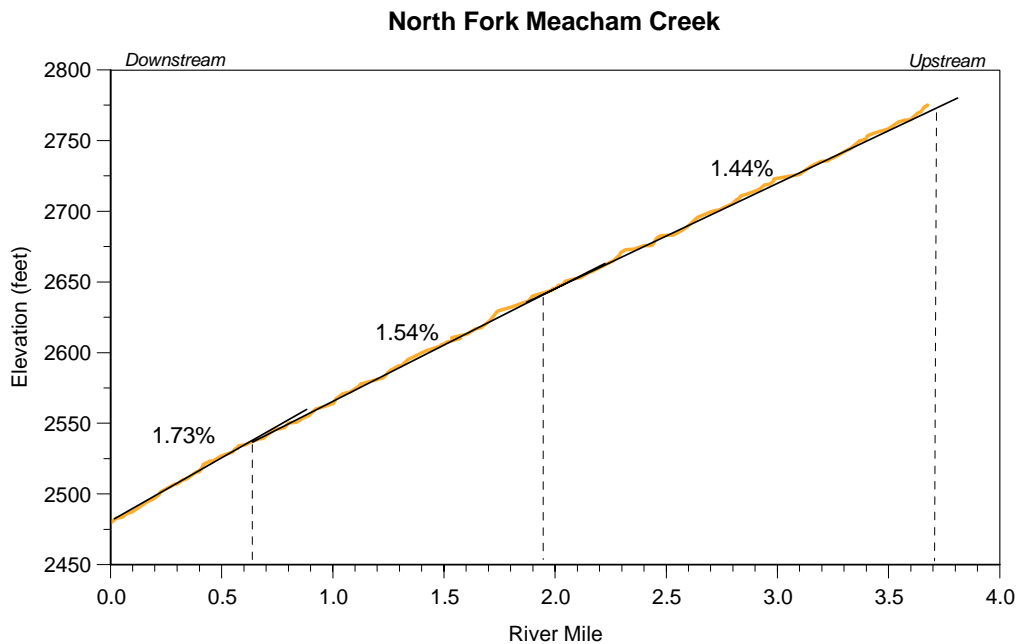
Figure 3. Water surface gradient (or channel bottom in dry sections) for Meacham Creek and North Fork Meacham Creek during July, 2002.

The average gradient for the Wenaha River reference reach was 1.17%, while its counterpart reach in Meacham Creek (reach 4b) was 1.00 to 1.08%.

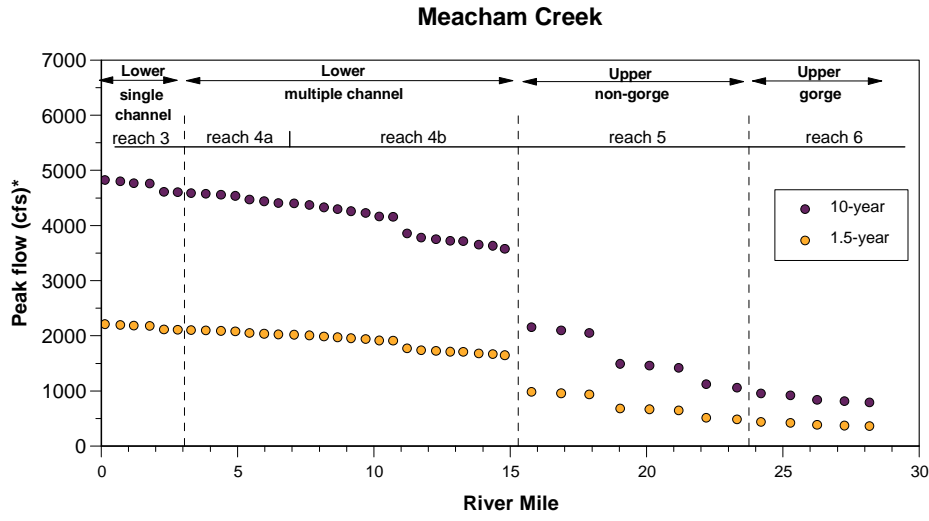
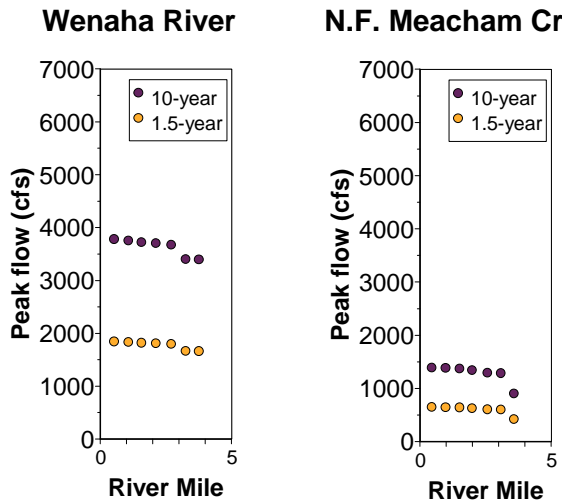
Figure 7. Calculated 1.5-year and 10-year peak flow for cross sections in Meacham Creek and in the Wenaha River and North Fork Meacham reference reaches.

The 1.5-year and 10-year peak flows for each of the cross sections established in this study are displayed in Figure 7. Starting at the base of the drainage, peak flow decreased only slightly in the upstream direction since the lower basin width is narrow and there are few tributaries. Where Meacham Creek and North Fork Meacham Creek converge, peak flows in Meacham Creek are about 1.6 times that of North Fork Meacham Creek.

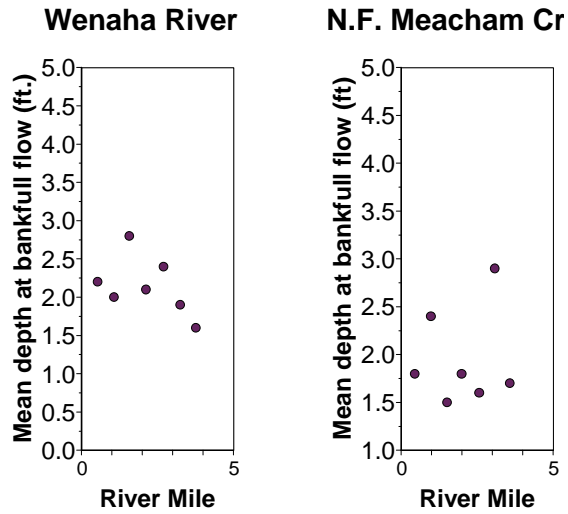
Figure 9. Mean water depth during bankfull flow for cross sections in Meacham Creek and in the Wenaha River and North Fork Meacham reference reaches.

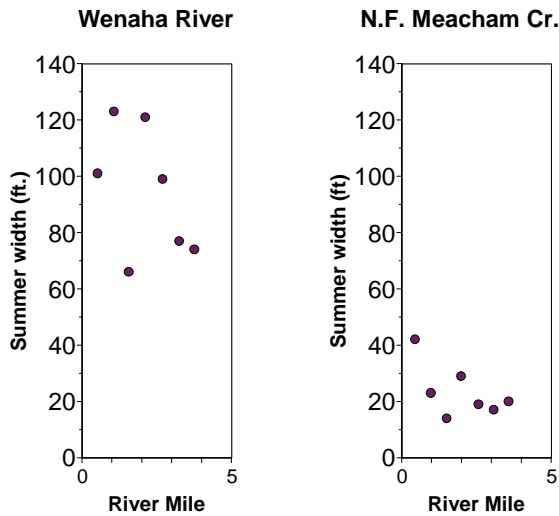
Figure 12. Summer widths for cross sections in Meacham Creek and in the Wenaha River and North Fork Meacham reference reaches.

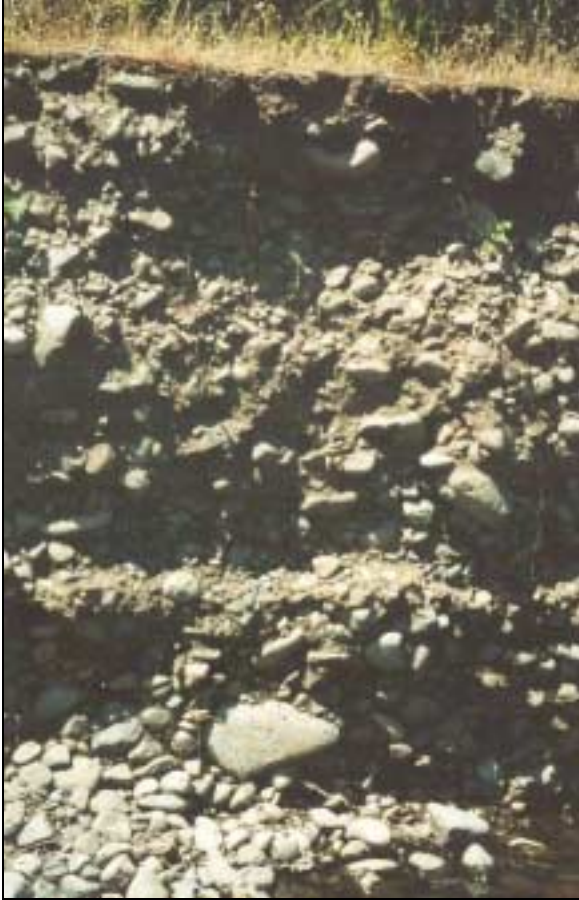
Figure 15. Substrate at the bare surface of a vertical streamside bank in lower Meacham Creek. The largest rock in the photograph is about 7 inches across.

The size distribution of stream substrate and evidence of layering can be observed at a number of locations throughout the study area where the stream has recently meandered into old alluvial terraces, leaving a vertical face. These areas had non-graded substrate deposits with a wide range of pebble sizes, as illustrated in Figure 15. Layering was uncommon. The random arrangement of particles in the terrace deposits and the wide range of pebble sizes suggest that the alluvium was deposited during very large floods that were perhaps accompanied by slope failures, debris torrents, and rapid movement of sediment down the valley. We did not do any sampling of aggregate directly below the surface of the streambed, but we assume that, like most streams, Meacham Creek has a surface layer of larger-sized aggregate over deposits of smaller-sized aggregate.

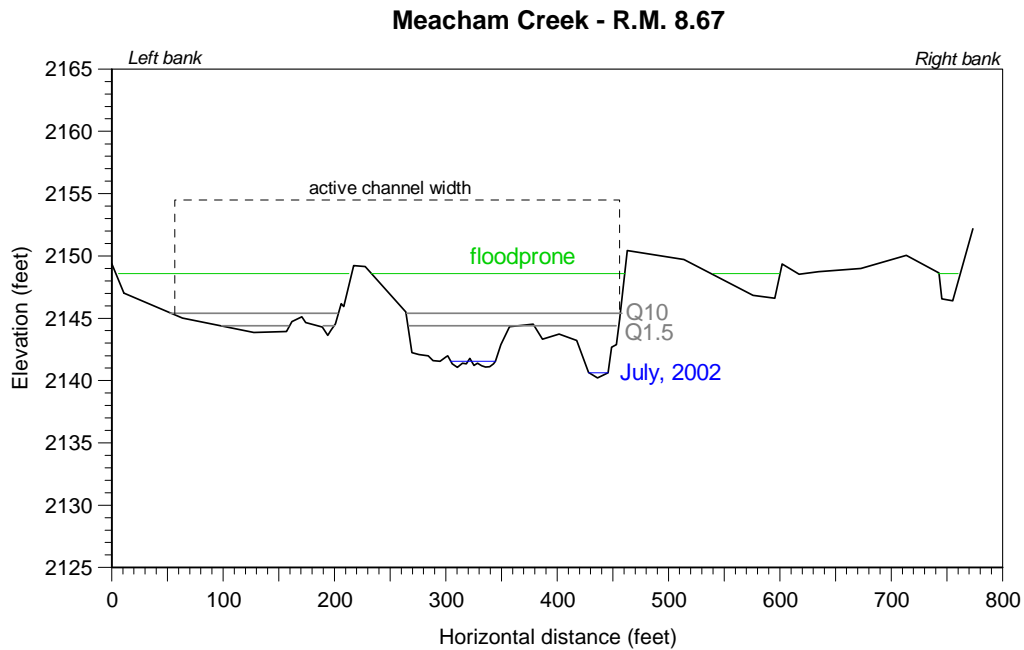
Figure 16. Example showing elevations of the surface of summer channels in blue, bankfull channels (Q1.5), and channels during a 10-year flow (Q10) in grey. Also shown is active channel width during a 10-year flow and the Rosgen floodprone elevation (green).

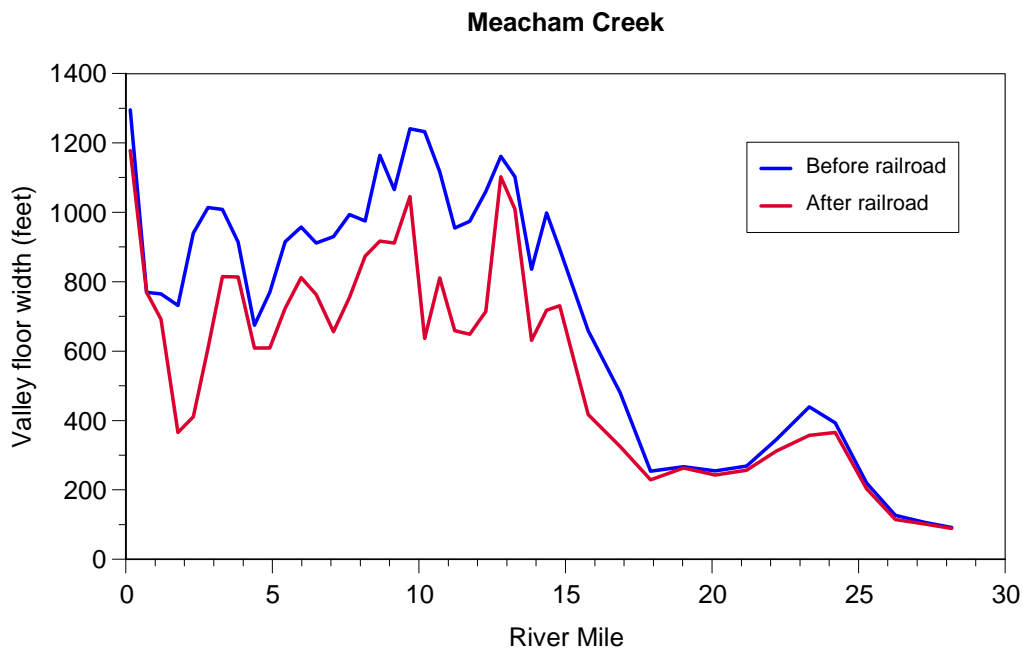
Figure 18. Valley floor width of Meacham Creek before and after the railroad was constructed. Reach 3 is from R.M. 0.00 to 3.30, Reach 4a is from R.M. 3.30 to 7.08, Reach 4b is from R.M. 7.08 to 14.90, Reach 5 is from R.M. 14.90 to 24.20, Reach 6 is from R.M. 24.2 to 28.18.

The railroad grade has narrowed the valley floor available for future stream meandering by 16 to 24% in lower Meacham Creek and 7 to 19% in upper Meacham Creek (Table 10). Losses in valley floor width were greatest from river mile 1.5 to 3.5 and from river mile 10 to 12 (Figure 18). The railroad crosses the stream twice in lower Meacham Creek and coincides with these locations of greatest valley floor width loss. In spite of the sizable losses in valley floor width in lower Meacham Creek, these altered reaches are still wider than the Wenaha River reference reach.

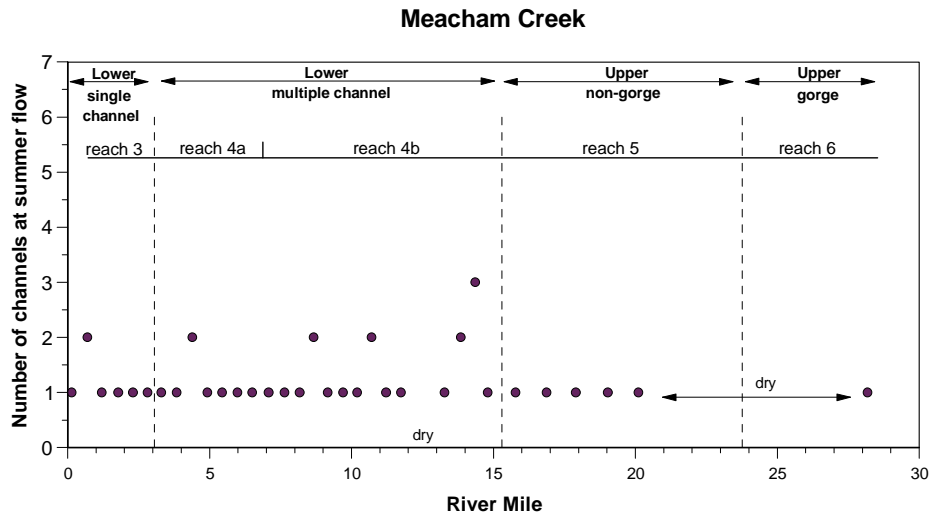
Figure 21. Number of discrete channels for Meacham Creek and for the Wenaha River and North Fork Meacham Creek reference sites during summer flow.

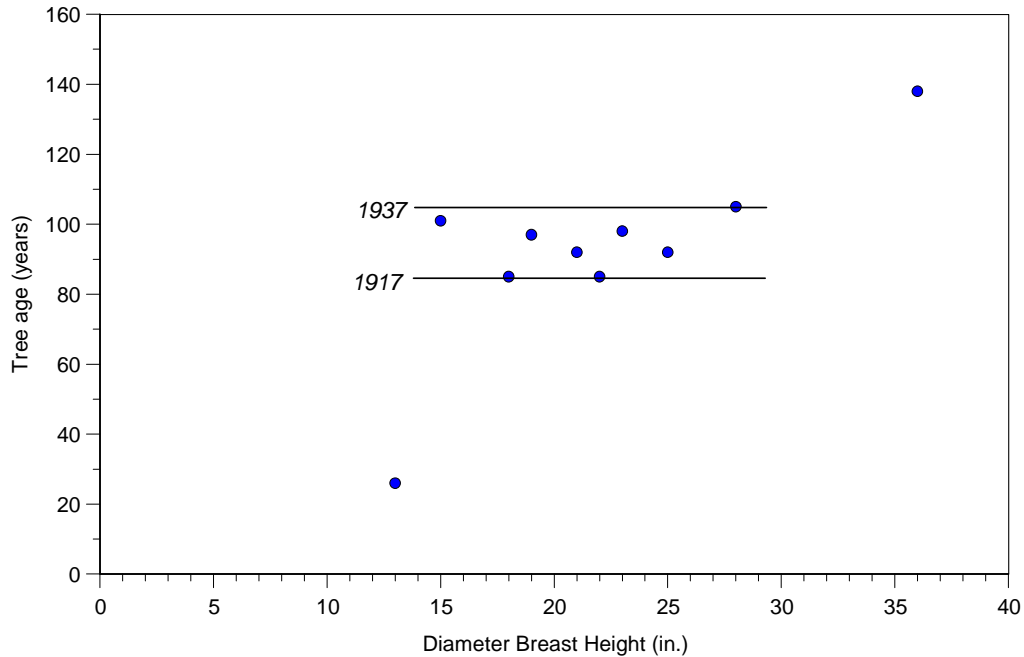
Figure 27. Tree age and diameter for dominant ponderosa pine trees growing along lower Meacham. Oldest and youngest year of origin for 8 out of 10 trees indicated by horizontal lines.

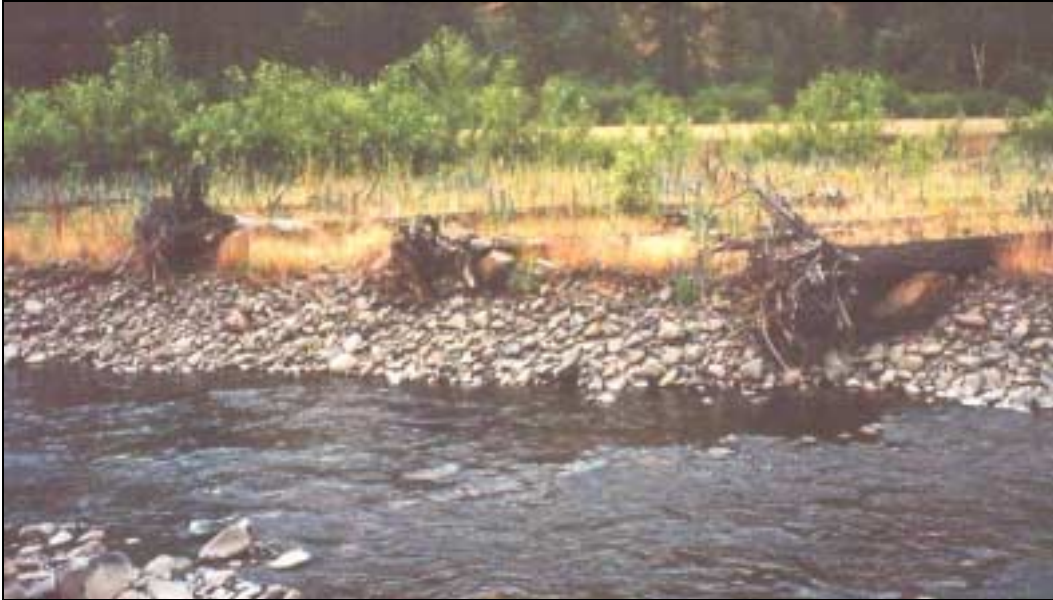
Figure 28. Log/boulder structures near river mile 3.6 rafted onto a low terrace during a high flow.

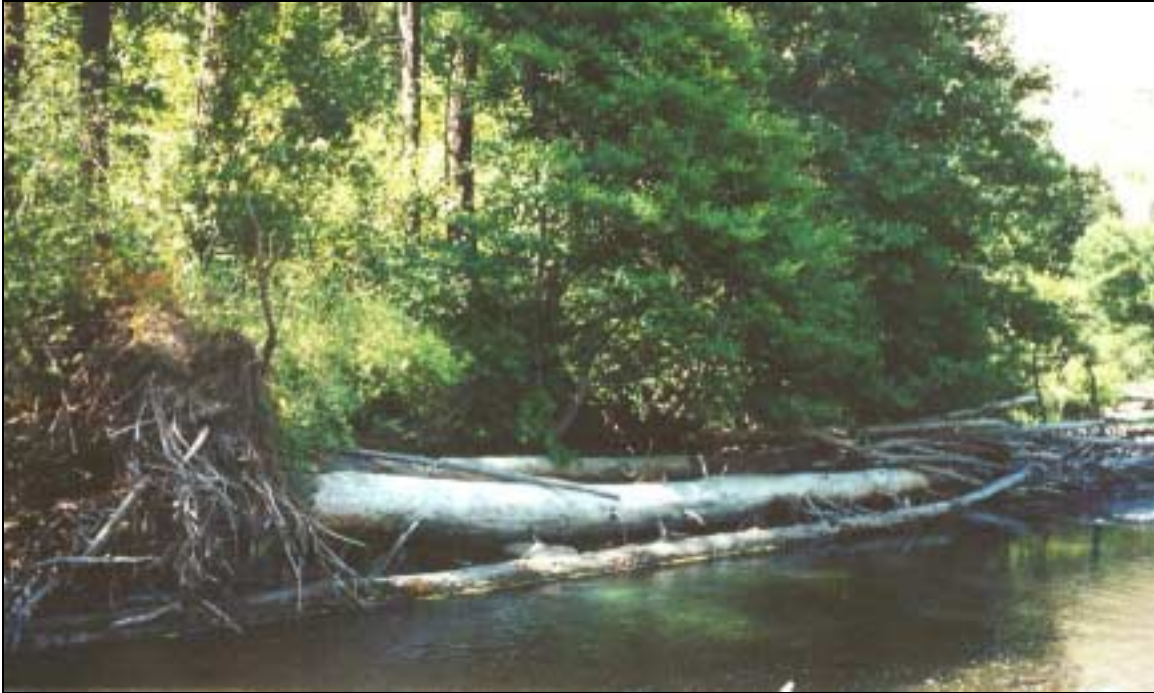
Figure 29. Well-designed log/boulder structure (# 26 at river mile 2.25) that creates year-round cover and pools.

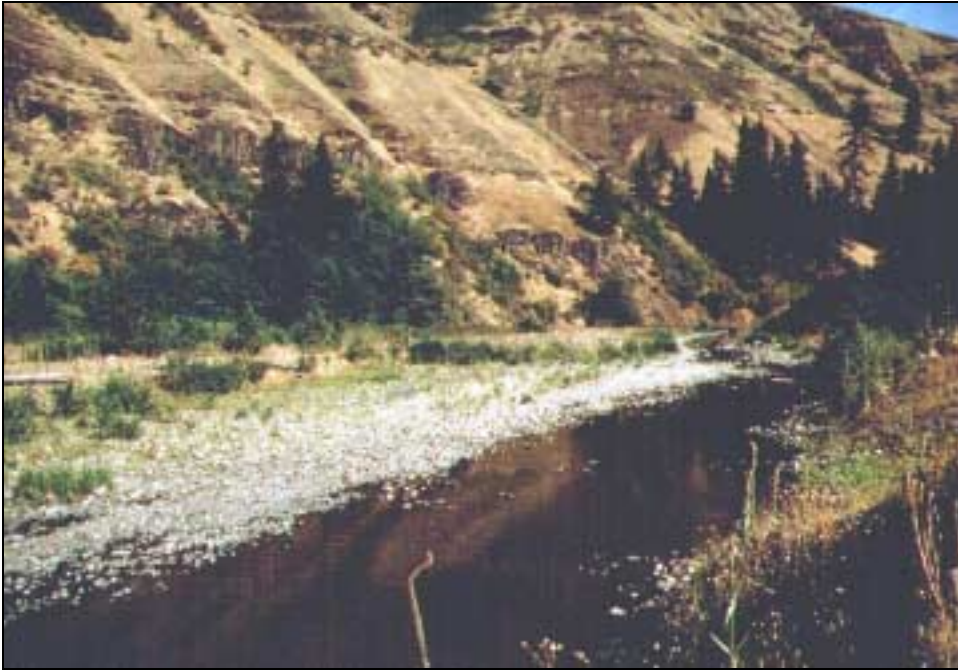
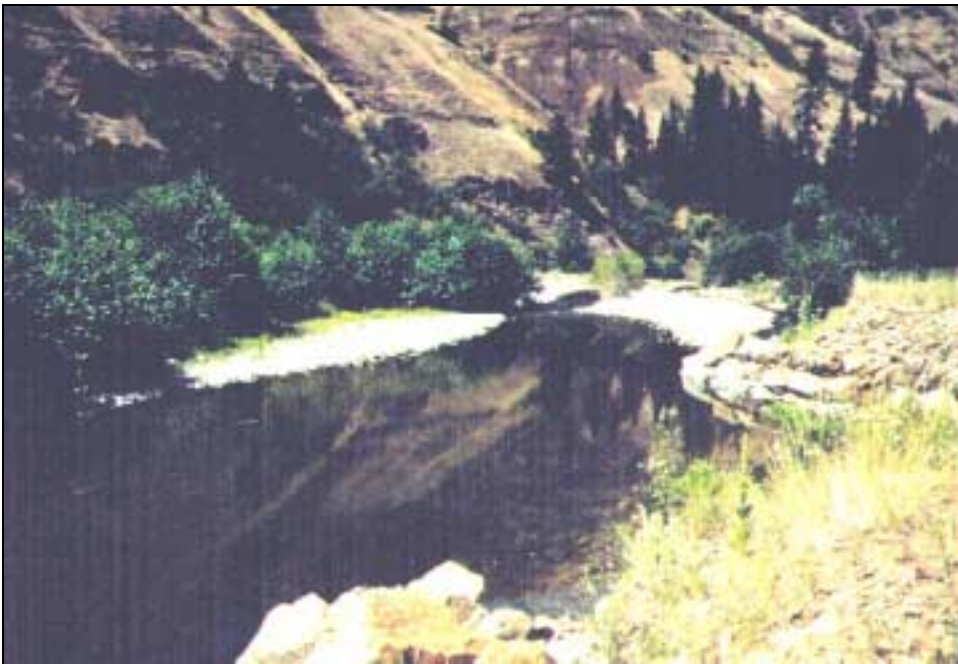
Figure 29.1. Regeneration of alder on gravel bar following 4 years of grazing exclusion (1988 to 1992).

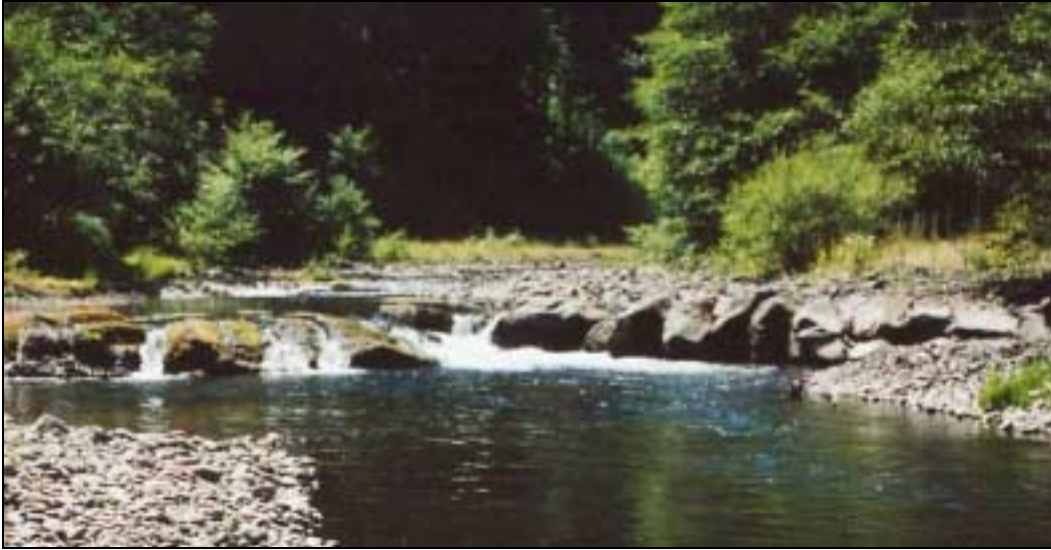
Figure 33. Cabled boulders added to the top of a bedrock cascade now prevent upstream passage of juvenile fish during summer low flow. Site number #7 in Appendix D.
