CTUIR UMATILLA ANADROMOUS FISHERIES HABITAT PROJECT

Annual Report

February 1, 2007 to January 31, 2008
Fiscal Year 2007

CONTRACT # 32047
Northwest Power Planning Council Project # 1987-100-01

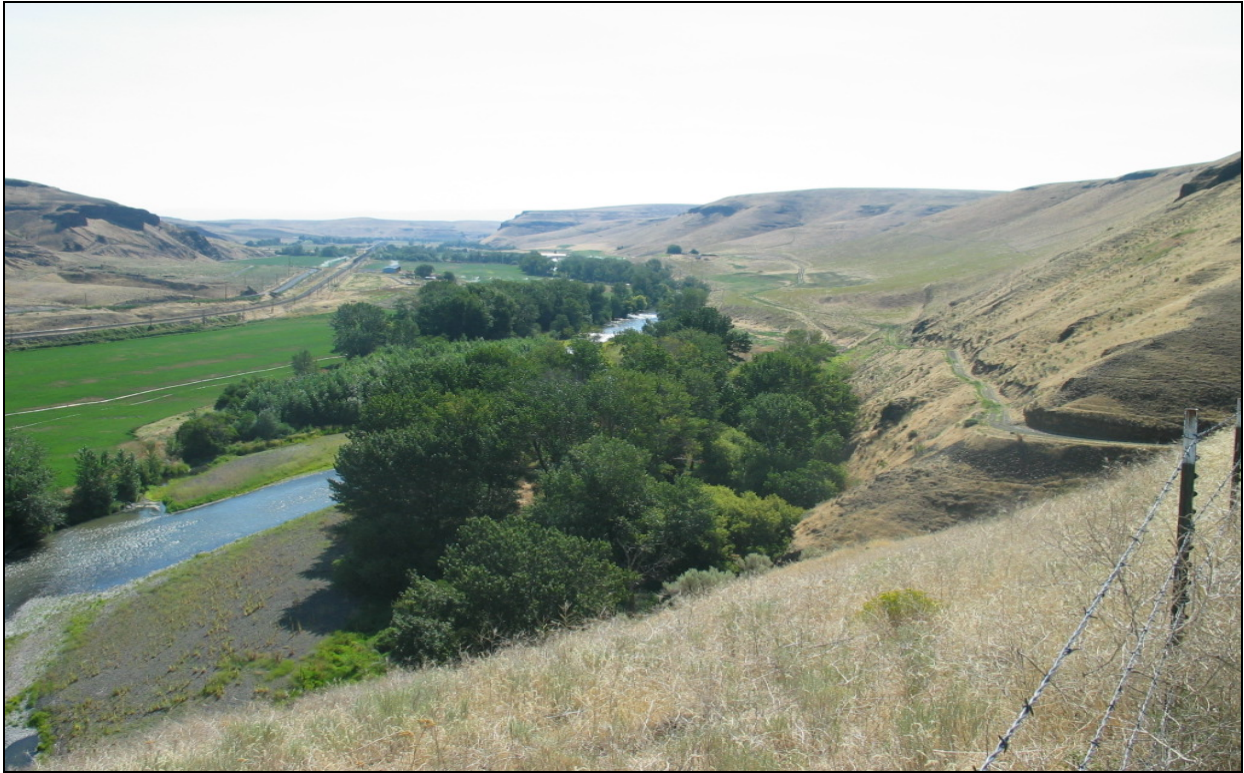
Figure 3. Typical Reach of the Mid-Umatilla River Basin (RM 44) Showing the Valley Form and Degraded Fisheries Habitat Conditions: Disconnected Floodplain, Poor Width to Depth Ratios, Streambank Erosion, Channel Incision, Noxious Weeds, and Lack of Adequate Stream Shading Due to Narrow Riparian Belt Width Comprised of Secondary Growth and Located a Significant Distance from the Wetted Channel.

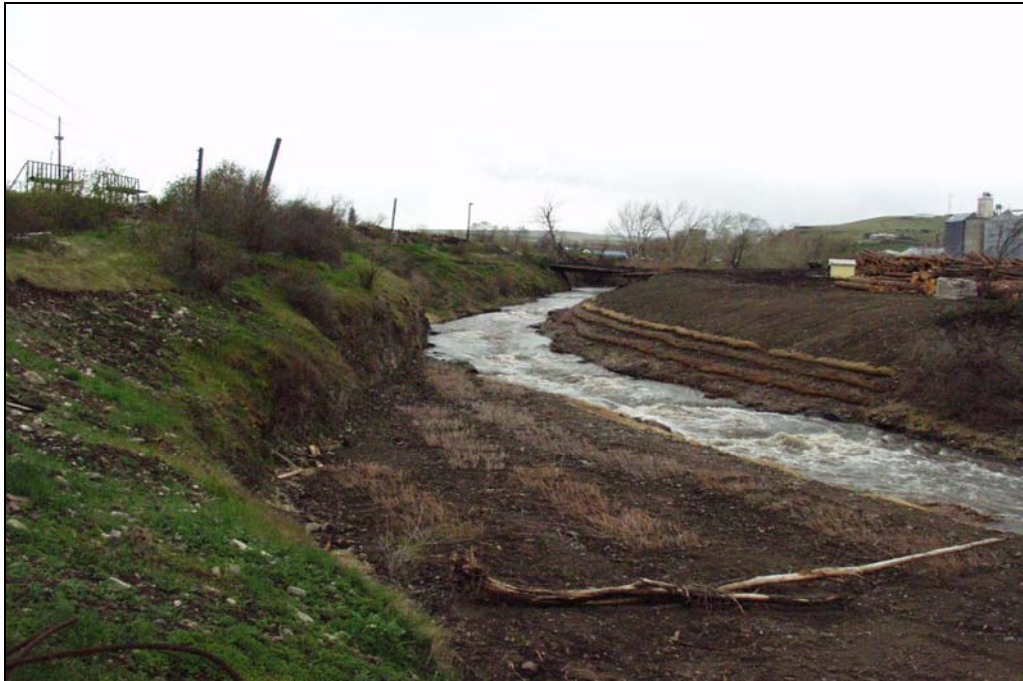
Figure 11. Weinke Dam Passage Rectification Project Partnership with ODFW Showing Willow Plantings, Birch Creek, RM 15.5 - December 2007

CTUIR UAFHP also contributes native plants and fencing materials to its partners to assist them in their restoration efforts. An example is the donation of 100 willows to ODFW for a restoration project at Weinke property (Figures 11 and 12) on Birch Creek (RM 15.5).

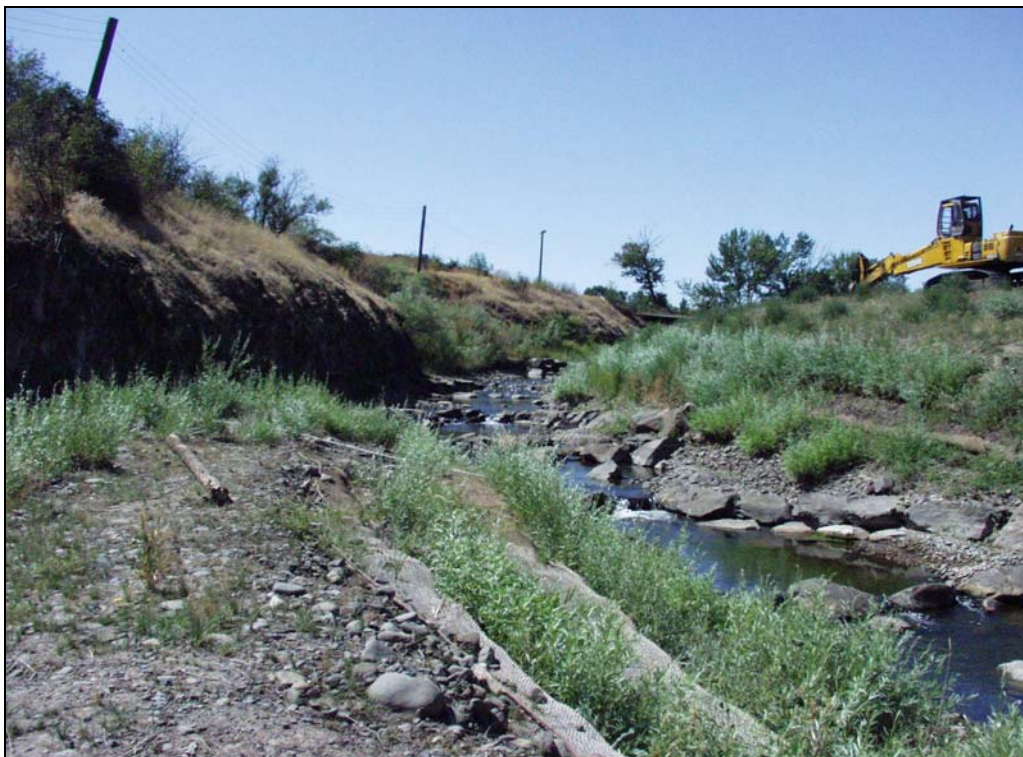
Figure 12. Weinke Dam Passage Rectification Project Partnership with ODFW Showing Progress of Willow Plantings, Birch Creek, RM 15.5 – July 2008

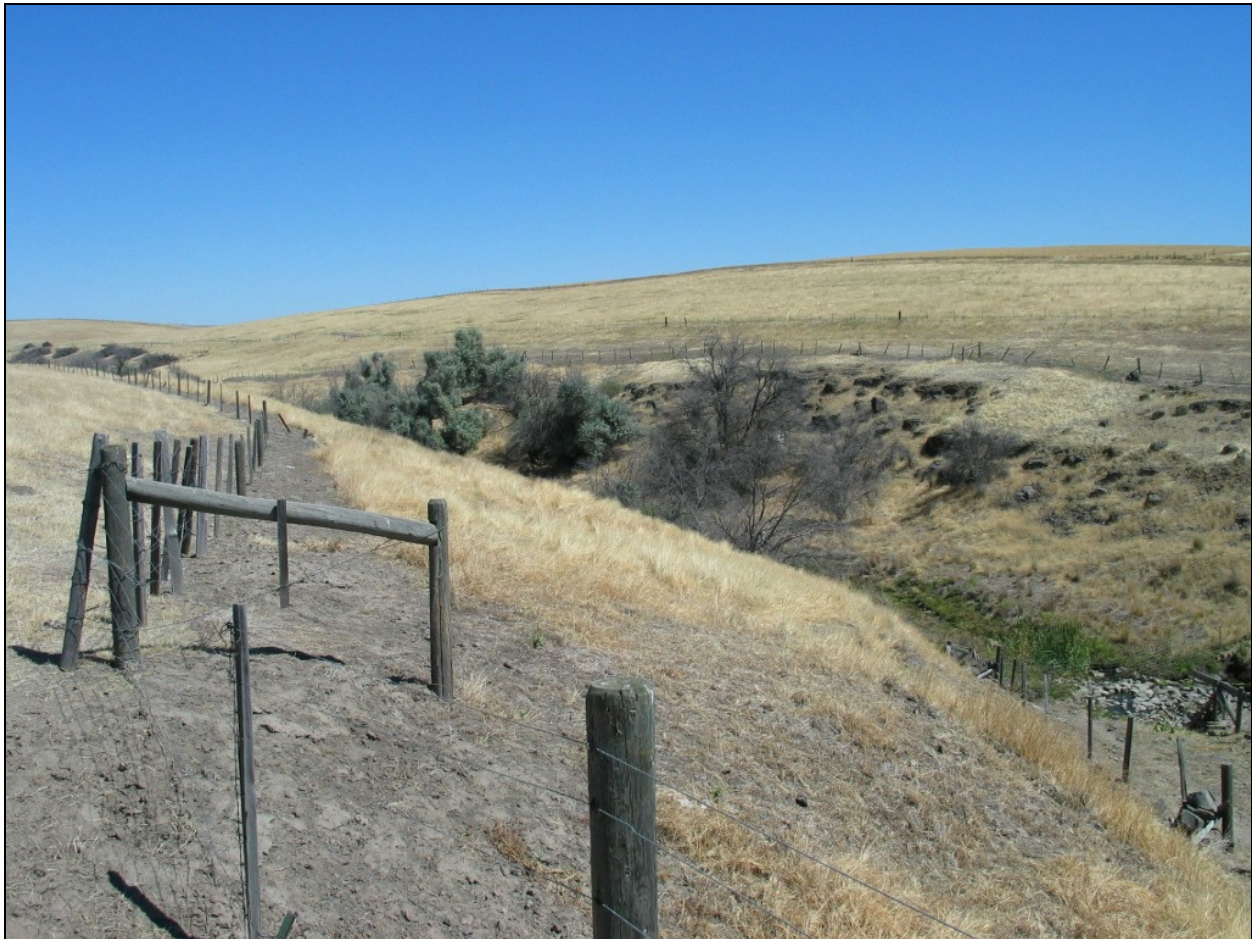
Figure 13. Example of Livestock Exclusion Fencing at Greasewood Creek Easement. Cattle Trespass Had Caused Significant Damage to the Riparian Area Prior to CTUIR Reinforcing the Fence in FY2007

Project maintenance includes conducting custodial responsibilities on individual projects to ensure that developments are functioning repair and habitat recovery is progressing towards meeting projects goals and objectives. Activities include, but are not limited to, maintaining communications and good standing with landowners, installing and repairing fences (Figure 13), maintaining or installing water gaps, or other developments that will protect or improve riparian and riverine conditions. Project sites are monitored regularly by CTUIR staff to ensure that adaptive management strategies can occur in a timely manner. For example, project impacts from trespass livestock were minimized by working with the owners to relocate problem livestock from project areas. Increased staffing and focus will target further improvements in project maintenance. Damaged fencing and gates were repaired in a timely manner at several CTUIR easements in FY2007.

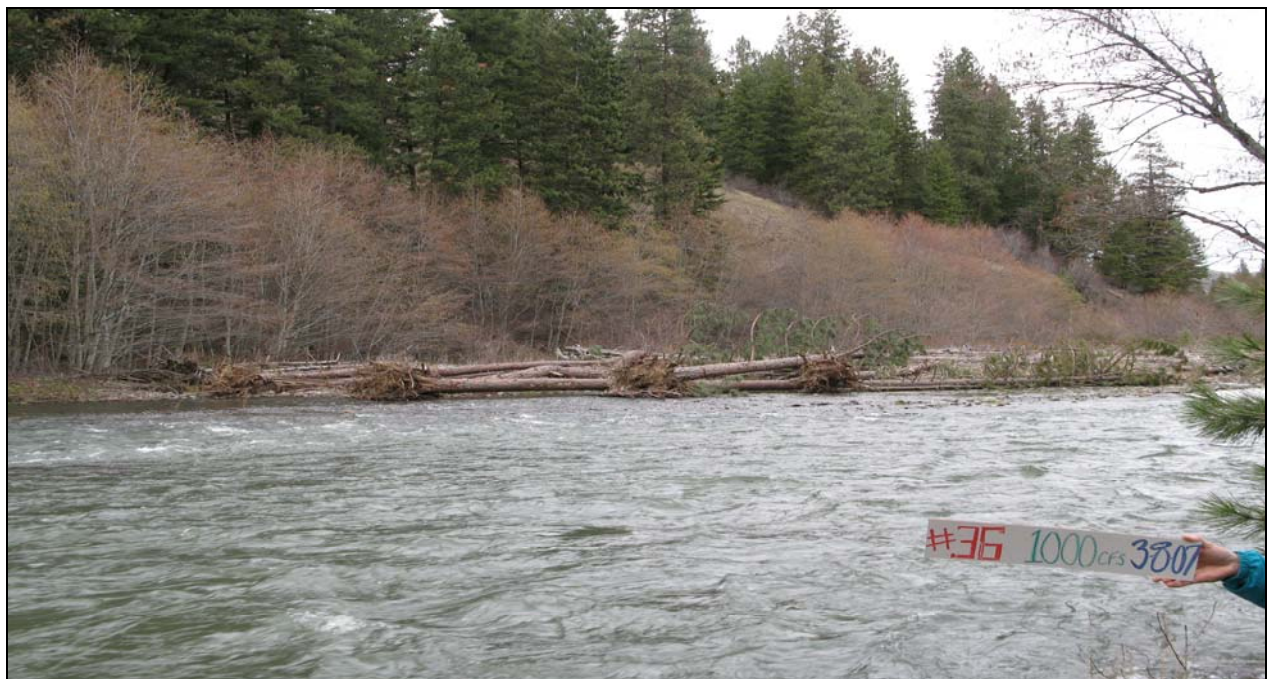
Figure 14. Photo Point Monitoring Methodology of Meacham Creek LWD Configurations

Permanent photo points have been taken on an annual basis to show project changes and are now schedule on a bi-annual basis. Photo points are established and repeated at various intervals at project implementation sites such as the Meacham Creek LWD project (Figure 14). In FY2007, standardized photos were taken to provide a visual record of changes in channel morphology and riparian recovery at the LWD Implementation sites in Meacham Creek and correlated to flow data derived from a USGS internet web site. Photos are cataloged and stored on computer hard drives and back up disks maintained by the CTUIR Fisheries Habitat Enhancement Project. This information provides a very valuable visual source of restoration progress and is also used for public education.

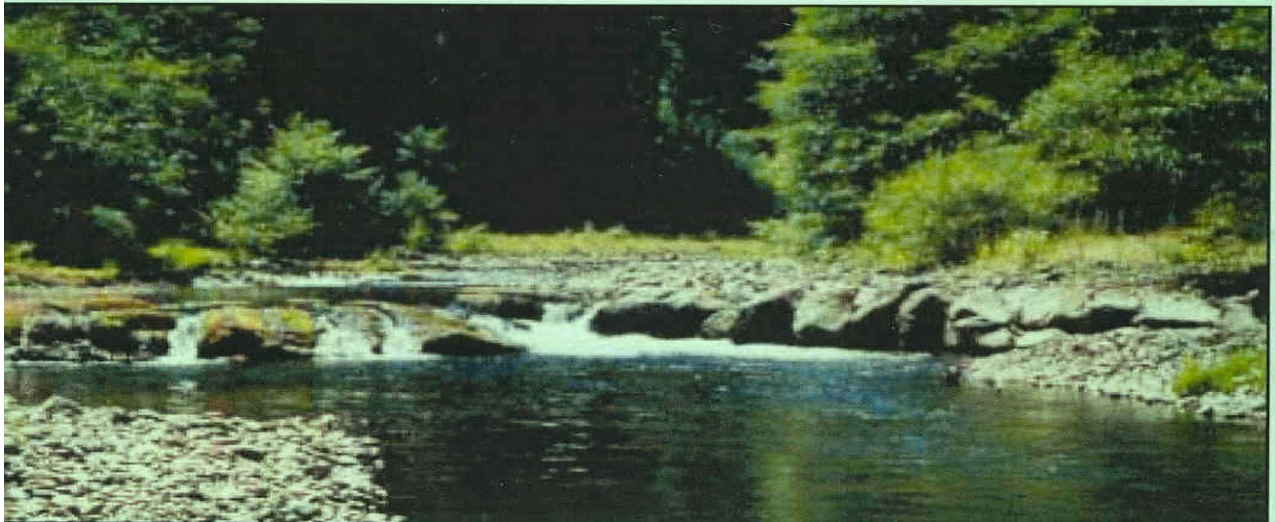
Figure 18. Meacham Creek Fish Passage Barrier RM 1.7, Prior to Rectification

Meacham Creek RM 1.7: This barrier (Figure 18) consisted of a series of large boulders cabled together in a line across the channel, creating a step height of 0.5 m (1.6 ft). The dimensions were 28 ft across by 3 ft thick. The structure was located about 300 m (984 ft) downstream from the first railroad bridge, approximately 150 m (492 ft) east of the railroad grade and 100 m (328 ft) downstream from a water quality gauging station. This formation of this barrier was constructed in the late 1980s as part of a habitat project that was attempting to increase holding areas by creating more pool cover. The scope of work included the following: (1) utilizing hand tools to cut cable to free up a large boulder located in the middle of the structure; (2) relocating the boulder to an adjacent area where it no longer impedes fish passage; and (3) planting trees in the adjacent riparian zones. No heavy equipment was required to rectify passage at this particular site as per landowner request, and there was minimal, if any disturbance. An aquatic habitat inventory survey was conducted prior to barrier removal. Figure 19 shows the project site post barrier removal.

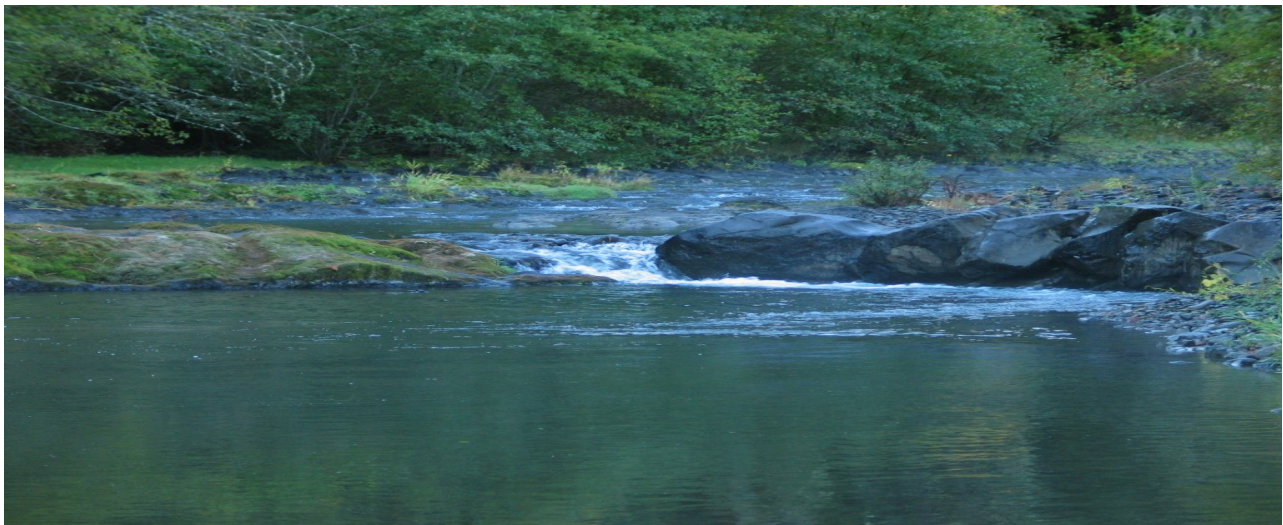
Figure 19. Meacham Creek Fish Passage Barrier RM 1.7, Post Rectification

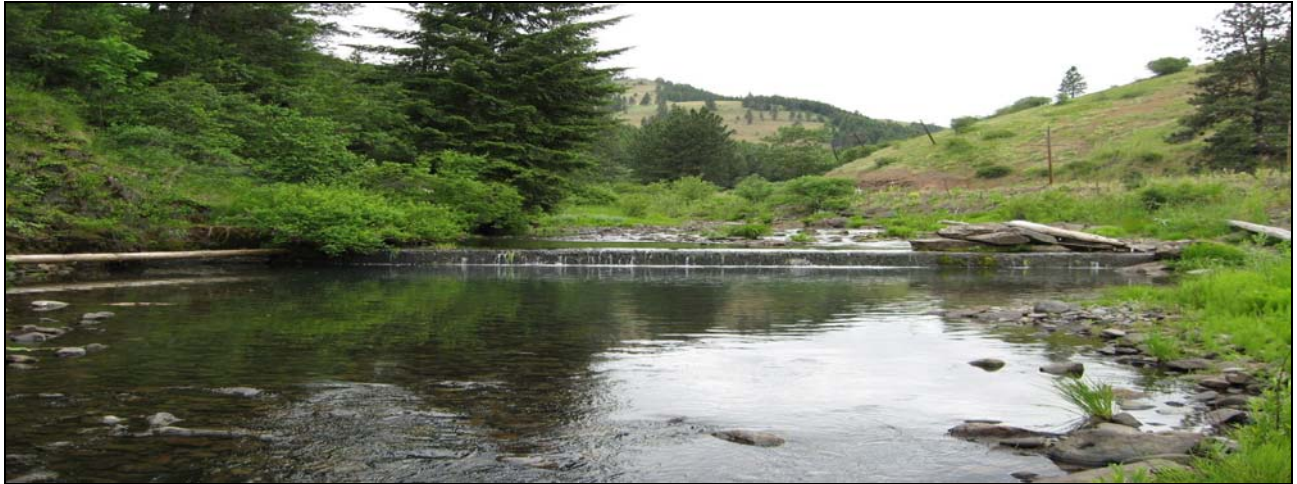
Figure 20. Meacham Creek Fish Passage Barrier, RM 20.2 Prior to Rectification

Meacham Creek RM 20.2: This barrier consisted of a concrete dam (Figure 20) measuring 57 ft across and 2 ft thick. Figure 21 shows the creek post barrier removal. The dam was set within 15 m (49 ft) of the adjacent railroad grade and was a relic from the early 1900s steam locomotive era. It created a step height of 0.5 m (1.6 ft). The scope of work for site activities included: (1) capturing fish located within 100 m (328 ft) of the work site and relocating them to adjacent upstream areas of the creek; (2) installing blocknets in the stream to prevent re-entry of fish (Figure 22); (3) using a concrete saw to remove the top 1-3 inches from a 10 ft portion of the dam to improve passage at moderate flows; (4) removing an additional 2 inches from the middle of the dam to improve passage at low flows; (5) using a dump truck to remove concrete from the area for proper disposal; (6) installing two cross vanes with rootwads using a track hoe for restoring proper grade, and (7) planting trees and seeding in the adjacent riparian zone and disturbed areas. One vane was constructed upstream and one downstream from the concrete structure. An aquatic habitat inventory survey was conducted prior to barrier removal.

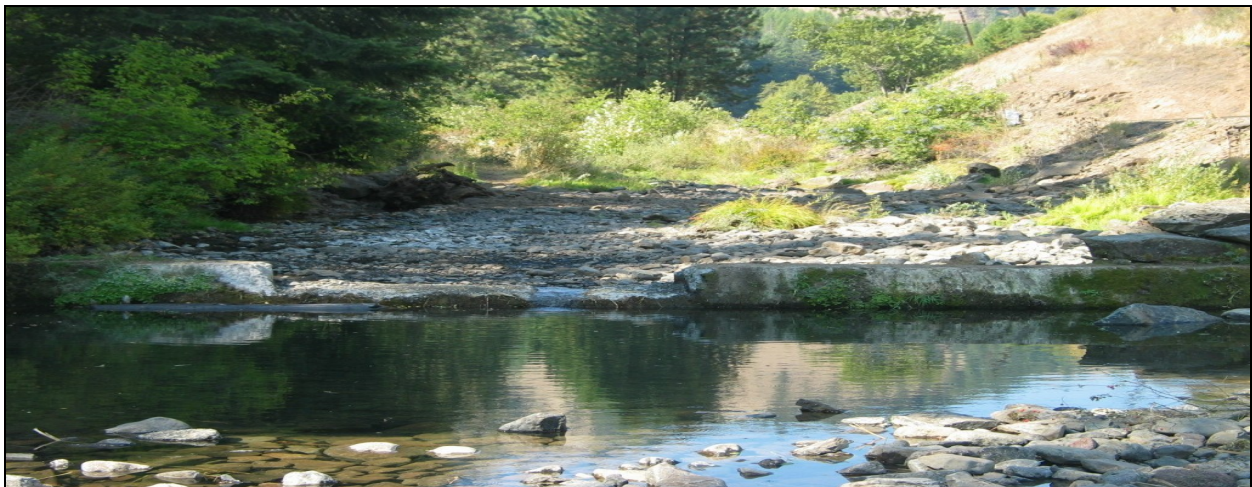
Figure 21. Meacham Creek Fish Passage Barrier, RM 20.2 Post Rectification

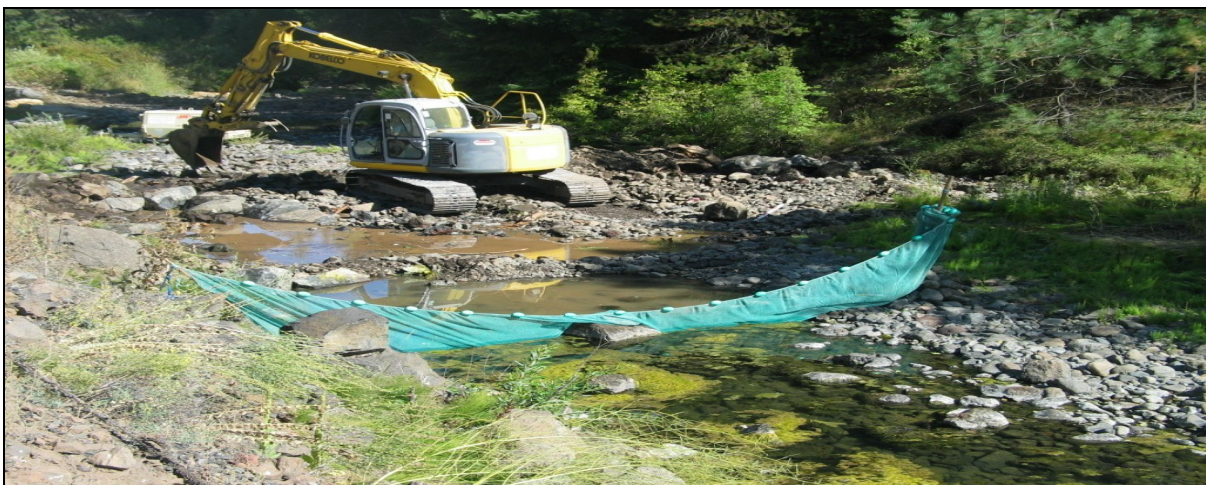
Figure 22. Meacham Creek RM 20.2 Construction of Upper Cross Vein Showing Site Isolation Method

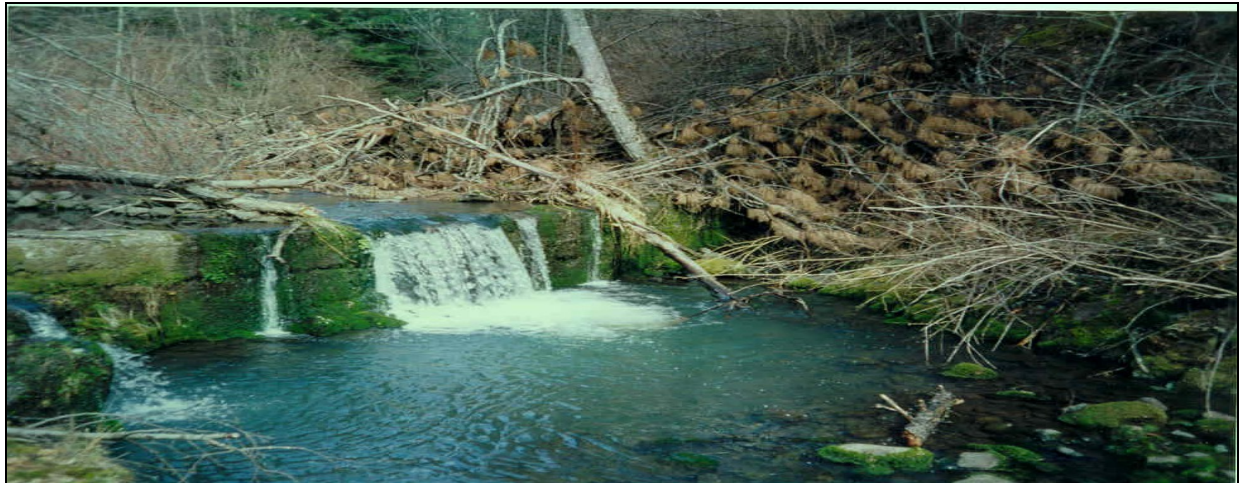
Figure 23. Camp Creek Fish Passage Barrier, RM 0.3 Prior to Rectification

Camp Creek RM 0.3: This barrier (Figure 23) consisted of a concrete dam measuring 33 ft across and 2 ft thick. This structure was in place for more than 50 years and was built as part of a gravity-fed irrigation system which delivered water to adjacent fields to improve grazing conditions for cattle. Prior to rectification, it presented a concern for passage, but was not a complete barrier due to increased flows over the crest, an adequate jump pool, and/or established braiding around the structure. The barrier was considered to be a complete barrier during low flow periods as step height measurements approached 1m (3.3 ft) with little flow over the crest. Work at this site included: (1) capturing fish from the work zone prior to construction and relocating them upstream; (2) capturing and relocating fish from the 2 creek crossings that were within the path of the implementation equipment; (3) setting blocknets upstream and downstream of the work zone to prevent organisms from moving back into the areas where fish removal occurred; (4) removing the top two feet from the dam using a concrete saw; (5) using a dump truck to remove concrete from the area for proper disposal; (6) using a track hoe to incorporate woody debris and construct one cross vane upstream from the concrete structure, and (7) retaining mature growth and planting trees and/or seeding the adjacent riparian zone and disturbed areas. An aquatic habitat inventory survey was conducted prior to barrier removal. Figure 24 shows the site after rectification of the barrier.

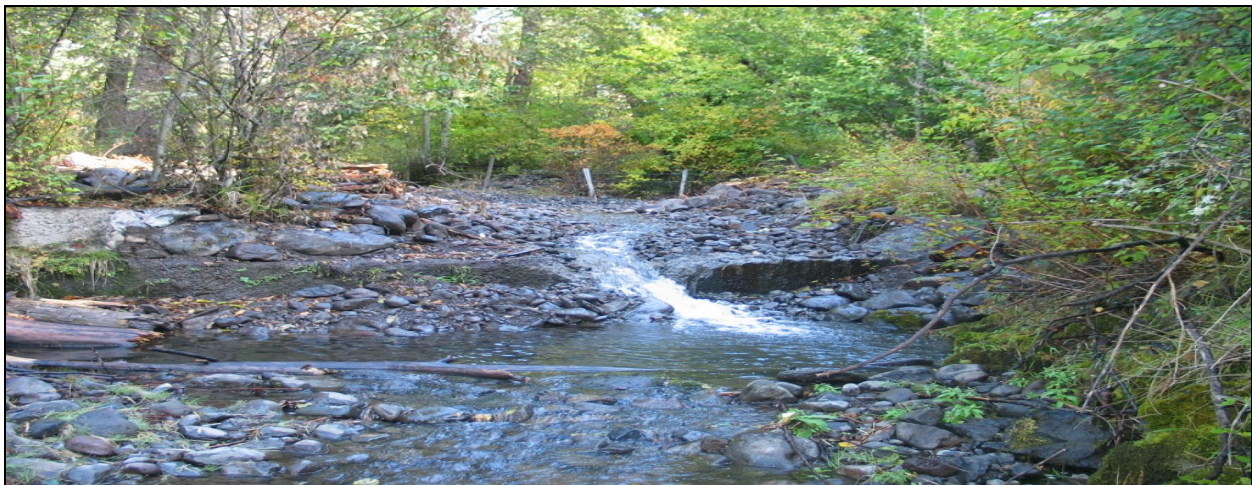
Figure 24. Camp Creek Fish Passage Barrier, RM 0.3 Post Rectification

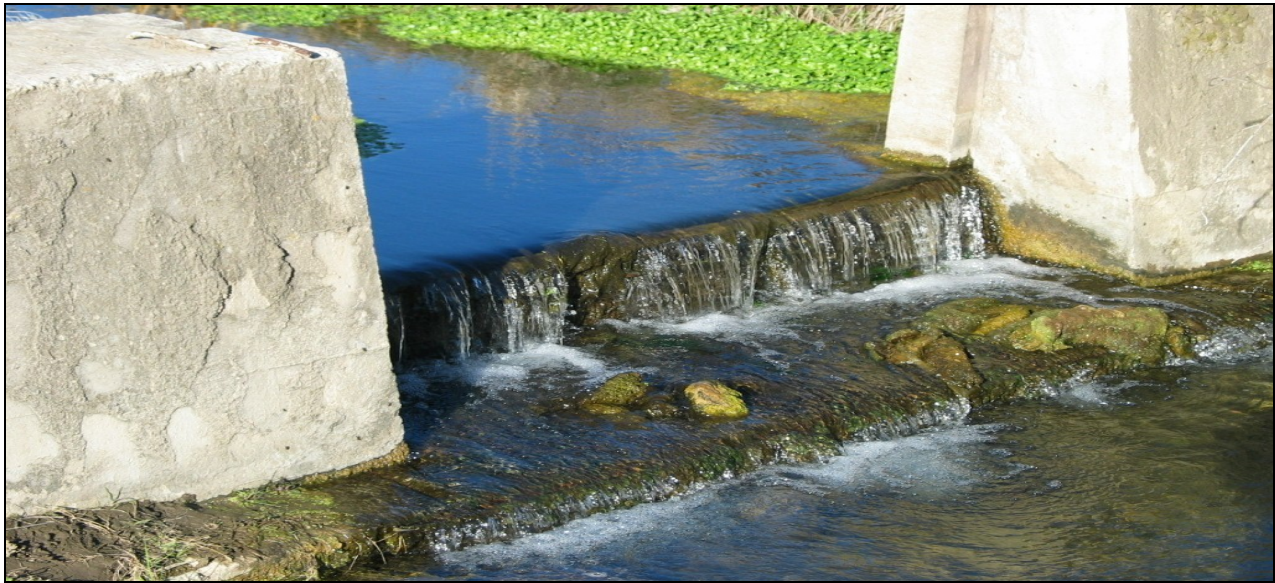
Figure 25. Greasewood Creek Fish Passage Barrier, RM 0.4 Prior to Rectification

Greasewood Creek RM 0.4: This barrier (Figure 25) was a concrete dam measuring 10 ft across and 2 ft thick. Wooden flash boards were used to manage water levels under different flow regimes. This dam was utilized by a private ranch in the past for irrigating cattle pastures but became obsolete. The landowner granted CTUIR permission to remove the final stop-log that the landowner had unknowingly left in place following deconstruction of the irrigation pipeline. Figure 26 shows the Greasewood Creek site at RM 0.4, after rectification of the barrier, which occurred on October 26, 2007.

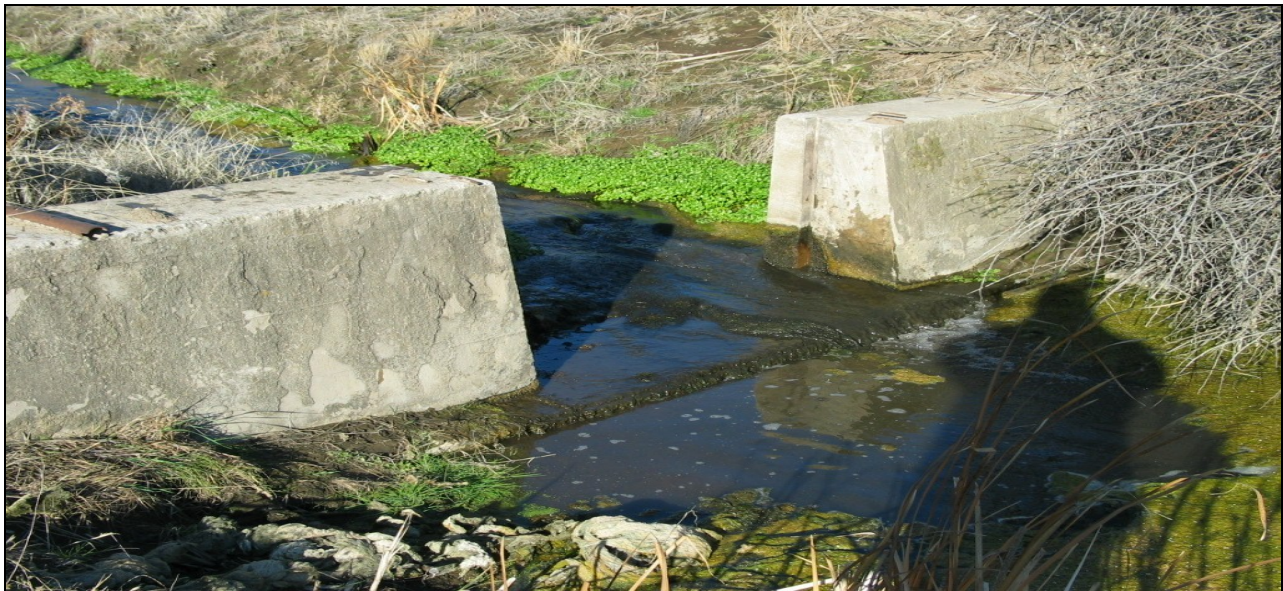
Figure 26. Greasewood Creek Fish Passage Barrier, RM 0.4 Post Rectification

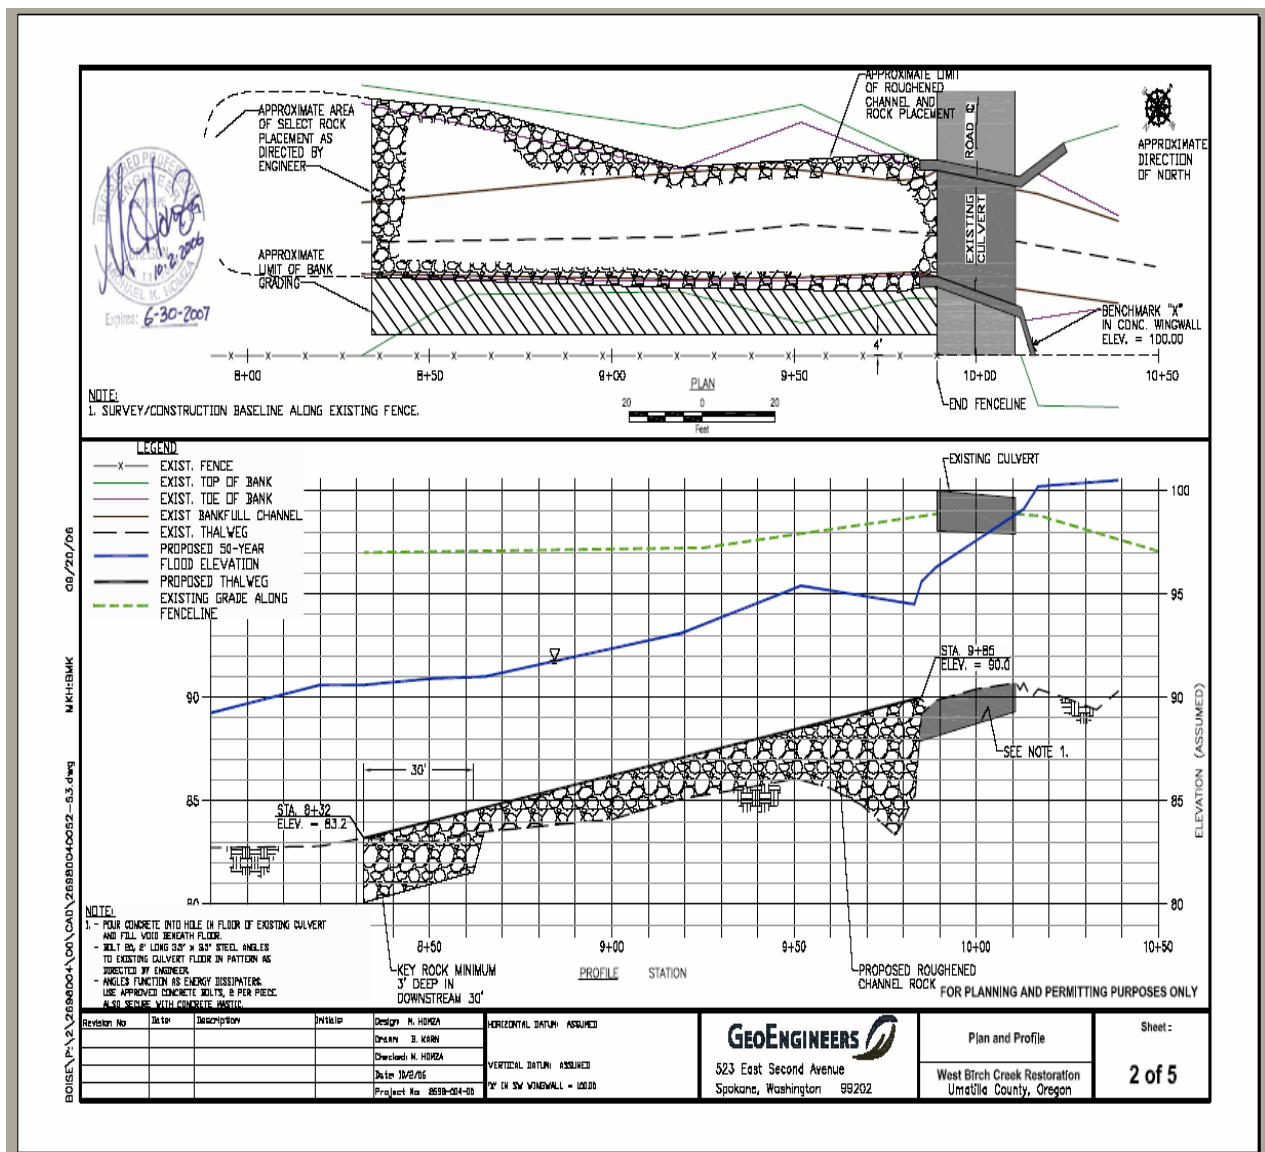
Figure 27. Blueprint Plan and Profile, Cunningham Bridge, West Birch Creek, RM 3.2

West Birch Creek, RM 3.2. CTUIR worked with Bio Engineers Inc. to design a roughened channel remedy to address passage concerns (Figure 27). This habitat restoration project was designed to enhance migratory fish passage conditions by incorporating stream channel roughness to restore proper gradient and reduce step height at a road bridge crossing (box culvert). The bridge (Figure 28) had been identified as a problem for fish passage in a high priority area for migratory salmonids. The bridge was constructed in 1956-57 to allow access to the other side of the creek for vehicles and sheep. Over time, the box culvert downcut the streambed and created a step height of 1 m (3.3 ft). The dimensions of the structure are 24.5 ft wide, 21.5 ft long, and 9.0 ft high. The walls and floor of the culvert are made of concrete. The box culvert design and flat concrete floor created an undesirable state of shallow, uniform, sheet-flow during the summer months, posing a passage problem for migrating fish. An additional concern was the creation of a velocity barrier during higher flows, due to the uniform design which concentrates hydraulic energy. To rectify this issue, 13 baffles were affixed to the floor of the box culvert Figure 29 shows the bridge post rectification.

- (9) Targeting step heights to comply with the 6 inches or less standard guideline as established by the ODFW.
- (10) Conducting an aquatic habitat inventory survey prior to implementation.

- (11) Sloping the banks from 90 degrees to a 45 degree angle prior to planting and re-seeding;
- (12) Planting and re-seeding with native grasses and shrubs.

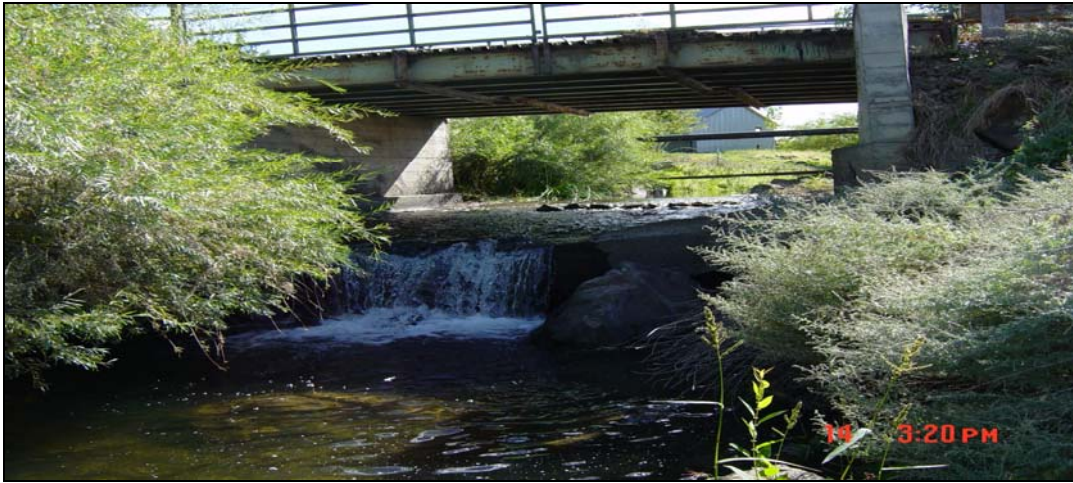
Figure 28. Cunningham Bridge on West Birch Creek, RM 3.2 Prior to Rectification

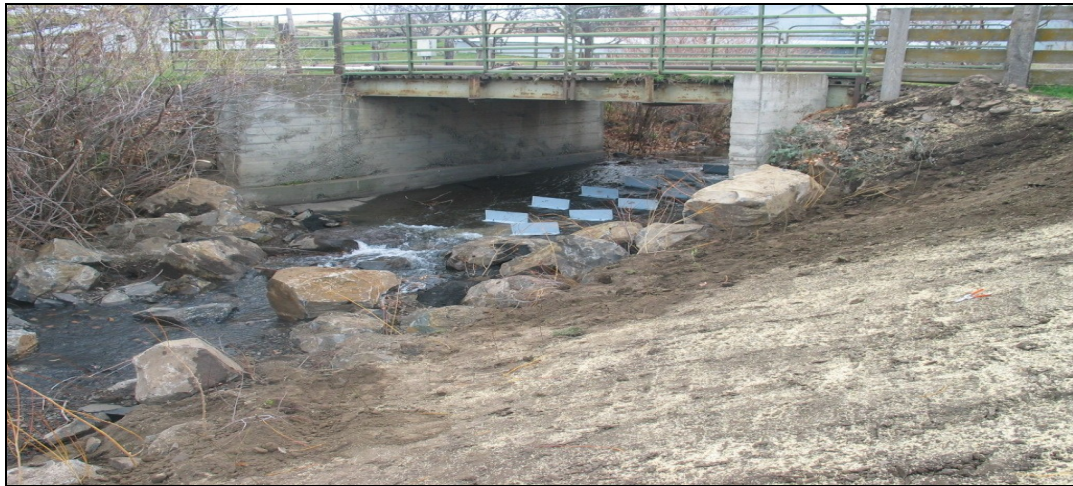
Figure 29. Cunningham Bridge on West Birch Creek, RM 3.2 Post Rectification

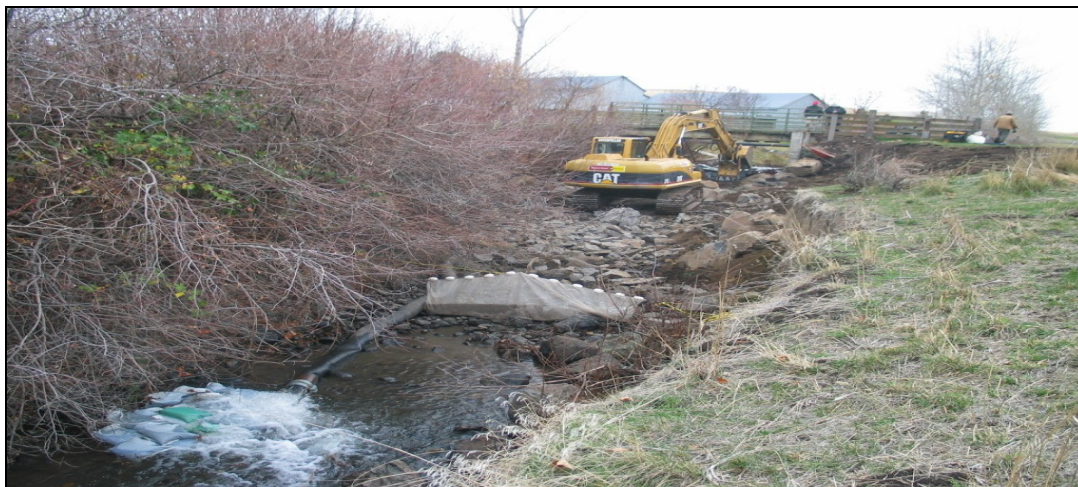
Figure 30. Dewatering and Site Isolation Method, West Birch Creek, RM 3.2, Cunningham Bridge

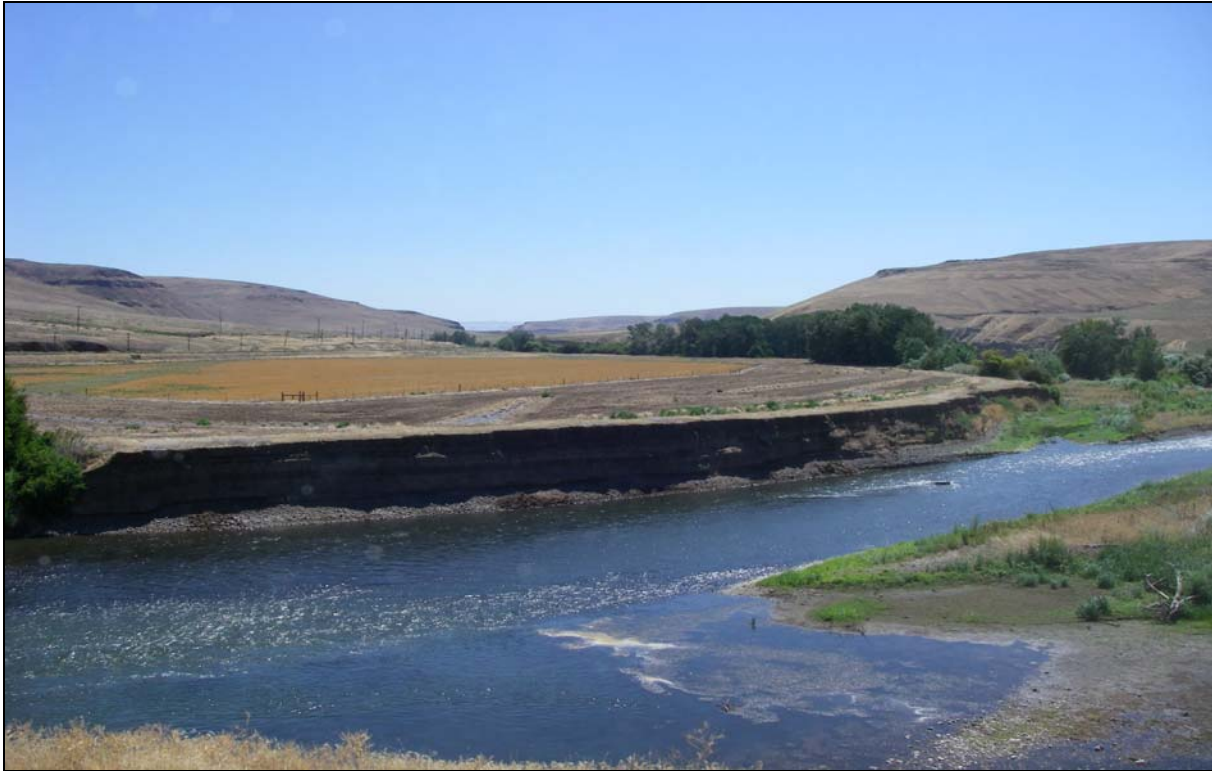
B&G Resources is located on lands where a large Corps of Engineers dam was removed abruptly via dynamite by disgruntled sportsmen in the 1950s. The abrupt, unprofessional demolition removal of the dam caused significant channel incision due to erosional forces and left 30-ft high terraces, most notably upstream (Figure 31) of the dam site.

Figure 31. Umatilla River RM 40, Showing Severely Incised Channel and Bank Erosion

The terraces are largely devoid of water due to the distance from the water table and arid climate of this location. CTUIR is planning to reestablish native grass and tree species upon the terraces in cooperation with NRCS and FSA in FY2009. Figure 32 shows B&G Property characteristics including two well location sites and four CREP tracts designated by the letters A-D. The CREP sites are intended to help provide improved riparian habitat conditions along the Umatilla River (RM 38-41). Drilling occurred in January 18, 2008 at two locations on the B&G property (Figure 33 and 34). The addition of solar panels and water troughs will also be accomplished in FY2008 to complete the well installation and the off-channel water source process. In previous years, CTUIR gathered baseline aquatic habitat and fish data in this area (CTUIR 1995).
