Final Camas Creek Oregon Geomorphic Assessment

March 2016

Prepared for:
Confederated Tribes of the
Umatilla Indian Reservation
46411 Timine Way
Pendleton, Oregon 97801
541-276-3447

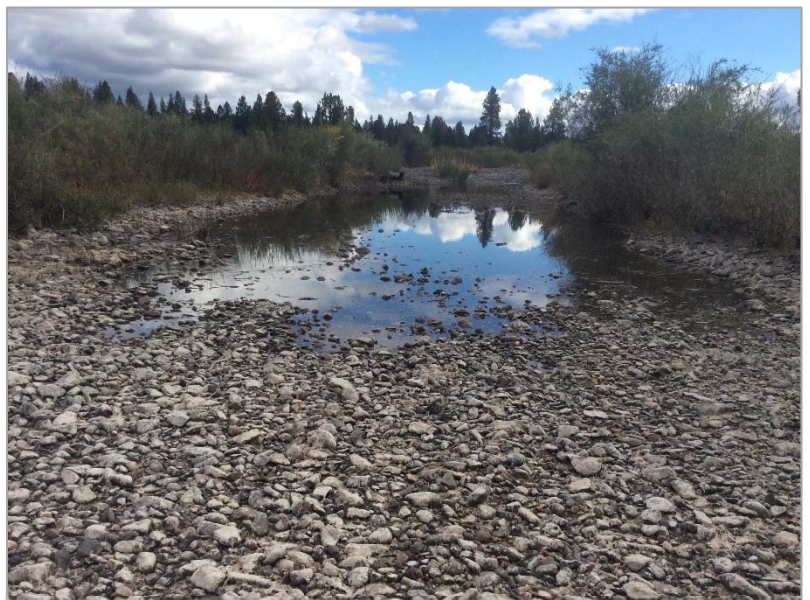
Figure 4. Downstream extent of wetted channel just upstream of Ukiah in September 2015.

Shallow soils and bedrock combined with steep topographic relief and limited vegetative cover result in a flashy hydrologic regime when rainfall occurs, concentrating flows into stream channels. Shallow soils and bedrock near the surface prevents the vertical movement of water to groundwater aquifers or soil storage areas. Steep topography combined with this lithology results in a largely lateral movement of water. In the absence of vegetative cover to intercept and utilize rainfall, storm water is directed to stream channels. This process has likely been exacerbated by historic timber harvest and fires throughout the watershed, stream channelization and floodplain infringement, and a reduction in wetland area due to beaver removal, flood control efforts, and water extraction. Hyporheic exchange and lateral groundwater movement can buffer summer flows in the lower gradient meadows of the valley bottom in lower Camas between June and late September, however portions of the stream channel near Ukiah can run dry in the late summer, depending on snowpack and summer precipitation (Figure 4). Groundwater flows of significantly lower temperature than surface waters enter Camas Creek near Pine Creek below Ukiah (Zakrajsek 2012). The groundwater table in Lower Camas

Creek has likely been lowered as a result of channel incision and a loss of floodplain connectivity and wetlands.

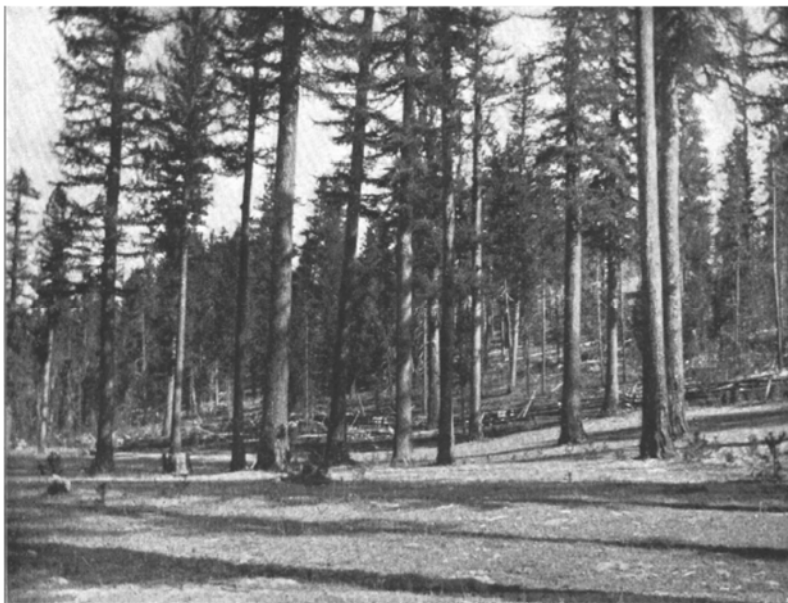
Figure 9. Photo of a Tamarack/Yellow Pine (PIPO) grove in the Blue Mountains. Gannett, circa 1900.

The timber species mentioned in early survey maps include pine, fir, and tamarack. Western larch (*Larix occidentalis*), the only native tamarack in Oregon, is generally associated with the more moist and cool north and east facing slopes within hot, dry ecoregions such as the Blue Mountains. Larch also thrive in open areas where burning has occurred, and they themselves are a fire tolerant species due to their thick bark. It is possible that references to tamarack refer to lodgepole pine, which is also known as tamarack pine in some areas. Grand fir (*Abies grandis*) is also native to northeastern Oregon, and prefers cool, moist sites but is less fire tolerant than larch or ponderosa pine. Ponderosa pine (*Pinus ponderosa*) is a fire tolerant species generally growing in dry, well-

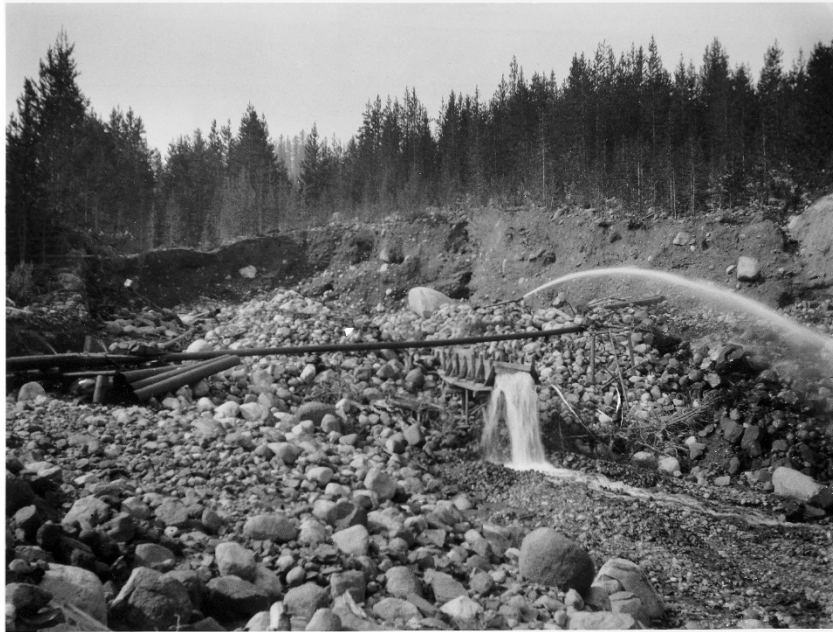
Figure 12. Hydraulic sluicing in the UNF. Photo from John Guthrie, circa 1930.

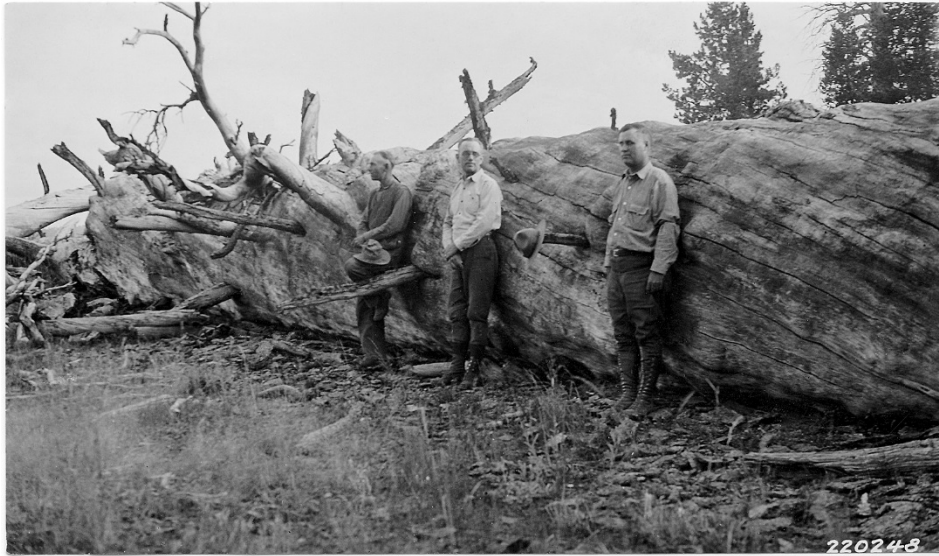
Figure 13. Large diameter PIPO was selectively harvested throughout the Camas watershed in the early 20th century. Photo from John Guthrie, 1927.

Reports as early as 1902 suggest that significant timber harvest had already occurred in the Blue Mountains of Umatilla County (Gannett 1902). A sawmill east of Ukiah was established sometime between 1907 and 1920, with most of the milled timber harvested from private lands (Popek 1995). Skidding logs with horses and later with tractors was used to transport timber to nearby roads or railways (Powell 2008). Skidding typically increased soil erosion, and was often done across stream corridors, impacting riparian vegetation and bank stability. A railroad constructed by the Mt. Emily Logging Company in the early 20th century enabled easy transport of selectively harvested large PIPO along Camas and Rancheria Creeks (Figure 13, Popek 1995). Large volumes of timber were transported to nearby La Grande for milling (Powell 2008). The 1937 Camas Creek timber sale to the Milton Box Company allowed the removal of more than 220 million

board feet of timber in most of Upper Camas and Hidaway Creeks, North Fork Cable Creek, Lane Creek, Bear Wallow Creek, Pine Creek, Bowman Creek, and Rancheria Creek (Powell 2008). Timber appraisal calculations suggest that the total timber sale allowed an ‘over-cut’ of 71 million board feet for a five year period (Powell 2008). In 1941 the Brown and Hoxie Mill opened shop in Ukiah, and is reported to have processed up to 1 million

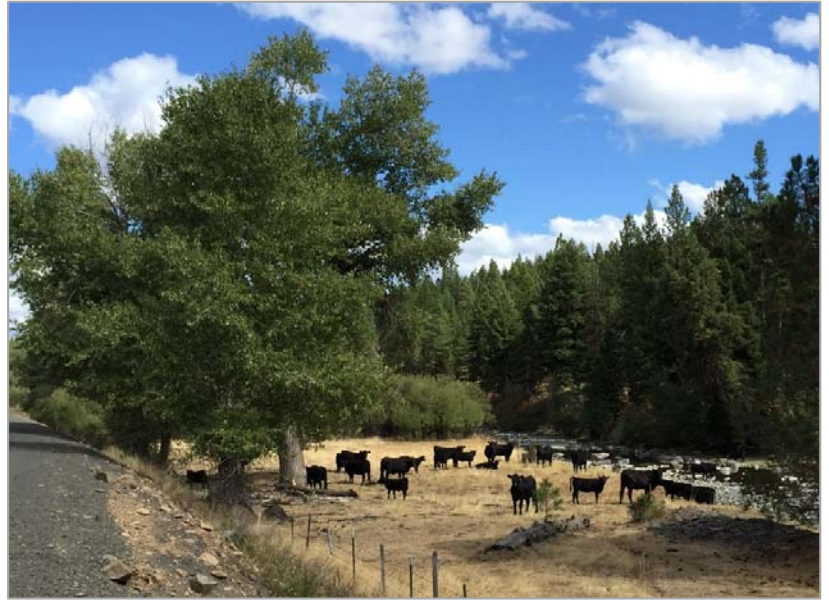
Figure 18. Cattle grazing along the right bank of Camas.

Current geomorphic conditions within Reach 1 vary considerably with changes in the active channel and floodplain width. At the upper end of the reach, the channel is confined to a single thread channel for approximately a half mile due to the placement of the ODOT maintenance site, a levee along the right bank, and SR 244. There are no large wood pieces or pools from RM 17.8 – 17.3, however riparian conditions are somewhat intact along the left bank, with continuous forest cover. The right bank has a few remnant patches of mature trees, but much of the bank is bordered by levees and the highway. At RM 17.25, the active channel widens to 280 ft, with several pieces of large wood, a small logjam, and a side channel spanning the right bank for 300 ft. Riparian cover along the right bank here is fair, with a small patch of mature trees, however the left bank is largely unvegetated until RM 17.1, where the valley wall steepens and coniferous forest is intact. Cattle grazing directly up to the channel was observed during the field visit, with obvious impacts to riparian vegetation and bank stability (Figure 18).

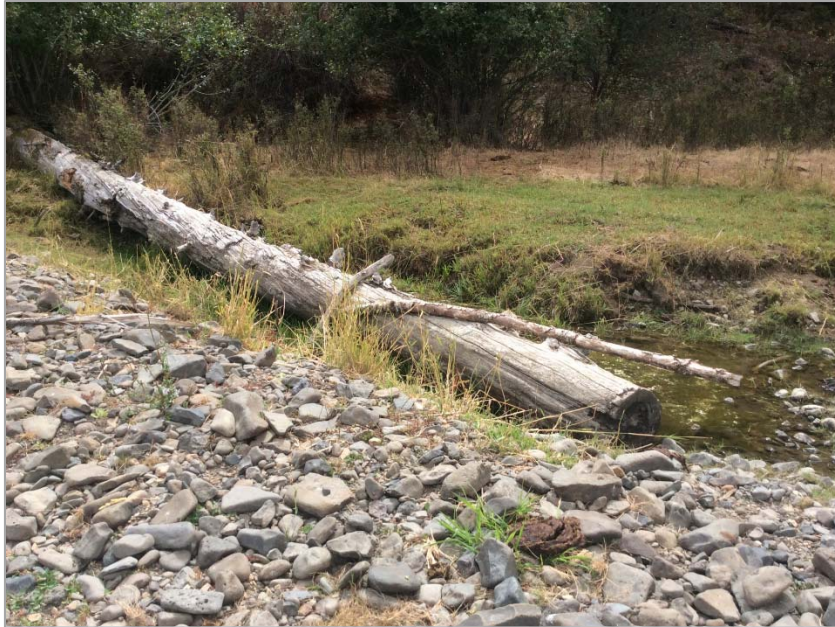
Figure 19. Large wood forced pool with stagnant water in Reach 1. Pool is only accessible during higher flows and lacks cover.

multiple pools, and an anabranch planform. Few of the pools have complex cover or shade, and some are only engaged during higher flows (Figure 19). A large wood assemblage near RM 16.1 has led to the formation of a gravel bar in its lee, creating a flow split within the right anabranch channel with several pools. Most of the wood within the reach is perched on gravel bars or low-lying floodplain and is not engaged at regular and low flows, limiting its influence on habitat. Riparian cover is non-existent along the right bank, with intact forest along the steep left bank to the south. The right anabranch conveys the majority of flow, and has virtually no complex cover or shade.

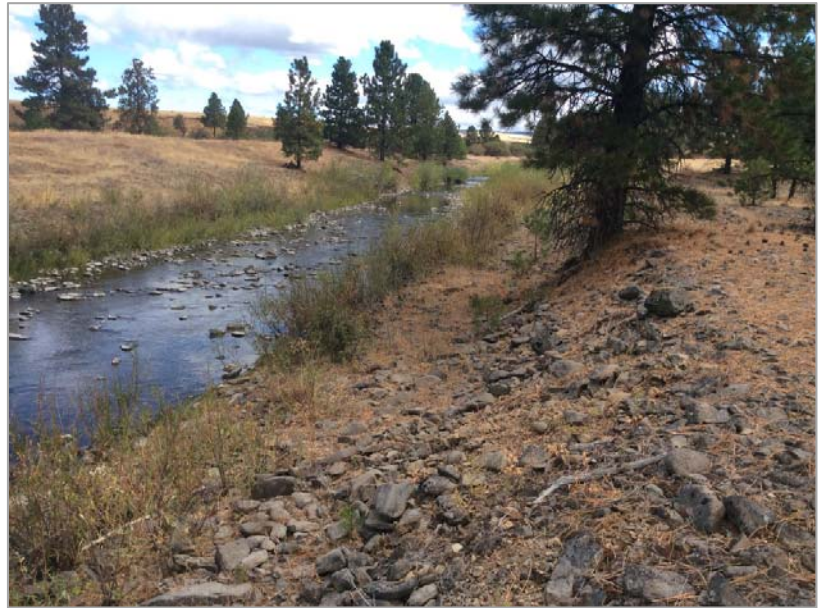
Figure 20. Reach 2 is confined to a bankfull width of 40 ft by levees on either side, resulting in a straight, plane bed channel with no cover.

Reach 2 is currently confined between levees on both banks for the entire channel length, resulting in a straight plane bed channel with no habitat complexity, pools, or large wood (Figure 20). The channel and floodplain width are constrained to 40 – 60 ft from RM 14.75 to 14.4. Riparian cover on both banks is very poor, with few trees and virtually zero cover or shade. There is relatively low lying floodplain on either bank beyond the levees, with some areas below the wetted channel surface (Appendix C). A high flow channel where some levee erosion appears to have occurred at RM 14.6 is engaged during the 100 year flow event, however the flow spanning the alluvial fan within this channel is predominantly shallow (< 0.5 ft) and thus provides little to no habitat or refugia during high flow events.

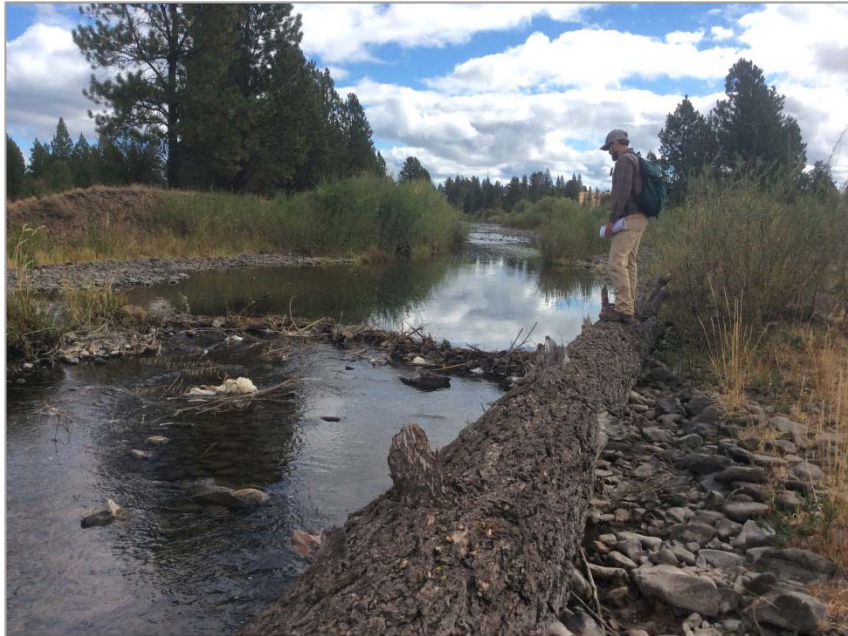
Figure 21. Beaver dam and large wood within Reach 3.

Reach 3 currently has an anabranch channel planform where the 1965 levees have been eroded. This process has allowed the channel to re-engage some of the low-lying floodplain to the north along SR 244 and to the south on the alluvial fan. Floodplain width in Reach 3 ranges from 340 to 600 ft, with an active channel width of 130 – 240 ft. Total channel length is nearly doubled by the amount of secondary or anabranched channels within the reach. These channels are not all perennial, however they likely provide flood storage and slow water off-channel habitat during winter and spring flows. Substrate within the secondary channels contained smaller gravels when compared to the main channel, which is consistent with bed mobility estimates from the 2D hydraulic model results. Several of the channels were wetted during the field visit, with pool habitats formed by both alluvial processes and wood recruited by beavers (Figure 21).

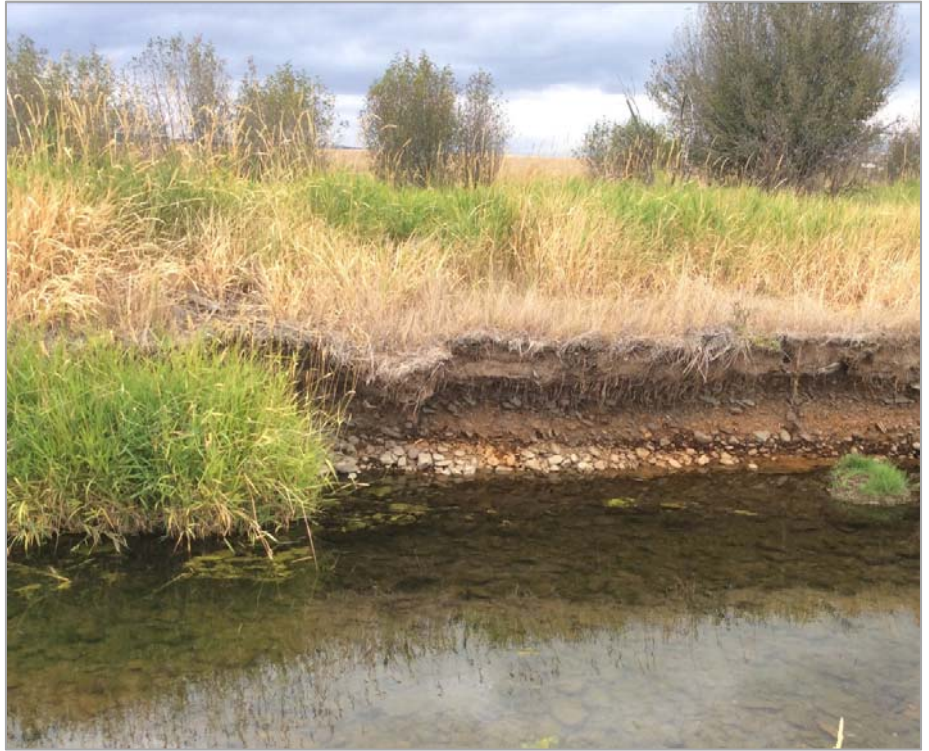
Figure 23. Bank erosion and possible channel incision within Reach 6 near RM 12.35.

Several areas of bank erosion with cobble lenses perched 3-4 ft above the channel bed suggest that Camas has also incised within some channel segments within Reach 6 (Figure 23). The left bank in the meander bend at RM 12 also shows some signs of bank erosion, however the cut bank is much lower than that observed upstream below the bridge.

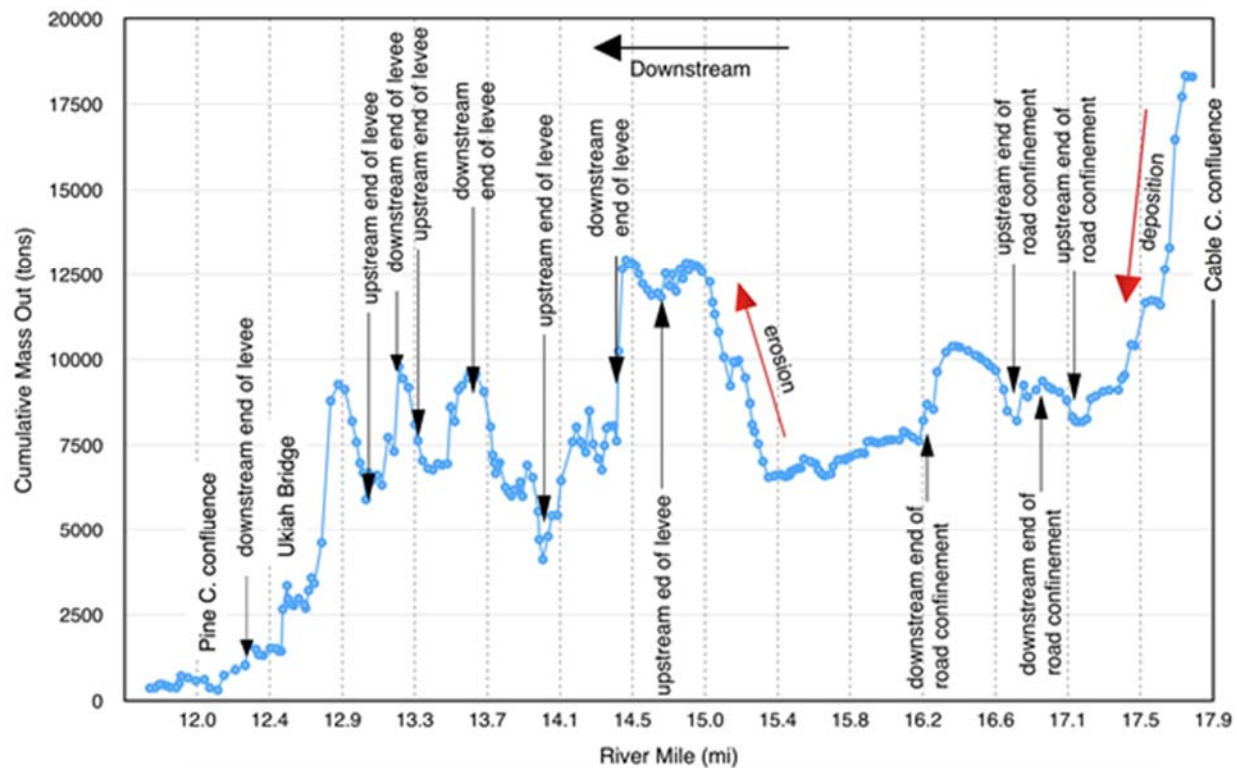
Figure 27. Model results of cumulative mass out (tons) for the duration of the 15-year peak flow (3500cfs) along the modeled reach.

At the upstream end of the model at the Cable Creek confluence (near RM 17.8) there is a significant sediment load entering the model due to the equilibrium load boundary condition. This high sediment load quickly deposits in the immediate downstream cross sections, down to RM 17.3. This modeled deposition (and associated aggradation in the channel) is a relic of the modeling software and equilibrium load boundary condition, and is not representative of expected sediment transport in this reach of the channel. Downstream of RM 17.3 the model results are representative of the anticipated sediment transport character of the channel. Near RM 17.1 approximately 1/3rd of the floodplain to the north of the channel is disconnected from the creek by SR 244 (Appendix C), and continues downstream to near RM 16.9. The response of the channel is to erode (increasing cumulative mass out) through this confined section of the channel, transitioning to deposition (decreasing cumulative mass out) immediately downstream of the confinement (Figure 27).

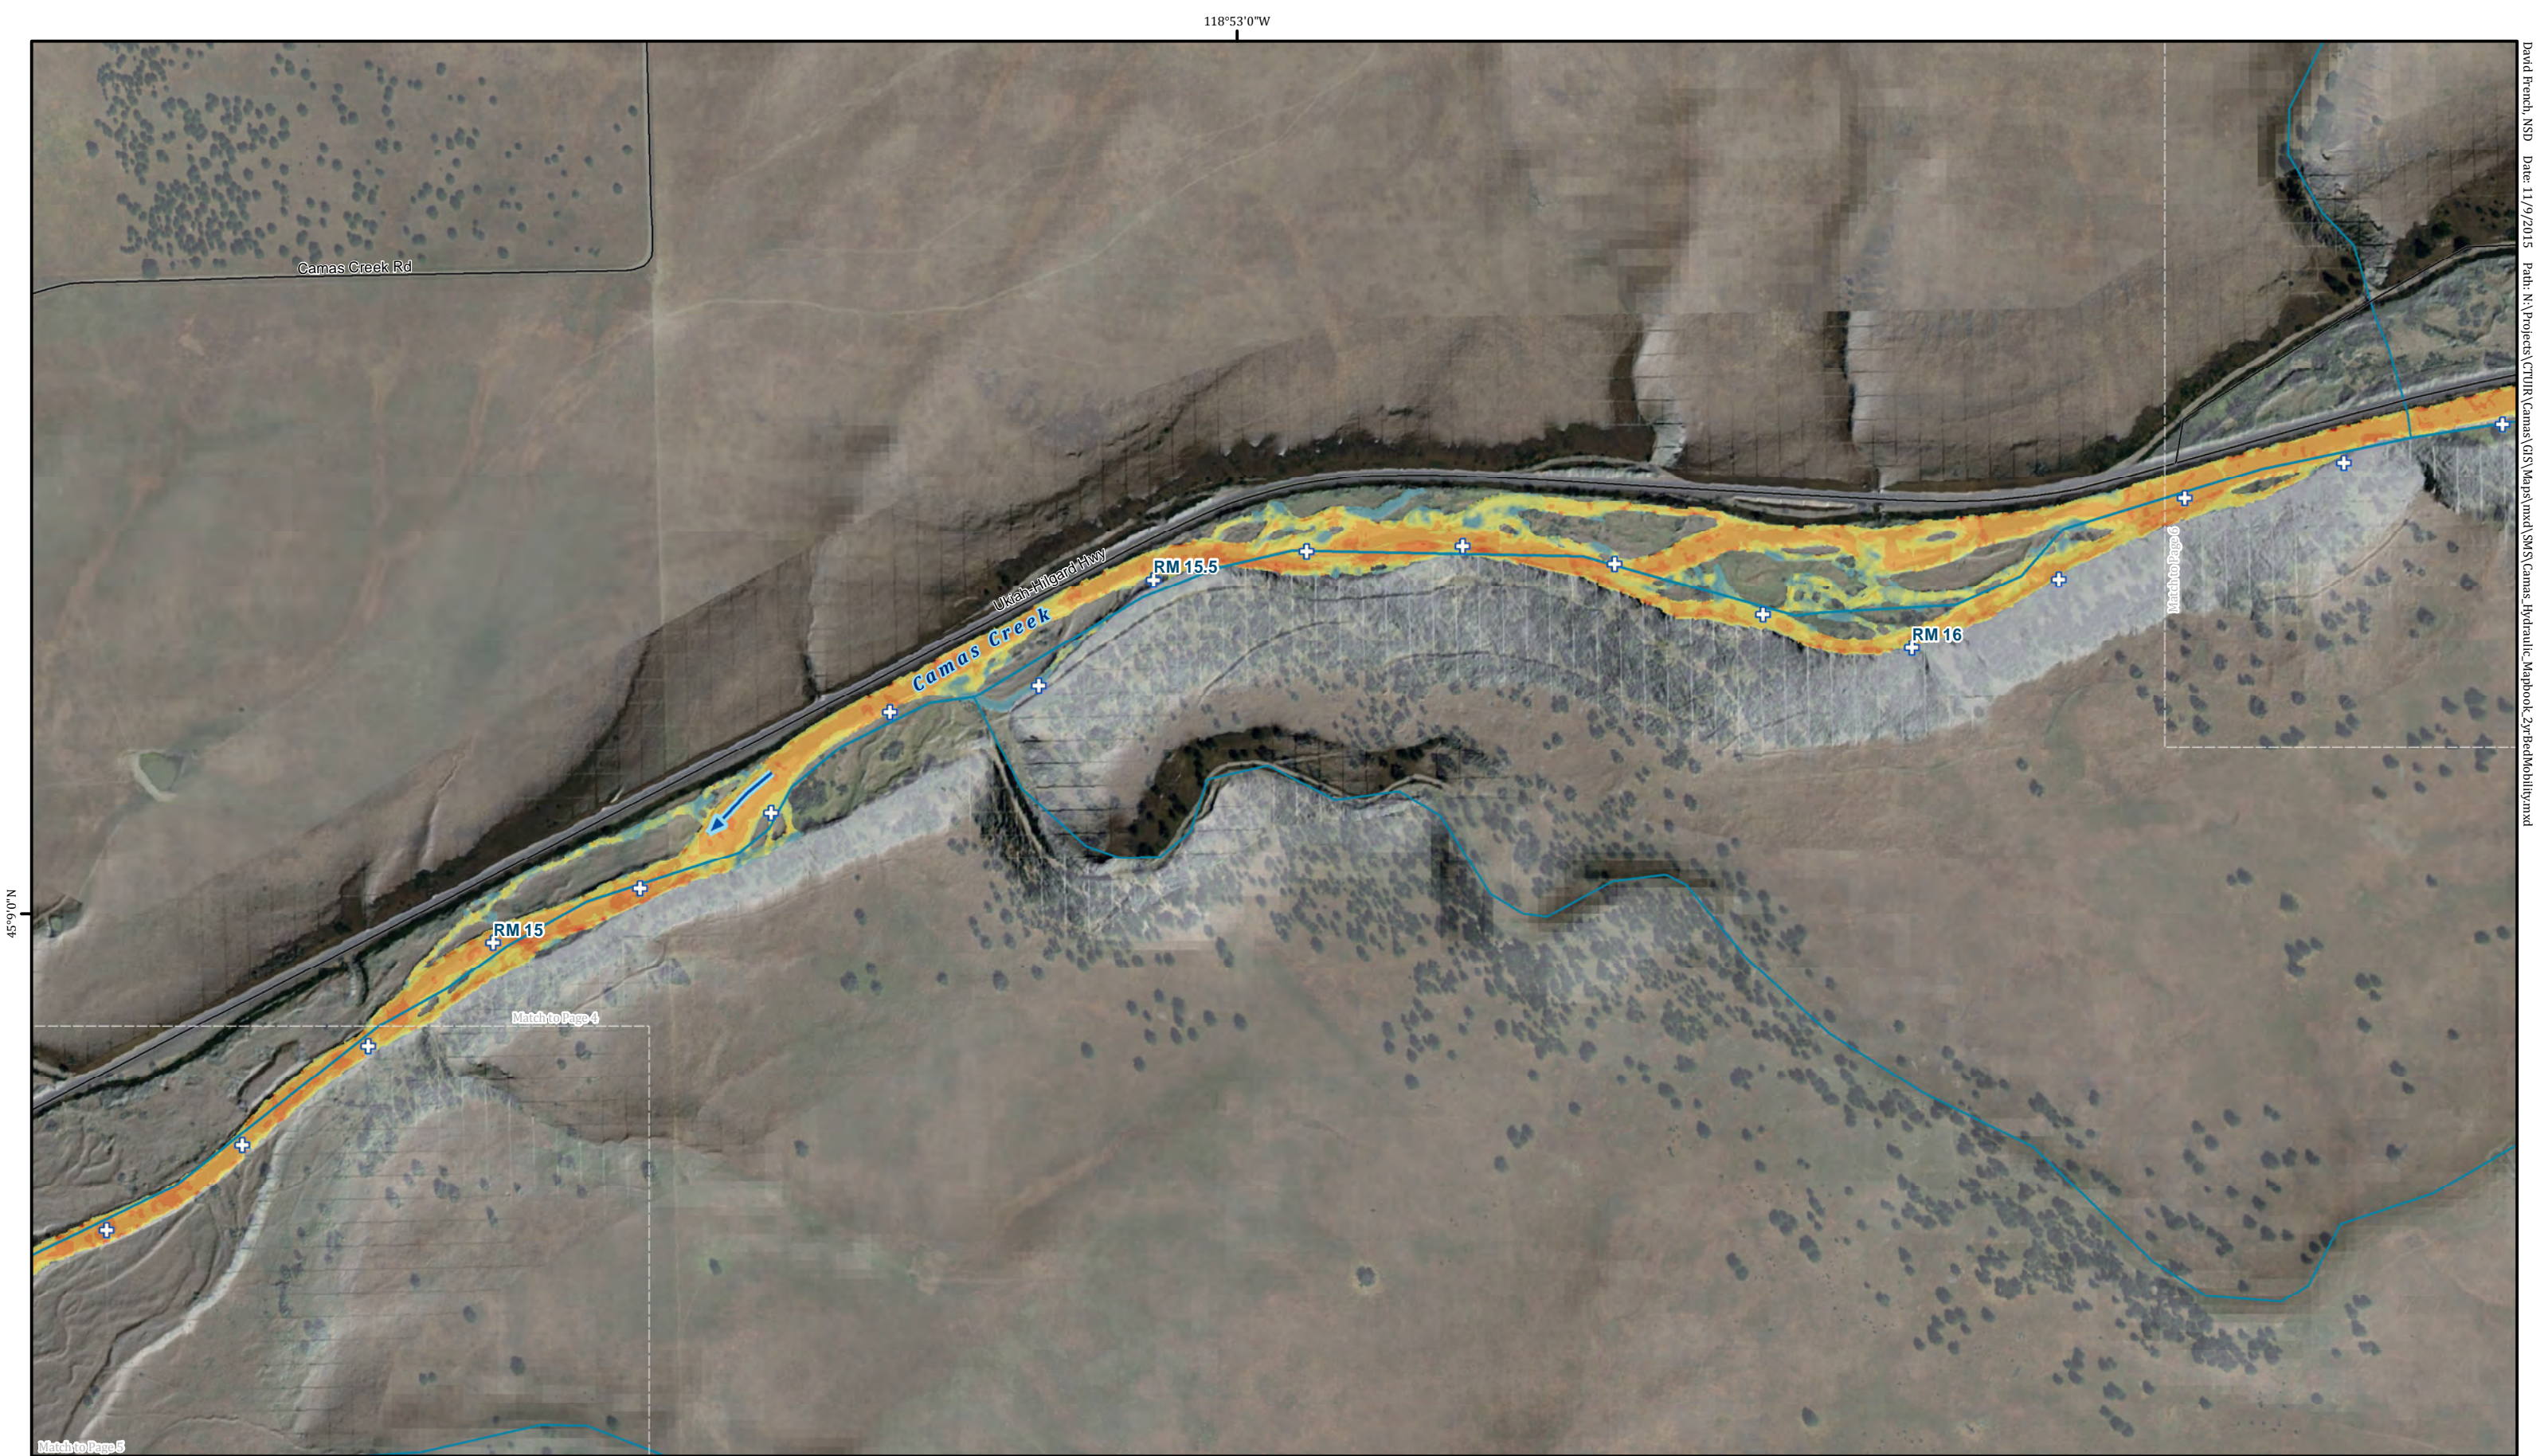
Existing Conditions 2 yr Flow Bed Mobility - Page 5 of 6

Average (D50) Minimum
Stable Partical Size (mm)

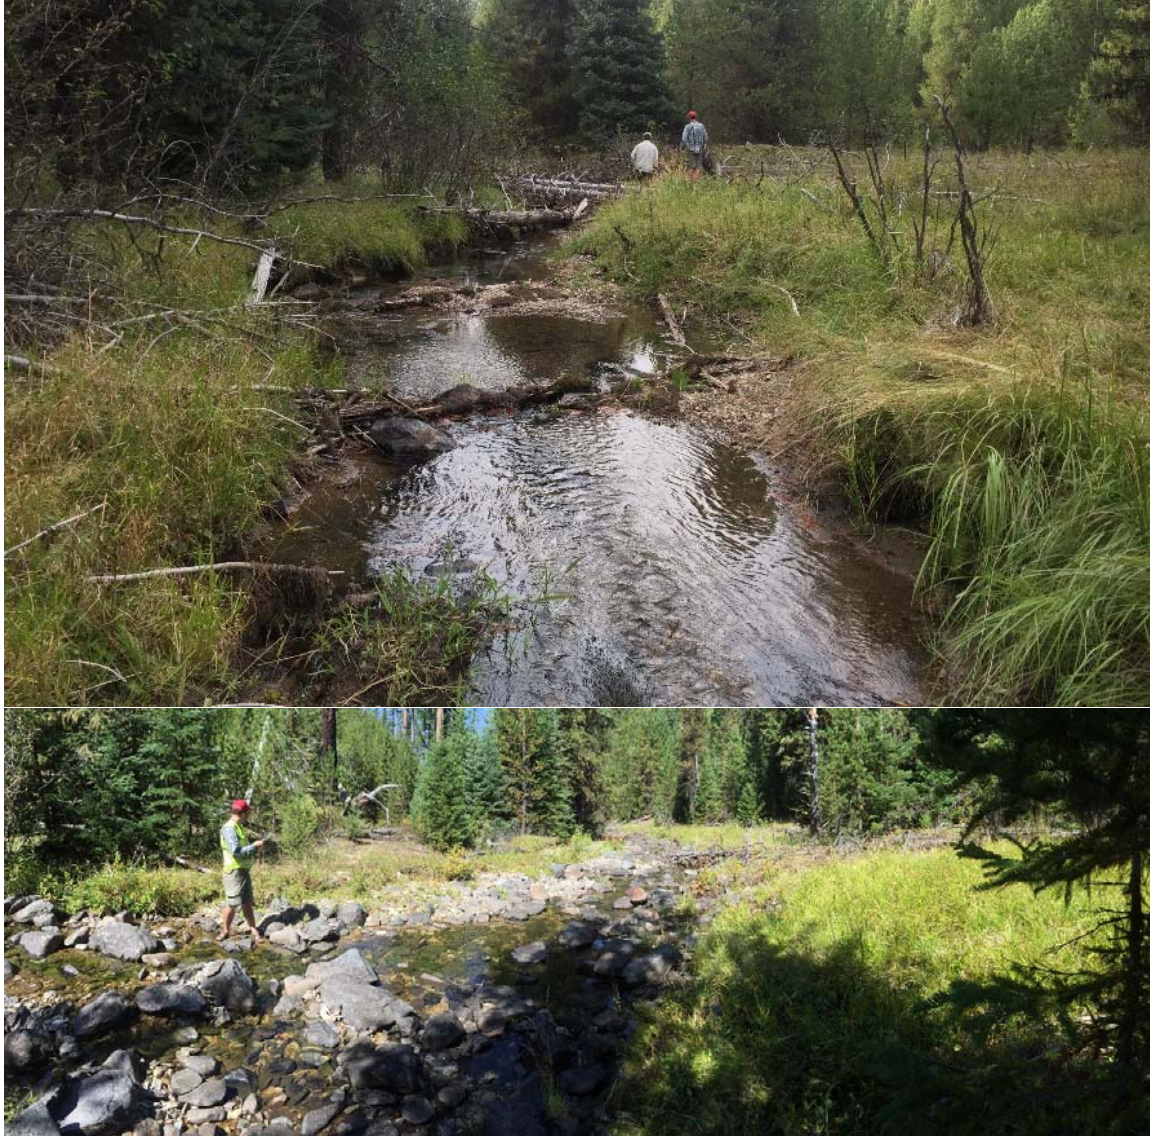
Figure 3. Typical channel types where beaver dam analog construction would occur.

The construction of simulated beaver dams or beaver dam analogs has been used in the west to address channel incision, reduce stream power, increase floodplain engagement, and restore riparian vegetation (e.g. Pollock et al. 2014). Based on current research, beavers typically build dams in perennial stream channels with slopes of less than 6%, an unconfined valley, and a bankfull stream power of less than 2000 watts per meter (Pollock et al. 2014). Upper Cable and Hidaway Creeks and their tributaries are prime examples for such conditions. In the Camas Creek watershed the construction of beaver dam analogs would target 2nd, 3rd, and select 4th order stream channels and portions of Cable Creek that fall well within these geomorphic and hydraulic parameters (Figure 3).

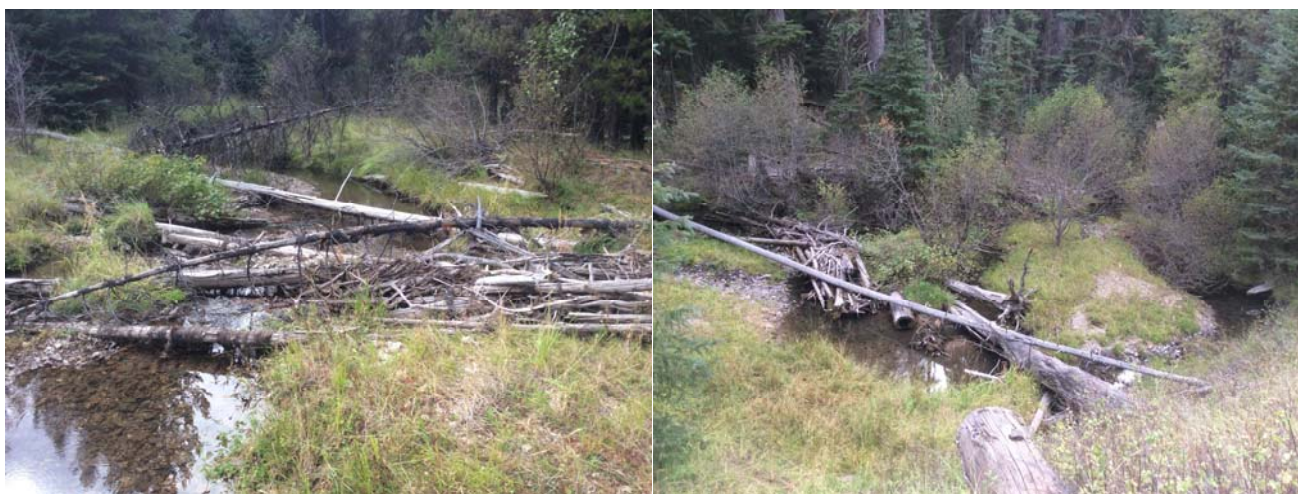
Figure 6. Naturally occurring debris bundles in the upper Camas watershed. In addition to channel-spanning beaver dam analogs, bundles can be placed in portions of the channel to improve hydraulic complexity and habitat formation.

capacity while improving aquatic and riparian habitat. Wood bundles can also be placed laterally or perpendicular to flow in portions of the channel to deflect flow away from eroding banks, increase channel sinuosity and flow splits, and to encourage pool formation (Figure 6).

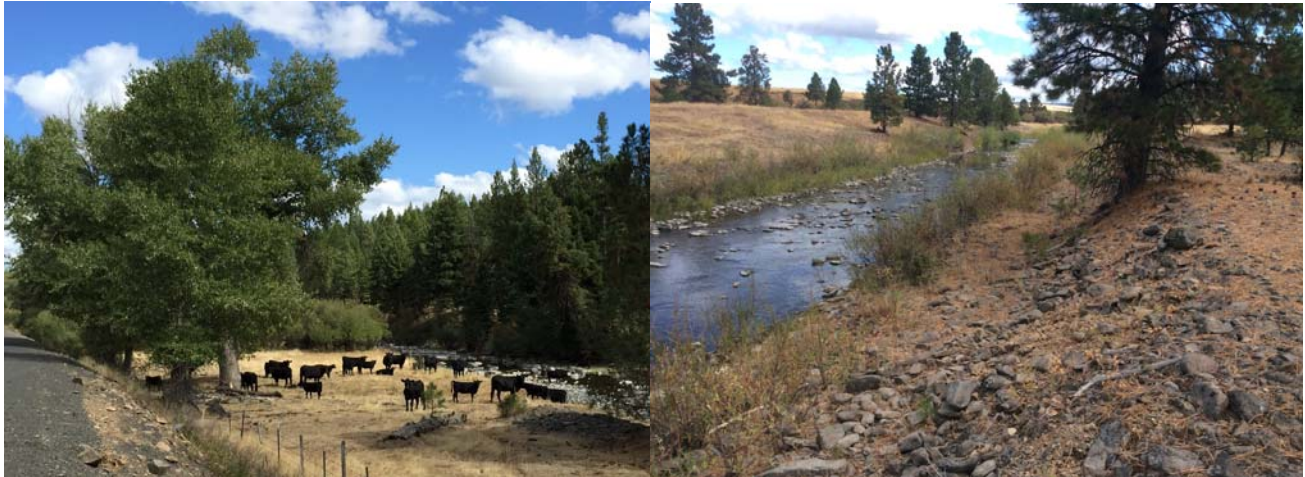
Figure 7. Cattle grazing along the right bank of Camas Creek (left). Grazing, historical vegetation removal, and an incised channel has resulted in very limited riparian growth (right).

Riparian health from Cable Creek to Ukiah is primarily poor to very poor in condition (NSD 2016, Ecovista 2003). Historically, the riparian corridor was likely characterized by robust populations of willow, alder, hawthorne, cottonwood, fir, aspen, and ponderosa pine (Thorson et al. 2003). Timber harvest and subsequent grazing by cattle and elk has reduced riparian health throughout the Primary AOI and in portions of the Secondary AOI, including Cable Creek. Recovery of a functioning riparian zone is essential to addressing limiting factors associated with the lack of wood and pool formation, forming and maintaining an anabranching channel form, improving bank stability and reducing sediment input, and lowering high summer water temperatures (NSD 2016). Figure 7 shows typical riparian conditions within the Primary AOI.

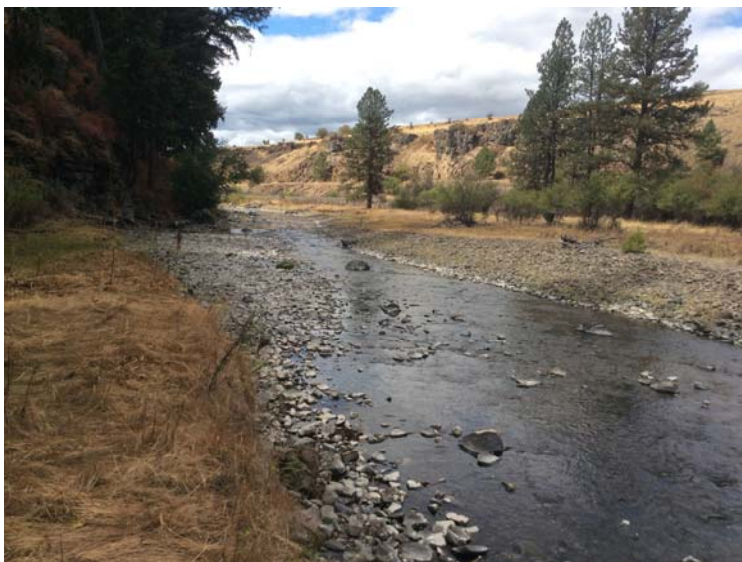
Figure 8. Typical conditions in mainstem Camas Creek at RM 15.7.

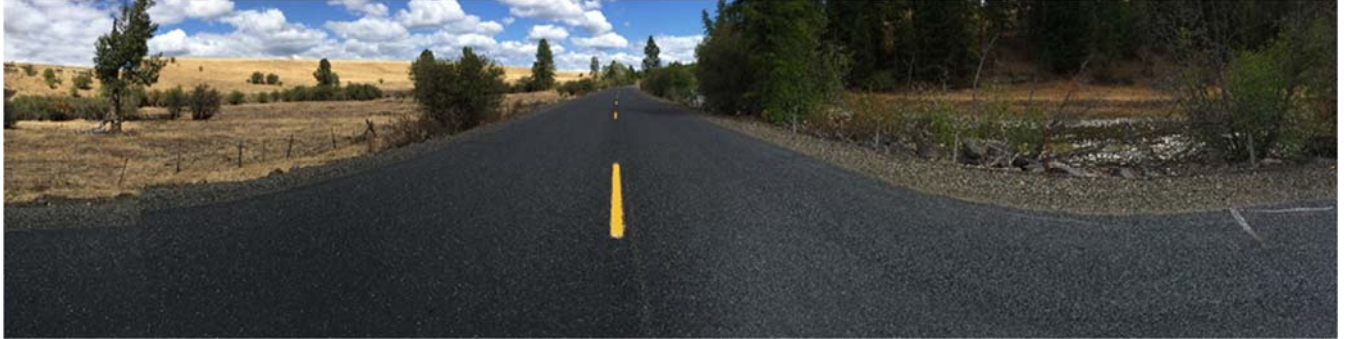
Figure 11. Typical floodplain infringement from SR 244 within the Primary AOI.

With the 1954 completion of SR 244, the floodplain was bifurcated in many places, including the alluvial fan from RM 13.6 – 14.7; in the unconfined valley bottom from RM 16.2 – 16.7, RM 17.4 – 17.7, RM 17.9 – 18.3, RM 18.5 – 18.9, RM 20.4 – 20.5, and RM 21.5 – 21.8; and in the upper watershed at 29.3. In many places, the SR 244 road alignment acts as a levee, and results in more than 85 acres of disconnected floodplain and potential off-channel habitat areas (Figure 11).

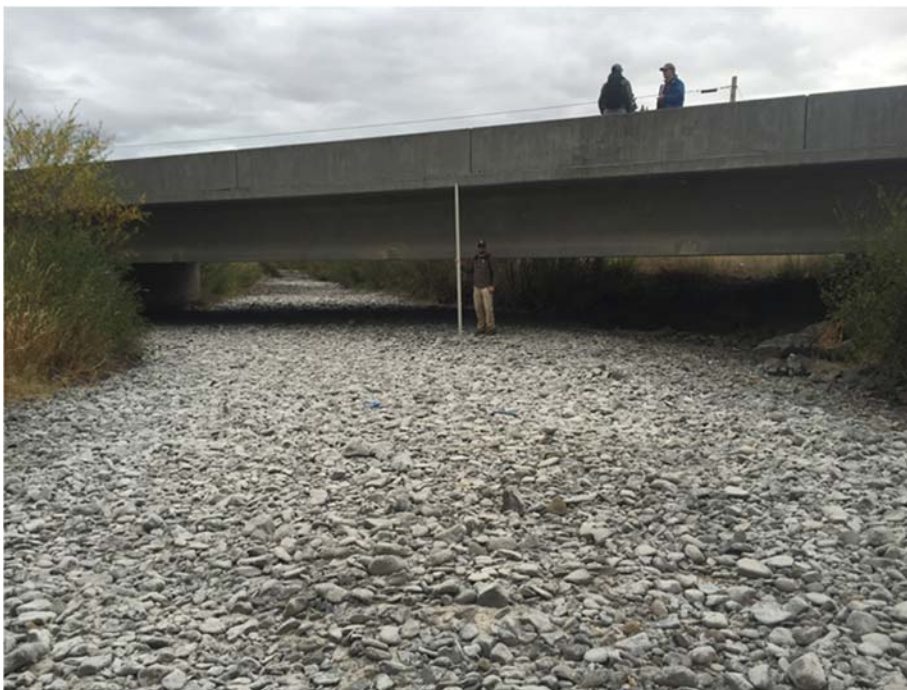
Figure 12. Camas Creek aggradation at the Camas Street Bridge (Sep. 2015).

Dredging of the channel through Ukiah to increase flood capacity without associated levee setback would be an expensive and short term solution, requiring periodic additional dredging following larger flood events to clear newly deposited sediments. The configuration of the levees, with an increase in the width of the channel through Ukiah relative to upstream of town, creates hydraulic conditions through town that encourages the deposition of sediment. Additionally, the Camas Street bridge creates a local hydraulic obstruction that slows water during high flows, creating conditions for the accumulation of sediment. Figure 12 shows the aggradation that has taken place since the construction of the new bridge in 1983, exacerbating seasonal dewatering of the creek. The establishment of vegetation on these accumulated sediments suggests that the creek is in a state of disturbed equilibrium, where little to no additional sediment will accumulate during normal flooding events. Thus, any dredging of these accumulated sediments without levee setback would only create conditions for sediment to again deposit in the reach through Ukiah. In order to maintain flow capacity realized through dredging without levee setback, it would need to happen regularly and would likely still be insufficient to prevent the 100 yr flood from overtopping the levees through Ukiah.

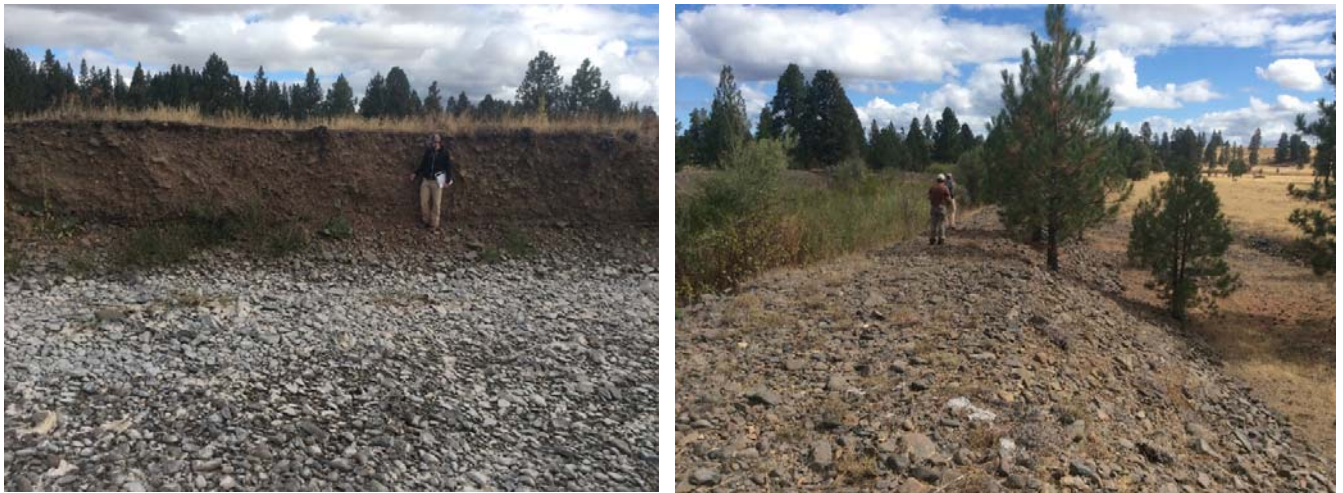
Figure 13. Eroding levee along Camas Creek at RM 14.2 (left) and intact left bank levee at RM 14.4 (right).

- ▶ RM 14.4 – 14.7. 3,400 linear feet of relict levee on the left and right banks confine the channel and isolate adjacent floodplains from inundation. No infrastructure immediately adjacent to the levee removal areas would be at risk. Figure 13 shows the left bank levee within this area. Levee removal in this location should also evaluate potential future channel migration risk along SR 244.

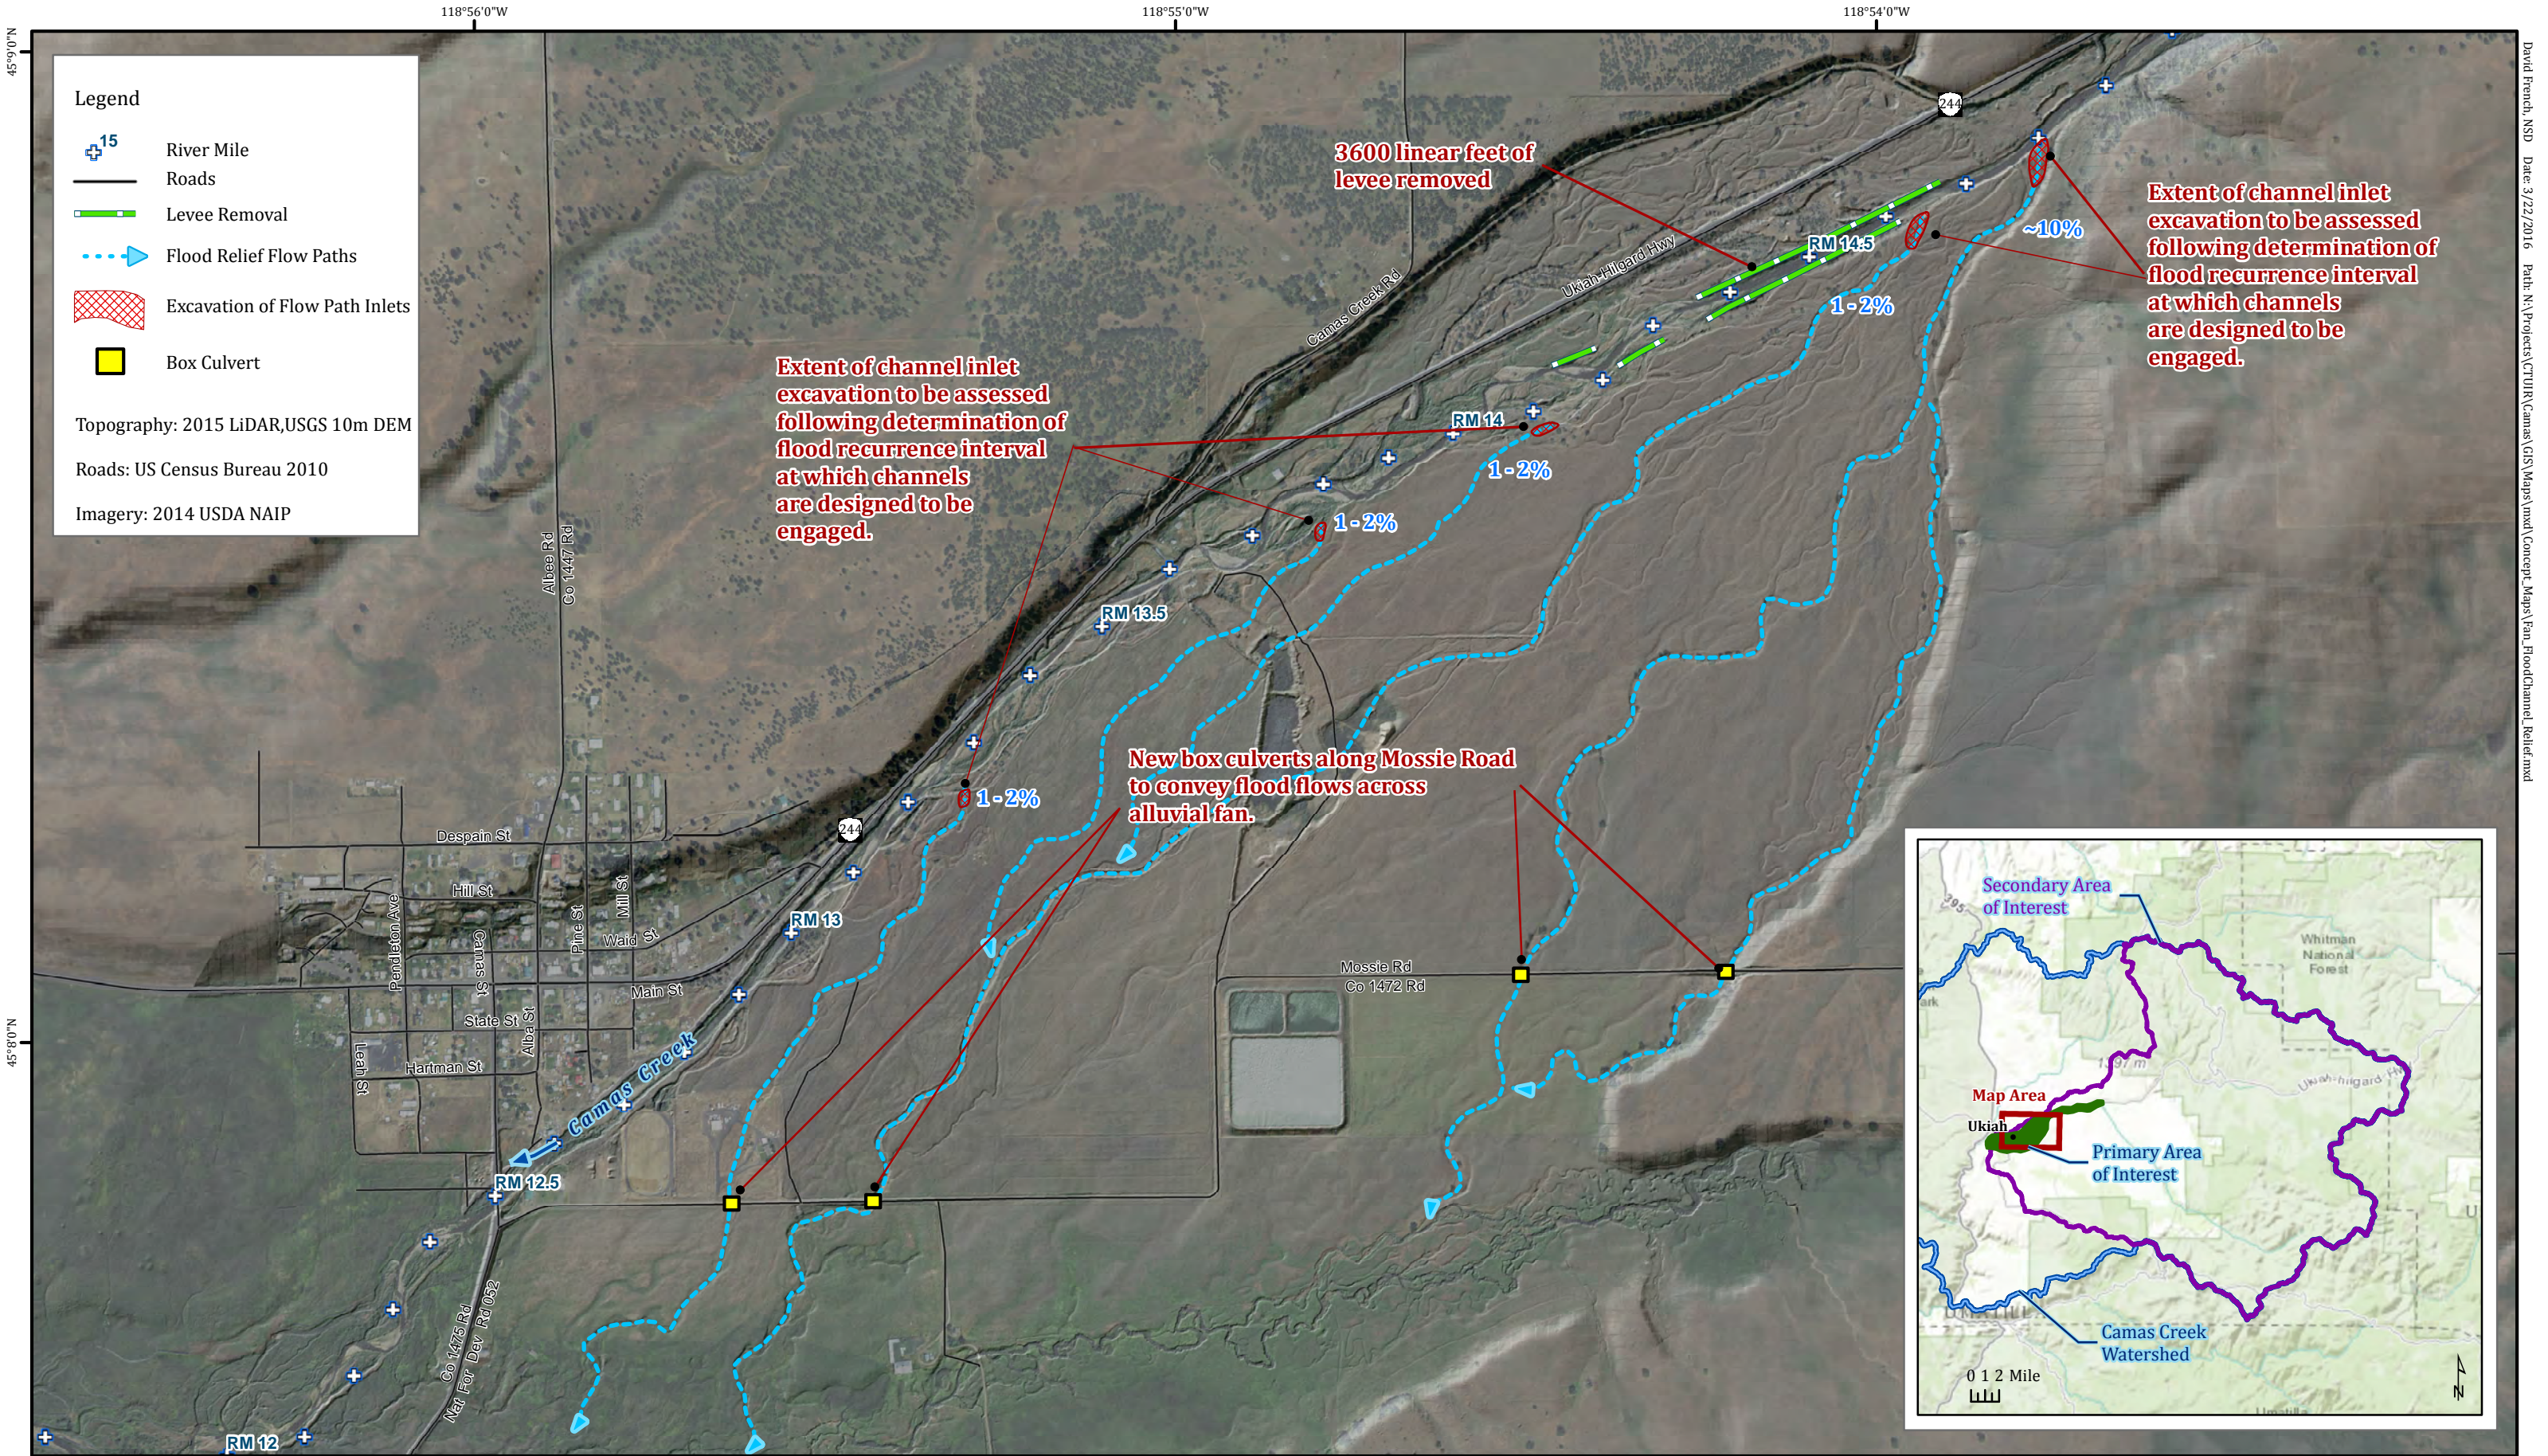
Camas Creek Geomorphic Assessment & Action Plan
Map 12 - Levee Removal Upstream of Ukiah

Levee removal upstream of Ukiah will allow for the establishment of a new active channel corridor 100 – 1000 feet in width (average width of 750 ft.), increased floodplain activation, and the elimination of levee erosion and gravel mobilization (Map 12). Approximately 8 acres of additional floodplain area could be immediately reconnected with the removal of the right bank levee between RM 14.4 – 14.6. Removal of other levees would allow the channel to re-establish an active channel corridor and anabranching planform. This action can be implemented independently of other actions but the overall effectiveness will increase with the relocation of SR 244 from RM 13.6 – 14.7, and the installation of large woody material (LWM) within the stream channel.
