CTUIR GRANDE RONDE SUBBASIN RESTORATION PROJECT

A Columbia River Basin Fish Habitat Project

Annual Report

Fiscal Year 2006

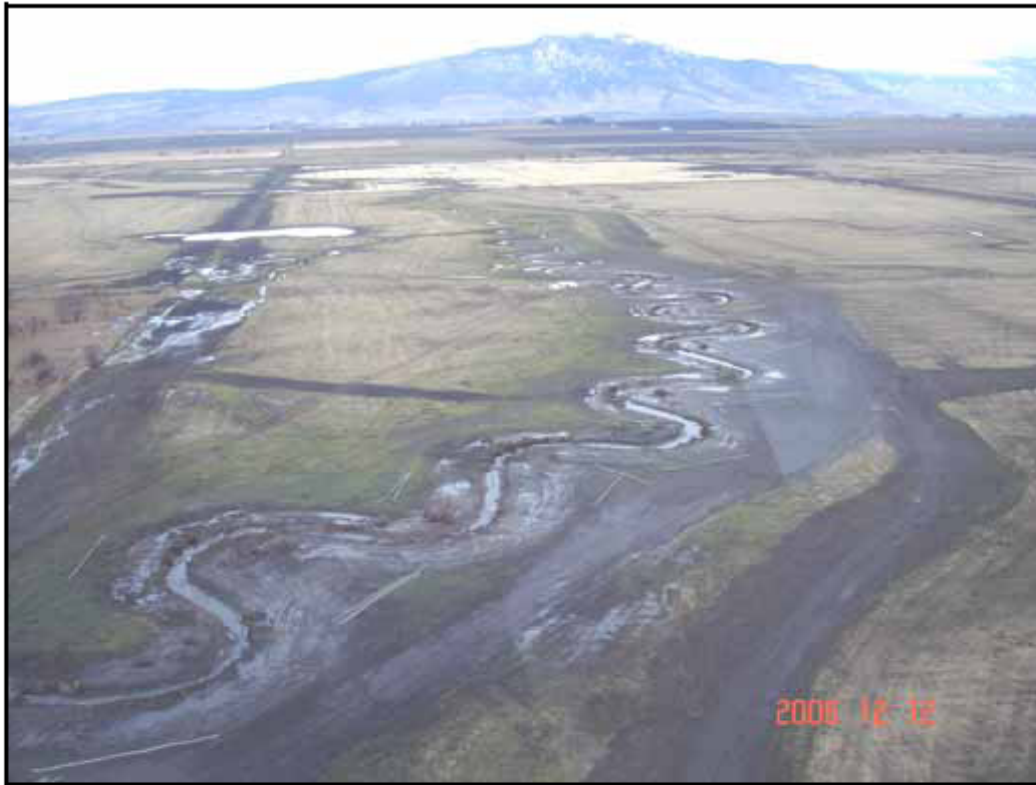
Upstream reach of End Creek (Rice) Restoration Channel, viewing east (downstream) towards South Fork Willow Creek confluence. Note reclaimed channelized reach in left corner of photo and floodplain ponds incorporated into reclamation plan. December 2006

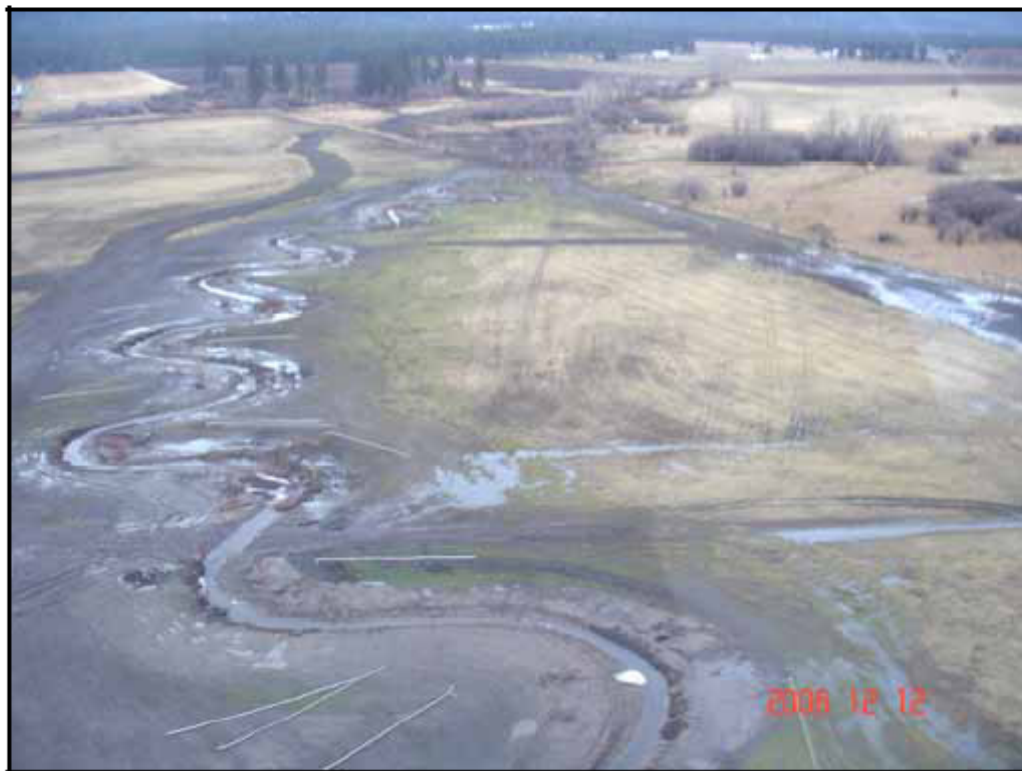
Upstream view of upper End Creek restoration channel. December 2006

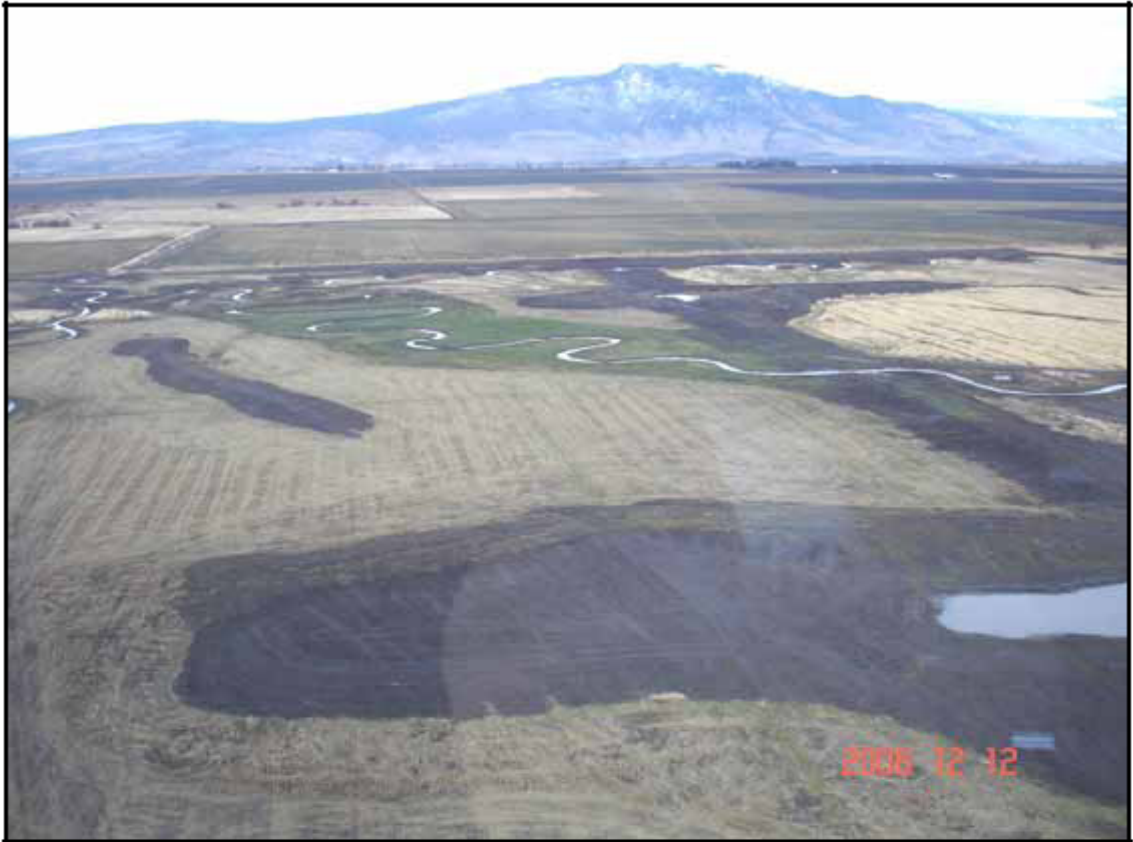
Lower End Creek Restoration Channel with floodplain pond in middle foreground. December 2006

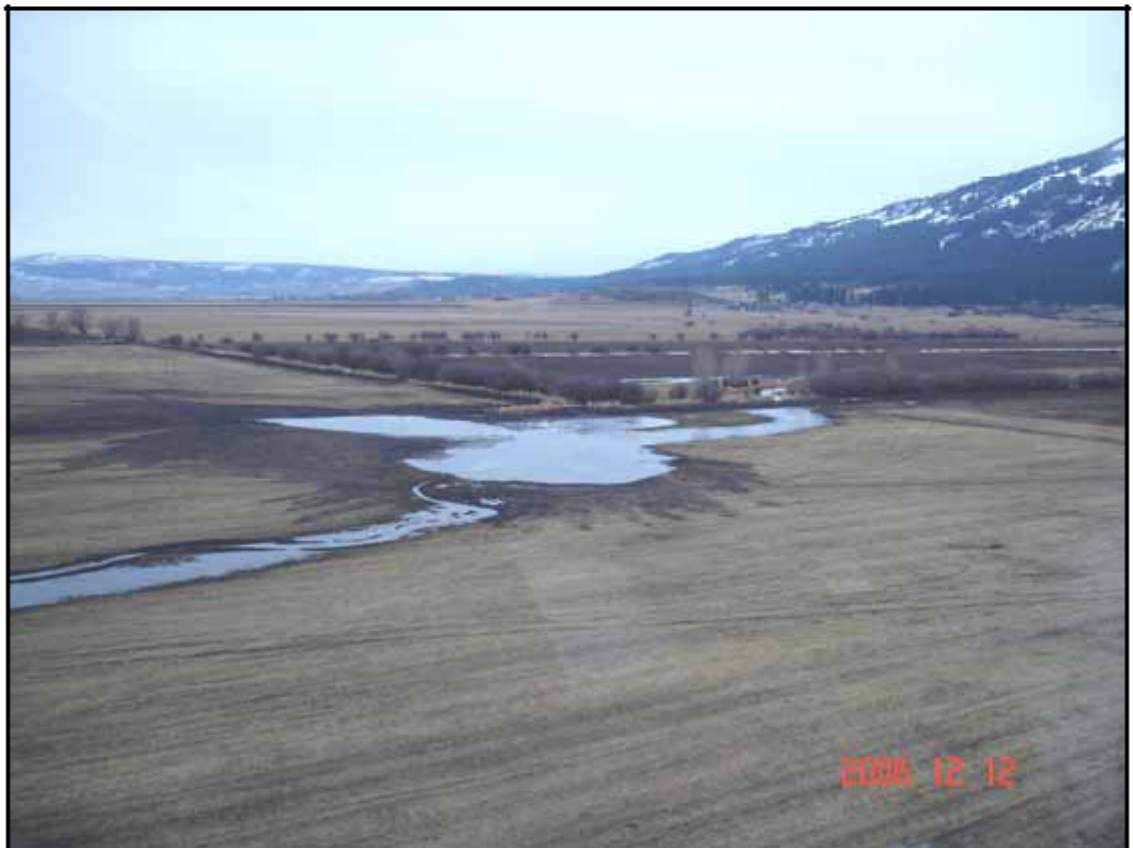
Floodplain pond with spring channel outlet. December 2006

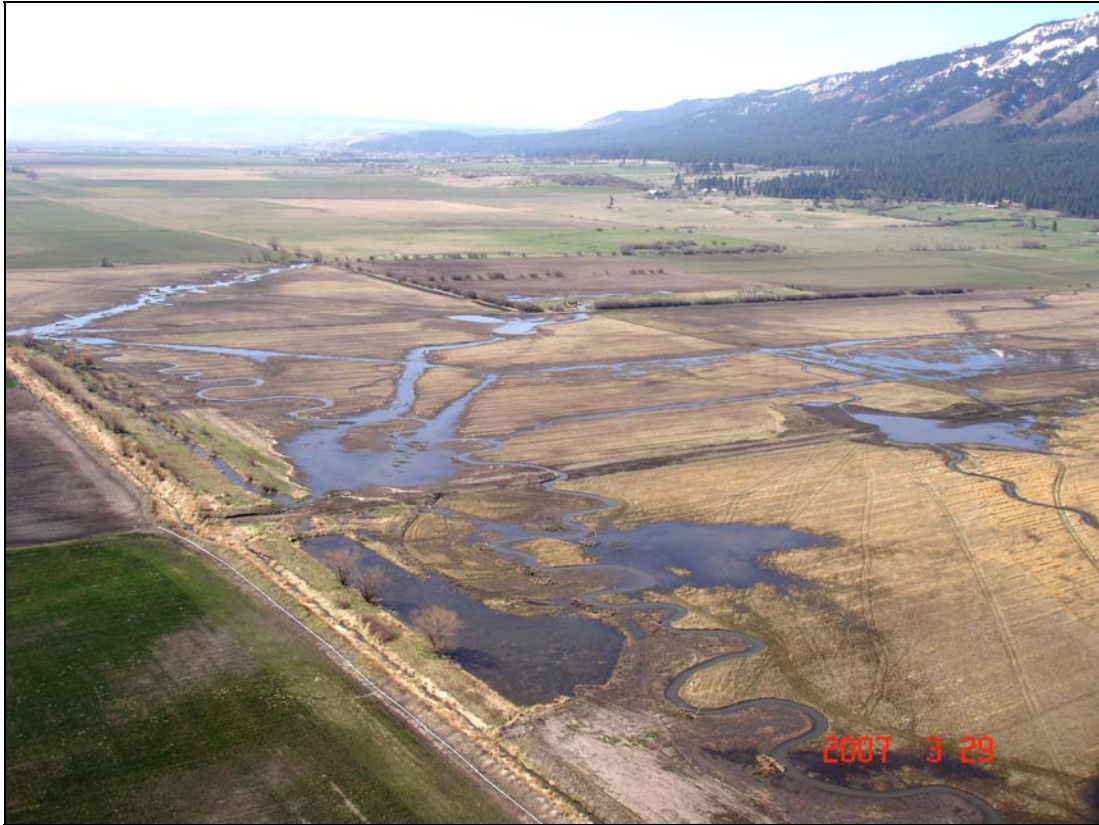
March 2007 – End Creek project complex illustrating spring high flow conditions.

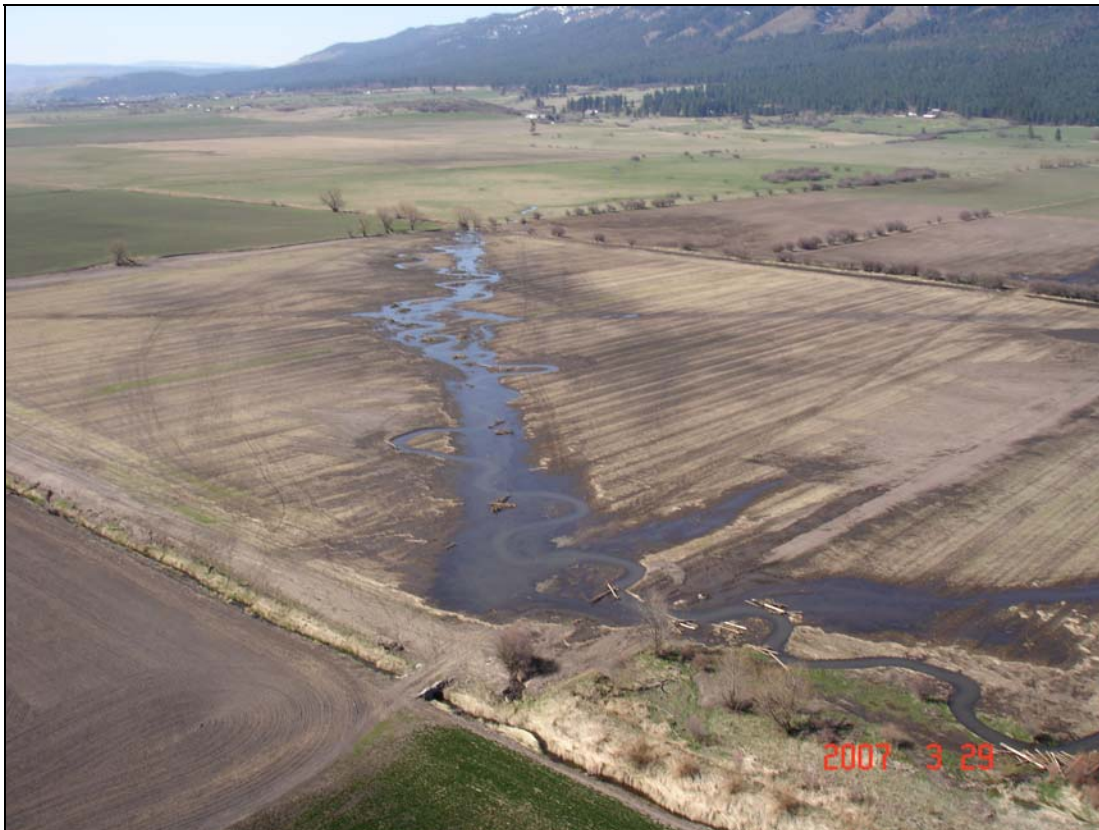
March 2007- End Creek project complex illustrating South Fork Willow Creek restoration channel during spring high flow conditions.

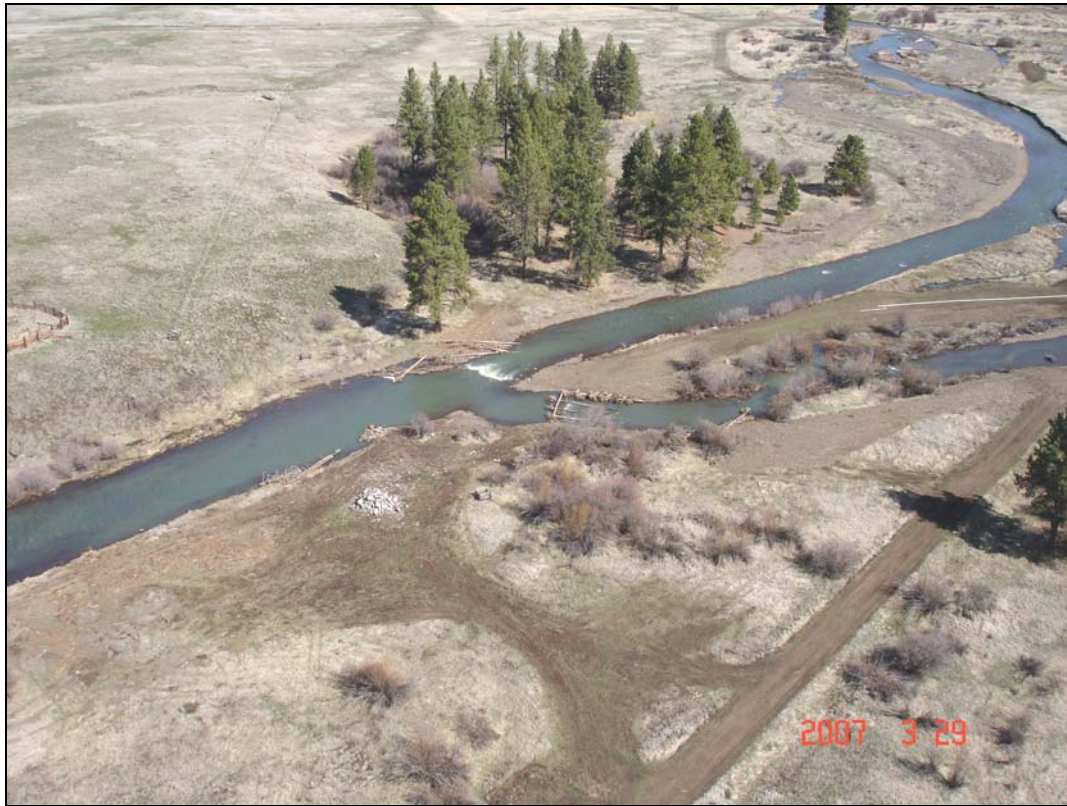
March 2007, Meadow Creek Restoration Project – Photo illustrates upper project area and entrance to wetland channel restoration network adjacent to Meadow Creek.

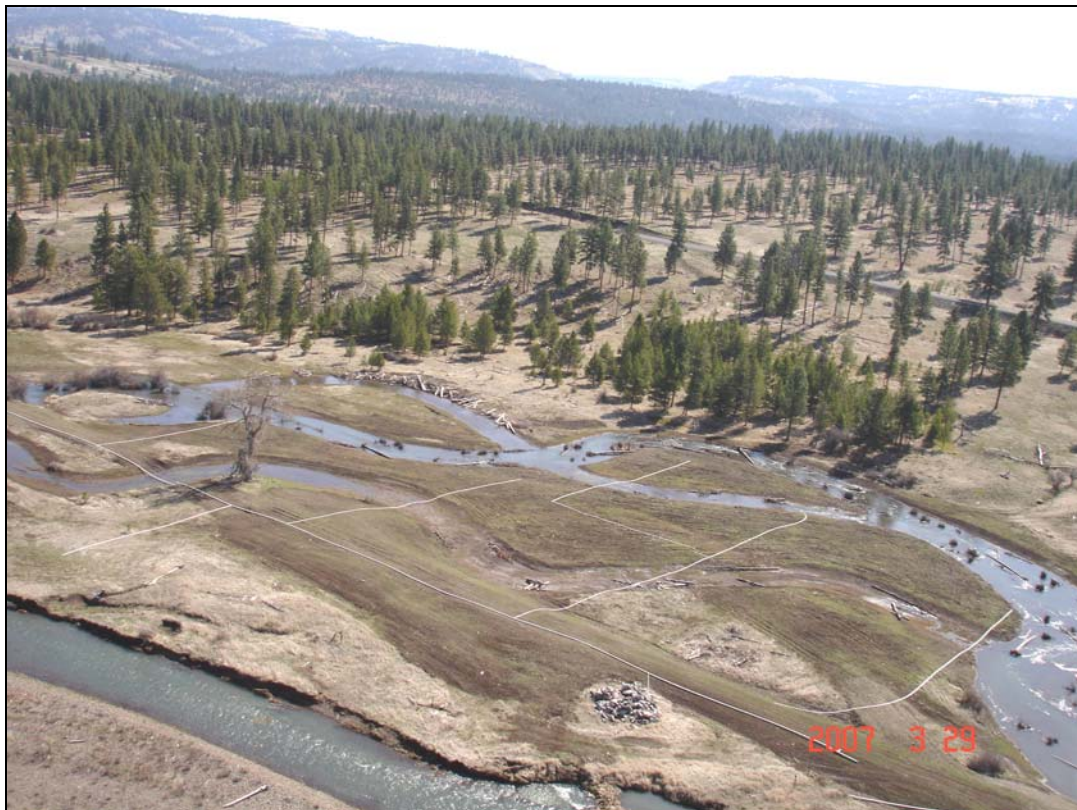
March 2007, Meadow Creek Restoration Project – Photo illustrates upper project area during spring high flow conditions. Note temporary irrigation system installed during summer 2006 to facilitate vegetative recovery.

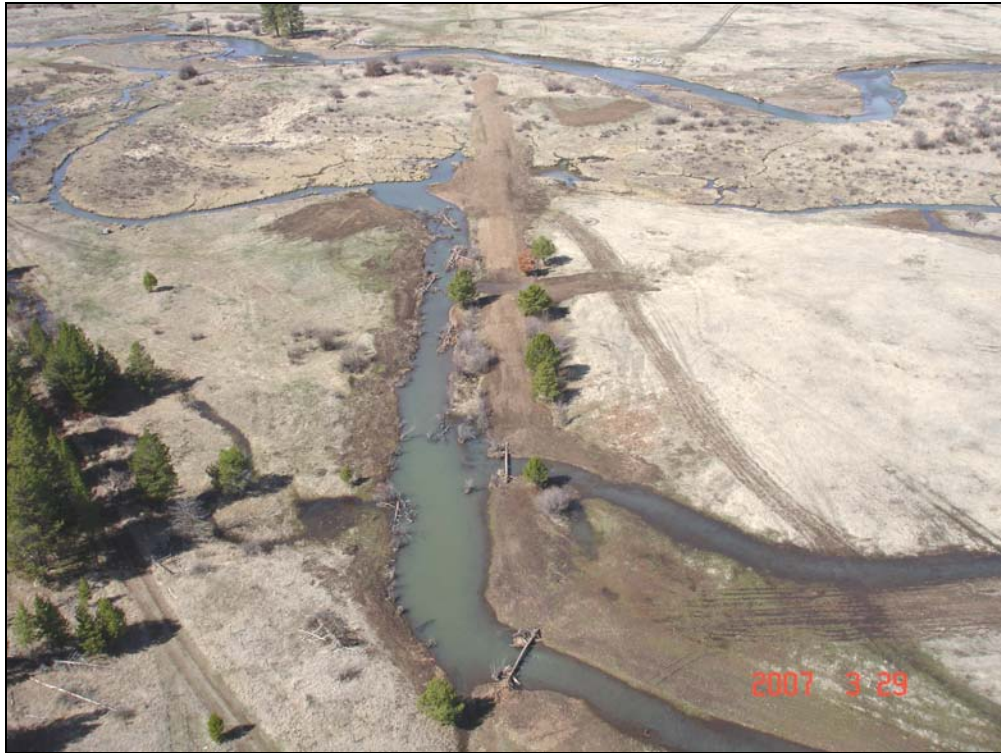
March 2007, Meadow Creek Restoration Project – Photo illustrates pond manifold developed by taking advantage of an old highway road prism. Manifold is utilized as a water control structure to manage streamflow into wetland restoration network.

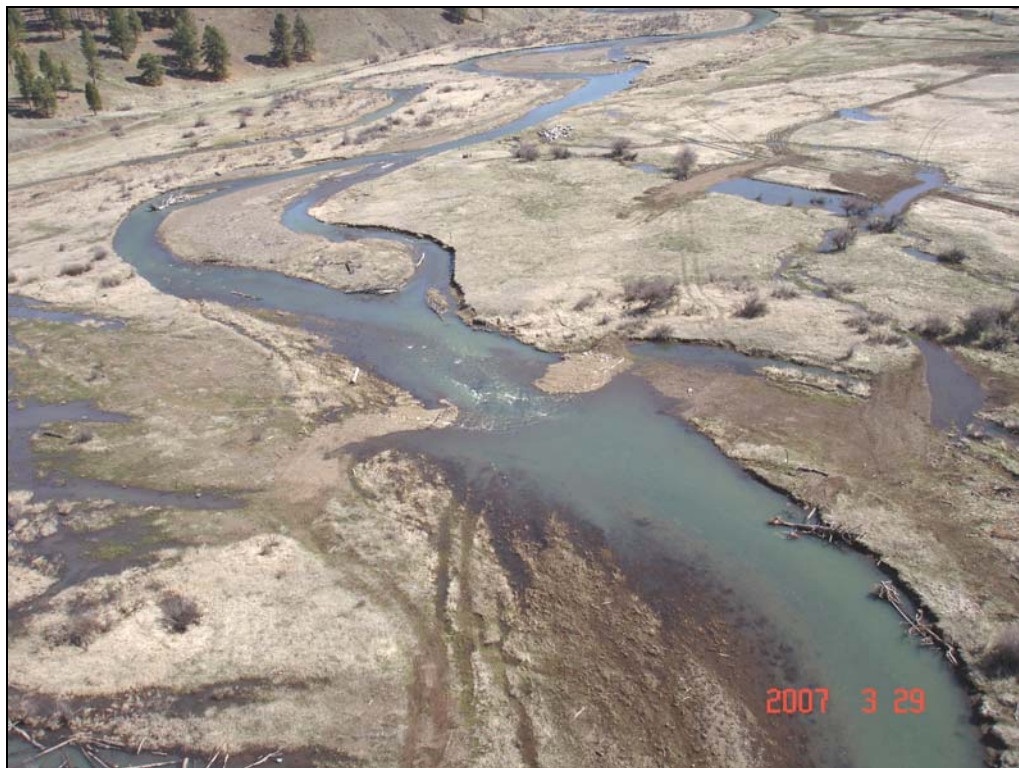
March 2007, Meadow Creek Restoration Project – Photo illustrates graded riffle weirs and large wood placement along Meadow Creek.

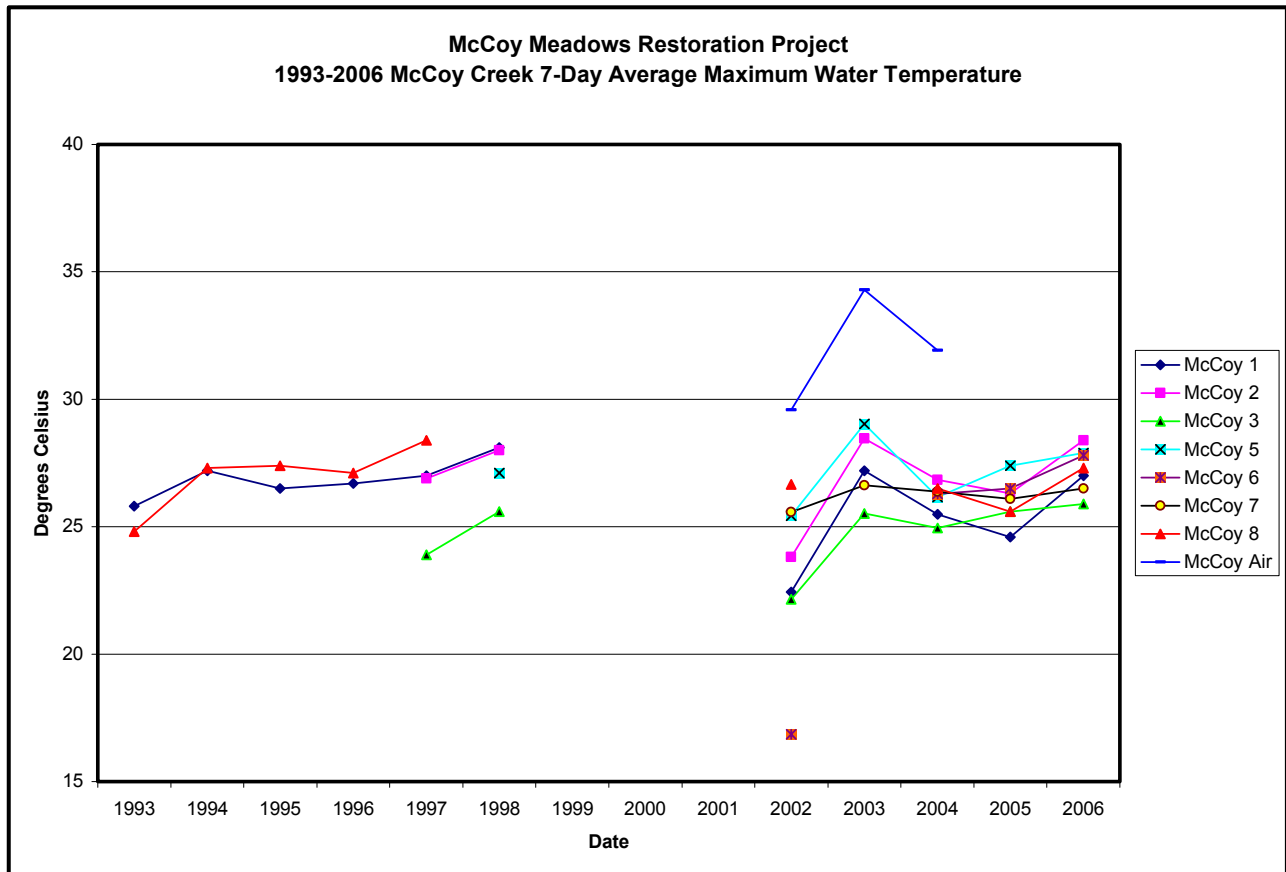
Figure 8 McCoy Meadows average 7 day maximum water temperatures

Average 7 day maximum water temperatures from 1993 to 2006 taken at McCoy 1 through McCoy 8, including air temperature from 2002 to 2004. 1993 to 1998 data from ODEQ.

A comparison of ODEQ and CTUIR data does not show significant changes in water temperature in McCoy and Meadow Creeks, although cold water inputs from groundwater have been detected as indicated above. For example, 1997 data for McCoy 1 and McCoy 3 show a 3.1 degree Celsius decrease in the upper bracketed reach. Similar results were detected through 2006 as well. Monitoring sites in lower McCoy Creek consistently detect increased water temperatures, indicating thermal loading. High temperatures at Meadow Creek in 2006 may have been a result of disturbance caused by channel work that August.

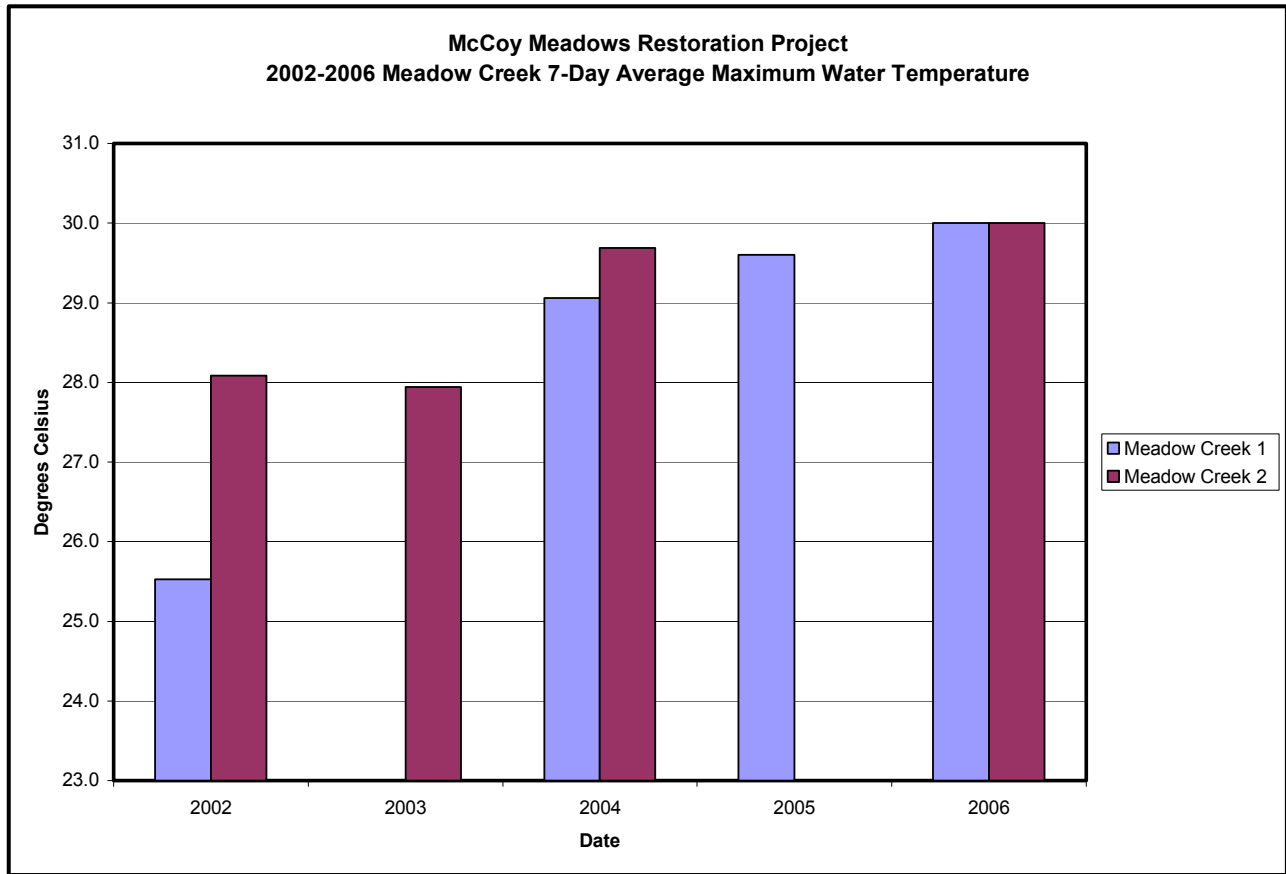
Average 7 day maximum water temperatures from 2002 to 2006 taken at Meadow Creek 1 and 2.

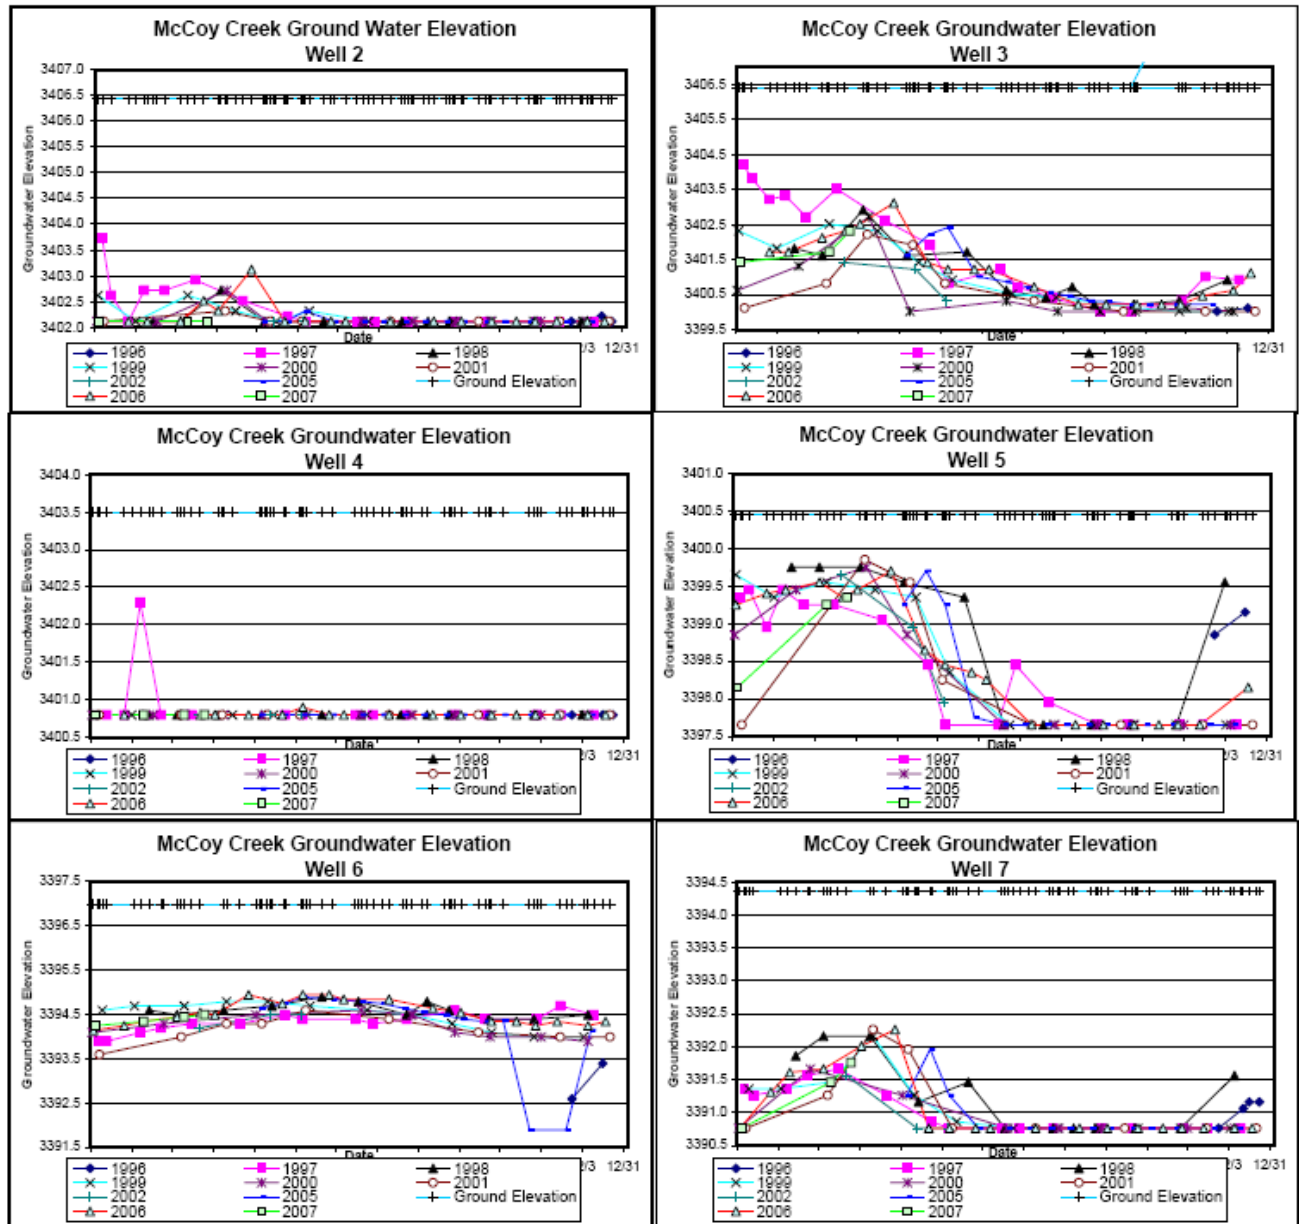
Figure 11 McCoy Creek Groundwater Well Data (Wells 2-7)

Groundwater monitoring data in the middle reaches of the McCoy Creek restoration channel illustrate the effects of channel incision incurred following several high flow events in the vicinity of the new bridge located on the McIntyre Road. Resulting channel incision and lowered groundwater elevations have affected hydrophytic plant recovery and is limiting achievement of overall project objectives. CTUIR, ODFW, and NRCS are conducting additional evaluation to development an action plan to address shortcomings of the original project design, which did not sufficiently address issues associated with concentrated water flow through the road prism, a likely oversizing of channel dimension, and elevated stream gradient which all contributed to excess energy being focused on the stream channel thalweg and adjacent streambanks. Planning is currently underway with the objective of initiating improvements during 2008-2009.

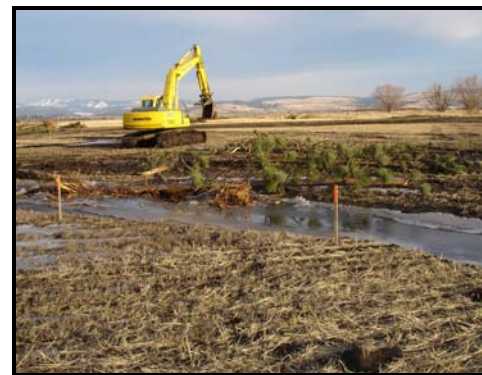
November 2006 photo illustrating wood placement along South Fork Willow restoration channel.

Approximately 200 pieces of large wood was placed along the South Willow Creek channel to enhance floodplain roughness and instream habitat complexity.

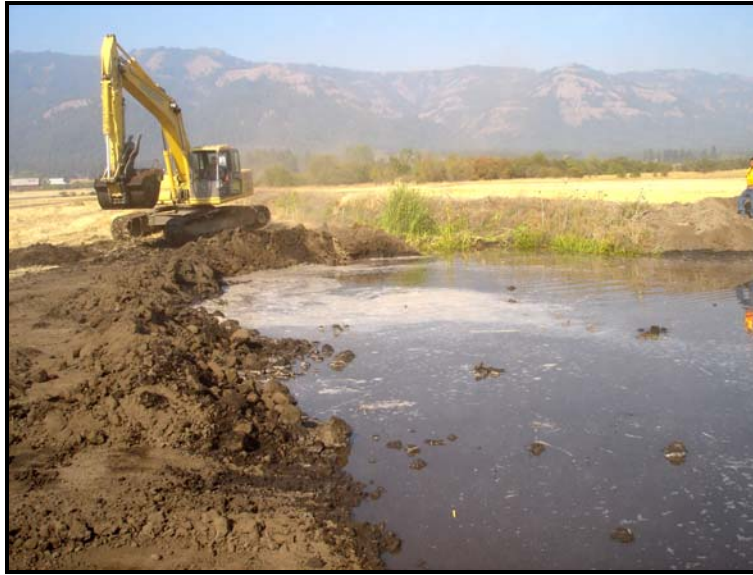
Floodplain pond construction. August 2006.

Ponds were shaped into various patterns (oxbow, meander) and contoured to develop diversity of macro topographic basins with both shallow and deep water habitat. Nearly all of the ponds filled with groundwater upon completion. Within two months of construction, all ponds were overflowing and activating spillways constructed to maintain connection between the pond and adjacent floodplain and/or spring channel. Waterfowl and shorebird use was observed shortly following construction, including long-necked stilts, avocets, mallard, American wigeon, blue winged teal, Canada goose, and Tundra swan.

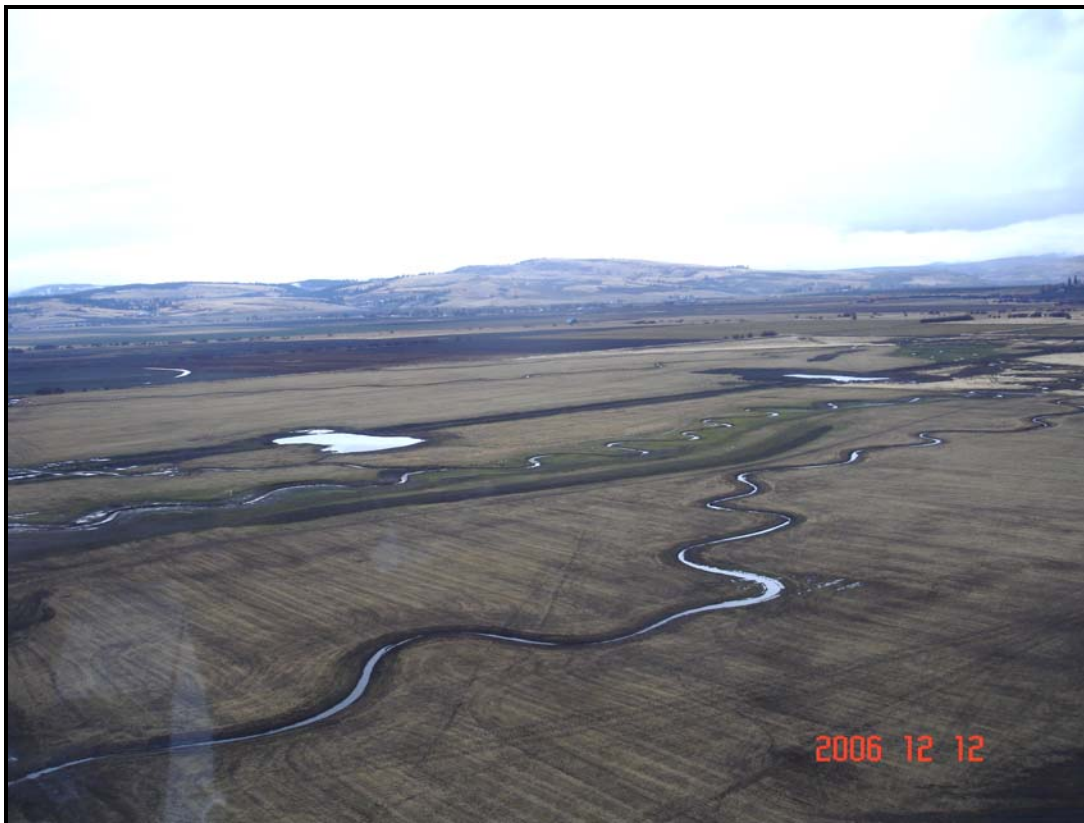
Restoration spring channel paralleling End Creek Restoration Channel. December 2006
