# **CTUIR GRANDE RONDE SUBBASIN RESTORATION PROJECT**

## **A Columbia River Basin Fish Habitat Project**

### **Annual Report**

May 1, 2009 to April 30, 2010

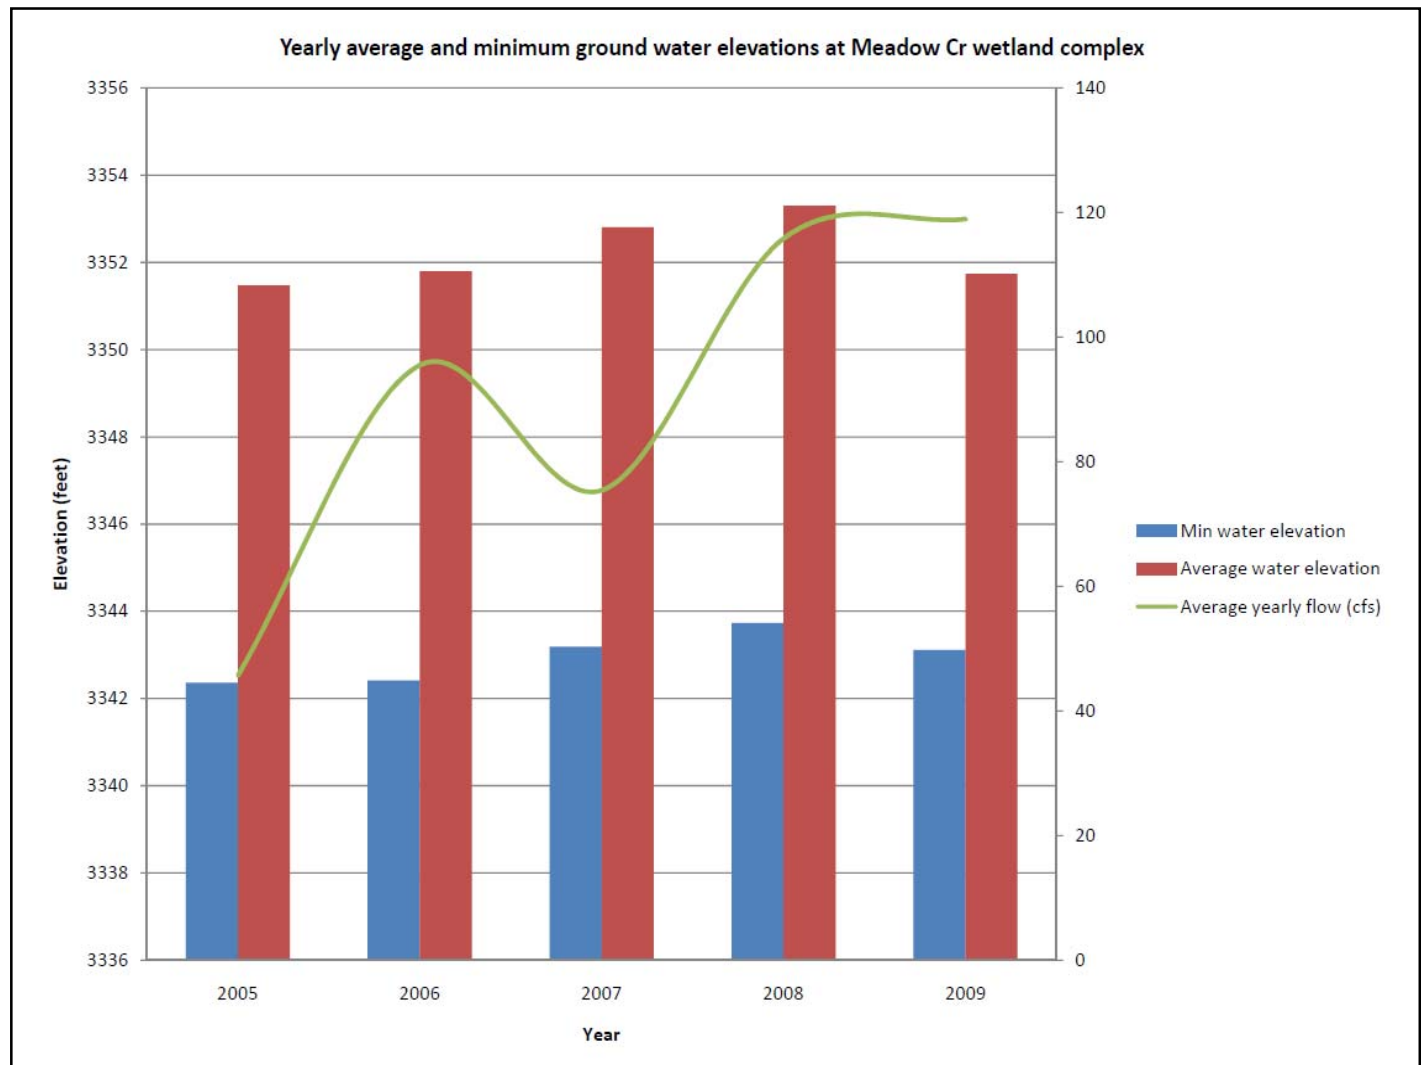
**FIGURE 5: YEARLY AVERAGES OF GROUNDWATER ELEVATIONS ACROSS MONITORING WELLS WITHIN THE MEADOW CREEK WETLAND WELL NETWORK, PLOTTED AGAINST YEARLY AVERAGE FLOWS WITHIN THE MAIN CHANNEL**

Plot also depicts yearly average minimum groundwater elevations and shows an increase in groundwater levels post project (2006 onwards) compared to the pre-project (2005) levels.

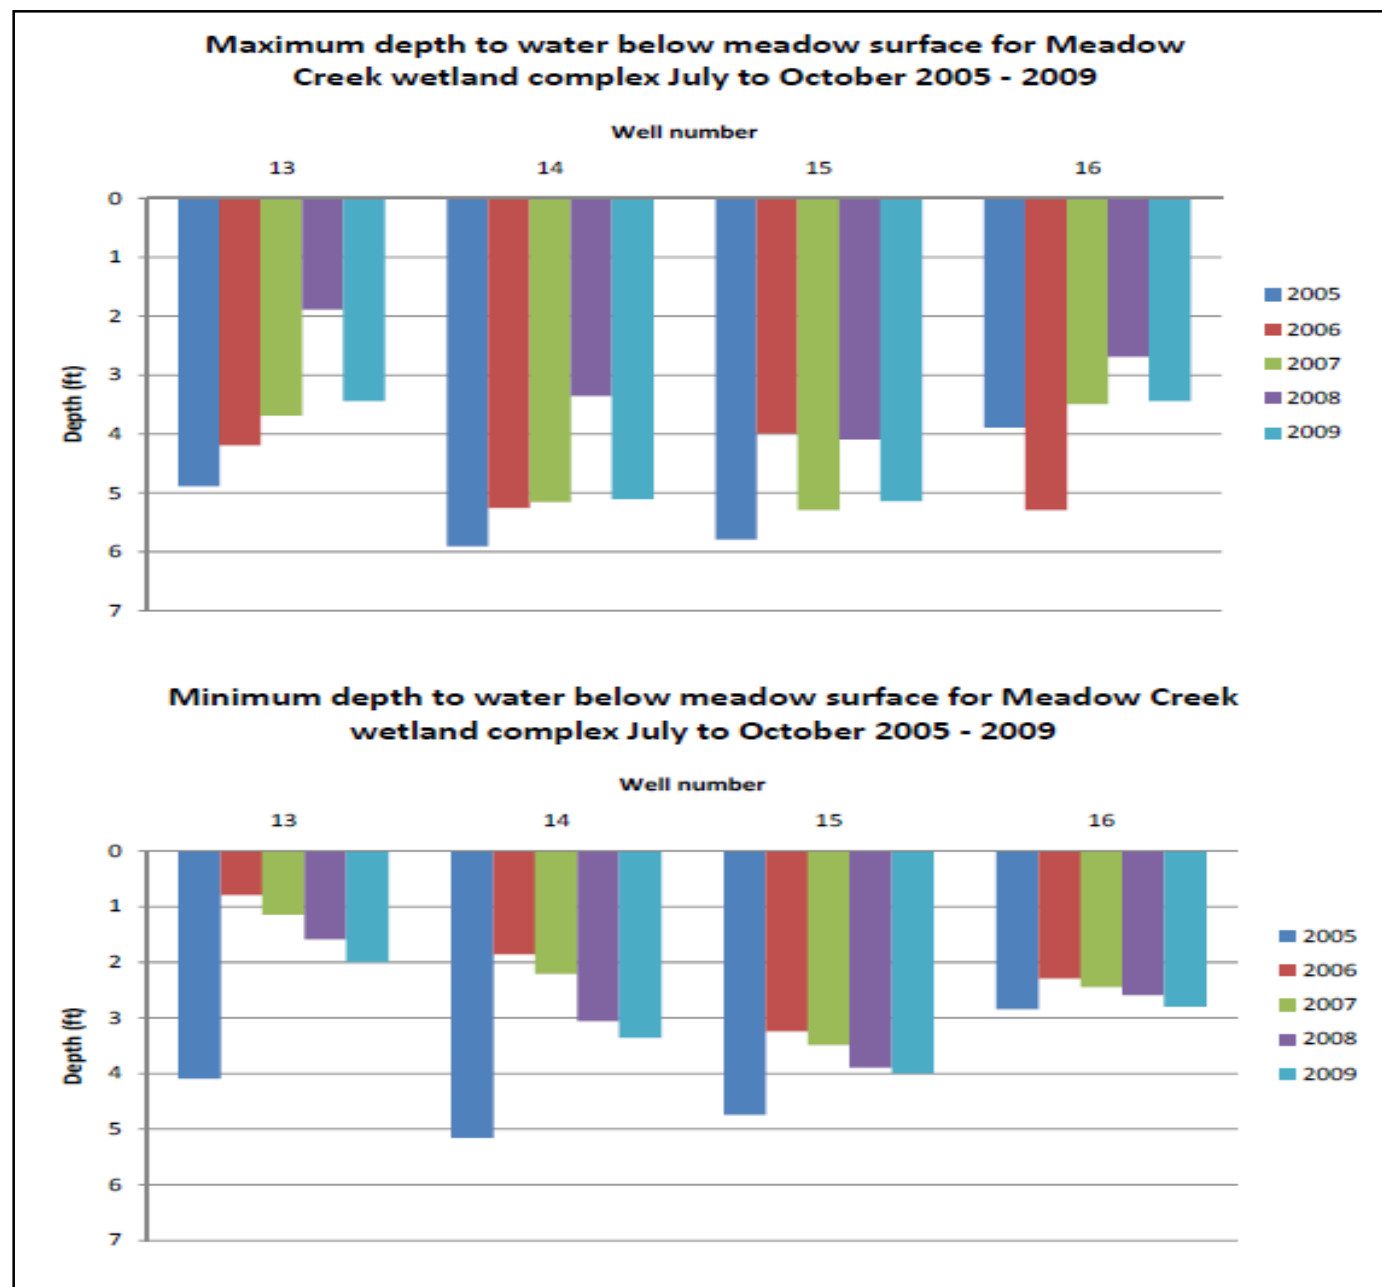
**FIGURE 6: MAXIMUM AND MINIMUM DEPTH TO GROUNDWATER AT GROUP 1 WELLS WITHIN THE MEADOW CREEK WETLAND COMPLEX**

Zero represents the ground elevation at each well with the bars showing the depth that water levels were recorded below the surface during July - October, 2005 to 2009.

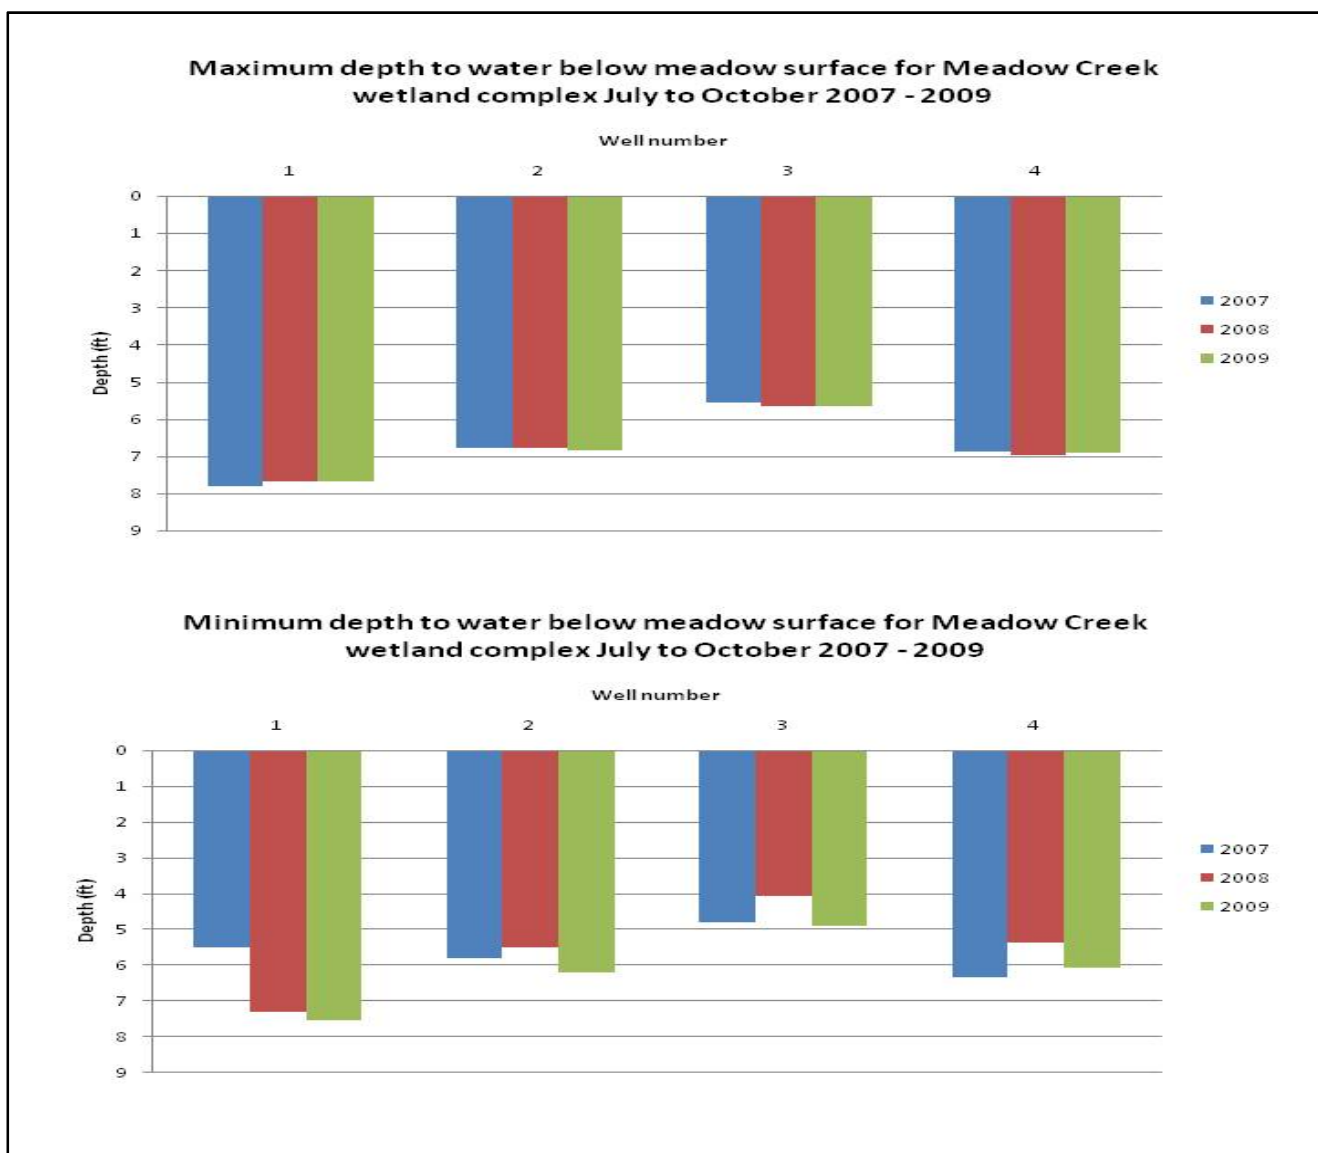
**FIGURE 7: MAXIMUM AND MINIMUM DEPTH OF GROUNDWATER AT GROUP 2 WELLS WITHIN THE MEADOW CREEK WETLAND COMPLEX**

Zero represents the ground elevation at each well with the bars showing the depth that water levels recorded below the surface during July - October, 2007 to 2009. Dry wells were recorded in 2005 and 2006 (pre-project) and are not represented.

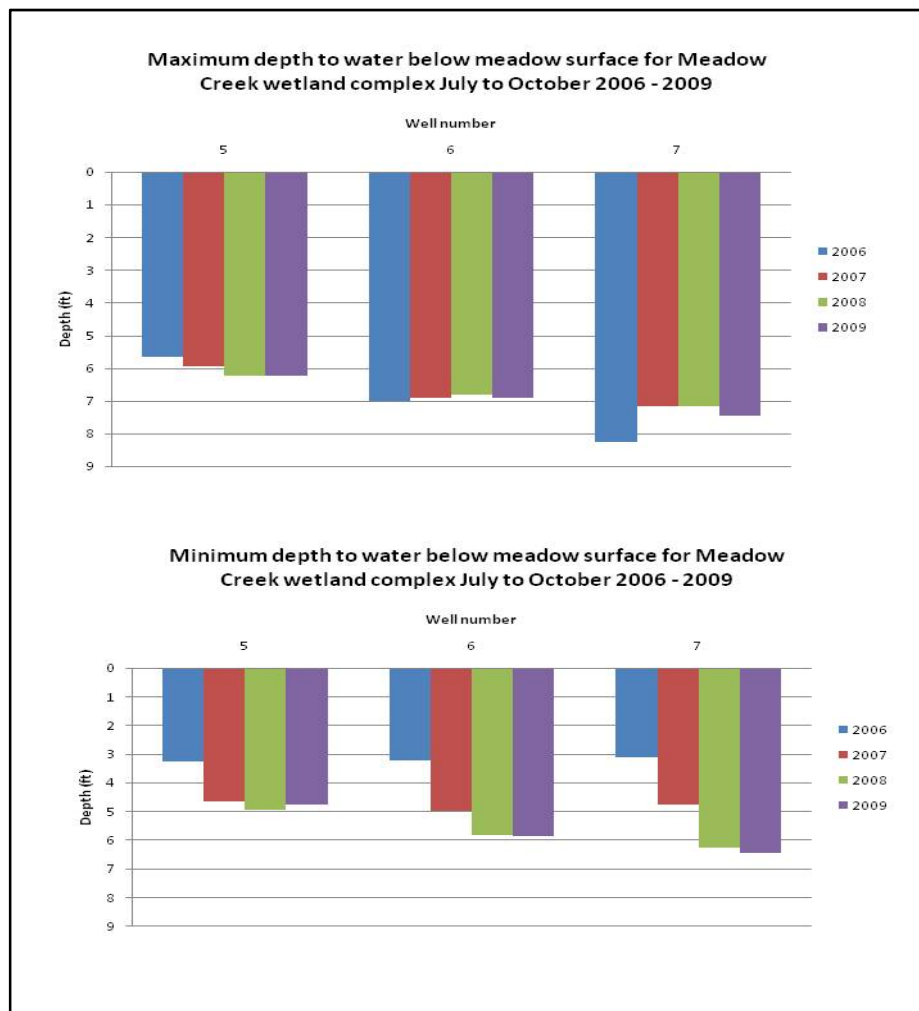
**FIGURE 8: MAXIMUM AND MINIMUM DEPTH OF GROUNDWATER AT GROUP 3 WELLS WITHIN THE MEADOW CREEK WETLAND COMPLEX**

Zero represents the ground elevation at each well with the bars showing the depth that water levels were recorded below the surface during July - October, 2006 to 2009. Dry wells were recorded in 2005 and are not represented.

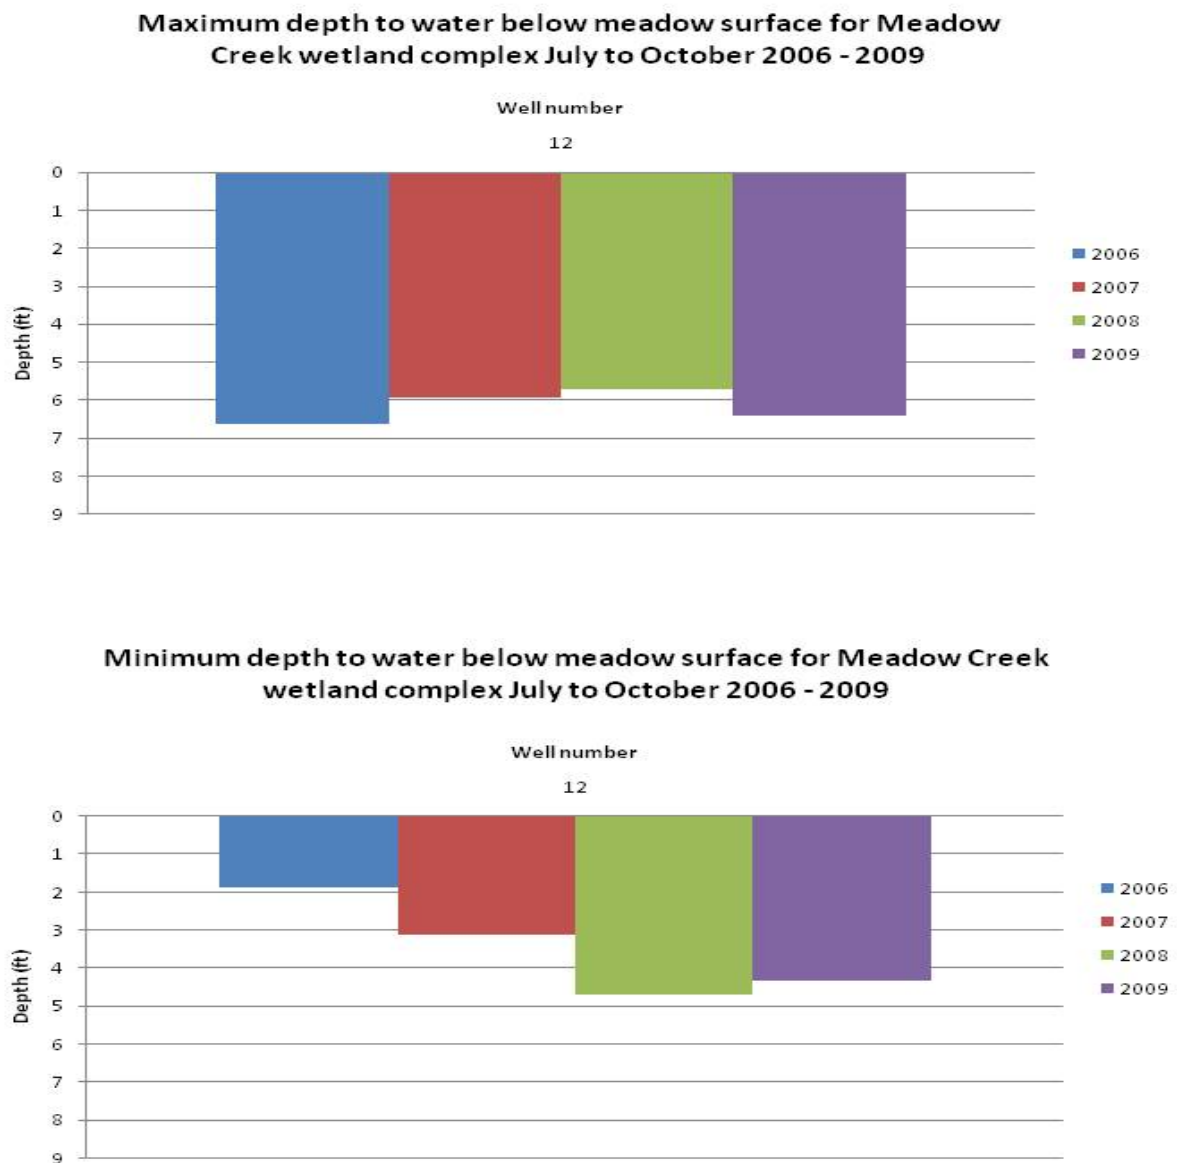
**FIGURE 9: MAXIMUM AND MINIMUM DEPTH OF GROUNDWATER AT GROUP 4 (WELL #12) WITH THE MEADOW CREEK WETLAND COMPLEX**

Zero represents the ground elevation at the well with the bars showing the depth that water levels were recorded below the surface during July - October, 2006 to 2009. Dry records were recorded in 2005 and are not represented.

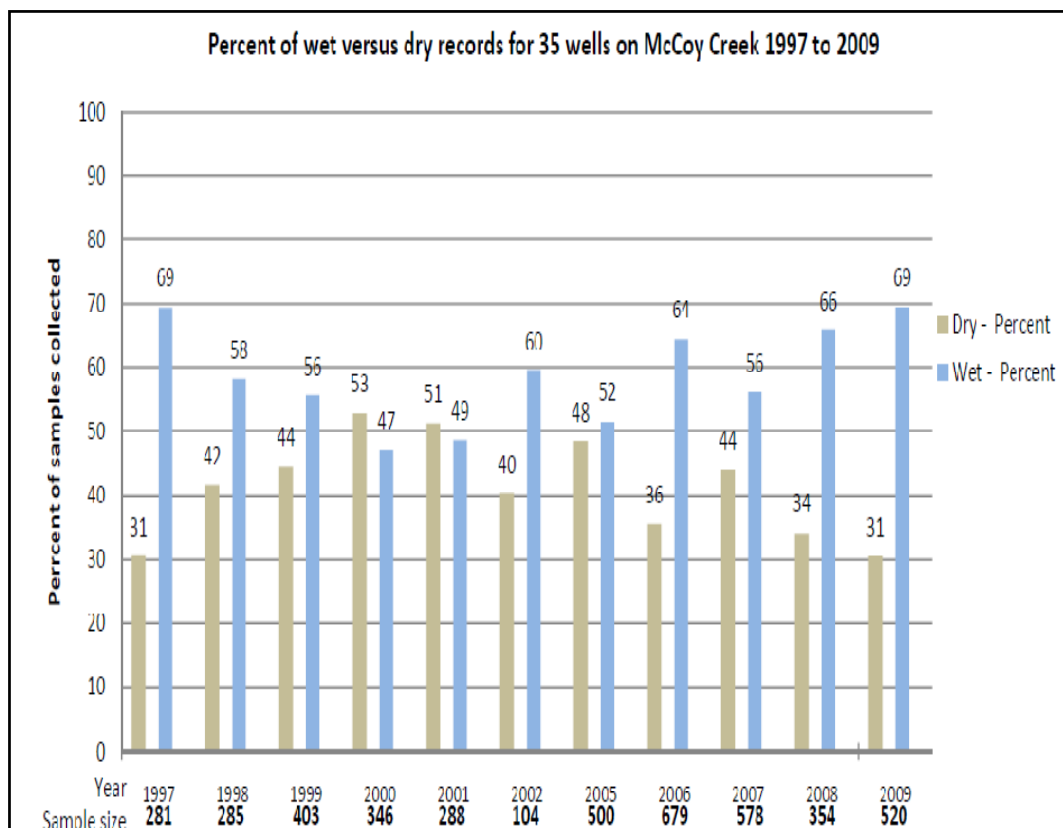
**FIGURE 13: PLOT OF THE PERCENT OF WET VERSUS DRY RECORDS FOR 35 WELLS ALONG MCCOY CREEK FROM 1997 TO 2009.**

The plots show a decline in the percent of water within the well pipes from 1997 to 2001, then an increase from 2002 to 2009.

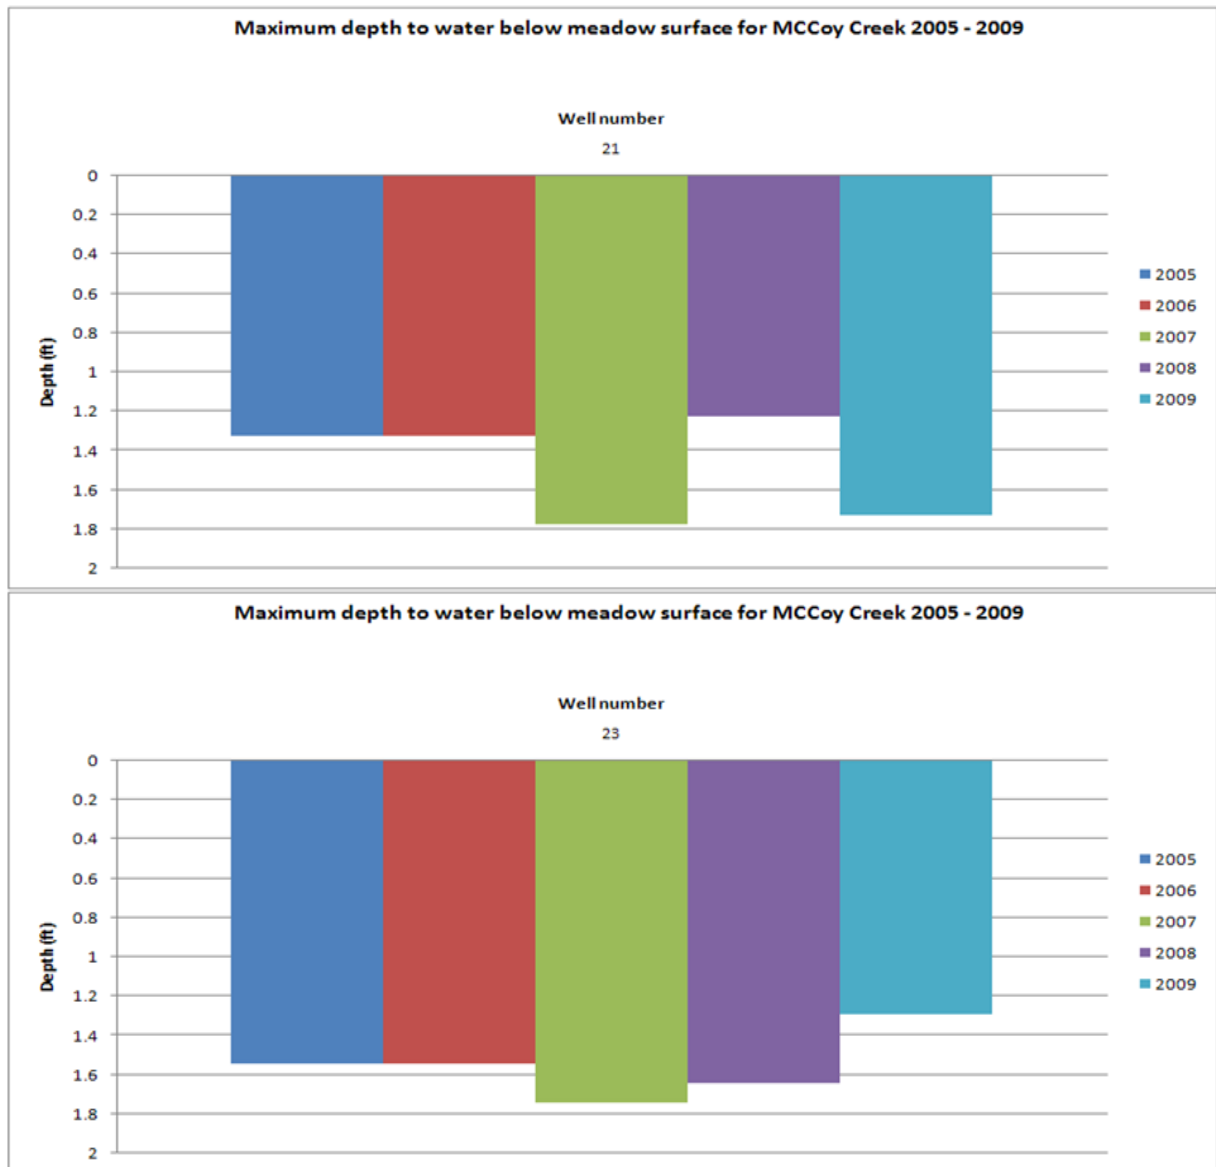
**FIGURE 17: PLOTS OF MAXIMUM SUB-SURFACE WATER DEPTHS FOR TWO LOCATIONS BELOW THE MCCOY CREEK BRIDGE FROM 2005 TO 2009**

Plots show sub-surface water to within 1.8 feet of the meadow surface for each year and a difference between 2005 and 2009 of 0.4 ft for well #21 and 0.2 ft for well # 23. For these plots zero on the Y axis indicates the meadow surface.

Well #'s 21 and 23 (Figure 17):

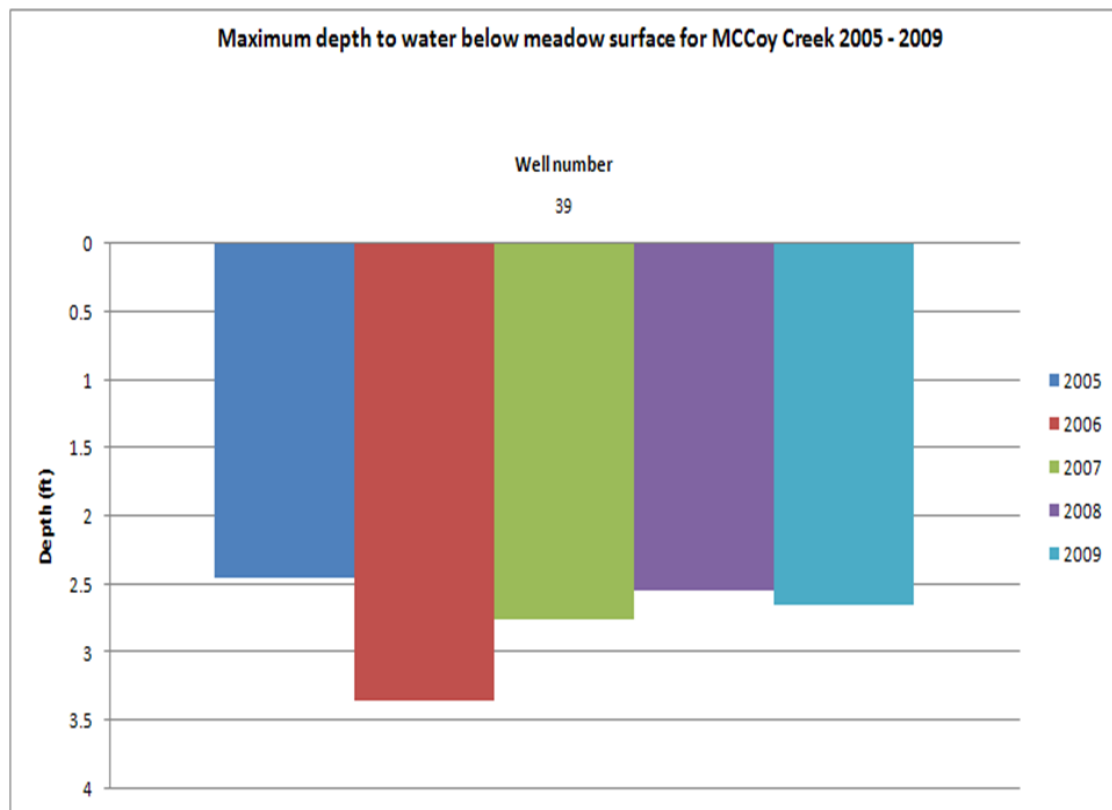
**FIGURE 19: PLOTS OF MAXIMUM WATER DEPTHS FROM 2005 TO 2009 FOR WELL # 39 AT THE MCCOY CREEK RESTORATION PROJECT**

Plots show water depths below the meadow surface at a maximum of >3.5 feet in 2006 to >2.5 feet in 2005. For these plots zero on the Y axis indicates the meadow surface.

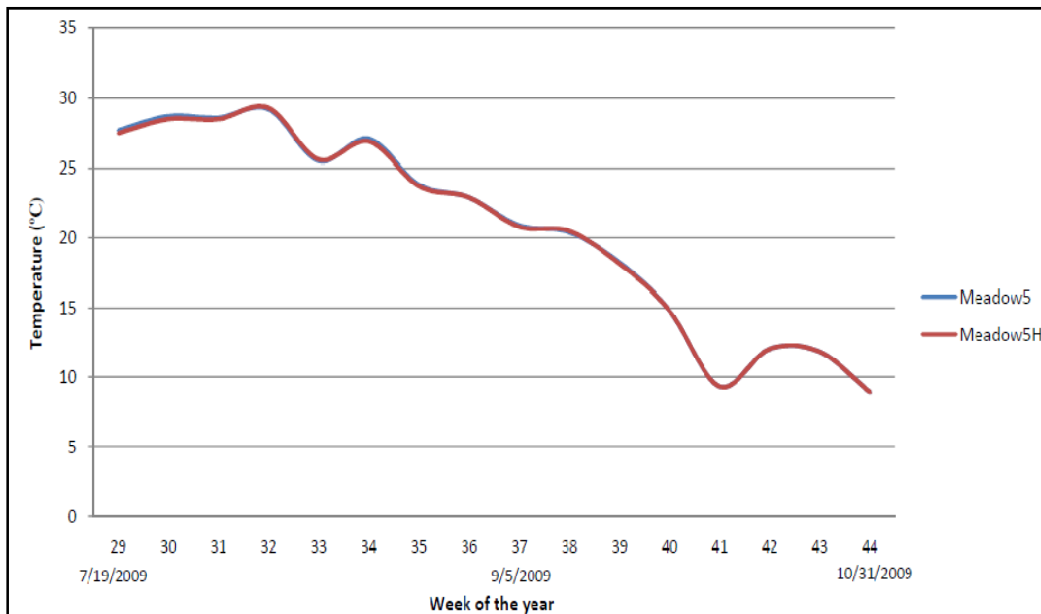
**FIGURE 20: WATER TEMPERATURE ON MEADOW CREEK AT RIVER MILE 7.53 DURING 2009.**

Plot is 7-day maximum temperature for two types of probe at the same location – an Onset Hobo (red line) and an Onset Pendant logger (blue line). Plot shows the similarity in temperature recording between the probes.

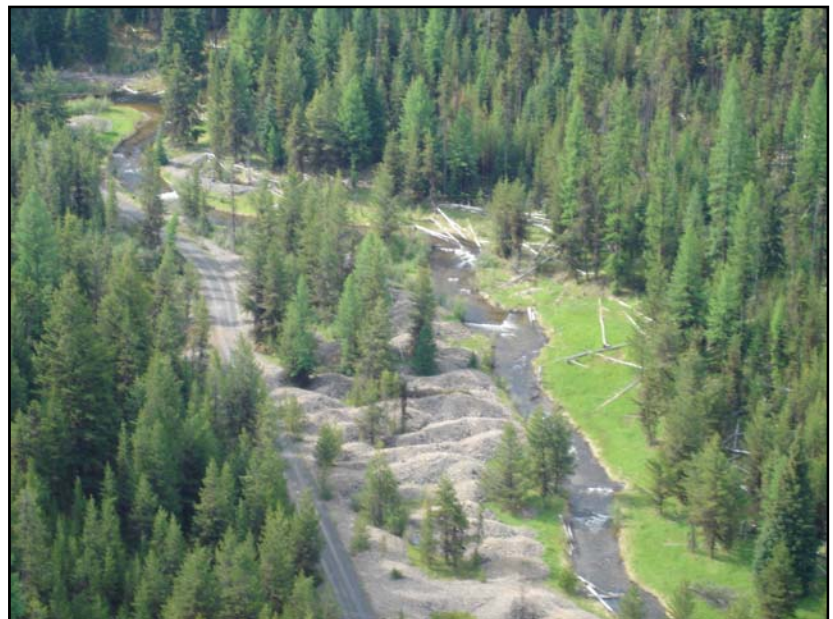
**FIGURE 37: AERIAL PHOTOGRAPH OF MINE TAILINGS PROJECT 2008 (PRE-PROJECT)**

The Upper Grande Ronde River (UGRR) provides spawning and rearing habitat for Snake River Basin summer steelhead, Snake River Basin spring/summer chinook salmon and bull trout, all of which are federally listed as Threatened under the Endangered species Act. Historic timber harvest and gold mining, conducted in 1940 and 1941 utilizing a dredge, has removed larger conifers from the valley bottom and created piles of tailings within the floodplain, where in many cases they cross the valley floor and extend toe slope to toe slope. The tailing piles have constricted the river channel, pushed it to one side of the valley floor and simplified the channel disconnecting the river from its floodplain (Figure 37). Therefore, floodplain function, habitat complexity, pool quality and quantity, riparian vegetation, stream shading, and instream channel function were severely altered. Restoration activities occurred in the late 1980's and early 1990's, where large wood structural elements were added to the channel. However, those restoration activities did not address floodplain function, riparian vegetation, and stream shading. Furthermore, many of the structures placed in the channel have caused juvenile fish passage problems and undesirable changes to stream channel morphology, such as increased width to depth ratios.

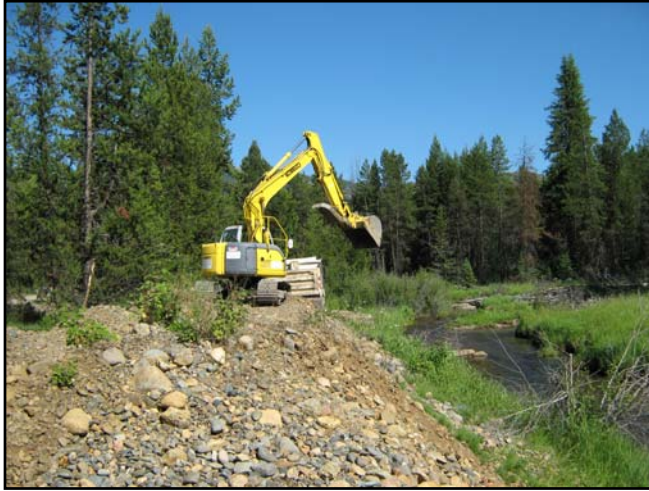
**FIGURE 39: PHOTO OF MINE TAILINGS BEFORE/DURING REMOVAL**

within the floodplain to act as roughness elements. 44 of the existing restoration structures were either removed or modified in order to allow for suitable stream morphological processes to occur. Furthermore, all areas of disturbance (over 5 miles) were seeded with a native riparian and upland grass seed blend and subsequently, weed-free straw mulch was spread over disturbance areas to act as an erosion and moisture control tool. In the fall of 2009, CTUIR staff planted sedge plugs (harvested from near site locations) in the 4 constructed side channels and in all low areas within the reclaimed floodplain in order to give the riparian and wetland plant communities a jumpstart in establishment.

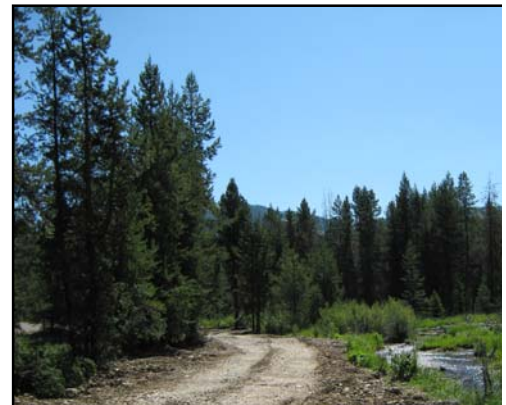
**FIGURE 40: PHOTO OF MINE TAILINGS AFTER REMOVAL**

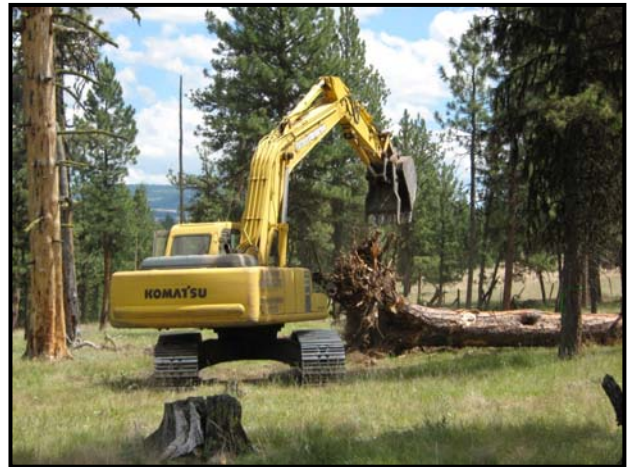
**FIGURE 43: HABBERSTAD PROPERTY UPLAND TREE HARVEST**

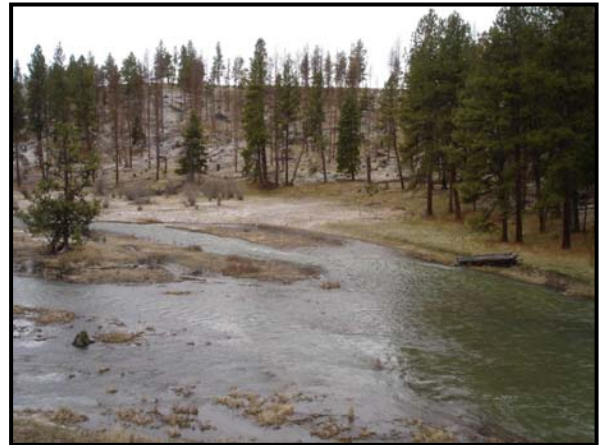
**FIGURE 44: UPPER HABBERSTAD PROJECT AREA IN APRIL, 2009 (PRE-PROJECT)**

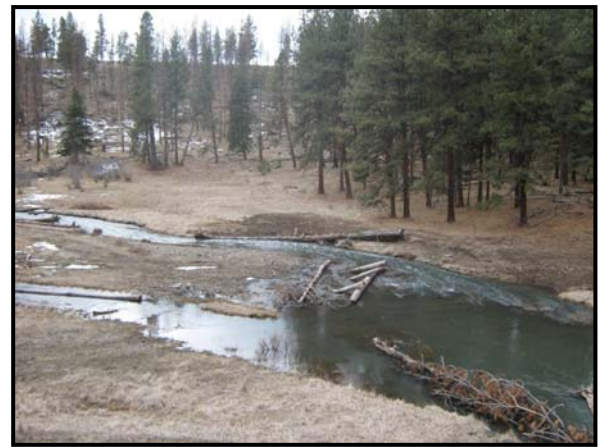
**FIGURE 45: UPPER HABBERSTAD PROJECT AREA IN MARCH, 2010 (POST-PROJECT)**
