# **CTUIR GRANDE RONDE SUBBASIN RESTORATION PROJECT ANNUAL REPORT**

## **A Columbia River Basin Fish Habitat Project**

**Northwest Power Planning Council Project # 199608300**

Report covers work performed from: May 1, 2014 to April 30, 2015

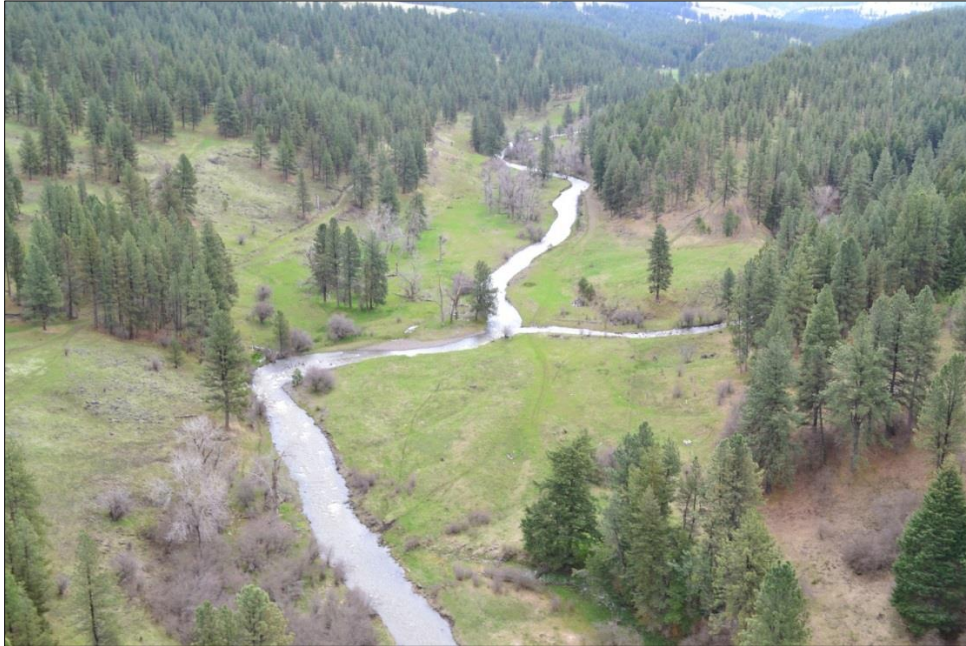
**FIGURE 5** TWO AERIAL PHOTOGRAPHS OF THE EXISTING CONDITIONS ON ROCK CREEK (UPPER IMAGE IS LOOKING UPSTREAM FROM RIVER MILE 3.5 AT THE CONFLUENCE OF GRAVES CREEK AND ROCK CREEK; LOWER IMAGE IS LOOKING UPSTREAM AT ROCK CREEK FROM RIVER MILE 0.75). NOTE LACK OF RIPARIAN VEGETATION, LACK OF INSTREAM HABITAT COMPLEXITY (LARGE WOOD), CHANNEL CONFINING ROAD, AND SIMPLIFIED CHANNEL.

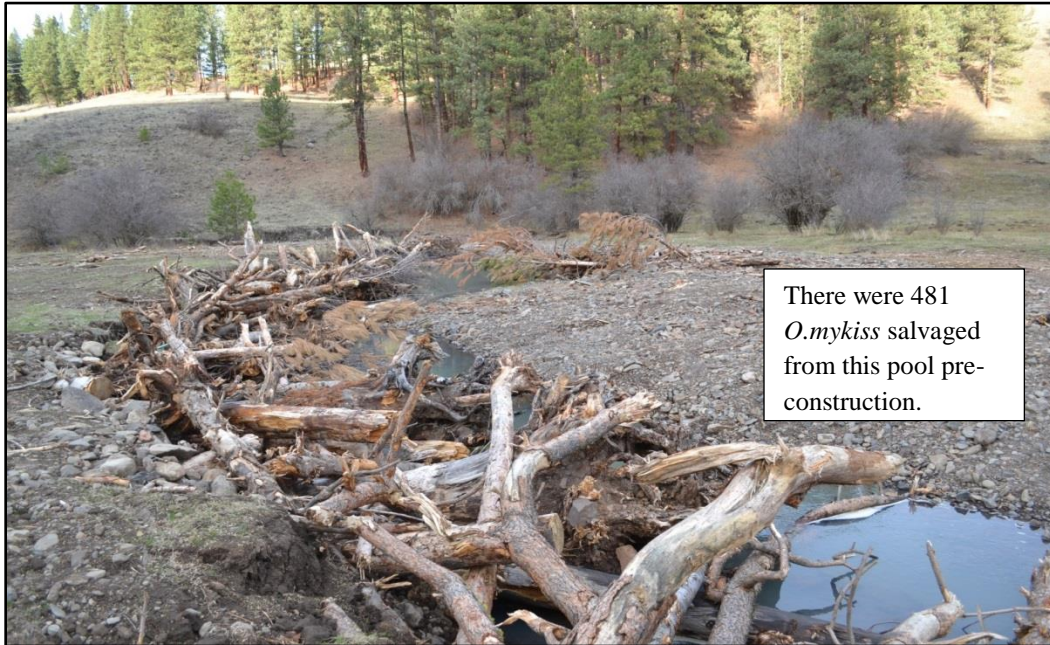
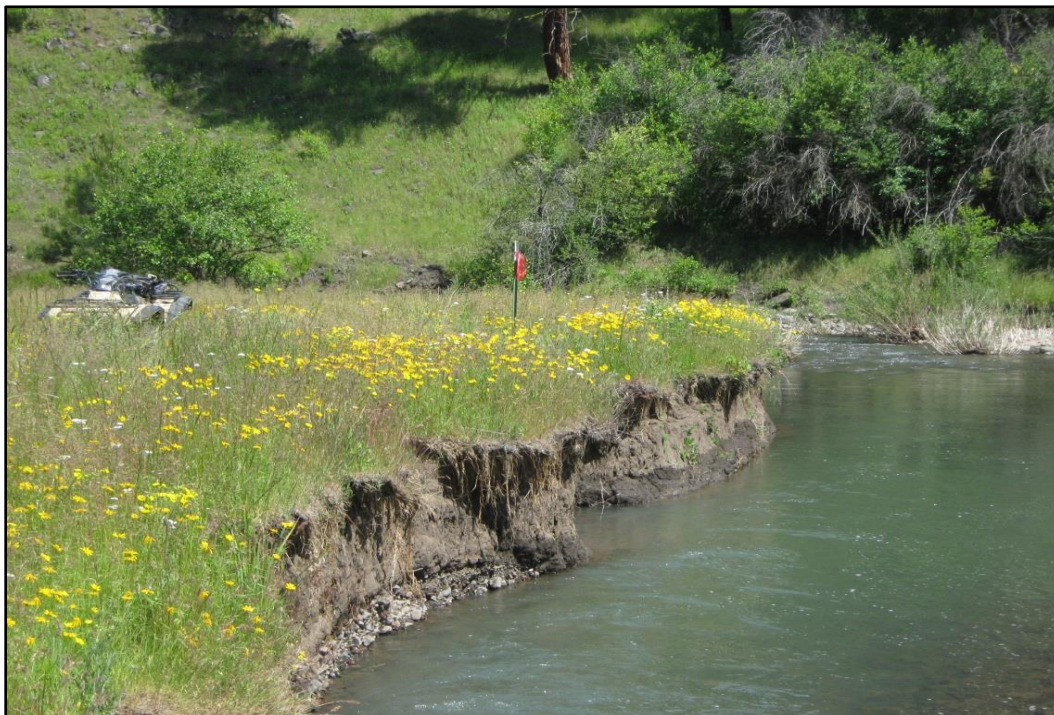
**FIGURE 20** POST CONSTRUCTION WOOD ADDITION SITE ON THE LARGEST POOL WITHIN THE PROJECT AREA, (UPPER PHOTO) AND ERODING BANKS AT SAME LOCATION PRE PROJECT (LOWER PHOTO).

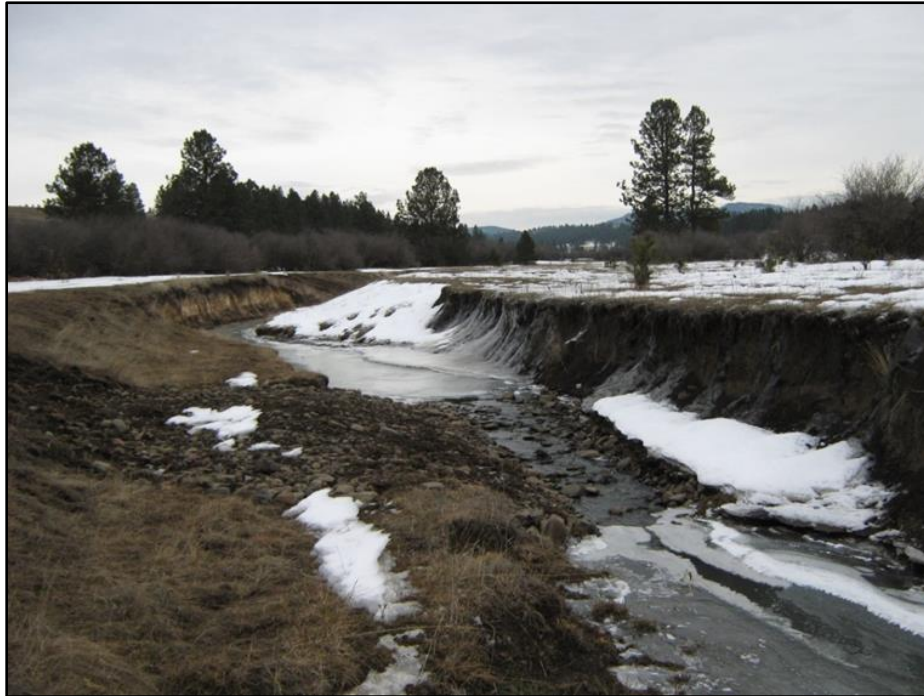
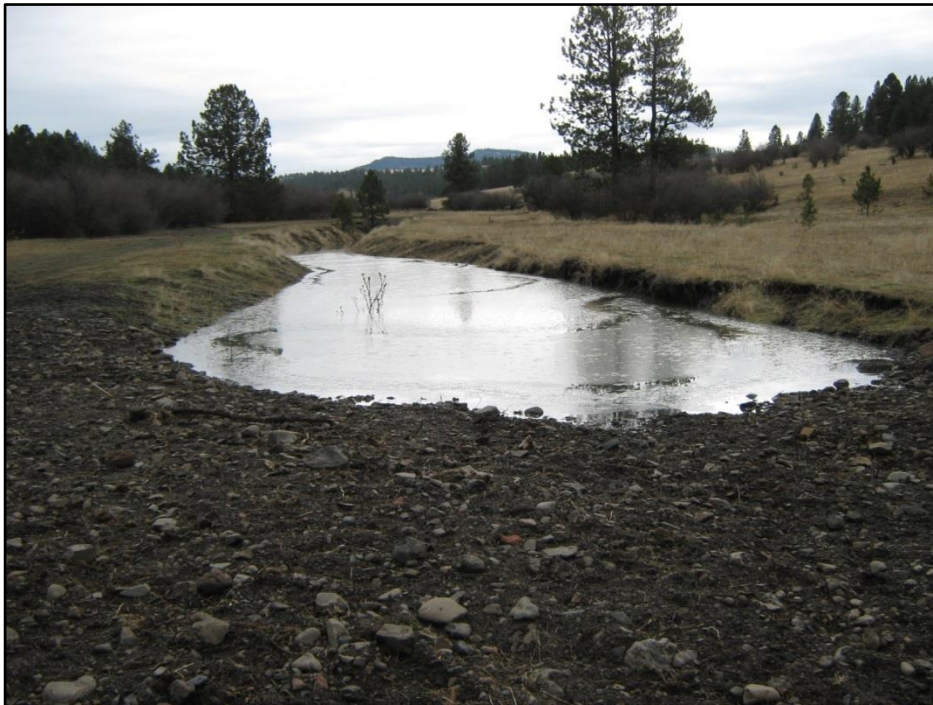
**FIGURE 21** ONE OF THE PLUGS ALONG THE CHANNELIZED REACH OF GRAVES CREEK MADE FROM LEVEE MATERIAL REMOVED FROM THE ROCK CREEK FLOODPLAIN. TOP PHOTO WAS TAKEN LOOKING UPSTREAM IN 2013 AND BOTTOM PHOTO WAS TAKEN IN DECEMBER 2014 – 3 MONTHS AFTER CONSTRUCTION OF THE PLUG.

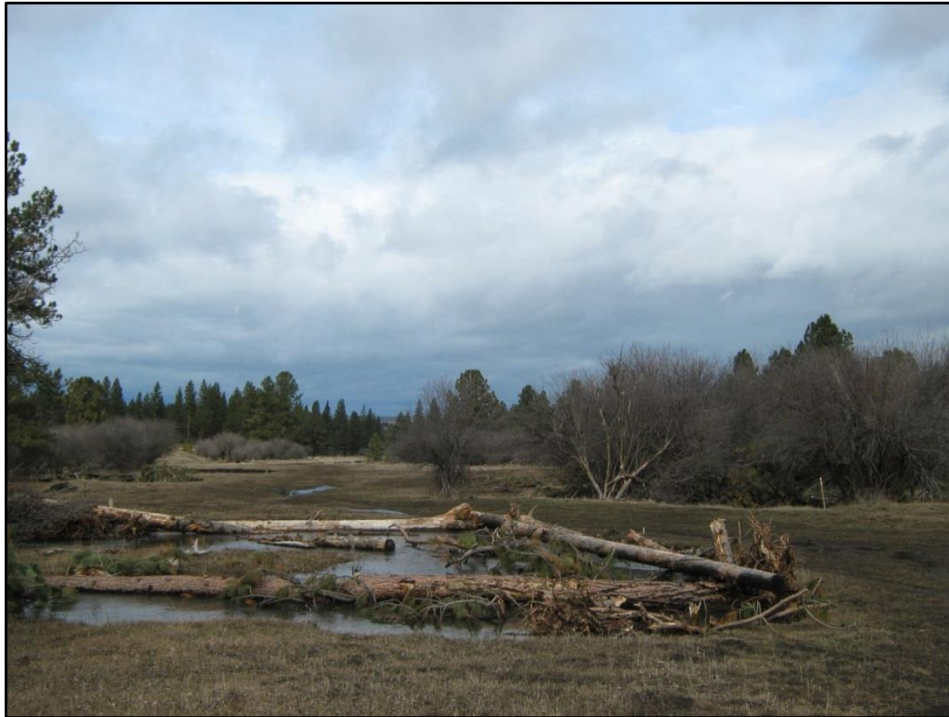
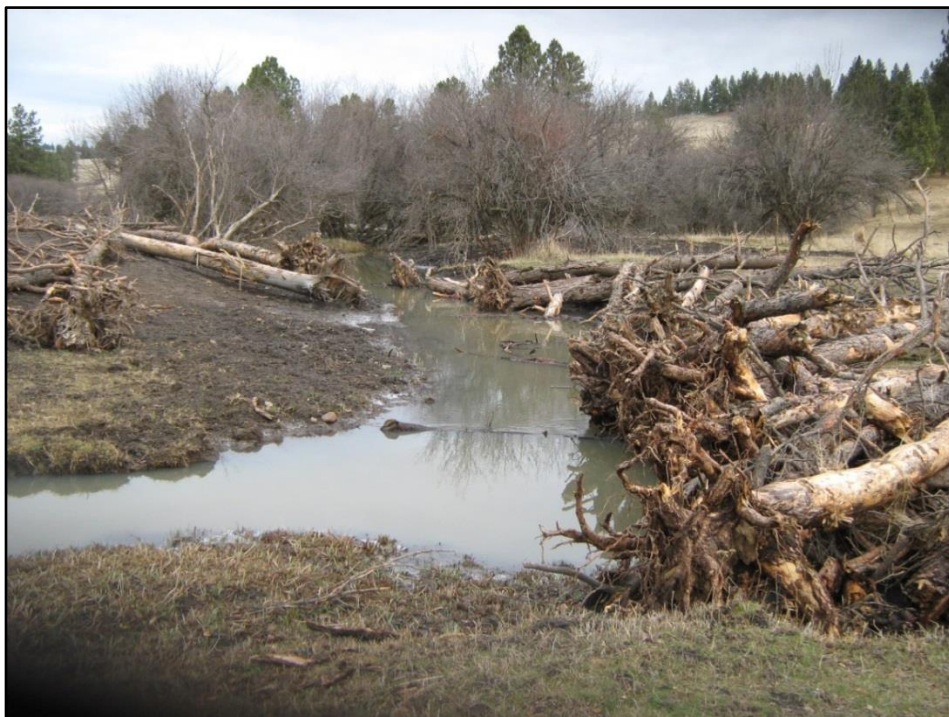
**FIGURE 22 THE ENTRANCE TO THE HISTORIC CHANNEL OF GRAVES CREEK IN 2013 (TOP PHOTO) AND IN 2014, THREE MONTHS POST CONSTRUCTION (BOTTOM PHOTO).**

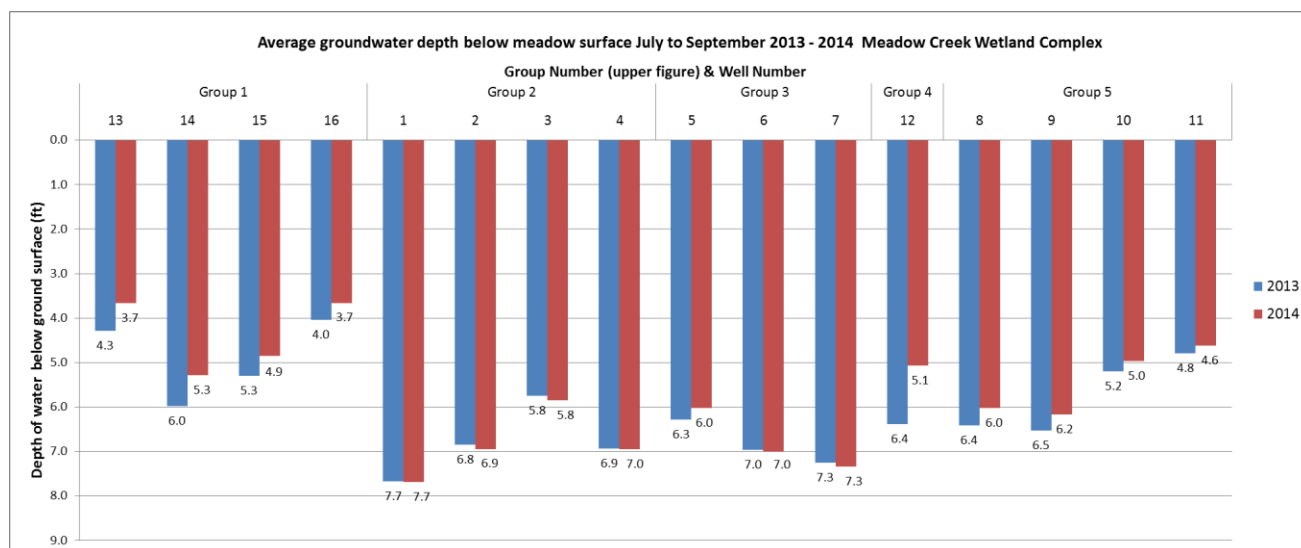
**FIGURE 29 AVERAGE GROUNDWATER ELEVATIONS ALONG MEADOW CREEK WITHIN THE MCCOY MEADOWS RANCH.**

Average summer groundwater depths from months July to September 2008 to 2014 for the most upstream wells (Group 1) and most downstream wells (Group 5) were graphed (see Figure 25). In addition, pre-project measurements taken in 2005 during the same months are also shown for comparison. There is a six-year trend in decreasing groundwater elevation from 2008 to 2013. Groundwater records from 2013 are the furthest below meadow surface since 2005 pre-project levels. It is possible that sediment build up at the Meadow Wetland Intake prevented desired flows from main channel Meadow Creek to access the wetland channel and contributed to this drop in groundwater elevation. A possible down-cutting of Meadow Creek, and coinciding dropping of the water table, may also have been a factor in these groundwater differences. Groundwater depth measurements taken in 2014 indicate a consistent increase in groundwater elevation when comparing to summer seasonal average depths recorded from 2013 for Group 1 and Group 5 wells. The average increase in groundwater elevation in 2014 for these eight well sites was +0.4 feet. A possible explanation for the increase in groundwater elevation could be that mainstream Meadow Creek flows were allowed more access to floodplain and side channels, or that high flow diversion from the main channel persisted longer in these areas. All but one of the 8 wells (well #16) from Groups 1 and 5 retained water below pre-project levels. The average increase in groundwater elevation in 2014 compared to 2005 pre-project levels was +0.7 feet, which could be the result from seasonal high flows accessing the constructed Meadow Creek Wetland side channel.

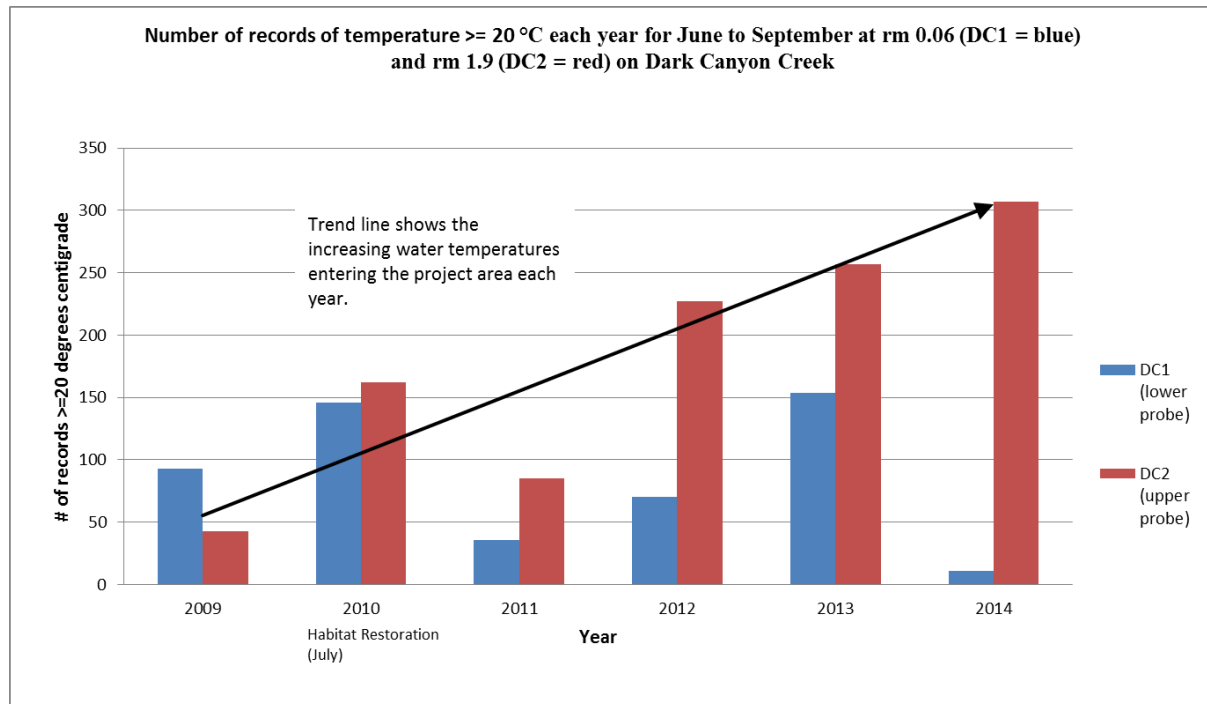
**FIGURE 35** PLOT OF THE NUMBER OF WATER TEMPERATURES  $\geq 20^{\circ}\text{C}$  ON DARK CANYON CREEK. PLOTTED TREND LINE DEMONSTRATES THAT WARMER WATERS ARE ENTERING THE PROJECT AREA EACH YEAR (RED BARS), BUT THIS WATER IS COOLING AS IT MOVES THROUGH THE PROJECT AREA TO THE LOWER PROBE SITE (BLUE BARS).
