CTUIR GRANDE RONDE SUBBASIN RESTORATION PROJECT ANNUAL REPORT

A Columbia River Basin Fish Habitat Project

Northwest Power Planning Council Project # 199608300

Report covers work performed under BPA contract # 69118
Report was completed under BPA contract #69118
Report covers work performed from: May 1, 2015 to April 30, 2016

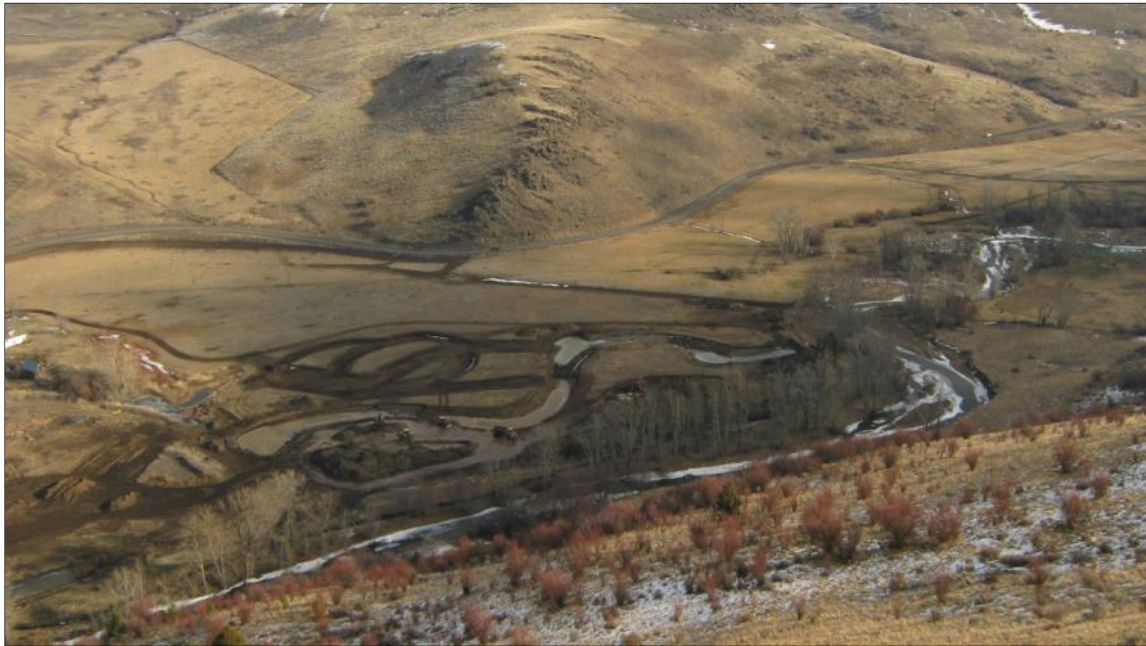
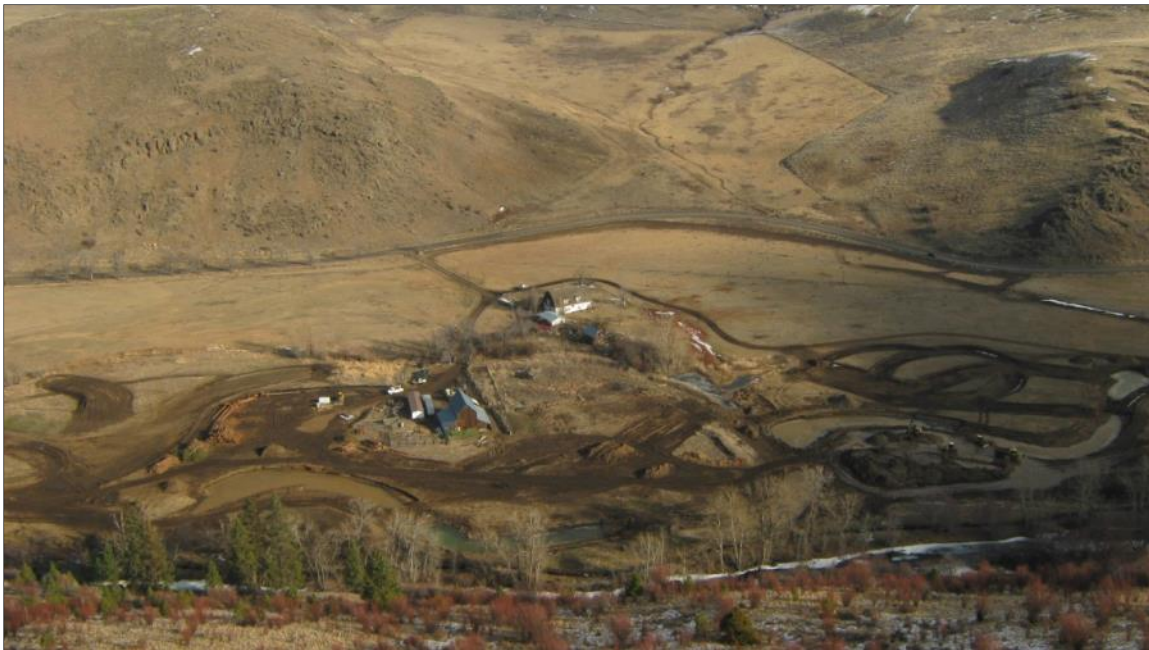
FIGURE 9 TWO PHOTOGRAPHS OF SOUTHERN CROSS CONSTRUCTION AT THE UPPER AND MID PROJECT AREAS.

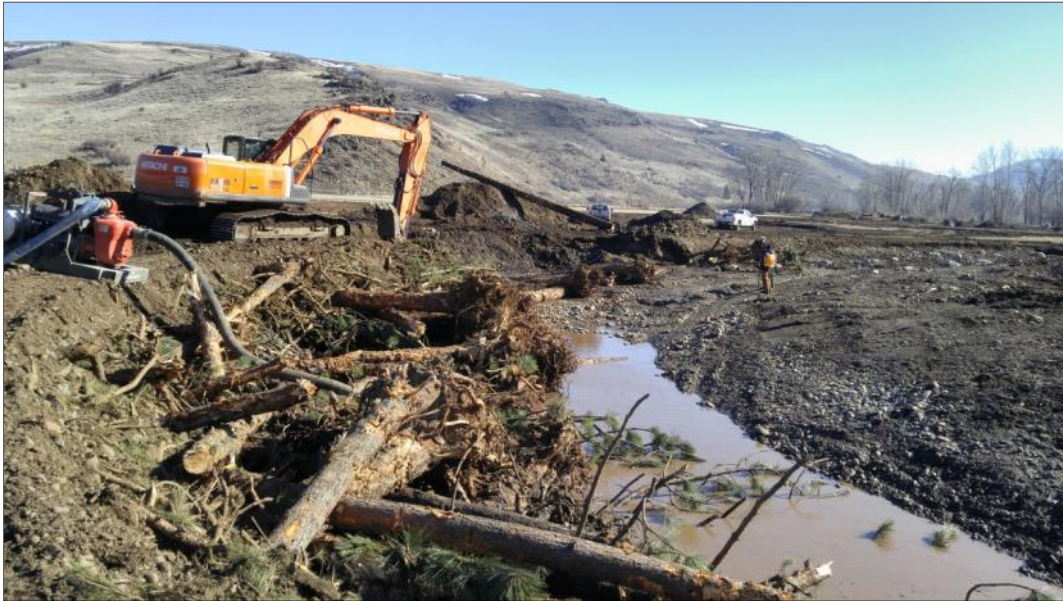
FIGURE 10 CONSTRUCTION OF SIDE CHANNEL 1 INLET AT STATION 17+50.

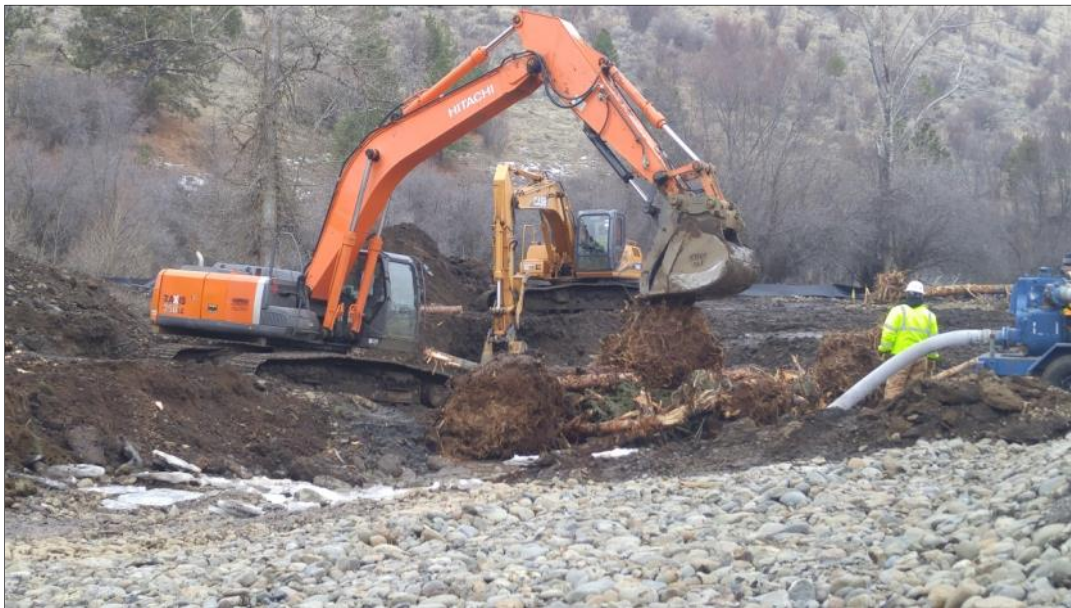
FIGURE 11 CONSTRUCTION OF DOWNSTREAM BEND STRUCTURE AT STATION 46+50.

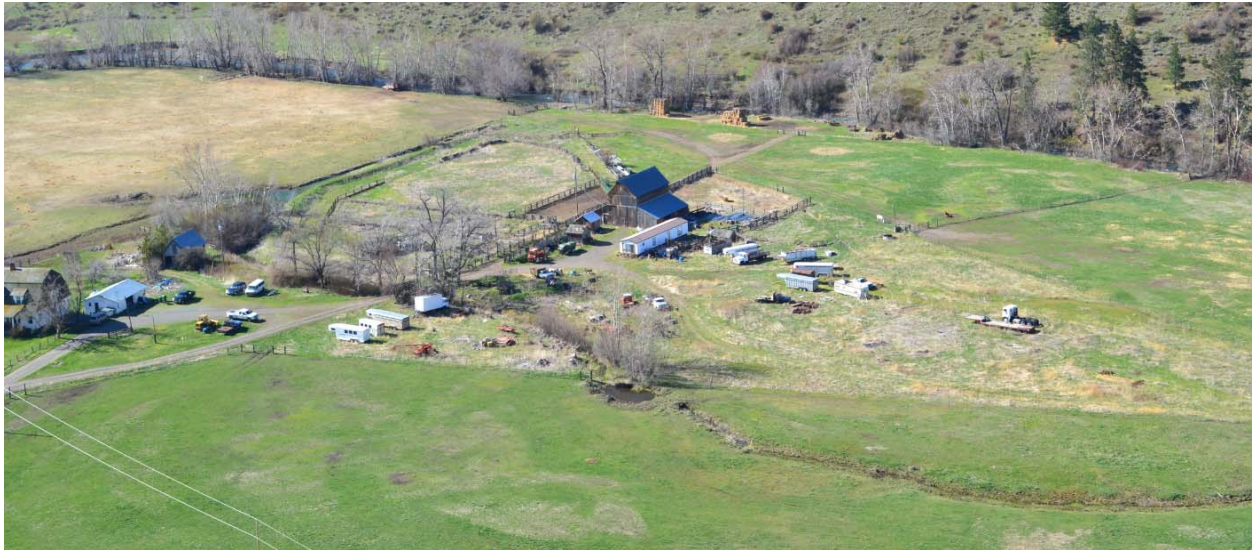
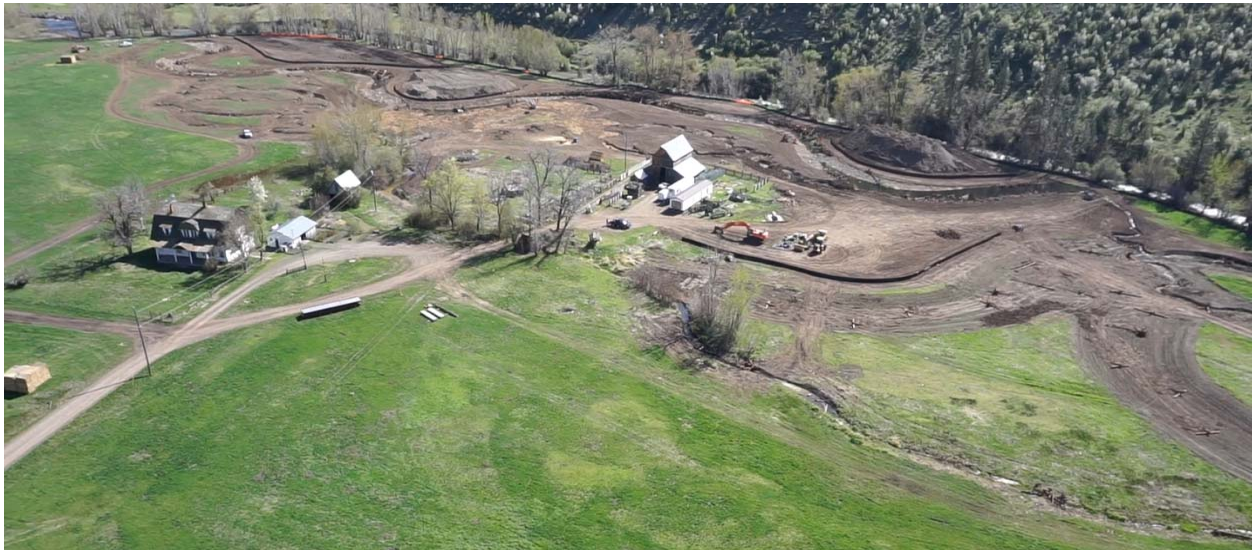
FIGURE 12 TWO AERIAL PHOTOPOINTS OF THE SOUTHERN CROSS PROPERTY MID-PROJECT AREA. THE UPPER PHOTO WAS TAKEN IN APRIL, 2009 AND THE LOWER PHOTO WAS TAKEN IN MARCH 2016.

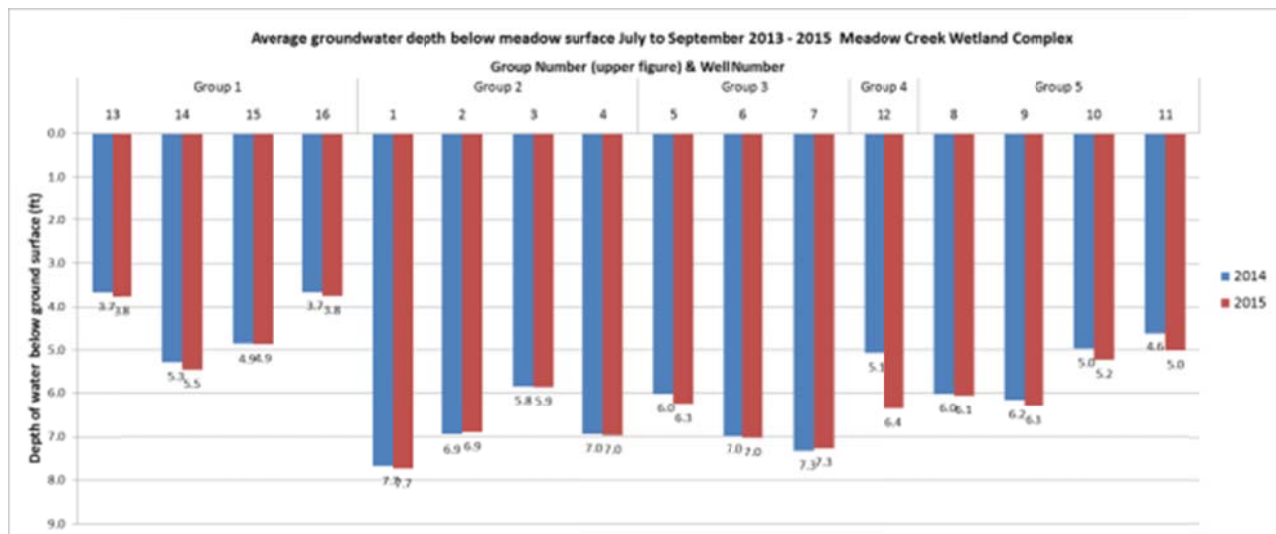
FIGURE 18 AVERAGE GROUNDWATER ELEVATIONS ALONG MEADOW CREEK WITHIN THE MCCOY MEADOWS RANCH.

Average summer groundwater depths from months July to September 2008 to 2014 for the most upstream wells (Group 1) and most downstream wells (Group 5) were graphed (see Figure 19). In addition, pre-project measurements taken in 2005 during the same months are also shown for comparison. There is a six-year trend in decreasing groundwater elevation from 2008 to 2013. Groundwater records from 2013 are the furthest below meadow surface since 2005 pre-project levels. It is possible that sediment build up at the Meadow Wetland Intake prevented desired flows from main channel Meadow Creek to access the wetland channel and contributed to this drop in groundwater elevation. A possible down-cutting of Meadow Creek, and coinciding dropping of the water table, may also have been a factor in these groundwater differences. Groundwater depth measurements taken in 2014 indicate a consistent increase in groundwater elevation when comparing to summer seasonal average depths recorded from 2013 for Group 1 and Group 5 wells. The average increase in groundwater elevation in 2014 for these eight well sites was +0.4 feet. A possible explanation for the increase in groundwater elevation could be that mainstream Meadow Creek flows were allowed more access to floodplain and side channels, or that high flow diversion from the main channel persisted longer in these areas. All but one of the 8 wells (well #16) from Groups 1 and 5 retained water below pre-project levels. The average increase in groundwater elevation in 2014 compared to 2005 pre-project levels was +0.7 feet, which could be the result from seasonal high flows accessing the constructed Meadow Creek Wetland side channel.

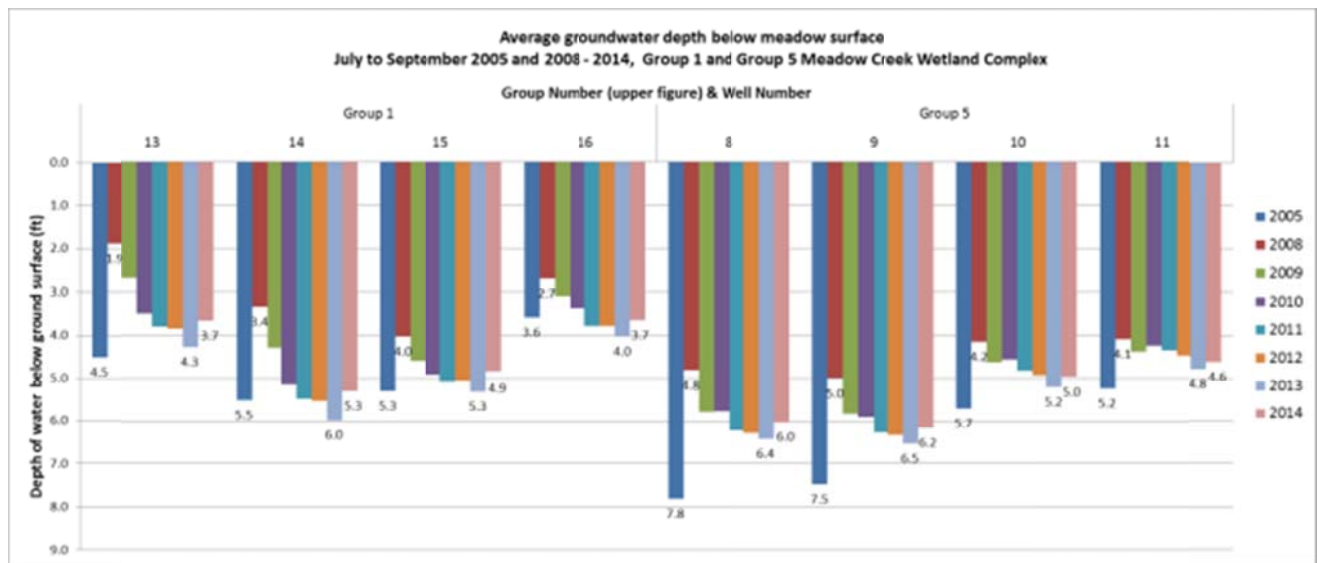
FIGURE 19 2005 (PRE-PROJECT), 2008-2014 AVERAGE GROUNDWATER ELEVATIONS ALONG MEADOW CREEK WITHIN THE MCCOY MEADOWS RANCH.

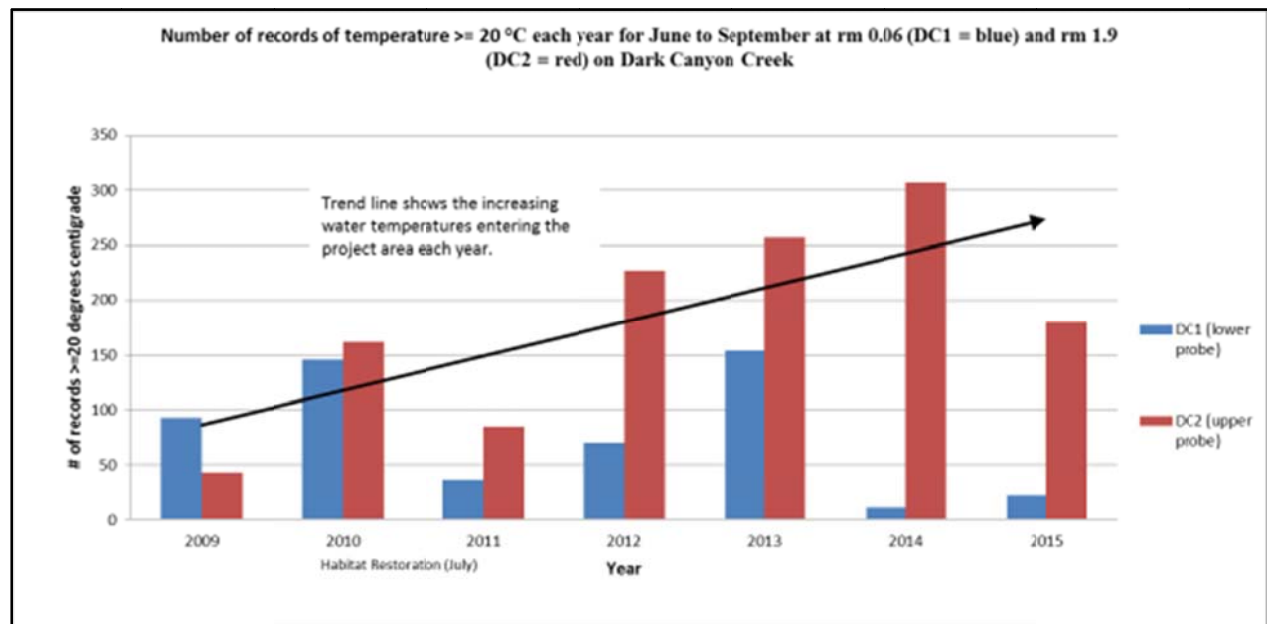
FIGURE 24 PLOT OF THE NUMBER OF WATER TEMPERATURES >=20°C ON DARK CANYON CREEK. PLOTTED TREND LINE DEMONSTRATES THAT OVERALL WARMER WATERS ARE ENTERING THE PROJECT AREA EACH YEAR (RED BARS), BUT THIS WATER IS COOLING AS IT MOVES THROUGH THE PROJECT AREA TO THE LOWER PROBE SITE (BLUE BARS).

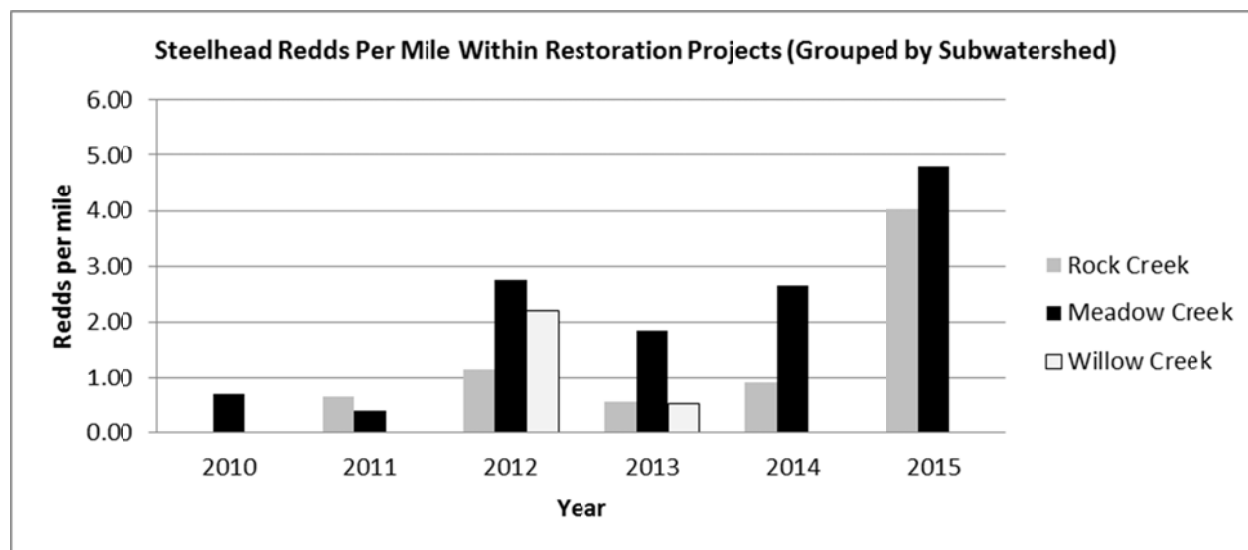
FIGURE 27 STEELHEAD REDD DENSITY PER MILE OF SURVEYED STREAM GROUPED BY SUB-WATERSHED 2010 TO 2015. SURVEYED REACHES ARE ALL WITHIN CTUIR HABITAT RESTORATION PROJECTS.

There was a considerable increase in the number of steelhead redds observed in 2015 compared to other years, with 131 redds observed between 2010 and 2014 compared to 158 in 2015. This also increased the density of redds (redds/mile of survey) - for example, the Rock Creek sub-watershed went from an average of approximately one redd/mile to four redds/mile. Similarly, the Meadow Creek sub-watershed went from 2.6 redds/mile in 2014 to 4.8 redds/mile in 2015 (figure 27) within the same survey area.
