# **CTUIR GRANDE RONDE SUBBASIN RESTORATION PROJECT ANNUAL REPORT**

## **A Columbia River Basin Fish Habitat Project**

**Northwest Power Planning Council Project # 199608300**

Report covers work performed under BPA contract # 72551  
Report was completed under BPA contract #72551  
Report covers work performed from: May 1, 2016 to April 30, 2017

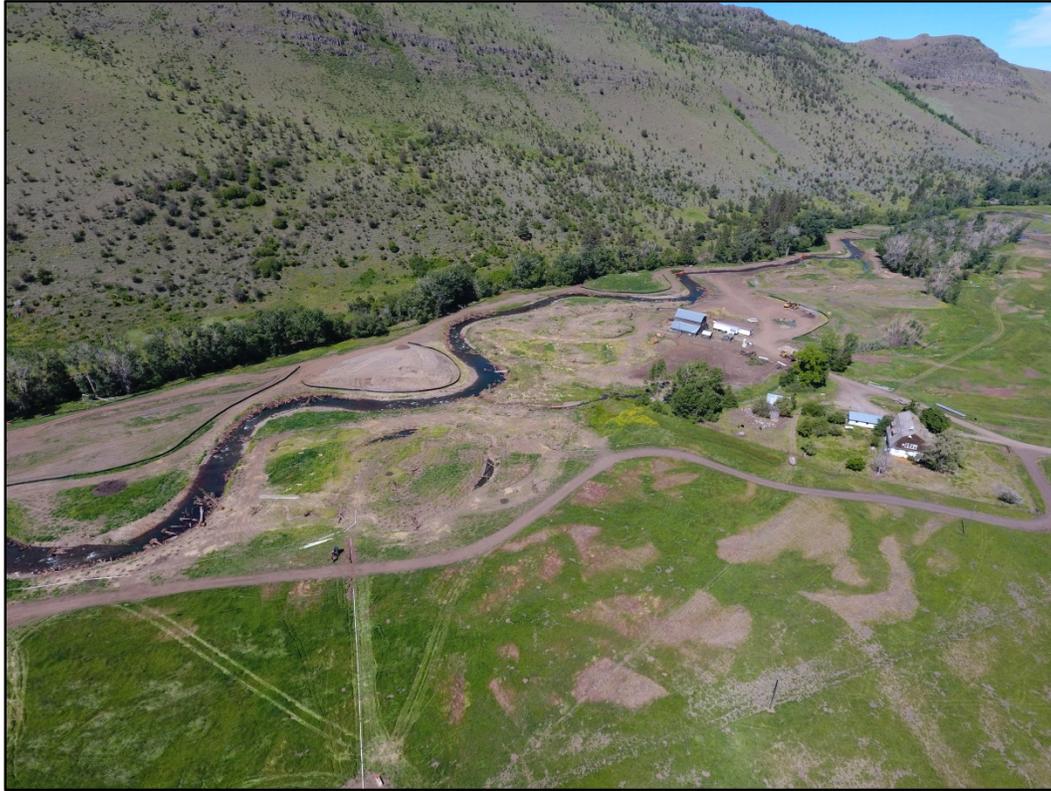
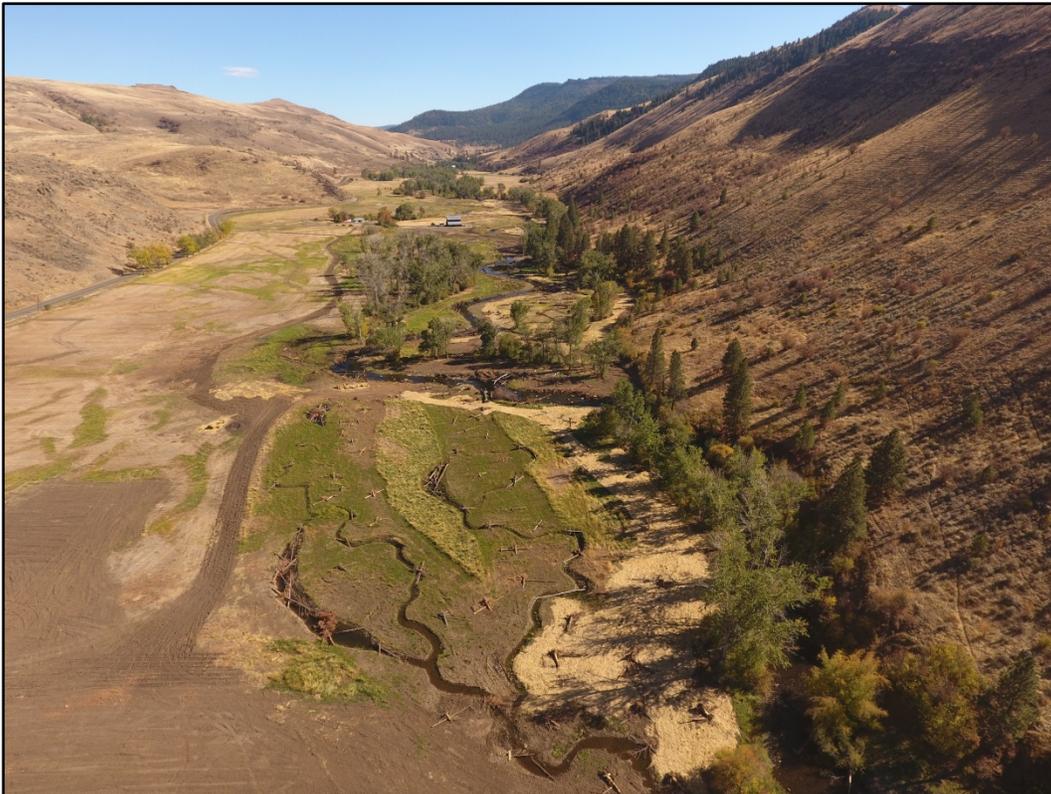
**FIGURE 9 TWO PHOTOGRAPHS OF SOUTHERN CROSS CONSTRUCTION AT THE UPPER AND MID PROJECT AREAS  
JUNE 2016 AND SEPTEMBER 2016.**

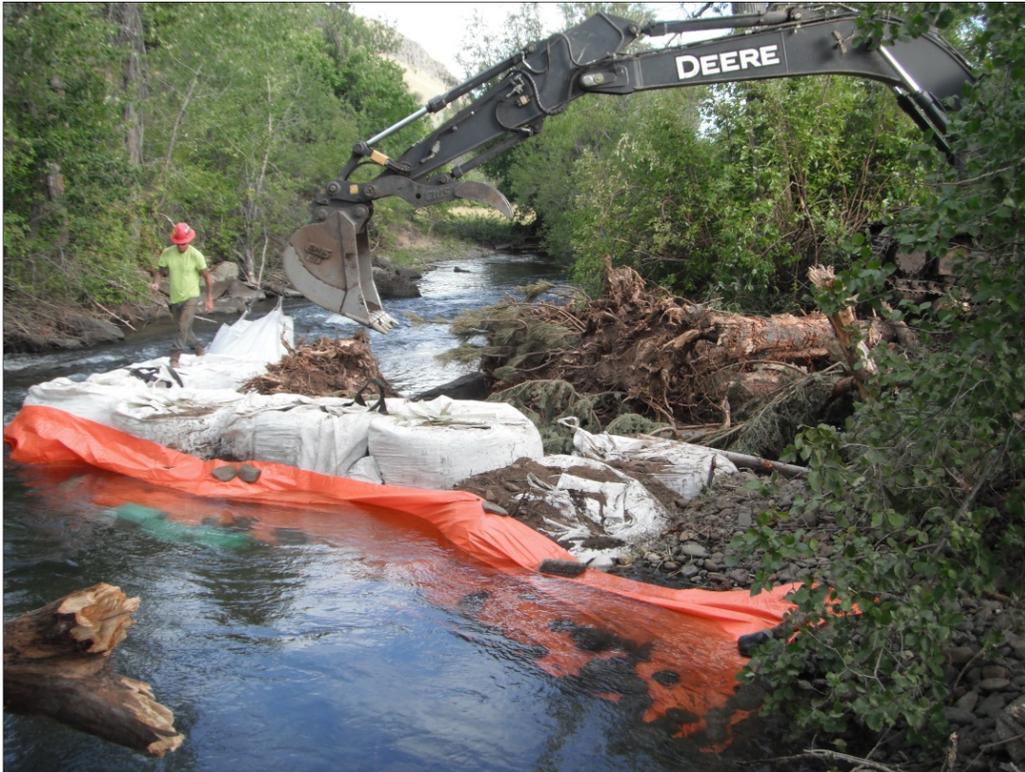
**FIGURE 10 CONSTRUCTION OF LARGE WOOD STRUCTURE AT LOWER PROJECT AREA.**

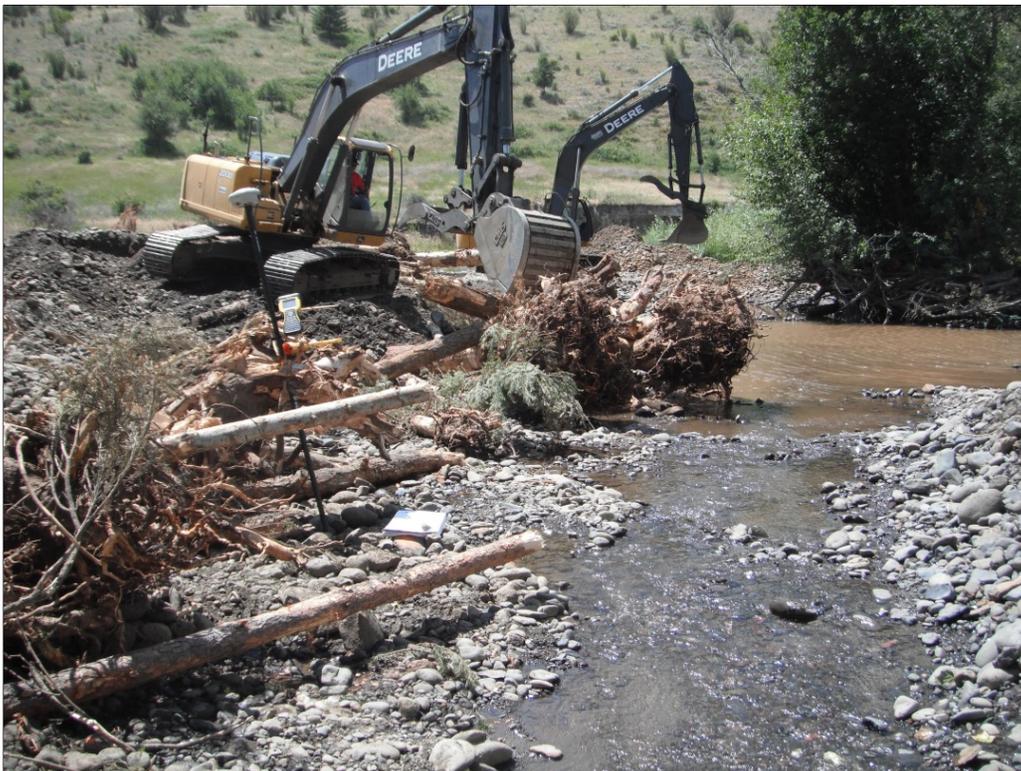
**FIGURE 11 CONSTRUCTION OF LARGE WOOD STRUCTURE AT UPPER PROJECT AREA.**

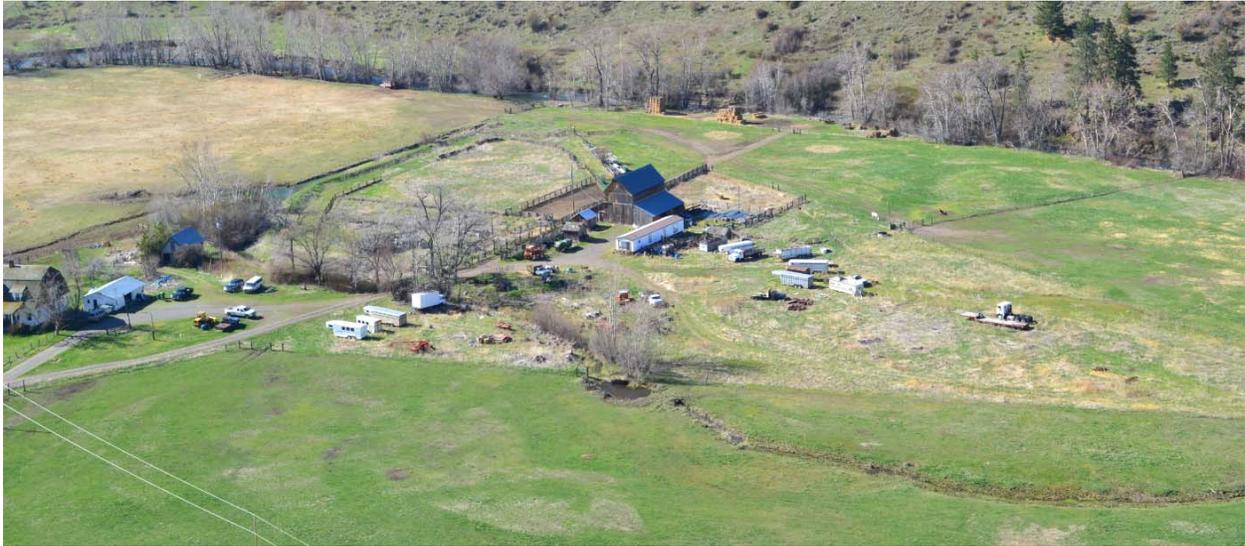
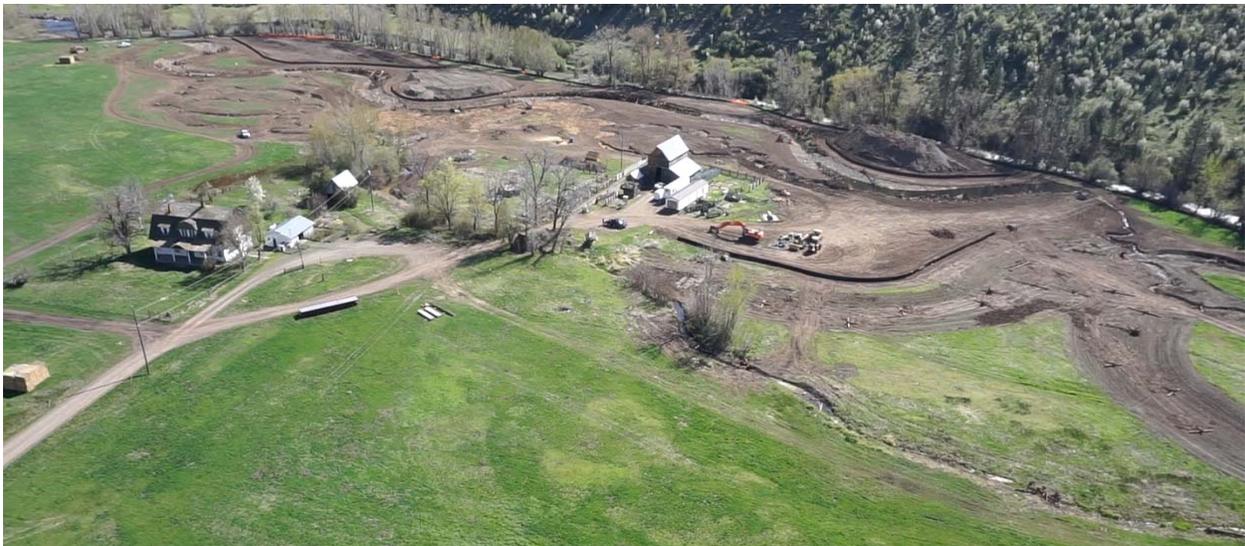
**FIGURE 12** TWO AERIAL PHOTOPOINTS OF THE SOUTHERN CROSS PROPERTY MID-PROJECT AREA. THE UPPER PHOTO WAS TAKEN IN APRIL, 2009 AND THE LOWER PHOTO WAS TAKEN IN MARCH 2016.
