# **ANNUAL REPORT CTUIR GRANDE RONDE WATERSHED RESTORATION PROJECT**

## **A Columbia River Basin Fish Habitat Project**

**Northwest Power Planning Council Project # 1996-083-00**

Report covers work performed under BPA Contract 73982 REL 135  
May 1, 2021 to April 30, 2022

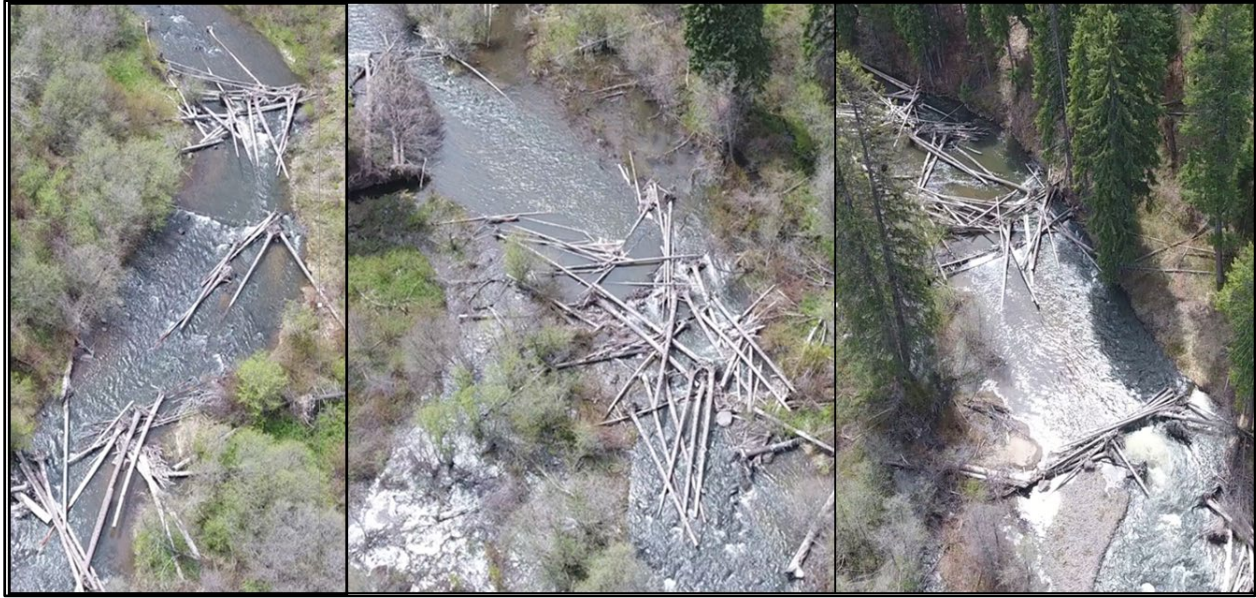
**FIGURE 17** DRONE IMAGERY ILLUSTRATING WOOD COMPLEXITY, DIVERSITY, VELOCITY DIVERSITY, AND ISLAND BRAIDING

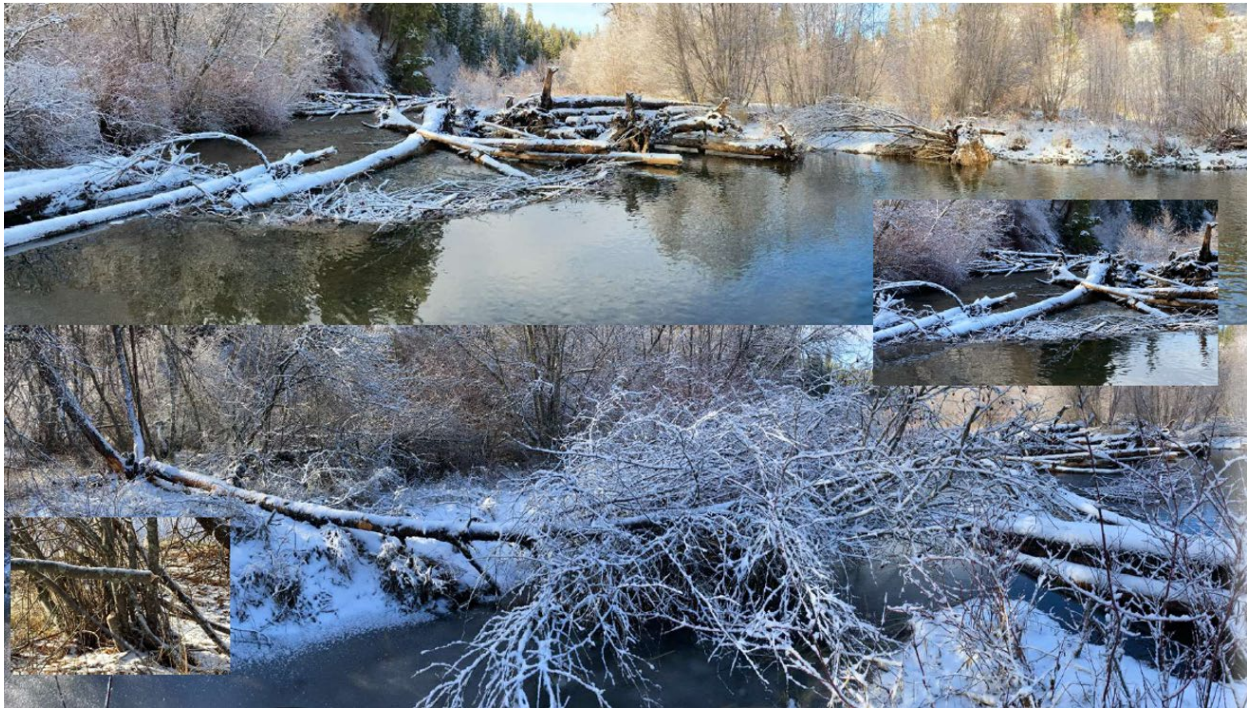
**FIGURE 18** IMAGERY ILLUSTRATING BEAVER DAMS AND ACTIVITY NEAR PLACED WOOD STRUCTURES

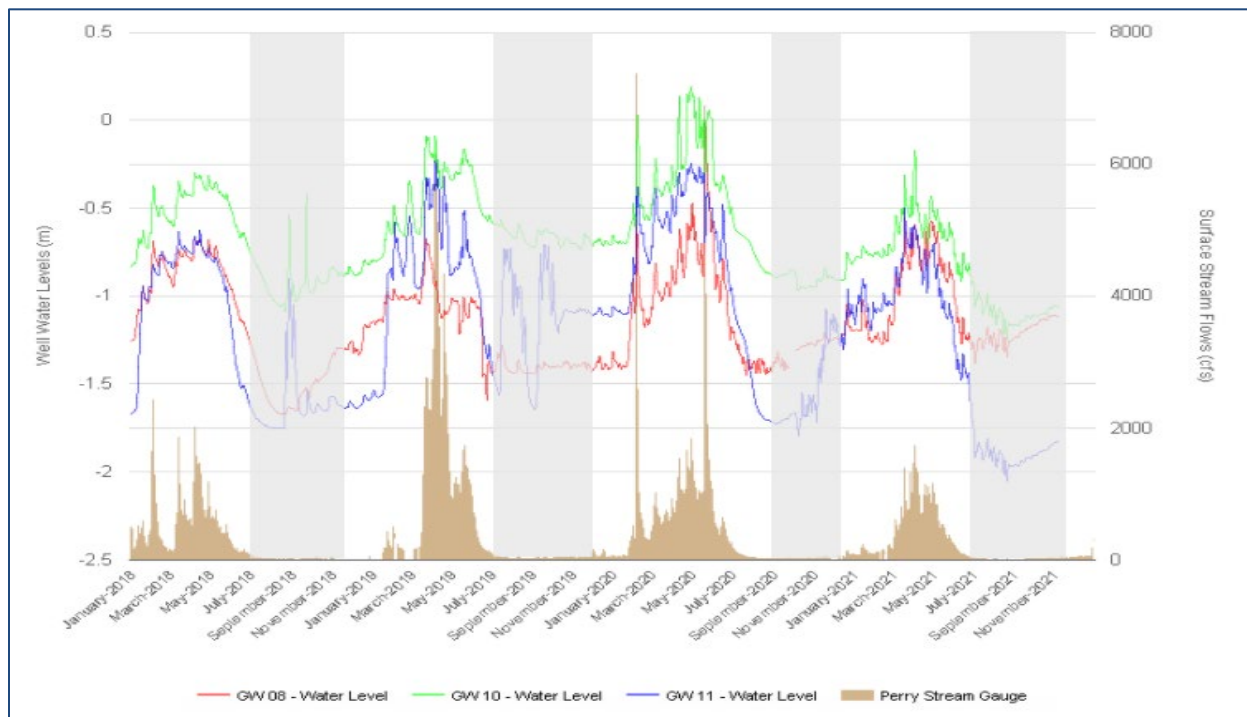
**FIGURE 33 AVERAGE DAILY GROUND WATER LEVELS FOR WELLS 8-11 AT BIRD TRACK SPRINGS AND DISCHARGE AT THE PERRY GAUGE, JANUARY, 2018 TO NOVEMBER, 2021.**

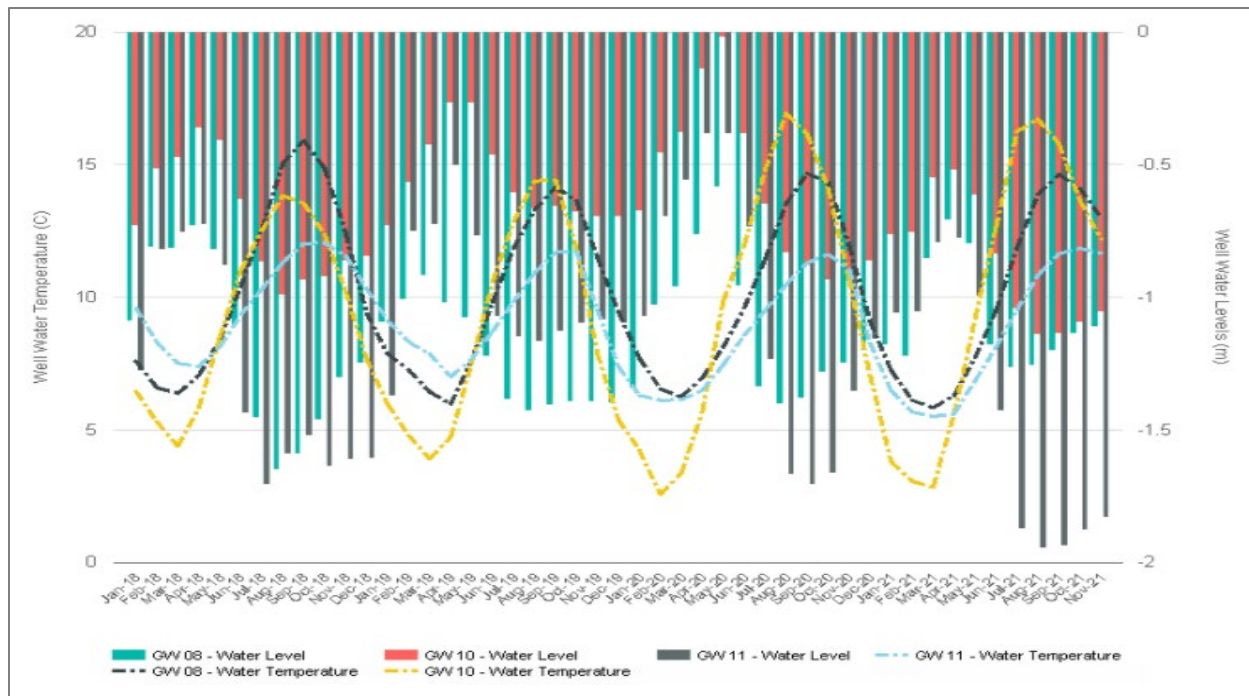
**FIGURE 34 MONTHLY AVERAGE GROUNDWATER LEVELS FOR WELLS 8-11 AT BIRD TRACK SPRINGS AND CORRESPONDING GROUNDWATER TEMPERATURES, JANUARY, 2018 TO NOVEMBER, 2021.**

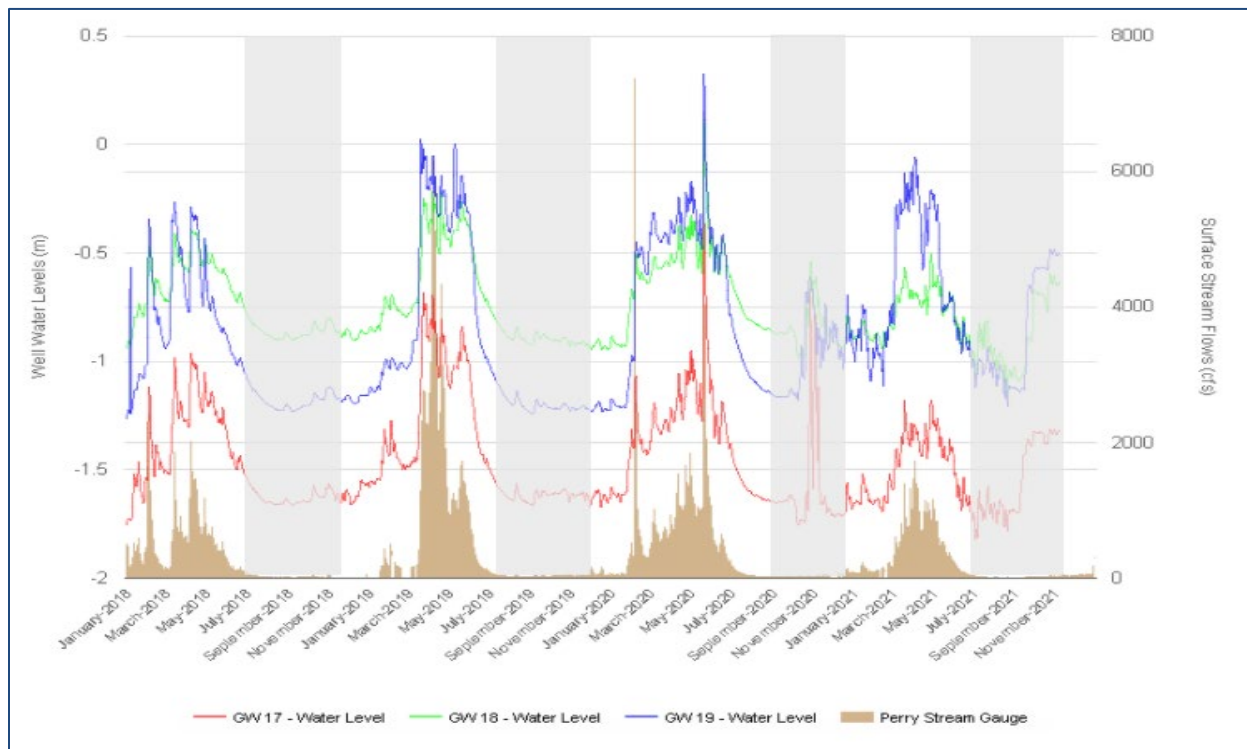
**FIGURE 35 AVERAGE DAILY GROUND WATER LEVELS FOR WELLS 17-19 AT LONGLEY MEADOWS AND DISCHARGE AT THE PERRY GAUGE, JANUARY, 2018 TO NOVEMBER, 2021.**

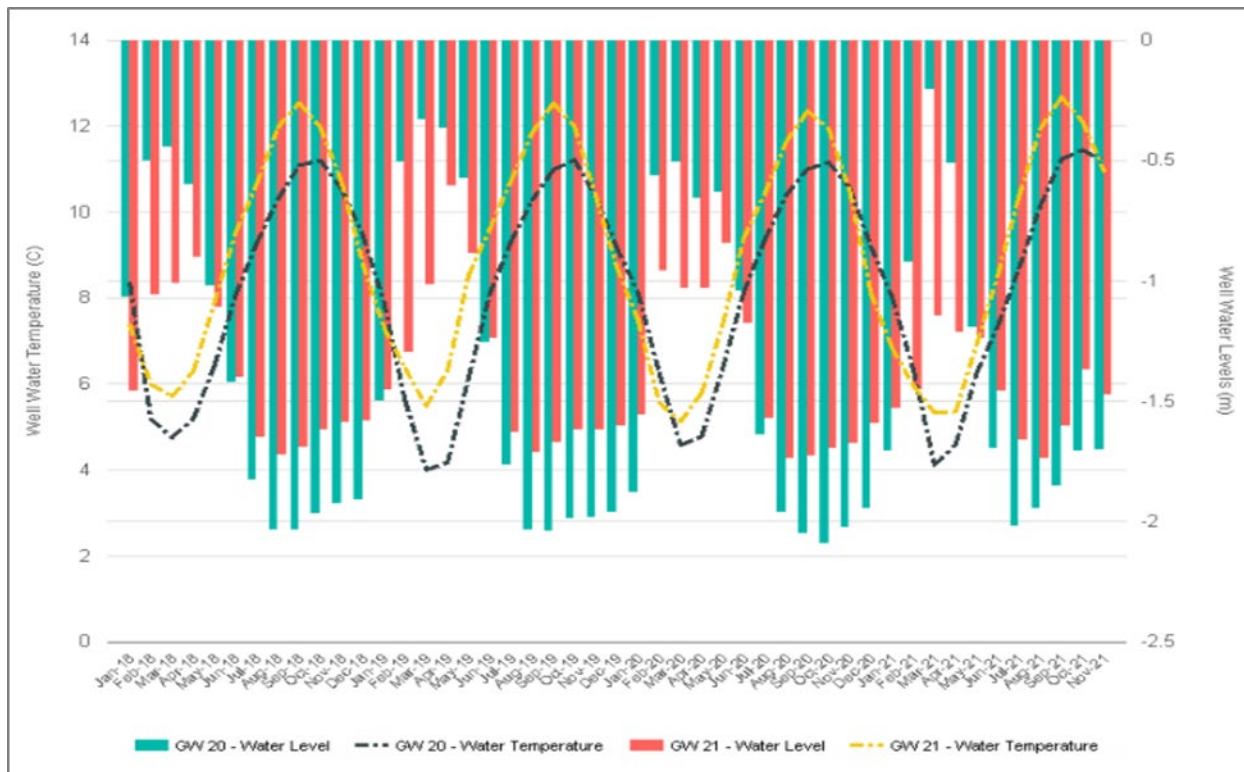
**FIGURE 38** MONTHLY AVERAGE GROUNDWATER LEVELS FOR WELLS 20-21 AT LONGLEY MEADOWS AND CORRESPONDING GROUNDWATER TEMPERATURES, JANUARY-18 TO NOVEMBER-21.

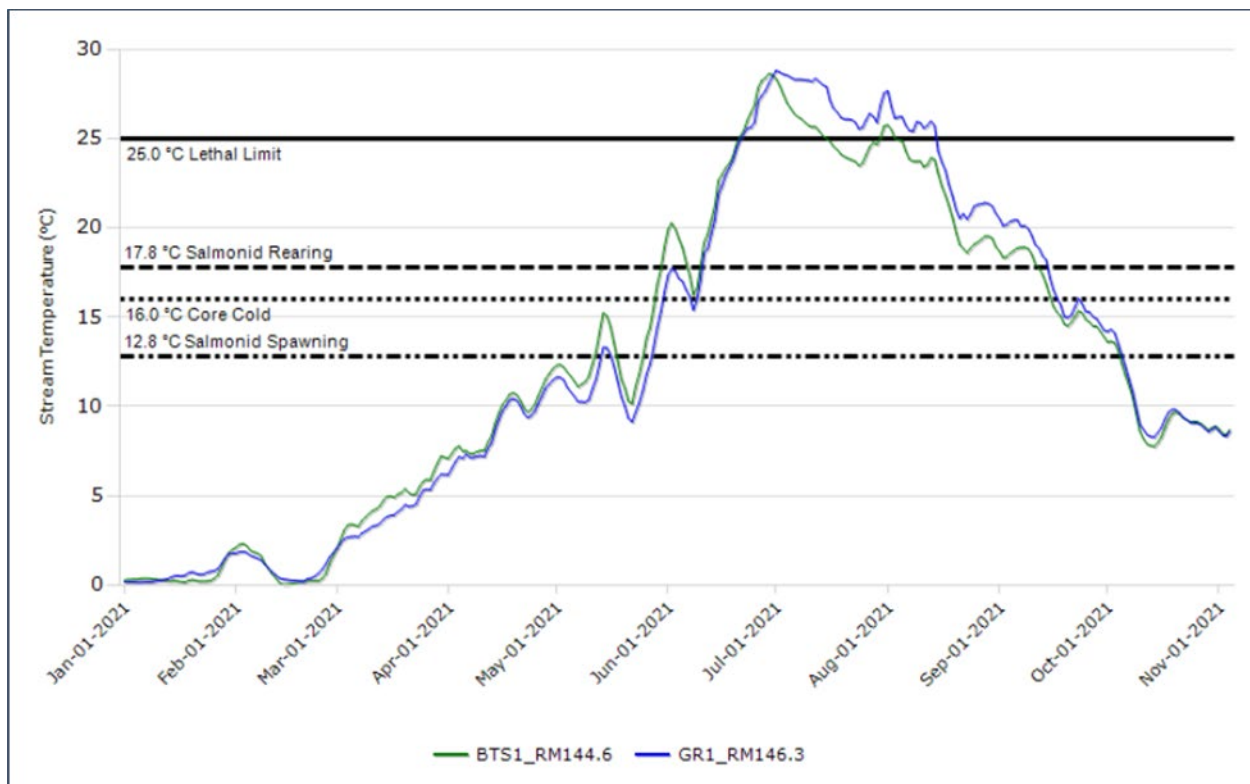
**FIGURE 50 7DADM FOR GRANDE RONDE RIVER WITH PROBES BRACKETING THE BIRD TRACK SPRINGS RESTORATION PROJECT, JANUARY-NOVEMBER, 2021**

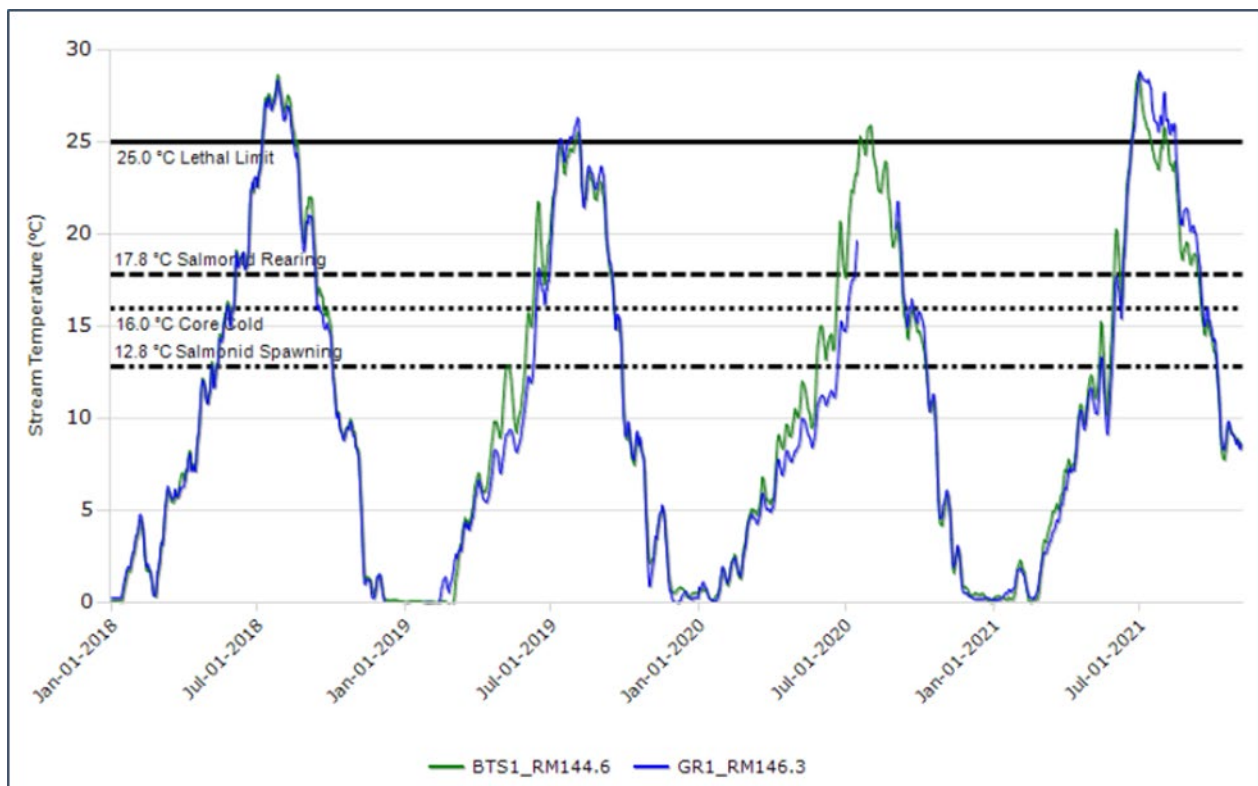
**FIGURE 51 7DADM FOR GRANDE RONDE RIVER (BIRD TRACK SPRINGS) BRACKETED RESTORATION PROJECT, JANUARY-JULY, 2021**
