**APPENDIX G – ODFW FISH HABITAT IN THE  
CATHERINE CREEK GRANDE RONDE RIVER BASIN  
JANUARY 2011**

FISH HABITAT ASSESSMENT IN CATHERINE CREEK,  
GRANDE RONDE RIVER BASIN

January, 2011

Oregon Department of Fish and Wildlife  
Aquatic Inventories Project  
28655 Highway 34  
Corvallis, Oregon 97333

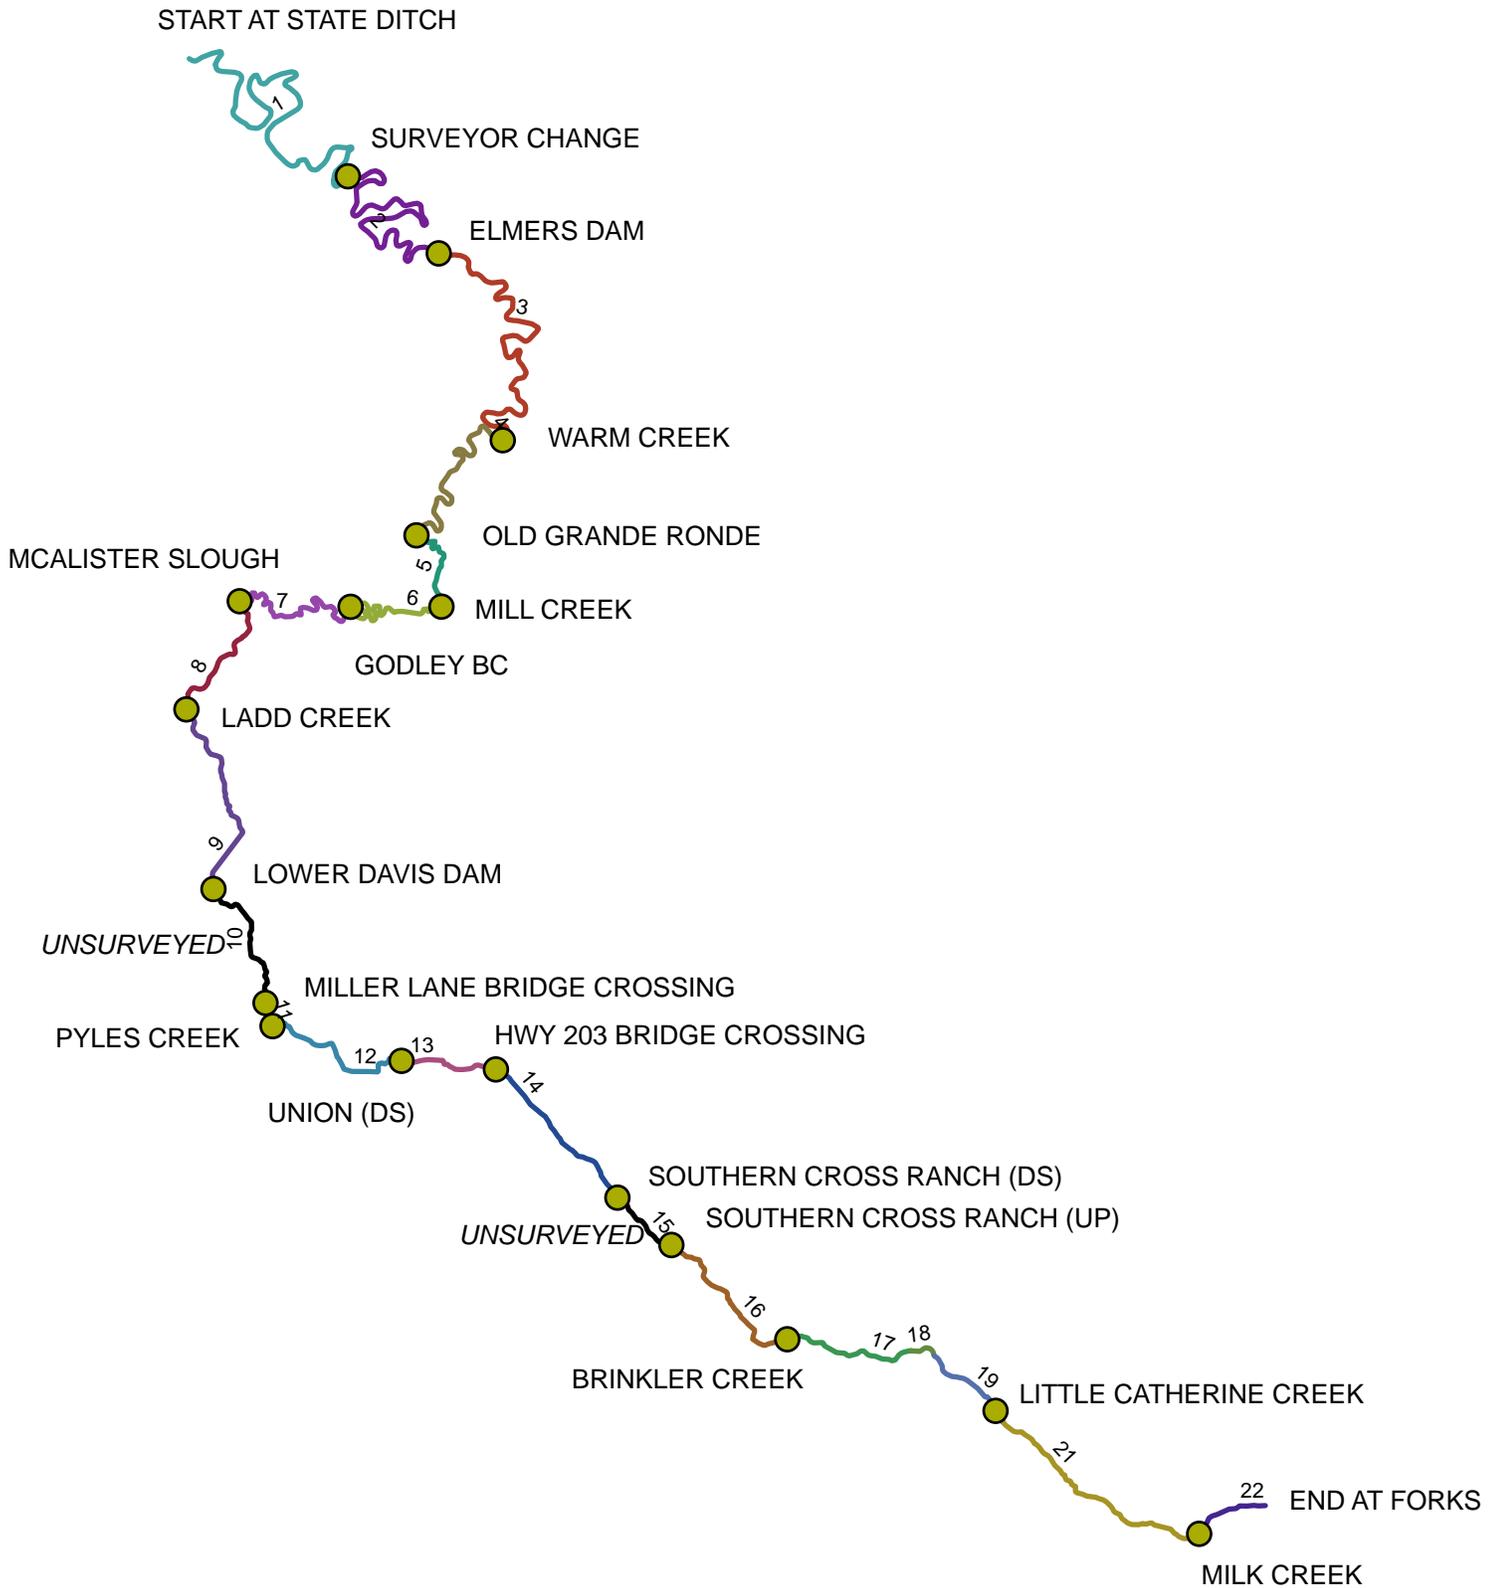
Figure 2. Catherine Creek reach breaks based on 2010 habitat survey data  
Note that Reaches 10 and 15 were not surveyed

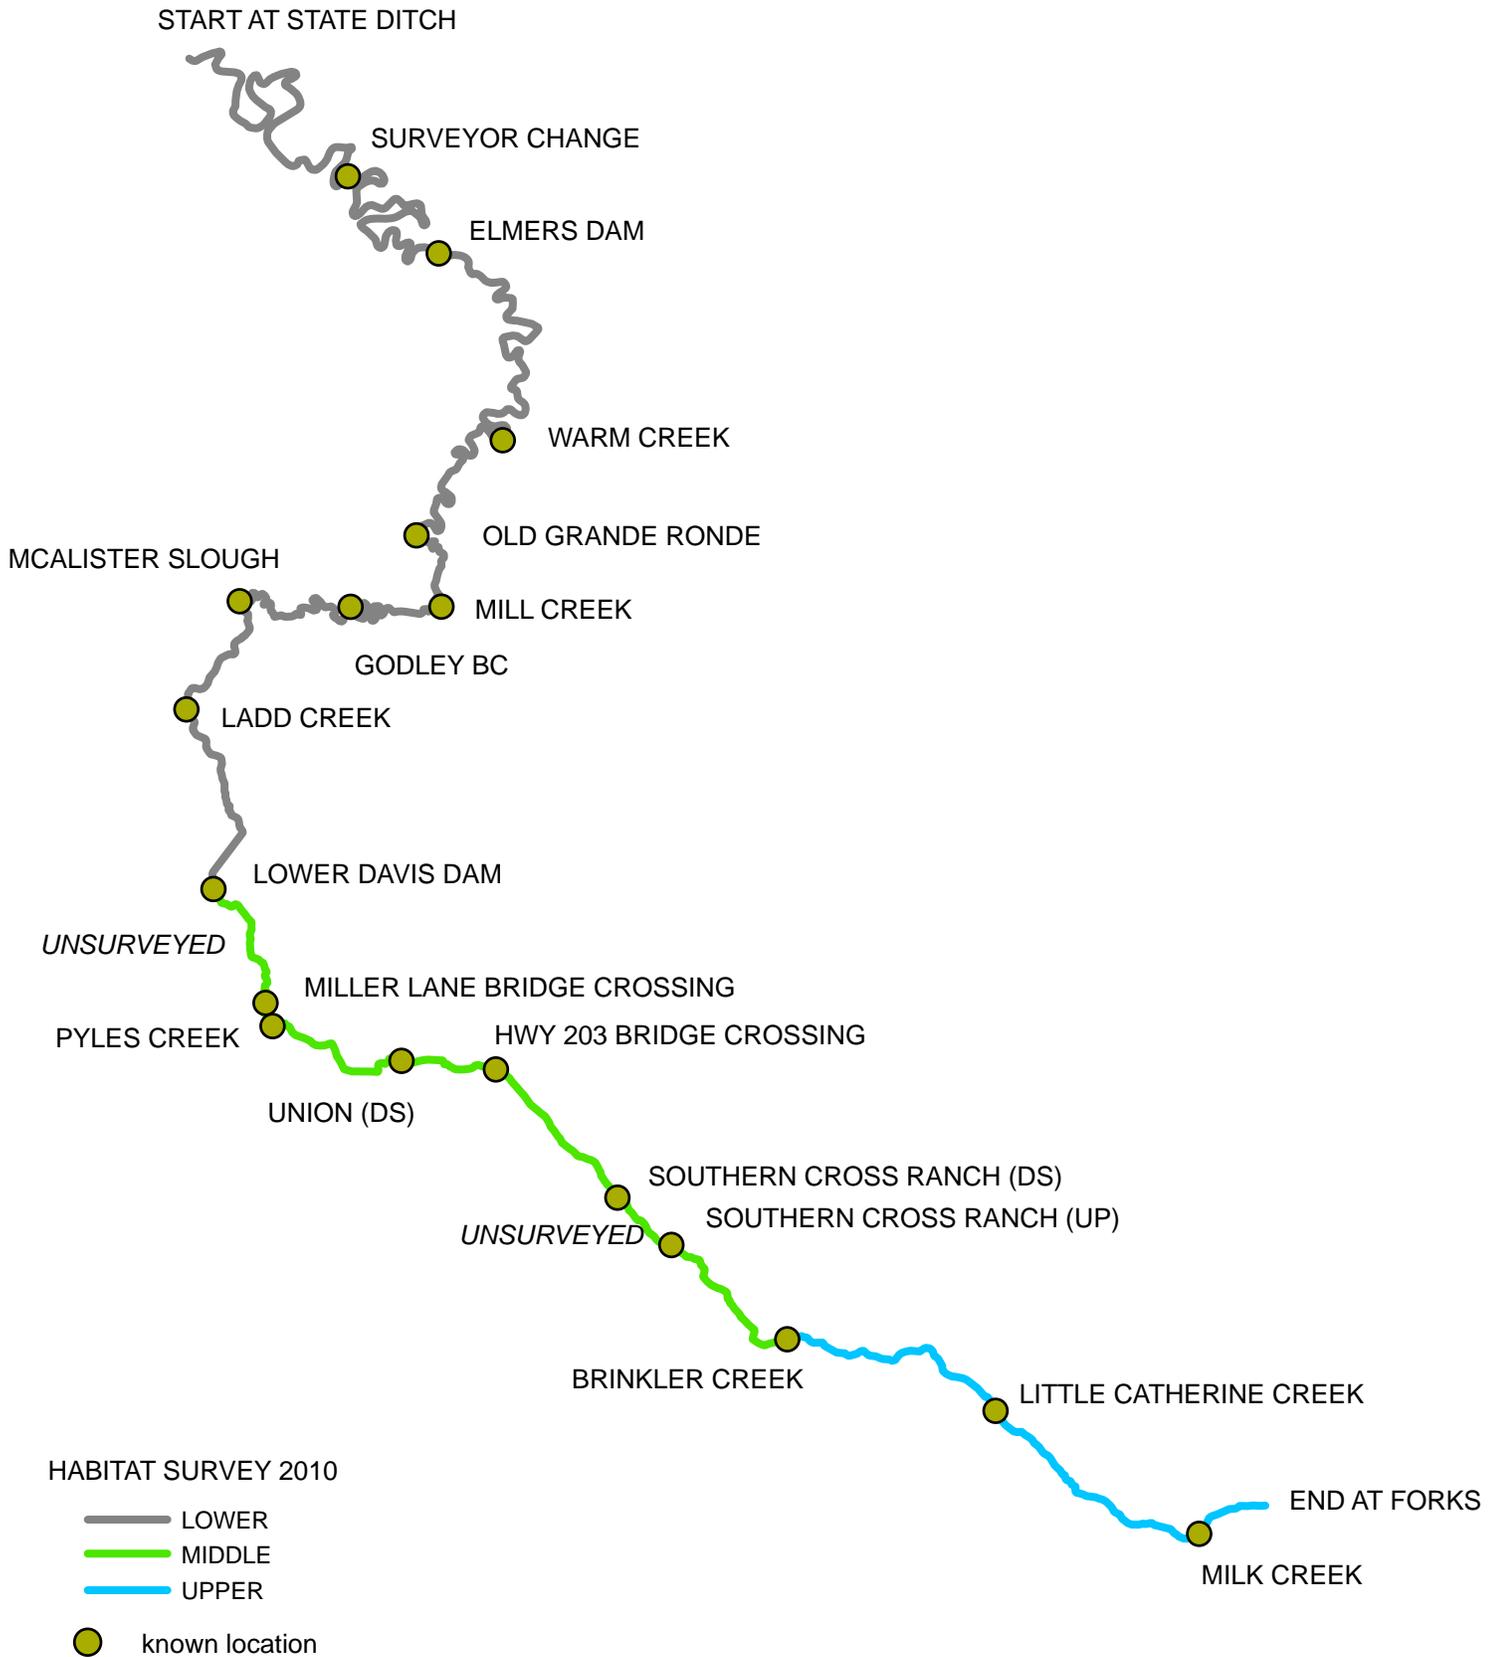
Figure 3. Catherine Creek 2010 habitat survey split into three sections: lower, middle, upper.

The survey was divided into three sections for this general discussion: a lower section (mouth to Davis Dam), middle section (Davis Dam to Brinkler Creek), and an upper section (Brinkler Creek to North Fork and South Fork Catherine Creeks) (Figure 3). More detail by reach can be found in the Catherine Creek 2010 Habitat Report (Appendix A).

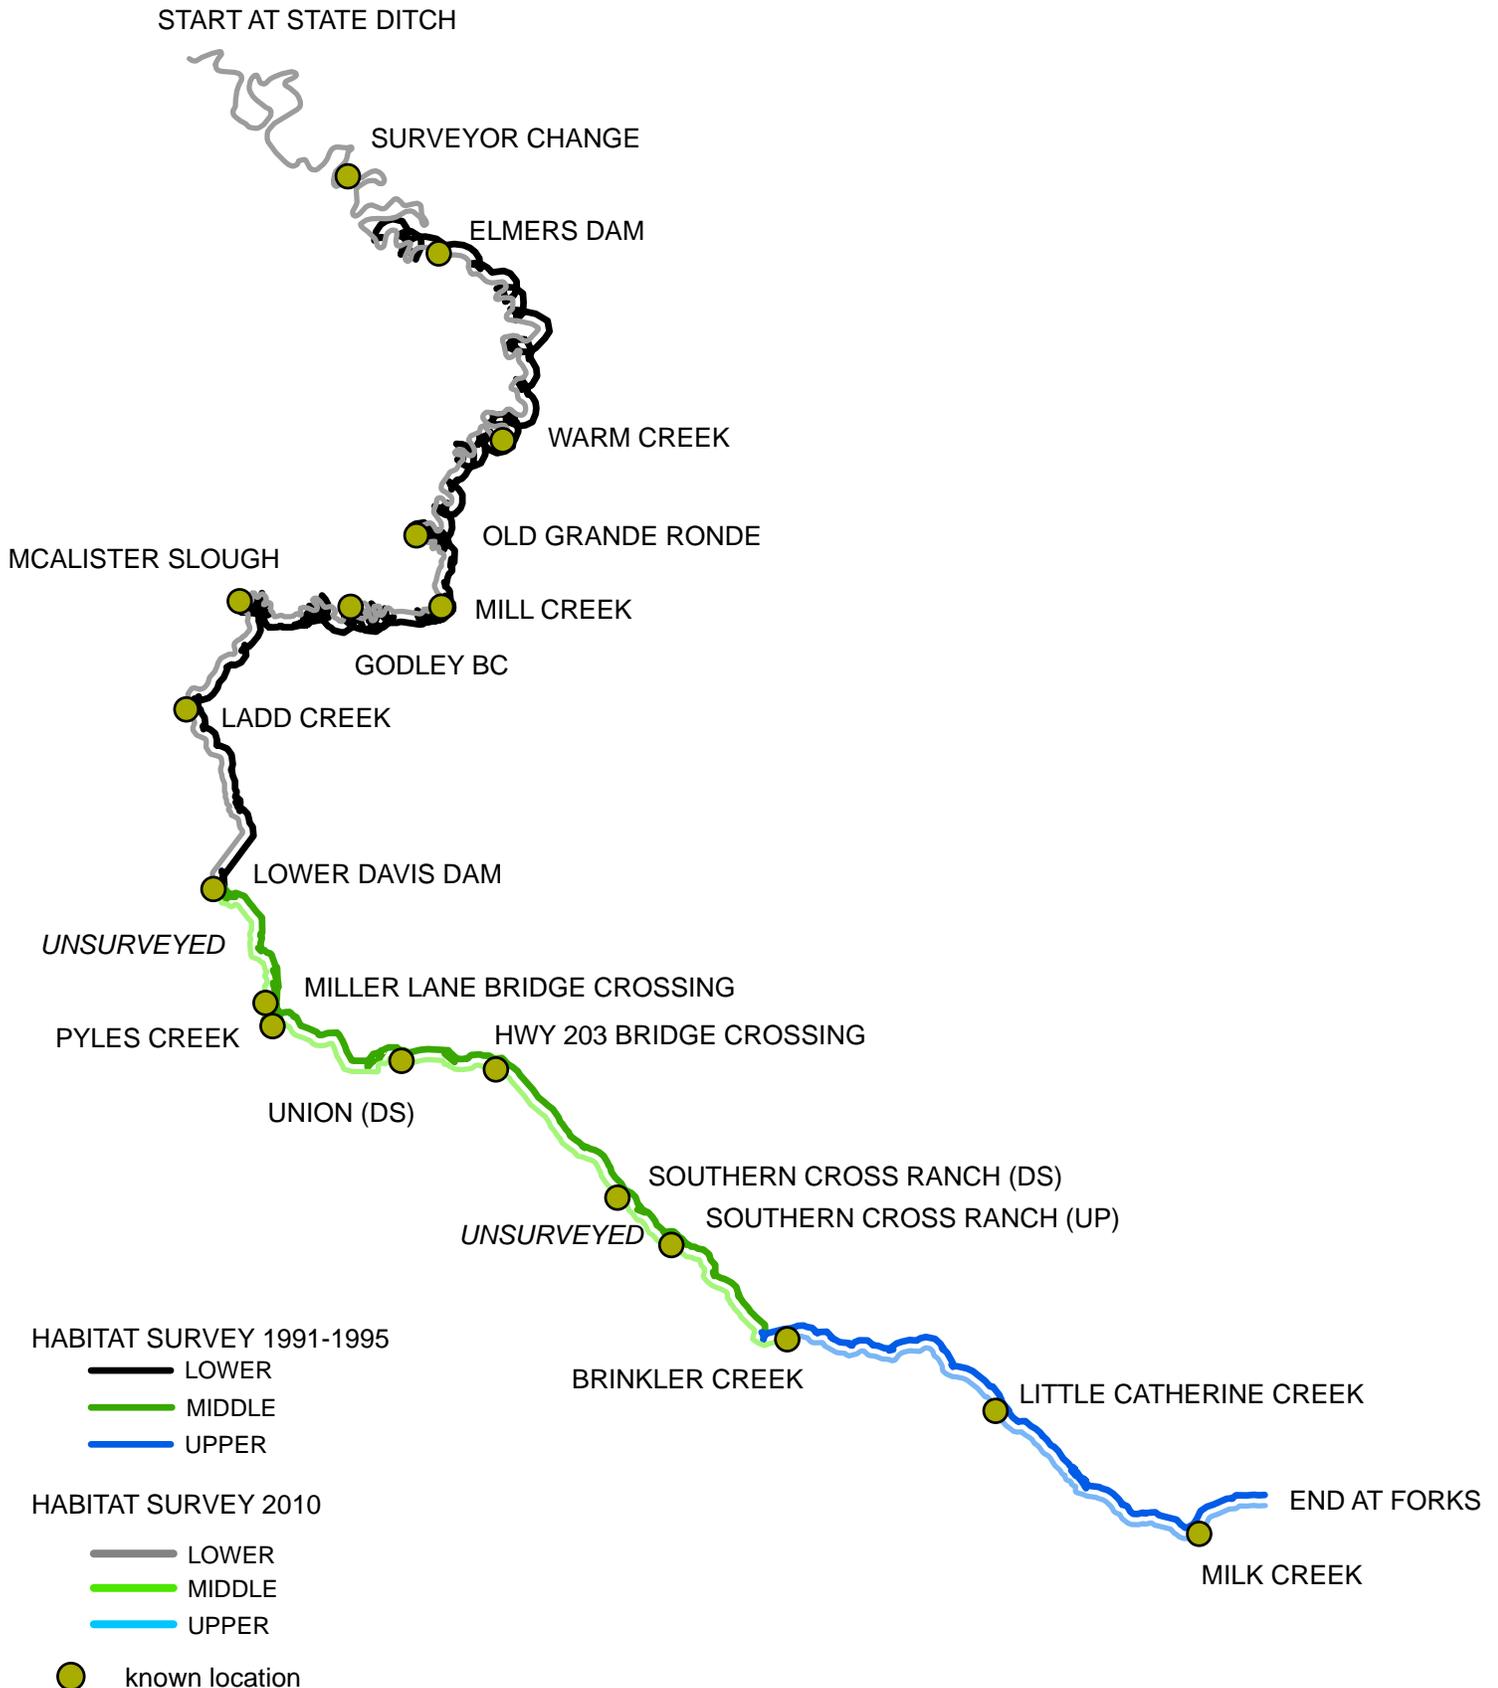
Figure 4. Catherine Creek divided into three sections (lower, middle, upper) for comparison of 1991-1995 and 2010 habitat survey data.

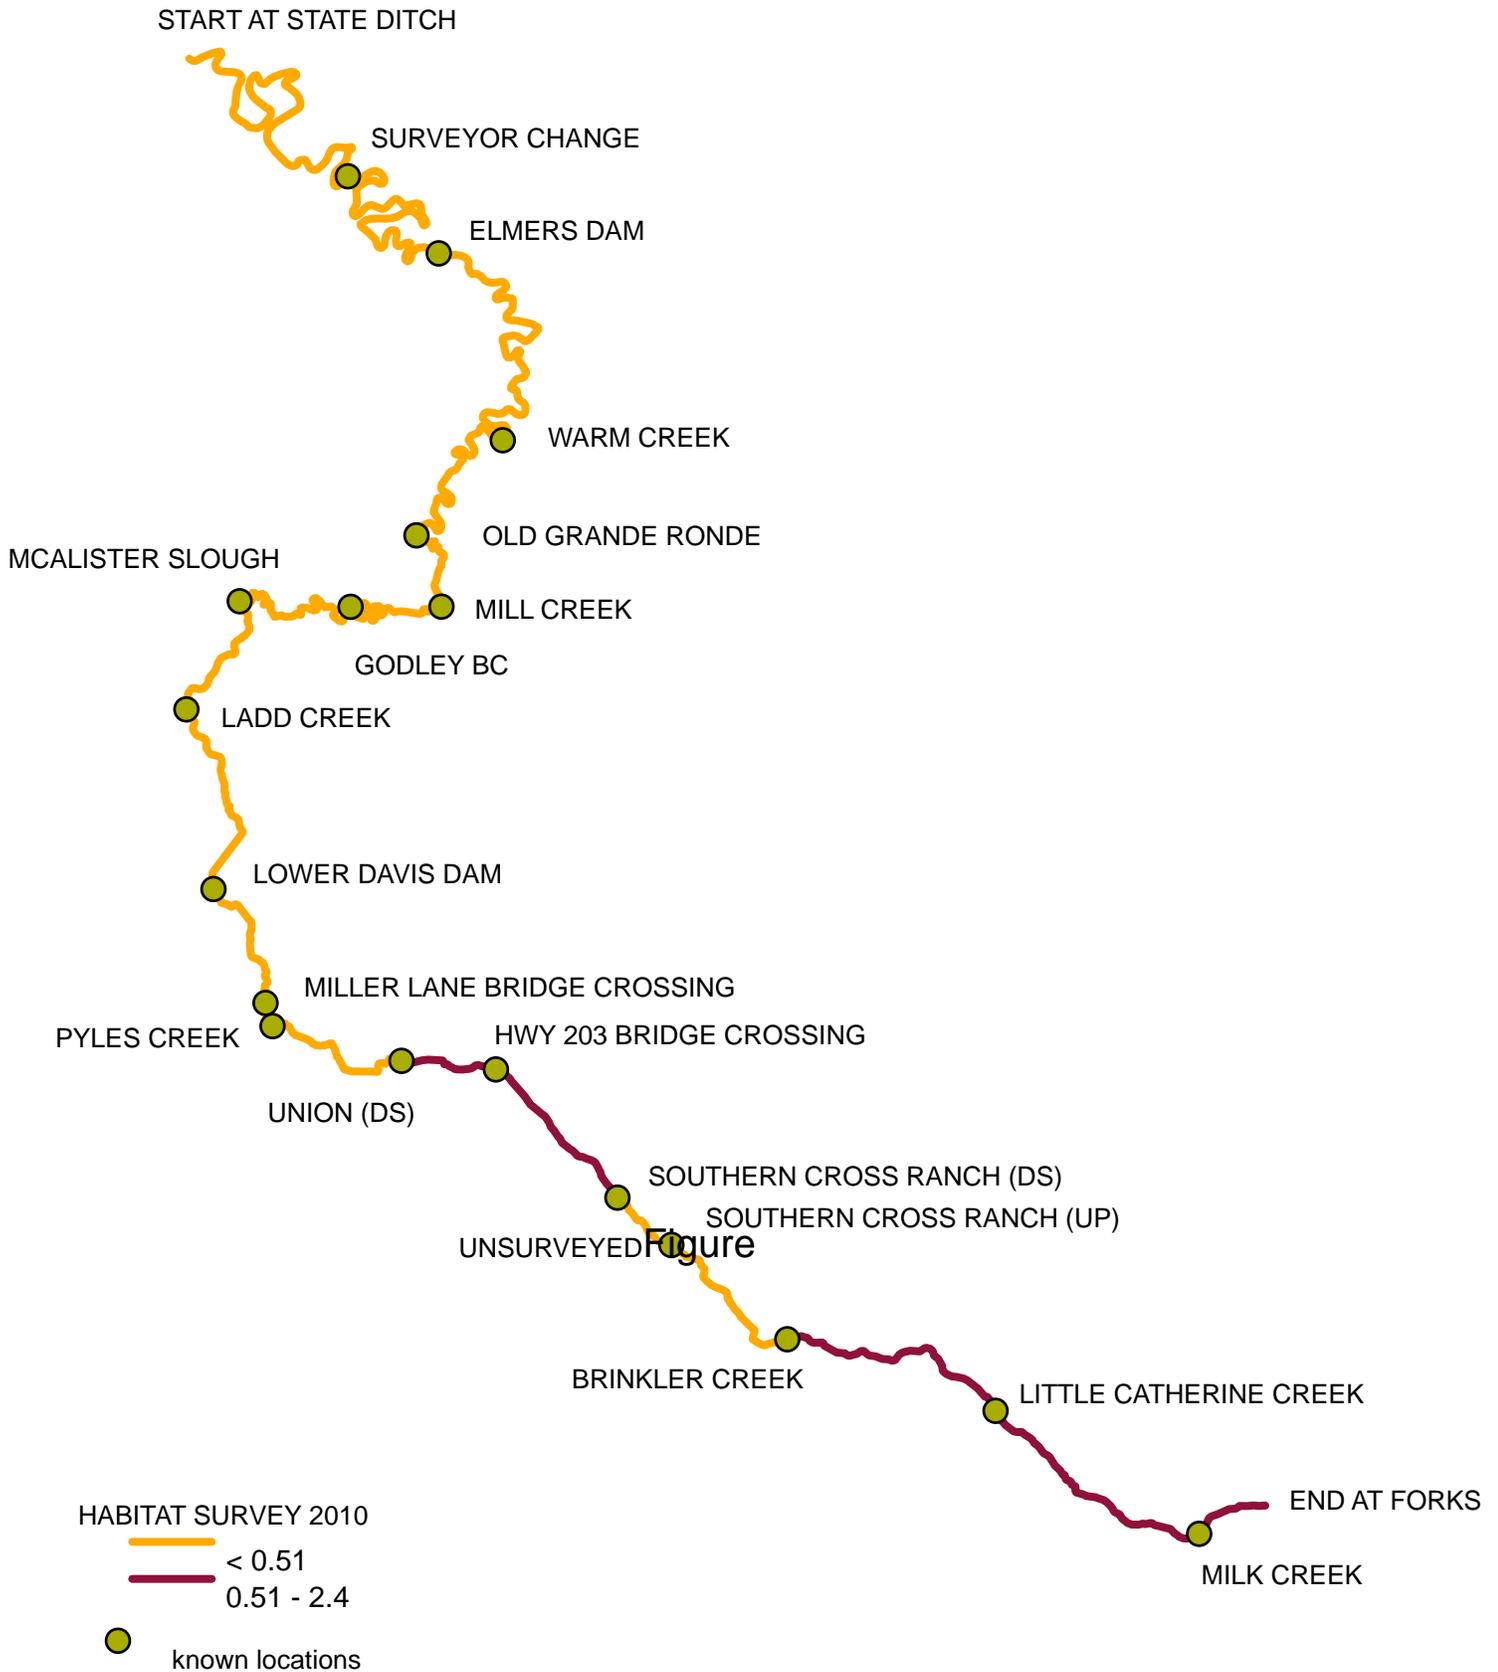
Figure 5. Catherine Creek gradient based on 2010 habitat survey data

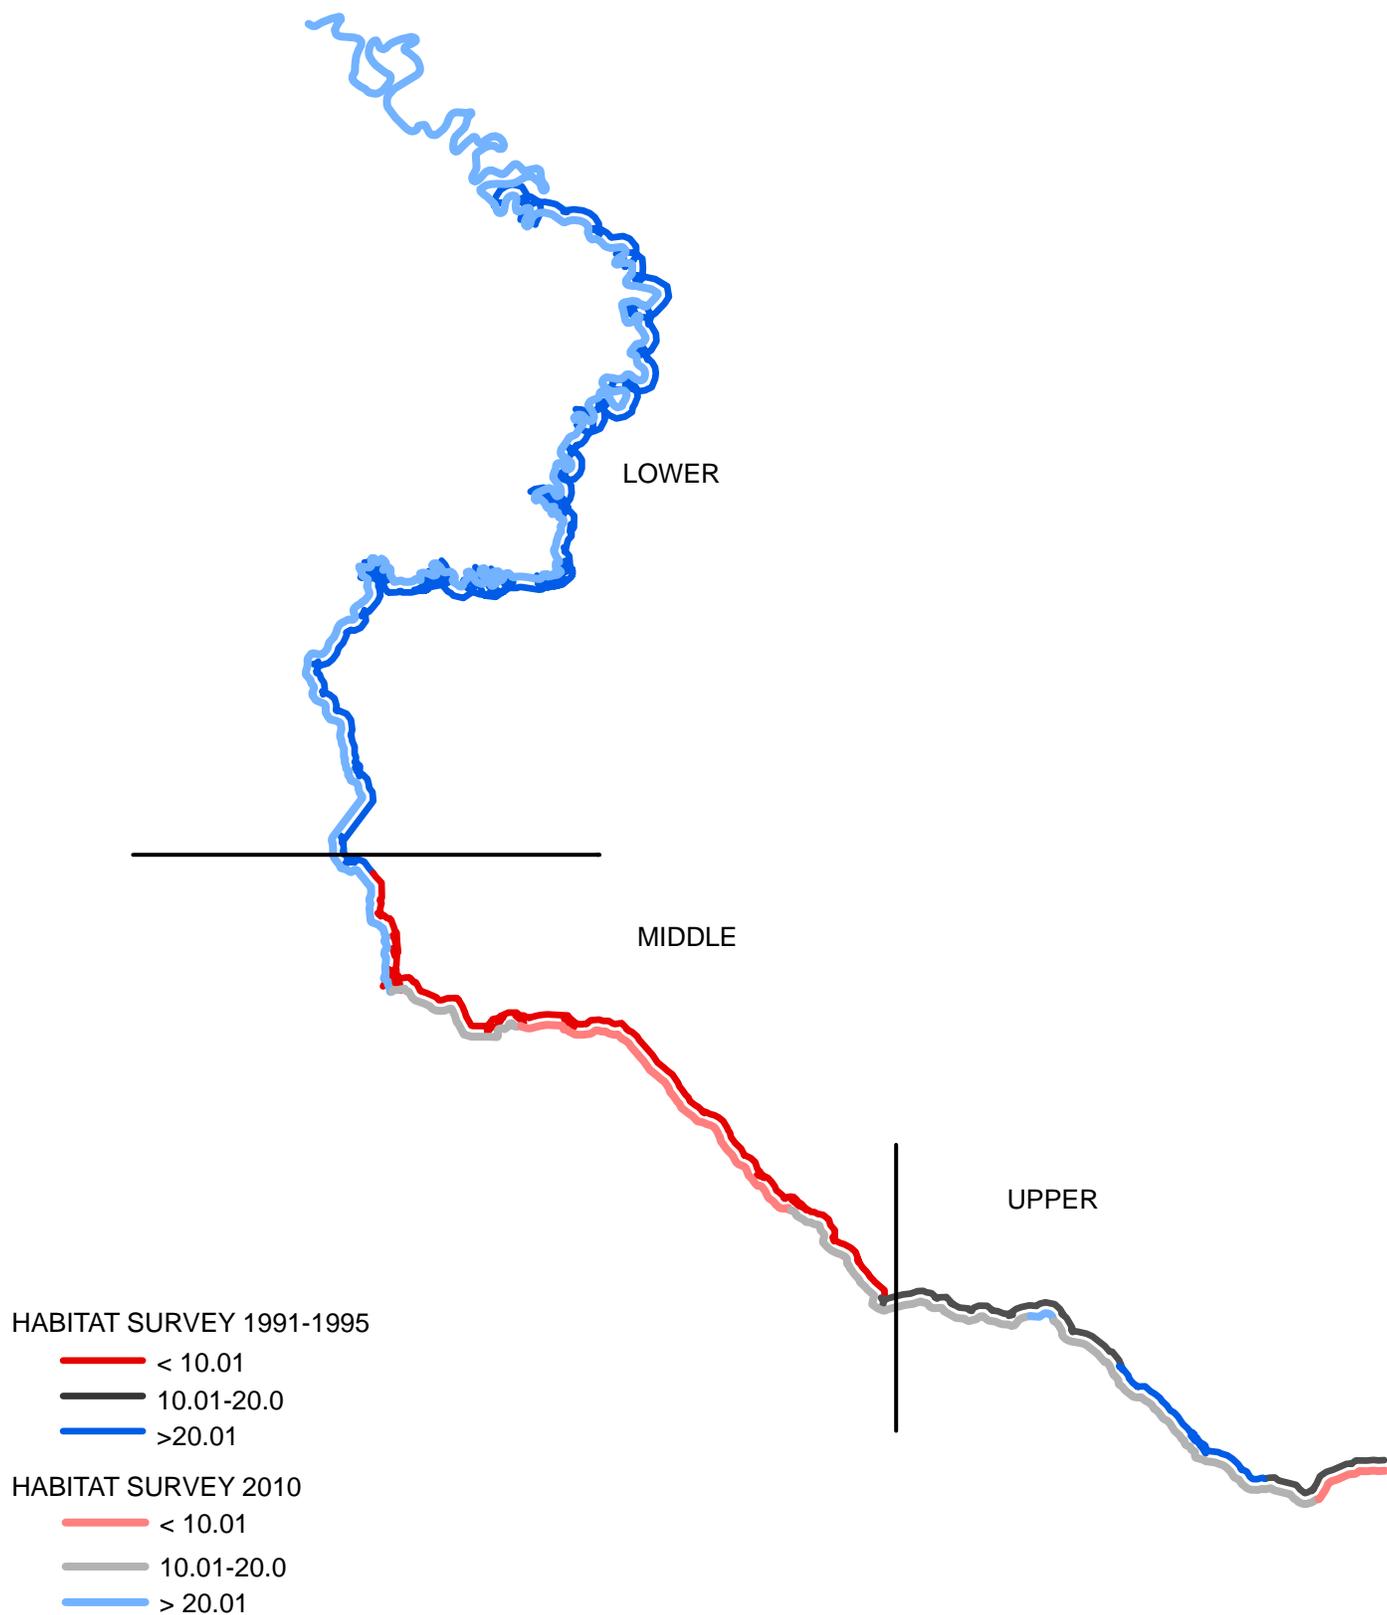
Figure 6. Catherine Creek divided into three sections for comparison of Percent Fine Sediment based on 1991-1995 and 2010 habitat survey data.

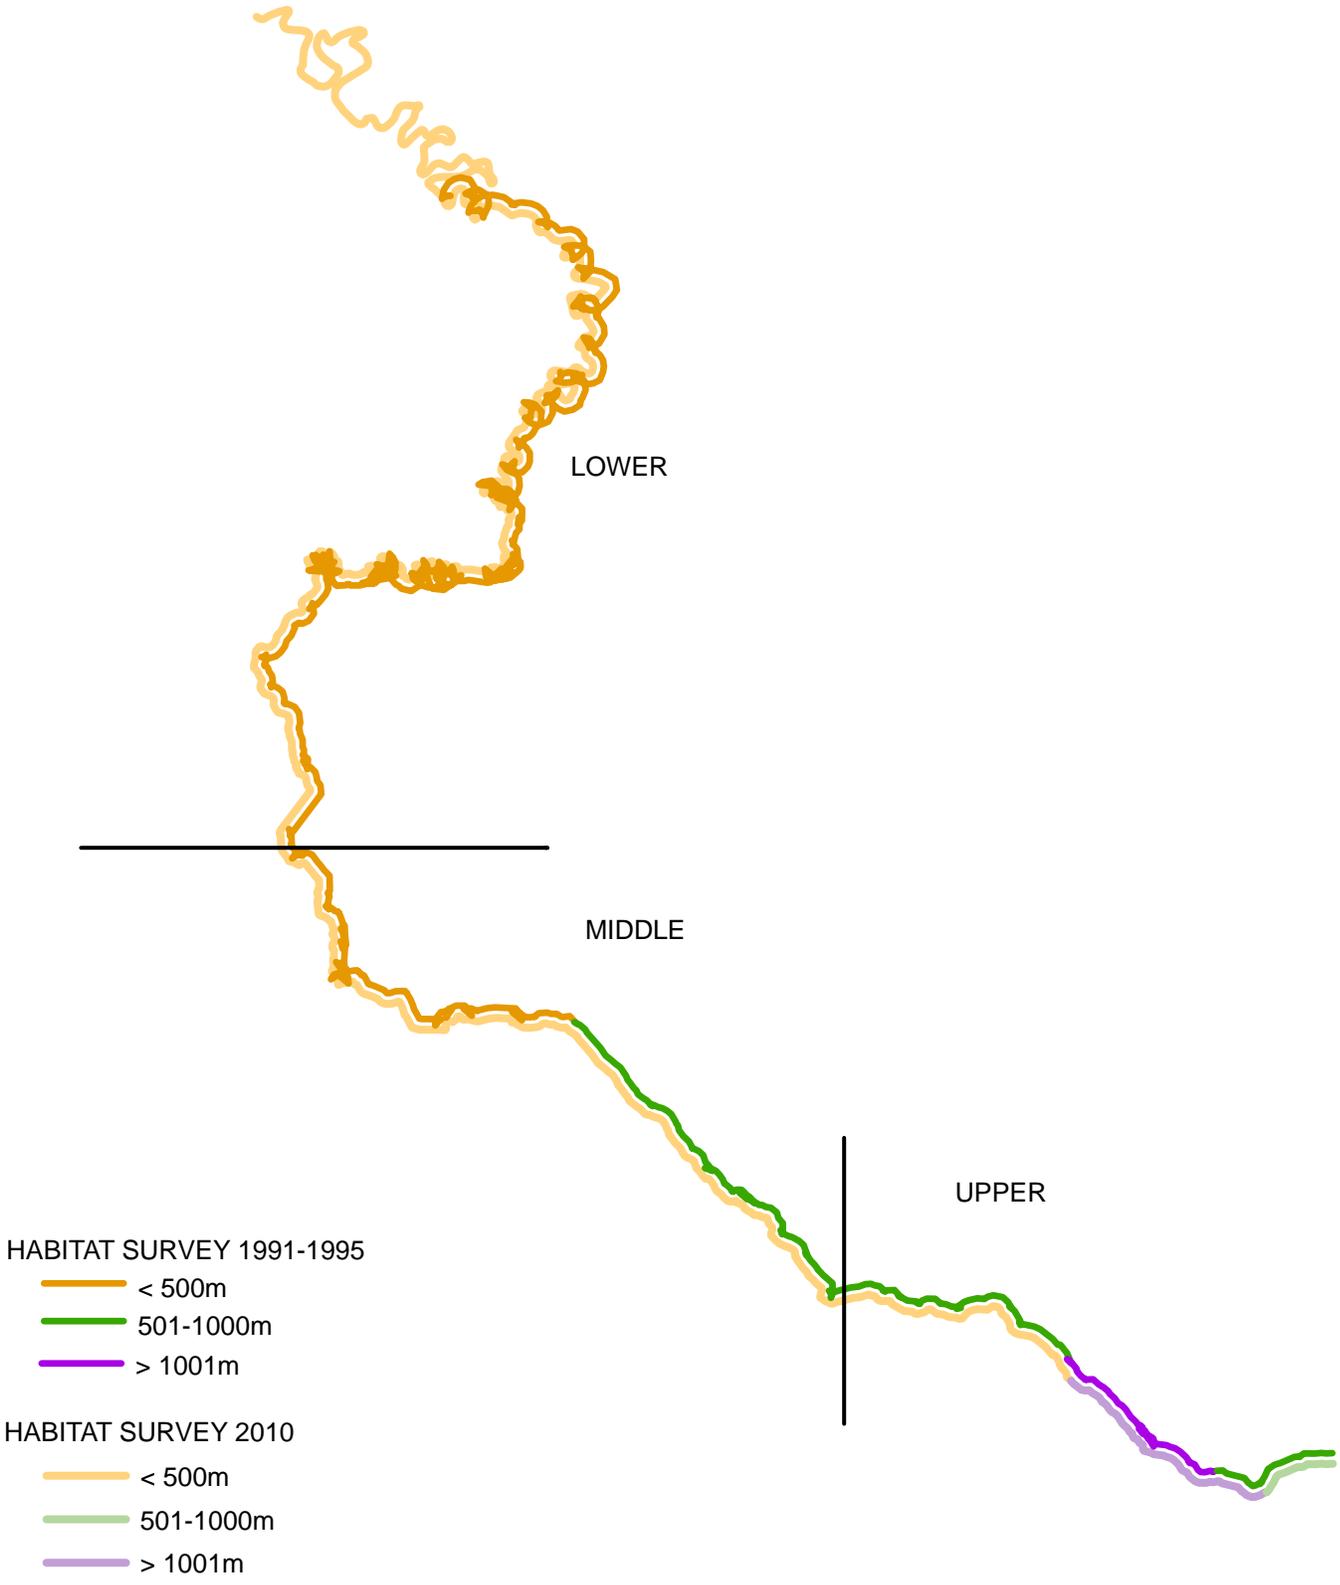
Figure 7. Catherine Creek divided into three sections for comparison of Percent Secondary Channel Length based on 1991-1995 and 2010 habitat survey data.

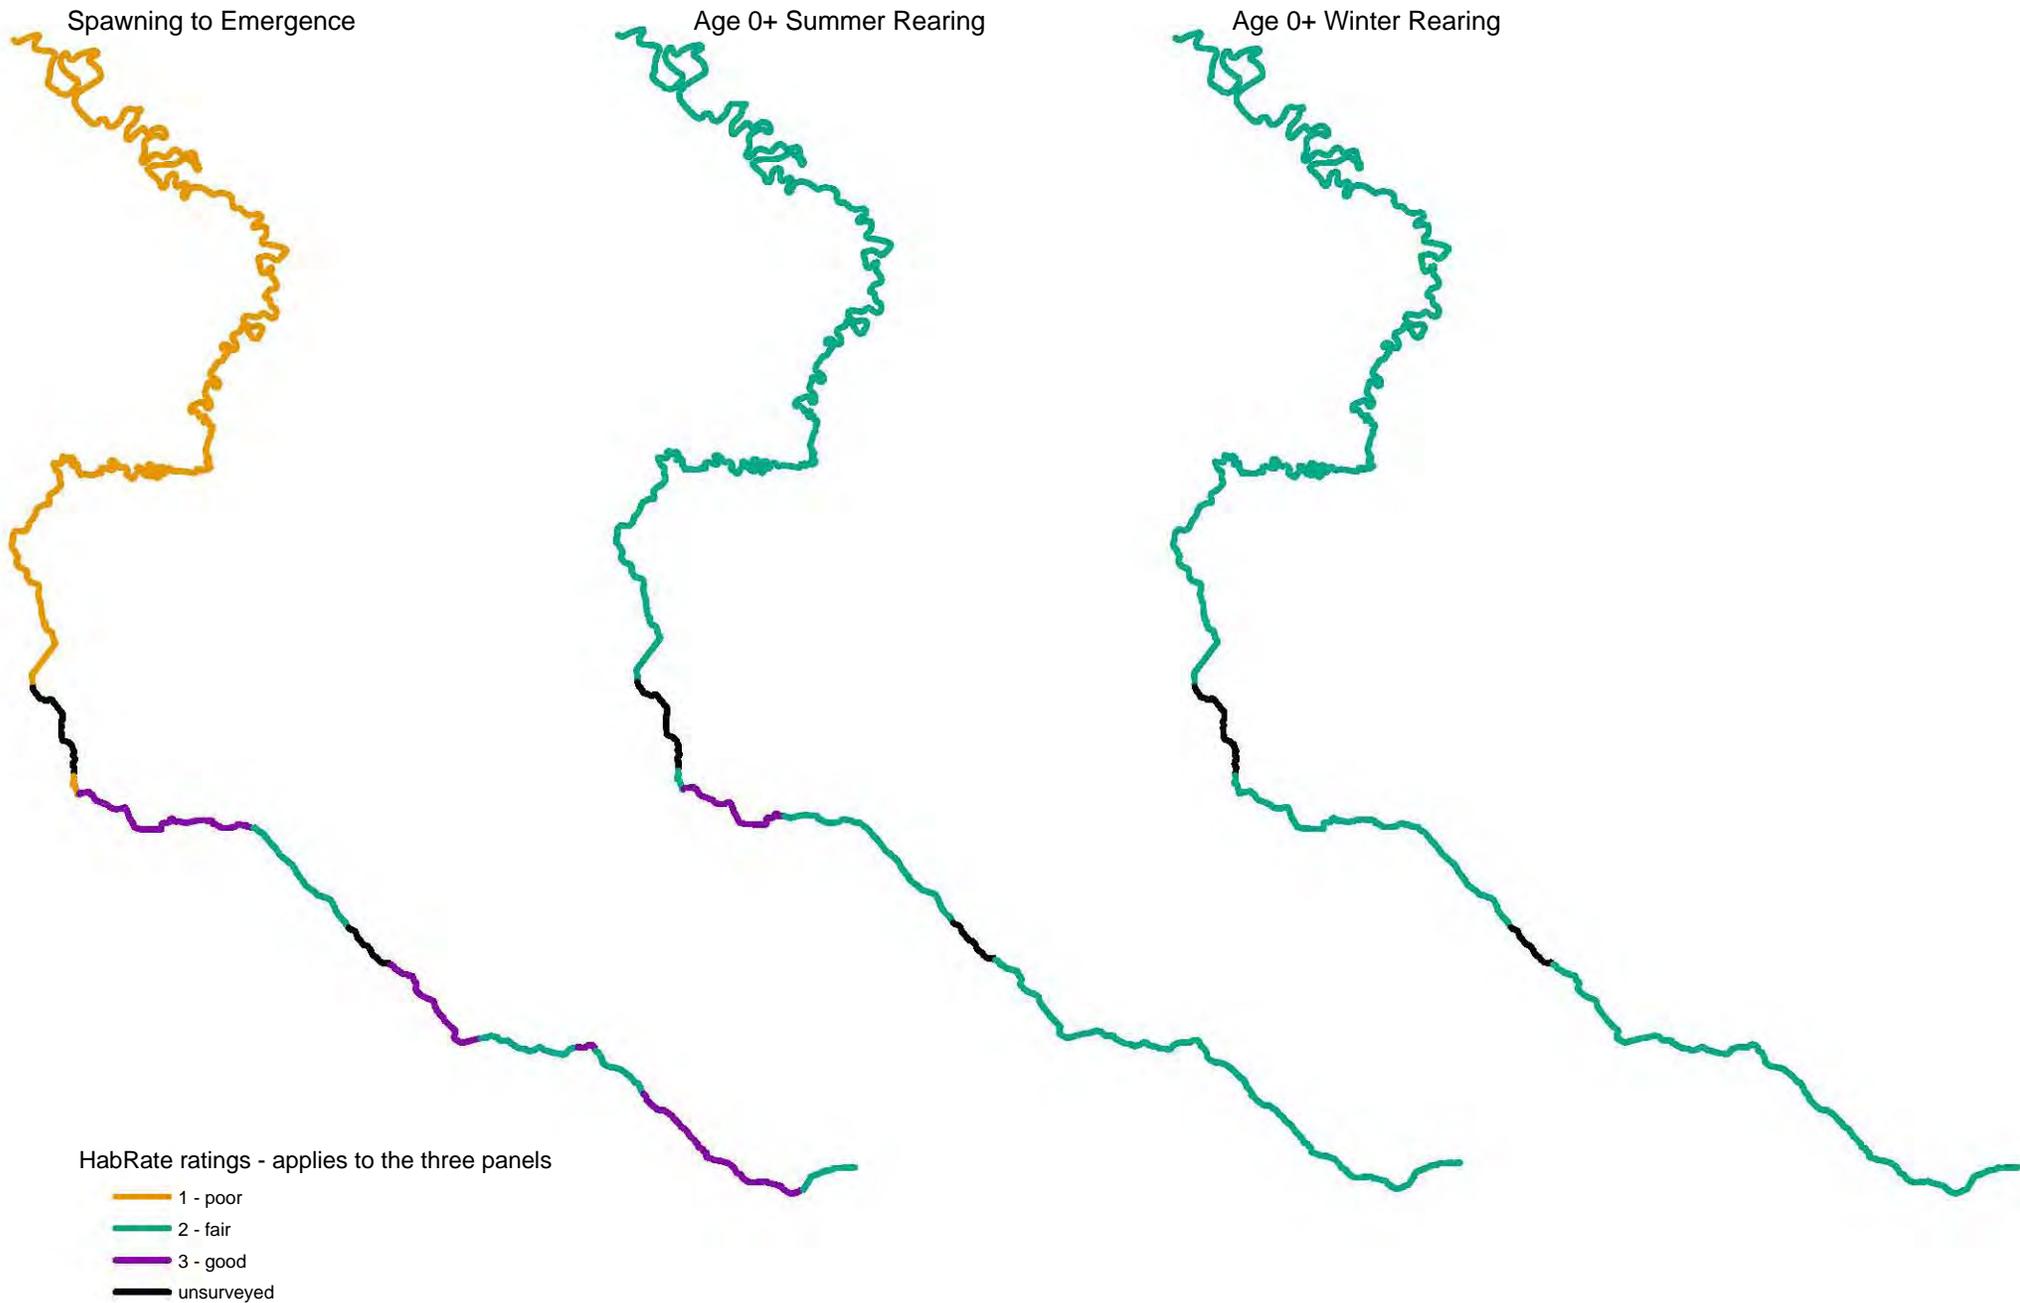
Figure 8. Catherine Creek 2010 habitat survey data applied to Chinook salmon HabRate life history ratings

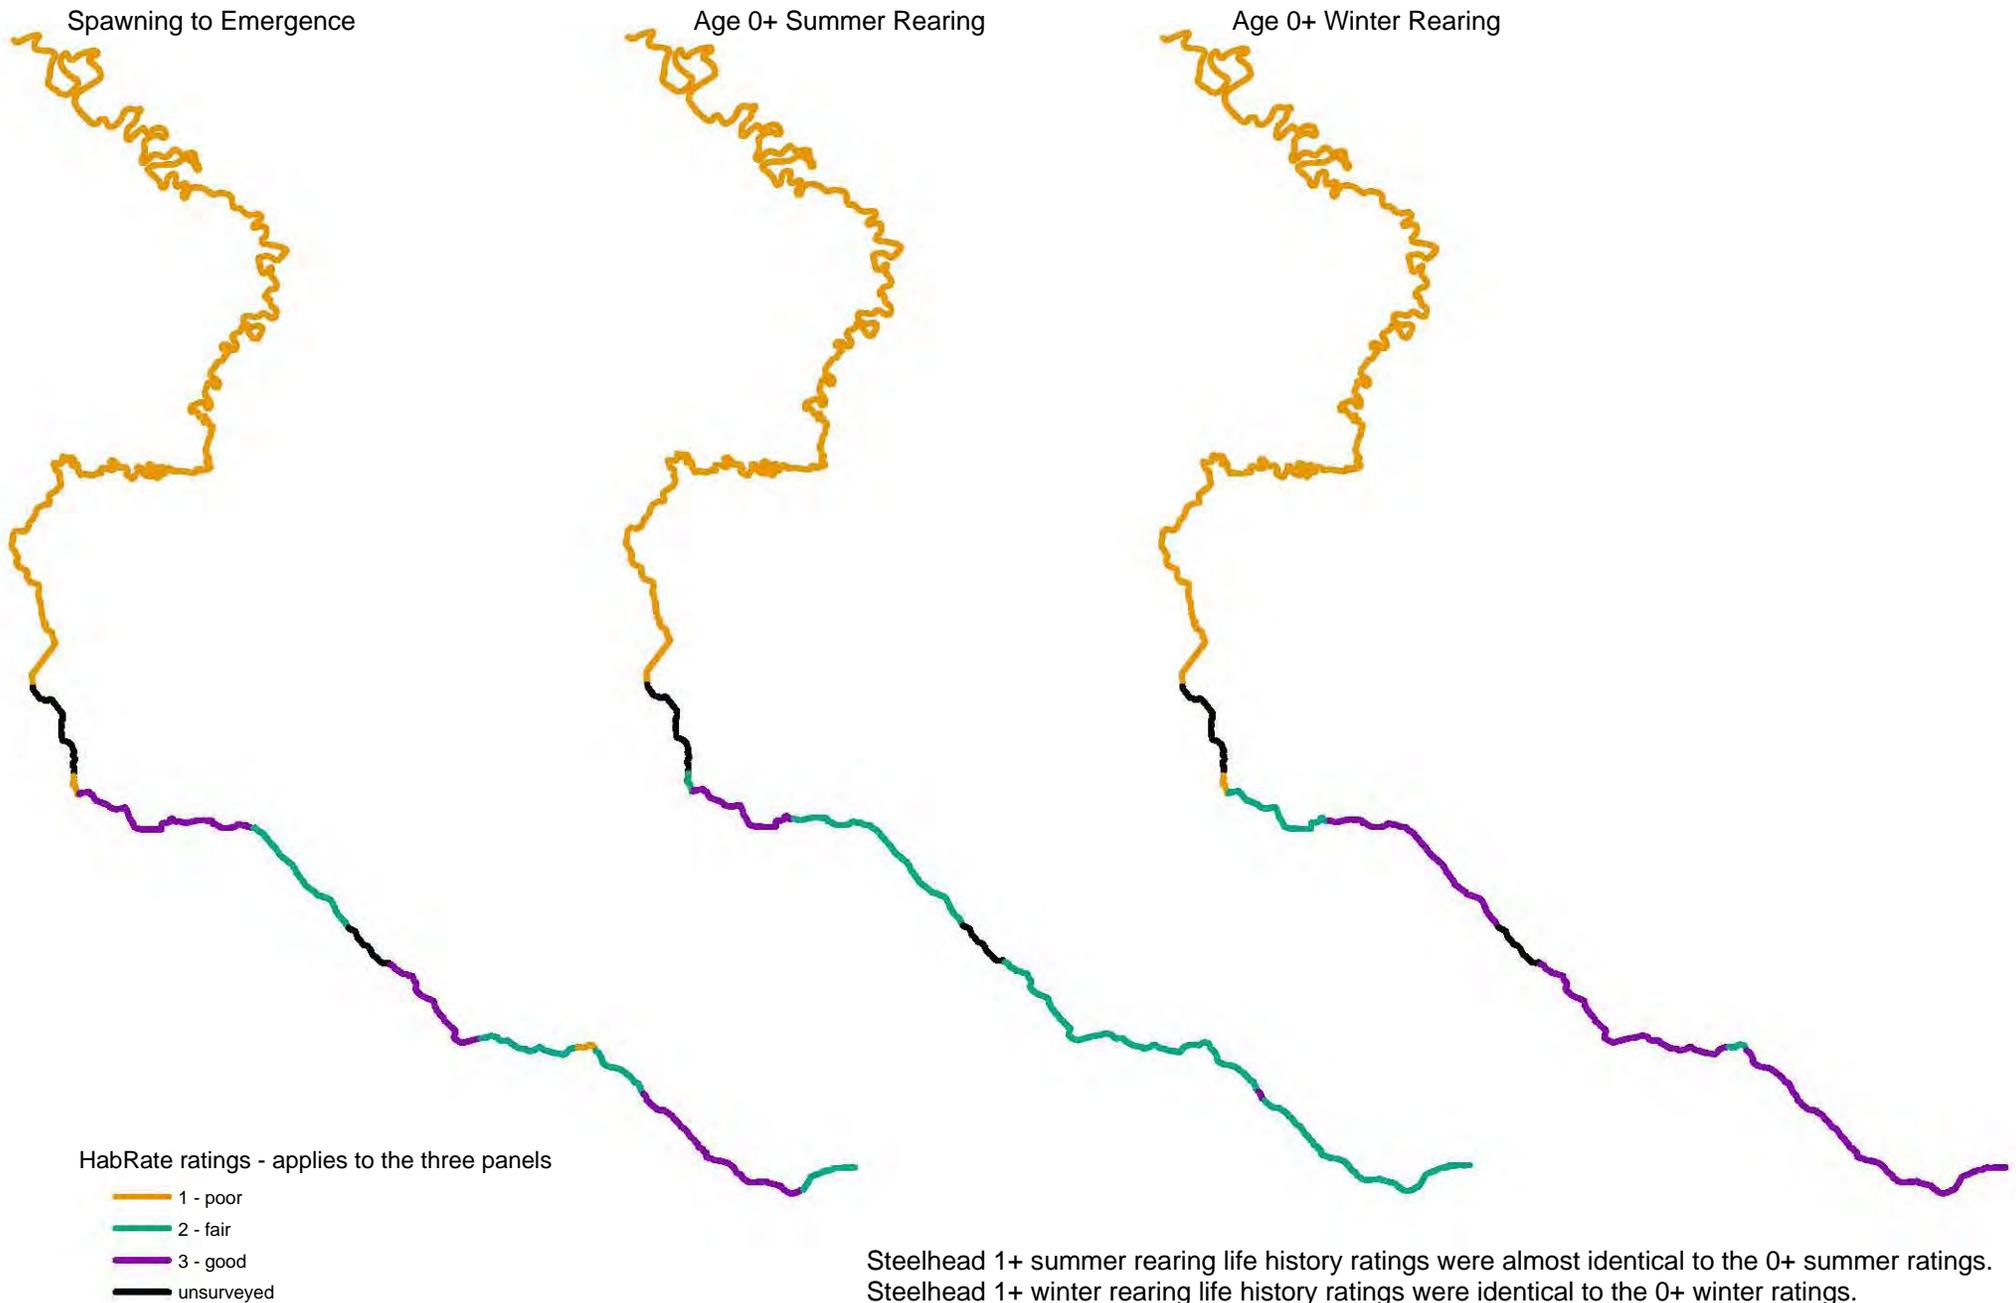
Figure 9. Catherine Creek 2010 habitat survey data applied to Steelhead trout HabRate life history ratings

Habitat quality for summer and winter rearing of age-0 and age-1 juvenile steelhead was poor in the lower section and fair in the middle and upper sections. Habitat was uniform with few pools and structurally-simple in the lower section. The middle and upper sections had few pools, although they had adequate depth and structure. The substrate complexity increase in the middle and upper sections, which provided better conditions for juvenile steelhead.

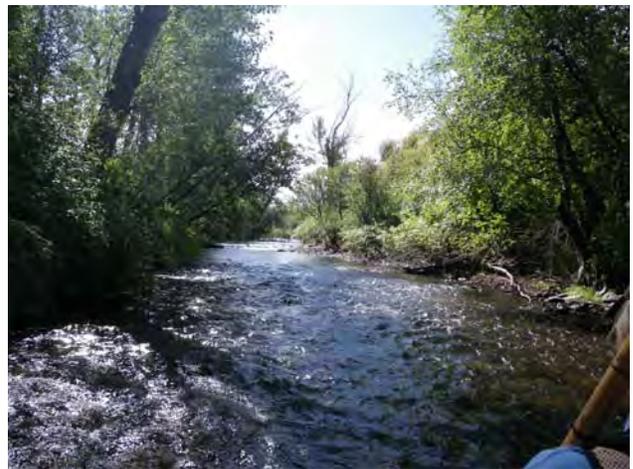
Catherine Creek- Reach 13 unit 559 – Culverts Diverting Water

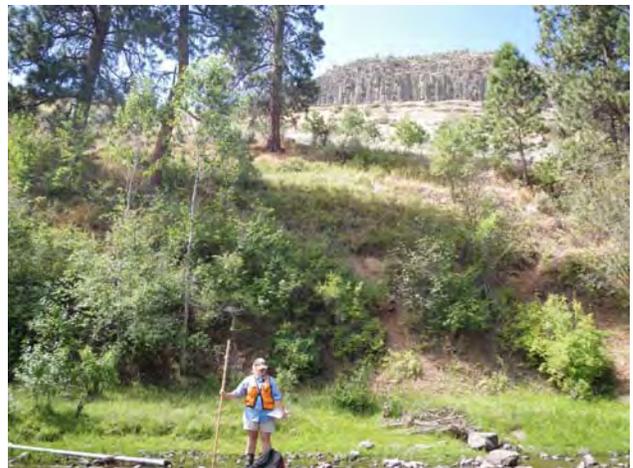
Catherine Creek- Reach 14 unit 624 – Umatilla Fish Trap Weir

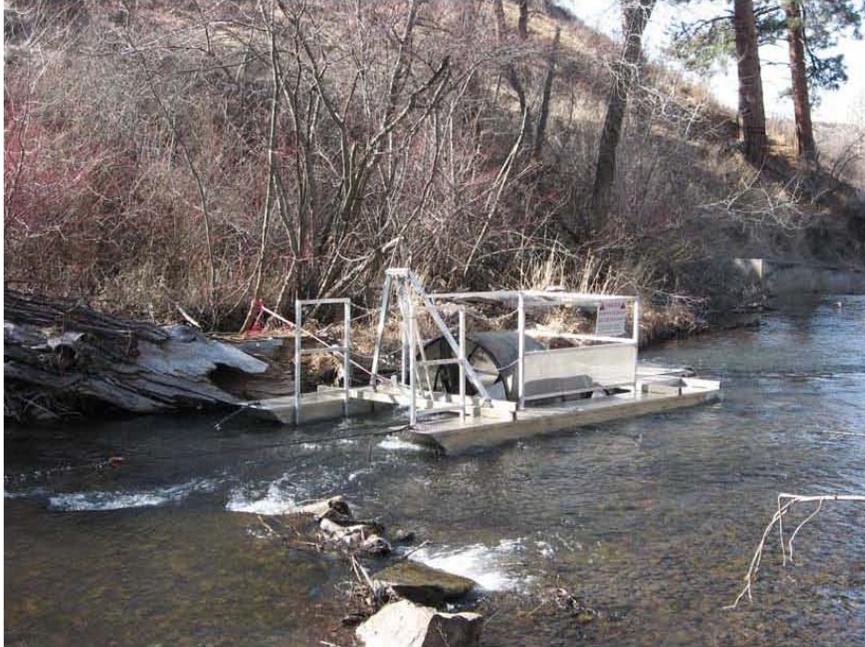
(a) Rotary screw trap used to sample early migrant juvenile Chinook salmon.

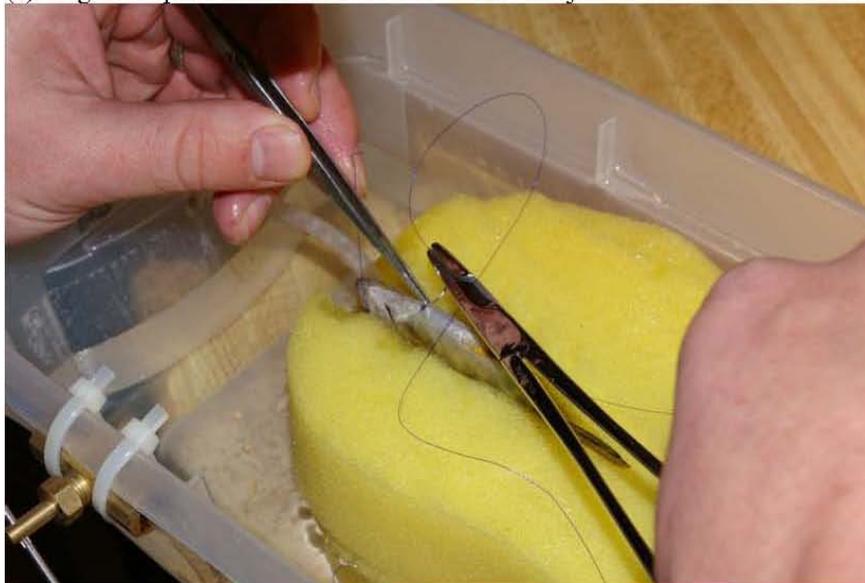
(b) Surgical implantation of a radio transmitter into a juvenile Chinook salmon.

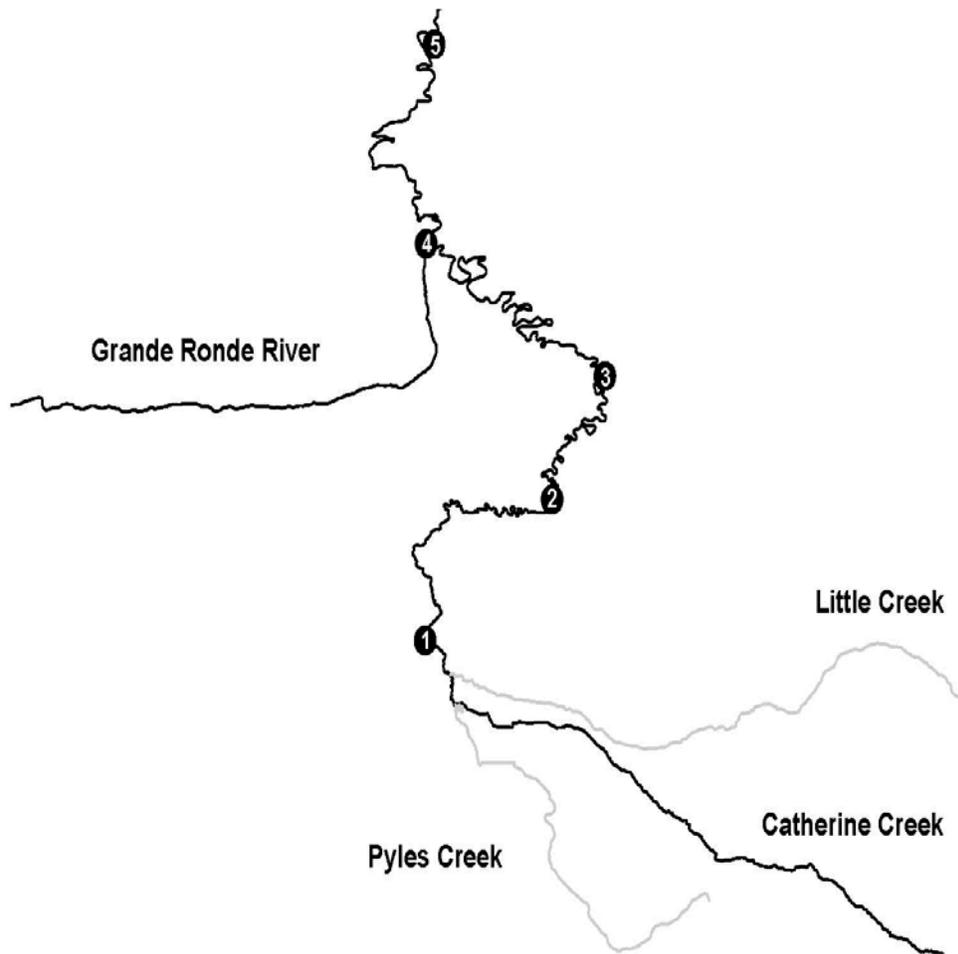
Figure 3.—Map of numbered stationary radio receiver locations installed to document downstream movement of Catherine Creek early migrant juvenile Chinook salmon overwintering in the Grand Ronde Valley. Numbered sites are in close proximity to (1) lower Davis Dam; (2) Gekler Lane; (3) Booth Lane; (4) Alice Lane and (5) Rhinehart Lane.

Stationary radio receivers (Lotek SRX-400 W7AS) were positioned throughout the Grande Ronde Valley to assist mobile tracking efforts (Figure 3). Four receivers were installed on lower Catherine Creek, while one receiver was installed on the Grande Ronde River downstream of the mouth of Catherine Creek. Specifically, stationary receivers were installed near lower Davis Dam, Gekeler Lane, Booth Lane, Alicel Lane and Rhinehart Lane. Stationary receivers were powered by a single 12-V battery that was replaced biweekly during site visits to download detection data.
