**APPENDIX G – ODFW FISH HABITAT IN THE  
CATHERINE CREEK GRANDE RONDE RIVER BASIN  
JANUARY 2011**

FISH HABITAT ASSESSMENT IN CATHERINE CREEK,  
GRANDE RONDE RIVER BASIN

January, 2011

Oregon Department of Fish and Wildlife  
Aquatic Inventories Project  
28655 Highway 34  
Corvallis, Oregon 97333

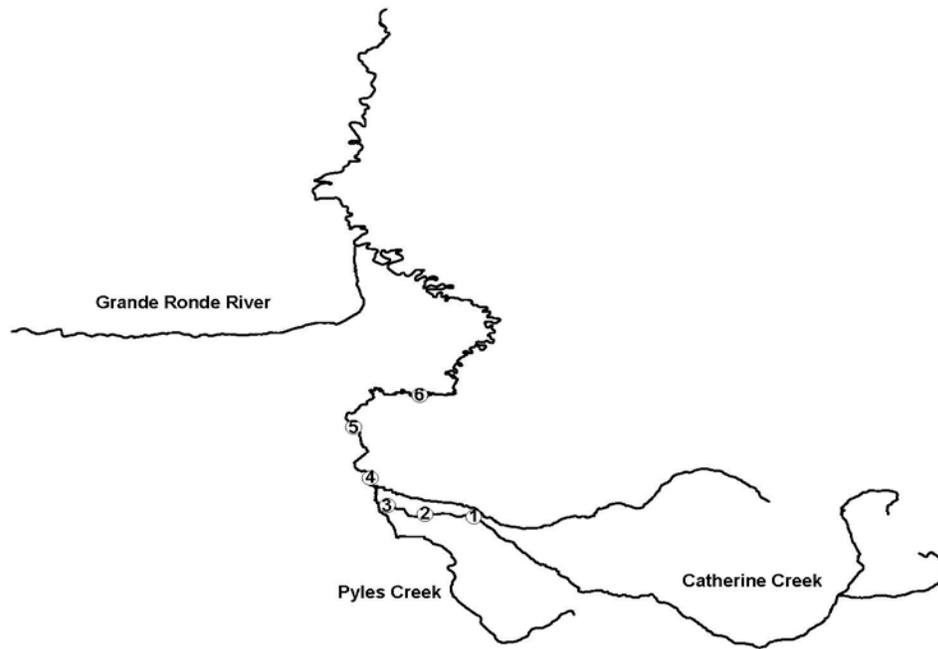
Figure 4.—Map of numbered stream reaches surveyed to quantify Catherine Creek early migrant juvenile Chinook salmon overwintering habitat availability. Numbered sites are in close proximity to (1) Union (Swackhammer fish ladder); (2) Union Recycling Center; (3) mouth of Pyles Creek; (4) HWY 203 Bridge; (5) Wilkinson Road and (6) Godley Lane.

Microhabitat availability data was obtained, within these sections, from reaches occupied by tagged fish during flow conditions synonymous to those associated with microhabitat use (Figure 4). Microhabitat variables measured at each transect point included depth (m), bottom velocity (m/s), mean column velocity (m/s), dominant substrate, subdominant substrate, cover type, distance to cover (m) and distance to bank (m). Morphological stream characteristics obtained during habitat availability surveys included bank angle ( $^{\circ}$ ), undercut bank distance (m), and 30-m riparian land use (%). Microhabitat availability data and morphological stream characteristics for Catherine Creek were collected during late-January and early-February 2010 (Table 3). Evenly spaced transects positioned two mean stream widths (2MSWs) apart were divided into evenly-spaced points from which microhabitat variables were measured (Simonson et al. 1994). A total of 57 transects were surveyed yielding 698 survey points, resulting in approximately 12 points per transect. A total of 1.3 km of the 29.9 km (~ 4.3%) regularly radio-tracked was included in these microhabitat availability surveys (Table 4).

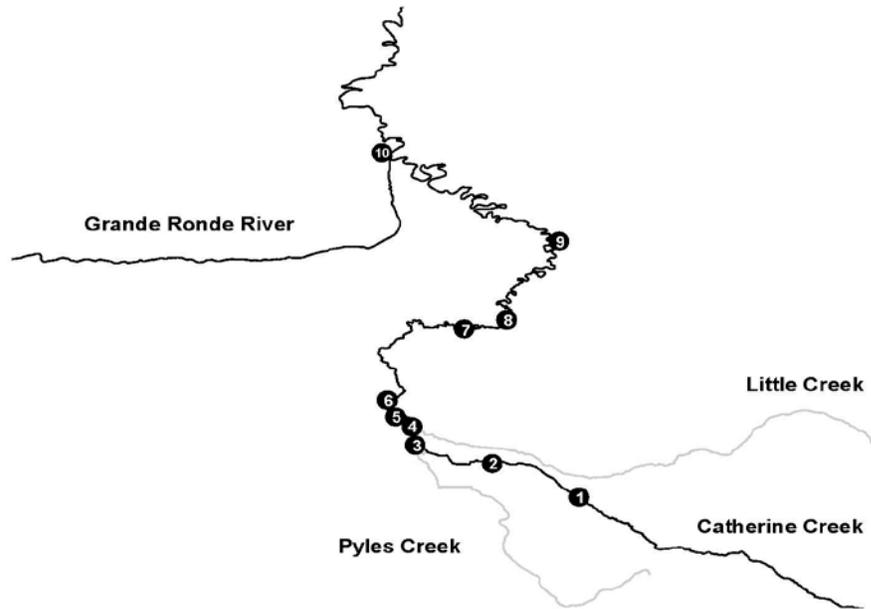
Figure 5.—Map of numbered temperature logger locations installed to document water temperatures associated with the fall migration and overwintering periods of Catherine Creek early migrant spring Chinook salmon. Numbered sites are in close proximity to (1) Catherine Creek screw trap; (2) 10<sup>th</sup> Street; (3) Miller Lane; (4) HWY 203; (5) lower Davis Dam (above); (6) lower Davis Dam (below); (7) Godley Lane; (8) Gekler Lane; (9) Booth Lane and (10) Alicel Lane.

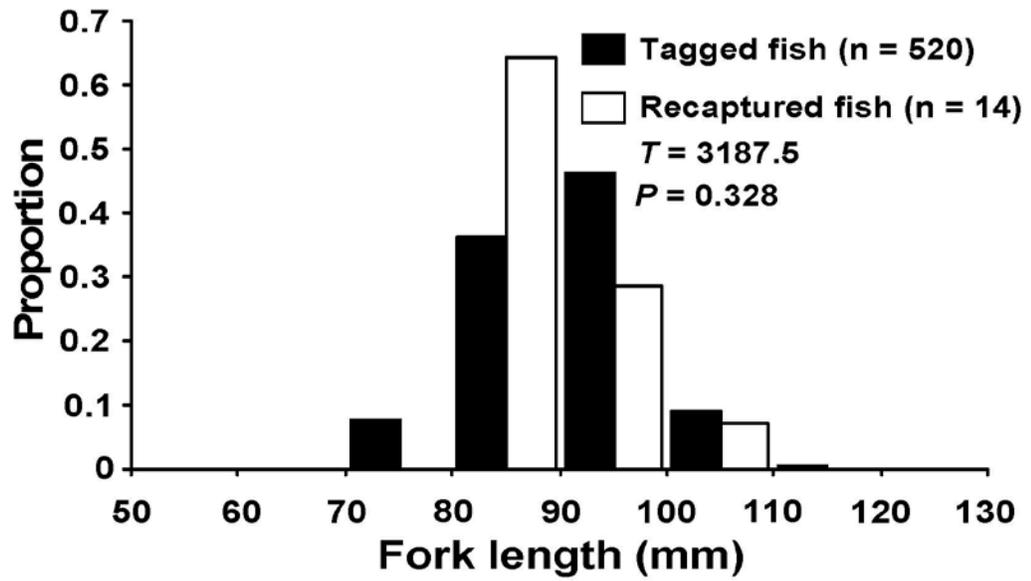
Figure 7.—Fork length comparison of PIT tagged Catherine Creek early migrant Chinook salmon sampled during the fall migration to recaptured PIT tagged fish from overwintering habitat. Recaptured PIT tagged fish were sampled from portions of Catherine Creek occupied by radio-tagged fish. Lengths were compared using the Mann-Whitney rank sum test.

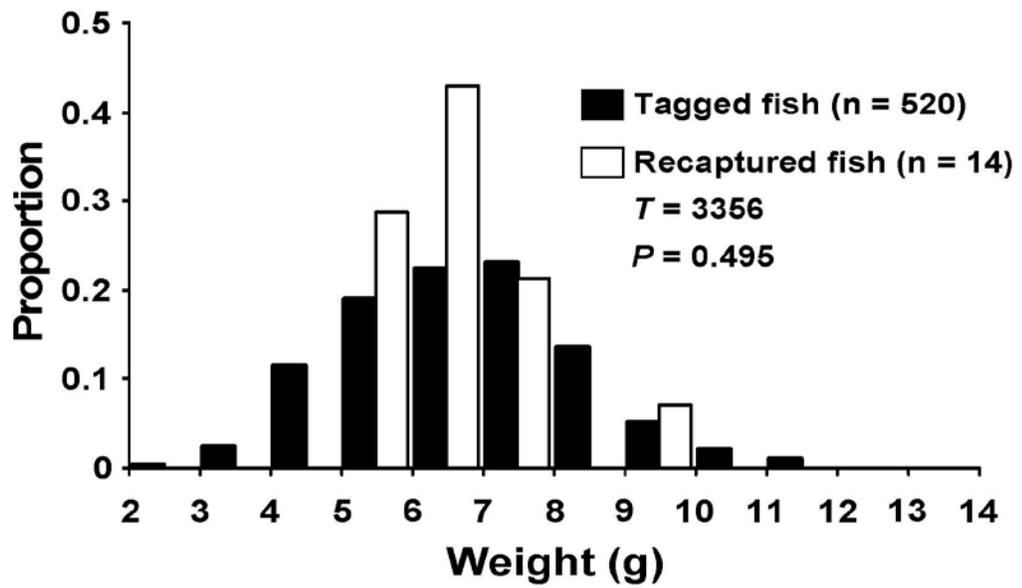
Figure 8.—Weight comparison of PIT tagged Catherine Creek early migrant Chinook salmon sampled during the fall migration to recaptured PIT tagged fish from overwintering habitat. Recaptured PIT tagged fish were sampled from portions of Catherine Creek occupied by radio-tagged fish. Weights were compared using the Mann-Whitney rank sum test.

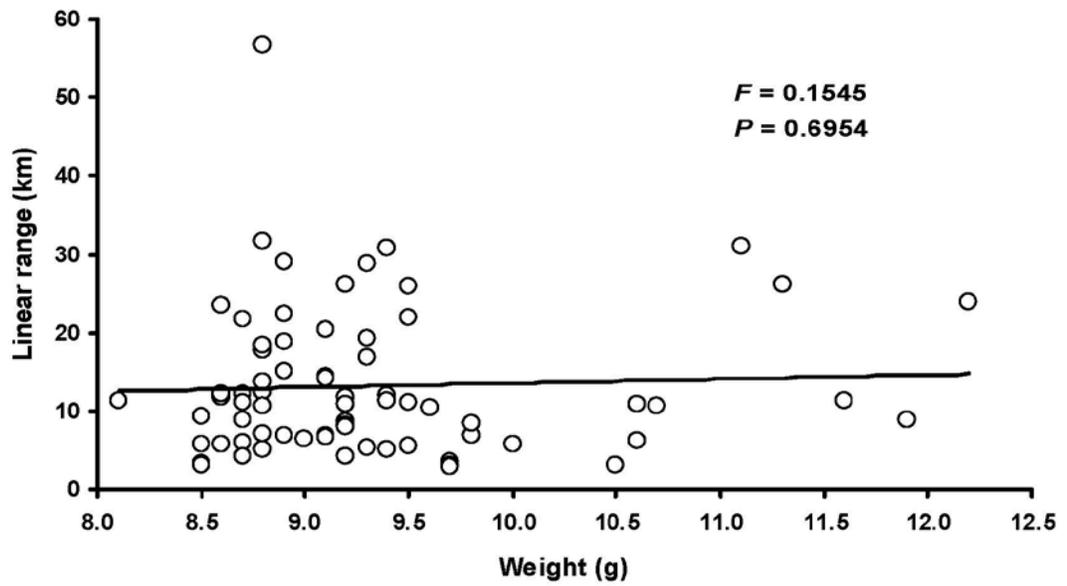
Figure 9.—Linear regression of weight and total linear range of radio-tagged early migrant juvenile spring Chinook salmon from Catherine Creek.

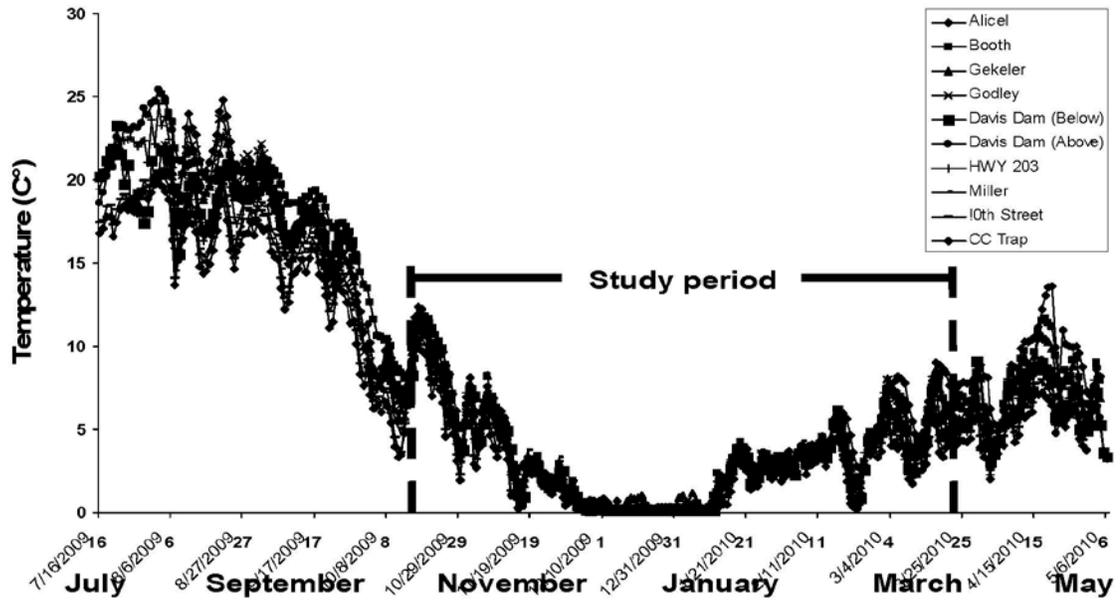
Figure 10.—Continuous water temperature data from lower Catherine Creek. The study period is designated by dashed lines and spans from late-October to late-March.

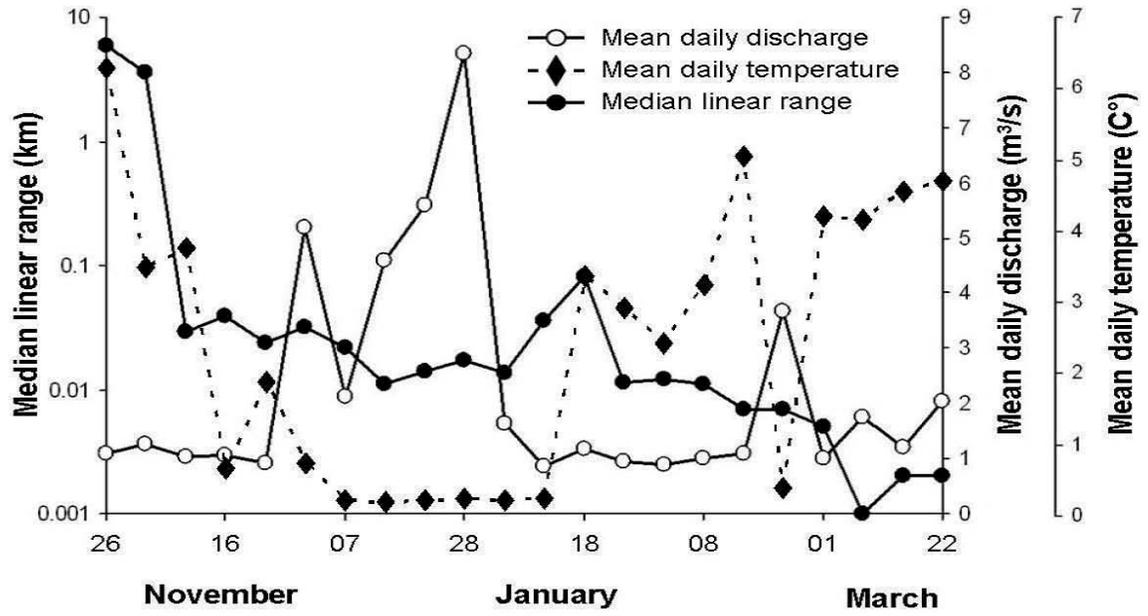
Figure 11.—Catherine Creek early migrant spring Chinook salmon median linear range per week during the fall migration and overwintering periods. Associated environmental variables discharge and water temperature are provided for comparison.

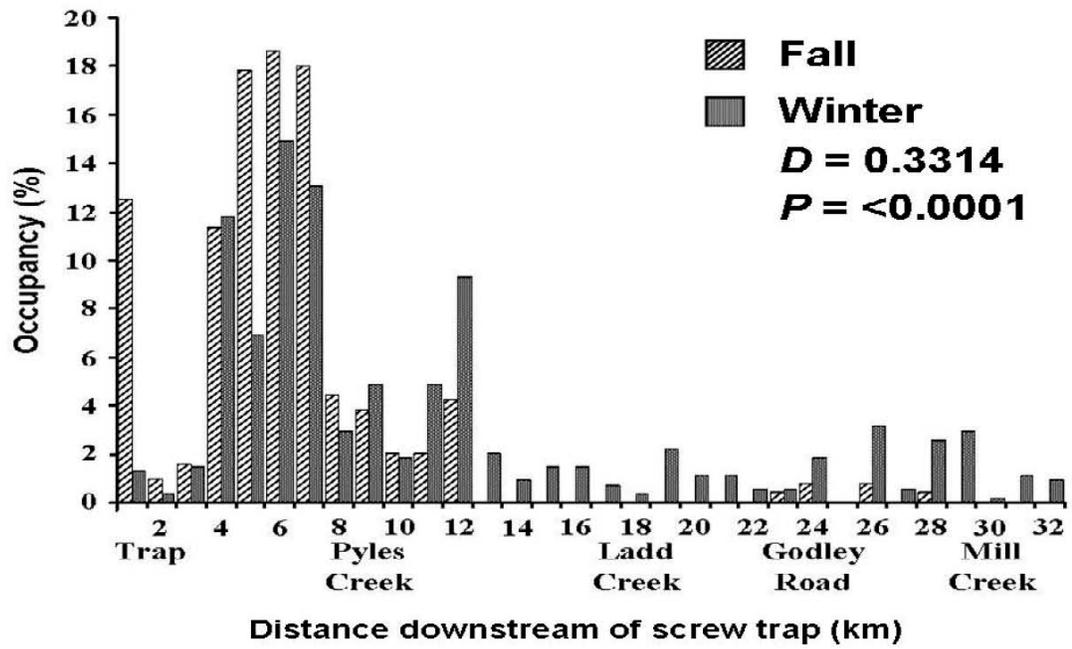
Figure 12.—Fall and winter occupancy by Catherine Creek early migrant spring Chinook salmon. Generated numbered reaches initialize at the Catherine Creek rotary screw trap and end at the confluence of the historic Grande Ronde River and Catherine Creek. Fall and winter relocations were compared using the Kolmogorov-Smirnov two-sample test.

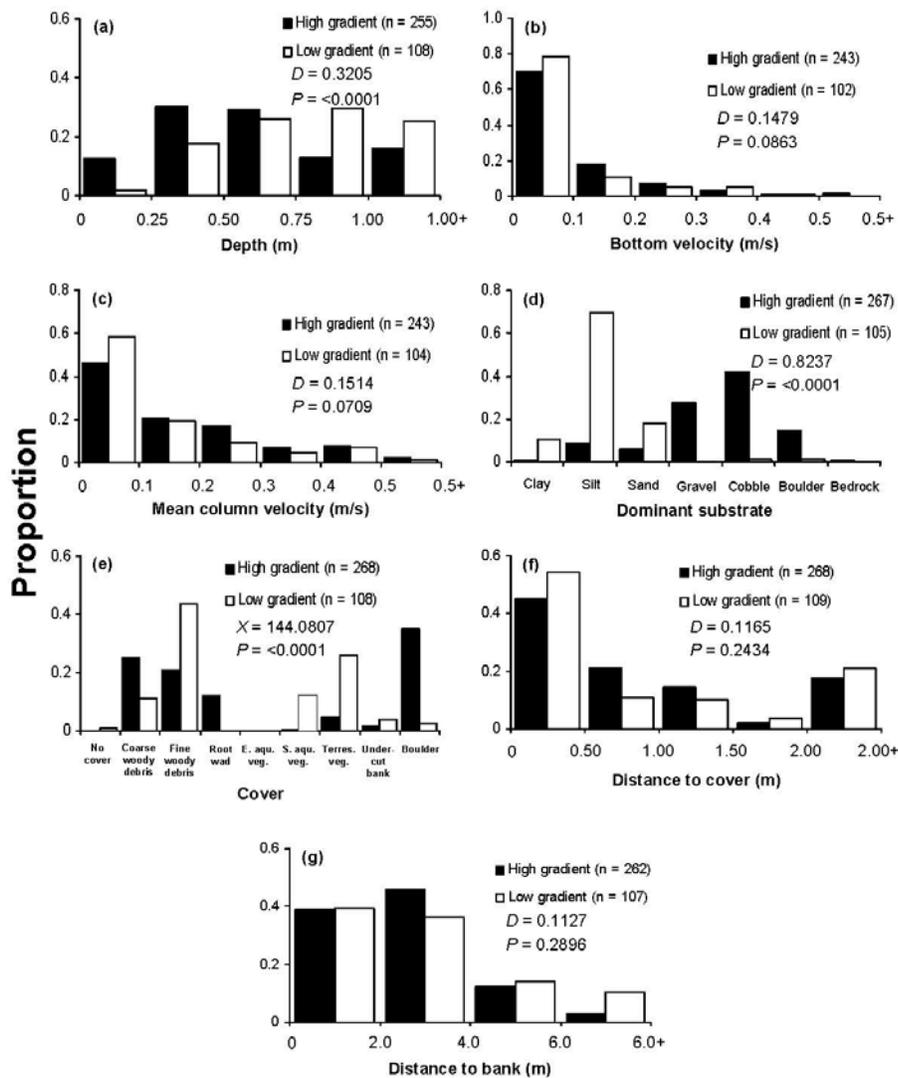
Figure 13.—Catherine Creek spring Chinook salmon high and low gradient microhabitat use variables depth (a), bottom velocity (b), mean column velocity (c), dominant substrate (d), cover (e), distance to cover (f), and distance to bank (g) and associated statistics. Continuous variables were compared using a Kolmogorov-Smirnov two-sample test; categorical variables were compared using a likelihood-ratio chi-square test.

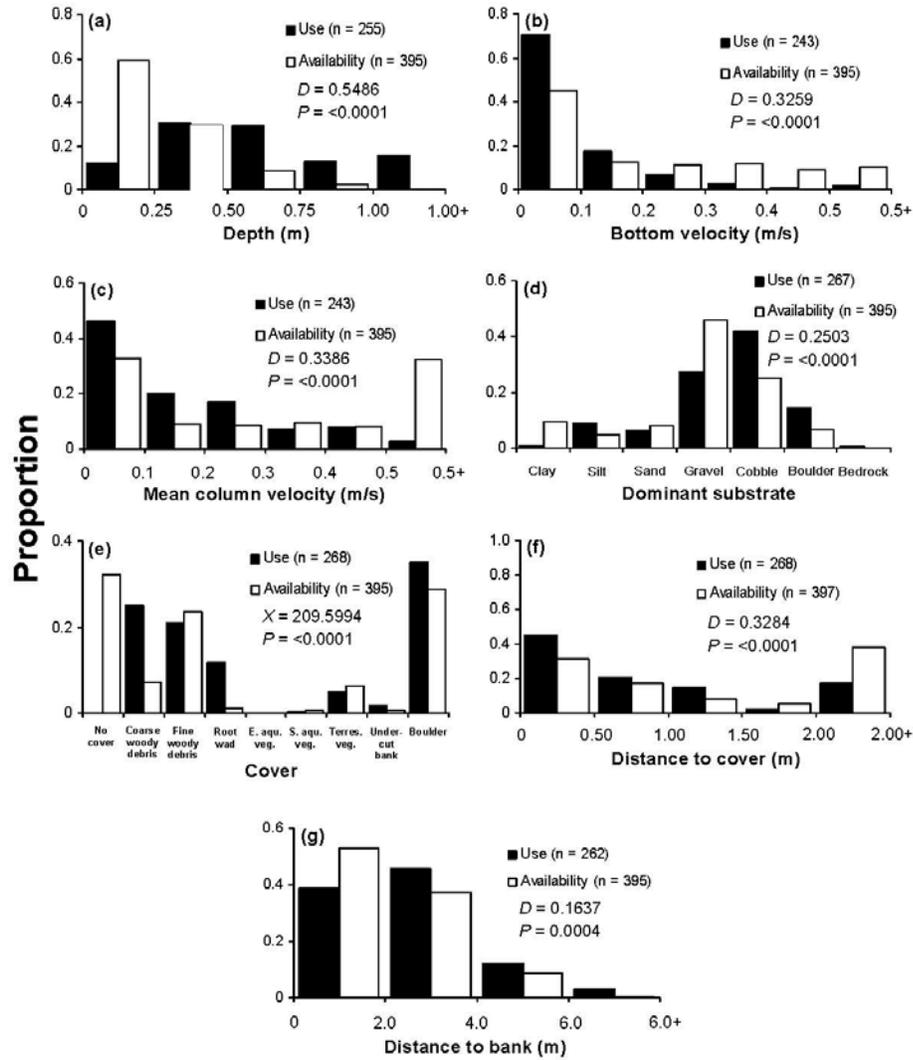
Figure 14.—Catherine Creek spring Chinook salmon high gradient microhabitat use and availability frequency distributions and associated statistics for variables depth (a), bottom velocity (b), mean column velocity (c), dominant substrate (d), cover (e), distance to cover (f) and distance to bank (g). Continuous variables were compared using a Kolmogorov-Smirnov two-sample test; categorical variables were compared using a likelihood-ratio chi-square test.

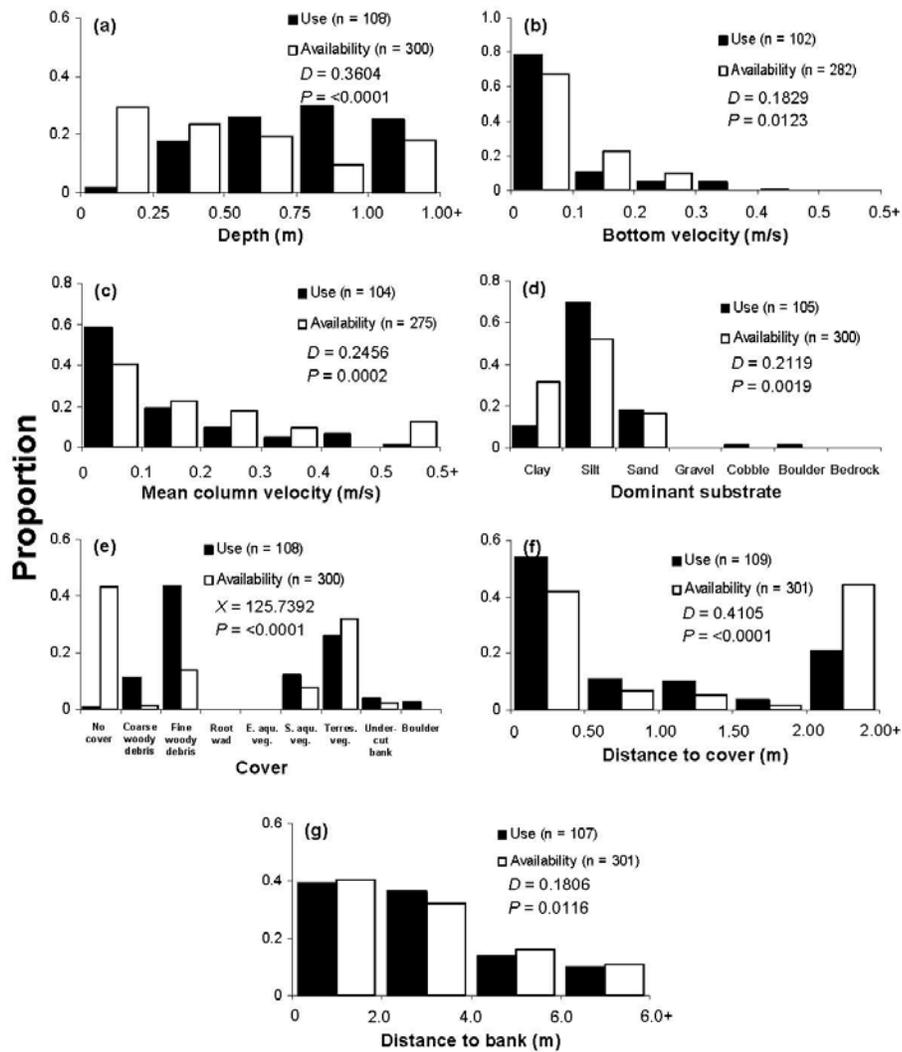
Figure 15.—Catherine Creek spring Chinook salmon low gradient microhabitat use and availability frequency distributions and associated statistics for variables depth (a), bottom velocity (b), mean column velocity (c), dominant substrate (d), cover (e), distance to cover (f) and distance to bank (g). Continuous variables were compared using a Kolmogorov-Smirnov two-sample test; categorical variables were compared using a likelihood-ratio chi-square test.

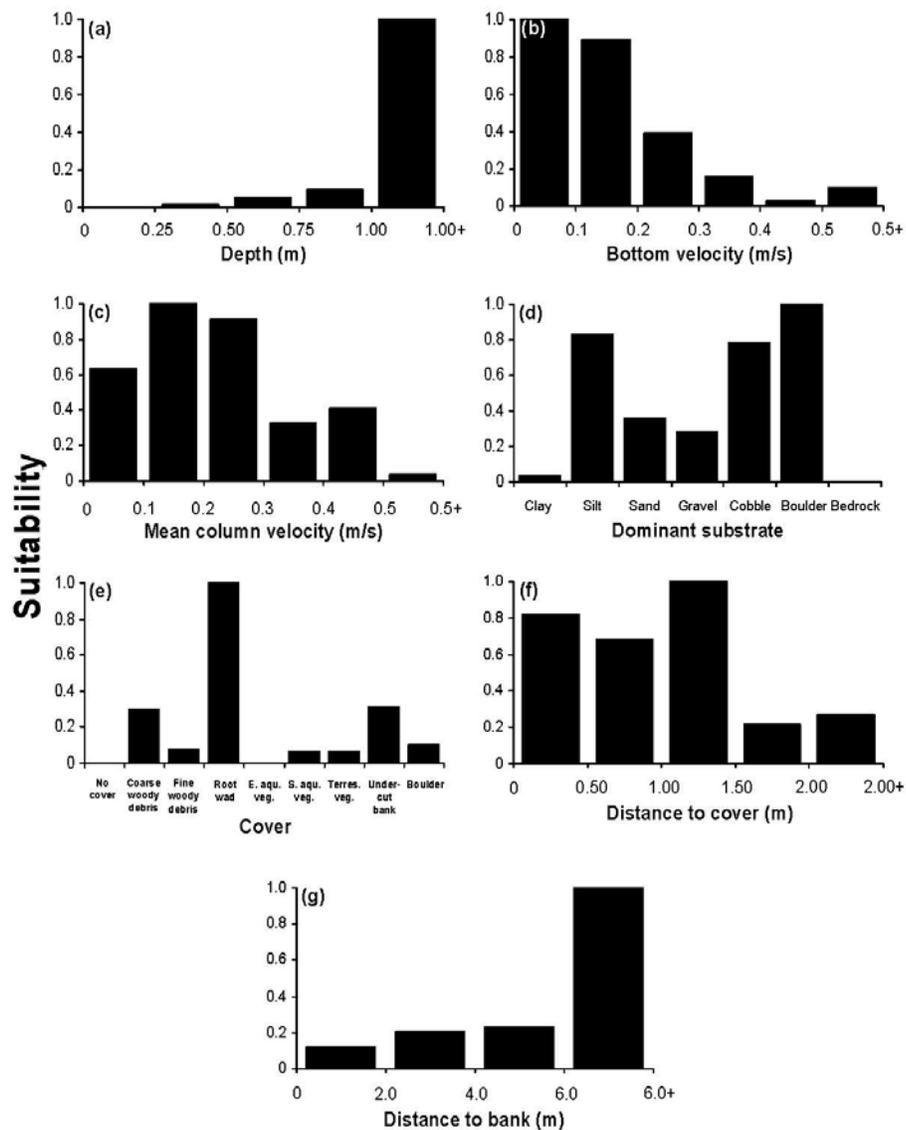
Figure 16.—Catherine Creek spring Chinook salmon high gradient microhabitat suitability indexes for variables depth (a), bottom velocity (b), mean column velocity (c), dominant substrate (d), cover (e), distance to cover (f) and distance to bank (g).

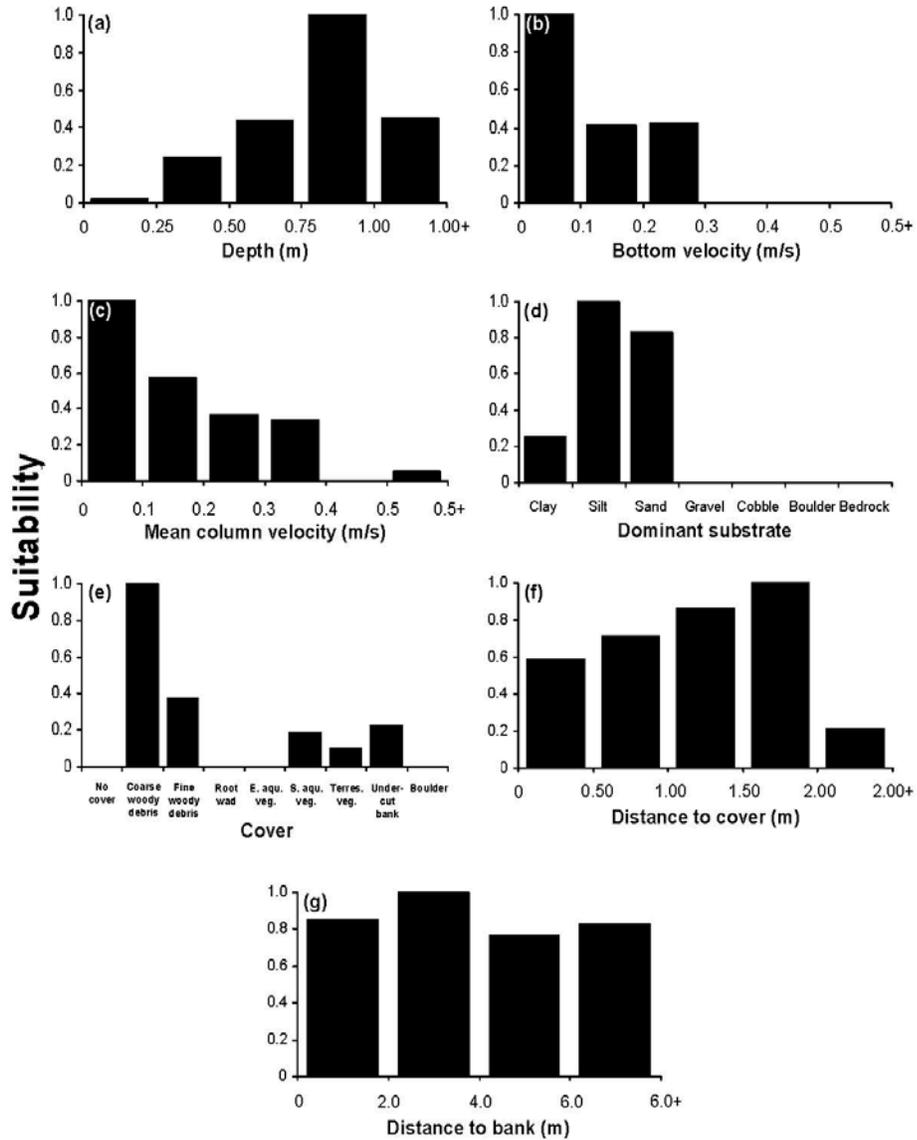
Figure 17.—Catherine Creek spring Chinook salmon low gradient microhabitat suitability indexes for variables depth (a), bottom velocity (b), mean column velocity (c), dominant substrate (d), cover (e), distance to cover (f) and distance to bank (g).

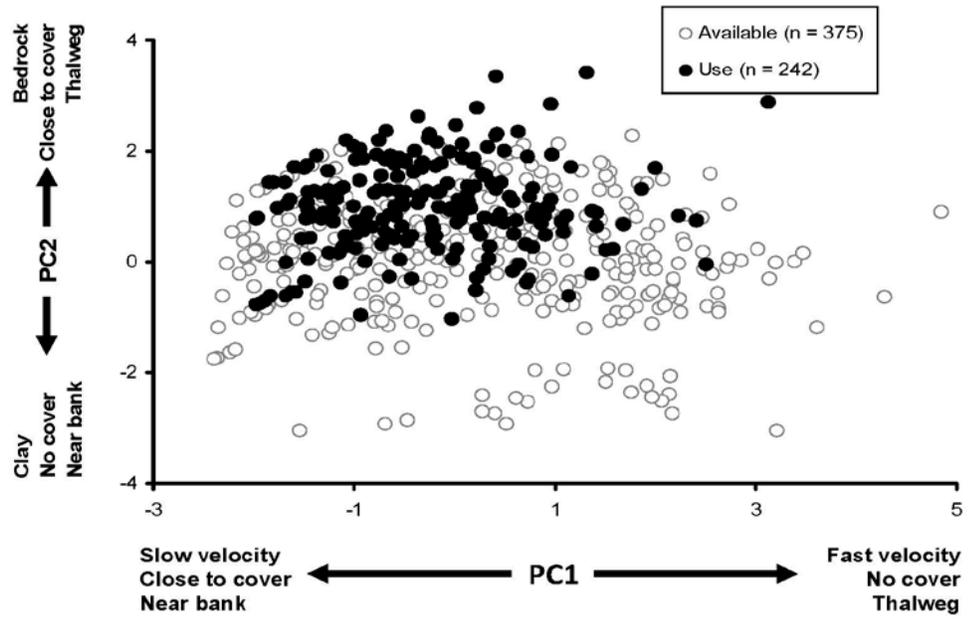
Figure 18.—Plot of juvenile early migrant spring Chinook salmon principal component scores for high gradient microhabitat use and availability, describing microhabitat variable combinations for principal components 1 and 2 that are most important in defining fall migration and overwintering macrohabitat.

Principal component analysis (PCA) was conducted on all continuous microhabitat variables (depth, bottom velocity, mean column velocity, dominant substrate, distance to cover, and distance to bank) to determine selected fall and winter macrohabitat. PCA allows the collective interaction among multiple microhabitat variables to be investigated and ranked by importance by creating sequential uncorrelated linear combinations (i.e., principle components) that maximize variation explanation. Components with eigenvalues greater than 1.0 were retained as recommended by Kaiser (1960), Stevens (1996), and Kwak and Peterson (2007). Habitat availability scoring coefficients were subsequently used to calculate microhabitat use principle component scores. A K-S test was conducted on retained principal component scores to investigate for statistically significant differences between microhabitat use and availability for both fall and winter.

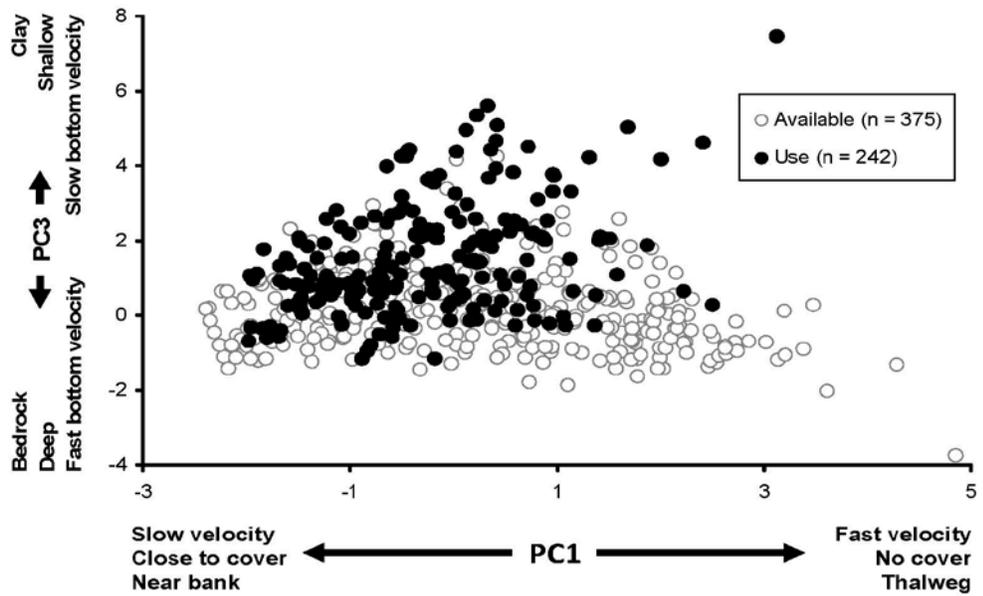
Figure 19.—Plot of juvenile early migrant spring Chinook salmon principal component scores for high gradient microhabitat use and availability, describing microhabitat variable combinations for principal components 1 and 3 that are most important in defining fall migration and overwintering macrohabitat.

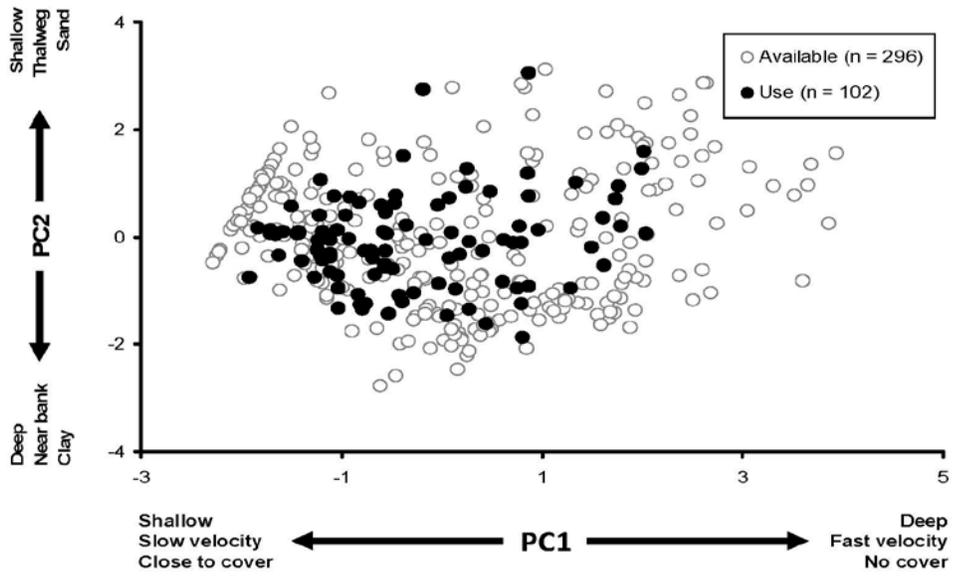
Figure 20.—Plot of juvenile early migrant spring Chinook salmon principal component scores for low gradient microhabitat use and availability, describing microhabitat variable combinations for principal components 1 and 2 that are most important in defining fall migration and overwintering macrohabitat.
