CUMMINGS CREEK (RM 2-4, 2008 & 2009):

RUSSEL SPRINGS CREEK (2 phases; RM 0-0.3 in 2009 and RM 0.3-0.7 in 2010): The project was a cooperative project between CTUIR and WDFW and located on state lands in Columbia County (Figure 20). Project Cooperators and financial contribution: CTUIR \$50,000, WDFW \$25,000. BPA funded the project under the Columbia Basin Fish Accords agreement. GPS points: 46.34366 and 117.67989

Tucannon Watershed Restoration
Spring Creek In-stream and Riparian Restoration 2010
 Hopkins Ridge Quadrangle

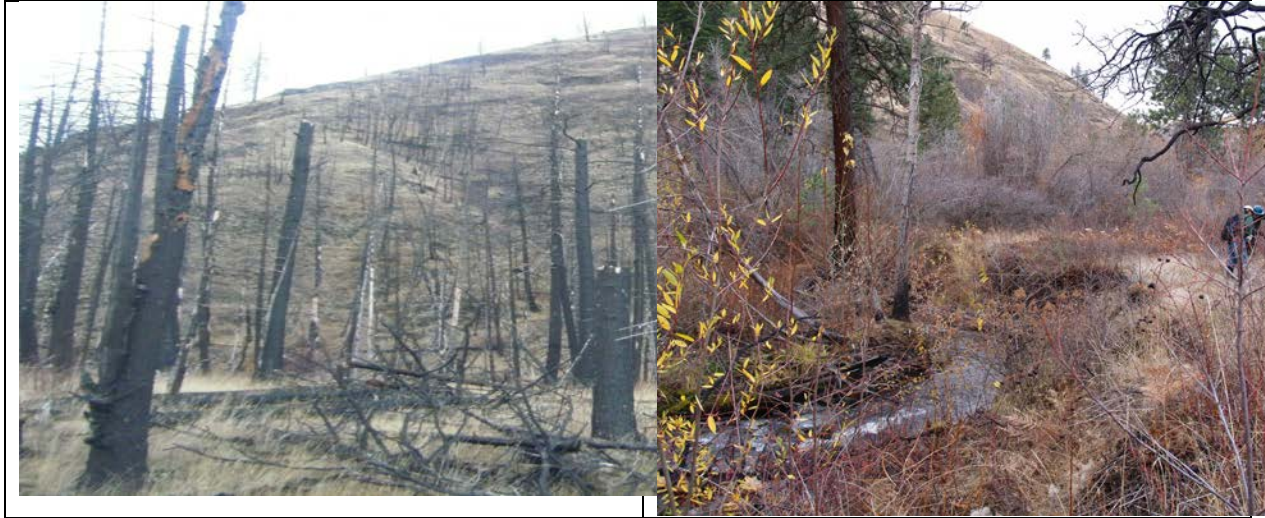
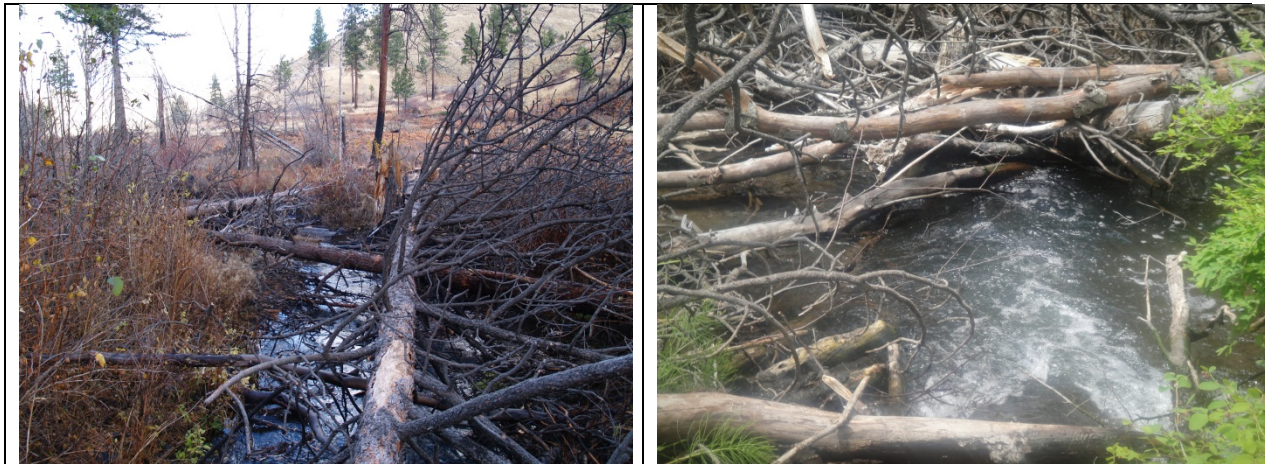
Figure 19. Pre and post restoration status of Cummings Creek

Project Cooperators and financial contribution: USFS \$5,000, WDFW \$1,500, CTUIR \$1000
Dozens of mature conifers killed by wildfire were felled into Cummings Creek, one of the most productive steelhead producing tributaries in the Tucannon Basin. Figure 19 illustrates Pre and post restoration status of Cummings Creek.

Objectives were to restore aquatic habitat complexity and in stream woody debris lost due to the School Canyon Fire, rebuild simplified channel characteristics which had become entrenched and simplified, comprised of barren features. Restore proper riverine function, channel complexity and efficiency. Attention was paid in regard to potential wildlife value of dead timber upon making decisions for selecting trees for treatment. Substrate was comprised of the following 78% were gravel, 18% cobble, 3% sand, 1% boulder. Elevation ranged from 2200 to 2900 feet. Gradient for the treatment area was approximately 2.8%. Sinuosity was estimated at 1.1. Bank full width was estimated at 4.5m and flood prone width was 14m. Increased # LWD in creek channel from 23 to 81 by adding 57 large coniferous trees resulting in the following improvements: habitat complexity ratings jumped from 1.4 to 3.1, mean DBH increased from .19 to .52m, stem length improved from 7.9 to 14.2m.

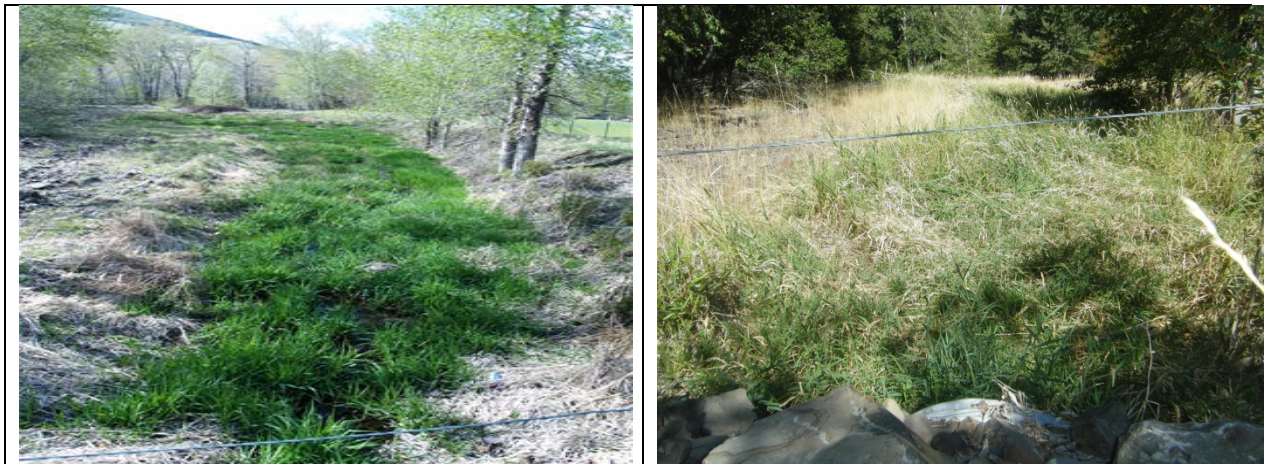
Figure 21. Pre and post restoration results

Spring Creek habitat was restored very effectively. Specific results of the restoration effort were; the addition of 100 logs and 200 boulders to wetted channel, planted 1000 saplings, 100 sedges, fixed 1 passage barrier, removed Reed Canary Grass, reduced erosion, re-connected and re-watered 212m previously dry channel. Improved; habitat complexity 163%, wetted channel depth 200%, undercut 17%, width:depth ration 36%, channel shade 18%, wood complexity rating 54%, steelhead redds from 0 to 9 annually. Pre project flows were estimated around 1 CFS, post project flows were estimated near 7 CFS after removing Reed Canary Grass and channel blockage. Results of the project are; improvements to fish passage at the culvert and through the migration corridor due to channel manipulation, increased habitat complexity in the channel due to an increase in the overall pool and pocket water, as well as increased quantities of boulders, woody debris and wood ratings in relation to fish habitat, increased spawning areas created by the incorporation of gravel substrate into strategic areas of the spring (Figure 21).

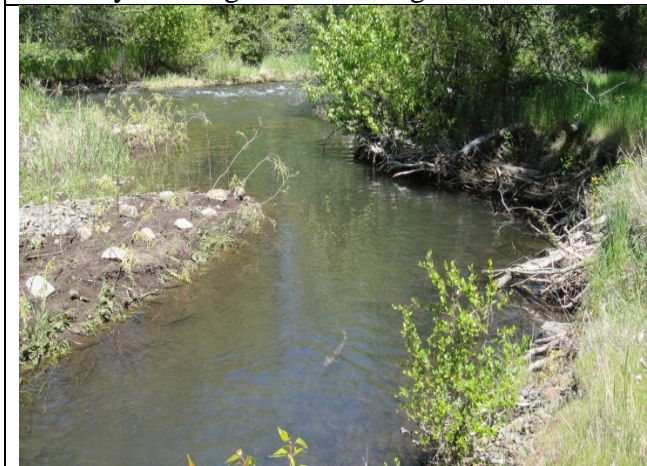
Actively Eroding Bank and High Terrace

ELJ Constructed to protect bank from eroding

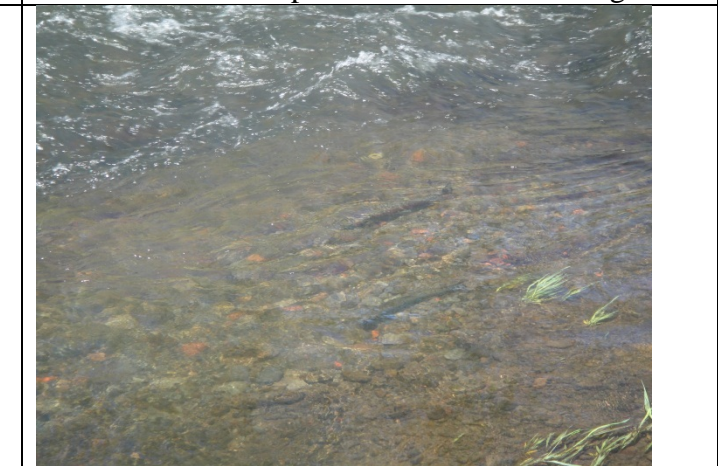
Creation of contrasting attraction water

2 steelhead attracted to spawn in spring outlet

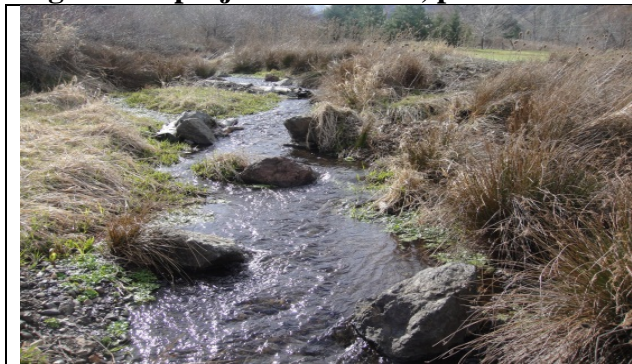
Riffle converted to sinuous riffle with pockets

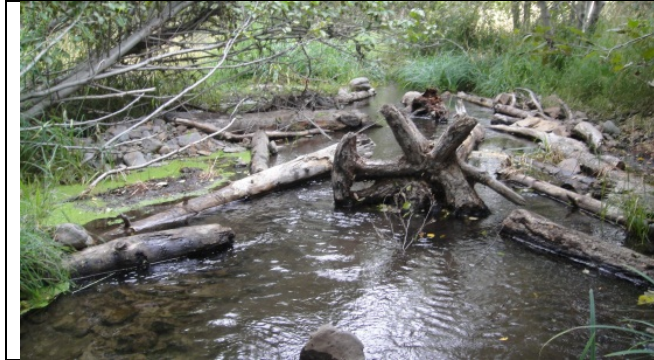
Conversion of glide to scour pool, reduced width

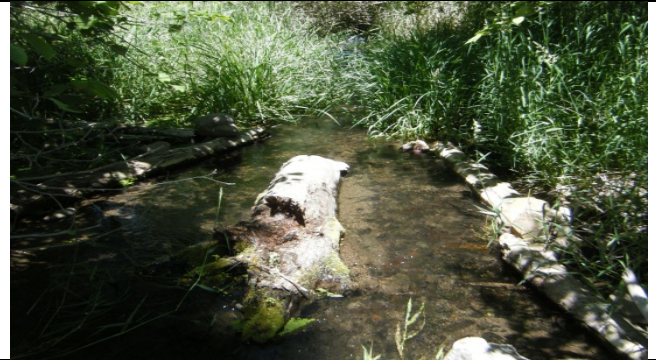
Edge effect habitat complexity created

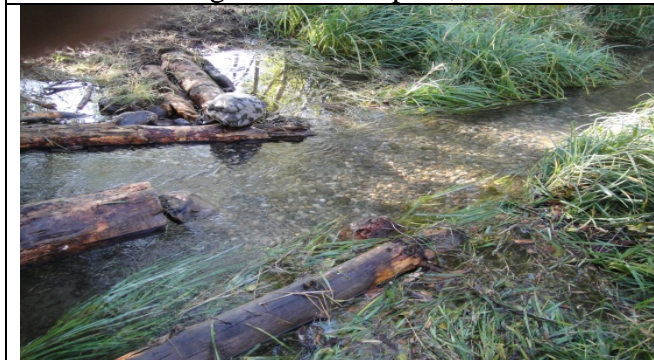
Spawning gravel added produced annual redds

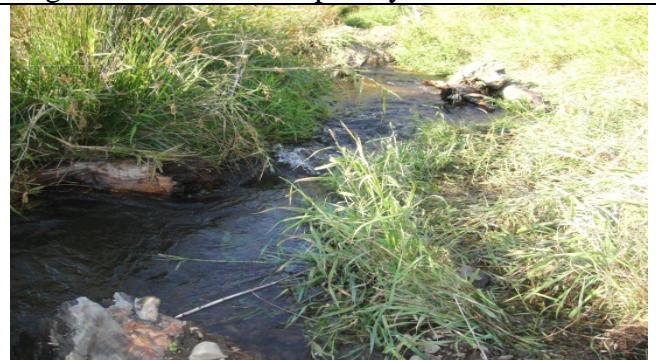
Forced meandering and lateral pools

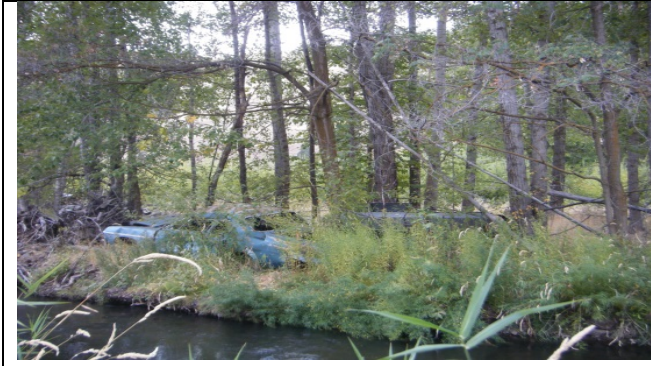
Cars in riparian areas

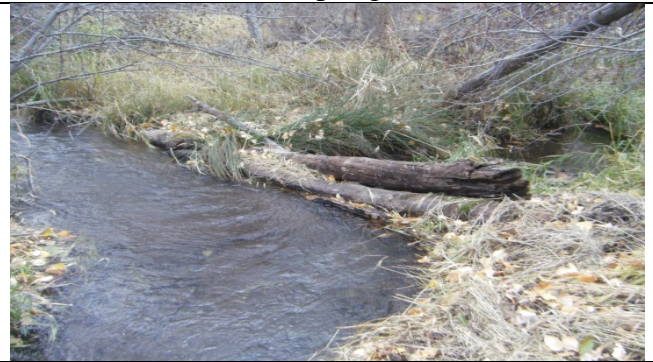
Upper plug created corner pool with undercut

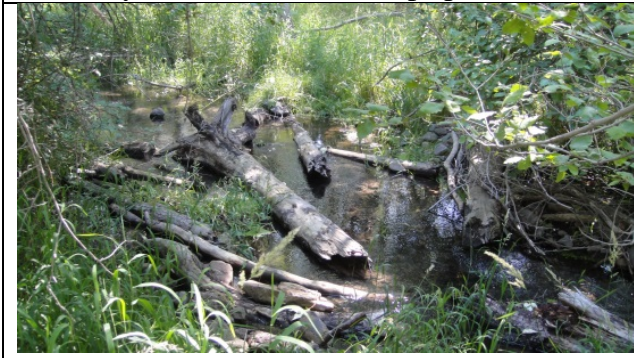
Complex habitat, Bull trout observed post-project

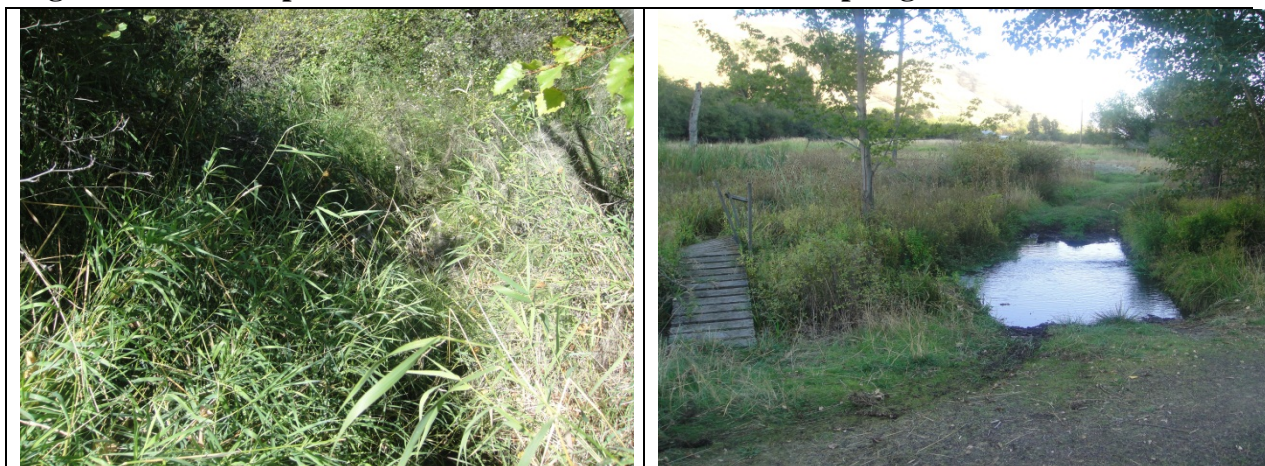
Figure 24. Pre and post restoration conditions at Hartsock Springs Creek

Project results showed the following increases; habitat complexity 129%, wetted channel depth 70%, undercut bank 48%, width:depth ratio 300%, channel shade 89%, wood complexity rating 91% (Figure 24), steelhead redds from 0 to 8 annually.

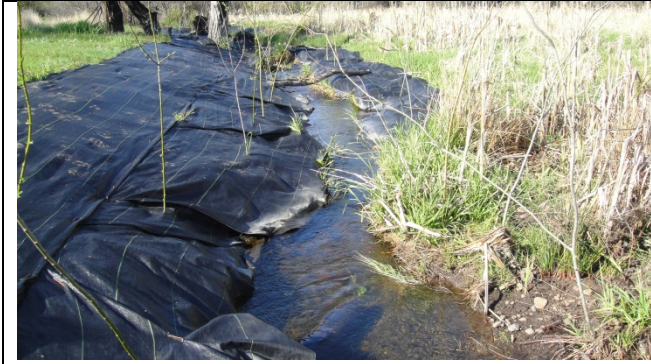
Tarp added, discourage regrowth of Reed Canary

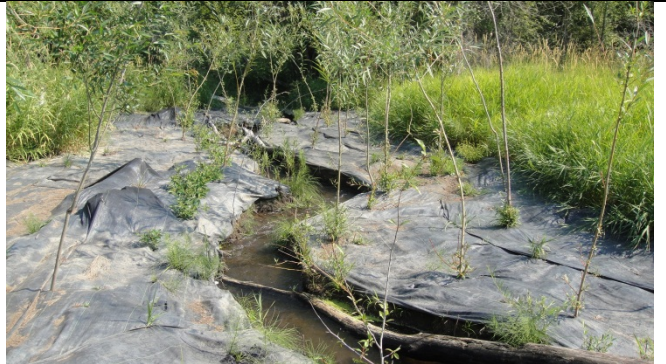
Sinuosity added and channel defined

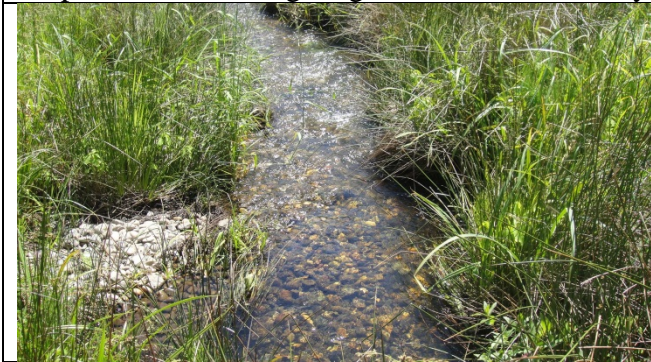
Spawning gravel added, steelhead redds annually

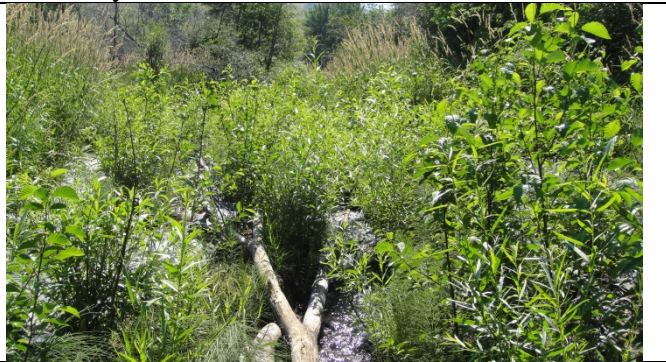
Two years recovery time, vegetation response

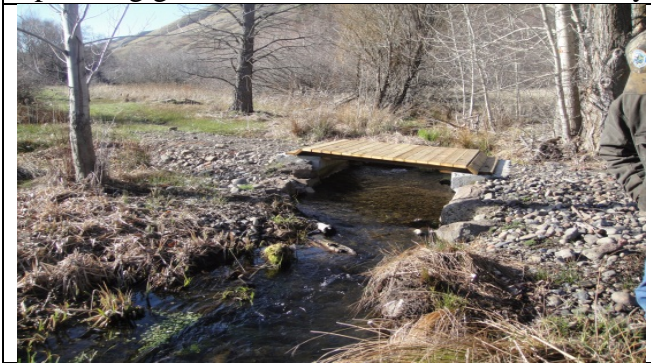
Drive thru crossing eliminated, bridge installed

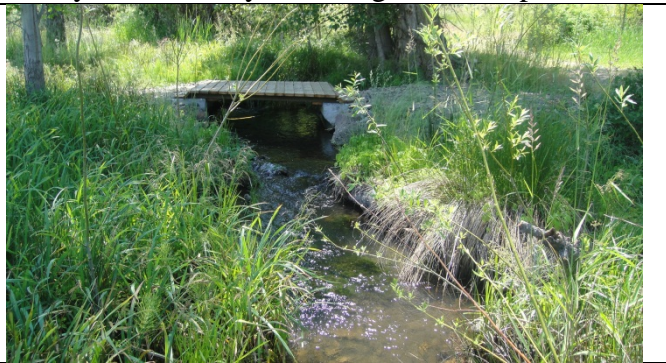
Pool and riffle sequence with undercut banks

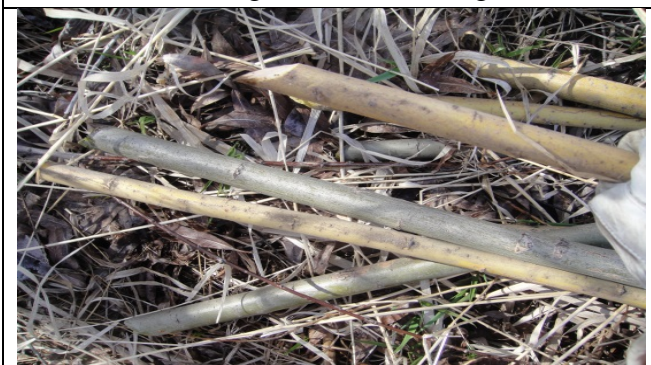
Willow whip technique

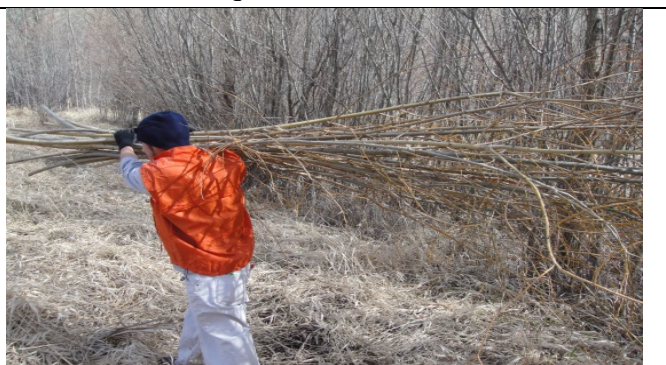
Tall whips used to establish shading

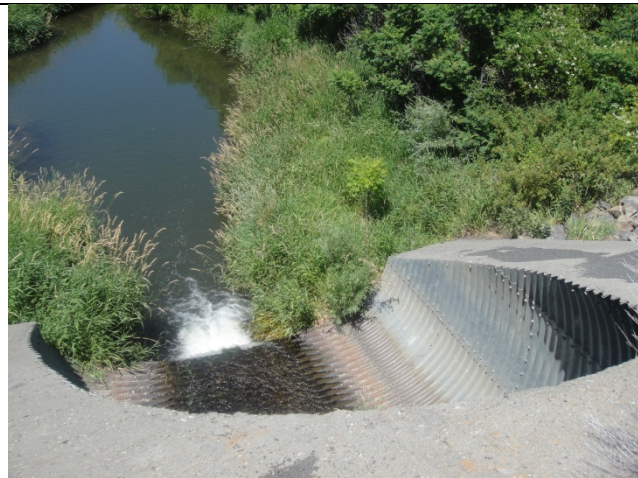
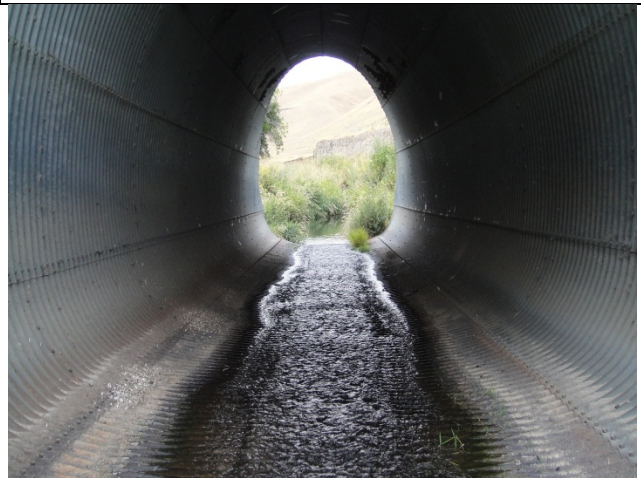
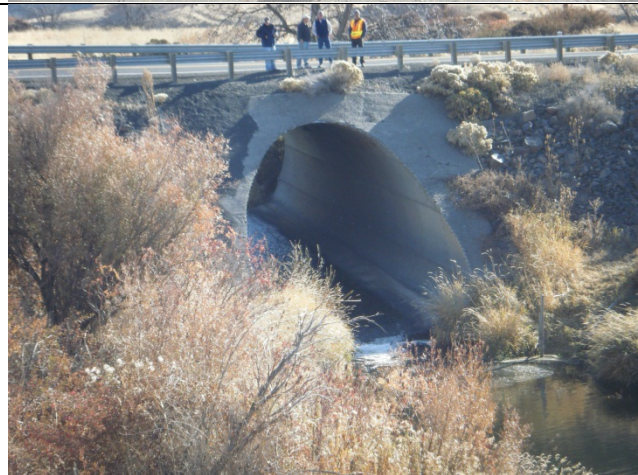
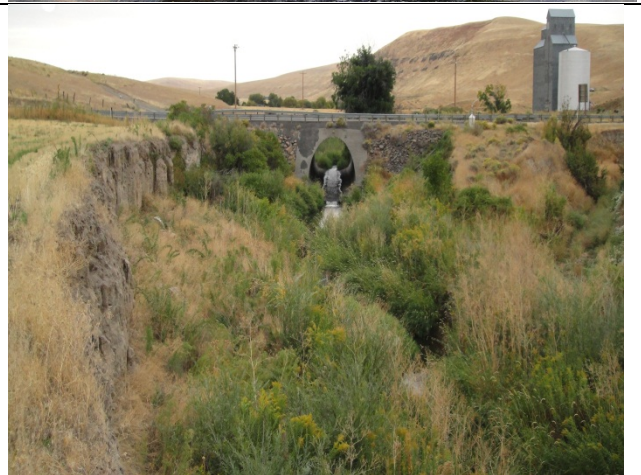
Figure. Pataha Creek, RM 1, Illustration of pre-restoration condition.

Incised channels, detrimental land use common

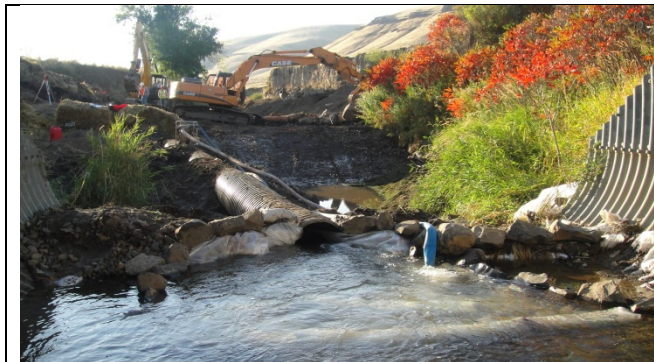
De-watering strategy

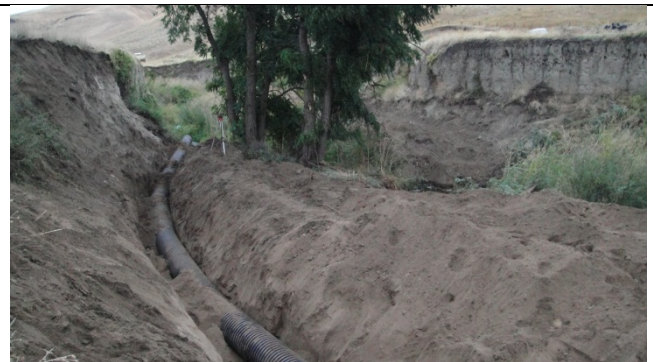
300' bypass pipe with all stream flow contained

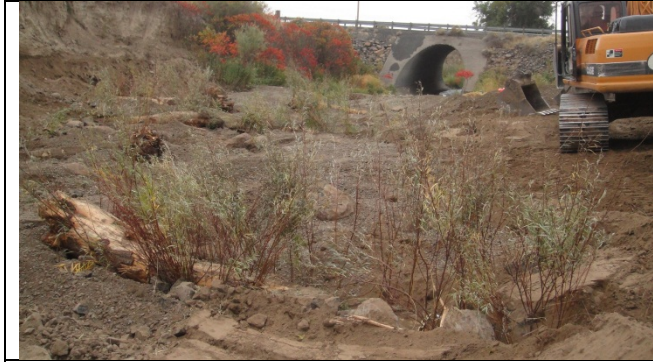
Roughened channel complete, ready to re-water

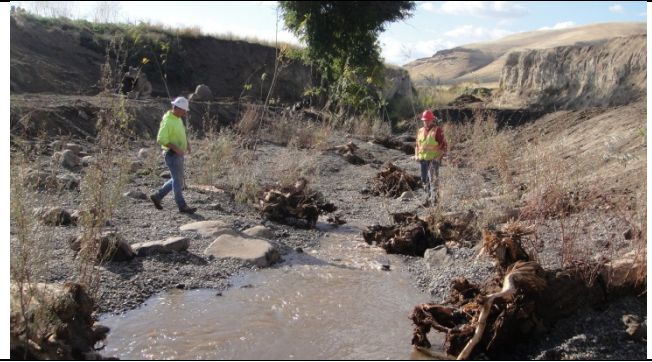
Slow re-establishment of flow to seal channel

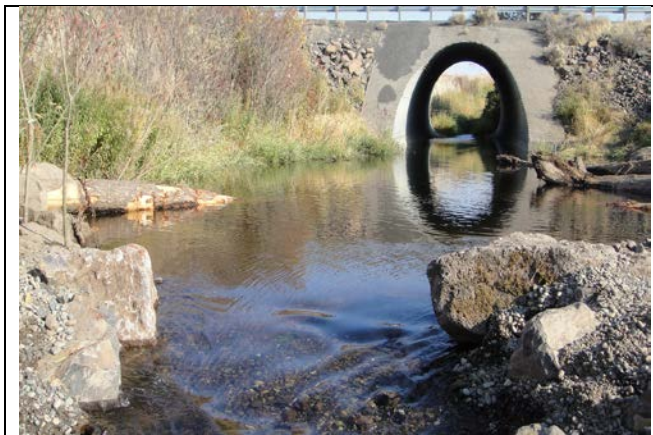
Elimination of 23" step at culvert achieved

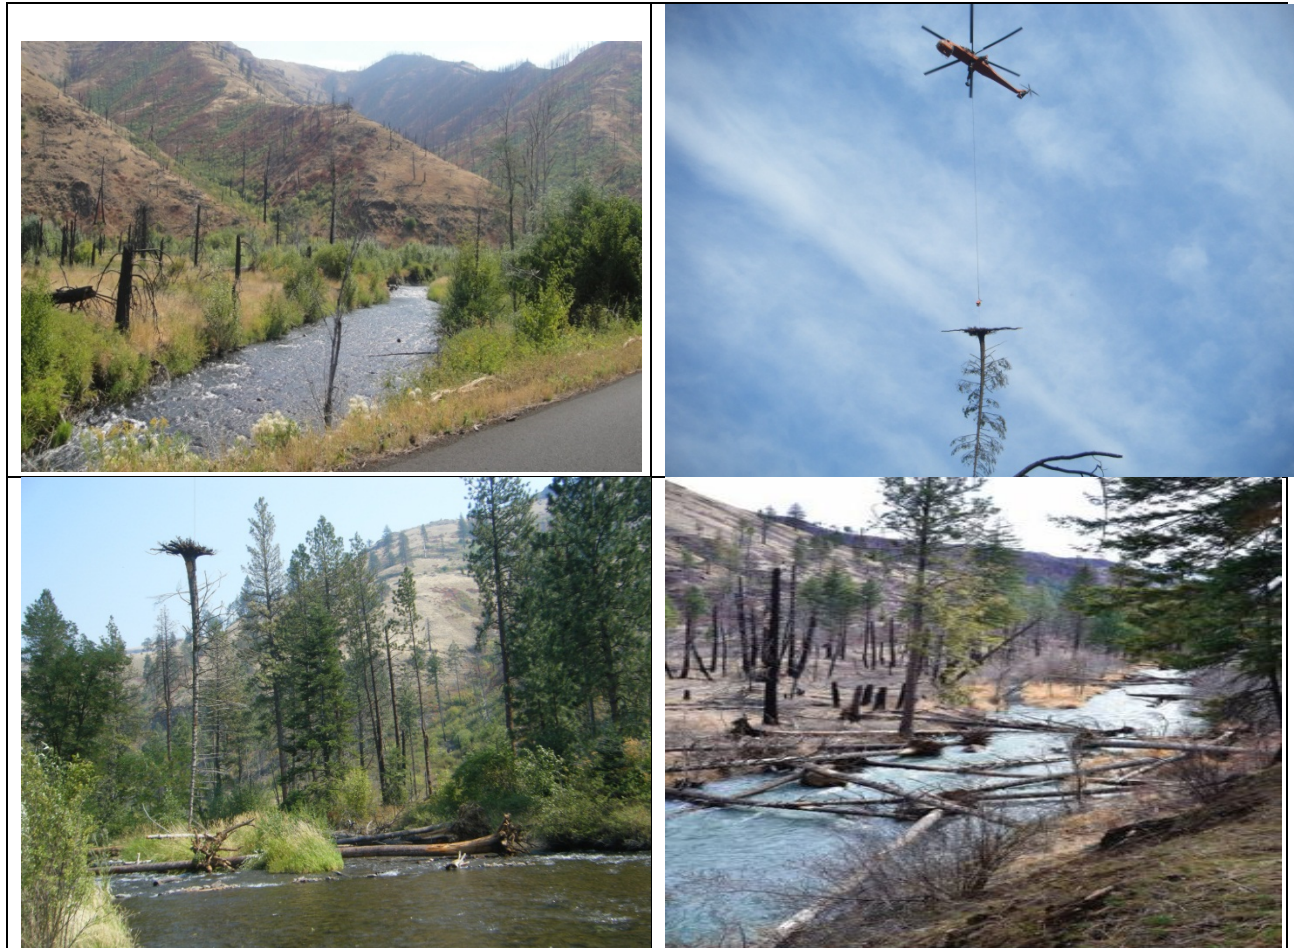
Figure 30. Pre project condition, results of habitat restoration actions, Tucannon R RM 42.

Whole trees were strategically-placed into areas of need identified during prior survey work. Boulders were added to enhance complexity and provide ballast. Riverine function and habitat complexity was significantly improved in the treatment reach (Figure 30).
