Protect and Restore Habitat; Tucannon Watershed

Annual Progress Report
(August 2009 through December 2012)

Northwest Power Planning Council Project #2008-202-00

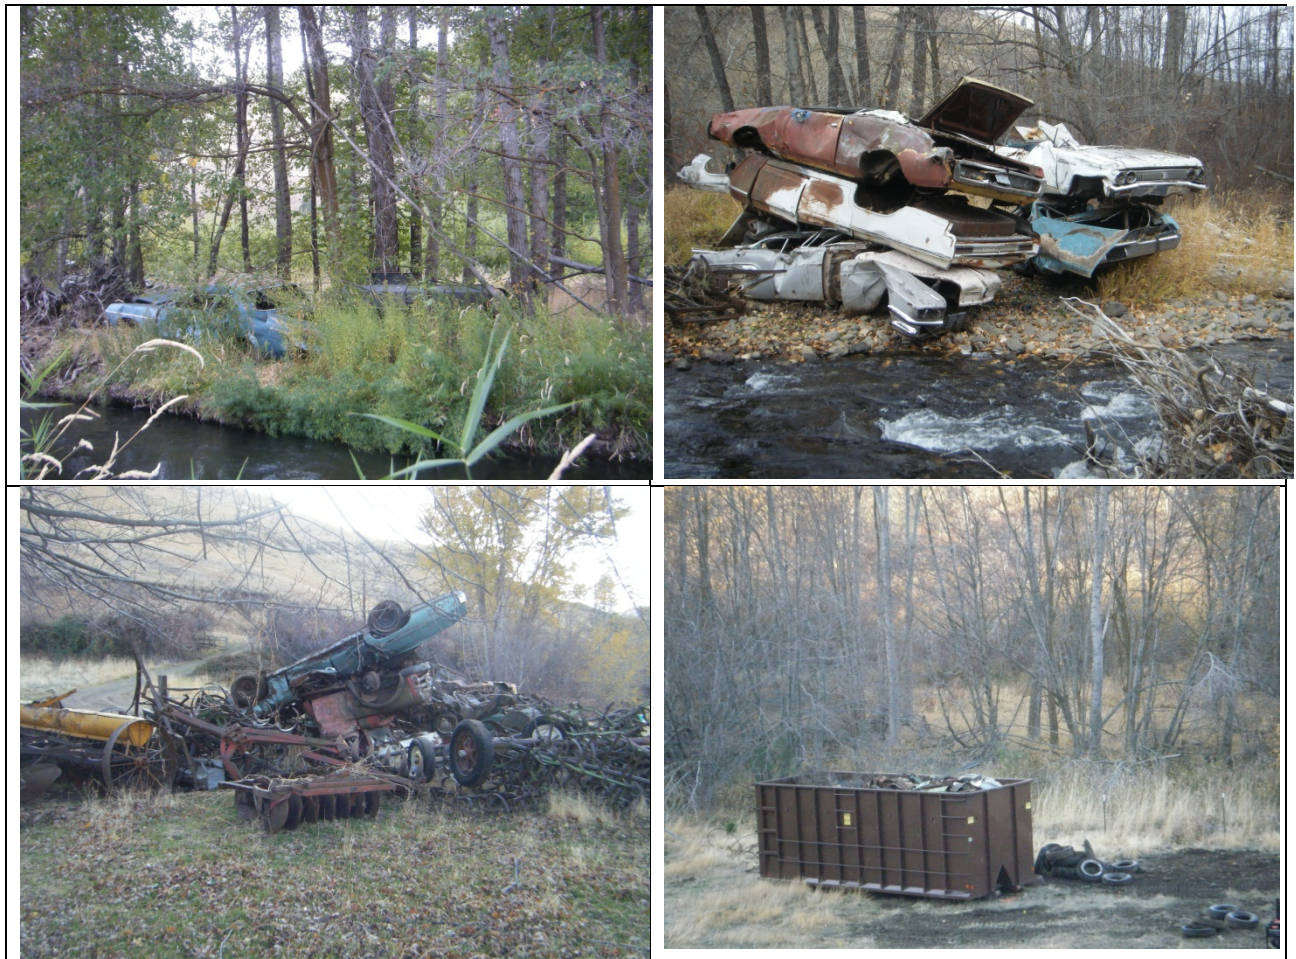
Figure. Restoration of Russel Springs involved high degree of debris removal from riparian

2009; 22 Car bodies and 1 20' x 10' waste container was filled with assorted metals extracted from the high water and riparian areas at Russel Springs Creek

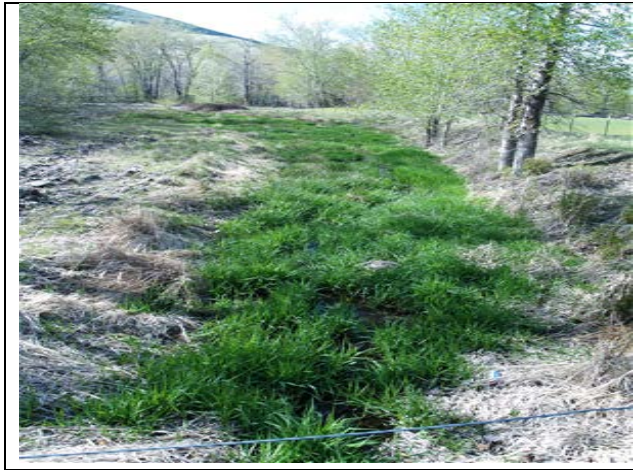
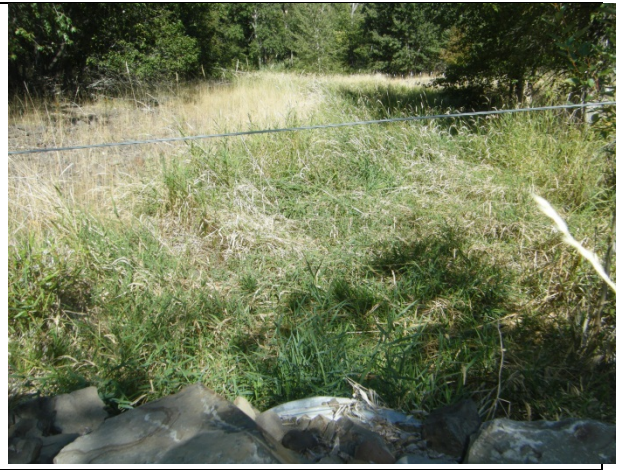
Figure Pre project conditions

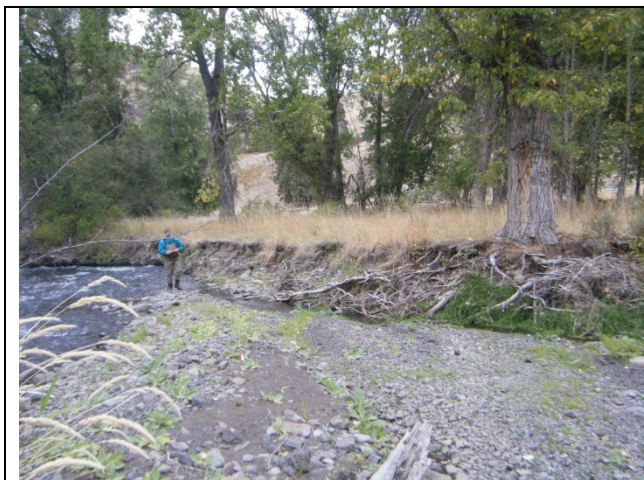
Actively Eroding Bank and High Terrace

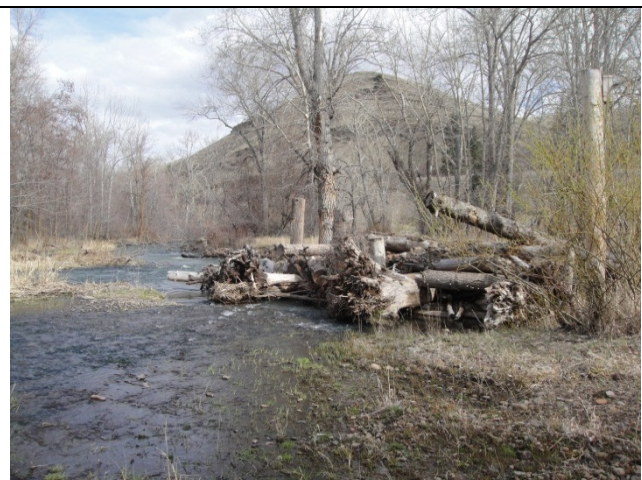
ELJ Constructed to protect bank from eroding

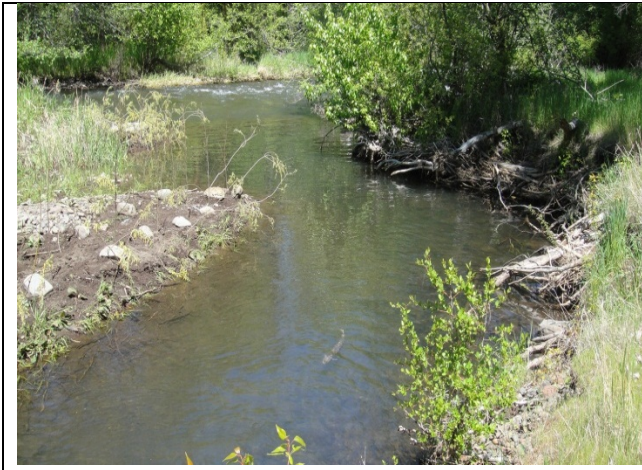
Creation of contrasting attraction water

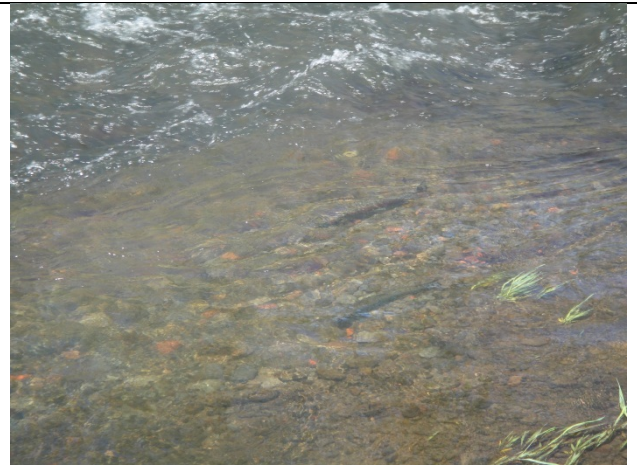
2 steelhead attracted to spawn in spring outlet

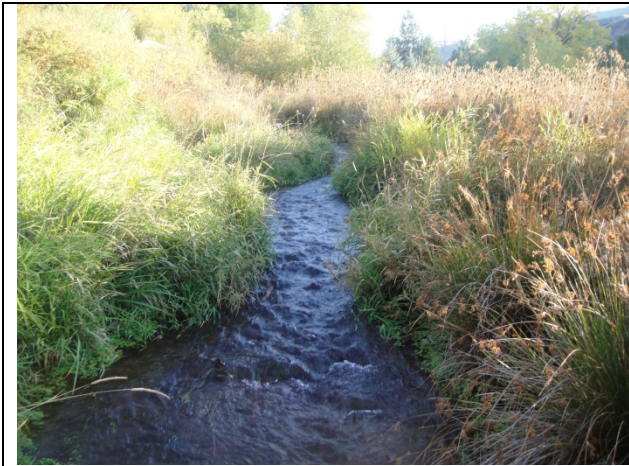
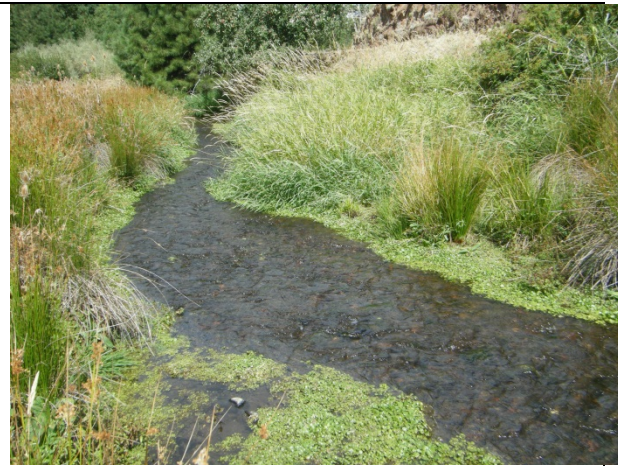
Figure Pre project conditions, plane bed form, straightened riffles

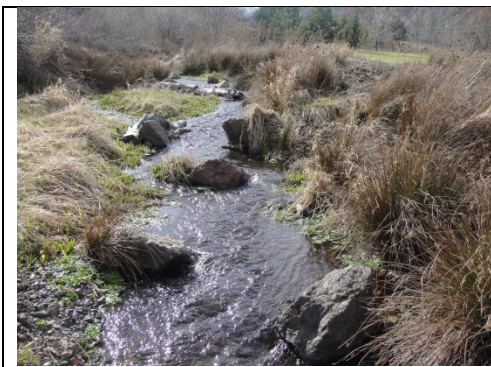
Riffle converted to sinuous riffle with pockets

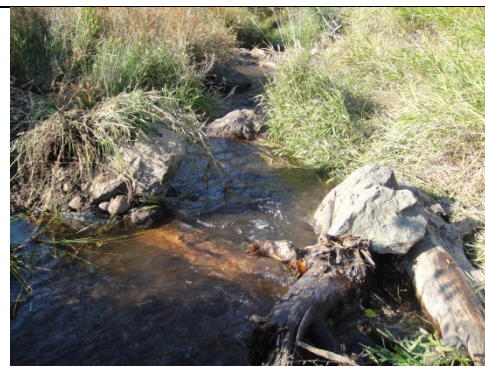
Forced Straight scour pool

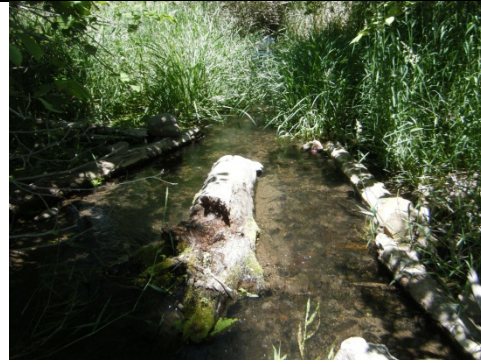
Edge effect habitat complexity created

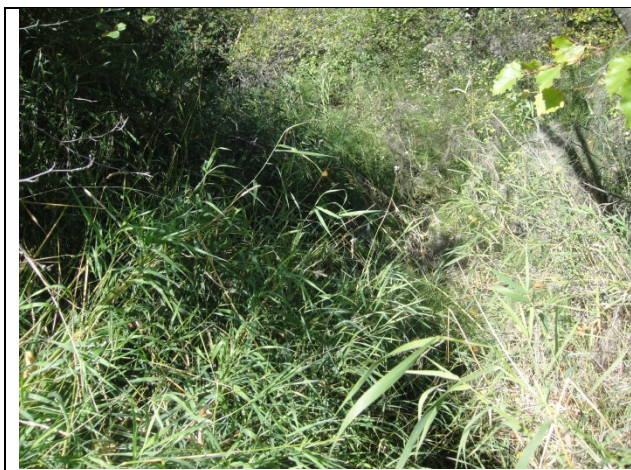
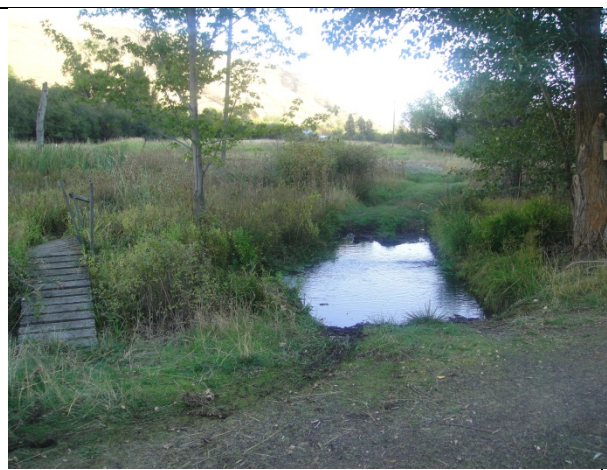
Figure Pre project conditions

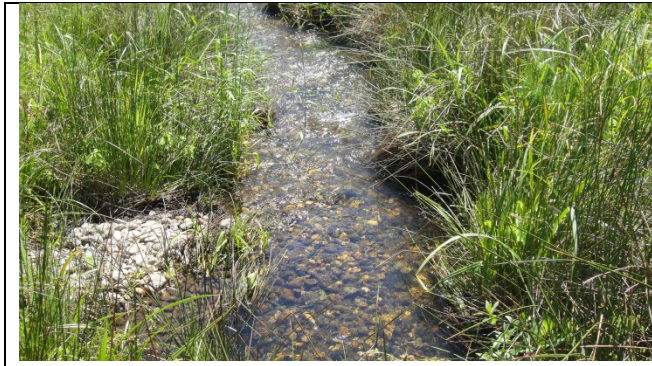
Spawning gravel added, steelhead use annually

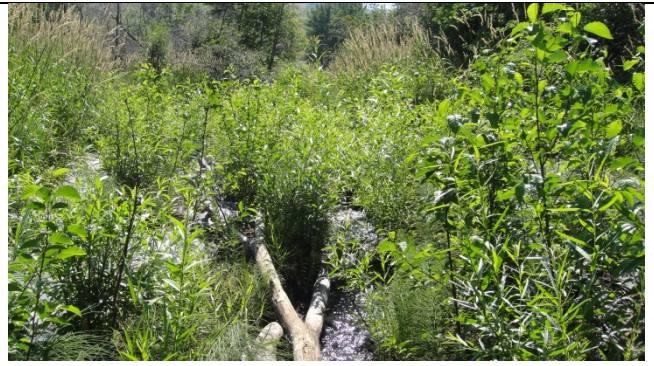
Two years recovery time, vegetation response

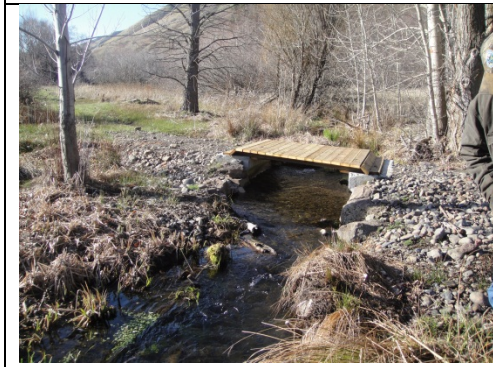
Drive thru crossing eliminated, bridge installed

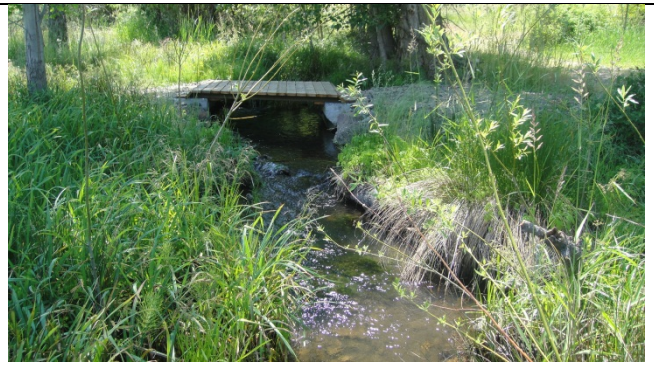
Pool and riffle sequence and undercut banks

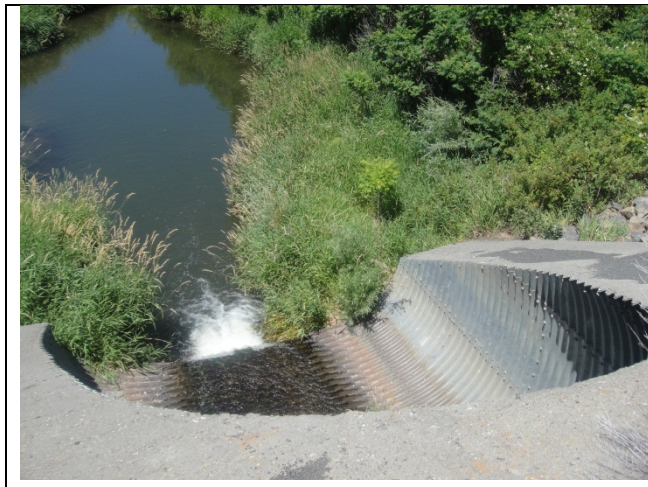
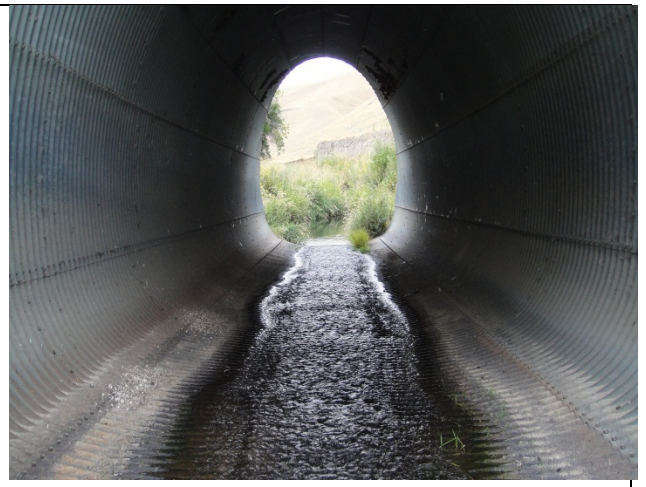
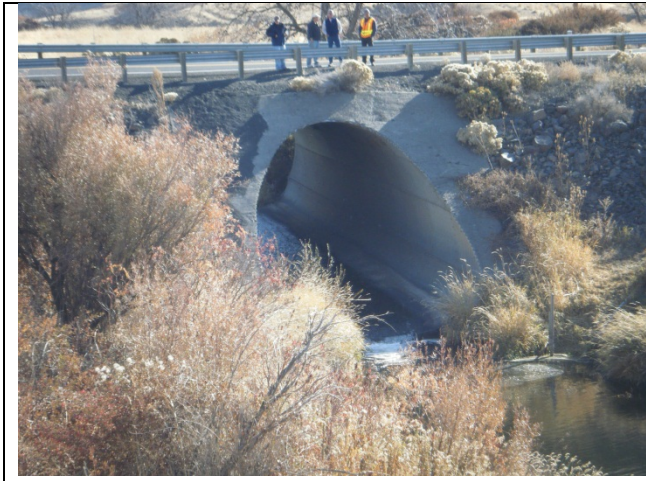
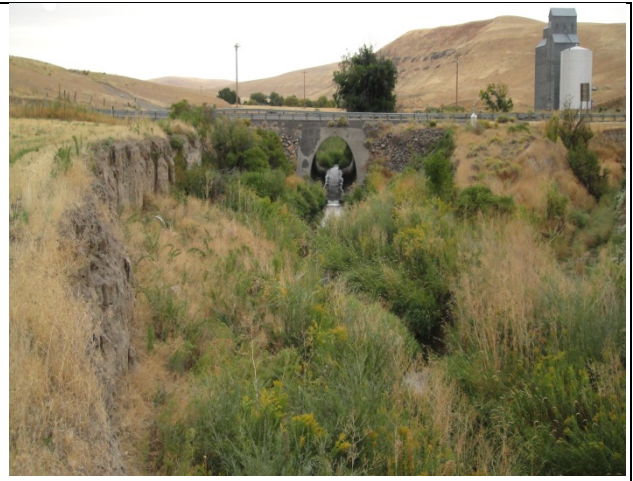
Figure. Pataha Creek, RM 1, Illustration of pre-restoration condition.

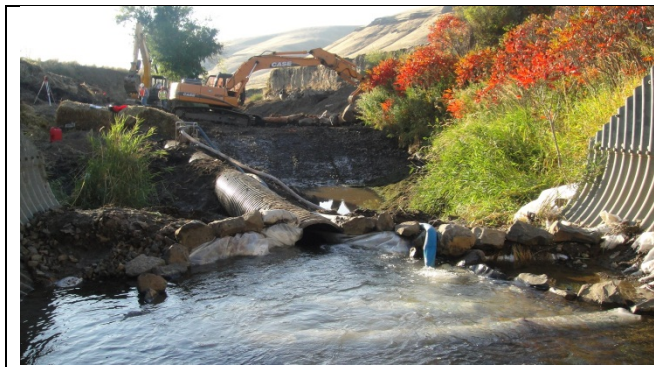
De-watering strategy

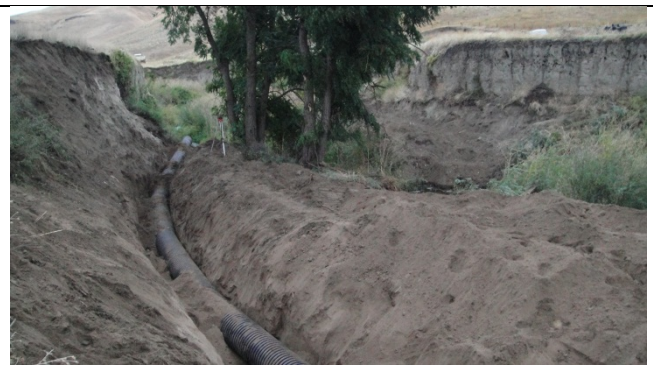
300' bypass pipe with all stream flow contained

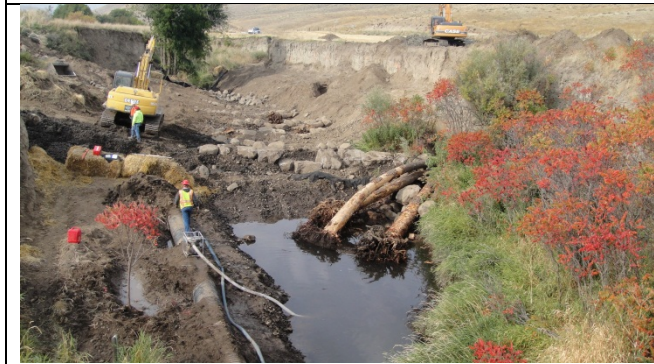
Generator pump used to reduce groundwater seep

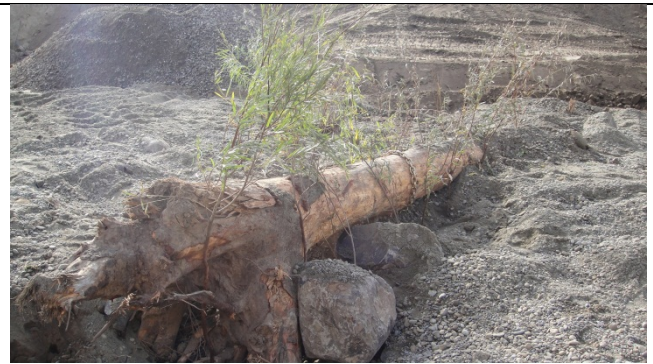
Stability methods for retaining LWD

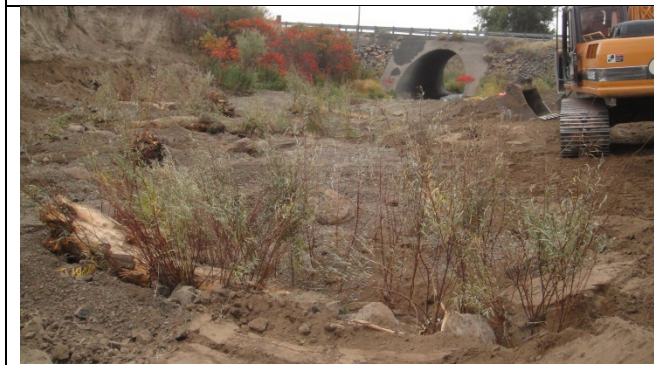
Roughened channel complete, ready to re-water

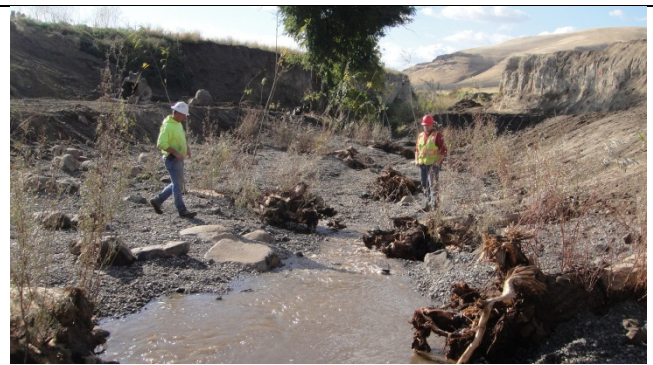
Slow re-establishment of flow to seal channel

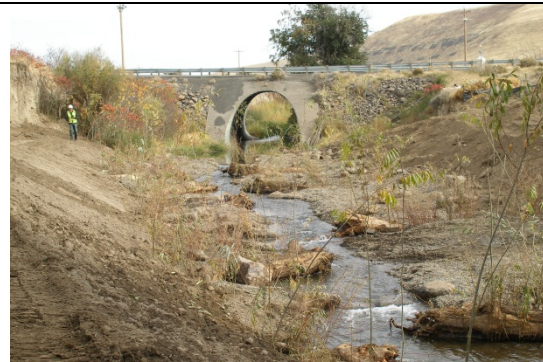
Large Wood Debris Accumulation

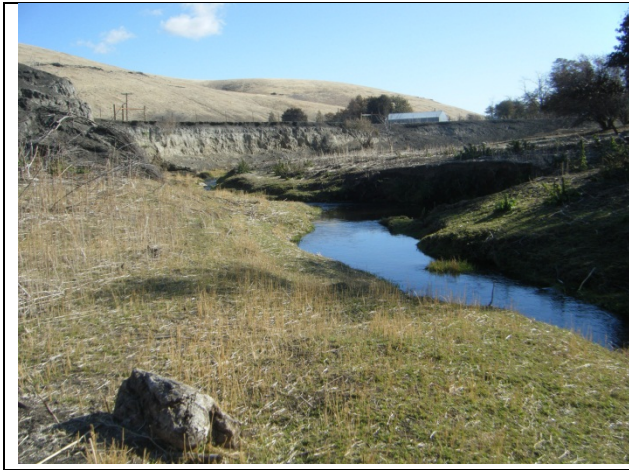
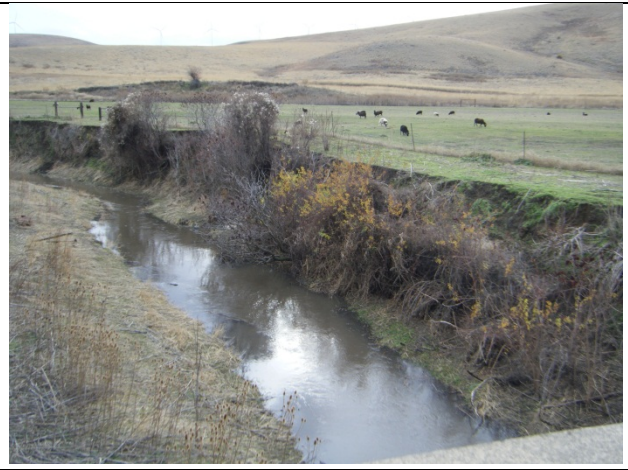
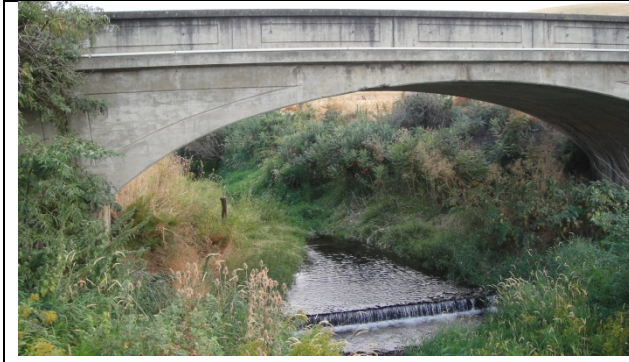
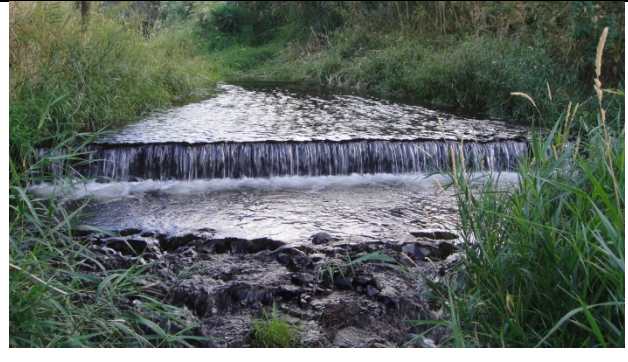
Figure Pataha RM 10 pre project conditions

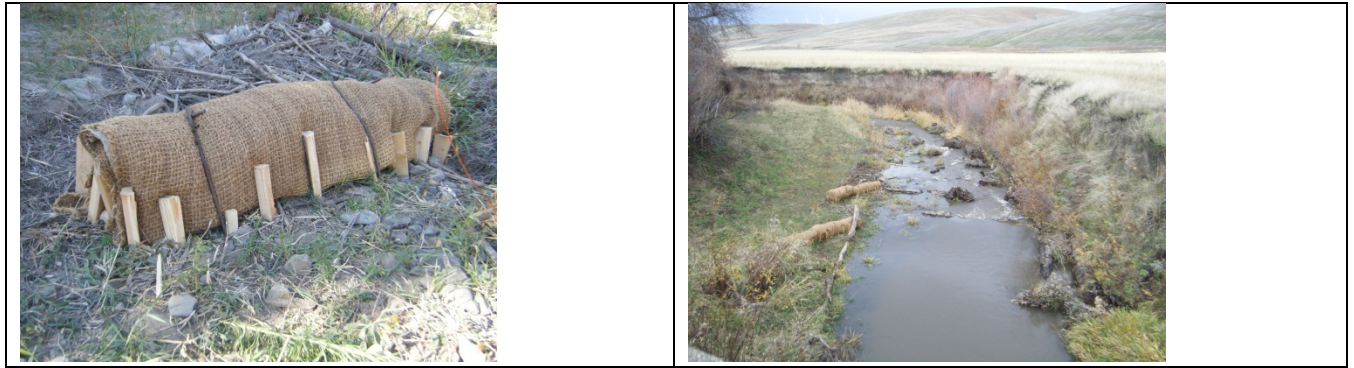
Figure Pataha RM 10 Implementation methods

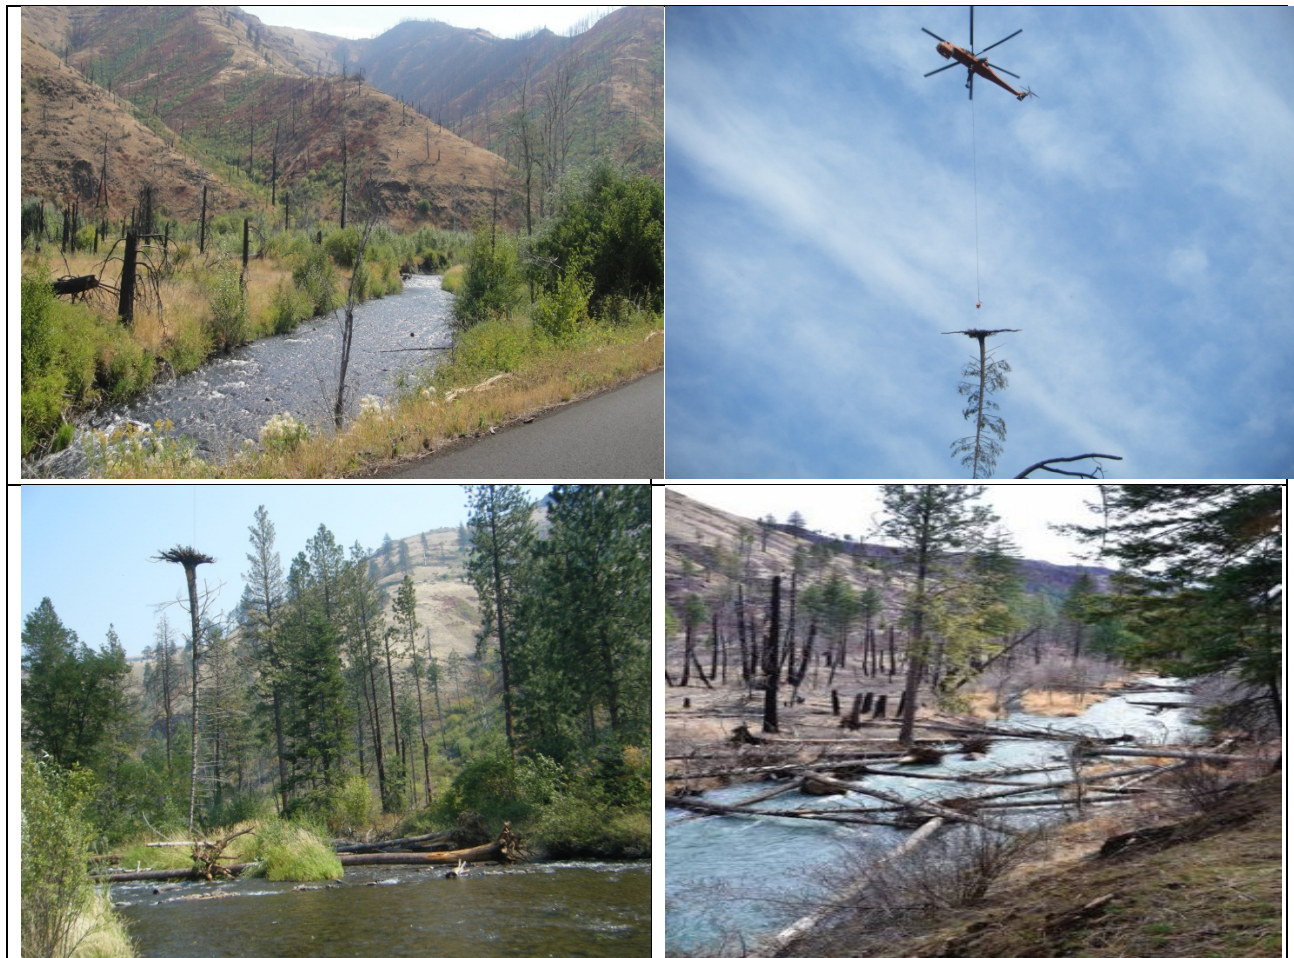
**Figure . Clockwise illustration of pre-restoration condition, to post treatment complexity.
Figure 1.**

Implementation by helicopter was chosen as the best available technique to reduce detrimental footprint and to retain critical length and complexity of whole trees. WDFW was the lead entity responsible for providing project management, and CTUIR identified as the primary project partner due to having the most experience partaking in this specific implementation strategy. . CTUIR provided technical review and input during the design process and field support prior to and during project construction. Implementation of PA 10 utilized a combination of constructed engineered log jams and unsecured log complexes. A total of 291 whole trees ranging in length

from 50 feet in length to over 100 feet and ranged in diameter from 15 inches to over 30 inches were added to the wetted channel via helicopter. Many were placed for the purpose of forcing pools or side channels. The stability of structures in the system is reliant on the size of trees placed; size was determined using the WDFW SHRUG guidelines developed in the Stream Restoration Manual. Additional trees and boulders were stacked in many locations to provide ballast to aid stability. Trees were transported from the US National Forest, approximately 3-6 miles to the project area and placed in stream using a S64 Sky Crane helicopter. Approximately 500 additional trees were transported to the project site ranging in size from 4-12 inches in diameter and 20-30 feet long and distributed throughout the project reach using the helicopter.

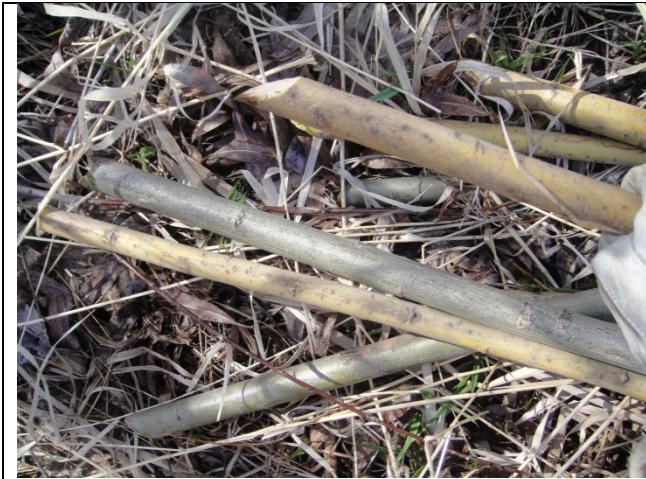
Cutting live Willow stakes near project site

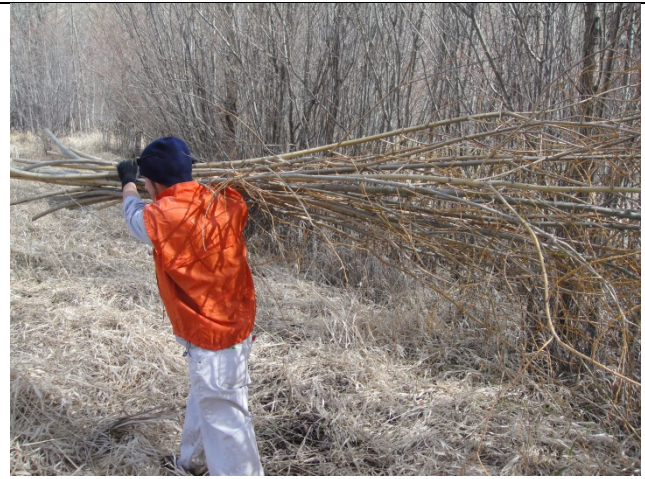
Willow stakes are kept at full length for planting

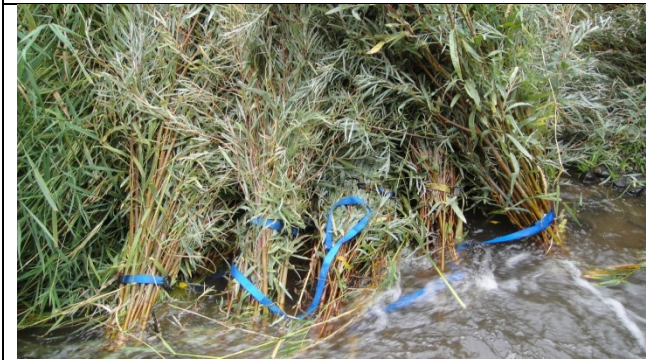
Salvaged cuttings soak during implementation

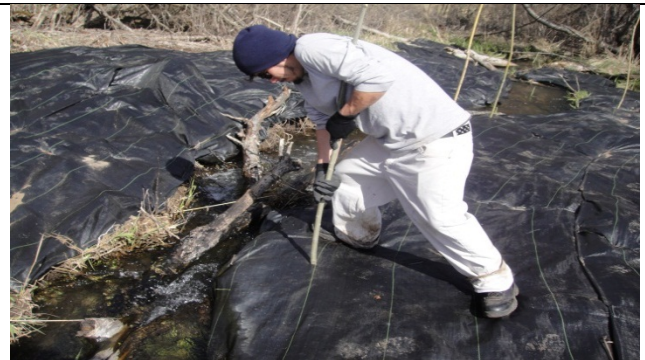
Full cuttings forced deep top reach ground water

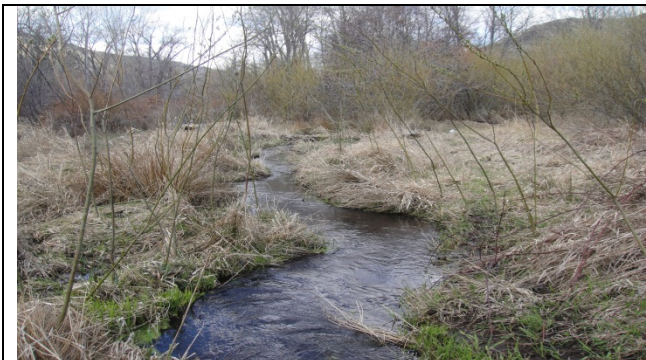
Instant Re-establishment of riparian shade

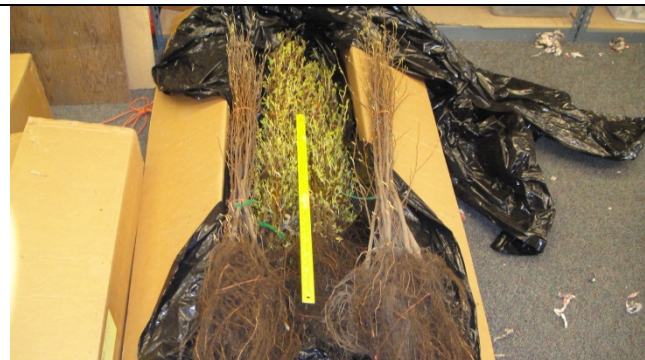
Bare root stock supplemented cuttings

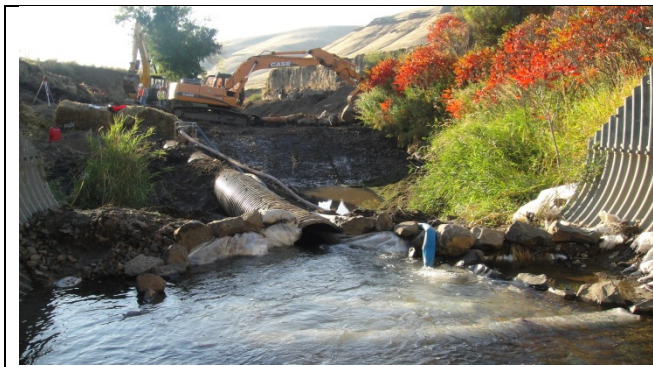
De-watering strategy

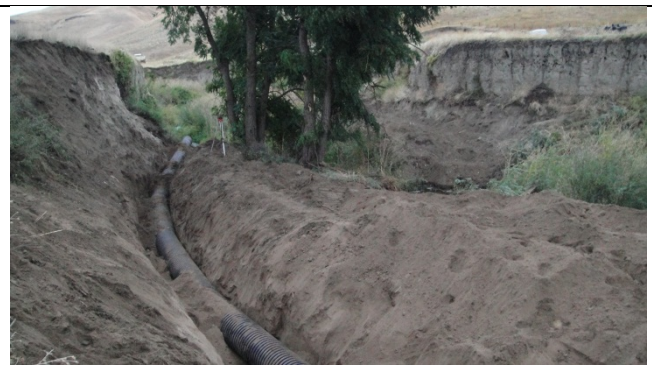
300' bypass pipe with all stream flow contained

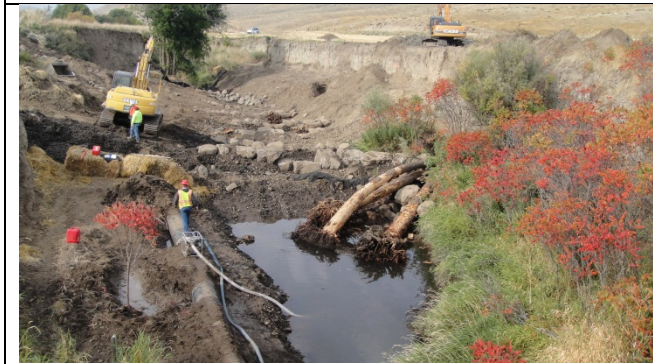
Generator pump used to reduce groundwater seep

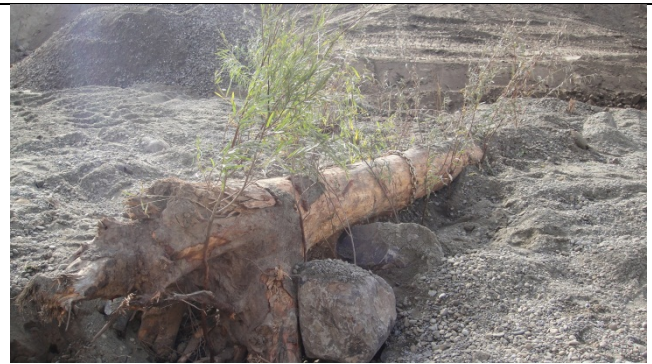
Stability methods for retaining LWD

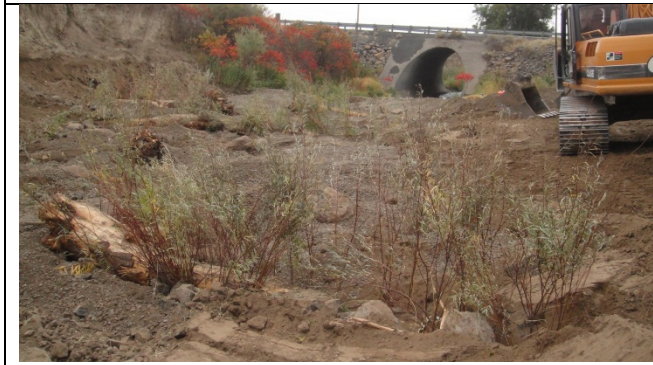
Roughened channel complete, ready to re-water

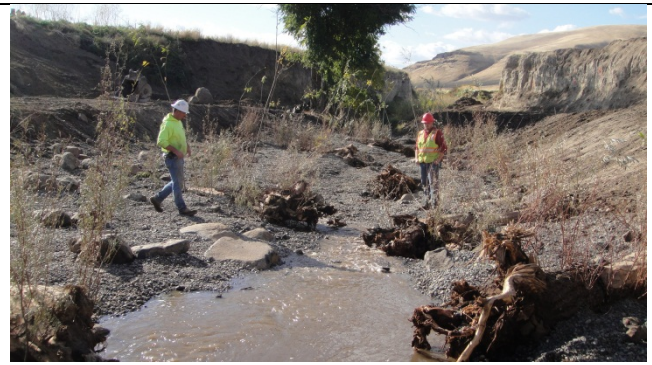
Slow re-establishment of flow to seal channel
