# CTUIR TUCANNON BASIN FISH HABITAT ENHANCEMENT PROJECT 2019-2020 BIENNIAL REPORT

## A Columbia River Basin Fish Habitat Project

### Northwest Power Planning Council Project # 2008-202-00

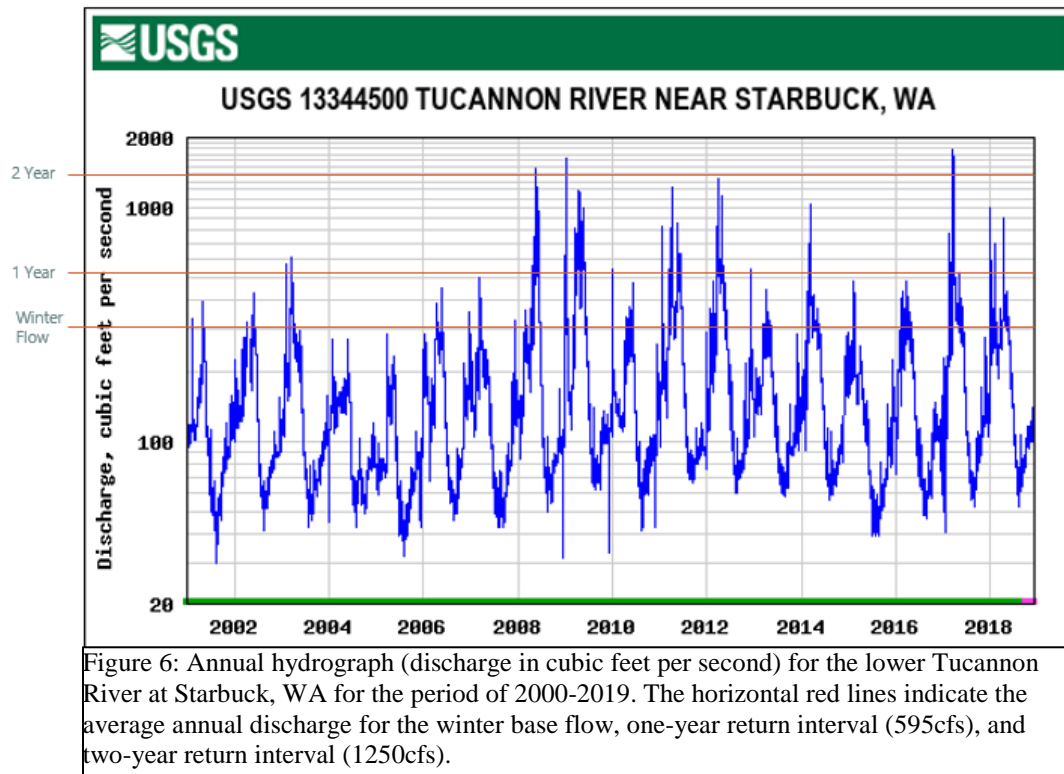
Figure 6: Annual hydrograph (discharge in cubic feet per second) for the lower Tucannon River at Starbuck, WA for the period of 2000-2019. The horizontal red lines indicate the average annual discharge for the winter base flow, one-year return interval (595cfs), and two-year return interval (1250cfs).

As you can tell by Figure 6, since 2000, the Tucannon has rarely seen flows above the 2-year event. It is believed that naturally occurring habitat-forming flows in the Tucannon River occur above the 2-year recurrence interval, which ranges from 1,275 cfs in the lower basin, to a low of 383 cfs and a high of 598 cfs in the upper basin (Figure 6). In the spring of 2020, the Tucannon received its first habitat forming flow since 2017 (Figure 7), and its largest flow since the flooding of 1996/97. The habitat work in the Tucannon relies on flows above the 2 year event to to increase channel complexity and floodplain connectivity through interaction with large wood structures. Habitat forming flows above the two-year discharge have only occurred four times since 2010 (the start of the BPA Programmatic Habitat Project). Consequently the rate of river-driven habitat formation has been slow during the last decade on the Tucannon River.

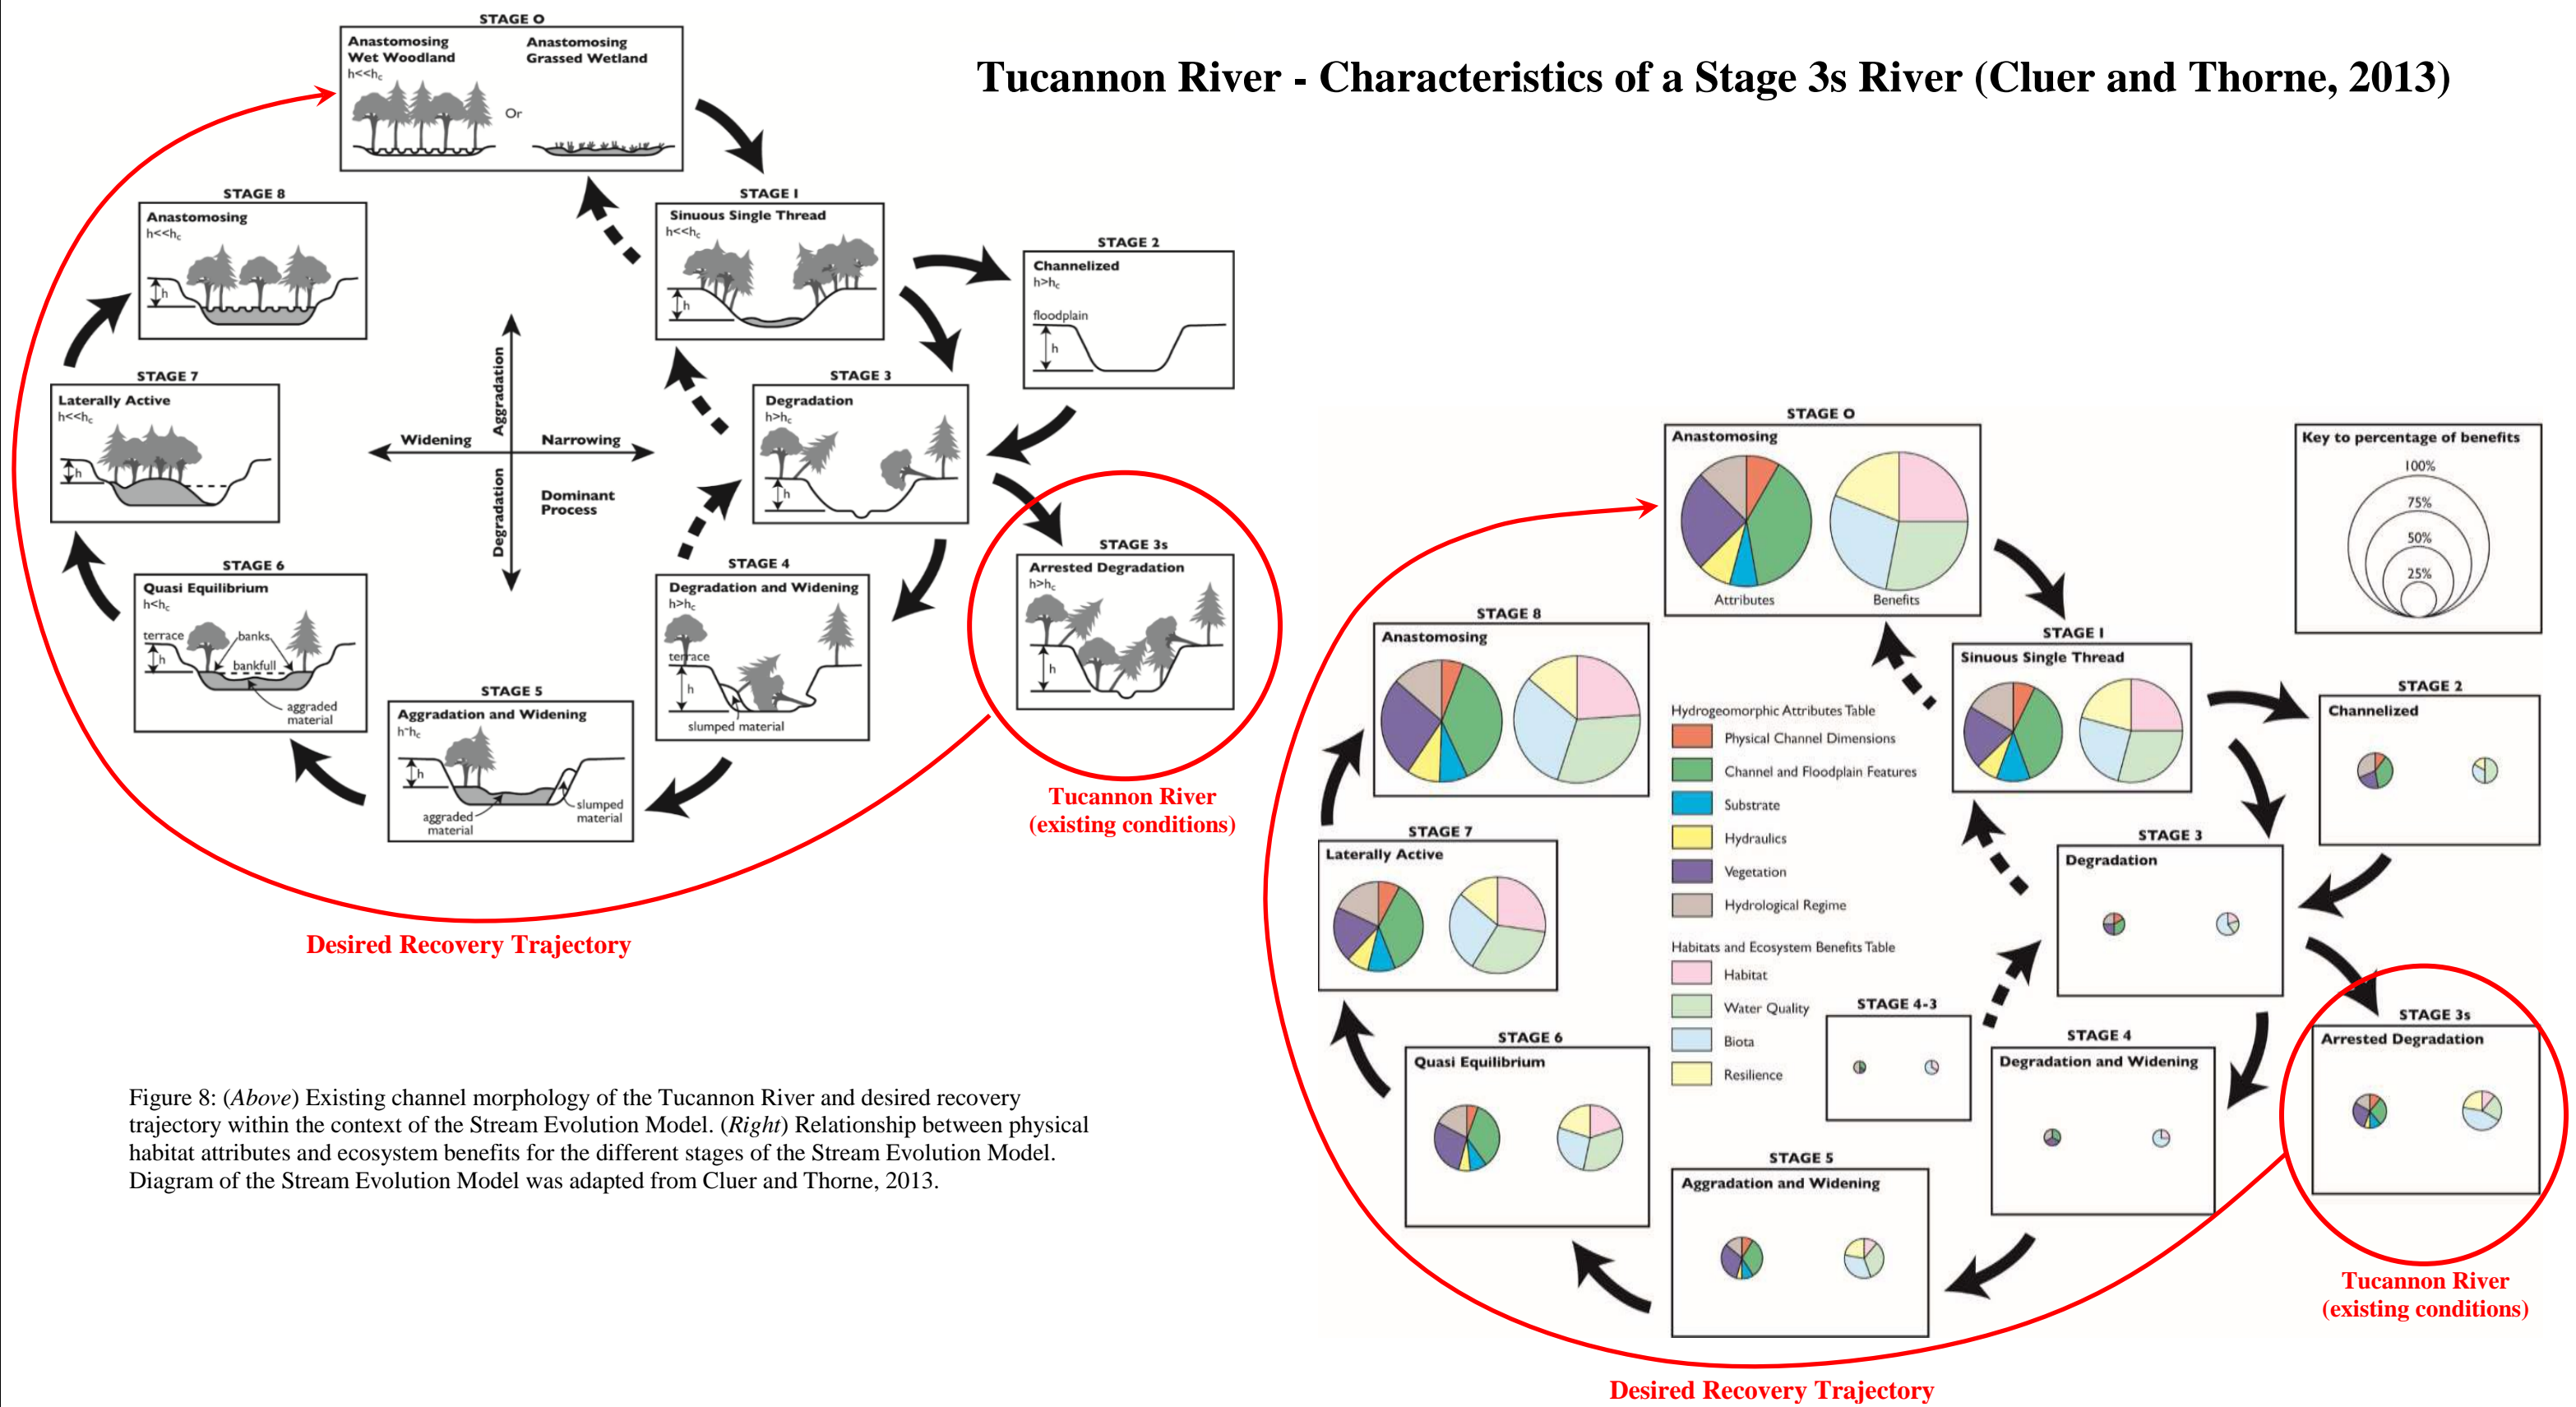
Figure 8: (Above) Existing channel morphology of the Tucannon River and desired recovery trajectory within the context of the Stream Evolution Model. (Right) Relationship between physical habitat attributes and ecosystem benefits for the different stages of the Stream Evolution Model. Diagram of the Stream Evolution Model was adapted from Cluer and Thorne, 2013.

Today much of the Tucannon River is stuck in a state of arrested degradation or what is referred to as Stage 3s in the Stream Evolution Model (Cluer and Thorne, 2013) (Figure 8). Ultimately, rivers in this stage of channel evolution are less productive biologically because of lack of floodplain connectivity and increased stream velocities that require higher energy to forage in these channel types.

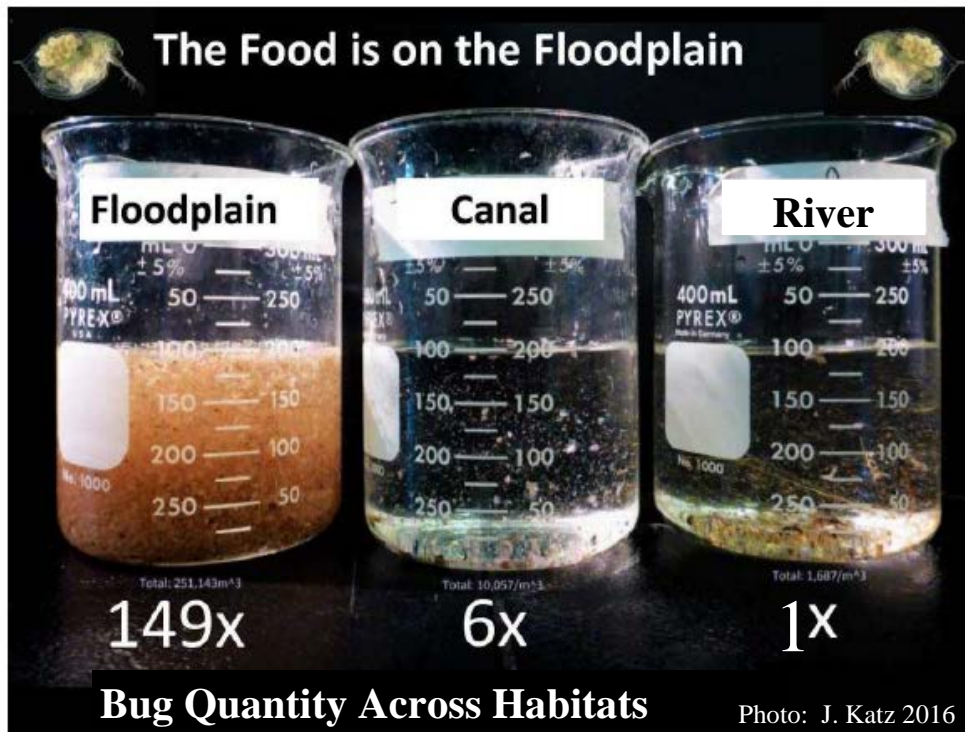
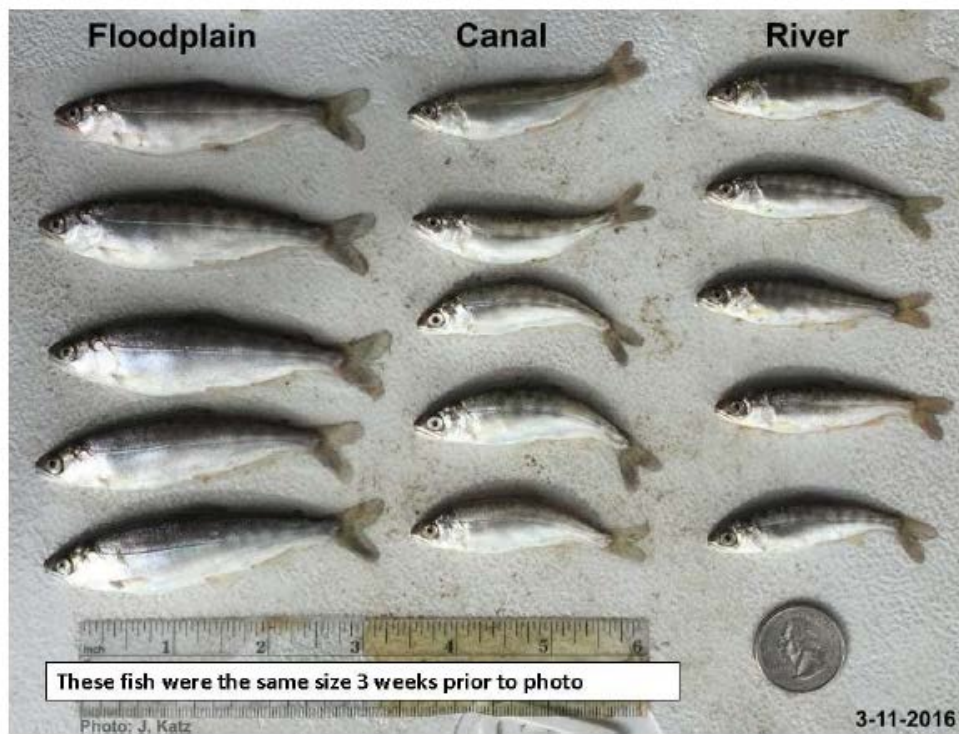
Figure 9: Results from Katz et al. 2017 – (Top) ephemeral inundation of floodplain habitats on a California river produced significantly larger densities of macroinvertebrates than adjacent habitats. (Bottom) Juvenile Chinook salmon that reared in these ephemeral floodplain habitats grew faster than their counterparts rearing in adjacent habitats.

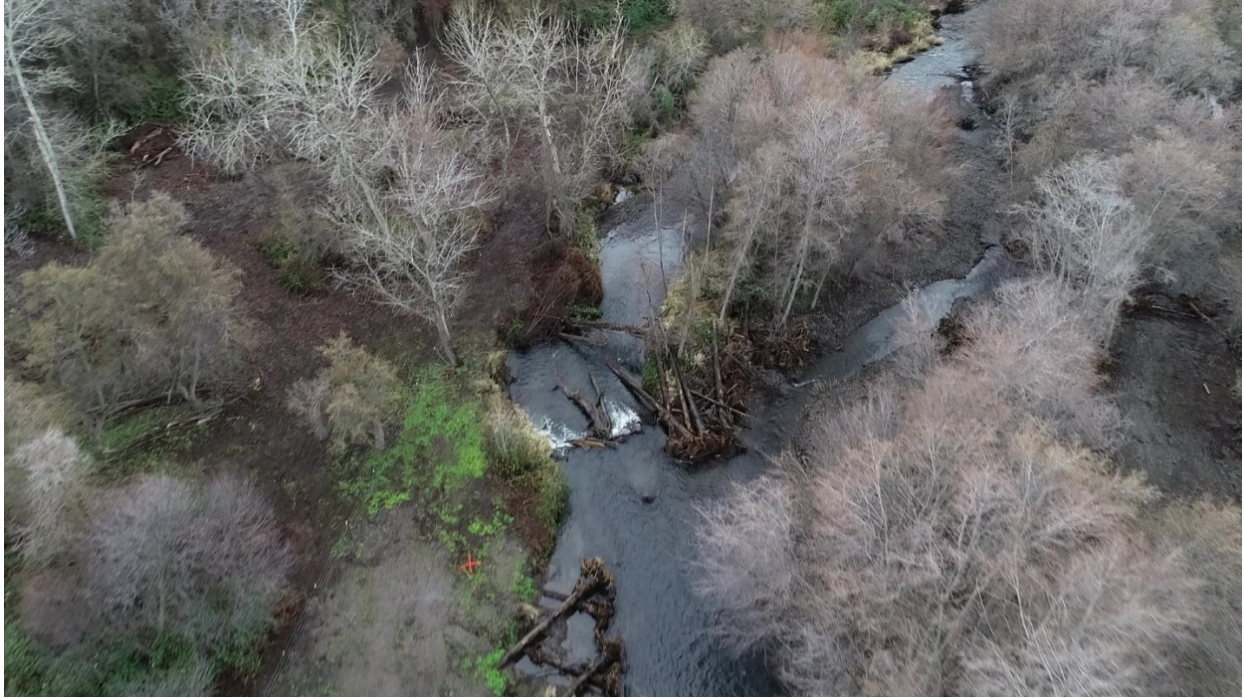
Large wood structures installed in PA27/28.1 during Phase 0.5 implementation. Image was taken from a drone survey on February 2021.

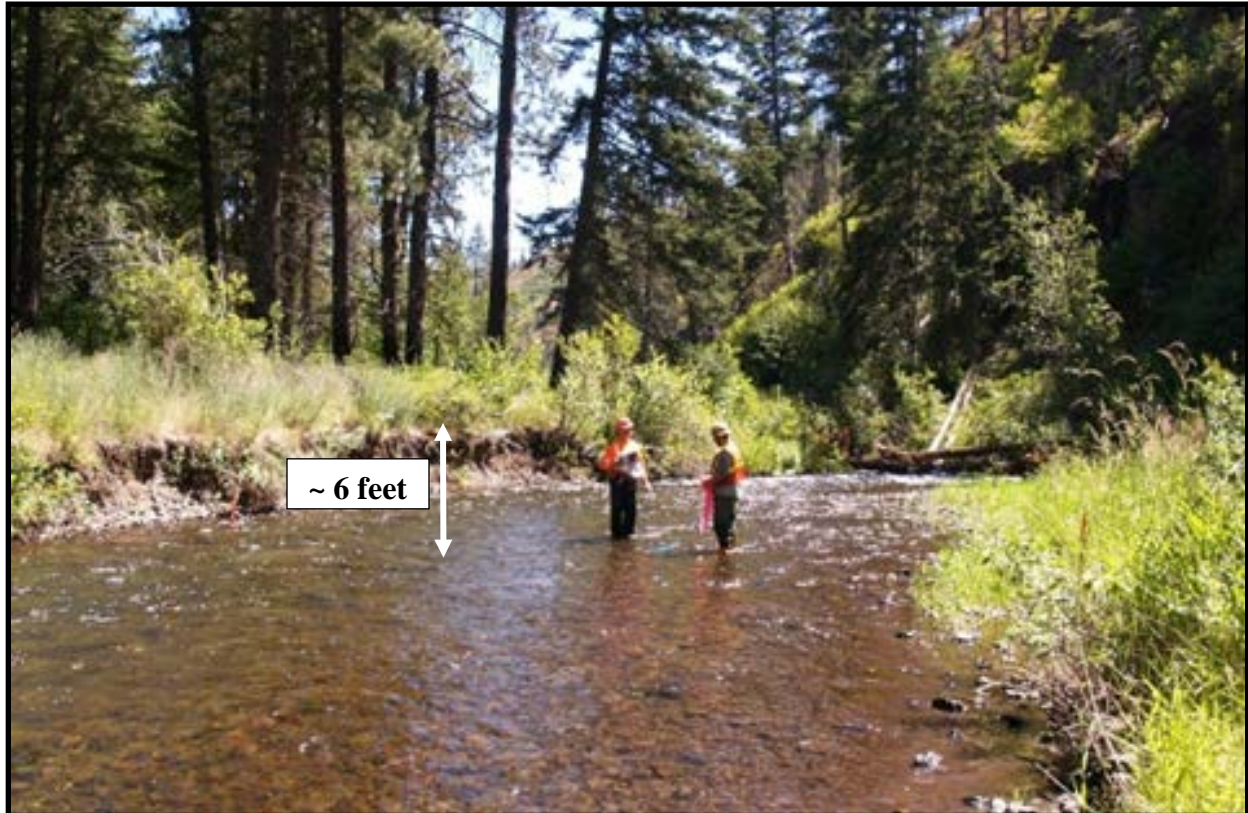
Figure 21: Pre-treatment condition of PA3, circa 2014. The difference in elevation between the stream bed and top of bank was approximately six feet. The channel width was also larger than expected for the reach.

“Two key pieces of wood per channel width” is the wood loading target for habitat restoration projects on the Tucannon River (SRSRB 2011). In the summer of 2014 large wood was placed in PA3 to aggrade the channel bed and increase in-stream habitat complexity. Prior to the addition of large wood in 2014, the PA3 reach possessed a high capacity for conveying river flows and sediment and the river was incised ~6 feet or more into the floodplain (Figure 21).

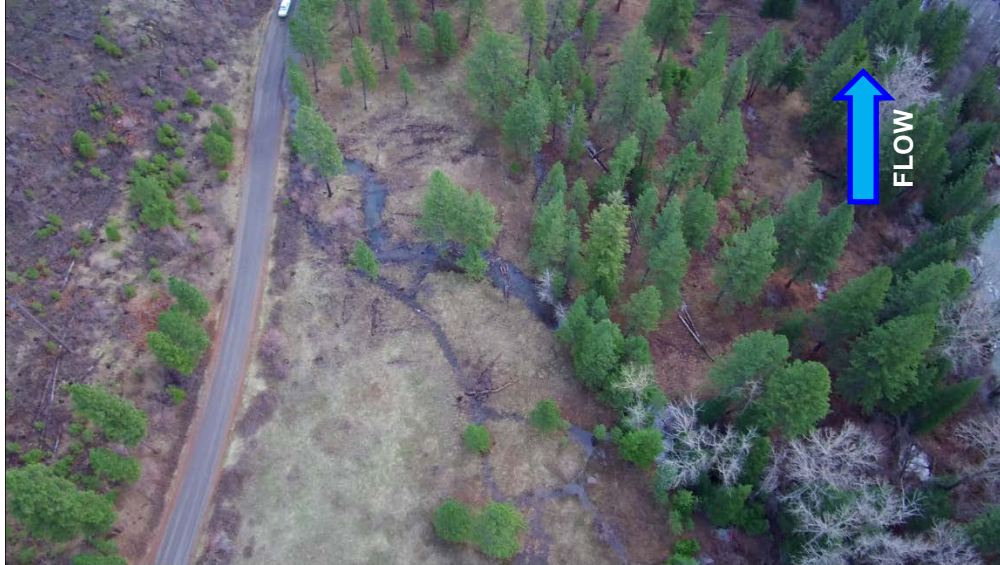
Figure 25: Imagery of PA3 floodplain inundation on April 10, 2019. Imagery was acquired by the CTUIR drone program. Discharge was estimated to be ~400-600 cfs within the reach. These estimates were derived from USGS Stream Stats and regression models developed by design engineers (Tetra Tech, 2014).

In April 2019 (less than a year after completion of the 2018 large wood treatment), targeted portions of the floodplain within PA3 were inundated under an estimated discharge of ~400-600 cfs (USGS Stream Stats; Tetra Tech, 2014) in PA3 (Figure 25 and Figure 26). Stream discharge in PA3 was estimated to be somewhere between bankfull and the two-year return interval during this time. Floodplain inundation had only been observed twice in PA3 during the 30 years prior to 2019 (Figure 27).
