Tucannon Fish Habitat Enhancement Project

Confederated Tribes of the Umatilla Indian Reservation

2017-2018 Annual Progress Report

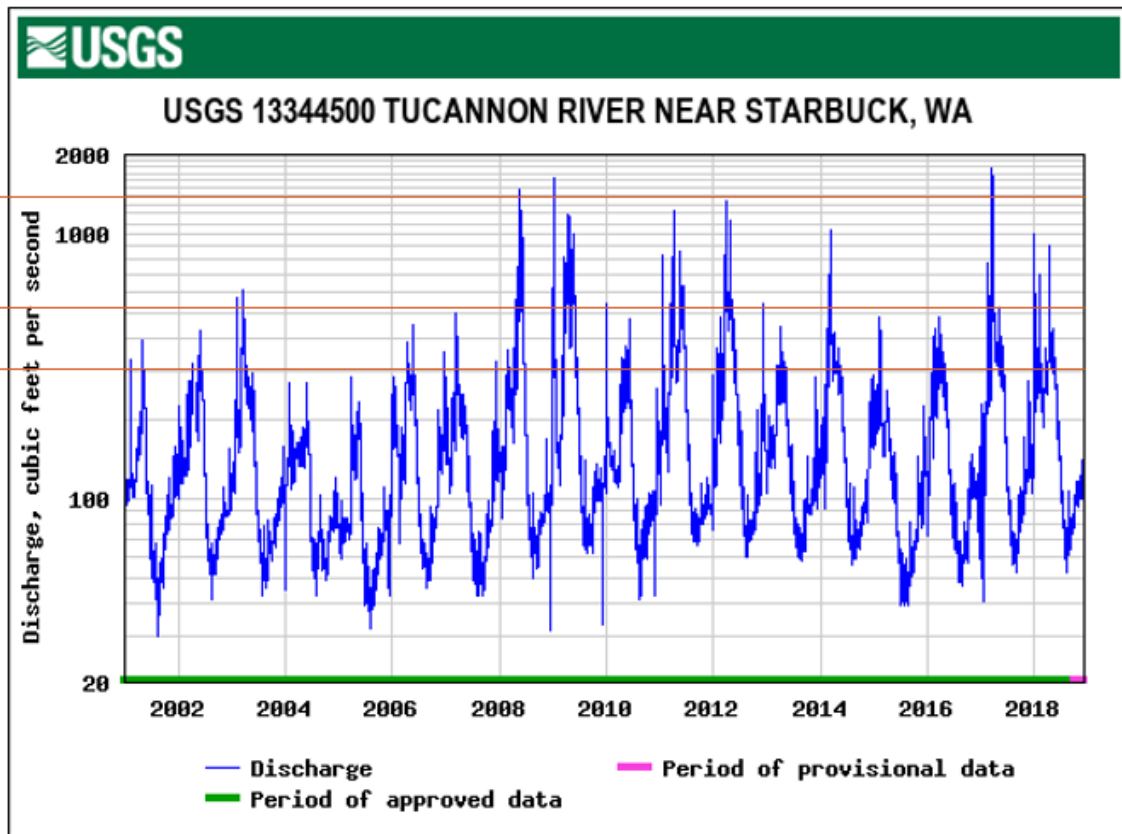
Annual hydrograph (discharge in cubic feet per second) for the lower Tucannon River at Starbuck, WA for the period of 2000-2019. The horizontal red lines indicate the average annual discharge for the winter base flow, one-year return interval (595cfs), and two-year return interval (1250cfs).

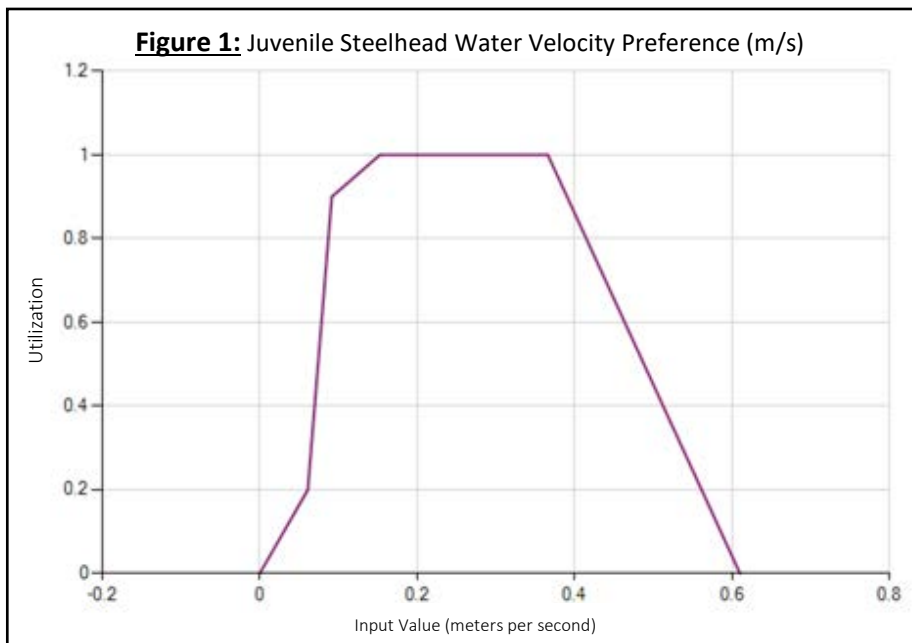
Low velocity areas are important physical conditions for optimizing energetics of foraging juveniles and migrating adult salmon. The optimum stream velocity for juvenile steelhead is between 1.5-3.5 meters per second (Figure 1). Figure 2 provides a spatial comparison of pre-treatment and post-treatment stream velocities within the CBW05583-079743 survey site. A qualitative observation of the pre-treatment and post-treatment spatial comparison of modeled velocities (Figure 2) suggests that the post-treatment condition has greater spatial heterogeneity in stream velocity. The 2016 pre-treatment velocity condition appears to have high velocity segments that are contiguous over longer stretches of space. There appear to be more frequent low velocity breaks interspersed throughout the survey area in the 2018 post-treatment condition which, if true, would improve habitat conditions for salmonids.

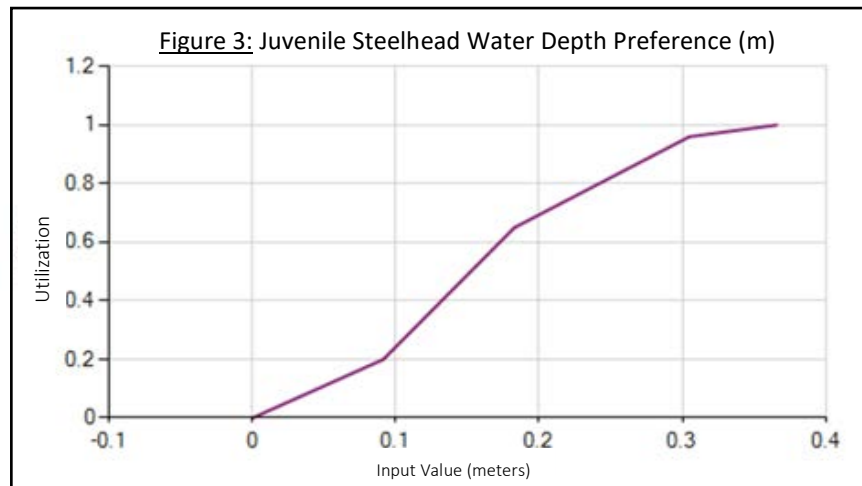
Deep water provides refuge from aerial predators for salmon. The optimum stream depth for juvenile steelhead is between 0.3 and 3 meters (Figure 3). Figure 4 provides a spatial comparison of pre-treatment and post-treatment stream depths within the CBW05583-079743 survey site. A qualitative assessment of the pre-treatment and post-treatment spatial comparison of surveyed stream depths (Figure 4) suggests that the post-treatment condition has an increased frequency of deep water conditions and a reduction in the amount of stream area that falls within the shallowest depth range. Water depths falling within the optimum range for juvenile steelhead, between 0.3 and 3 meters, appears to have improved.

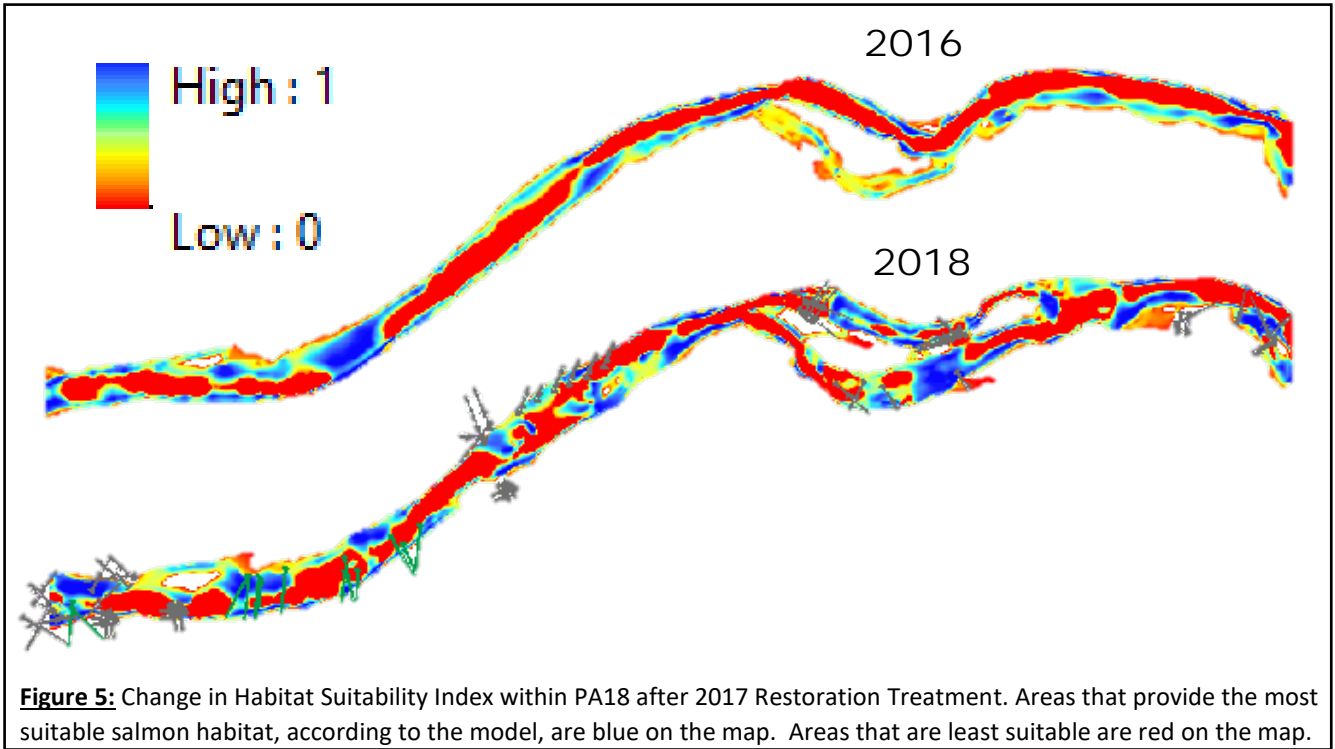
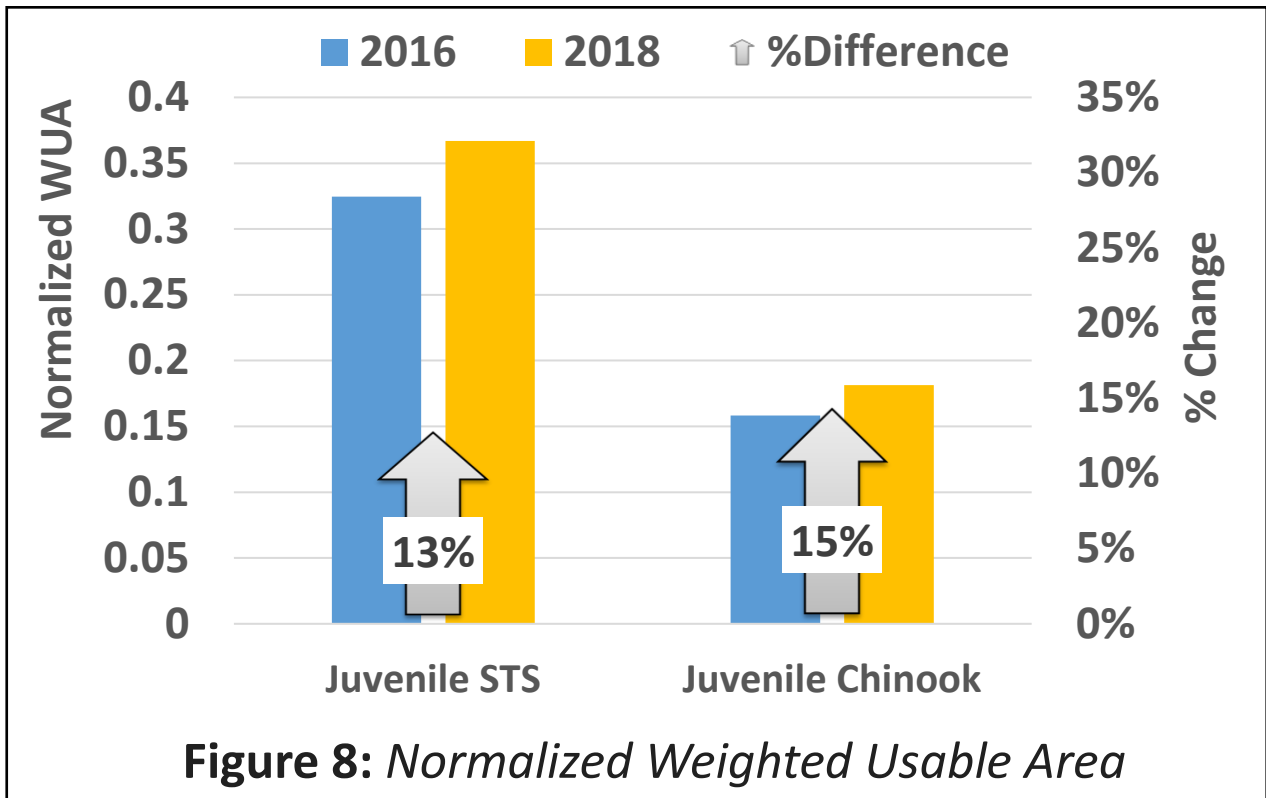
An HSI is a numerical index that represents the capacity of a given habitat to support a selected species. This HSI describes the suitability of pre-treatment and post-treatment salmonid habitat by combining the interactions of velocity and depth on a species' vital rates and survival. The HSI model used for CBW05583-079743 rates salmonid habitat quality on a scale of 0-1. Figure 5 provides a spatial comparison of pre-treatment and post-treatment HSI within the CBW05583-079743 survey site. Usable area (suitable salmonid habitat) increased after the 2017 restoration treatment was completed in PA18 (Figure 7 and 8).

The number of observed pools within the CBW05583-079743 survey site increased from four in the 2016 pre-treatment condition to six in the 2018 post-treatment condition (Figure 6).

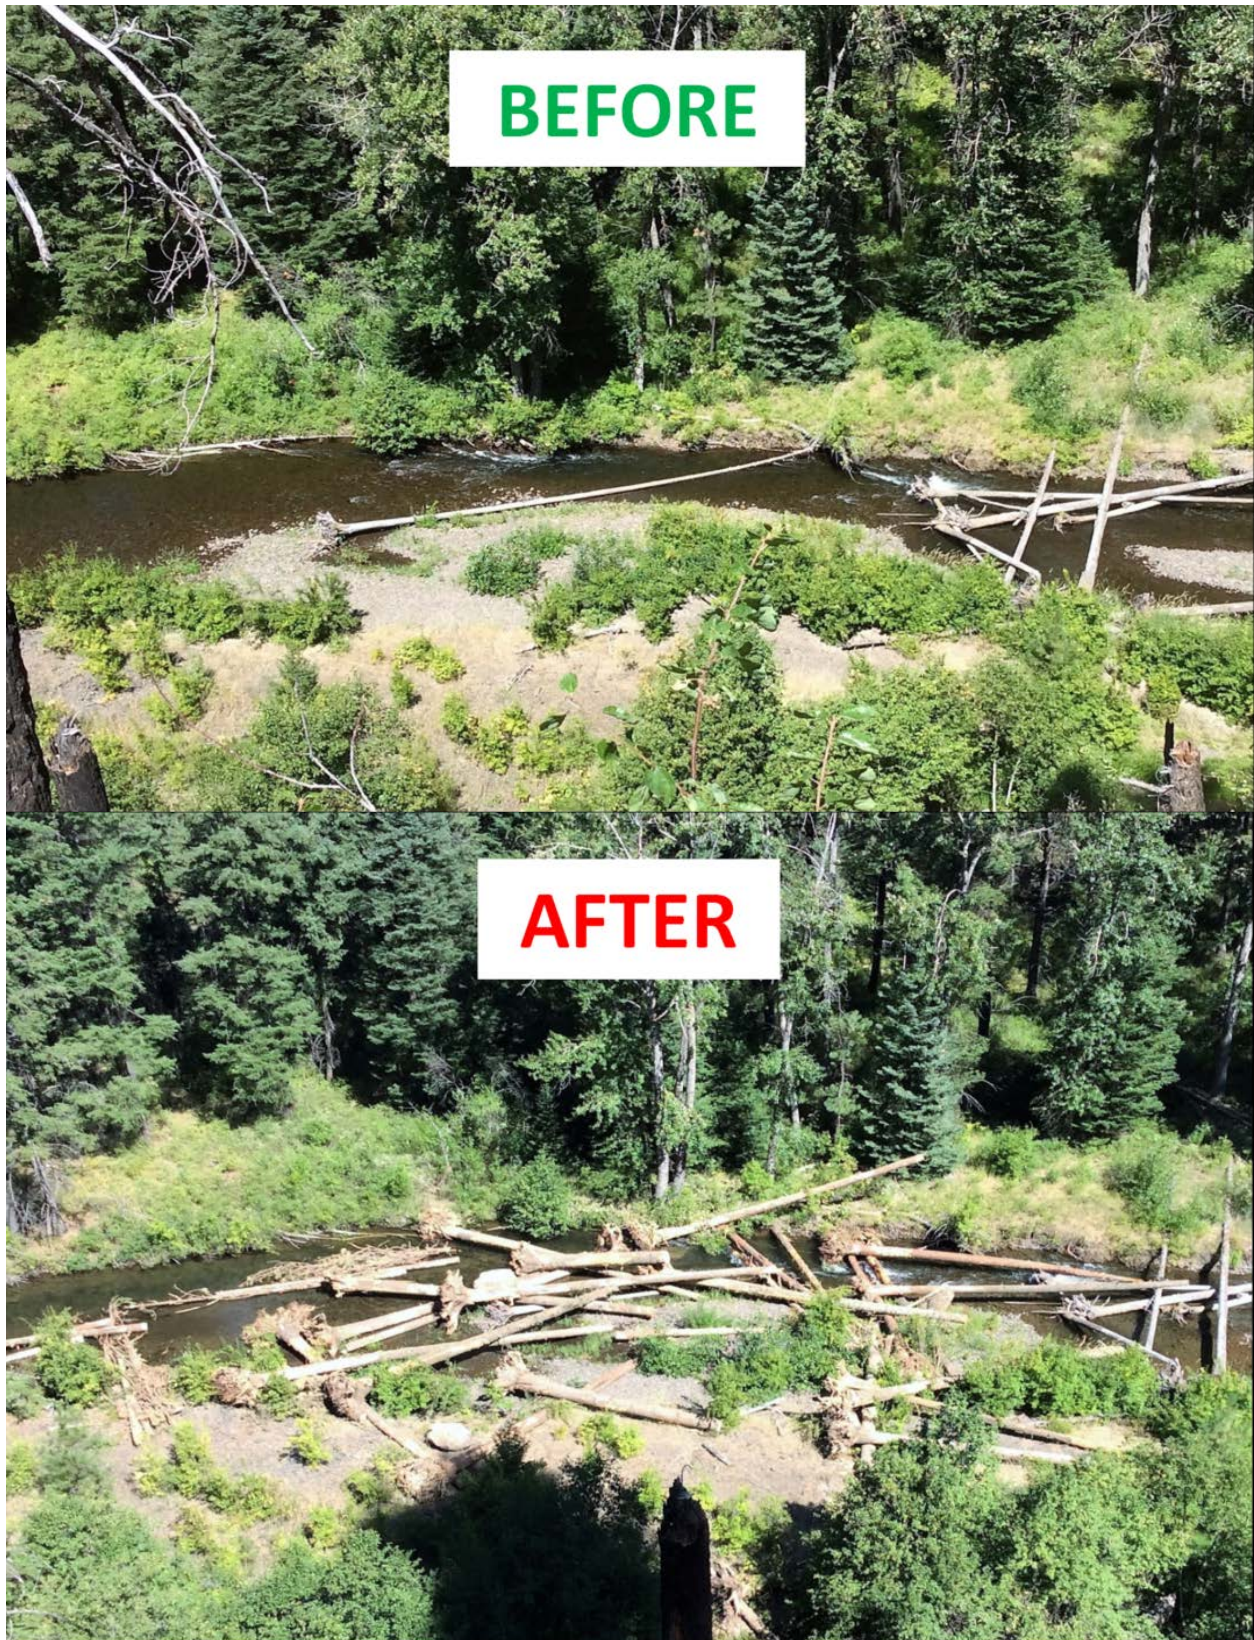
Figure 13: Pre-treatment and post-treatment conditions where a channel spanning wood structure was placed near the upstream opening to a paleochannel in PA3.

The adaptive management actions taken in 2018 added 720 key pieces of wood and 47 ballast boulders to the reach. Channel spanning large wood structures were strategically placed below the upstream opening to observed paleochannels in order to facilitate a backwatering effect and move surface water into the paleochannels (Figure 11). The number of key pieces of wood per channel width in the 2017 pre-treatment condition was 1.59. The 2018 restoration treatment in PA3 increased wood loading for the reach to 3.79 key pieces per channel width.
