# TUCANNON RIVER GEOMORPHIC ASSESSMENT AND HABITAT RESTORATION STUDY

**Prepared for**

Columbia Conservation District  
202 South 2nd Street, U.S. Post Office Building  
Dayton, Washington 99328

Anchor QEA, LLC  
1605 Cornwall Avenue  
Bellingham, Washington 98225

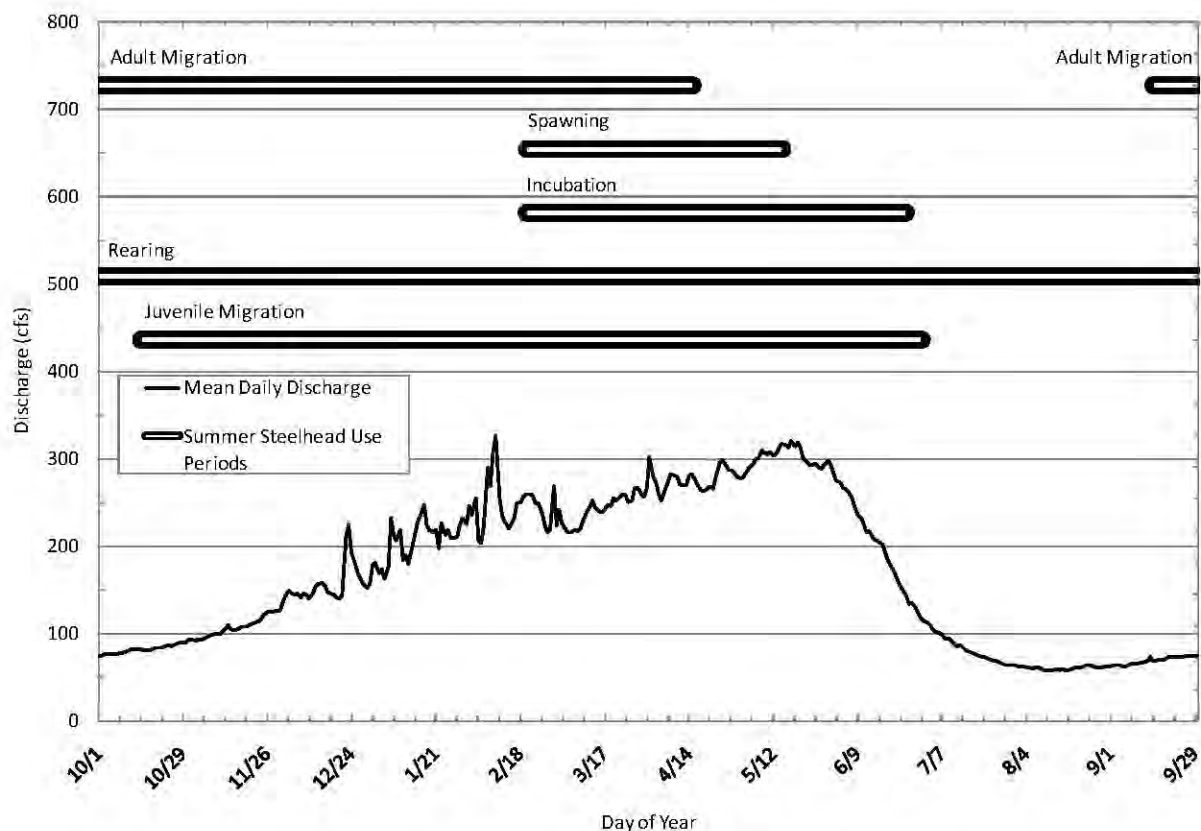
**Figure 4-1**  
**Mean Annual Hydrograph and Typical Timing of Life History Stages for Summer Steelhead Trout in the Tucannon Basin**

Steelhead trout in the Tucannon River are of the Snake River Basin steelhead evolutionarily significant unit (ESU), which was listed as threatened in 1997. Summer steelhead trout enter the Tucannon River in September and begin spawning in late February to early March until mid-May. Spawning occurs in the mainstem from Kellogg Creek (RM 4.8) upstream to the Tucannon headwaters, as well as within Cummings Creek and in the lower portions Panjab and Sheep Creeks; the greatest concentration of steelhead spawning is typically found in the mainstem between Tucannon Falls (RM 16.5) and Beaver Lake at approximately RM 42. Juveniles also rear throughout the mainstem but are typically found in the greatest numbers between approximately RM 18 and School Canyon (approximately RM 45).

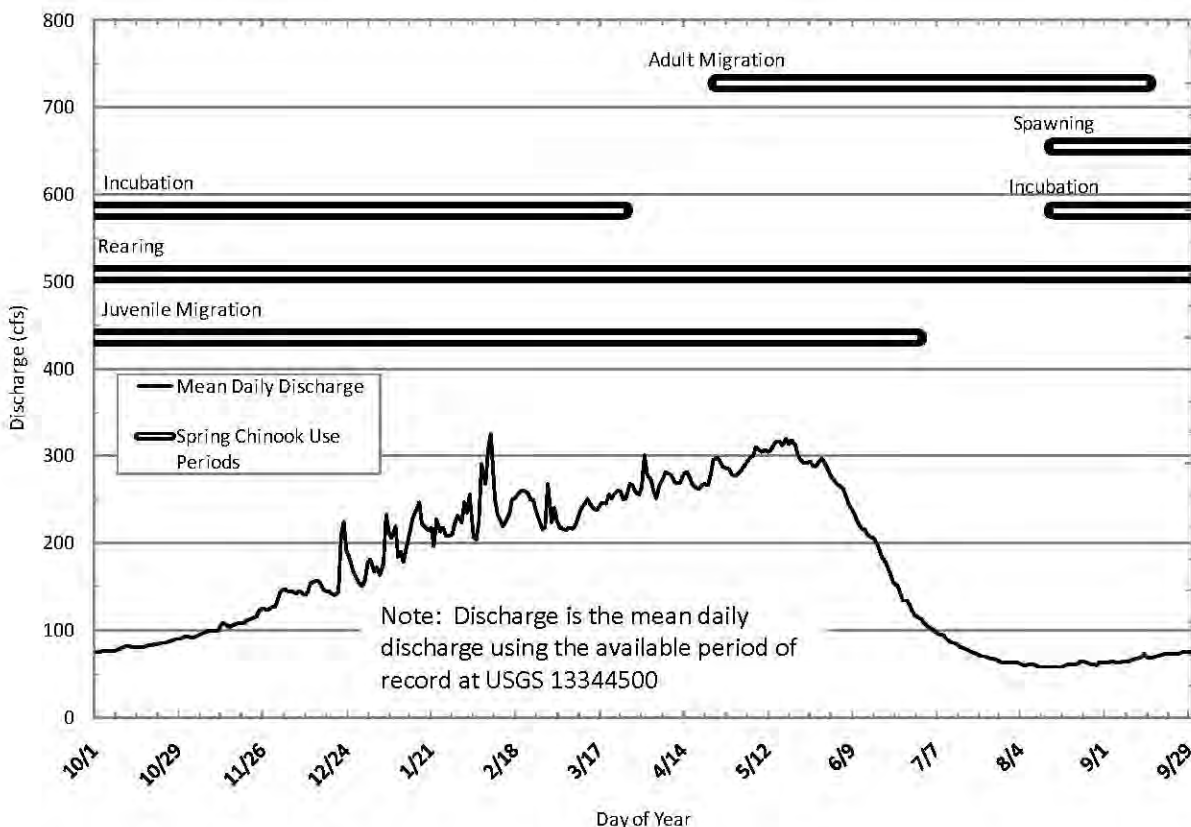
**Figure 4-2**  
**Mean Annual Hydrograph and Typical Timing of Life History Stages for Spring Chinook Salmon in the Tucannon Basin**

Spring Chinook salmon in the Tucannon River are of the Snake River spring/summer Chinook salmon ESU that was ESA-listed as threatened in 1992. Spring Chinook salmon enter the Tucannon River beginning as early as late April and as late as mid-September; spawning occurs from mid-August to the end of September. Spawning occurs almost exclusively in the main channel from approximately King Grade (RM 22.9) to the mouth of Sheep Creek near RM 55 (Gallinat and Ross 2010); the greatest densities are between Marengo and the Little Tucannon River (approximately RM 48.1). Juveniles rear from approximately Tucannon Falls (RM 16.5) to the headwaters, with the highest densities located between Marengo and School Canyon (approximately RM 45).

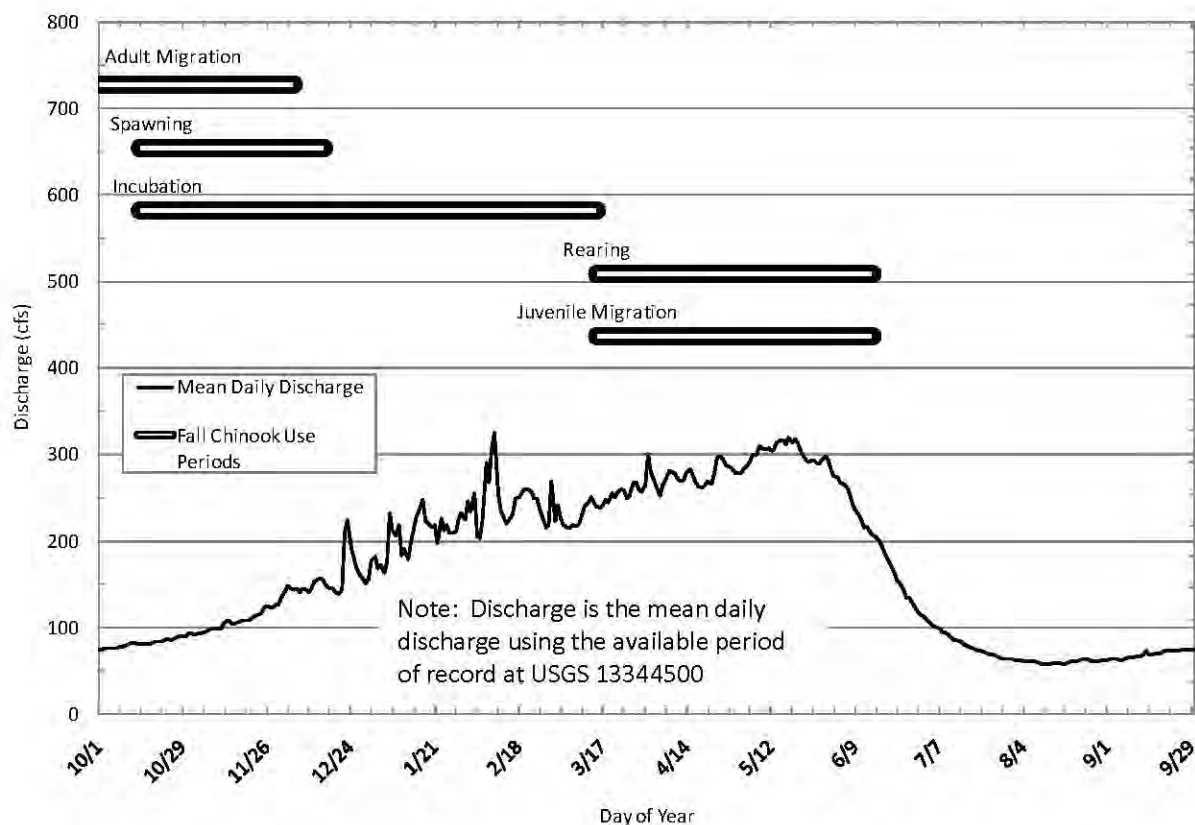
**Figure 4-3**  
**Mean Annual Hydrograph and Typical Timing of Life History Stages for Fall Chinook Salmon in the Tucannon Basin**

Fall Chinook salmon are of the Snake River fall Chinook salmon ESU, also listed as threatened in 1992. Fall Chinook salmon enter the lower Tucannon River beginning in early October and have a brief holding period until spawning begins in mid-October. Fall Chinook salmon use the main channel of the river from the mouth to upstream of Pataha Creek (RM 12.3), the highest concentration of spawning being from the mouth to around the Starbuck Dam near RM 5.5. Juvenile fall Chinook salmon do not overwinter in the Tucannon River and out-migrate shortly after emergence during the late winter to early summer.

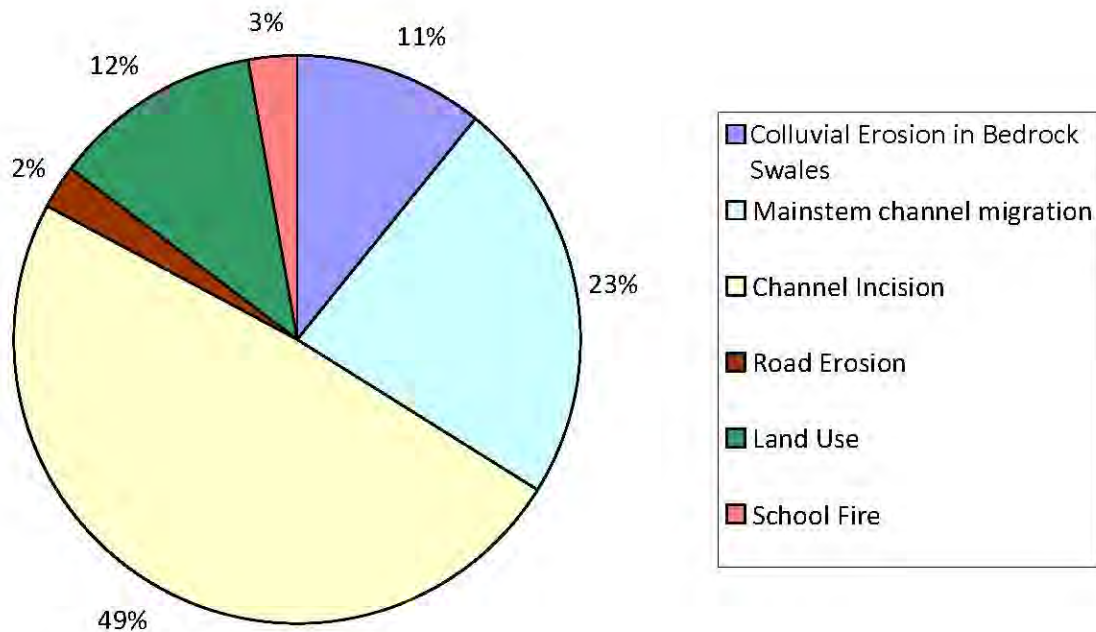
**Figure 6-1**  
**Current Sediment Inputs by Source**

U = unknown; mainstem channel migration was observed in the Little Tucannon-Tucannon River subbasin, as well as a minor amount in the Headwaters subbasin, but the magnitude of sediment input in these areas could not be quantified due to the lack of complete aerial photograph coverage. The estimate of average tons per acre for these subbasins may be affected.

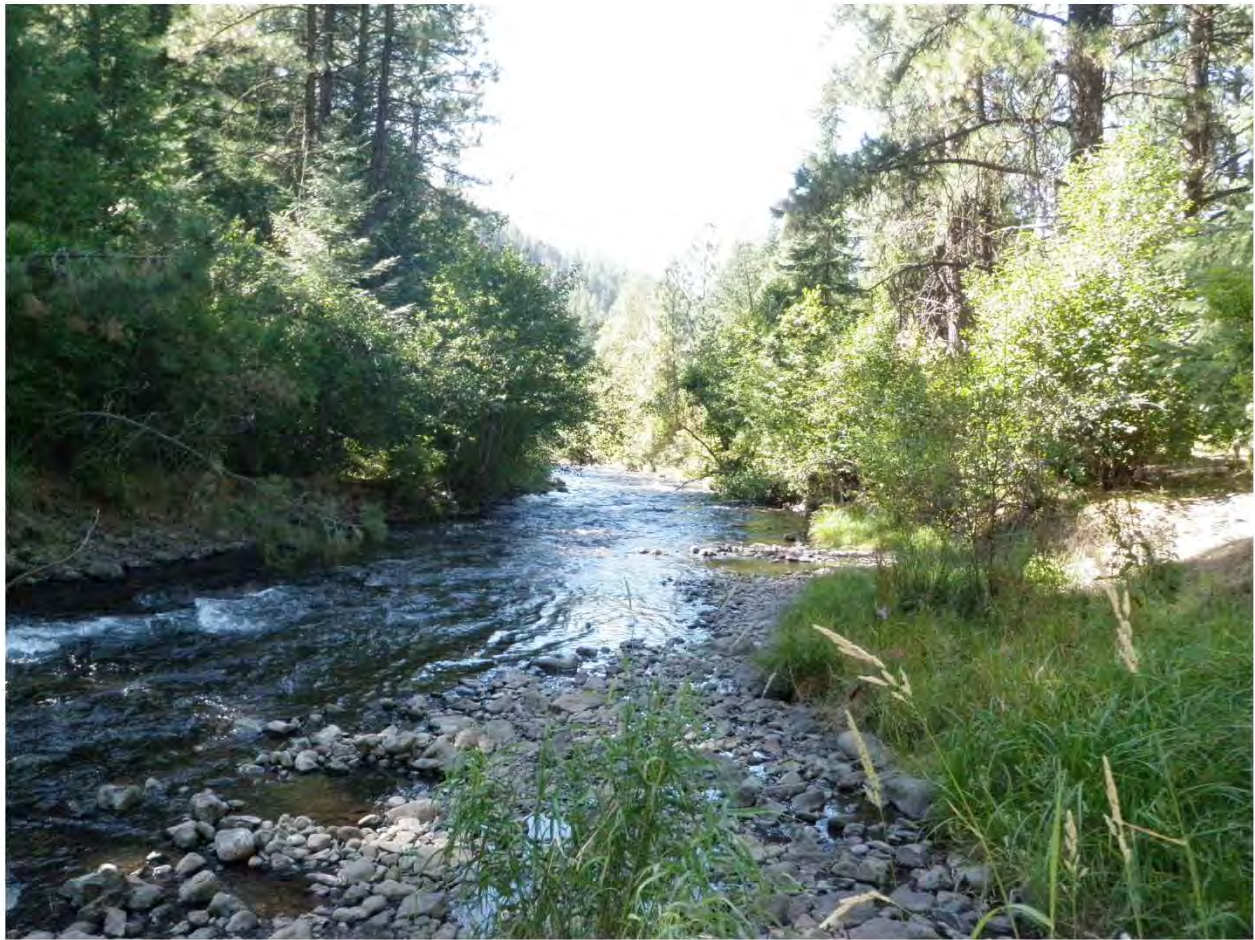
**Photograph 7-1**

**The Main Channel Near RM 49.1, Looking Upstream**

Reach 10 is located from the mouth of Panjab Creek at RM 50.2, to the downstream end of Big Four Lake (RM 44.0; Figure D-10a). The reach is within the Umatilla National Forest and Wenaha-Tucannon Wilderness area, and includes both public (WDFW) and private holdings such as the Camp Wooten natural resources learning center. The valley is forested with conifers that increase in density upstream of Panjab Creek (RM 50.2). A majority of the subbasin areas between the Little Tucannon River (RM 48.0) and the downstream end of Reach 10 were affected by the 2005 School Fire; the most severely burned areas were the Hixon and Grub Canyon basins (USFS 2008). Confinement in the reach is variable; confinement in the lower reach downstream of the Little Tucannon River is typically influenced by anthropogenic features, whereas confinement in the upper reach is associated with alluvial fans, debris flow deposits, and natural narrowing of the valley width.

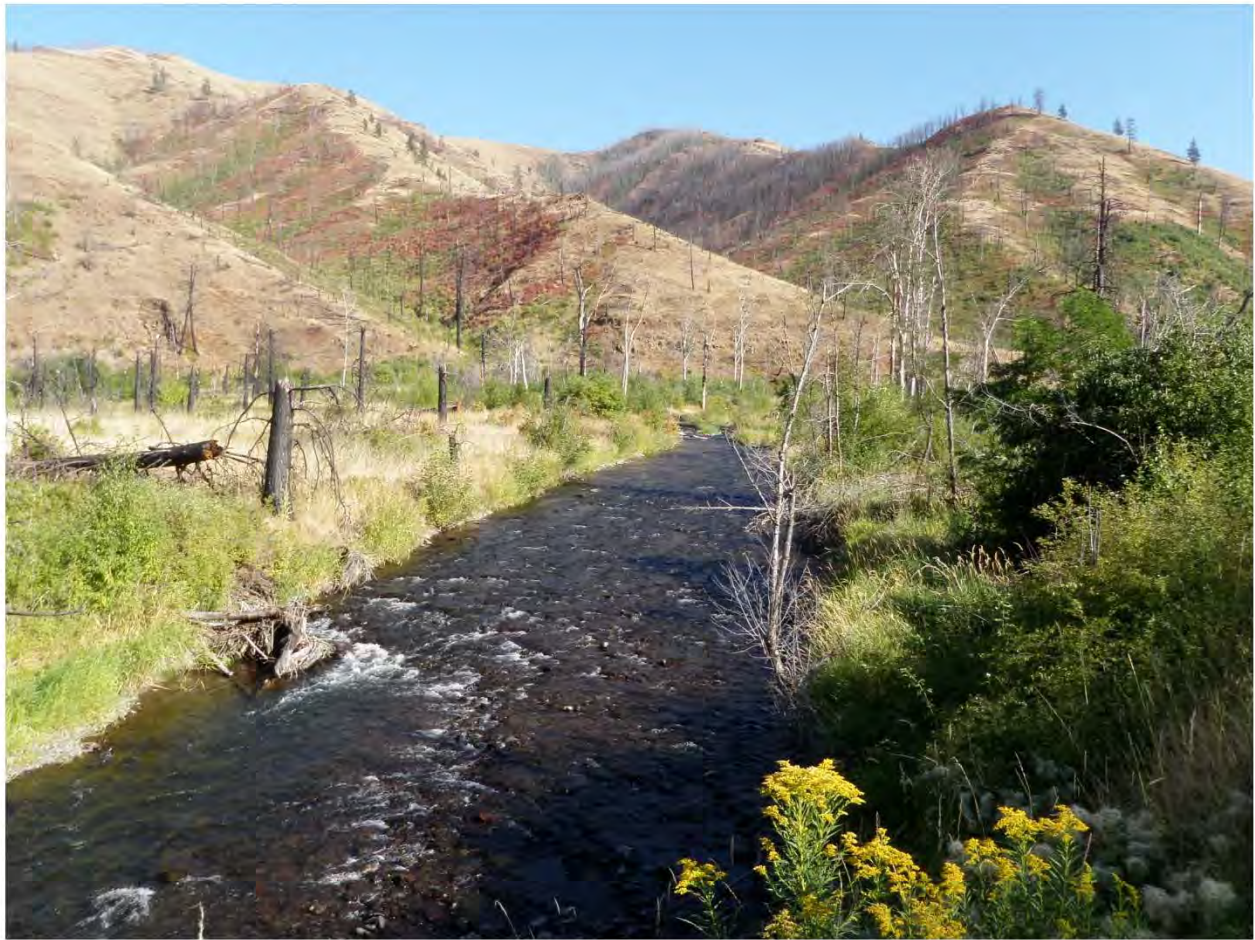
**Photograph 7-2**

**A Portion of the Valley Severely Burned in the School Fire Near RM 42.1**

Riparian conditions are poor due to the effects of the School Fire (Appendix D). Throughout much of this portion of the reach, the channel is exposed with little cover except for overhanging grasses and immature deciduous trees growing on the margins. In the unburned areas of the riparian zone, mature deciduous and conifer trees are present, although the density of vegetation is low in many places.

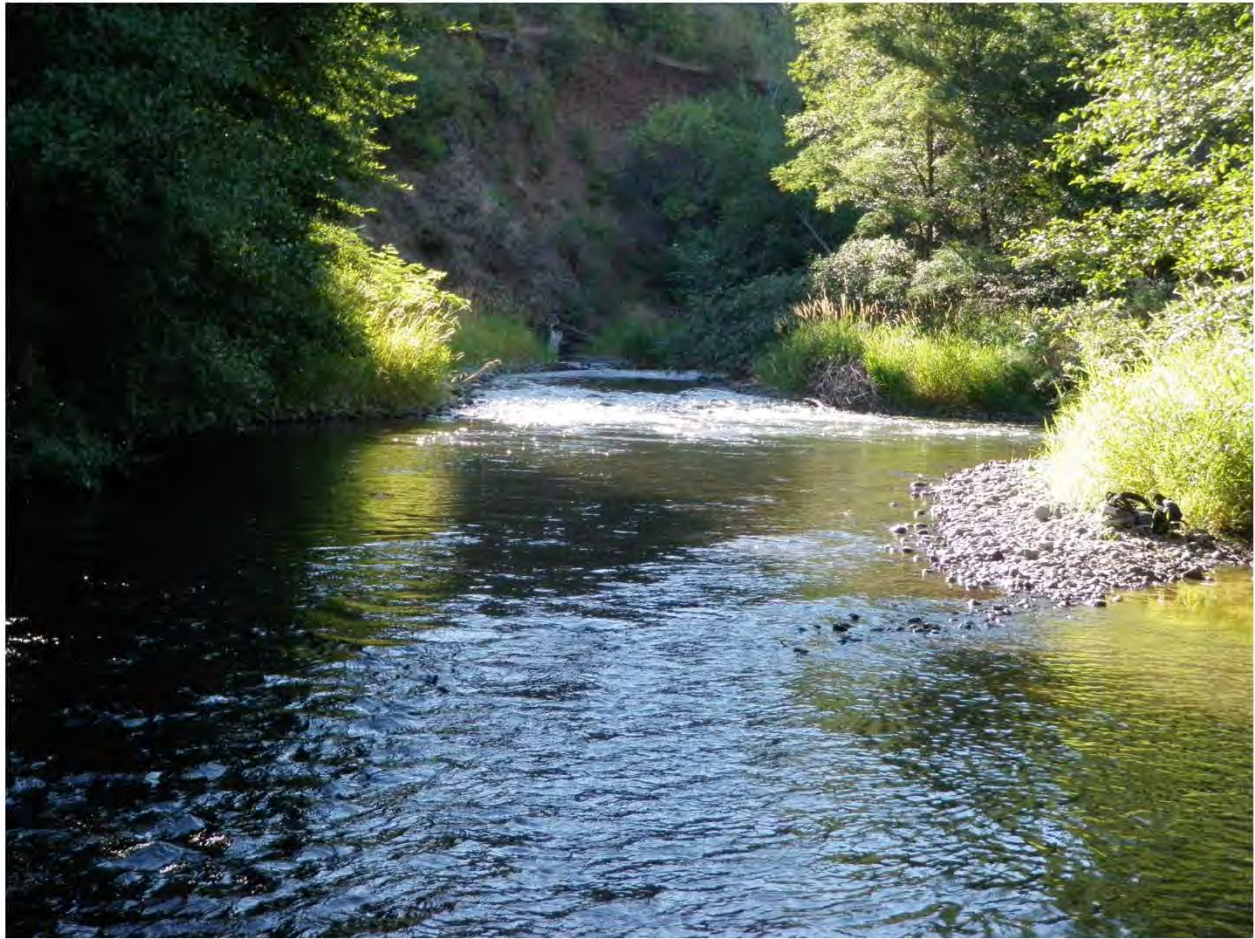
**Photograph 7-3**

**A Braided Channel Section Adjacent to a Bedrock Valley Wall Near RM 34.0**

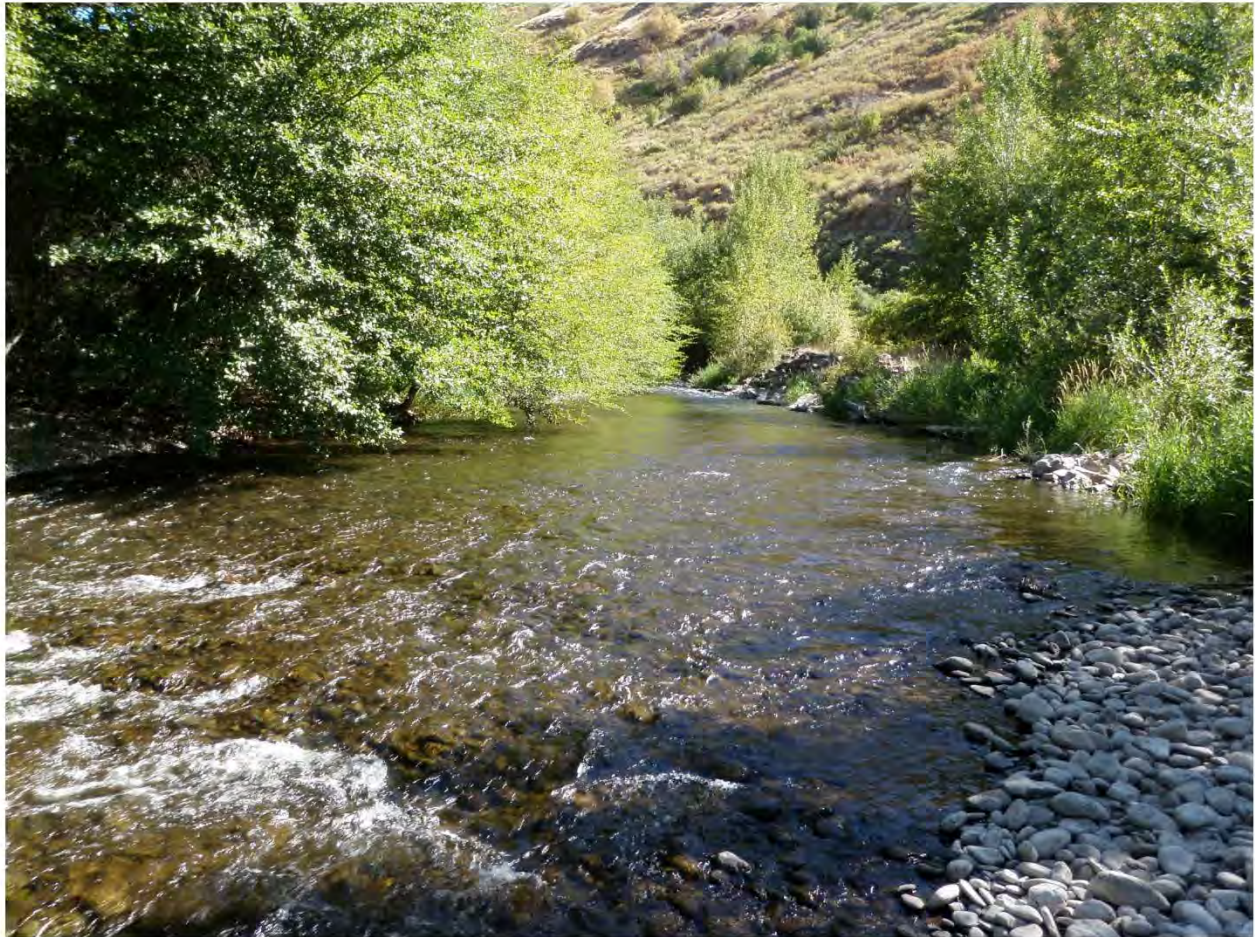
**Photograph 7-4**

**A Meander Bend Against the Bedrock Valley Wall Near RM 27.9**

amount of visible infrastructure as much of the confinement is due to the position of the river along the bedrock valley walls. A majority of confinement is due to anthropogenic features such as road grades, constrictions at bridges, and some levees.

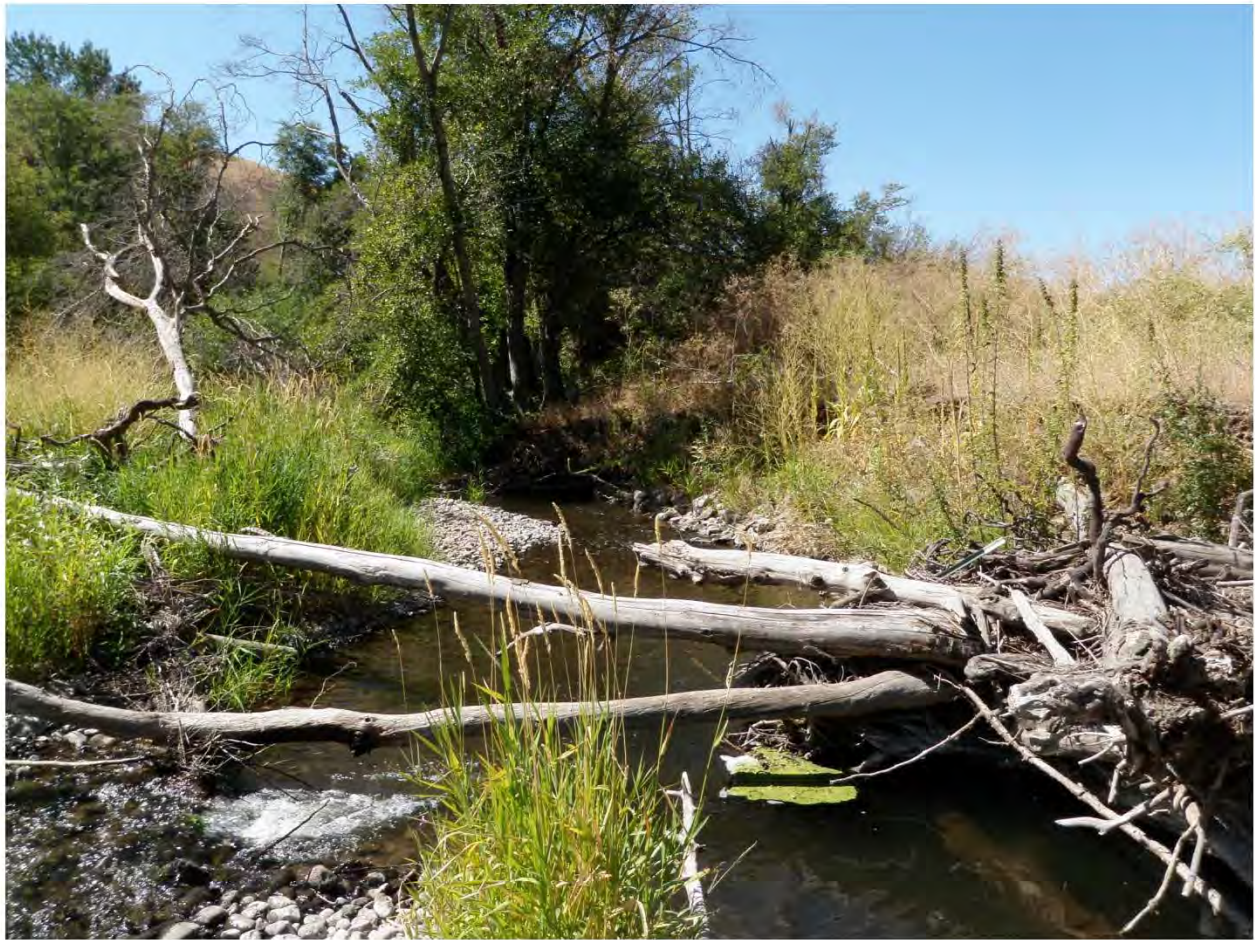
**Photograph 7-5**

**Large Woody Debris in an Unconfined, Braided Channel Section Near RM 21.6**

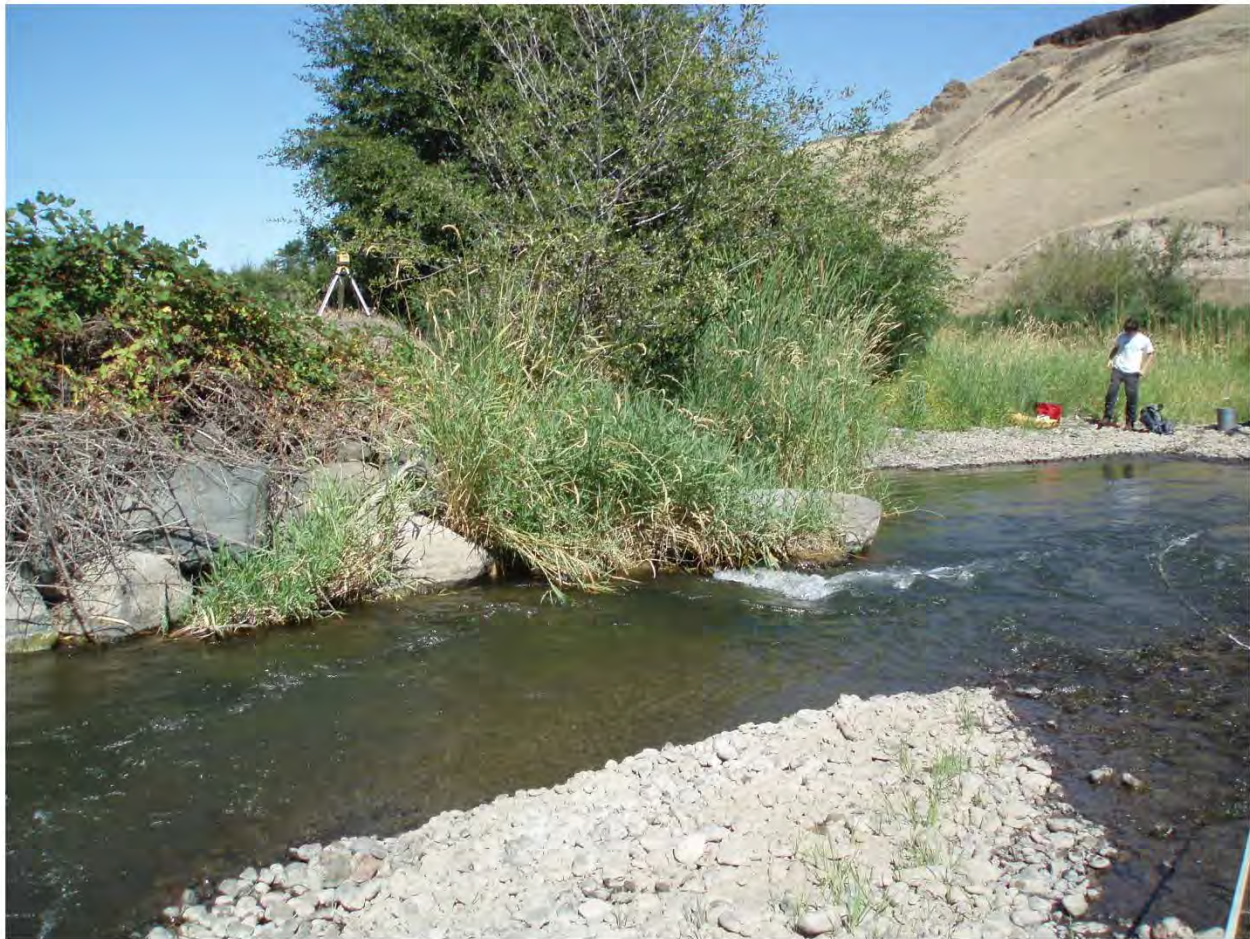
**Photograph 7-6**

**Stone Riprap at the Toe of a Levee Near RM 18.7**

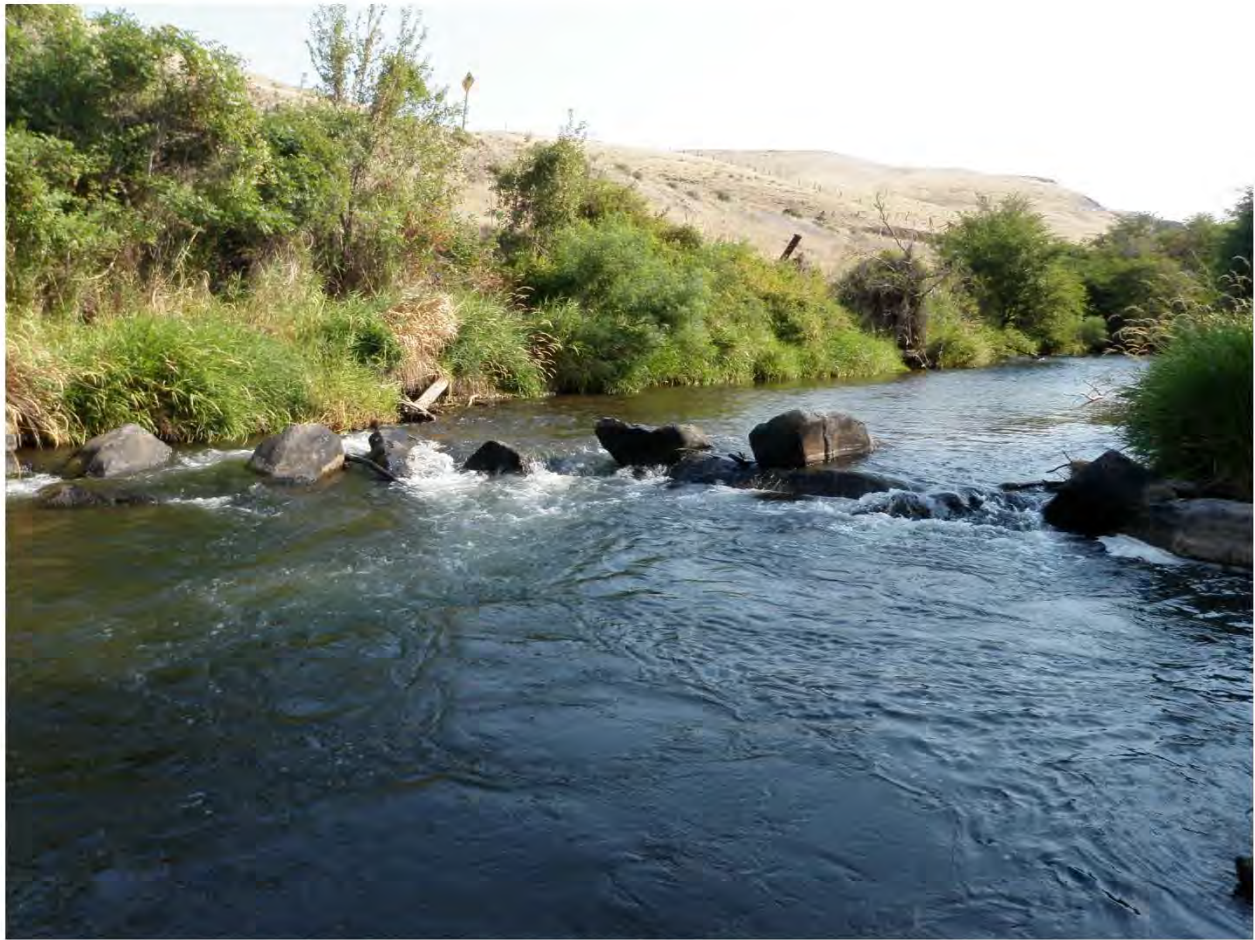
**Photograph 7-7**

**A Rock Weir in Confined Section Near RM 11.4**

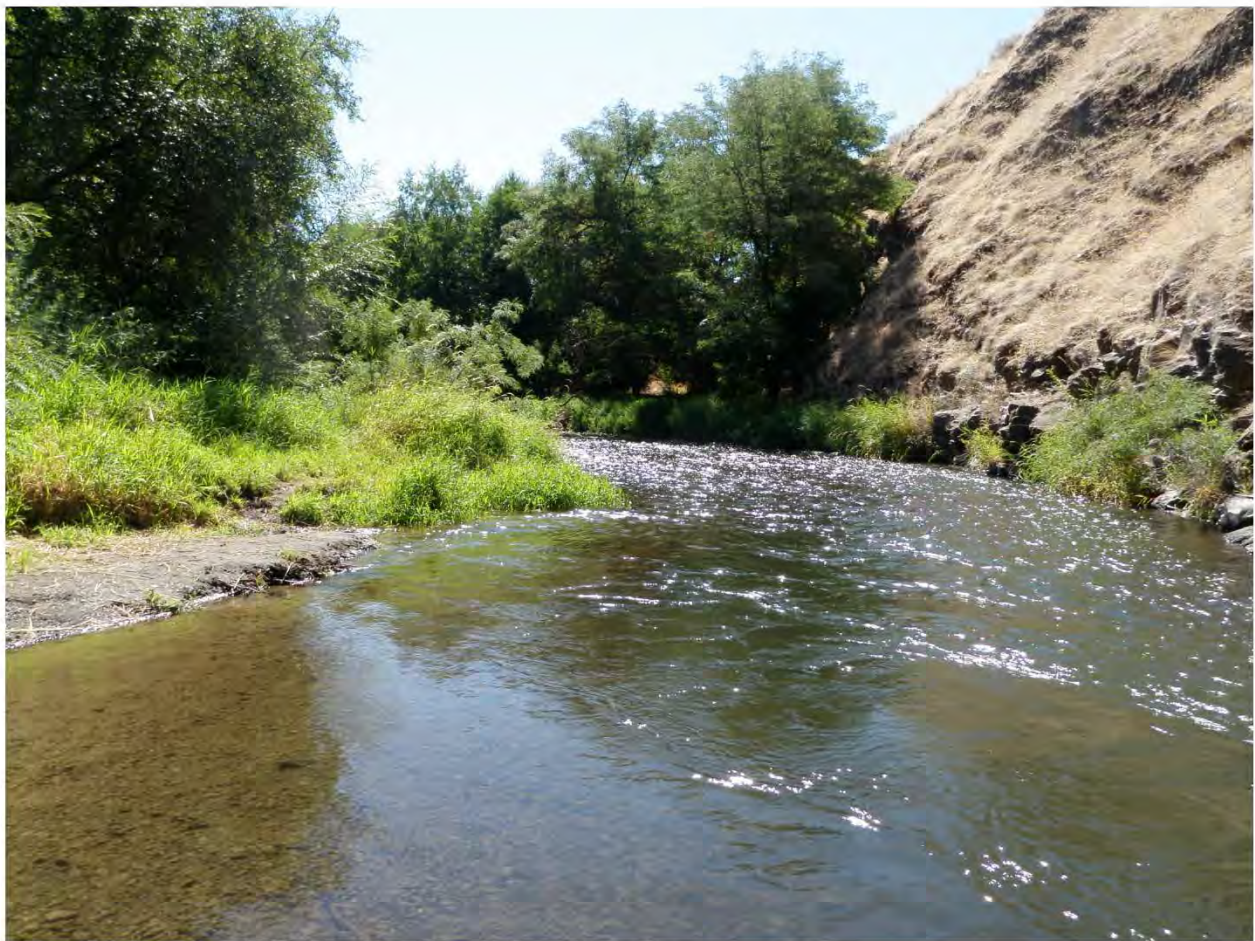
**Photograph 7-8**

**The Channel Confined Between the Starbuck Levee and the Bedrock Valley Wall Near RM 4.6**

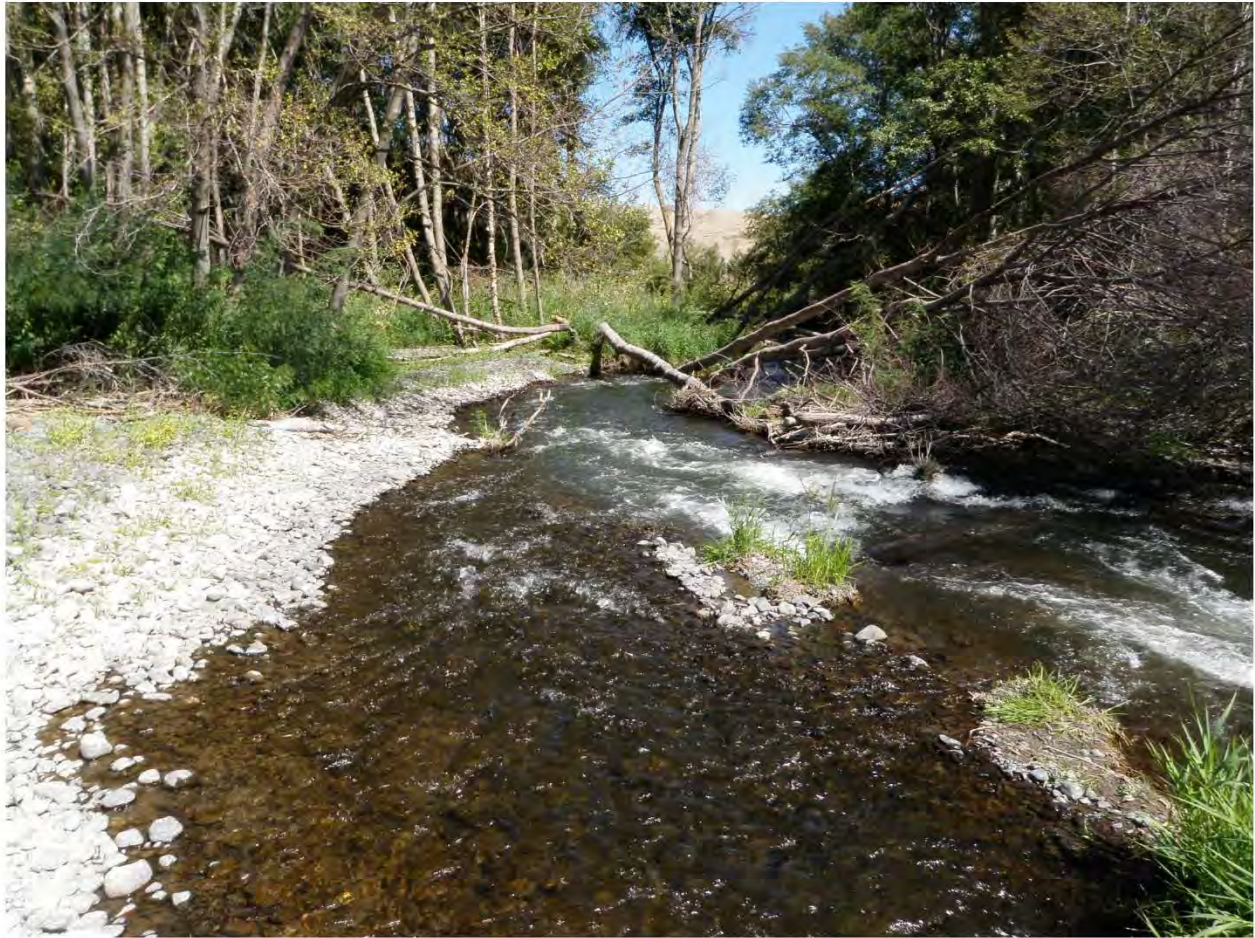
**Photograph 7-9**

**A Recent Channel Avulsion at the Split-Channel Section Near RM 3.9**
