# TUCANNON RIVER GEOMORPHIC ASSESSMENT AND HABITAT RESTORATION STUDY

## **Prepared for**

Columbia Conservation District  
202 South 2nd Street, U.S. Post Office Building  
Dayton, Washington 99328

Anchor QEA, LLC  
1605 Cornwall Avenue  
Bellingham, Washington 98225

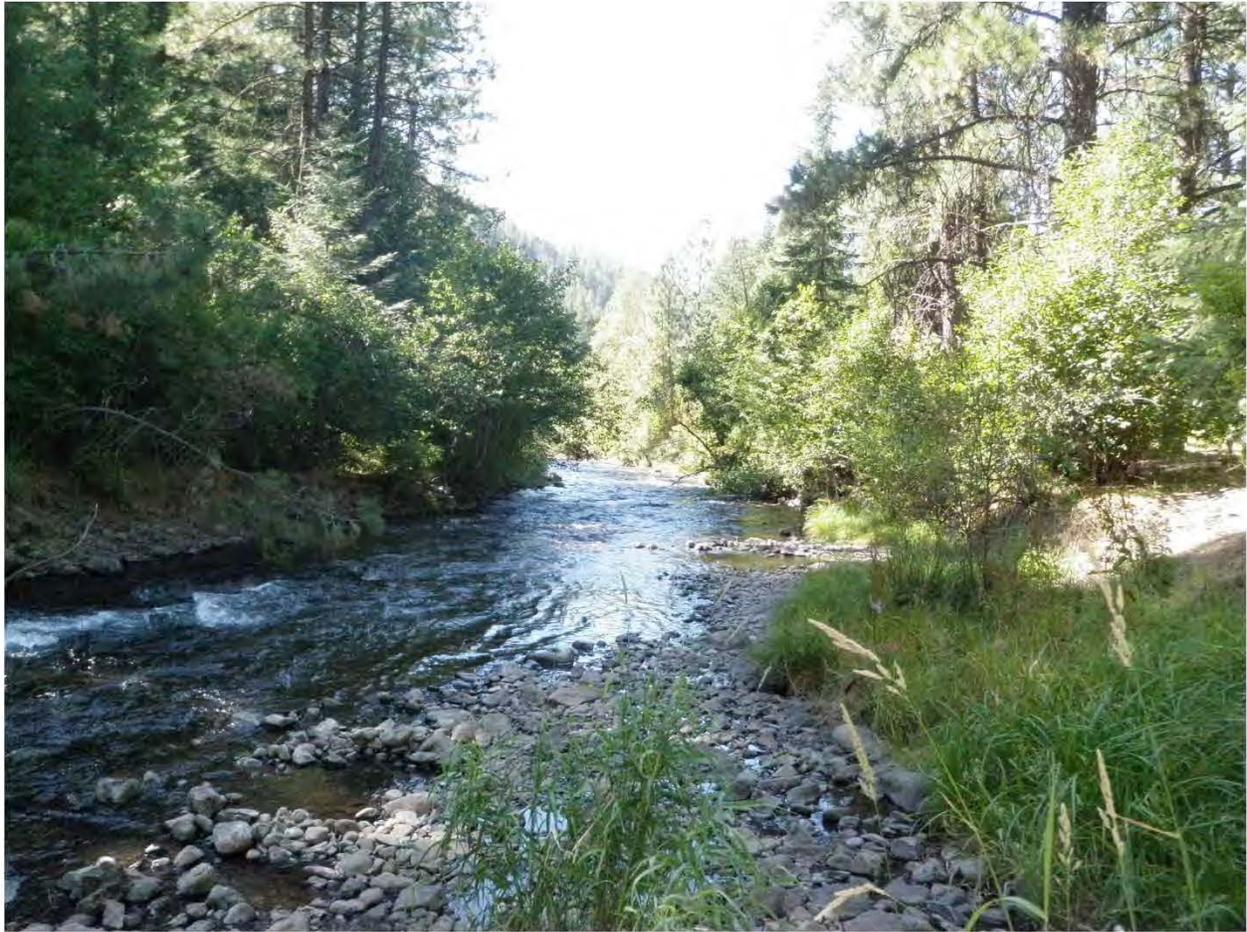
**Photograph 7-1**

**The Main Channel Near RM 49.1, Looking Upstream**

Reach 10 is located from the mouth of Panjab Creek at RM 50.2, to the downstream end of Big Four Lake (RM 44.0; Figure D-10a). The reach is within the Umatilla National Forest and Wenaha-Tucannon Wilderness area, and includes both public (WDFW) and private holdings such as the Camp Wooten natural resources learning center. The valley is forested with conifers that increase in density upstream of Panjab Creek (RM 50.2). A majority of the subbasin areas between the Little Tucannon River (RM 48.0) and the downstream end of Reach 10 were affected by the 2005 School Fire; the most severely burned areas were the Hixon and Grub Canyon basins (USFS 2008). Confinement in the reach is variable; confinement in the lower reach downstream of the Little Tucannon River is typically influenced by anthropogenic features, whereas confinement in the upper reach is associated with alluvial fans, debris flow deposits, and natural narrowing of the valley width.

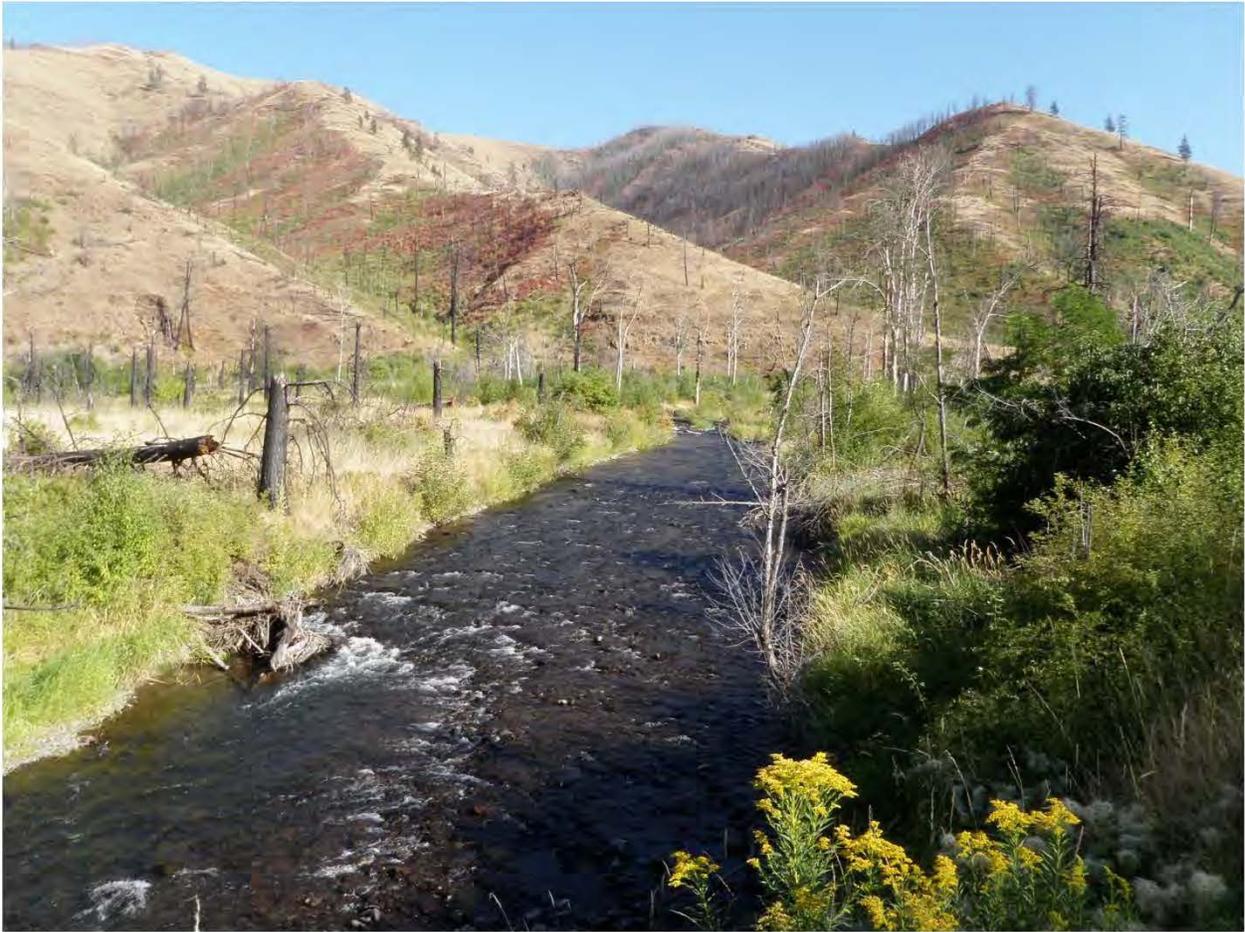
**Photograph 7-2**

**A Portion of the Valley Severely Burned in the School Fire Near RM 42.1**

Reach 9 is located from RM 44.0 near Big Four Lake to the hatchery dam at RM 40.0 (Figure D-9a). The reach spans the National Forest boundary at approximately RM 41.4. The portion of the main channel riparian zone from approximately RM 40.4 to 42.8 was moderately to severely burned in the 2005 School Fire, and all of the subbasins draining into Reach 9 were moderately to severely burned, including the Waterman Gulch and Big Four Canyon areas (Figure D-9a) (USFS 2008). The portion of the valley that was not burned is primarily conifer forest with sparse undergrowth. The burned zone has few remaining trees, little understory other than grasses, and burnt tree trunks (Photograph 7-2). Approximately half of the length of the reach is unconfined with the other half moderately confined (Appendix D). These conditions result in a reach that is relatively dynamic in terms of channel planform and migration.

Riparian conditions are poor due to the effects of the School Fire (Appendix D). Throughout much of this portion of the reach, the channel is exposed with little cover except for overhanging grasses and immature deciduous trees growing on the margins. In the unburned areas of the riparian zone, mature deciduous and conifer trees are present, although the density of vegetation is low in many places.

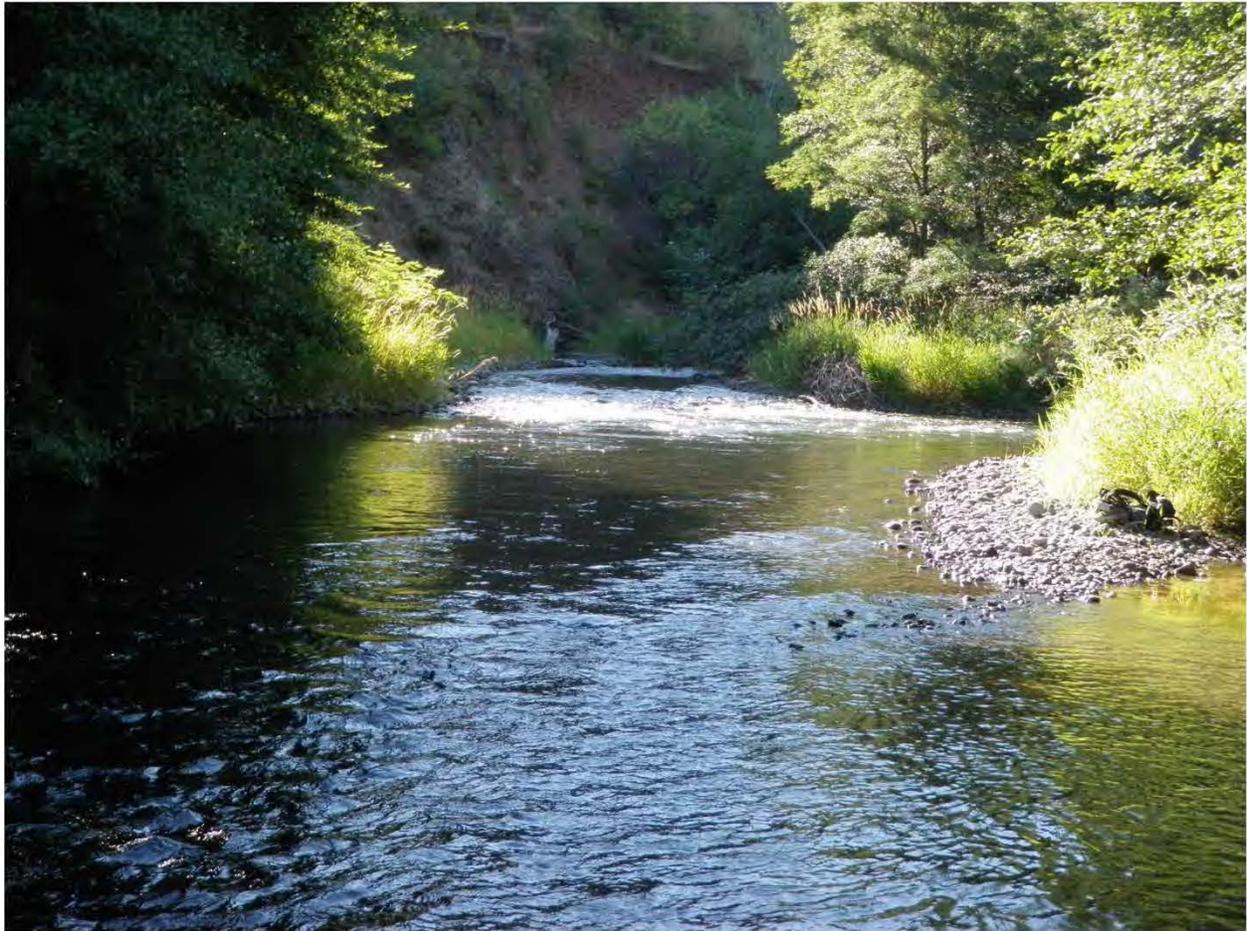
**Photograph 7-3**

**A Braided Channel Section Adjacent to a Bedrock Valley Wall Near RM 34.0**

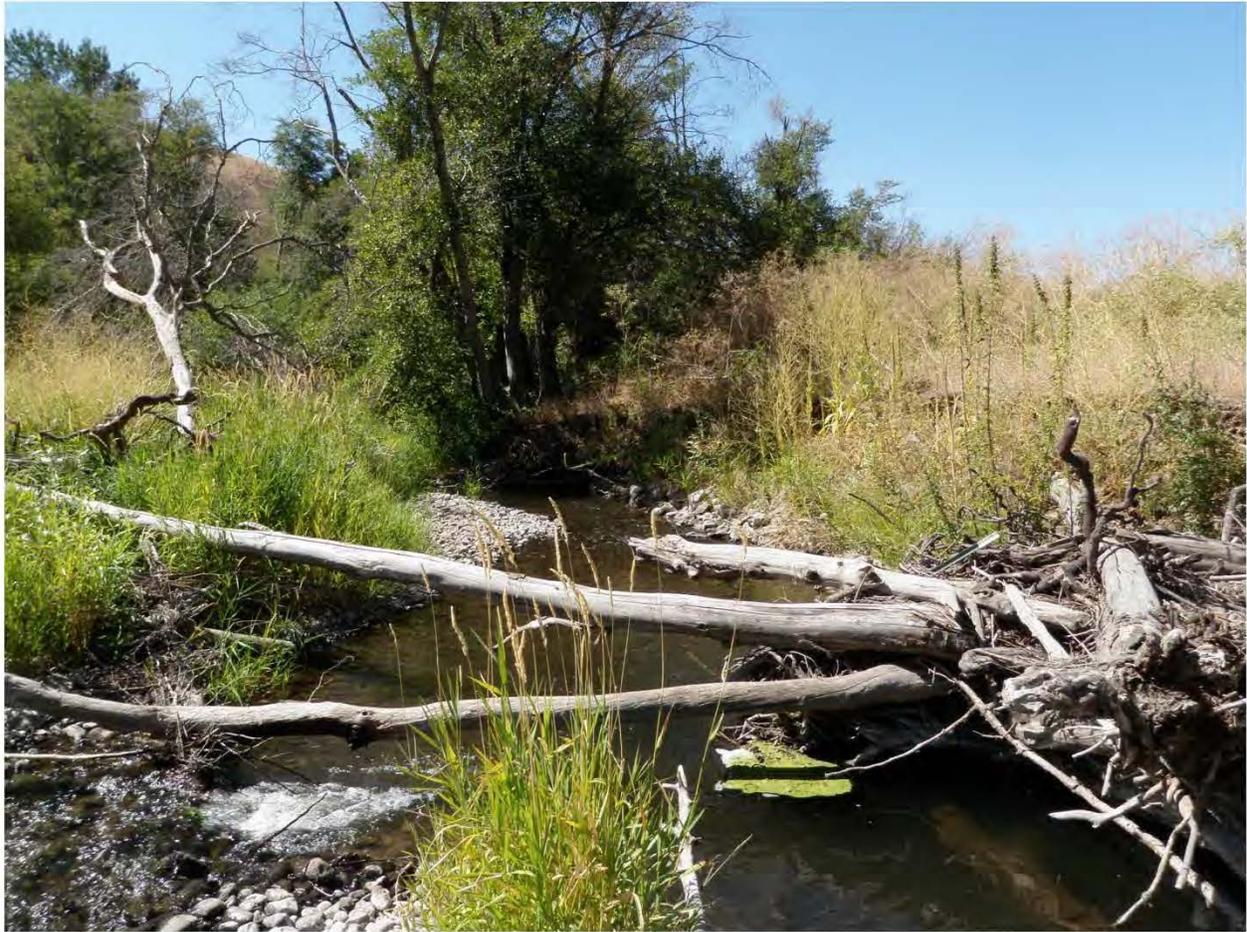
**Photograph 7-5**

**Large Woody Debris in an Unconfined, Braided Channel Section Near RM 21.6**

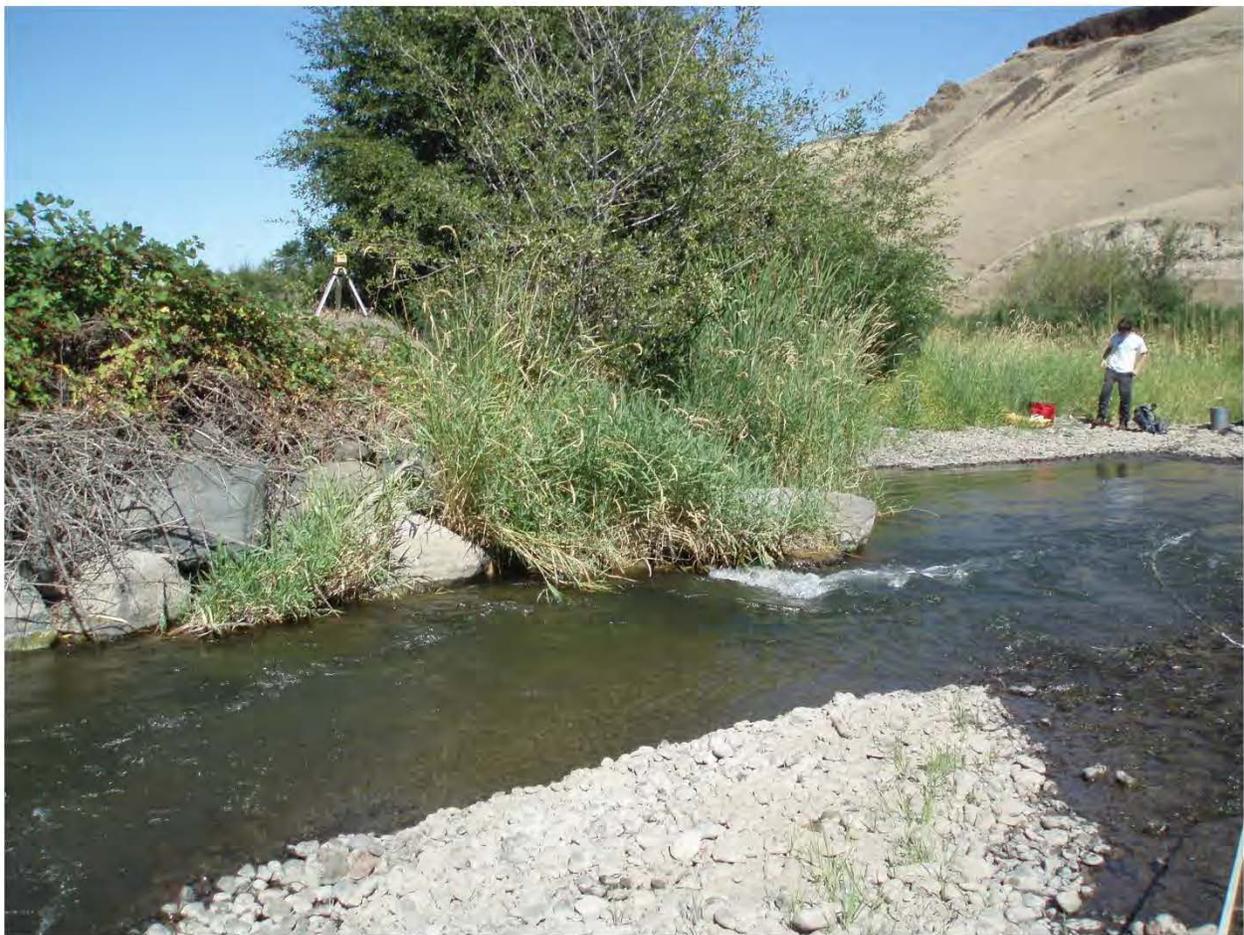
**Photograph 7-6**

**Stone Riprap at the Toe of a Levee Near RM 18.7**

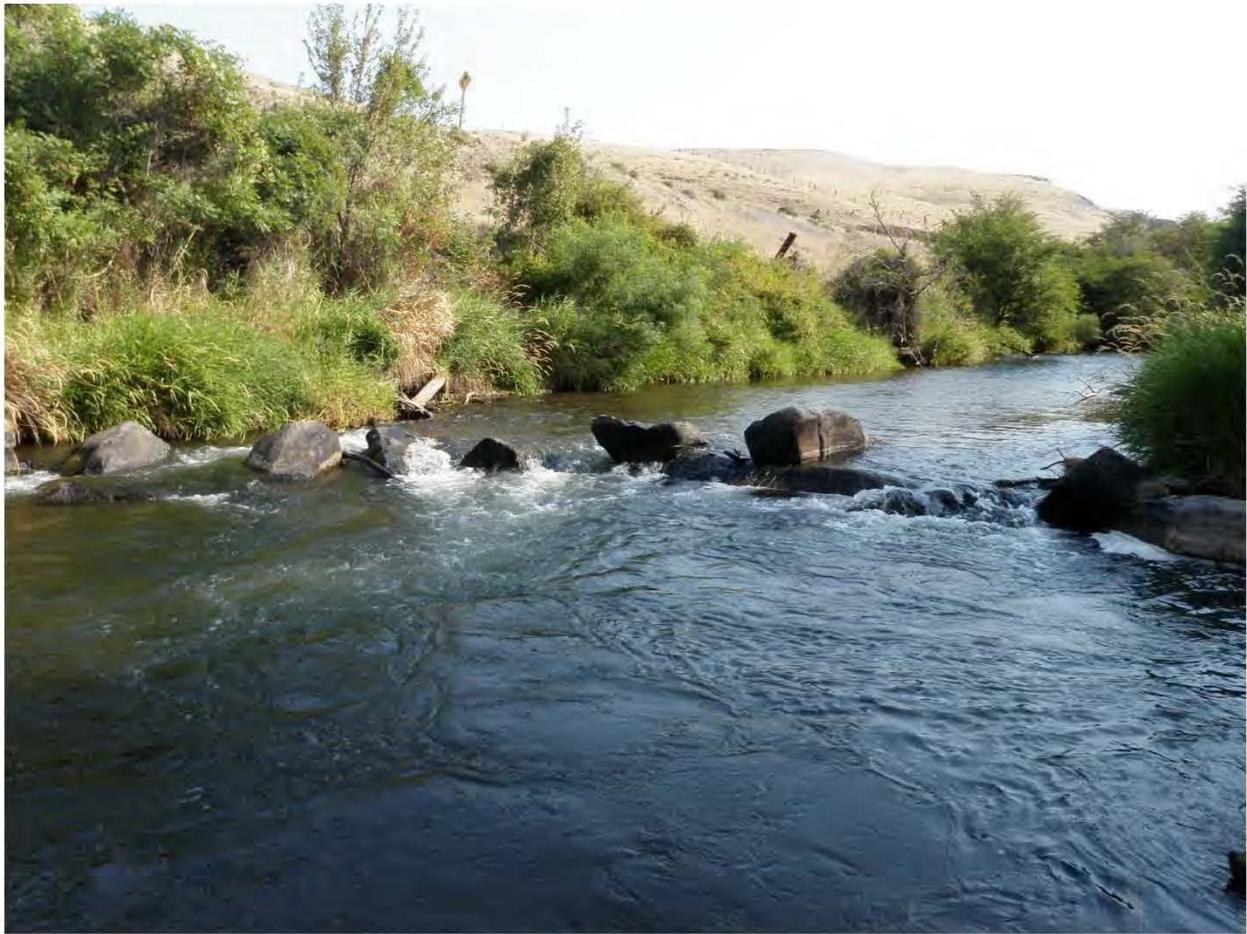
**Photograph 7-7**

**A Rock Weir in Confined Section Near RM 11.4**

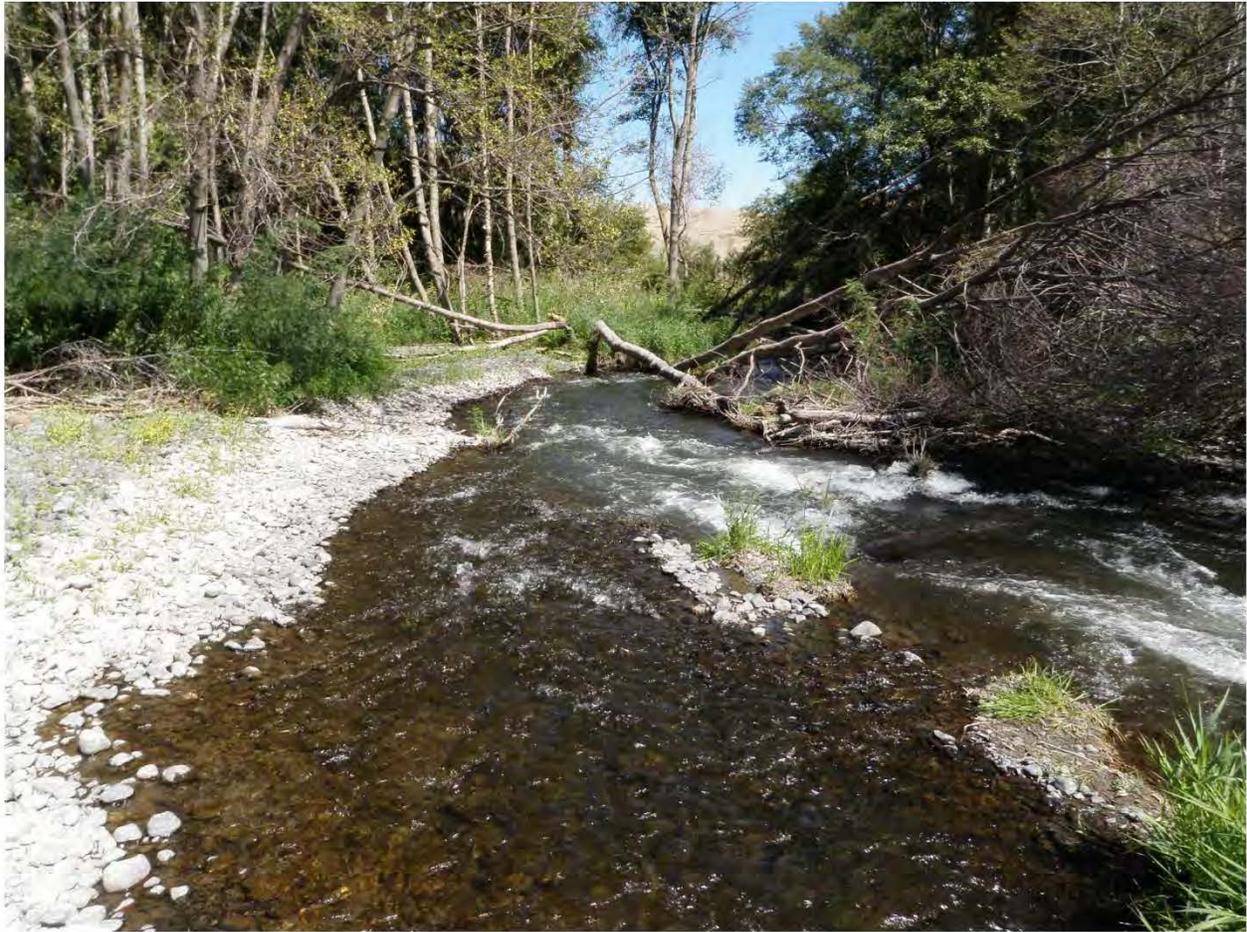
**Photograph 7-9**

**A Recent Channel Avulsion at the Split-Channel Section Near RM 3.9**

Reach 2 is located from the downstream terminus of the levee through Starbuck (RM 4.5) to the extent of backwater from the Snake River (RM 0.7; Figure D-1 and 2a). Downstream of the Highway 261 Bridge at RM 1.85, the valley is grassy with scattered trees and shrubs. Upstream of this location, the valley is occupied by grazing pastures that extend from the edge of the riparian buffer to the valley walls. Several channel and bank modifications were identified throughout the reach, including riprap, levees, berms composed of dredge spoils, rock weirs, and rock barbs. In many locations, these features restrict migration of channel bends.

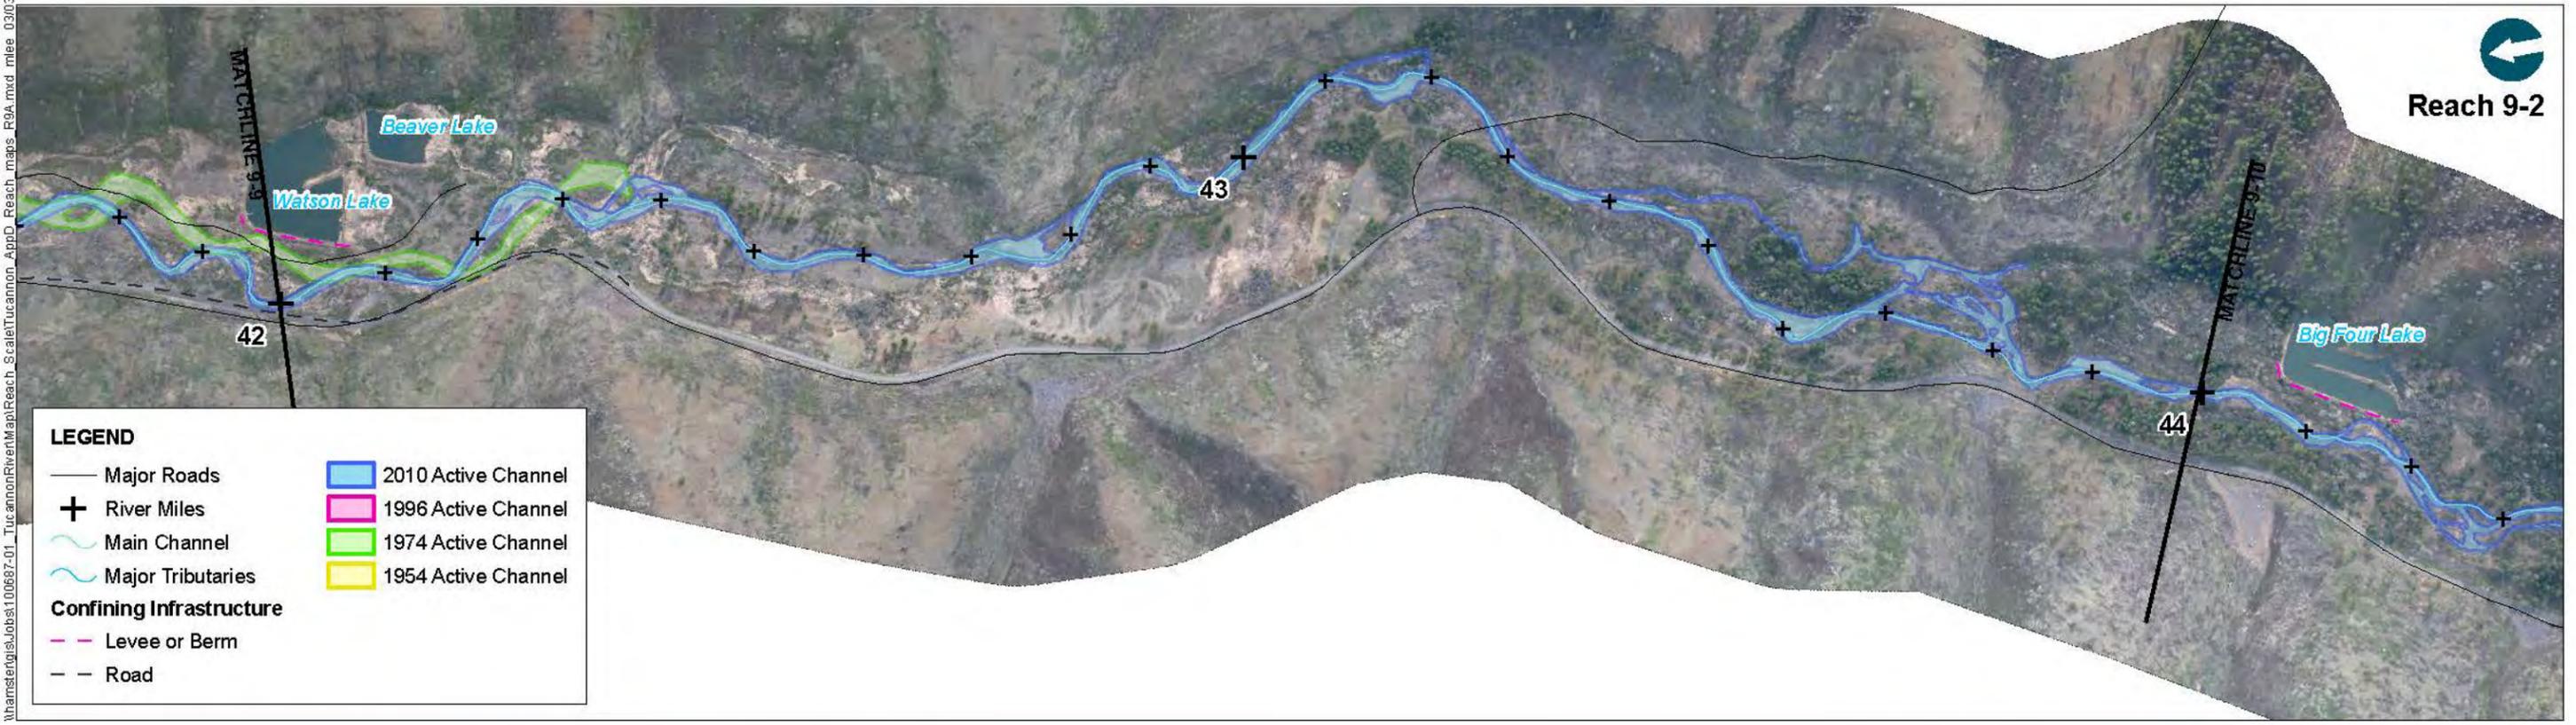
**Figure D-9a**  
 Reach 9 Current Aerial Photo and Historic Active Channel Positions  
 Tucannon River Geomorphic Assessment and Habitat Restoration Study  
 Columbia Conservation District

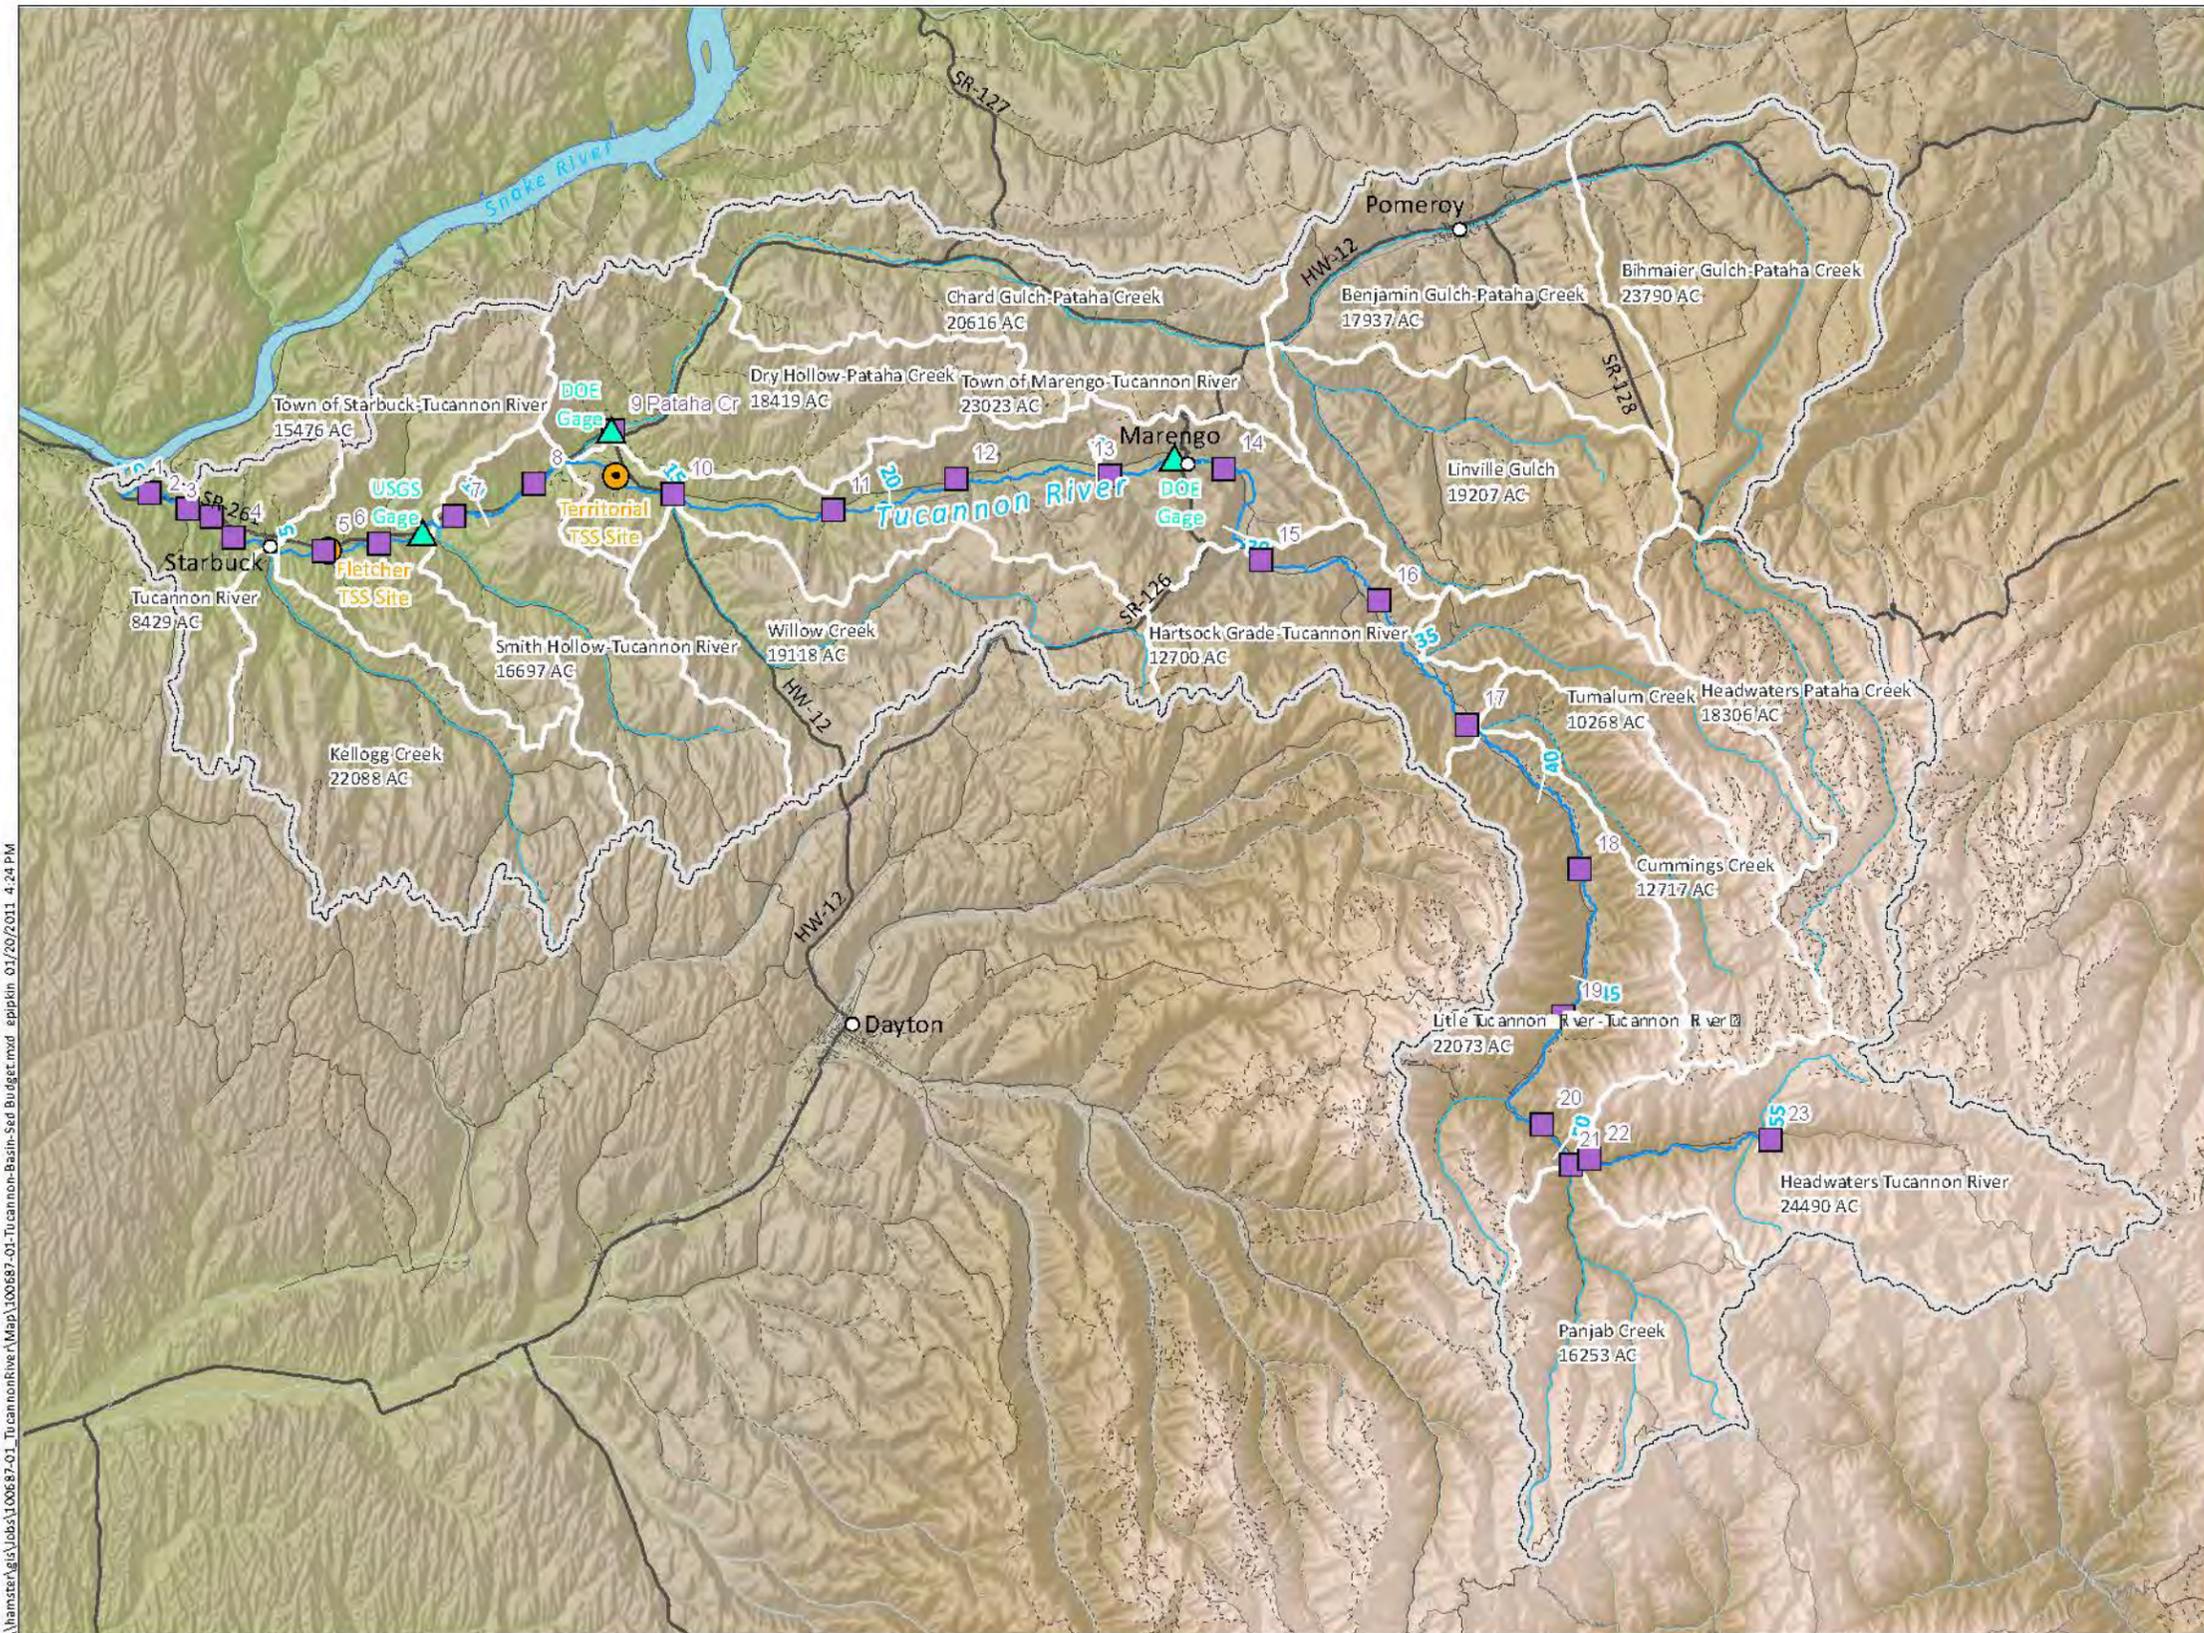
- Tucannon River Assessment Reaches (Ticks Indicate River Mile)
- Tucannon River Basin
- Tucannon River Sub-Basins (Drainage Area in Acres)
- ▲ Stream Gage
- TSS Sample Site
- 2010 Bedload Sampling Locations
