Tucannon Habitat Programmatic

Annual Summary Report

(January 2022– December 2022)

BPA Project #2010-077-00

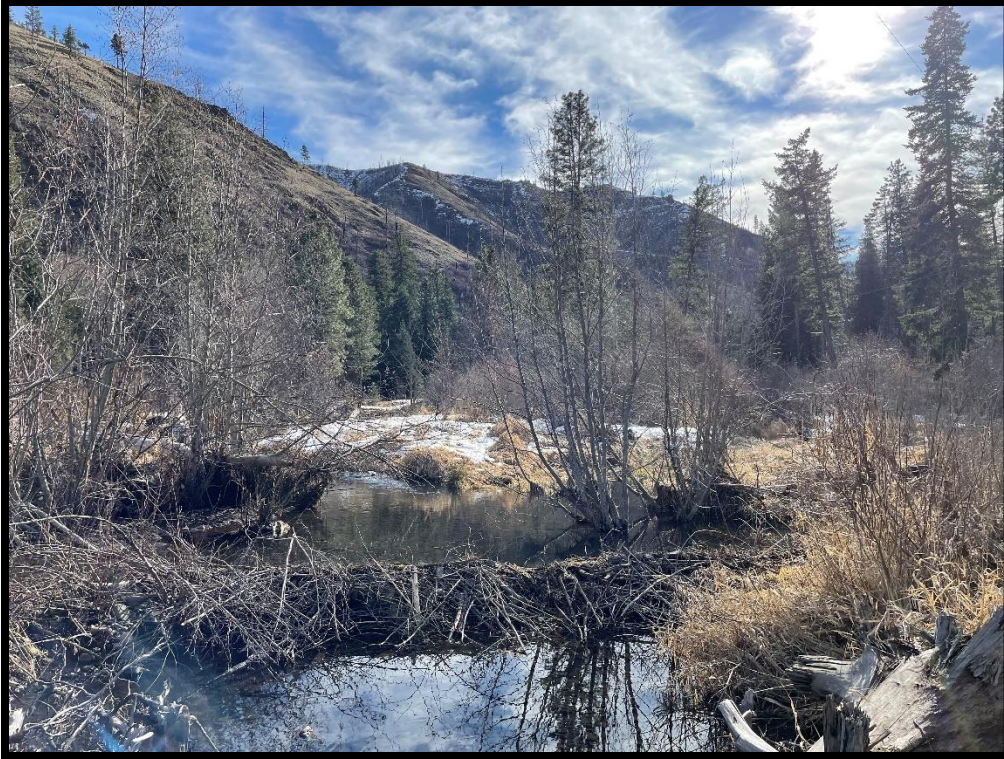
Project Area 8 implemented in 2017, new start of beavery dams and lodge 2-8-2022

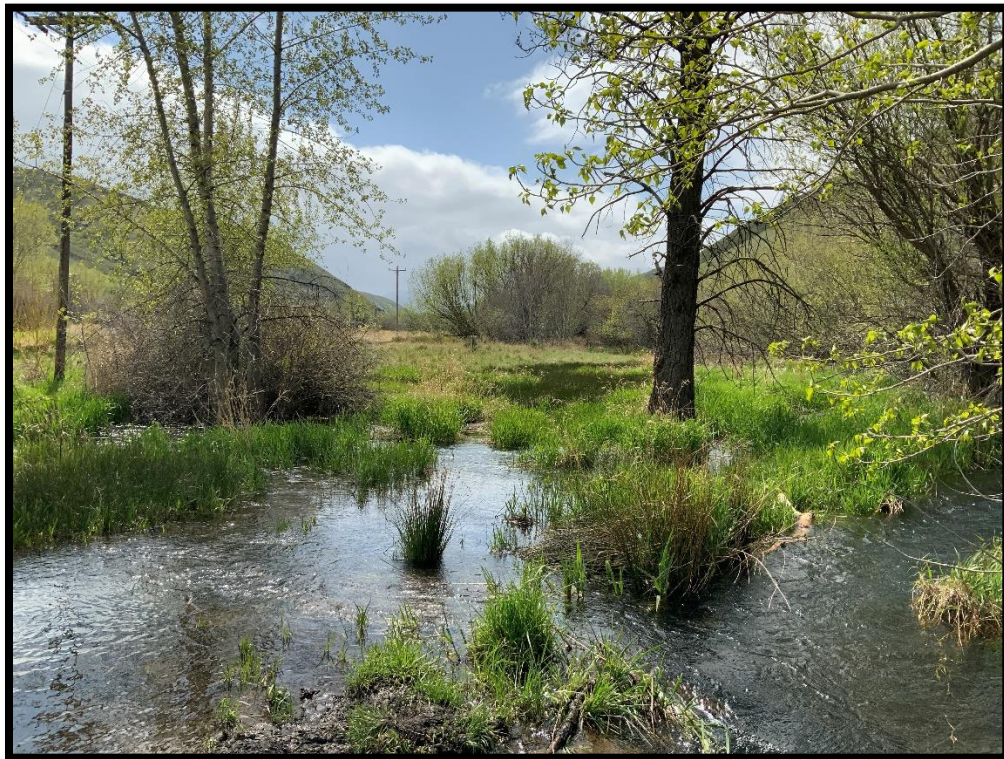
Project Area 18.1 implemented in 2017, newly developing riparian wetland 4-26-2022

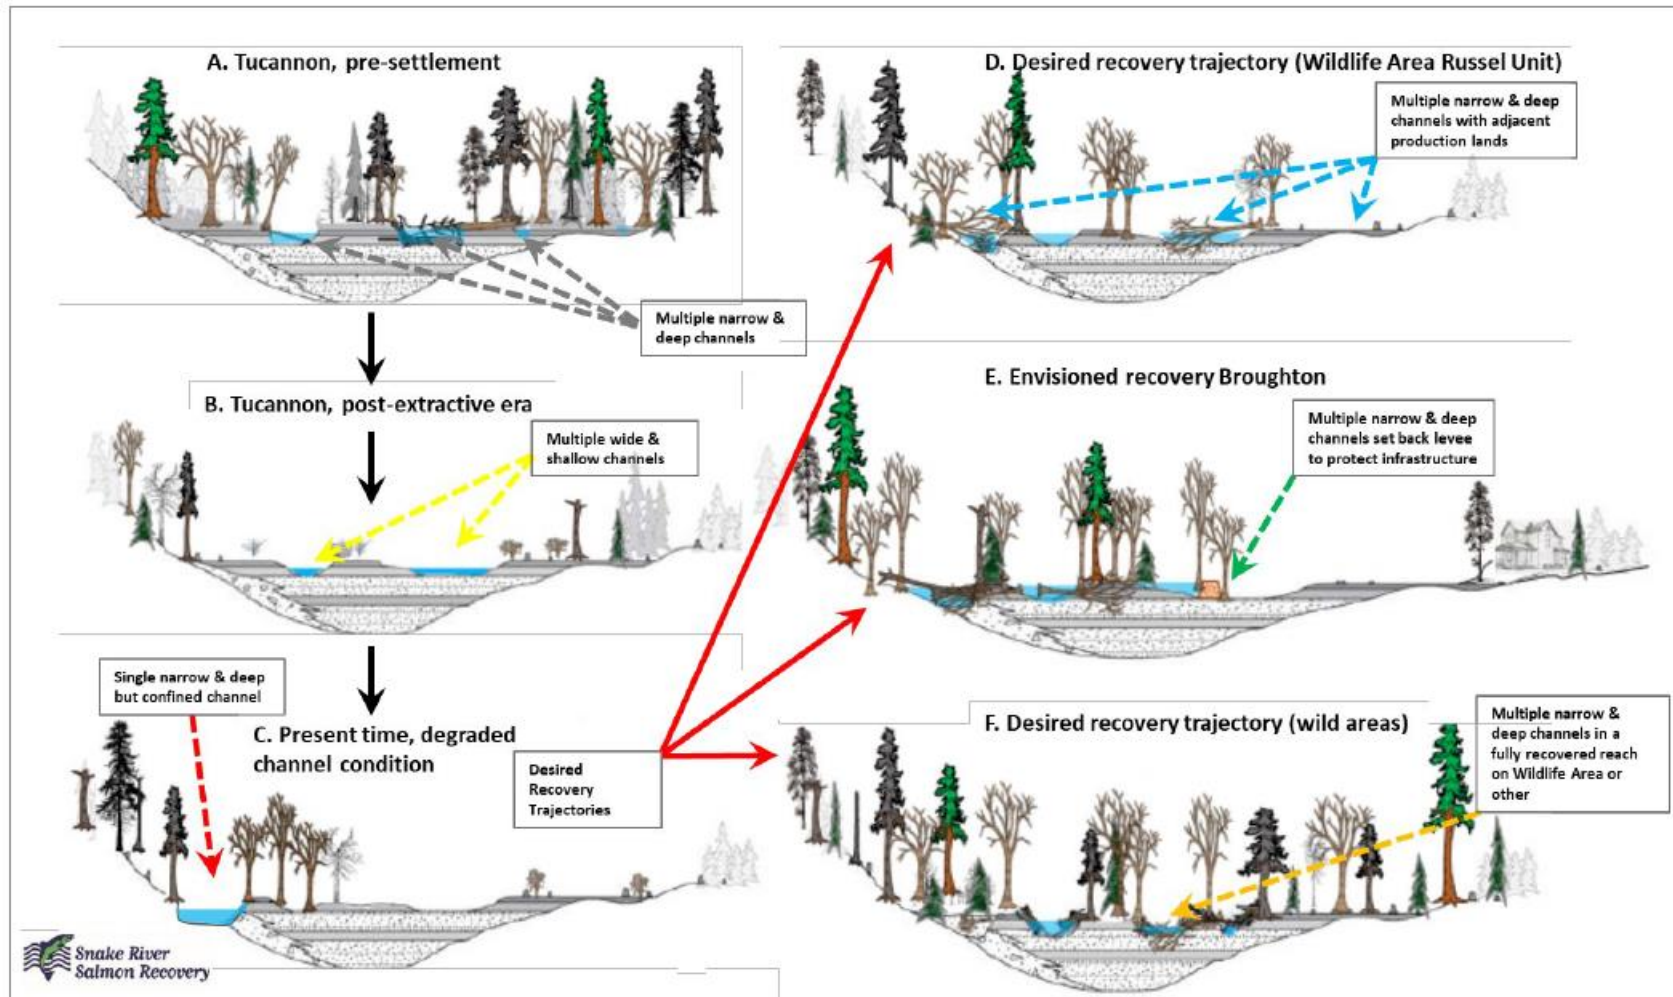
Figure 2. Tucannon Conceptual Stream Model

This model illustrates an idealized cross section of the Tucannon River floodplain and riparian forests over time since pre-settlement. Sections A and B illustrate changes that had occurred through the period of degradation with wide, shallow river channels, and Section C illustrates a modified condition with a single, narrow channel that has confinement and recovering riparian habitat. Sections D and E illustrate desired recovery trajectories for three different land types that all benefit salmon and steelhead. Section D illustrates working lands where occasional flooding is possible, Section E illustrates working lands with infrastructure protection setback levee, and Section F illustrates a full wild land restoration. Source: Kris Buelow, Snake River Salmon Recovery Board, via email communication.

An anabranching Tucannon River (Figure 2) existing on a narrow-forested valley bottom would have supported greater floodplain and channel complexity, along with greater flora and faunal diversity, and would have provided system resiliency to natural flood and draught cycles. The conversion to a single planner channel, followed by further straightening to protect infrastructure has precipitated habitat limiting factors associated with degraded modern-day rivers of the inter mountain west, including reduced summer flow, elevated summer temperatures, depressed winter temperatures and elevated stream power. The conversion in channel type, in its self would have had profound impacts to spring Chinook and other native salmonids populations, but the Tucannon was also undergoing change in spatial connectivity with barriers being constructed and water being diverted.

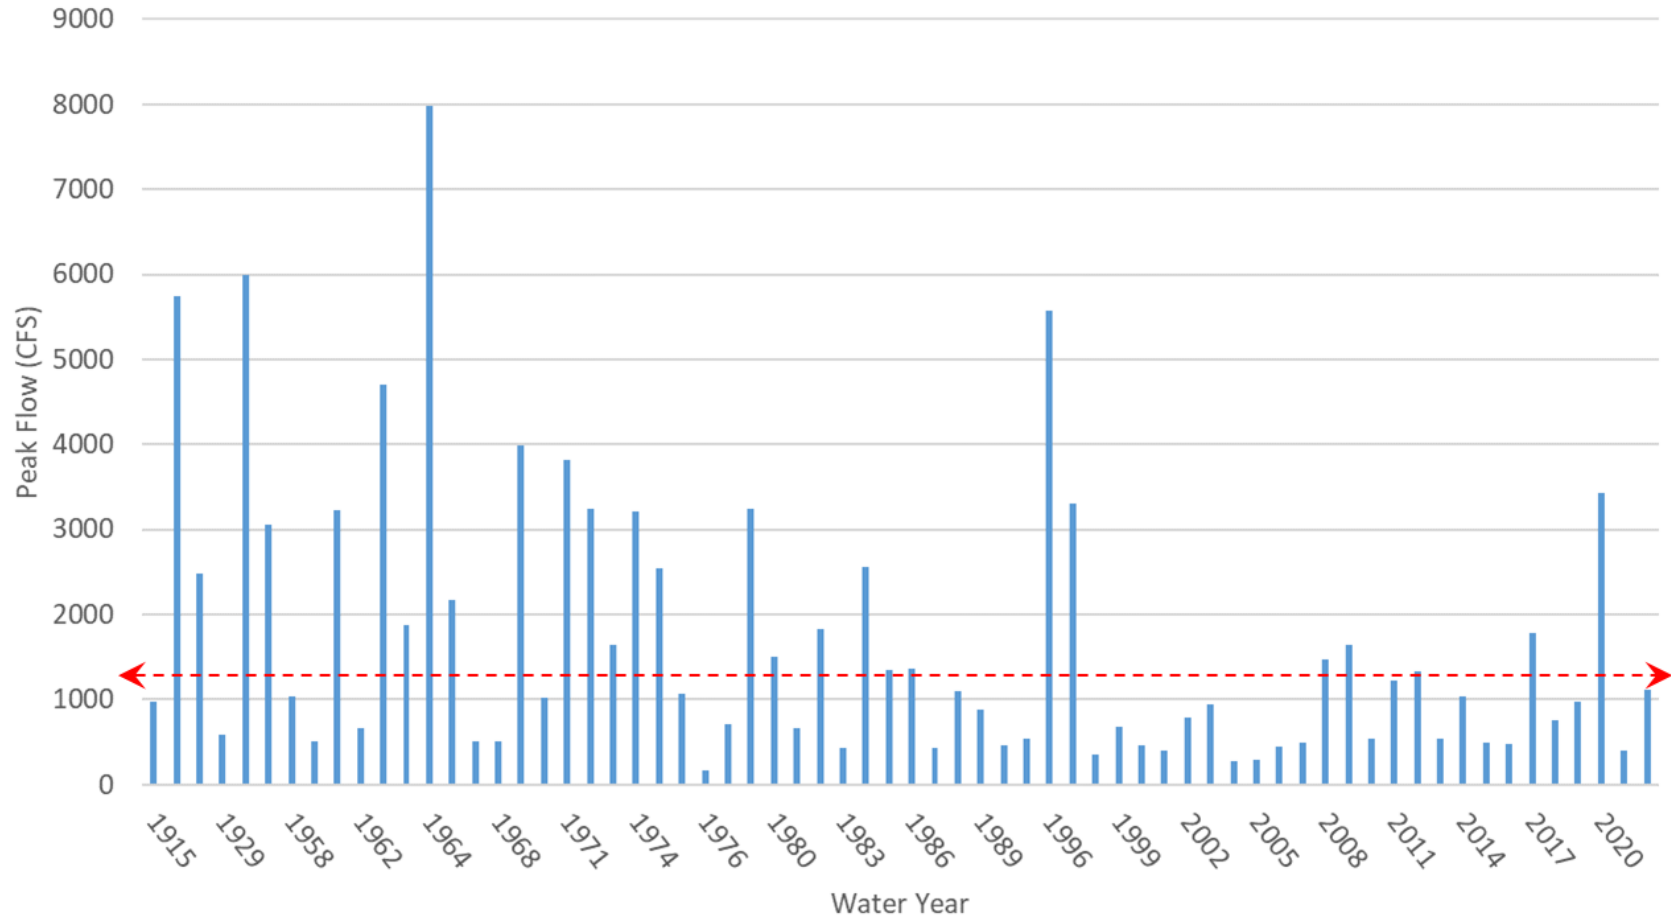
Figure 3: Peak stream flows recorded at the USGS Starbuck stream gage for the entire period of record 1914 to present. The dotted line indicated the approximate 2 yr flood return interval estimated for the basin at RM 8.8.

In early February of 2020, the upper Tucannon basin was impacted by a significant event flood (Figure 3) following a 5-9-inch rain on snow event which lead to significant landslides and road closures across the upper basin. As a result of the event and road closures the implementation of this project was delayed one work window from 2020 to 2021, with site access and materials sourcing being delayed into the spring of 2021. Site conditions were assessed and some minor adaptations were made to the design. Overall conditions in the project areas remained the same following the flooding however in areas where the river migrated and recruited LWD materials, habitat units like deep pools did form. A pre-construction survey was conducted prior to the window in 2021, with metrics available for comparison indicating very little change in 2020 following floods (Table 13-1).

Background: In 1964 and again in 1996, this reach was severely impacted by the large floods (Figure 3) of that time which lead to property damage, triggered the construction of levees and the placement of rip-rap. Following the 1997 flooding, five rock vein weirs were constructed for the purpose of increase large pool frequency. At the time of the 2015 RHS these weirs had been buried under gravel and cobble deposition and were not observed until the 2020 flood survey after they were exposed by bed scour.

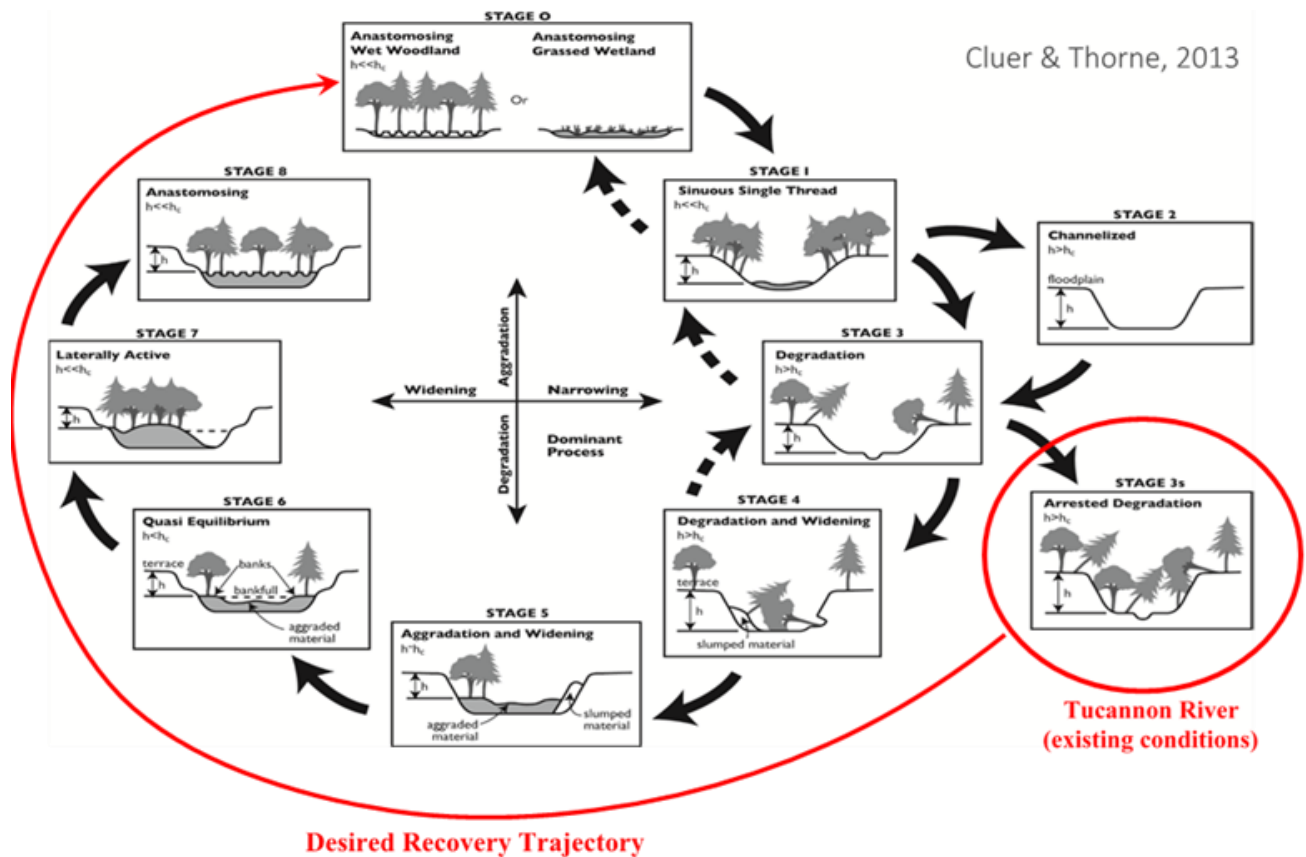
Figure 4: Stream Evolution Model (Clure & Thorn, 2013) illustrating the current channel shape for the most severely impacted reach of the Tucannon in red and the desired trajectory for recovery.

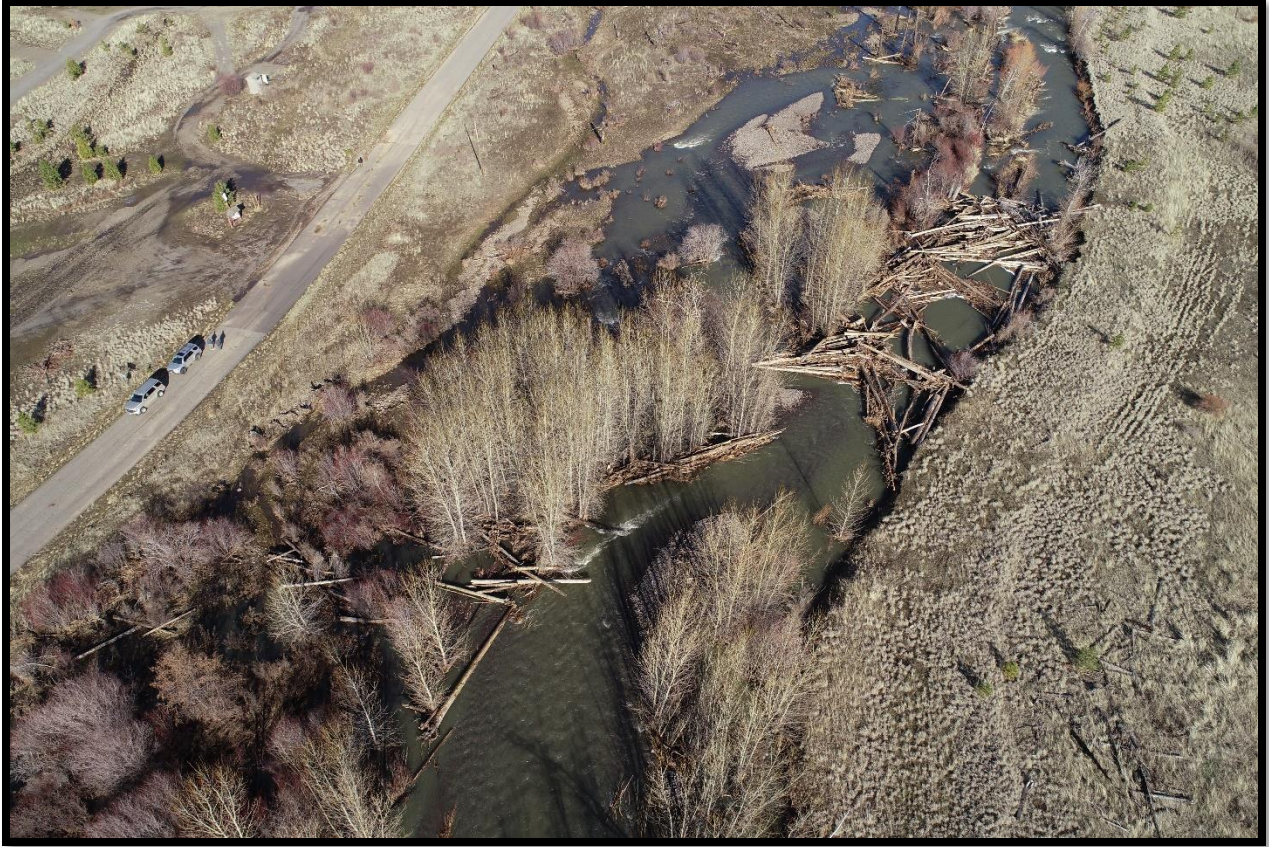
Figure 7: Example of large post 2020 flood log jam complex created by mobile LWD transported downstream from PA11.1 to form the large jam complex in PA11.2.

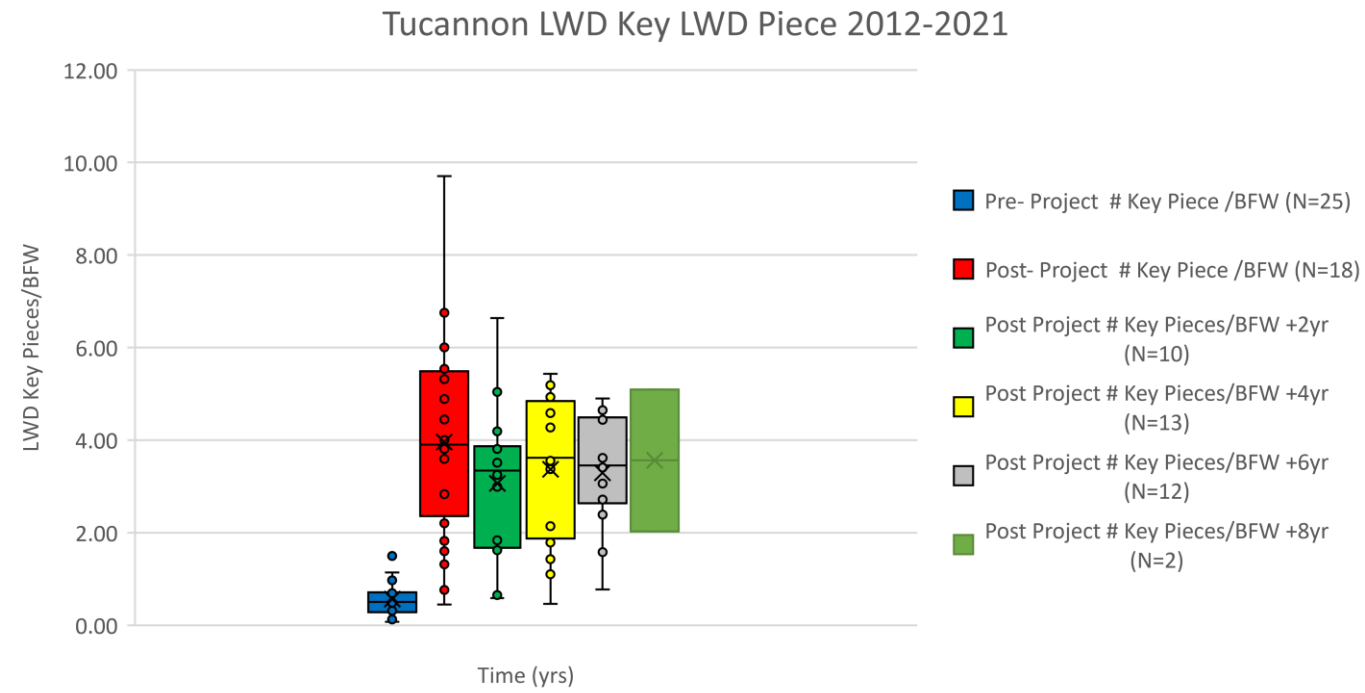
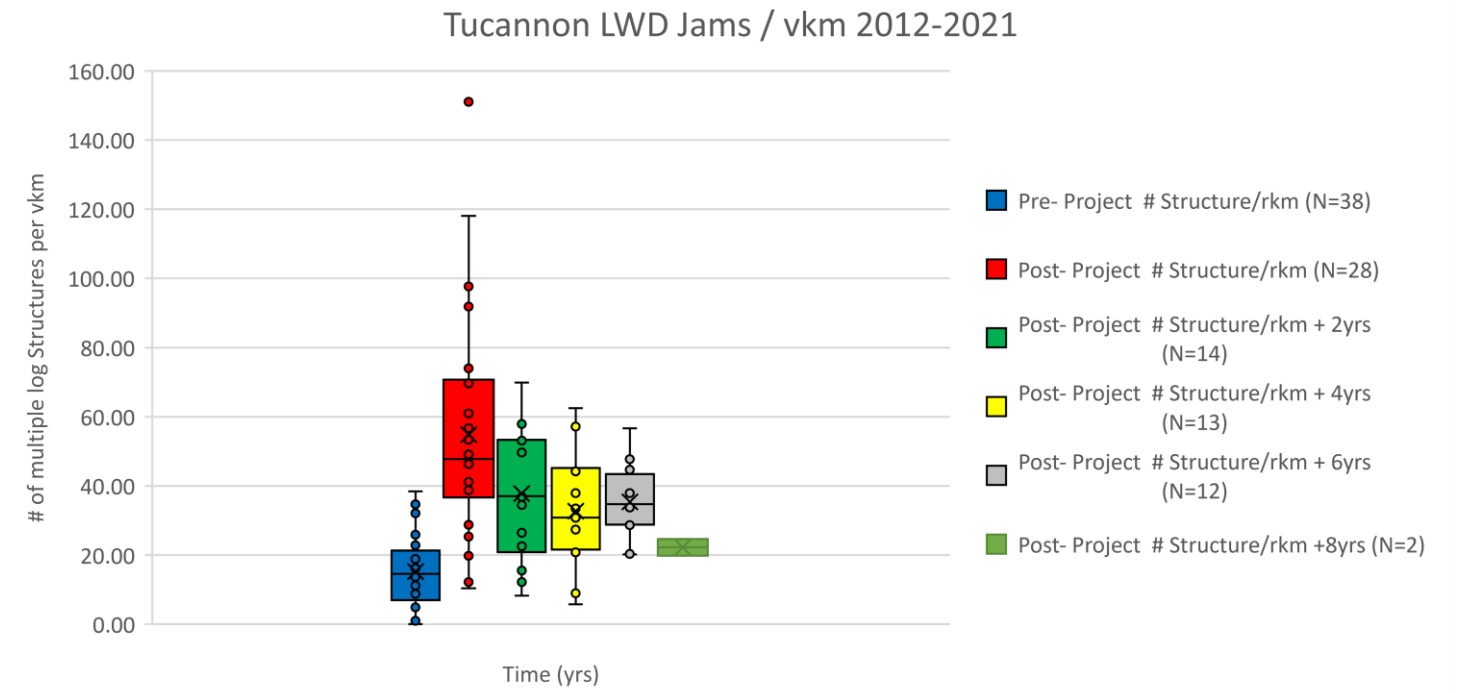
Figure 8: Mean number of large woody debris key pieces (>6 m long & 0.3 m dia.) per bank full width during pre-implementation immediately following implementation (post project) and then every 2 yrs. recurring up to 8 yrs. for the oldest project implemented in 2012 (Upper left). (Upper right) The mean number of log jams per valley km where a jam is a log structure containing 2 or more LWD key pieces.

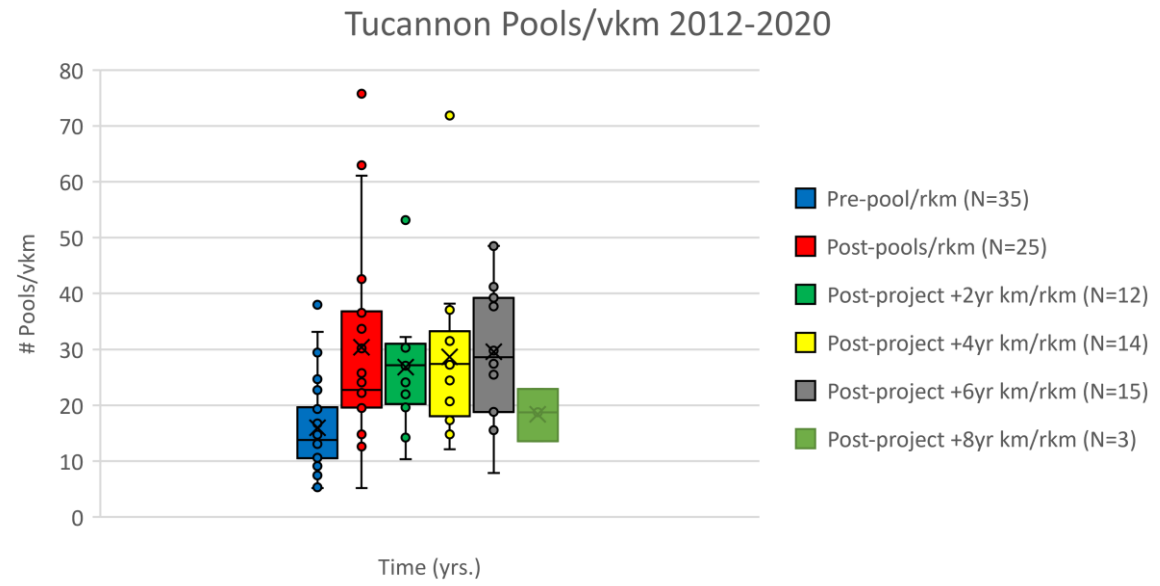
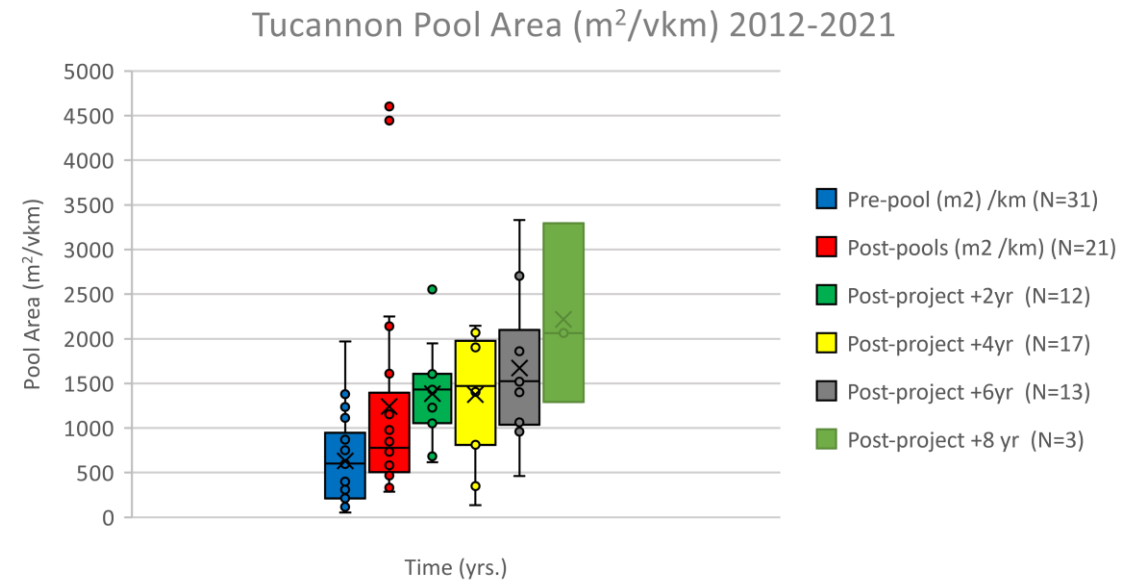
Figure 10: The mean pool frequency (above), area (upper right) and frequency deep pools (lower right) by sample period standardized by valley km, across all project implemented between 2012 and 2021. The dip in pool frequency for following 8yr post surveys was reflected by the deterioration of and mobilization of LWD jams indicated in Figure 8. It is important to note that pool area and depth did not significantly decline.

The development of pools across the projects also show an improving trend over pre-project conditions (Figure 10), however there are some indications that pool frequency declines from the post project peak, the farther out from implementation the project gets. This has been observed in several of the older projects following the 2020 flood, particularly in projects where the number of log jams declined. Although pool frequency declined pool area and the number of deep pools remain closer to the post -project high (Figure 10), indicating positive changes in the system are persisting. Pools are one of the key threshold triggers in the adaptive management plan, the Program will consider in upcoming assessments and actions.

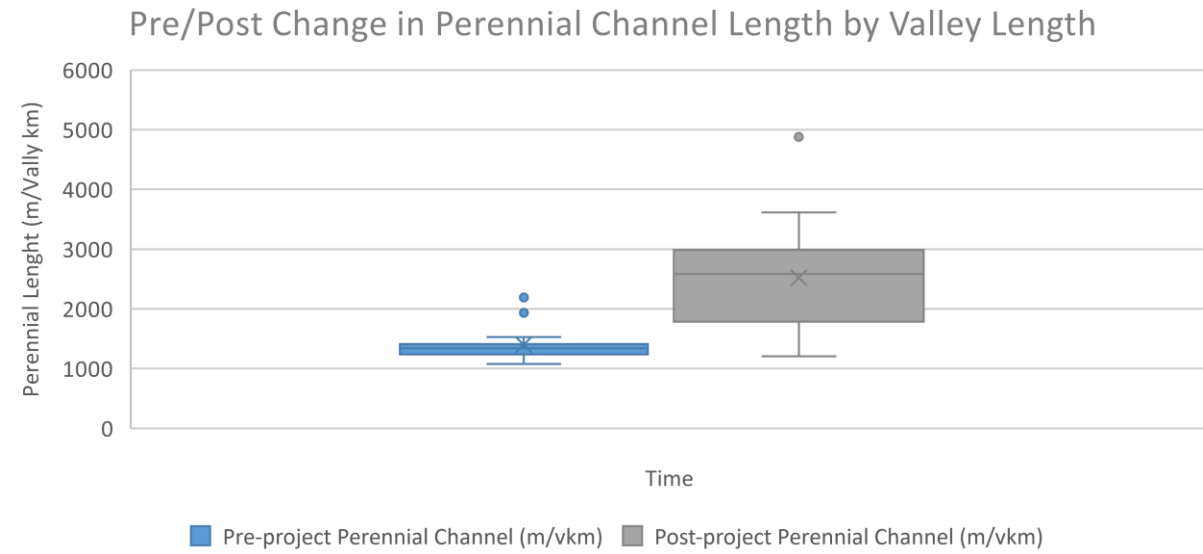
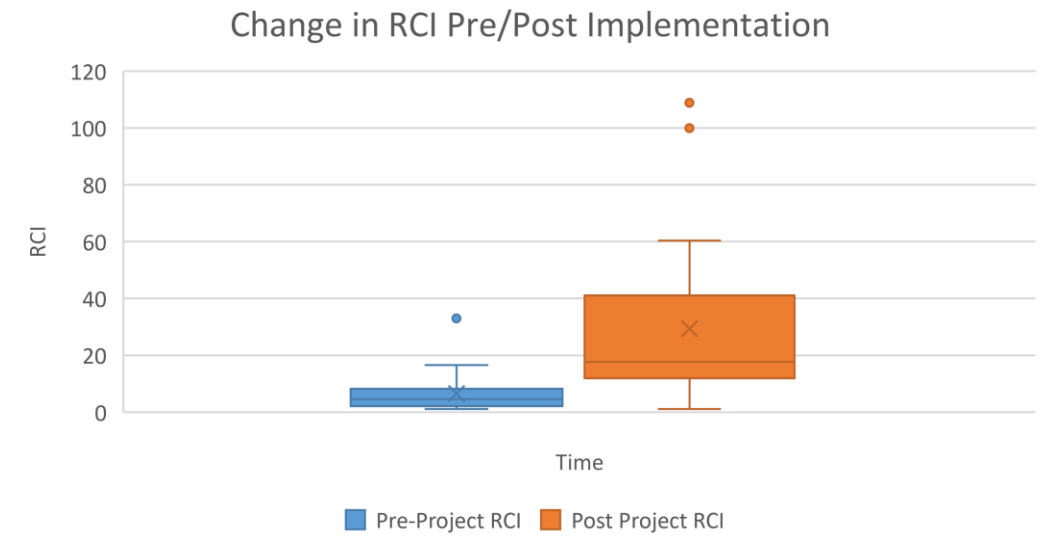
Figure 11: Changes in channel complexity for the Tucannon River project areas is captured using the changes in perennial channel length and reflected in change in River Complexity Index (Brown 2002). Data for project areas is collected in the RHS conducted by the SRSRB and supported by remote sensing data. Changes in perennial channel length standardized by valley km across all projects 2012-2022 prioritized for implementation (above left). Perennial length is shown for pre-project condition and post project condition as the summed total length delineated during RHS for main channels and side channels. The River Complexity Index is calculated for all project pre and post project (upper right) indicating an increase in the mean RCI from pre-project to post project conditions. Individual project changes are provided (right) indicating some project with significant increases in RCI value.

The Program tracks channel complexity through measuring perennial channel length and River Complexity Index (RCI) (Brown 2002). Channel length and connections(nodes) are mapped during RHS to tract habitat change from pre-project through as-built and 2 yr recurring intervals. Looking at all projects surveyed between 2012 and the present (Figure 11) main channel length was summed with perennial side channel length and standardized by valley km for all pre-project surveys and post project survey completed (Table 4) after the 2020 flood. The change illustrates a 50% increase in the mean perennial channel length per project area (Figure 11). The increase is driven largely by increasing side channel length, and is represented by > 24 km of new perennial side channel habitat (Table 5). Side channels for this analysis are channels separated from the main river by island which support terrestrial wood-stemmed plant species indicating at most seasonal inundations. The increase in perennial length has driven an increase in RCI, the measure we are using to track change in channel complexity across project implemented 2012-2022 (Figure 11). An assessment of projects implemented show an increase in RCI following implementation to pre-project to post 2020 flood, to have a pre-project mean RCI value of 8, to a mean of 33 (Figure 11). The goal for restoration is set based on available space and assessment of observed paleo-channels identified in imagery and LiDAR data models (REM), but a target of 25-60 will produce excellent results for most reaches of the Tucannon. The most aggressive restoration at some of the more responsive sites have shown RCI values >90 (Figure 11).

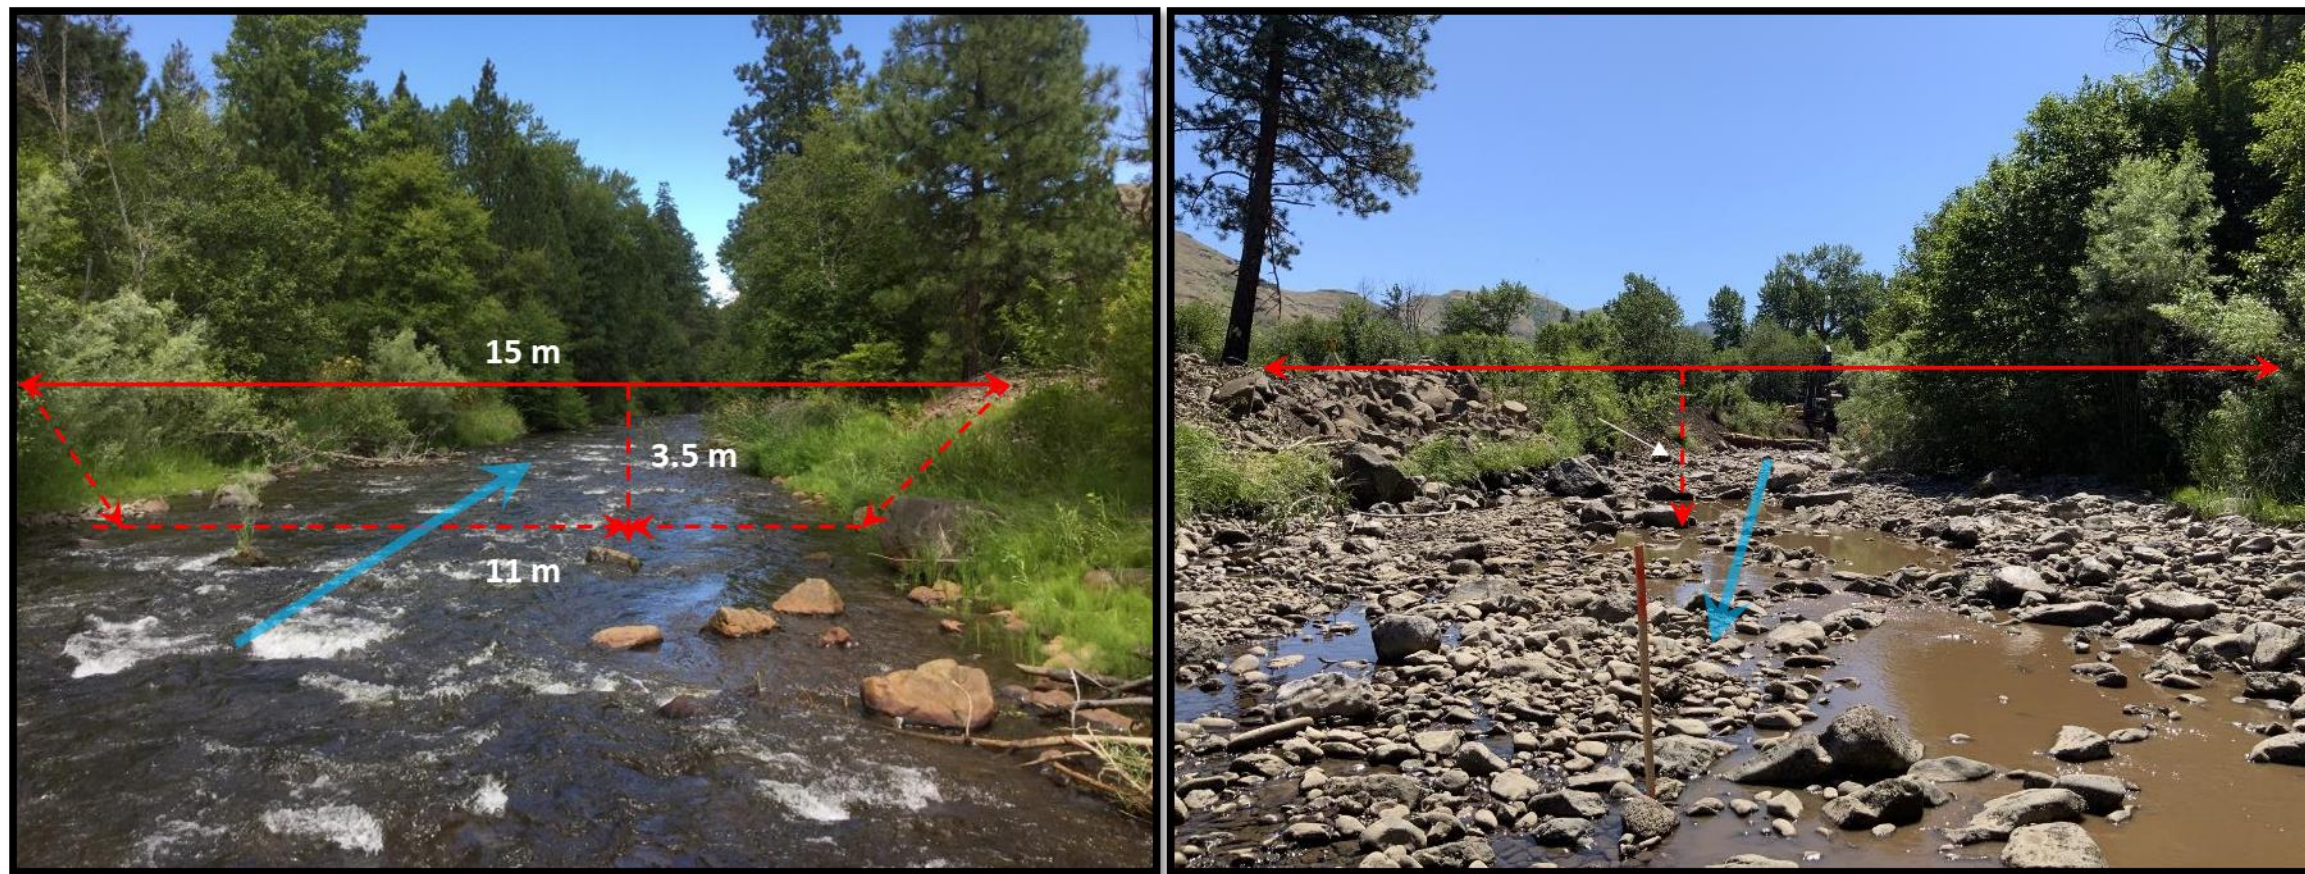
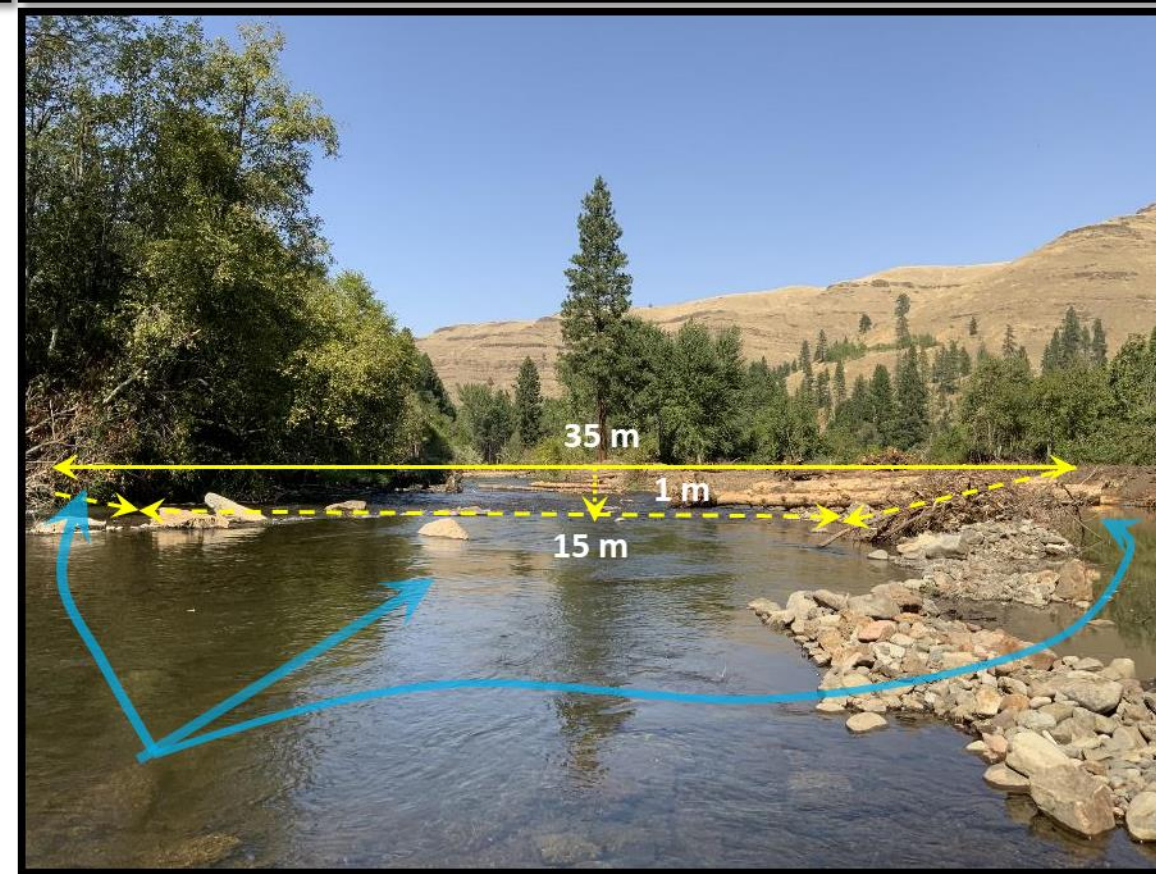
Figure 13-2: PA13 levee removal and channel plug location 2021 to post Phase I implementation in 2022. Upper left illustrates the river confined on the right by a steep rip-rap protected bank on the right and the valley wall on the left illustrating a confined bank full geometry which leads to unnatural stream power for the Tucannon and the stream bed exposed during construction dewatering (upper right). Removal of the right bank levee and rip-rap reduces the depth of bank full geometry (lower right) bring stream power back to values predicted based on valley metrics. The blue arrows indicate flow direction as well as flow paths during high water events.

Recovery Expectations: Due to the degraded nature of this project reach (Figure 13-2), and the aggressive active nature of the project design including levee removal and channel reconfiguration, it is anticipated that as-built conditions will be very close to the anticipated design objectives. Winter freshets and high flow are anticipated to redistribute and sort gravel and cobble to increase spawning habitat quality over a 2-5 yr time frame.

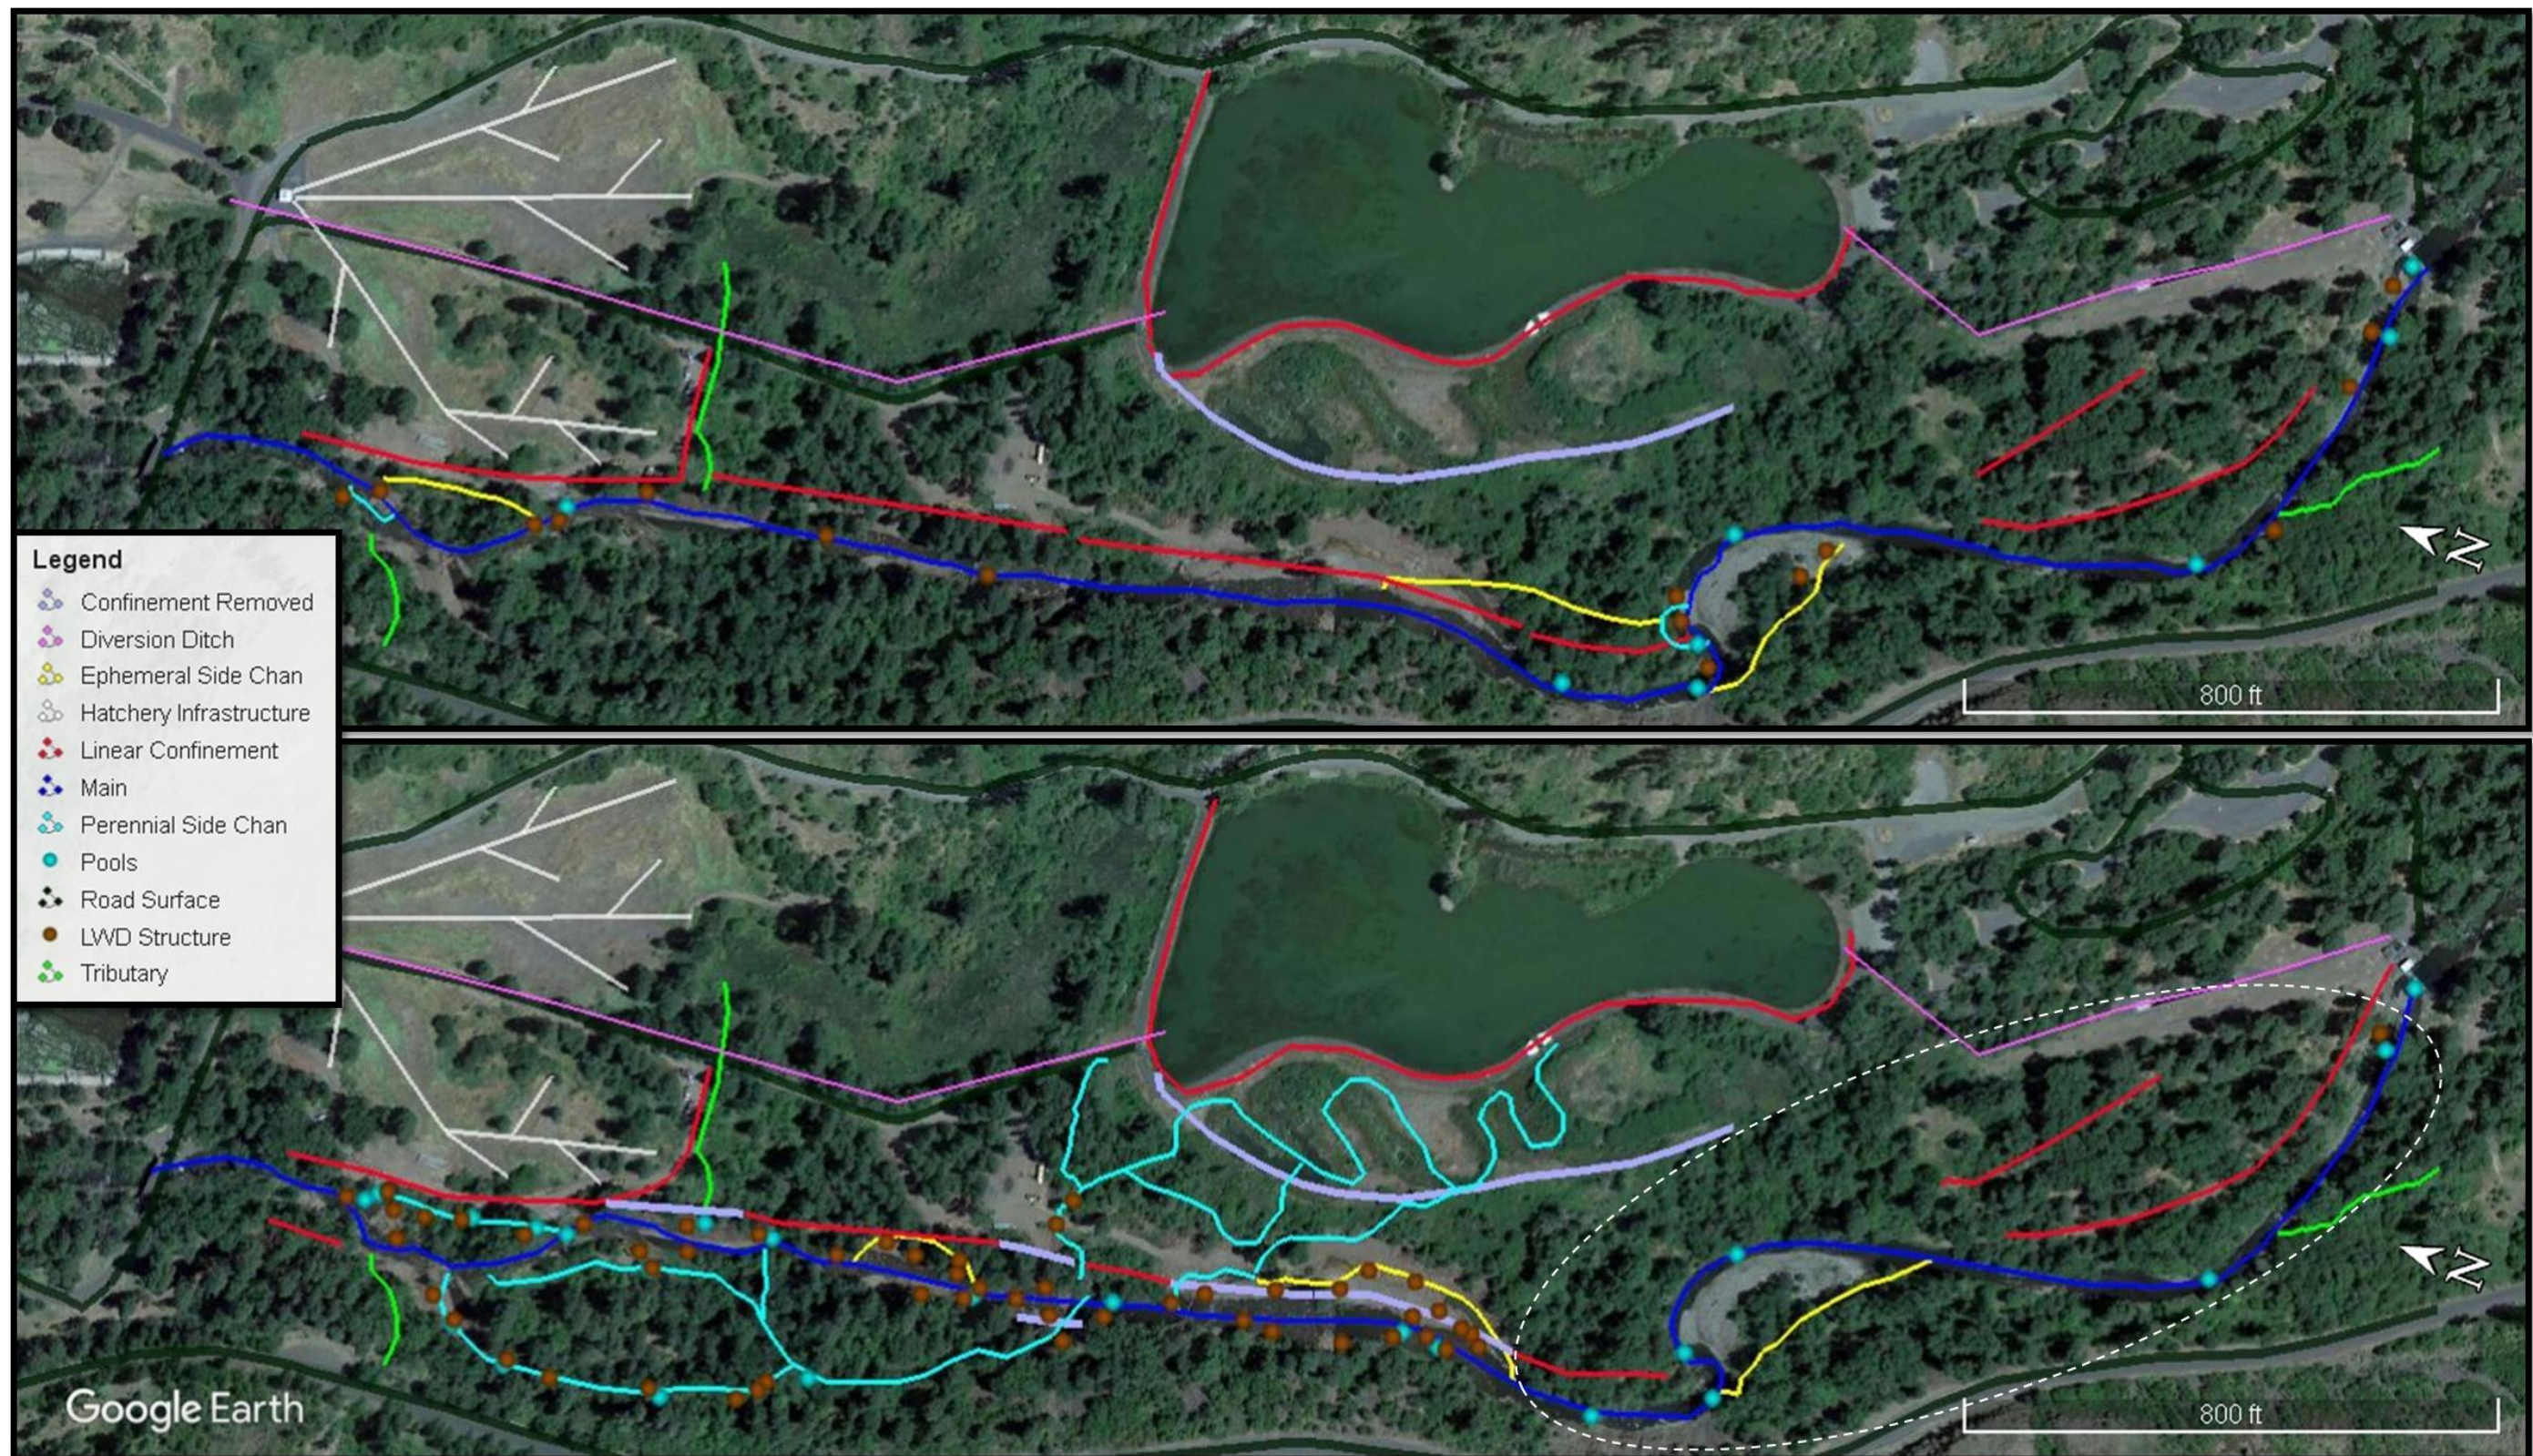
Figure 13-3: Project Area 13 (PA13) pre-project condition (upper map) as surveyed in the summer of 2020 in preparation for 2021/22 implementation. The pre-project condition exhibits a straight channel (Sinuosity of 1.15), which has been maintain adjacent to hatchery infrastructure (upper). In 2022, WDFW initiated Phase I implementation illustrated in the left half of the lower map image. The white dashed oval illustrates the project reach to be implemented during Phase II in 2023. Detailed habitat metrics can be viewed in the associated report (Table 13-1).

characterized as being highly confined by the levees protecting Rainbow Lake and the Tucannon Fish Hatchery infrastructure (Figure 13-3). As a result of infrastructure needs, the river reach had been straightened and became incised below the hatchery fish trap reducing channel complexity (Figure 13-2). The reach is located in the center of the Tucannon spring Chinook spawning reach and while a relatively high proportion of redds are observed within the reach annually, habitat conditions for spawning and redd integrity are poor due to high stream power (Anchor QEA 2020). Habitat complexity is also limiting, with few deep pools (Figure 13-3, Table 13-1) for adult holding or low velocities for juvenile rearing. Due to poor floodplain connectivity and low channel complexity the project design focused on expanding floodplain through a combination of removing confining levees, reducing channel incision and connecting disconnected side channels. The reach objectives for this project area were identified in the 2011 Plan and were supported and refined through data collected during the pre-project RHS in 2020 and 2021, which identified >1,200 m (Table 13-1) of disconnected perennial and ephemeral side channels that could be available for reconnection through removing confining features and reducing channel incision. Although mean pool depth was meeting the restoration objective in 2020, that value is a result of a couple very deep pools that formed during the 2020 flood, pool area and frequency remain below the objective for pools (Table 13-1).
