Tucannon Habitat Programmatic

Annual Summary Report

(January 2022– December 2022)

BPA Project #2010-077-00

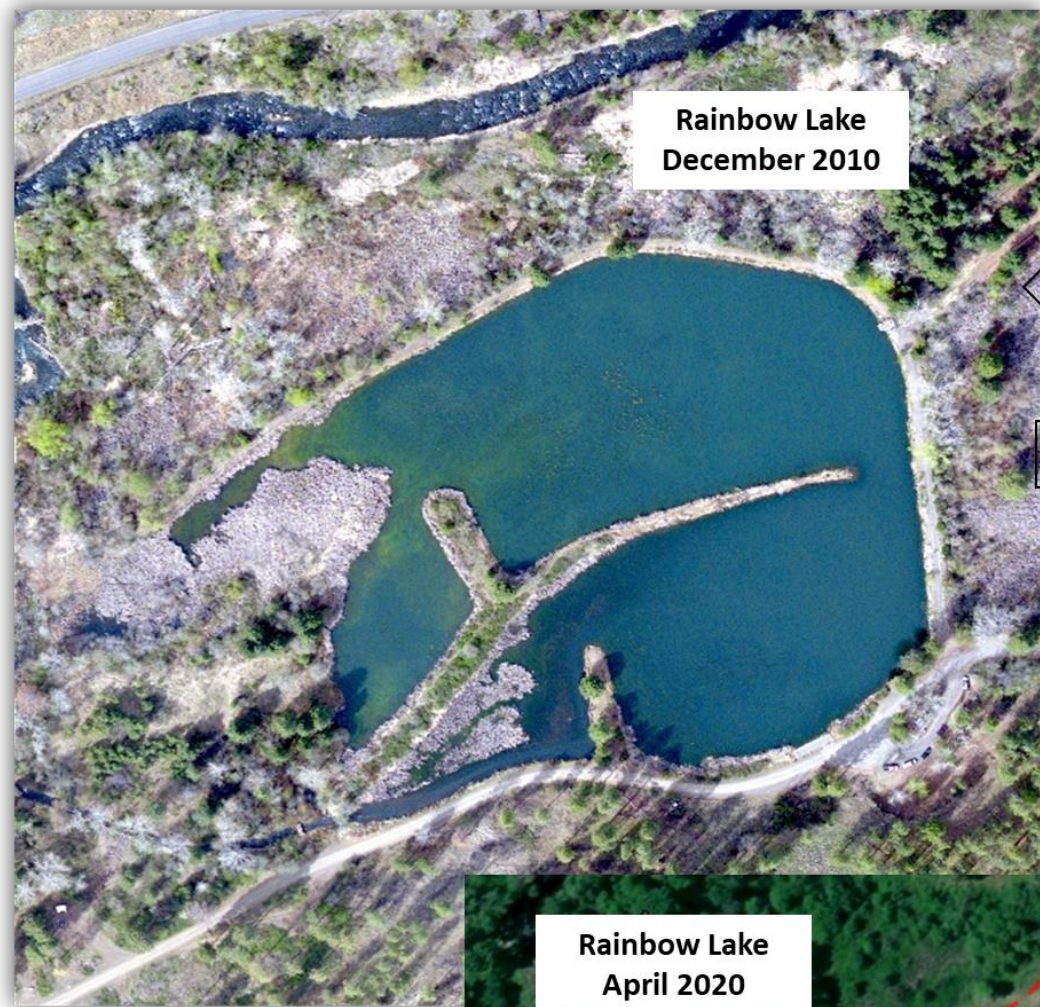
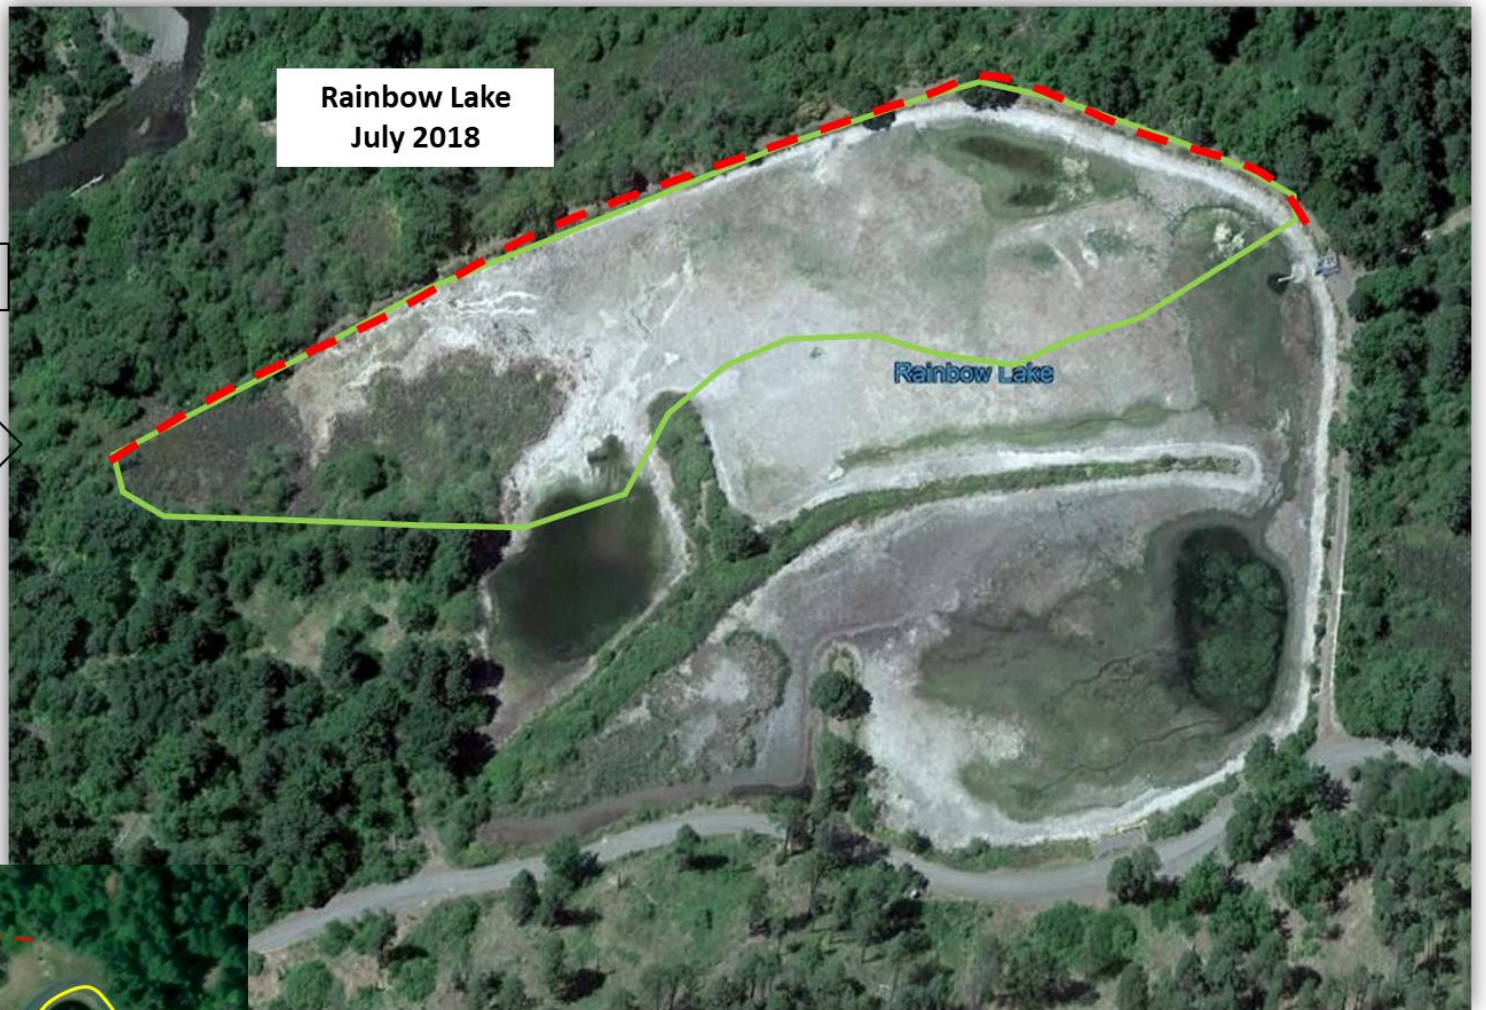
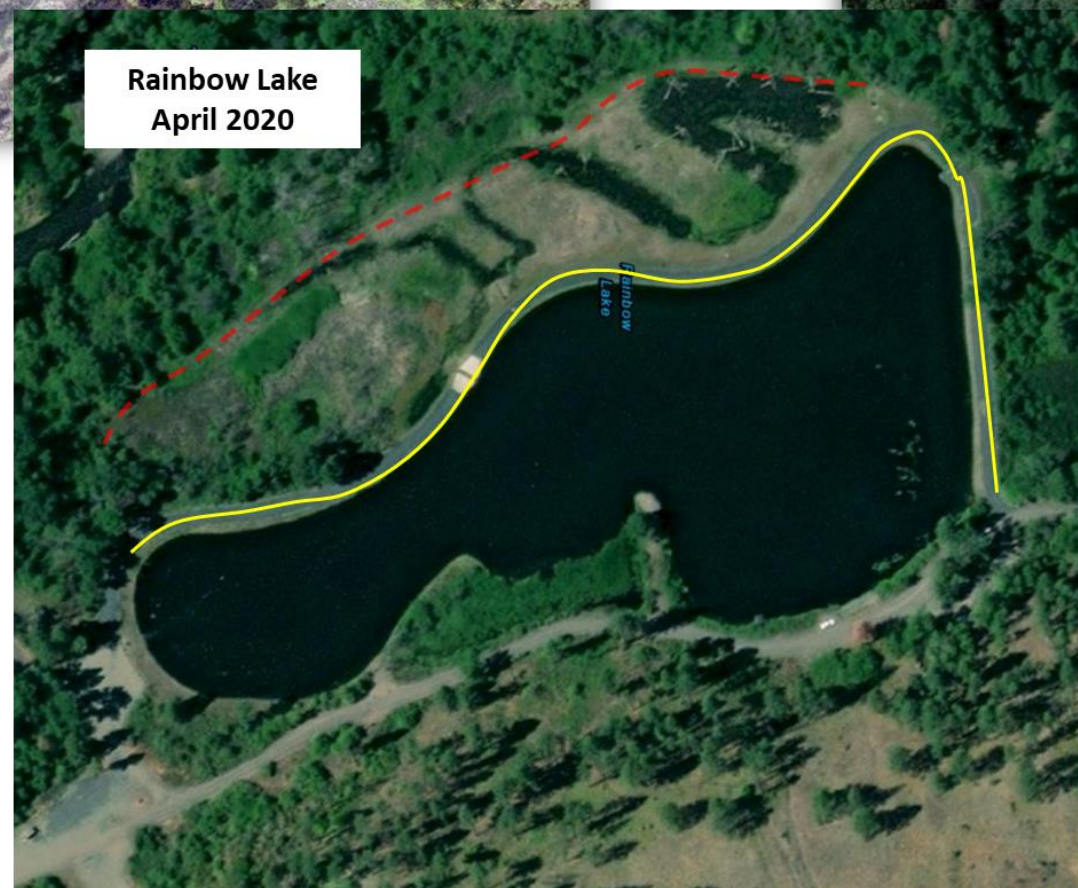
Figure 13-6: Floodplain connectivity measured in the field prior to implementation of Phase I in 2021 followed by the Phase I post construction survey in the autumn of 2022. Low lying floodplain is characterized as bring less than the 2 yr return interval. Disconnected floodplain is characterized as being greater than the 25 yr as measured in 2020 following an estimated 25 yr event in the basin. Floodplain disconnected and unavailable is floodplain separated from the active floodplain by levees protecting hatchery infrastructure. This site has a wetland within the riparian area and connectable to the low-lying floodplain. New low floodplain is floodplain connected through restoration actions in 2022 Phase I. Addition disconnected floodplain is targeted for connection in 2021

The removal of levees, associated channel plugs and placement of logjams reconnect 10.88 acres of low floodplain increasing connectivity by 28% (Figure 13-6 & Figure 13-8) at the 2 yr return flow or less. An additional 2.92 acres of existing wetland was connected just north of Rainbow Lake impoundment by replacing the culvert under the hatchery diversion pipeline access road (Figure 13-8). An additional 3.48 acres of wetland created in 2018/19 (Figure 13-5 & Figure 13.8) when 292 m of lake levee/dam was removed, is now included within the floodplain footprint, but is disconnected from the top end to perennial flow.

Overall floodplain connectivity increased 28 % (Figure 13-6 & Figure 13-8) and new low-lying floodplain increased 21%. The Phase II work in 2023 will further increase connected floodplain and connect the remaining wetland adjacent to Rainbow Lake (Figure 13-8) as well as the remaining available disconnected floodplain areas.

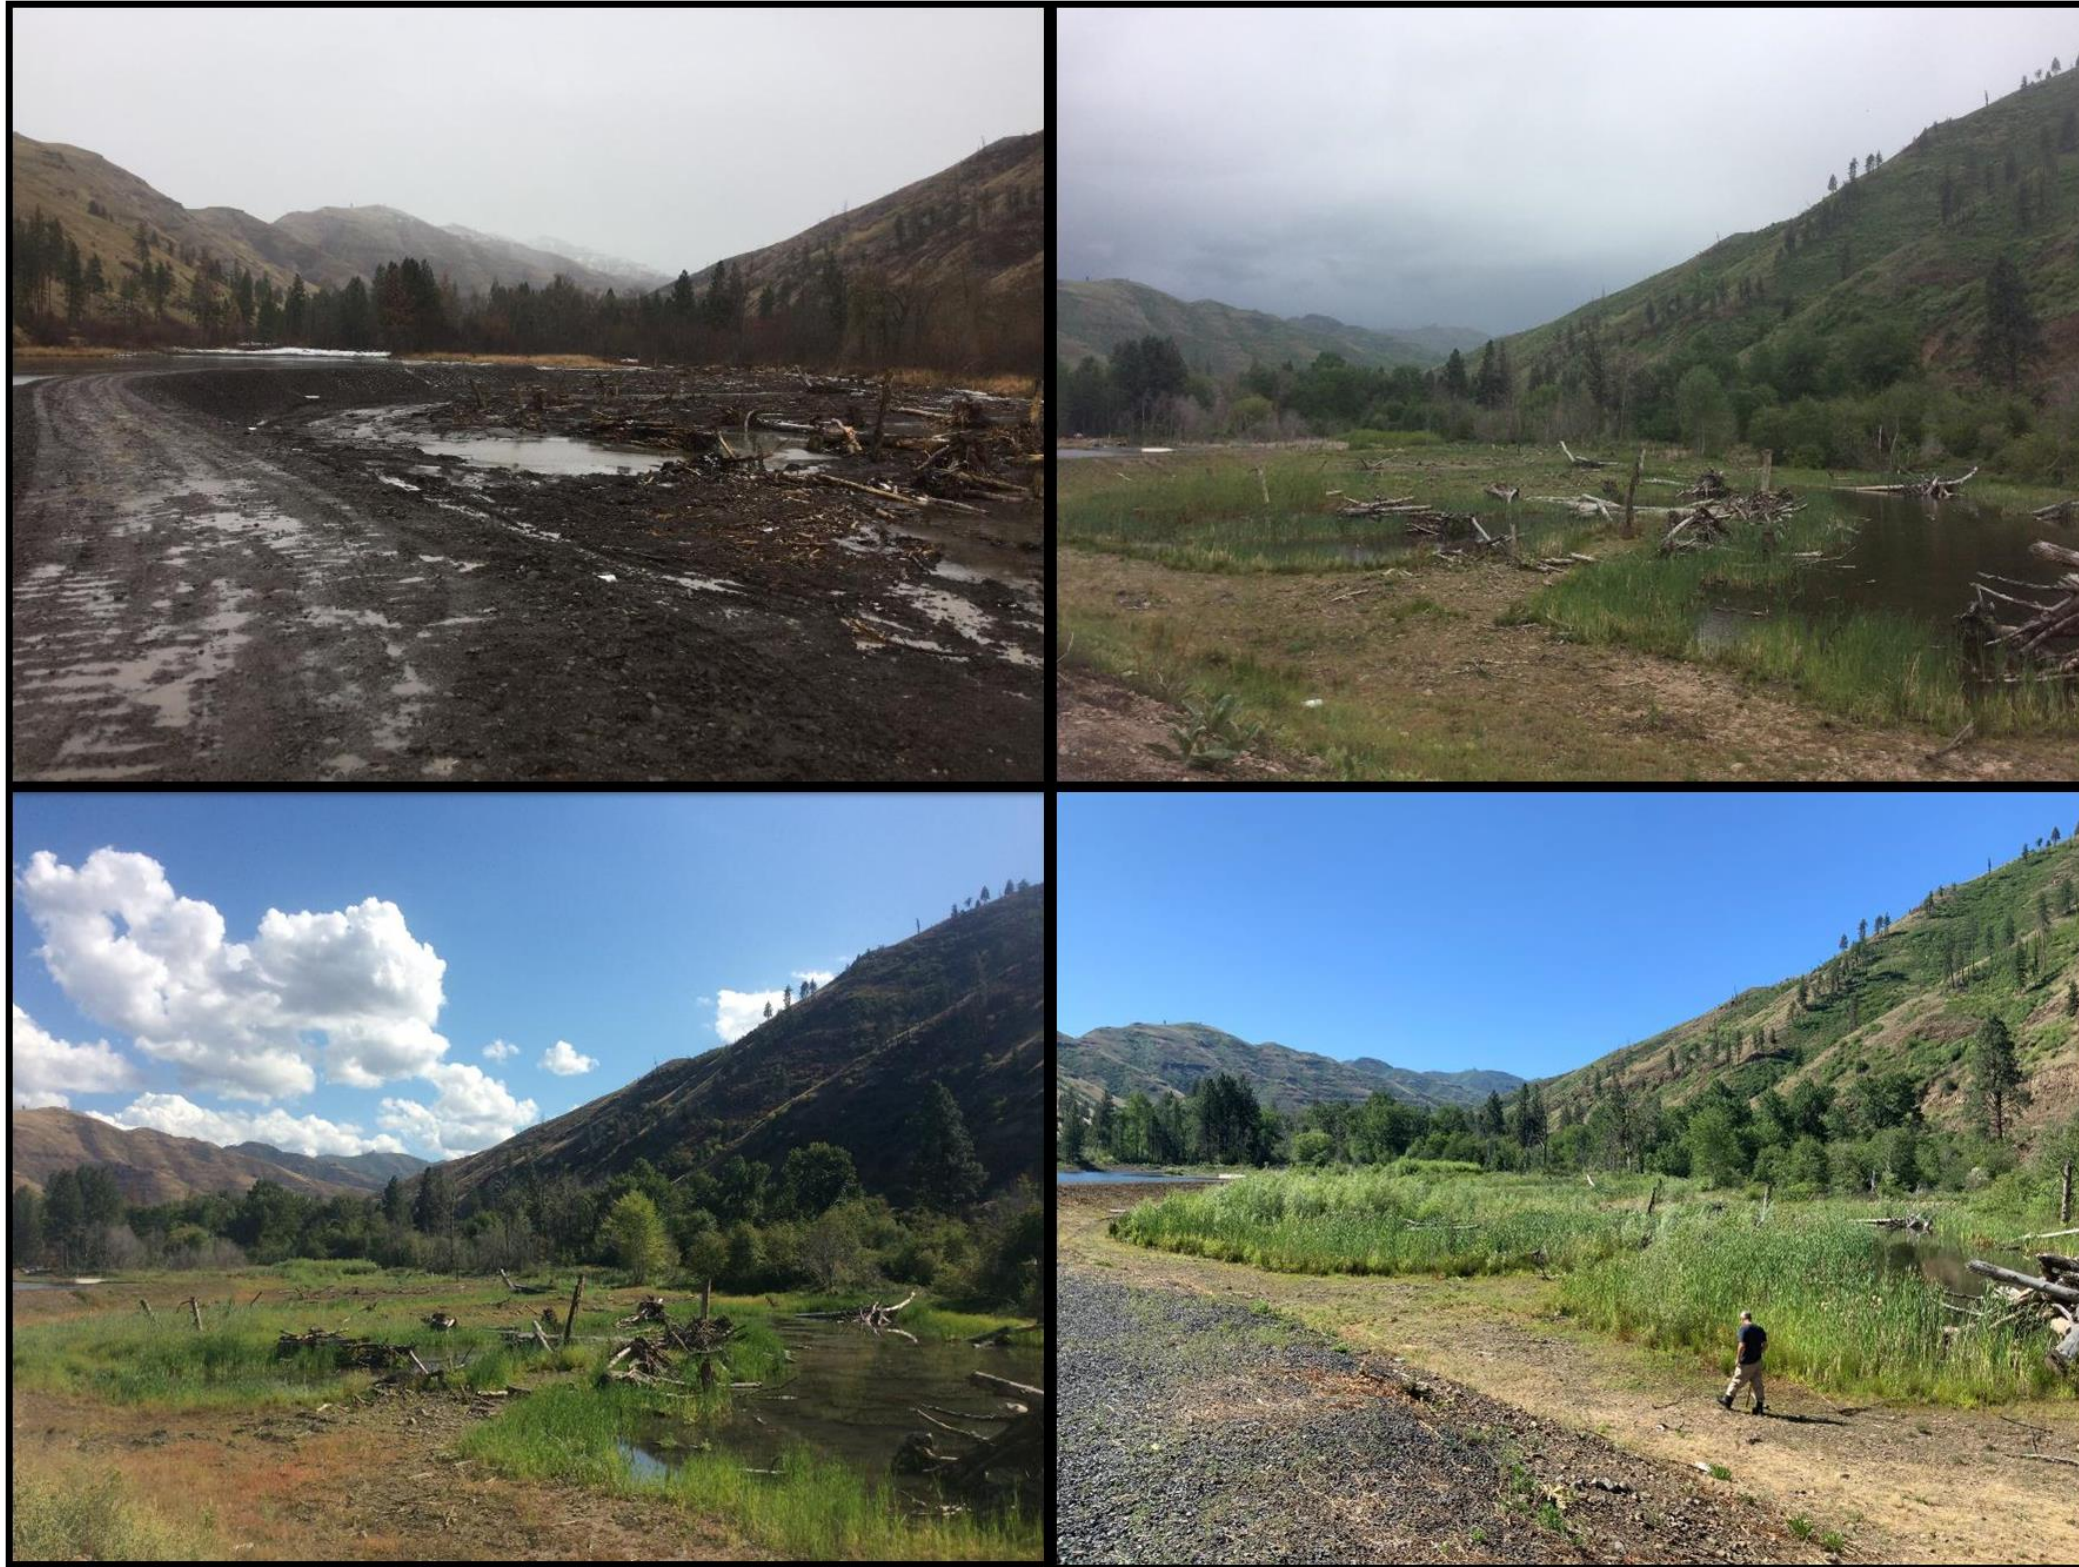
Figure 13-5: The Rainbow Lake Levee set back wetland was created in 2018/19 as part of an effort by WDFW to reduce the impacts of infrastructure on salmon habitats.

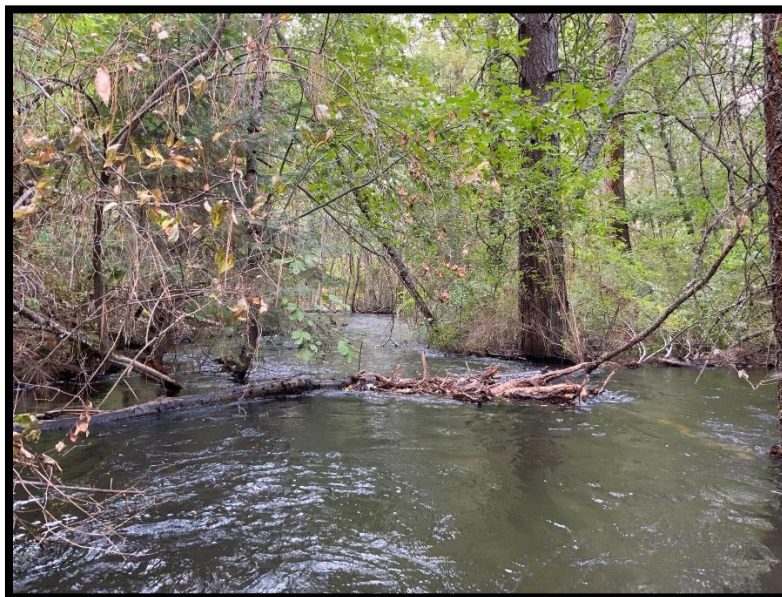
Figure 13-7: Low-lying floodplain reconnected in Phase I and inundated at base flow August 2022, at PA 13.

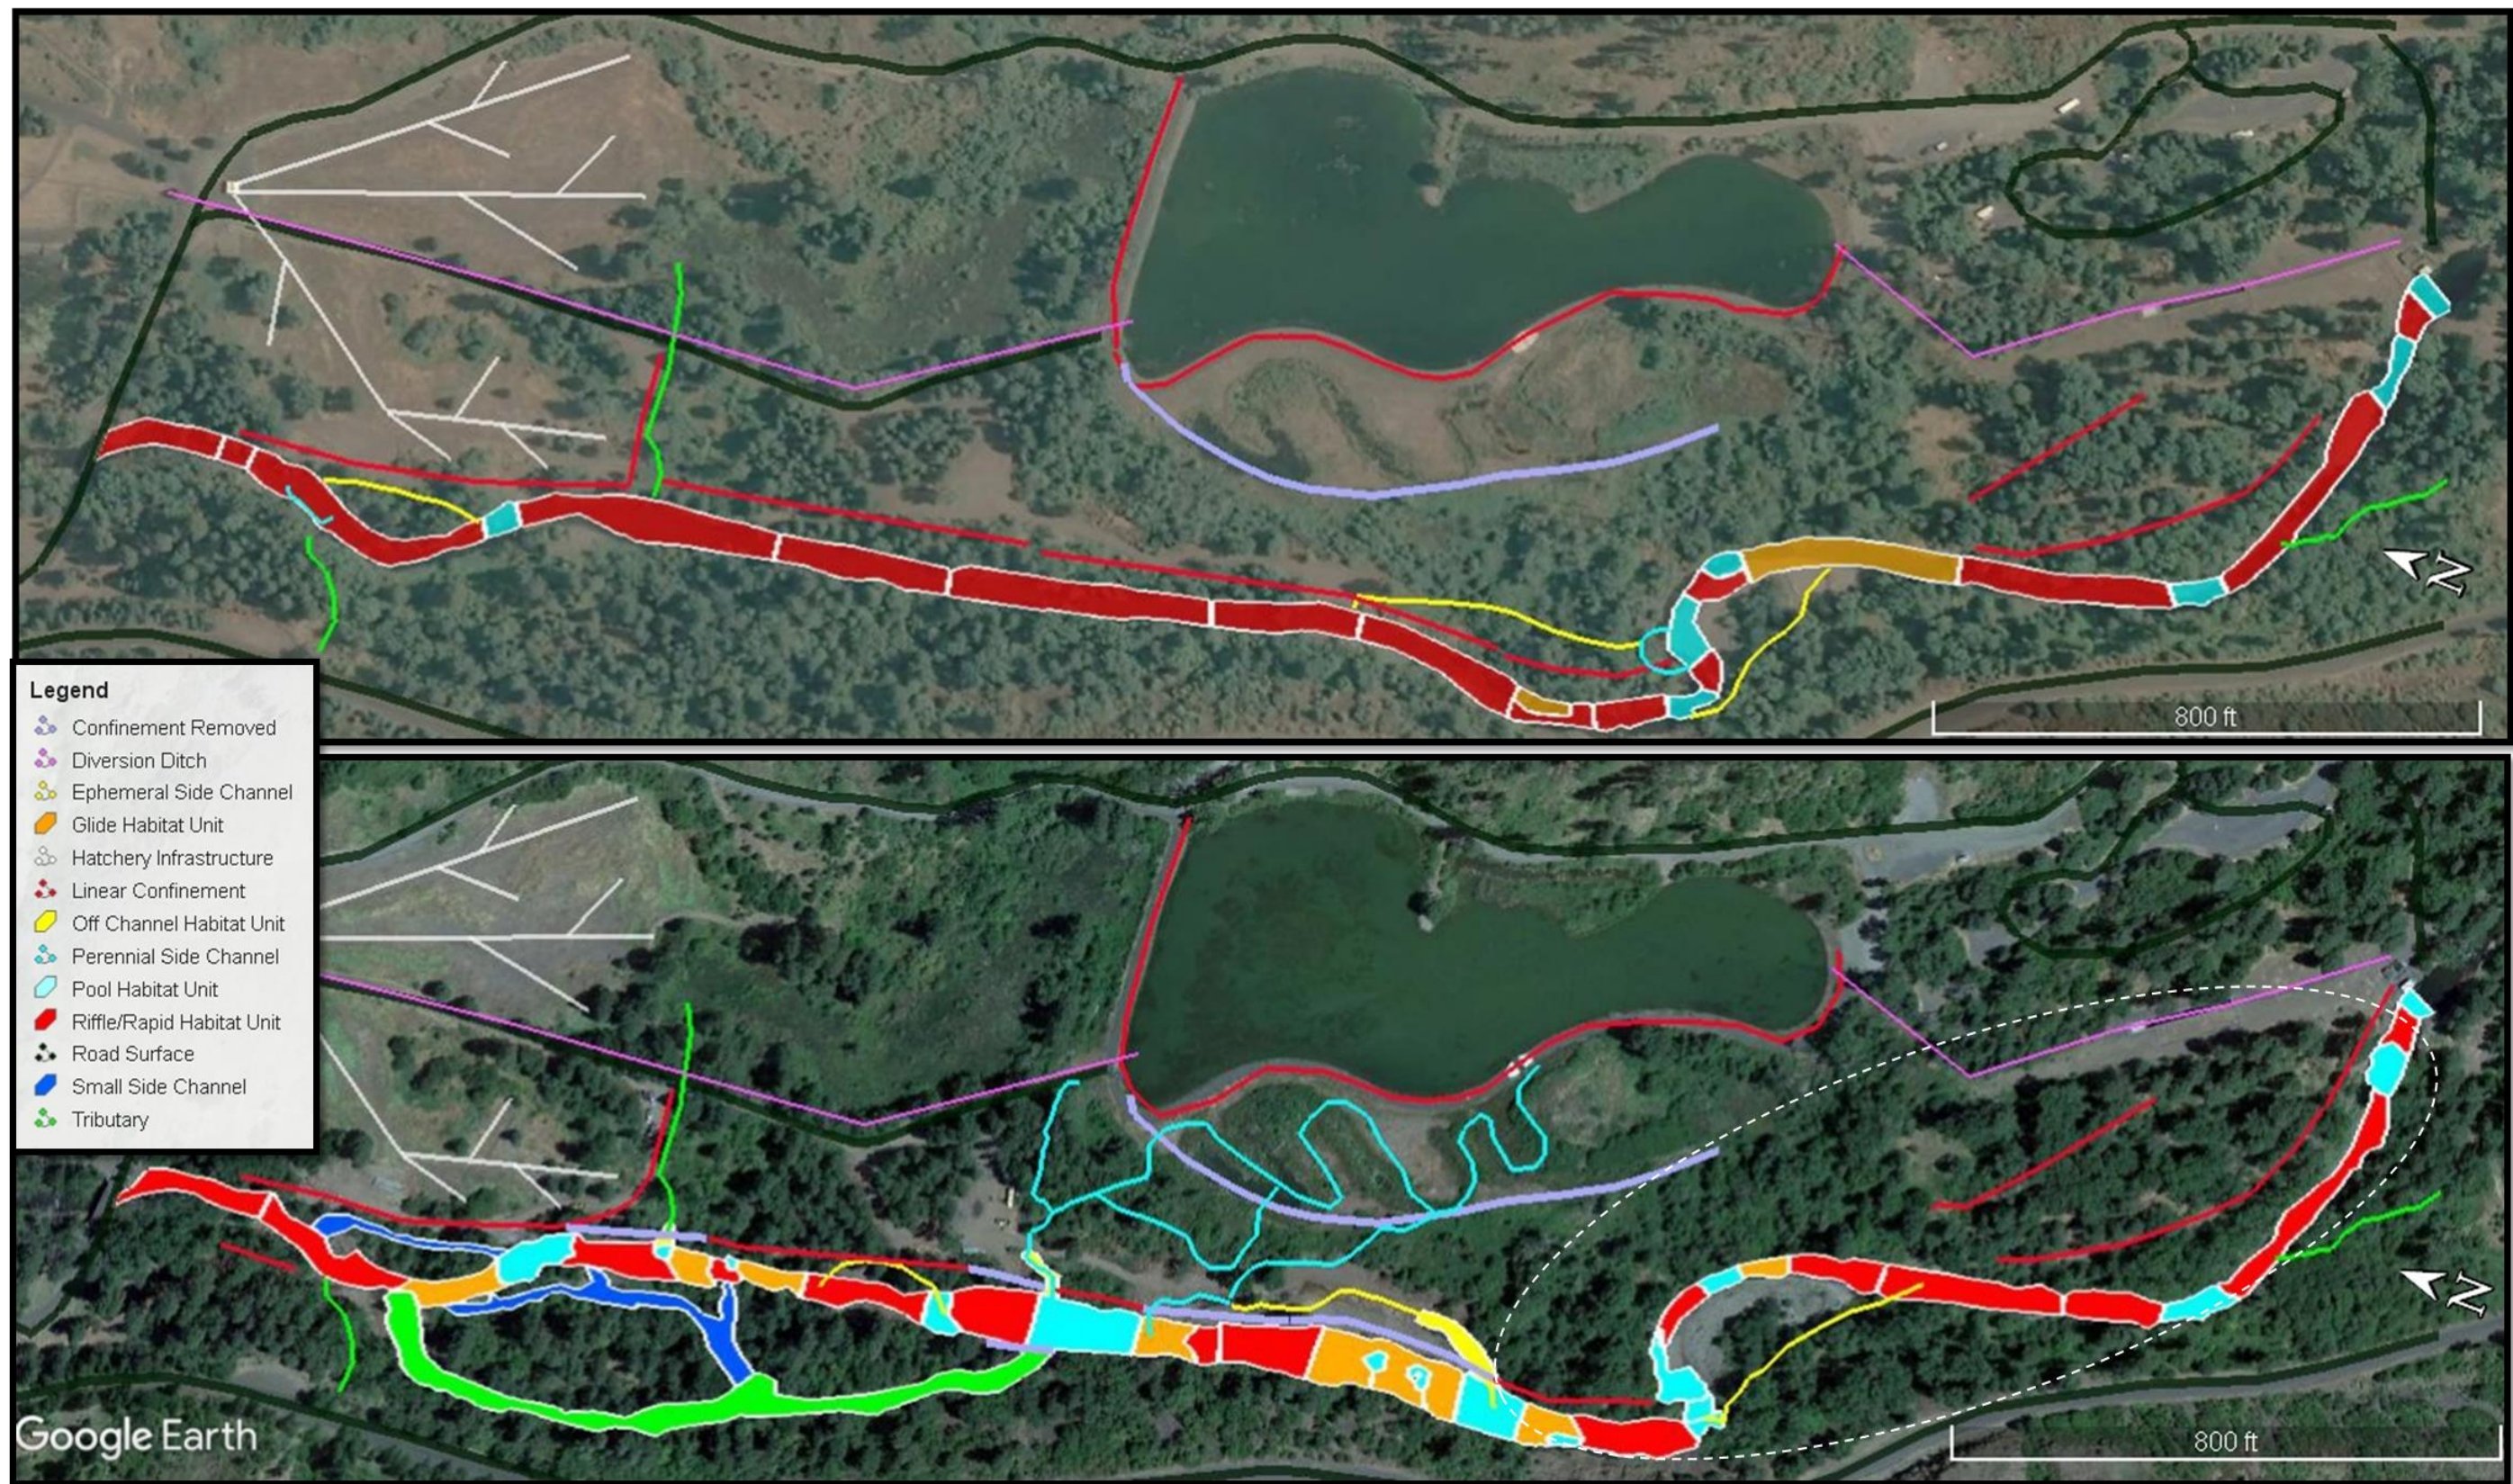
Figure 13-9: Project Area 13 channel habitat units assessed during rapid habitat surveys completed in 2021 (upper map) and post project 2022 (lower map). The white dashed oval indicated natural change that occurred between 2021 and 2022 in the Phase II reach of the project where implementation is planned for 2023. The large green polygon indicates the reconnection of a large side channel which was created in 2022 Phase I (lower map).

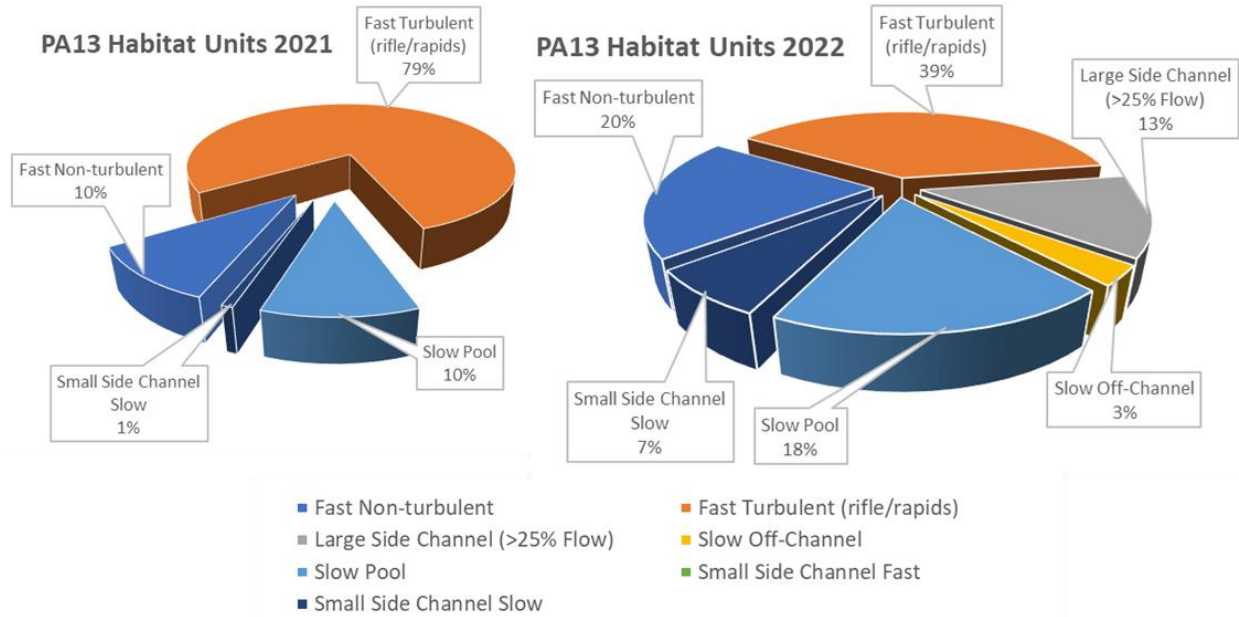
Figure 13-10: The Tucannon CHaMP program completed a habitat unit assessment in 2016 and found a ratio of 59% riffle rapids, 34% glide and 7 % slow pool. Following a similar strategy in 2021 the Program found the pre-project condition to be very similar (upper left). A follow up survey was completed in 2022 to capture the Phase I implementation (upper right) illustrating an increase in the number of channel unit especially an increase in slow water units.

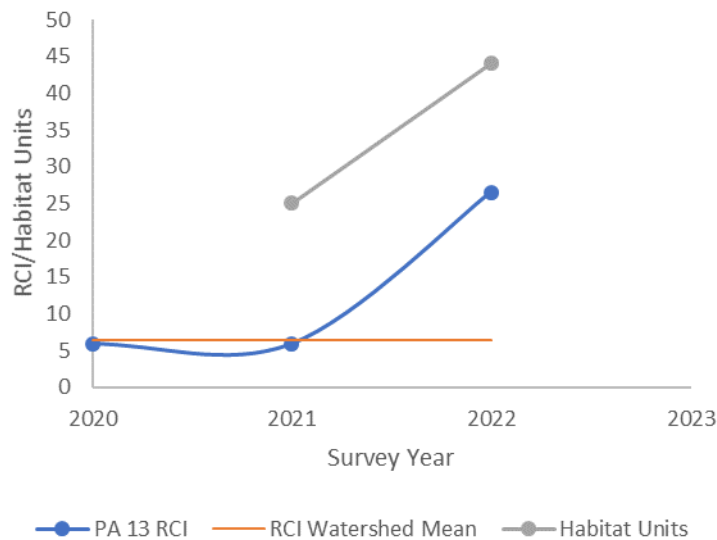
Figure 13-11: Project area 13 change in River Complexity Index (Citation) across three survey periods with two surveys prior to Phase I restoration actions and one following restoration in 2022. Channel complexity was calculated for the entire 1.28 miles survey reach although only the lower Phase I reach was implemented in 2022. It is anticipated this index will increase following restoration in 2023. The orange flat line represents the calculated mean RCI for all untreated project areas within the basin. The 2022 maximum

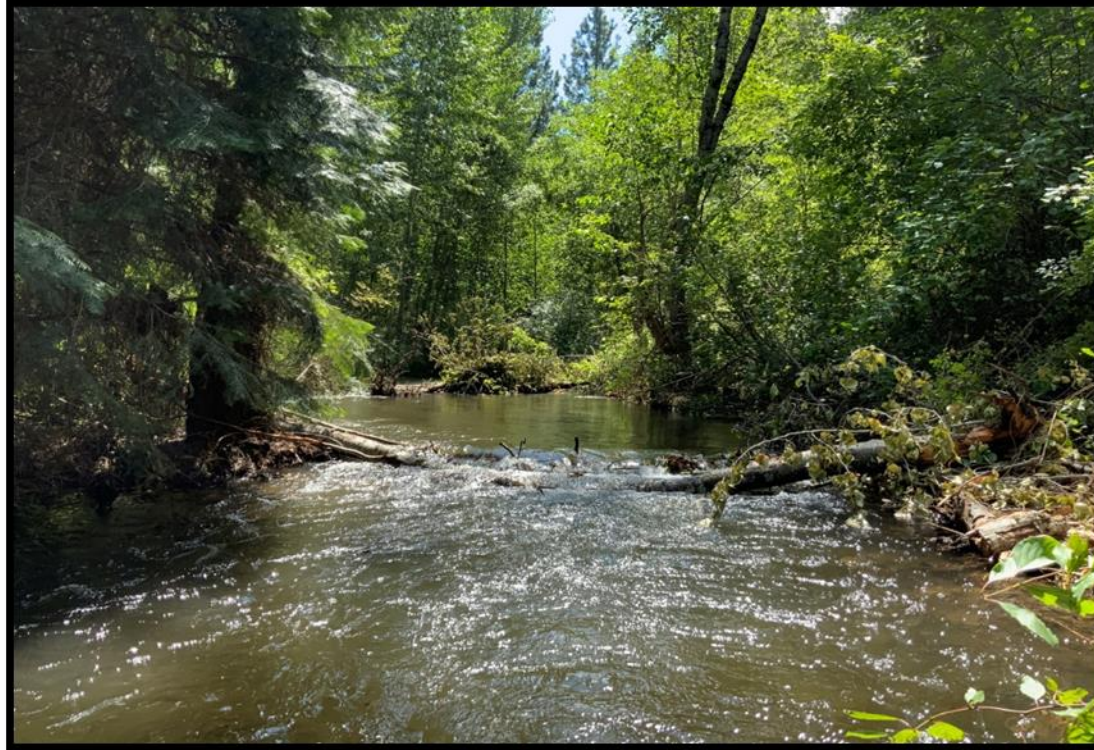
PA13-12: PA 13 Phase I side channel (upper right & left) and off channel units (lower left and right) created through removing confining features and channel plugs.

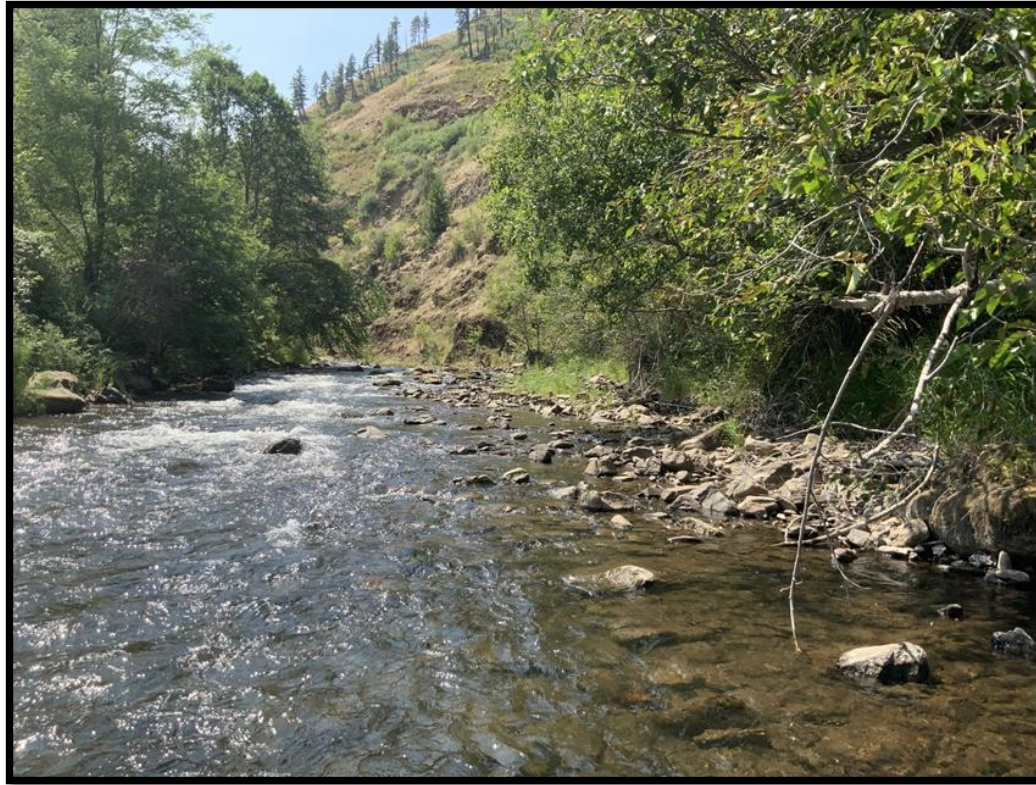
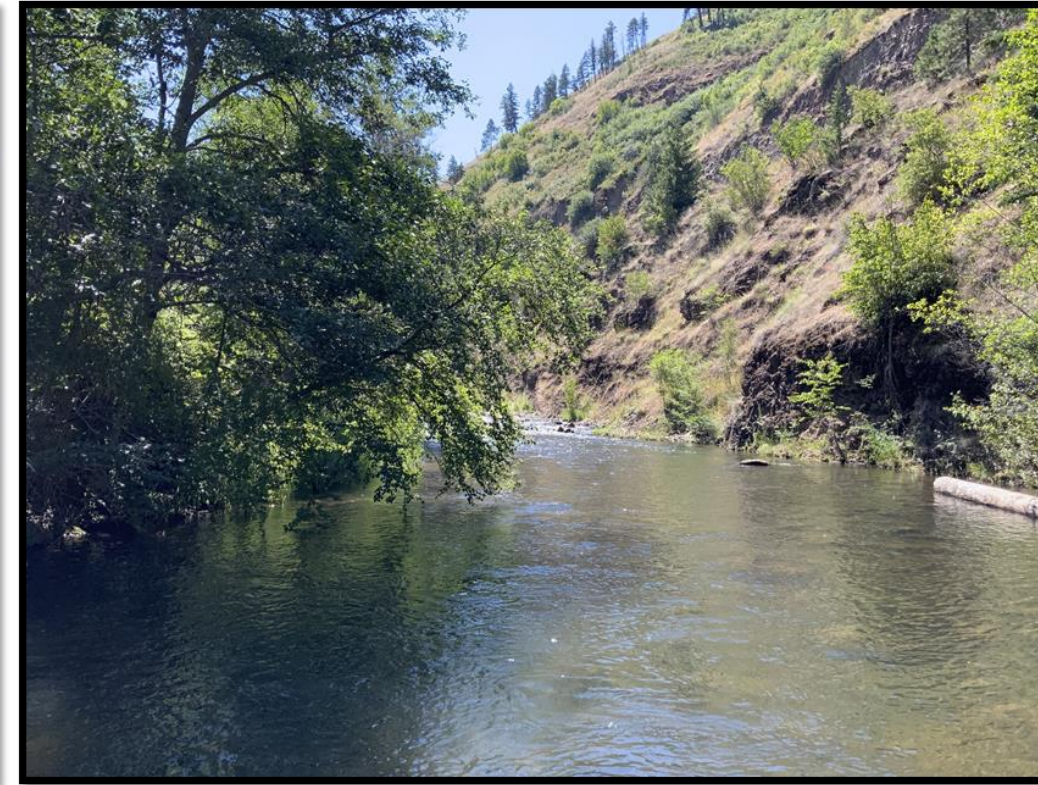
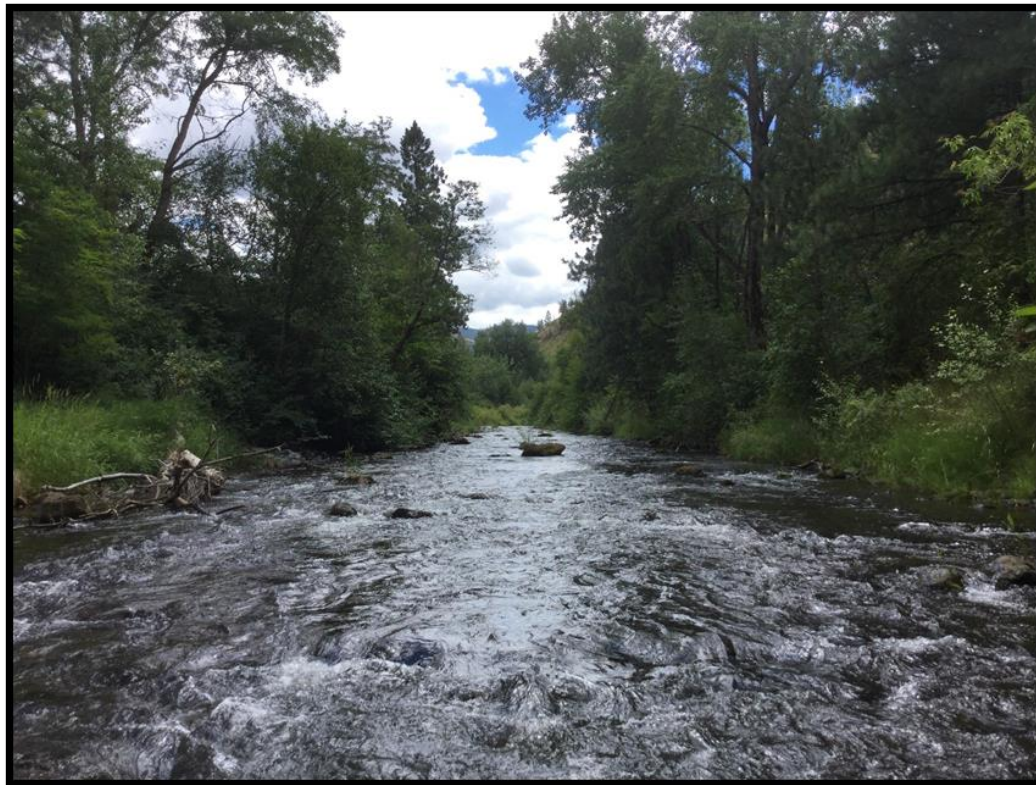
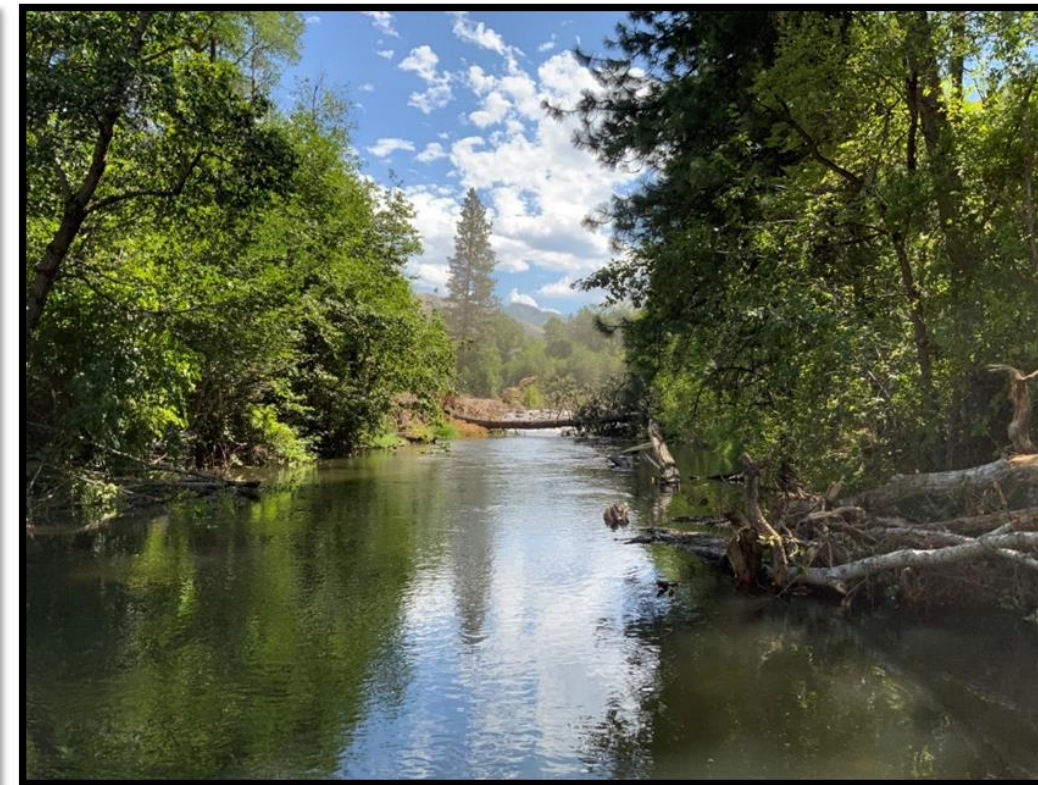
Figure 13-13: Project area 13 Phase I pre/post project images of areas influenced by channel plugs. The upper photo set illustrates the riffle rapids section of the river back watered and converted to a long glide by construction of the upper plug. The lower pair of images depicts the conversion of plain bed channel type to glide and deep pool habitats.

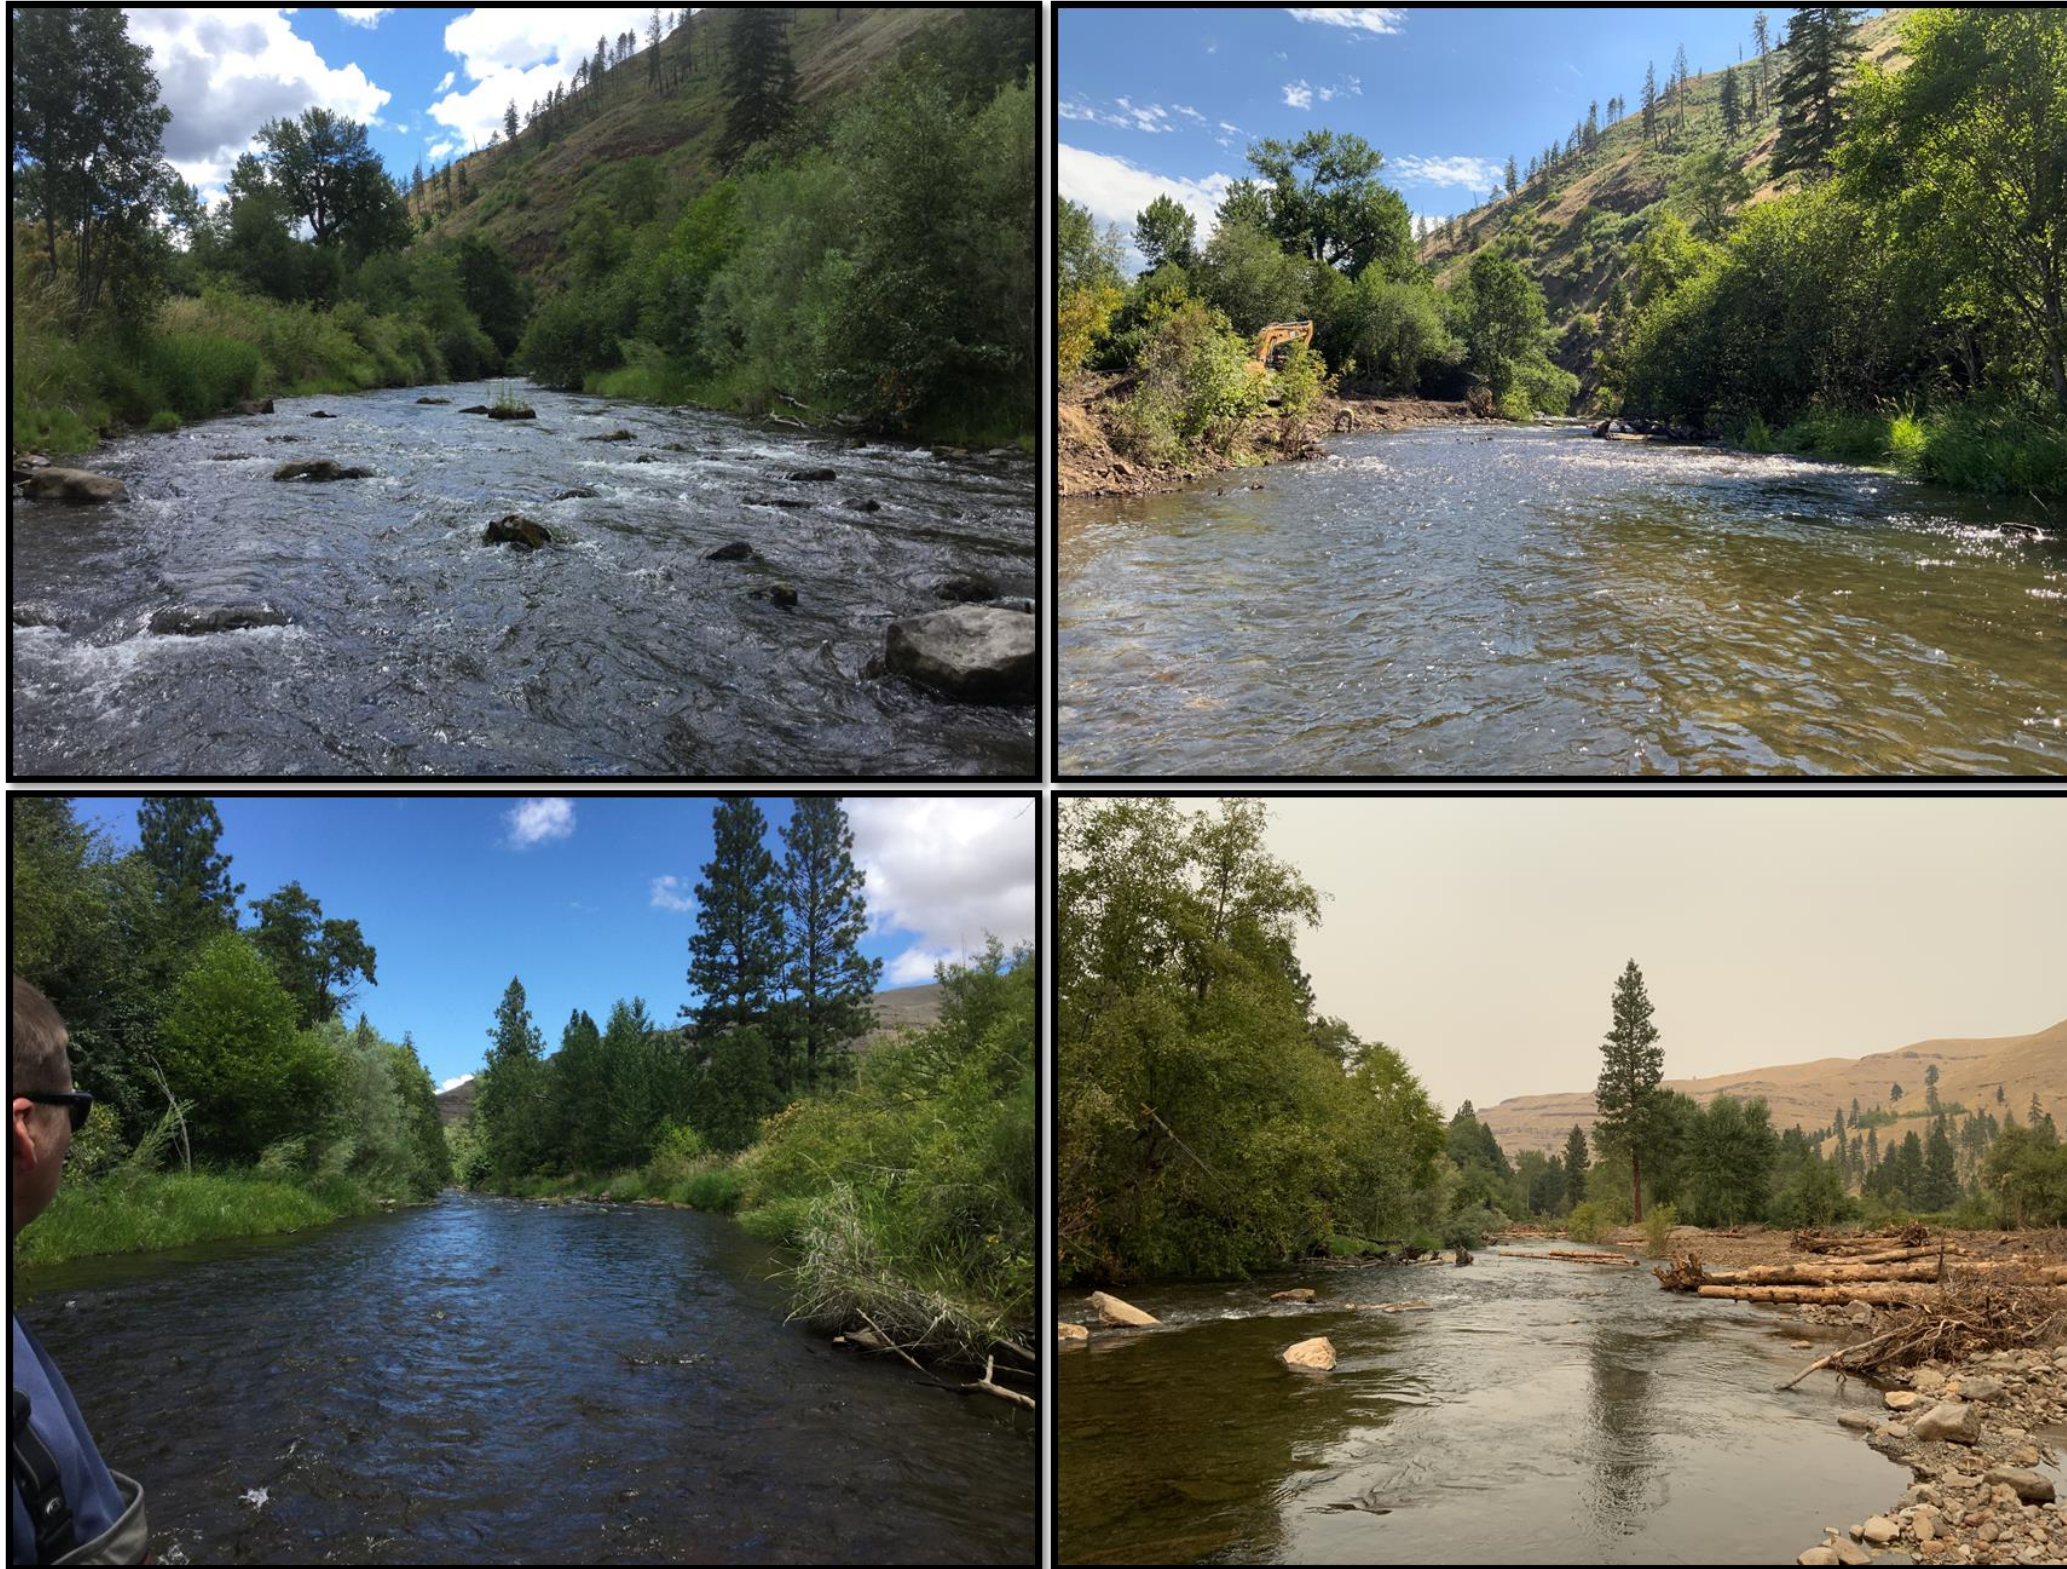
Figure 13-14: Project area 13 channel reached impacted by levee and rip-rap removal pre-project (left upper/lower) and post project as-built 2022. The upper photo set shows the upper leveed section with channel fill placed to elevate water surface to activate low-lying floodplain and side channels.
