Tucannon Habitat Programmatic

Annual Summary Report

(January 2022– December 2022)

BPA Project #2010-077-00

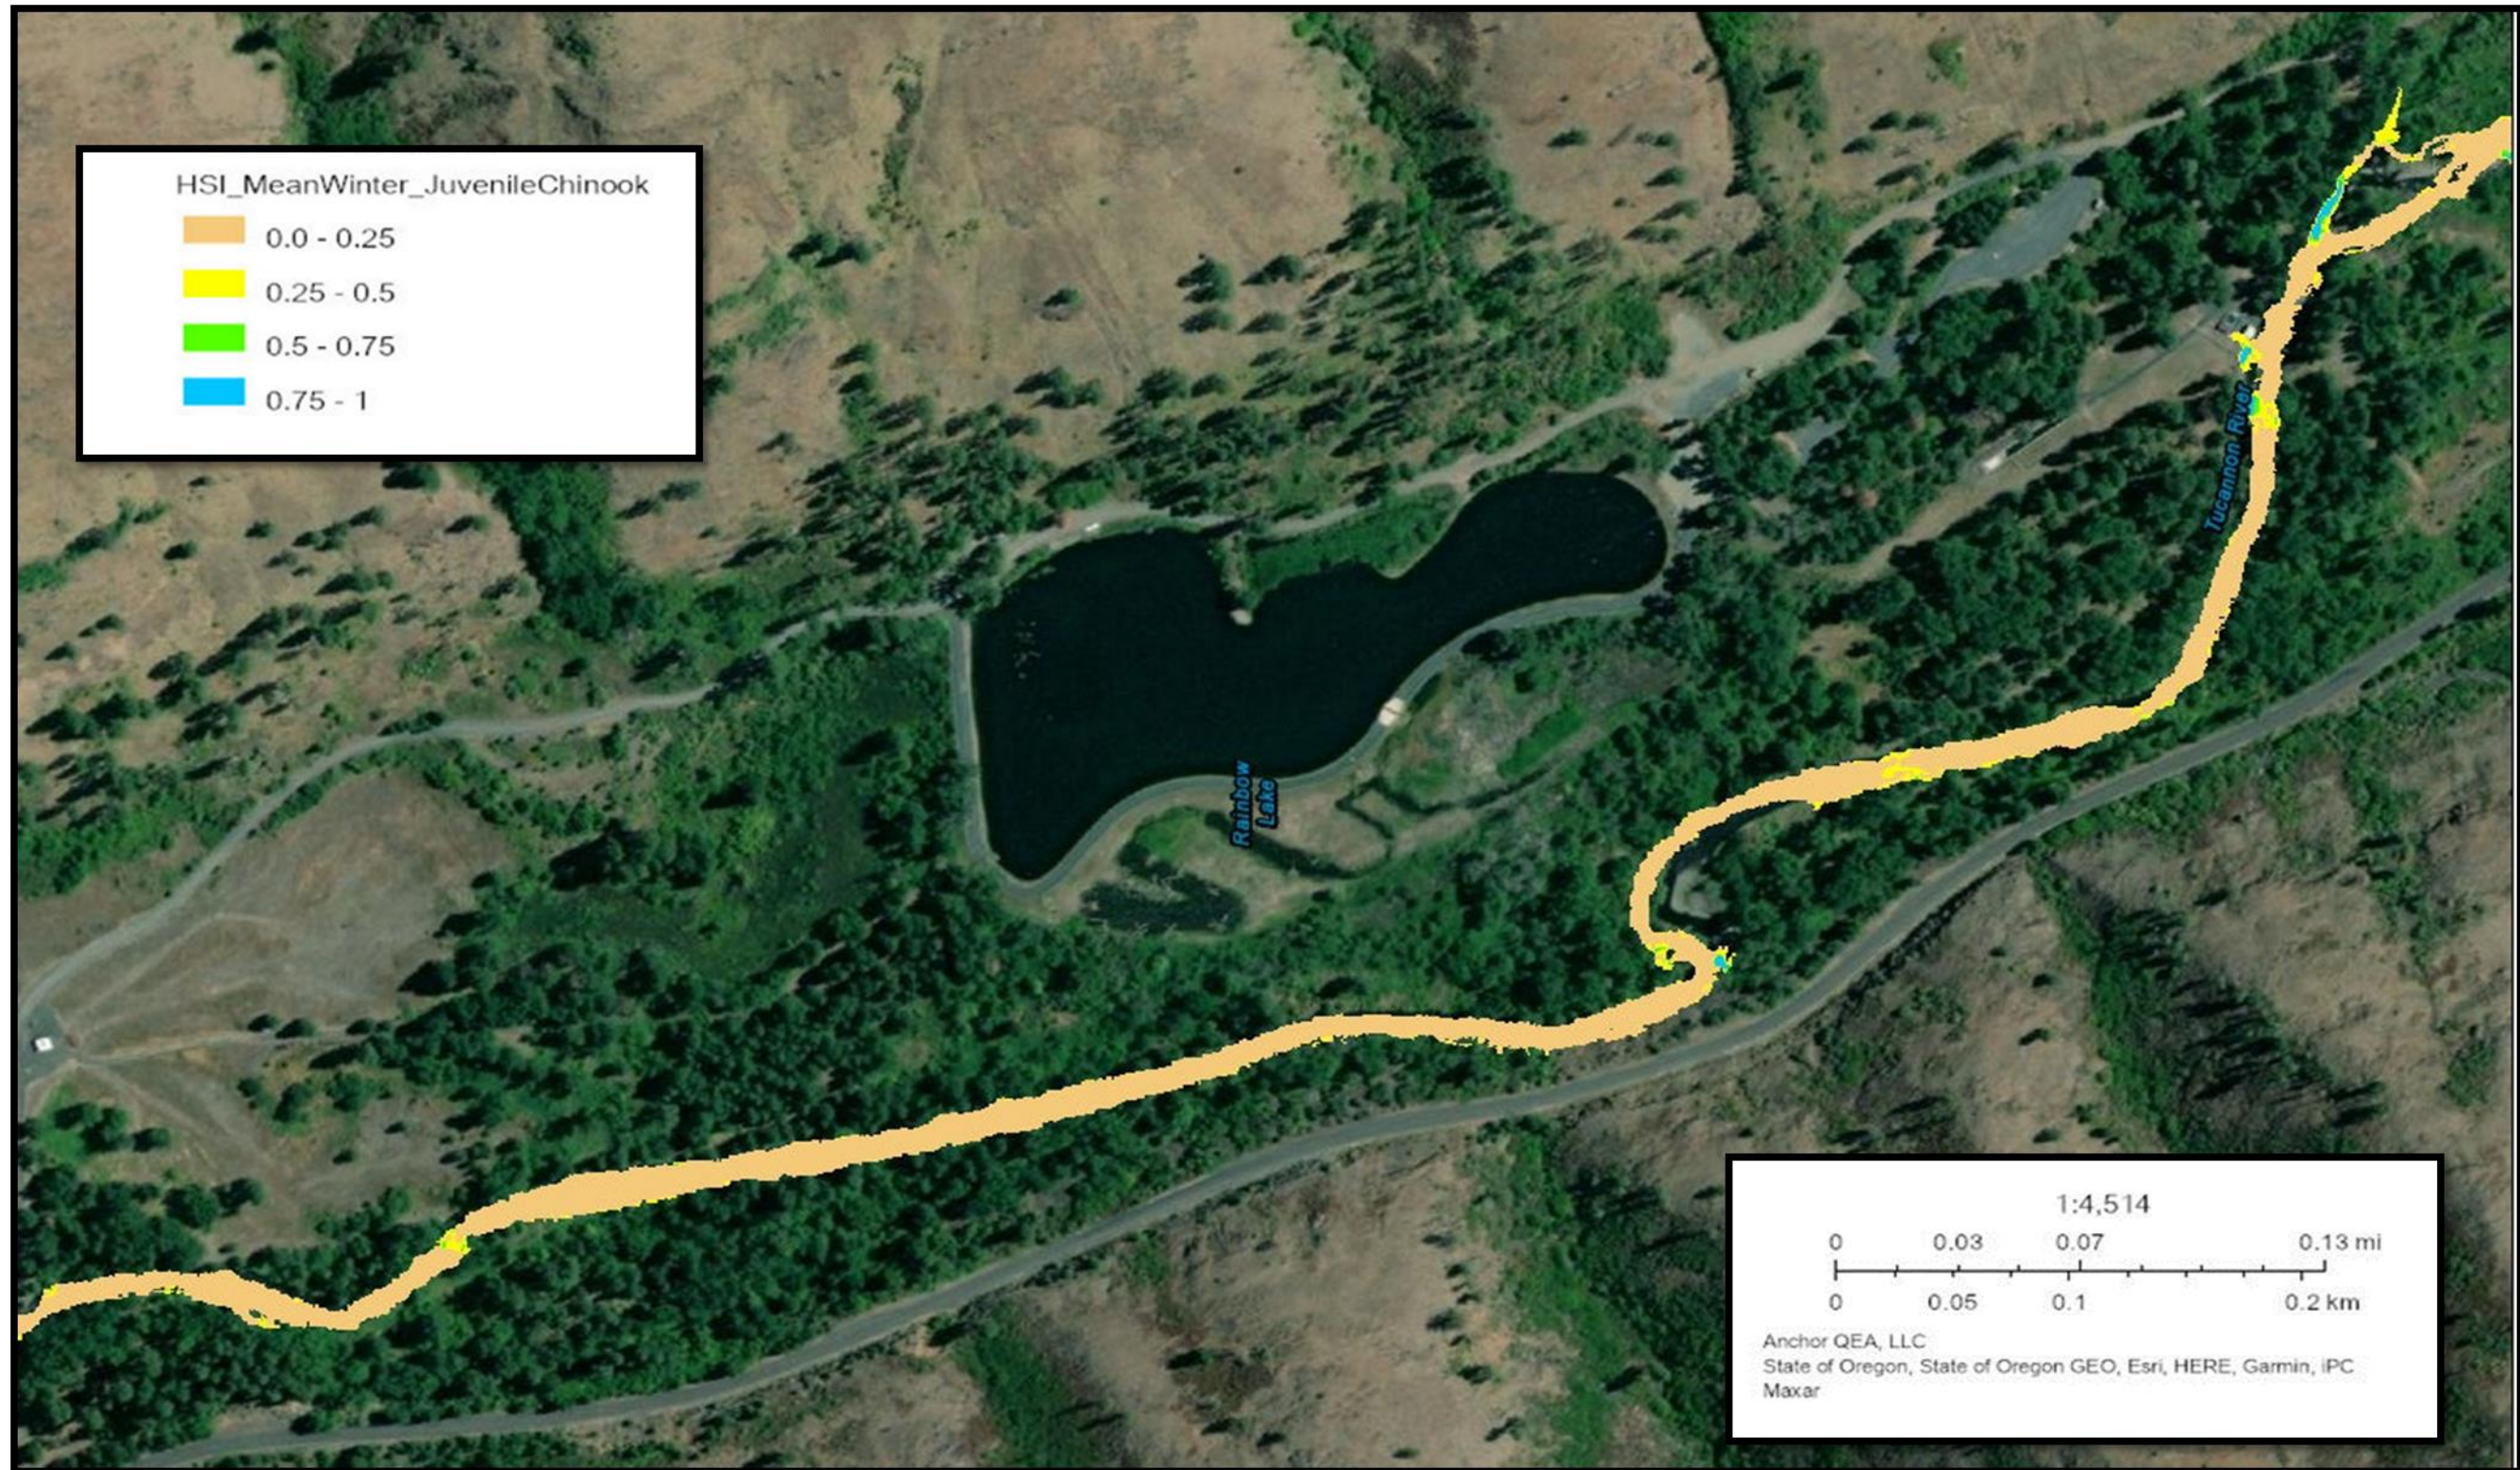
Figure 13-15: PA13 pre-project Habitat Suitability Index (HSI) for spring Chinook during under mean winter flows (300 cfs). Notice that pre-project condition harbored very little suitable habitat for spring Chinook in 2020 when this LiDAR data set and analysis was conducted. This is primarily due to the predominant plain bed channel form present 2020-up to construction in 2022 Phase I, illustrated by channel habitat unit surveys (Figure 13-9). A follow up survey will be conducted following completion of Phase II in 2023.

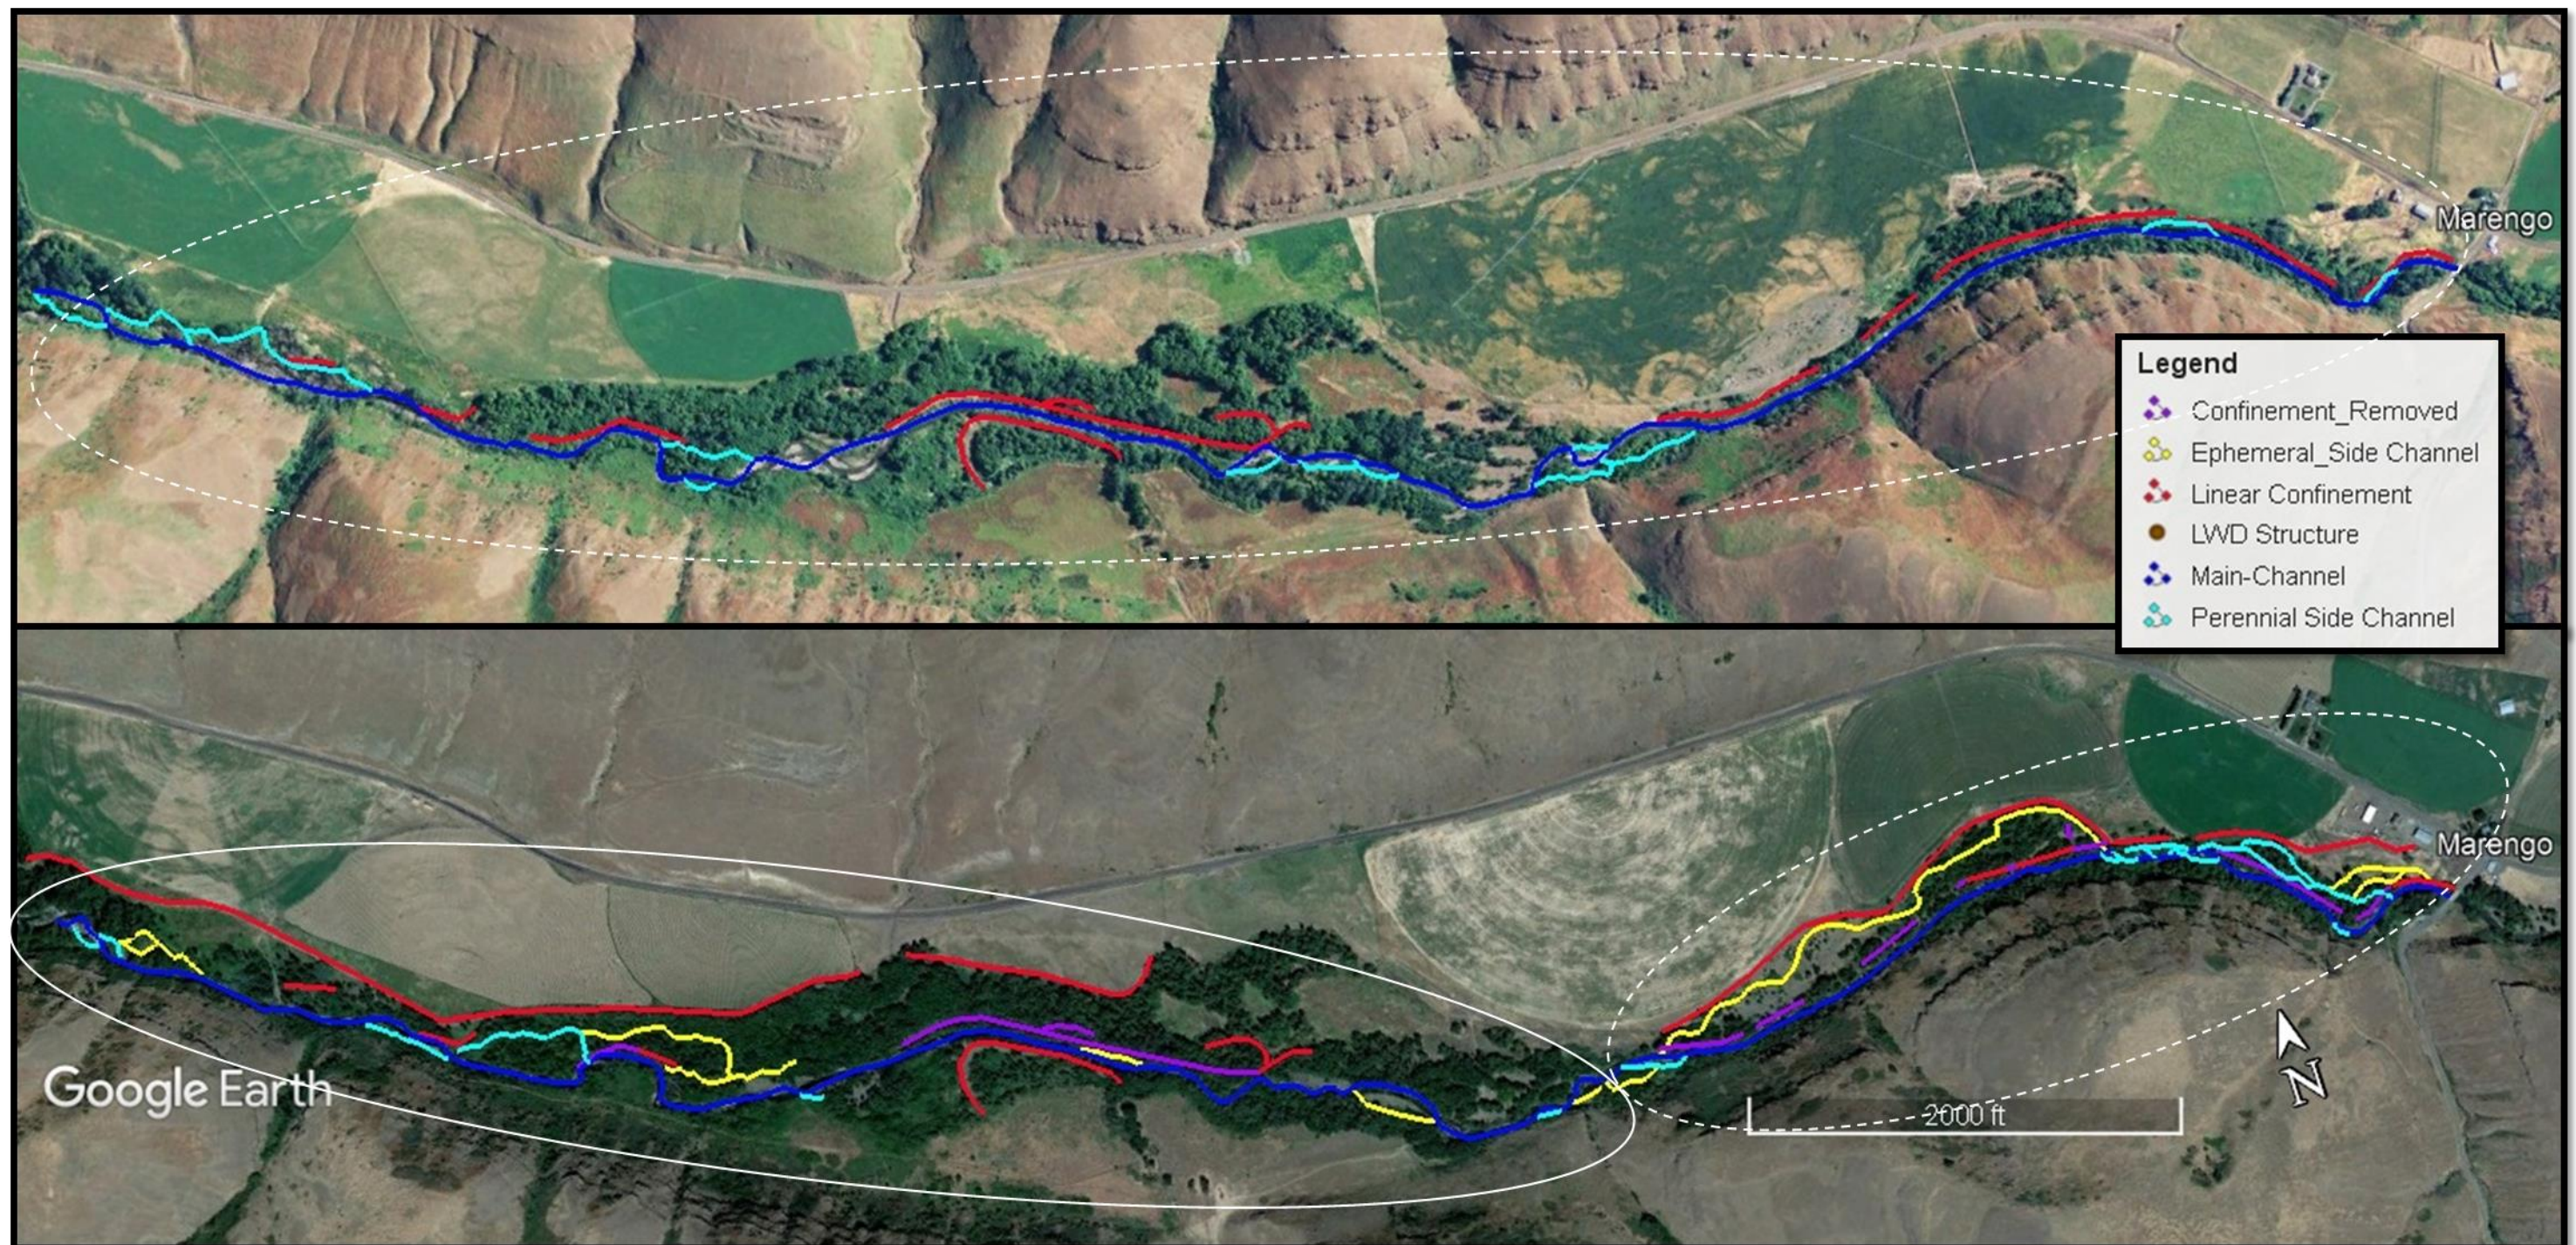
Figure 26-2: Project Area 26 located on the Tucannon River 2011 map (upper) and 2022 map (lower). The large white dashed oval on the upper map illustrates the approximate extent of Phase I, the smaller dashed oval (lower map) indicates the location of Phase II, while the large solid oval (lower map) indicated the footprint of Phase III and IV together. The upper map illustrates the position of river levees and other confinement in 2011 prior to the completion of Phase I. The lower map show the position of confinement removed in 2011, and the current remaining confining features including the levee set-back built in 2011.

Summary: In 2011, 945 m of river levees, rip-rap and gravel berms were removed or breached throughout the entire reach (Figure 26-2) as part of the 4.1 km long PA 26 Phase I project. The goal of Phase I was to restore properly functioning geomorphic condition by reducing river channel and floodplain confinement from disconnected to connected at a 2 yr interval. In 2011, levee removal was a relatively new and innovative restoration technique for SE Washington, resulting in a conservative approach being implemented where the levee was removed and set back in the first year, and channel modifications would be delayed to make observations on how the channel would recover naturally (“letting the river do the work”). Based on observations made in 2013 following two high water events, fifteen log jams were placed within the 4.1 km reach as a pilot effort in accordance with landowner’s wishes at the time. Monitoring surveys conducted by CHaMP and the Program between 2012 and 2017 indicated limited change in channel shape or gravel storage within the reach and that the ~60 ac of low floodplain liberated by the 2011 levee removal project had experienced very limited flood inundation in 2012 and none between 2013 & 2017. The CHaMP program recommended additional LWD structure placement to sort and retain gravel bars to encourage lateral channel migration and increased floodplain inundation frequency and duration (Hill 2017).

Results/Discussion: In 2011, a little over 945 m of levee, rip-rap and gravel berms were removed as part of the work completed in Phase I (Figure 26-2). Following two high flow events in 2012 (Figure 3), inundation of the available floodplain had not been observed and a low-density LWD structure treatment was conducted to initiate habitat gains. By 2017, changes in channel habitat complexity like pools and bar had increased (Hill 2017) but floodplain connectivity and complexity remained below targets set in the Salmon Recovery Plan SE WA (SRSRB 2011). It is hypothesized that channel size/volume had not been reduced through roughness and deposition significantly enough to reduce power or increase inundation of adjacent floodplain. In 2019-20, the CCD initiated an adaptive management action (Phase II & Phase III-IV) developing a design through a phased approach (Figure 26-2) to increase floodplain connectivity and channel complexity. The action would focus on increasing channel roughness, reducing stream power and increasing access to side channels and more frequent inundation of the floodplain as described in the next two sections of this report.

In 2011, river levees and gravel berms were removed or breached throughout the entire Phase II reach (Figure 26-2) as part of the 4.1 km long PA 26 Phase I project. The goal of Phase I was to restore properly functioning geomorphic condition by reducing river channel and floodplain confinement (discussed in the previous section). As part of Phase I, 5 log jams (15 key pieces) were placed within the 1.4 km Phase II (#87504) reach, to provide fish cover while river conditions were monitored. Surveys conducted by CHaMP and the Program between 2012 and 2017 indicated limited change in channel shape or gravel storage and that the ~14 ac of floodplain liberated by the 2011 levee removal project had experienced very limited inundation

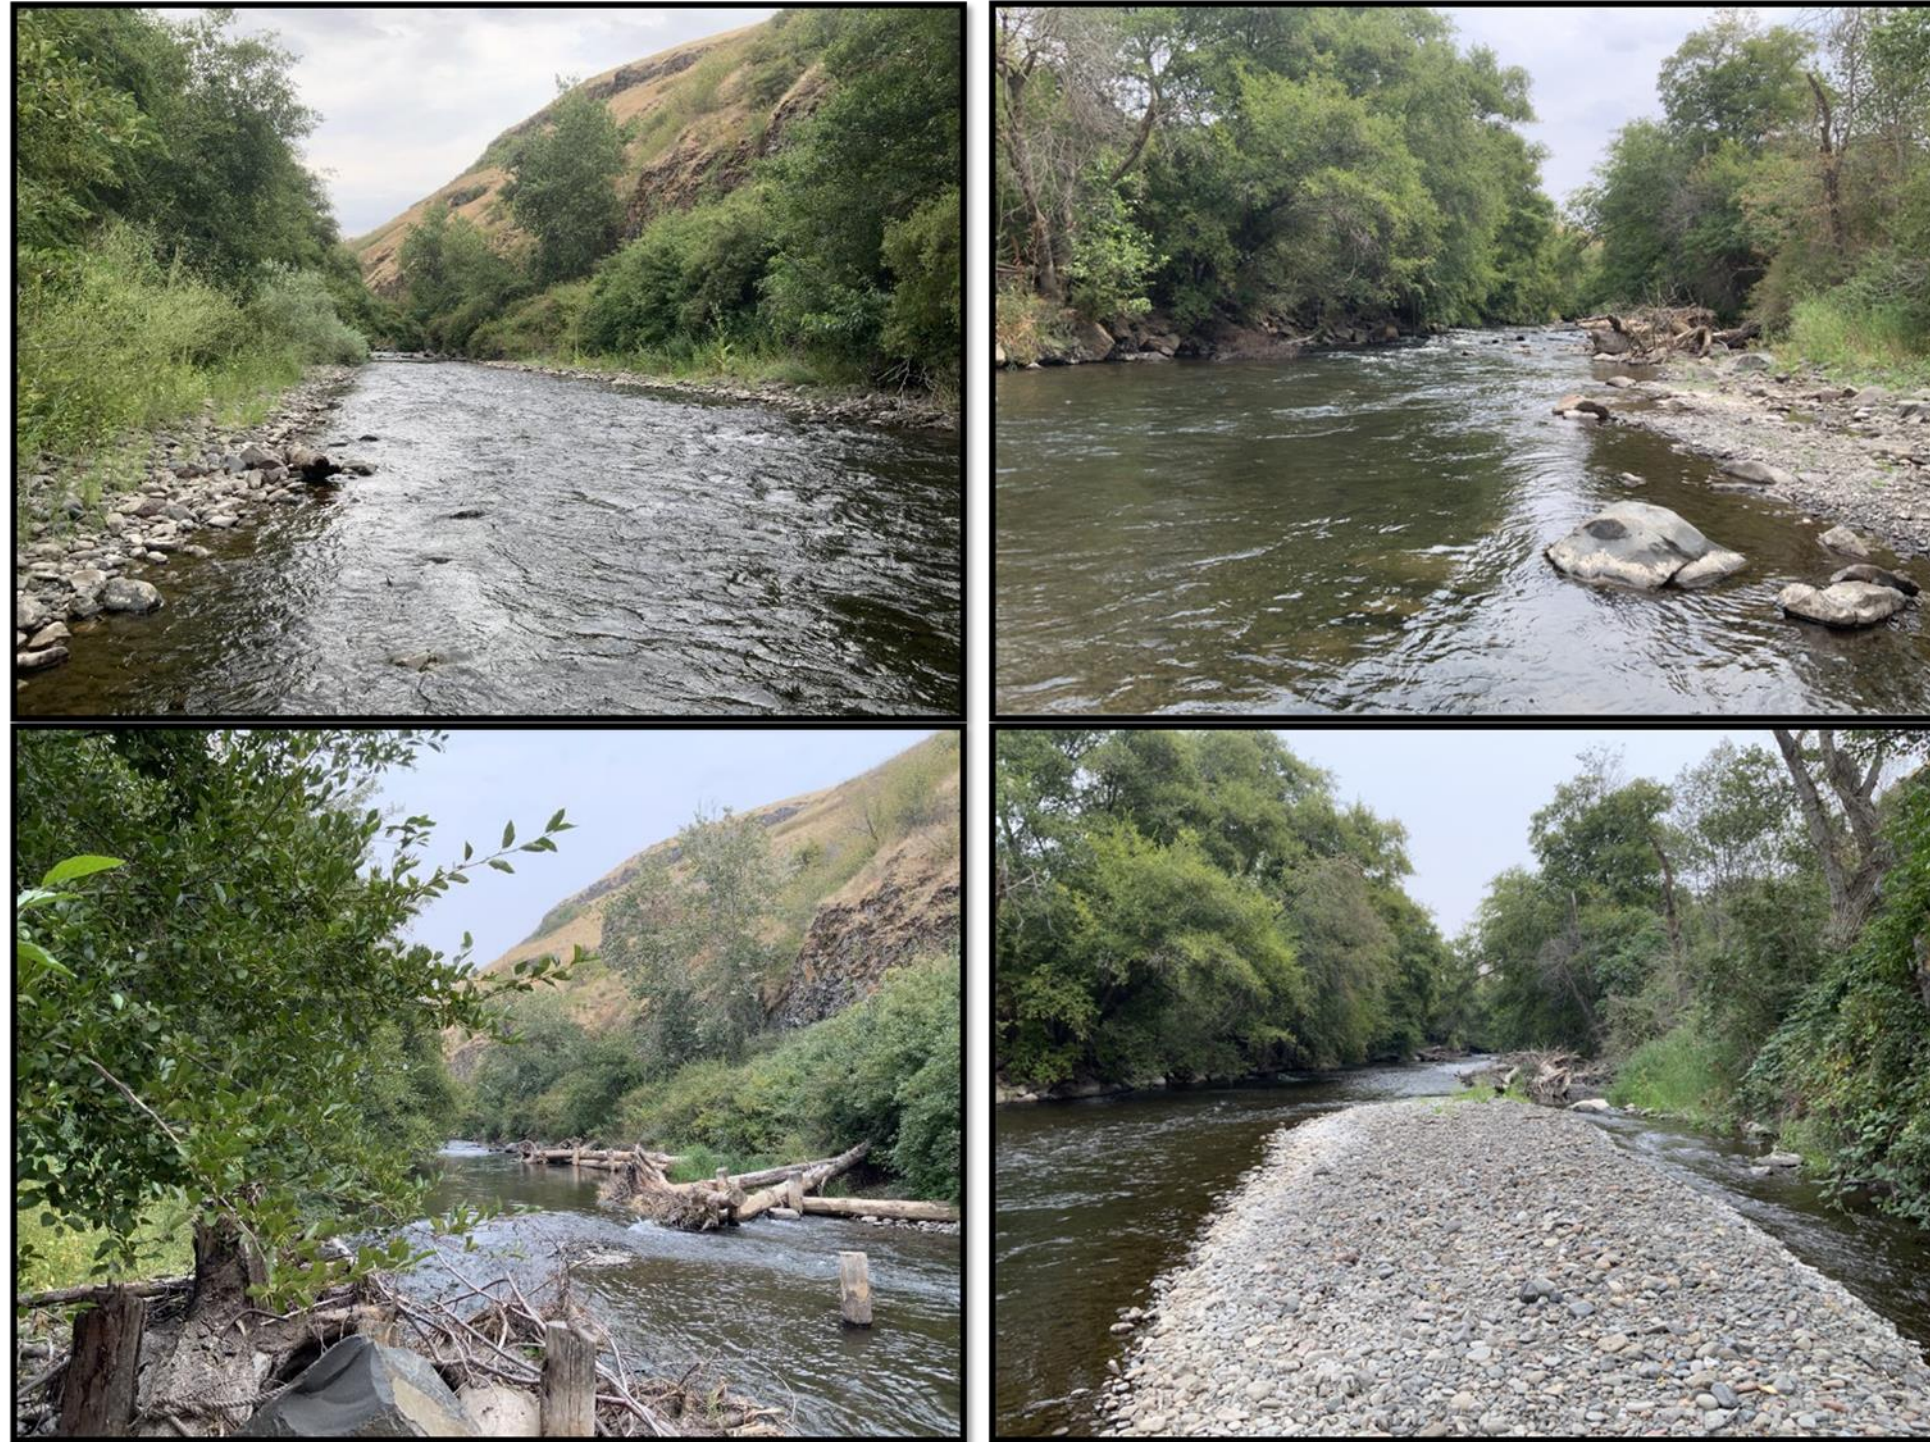
Figure 26-3: Project Area 26 Phase II 2021 implementation project before (upper two images) after (lower two images) images Taken in 2021 pre-project and 2022 following one year of high flow in 2021/22.

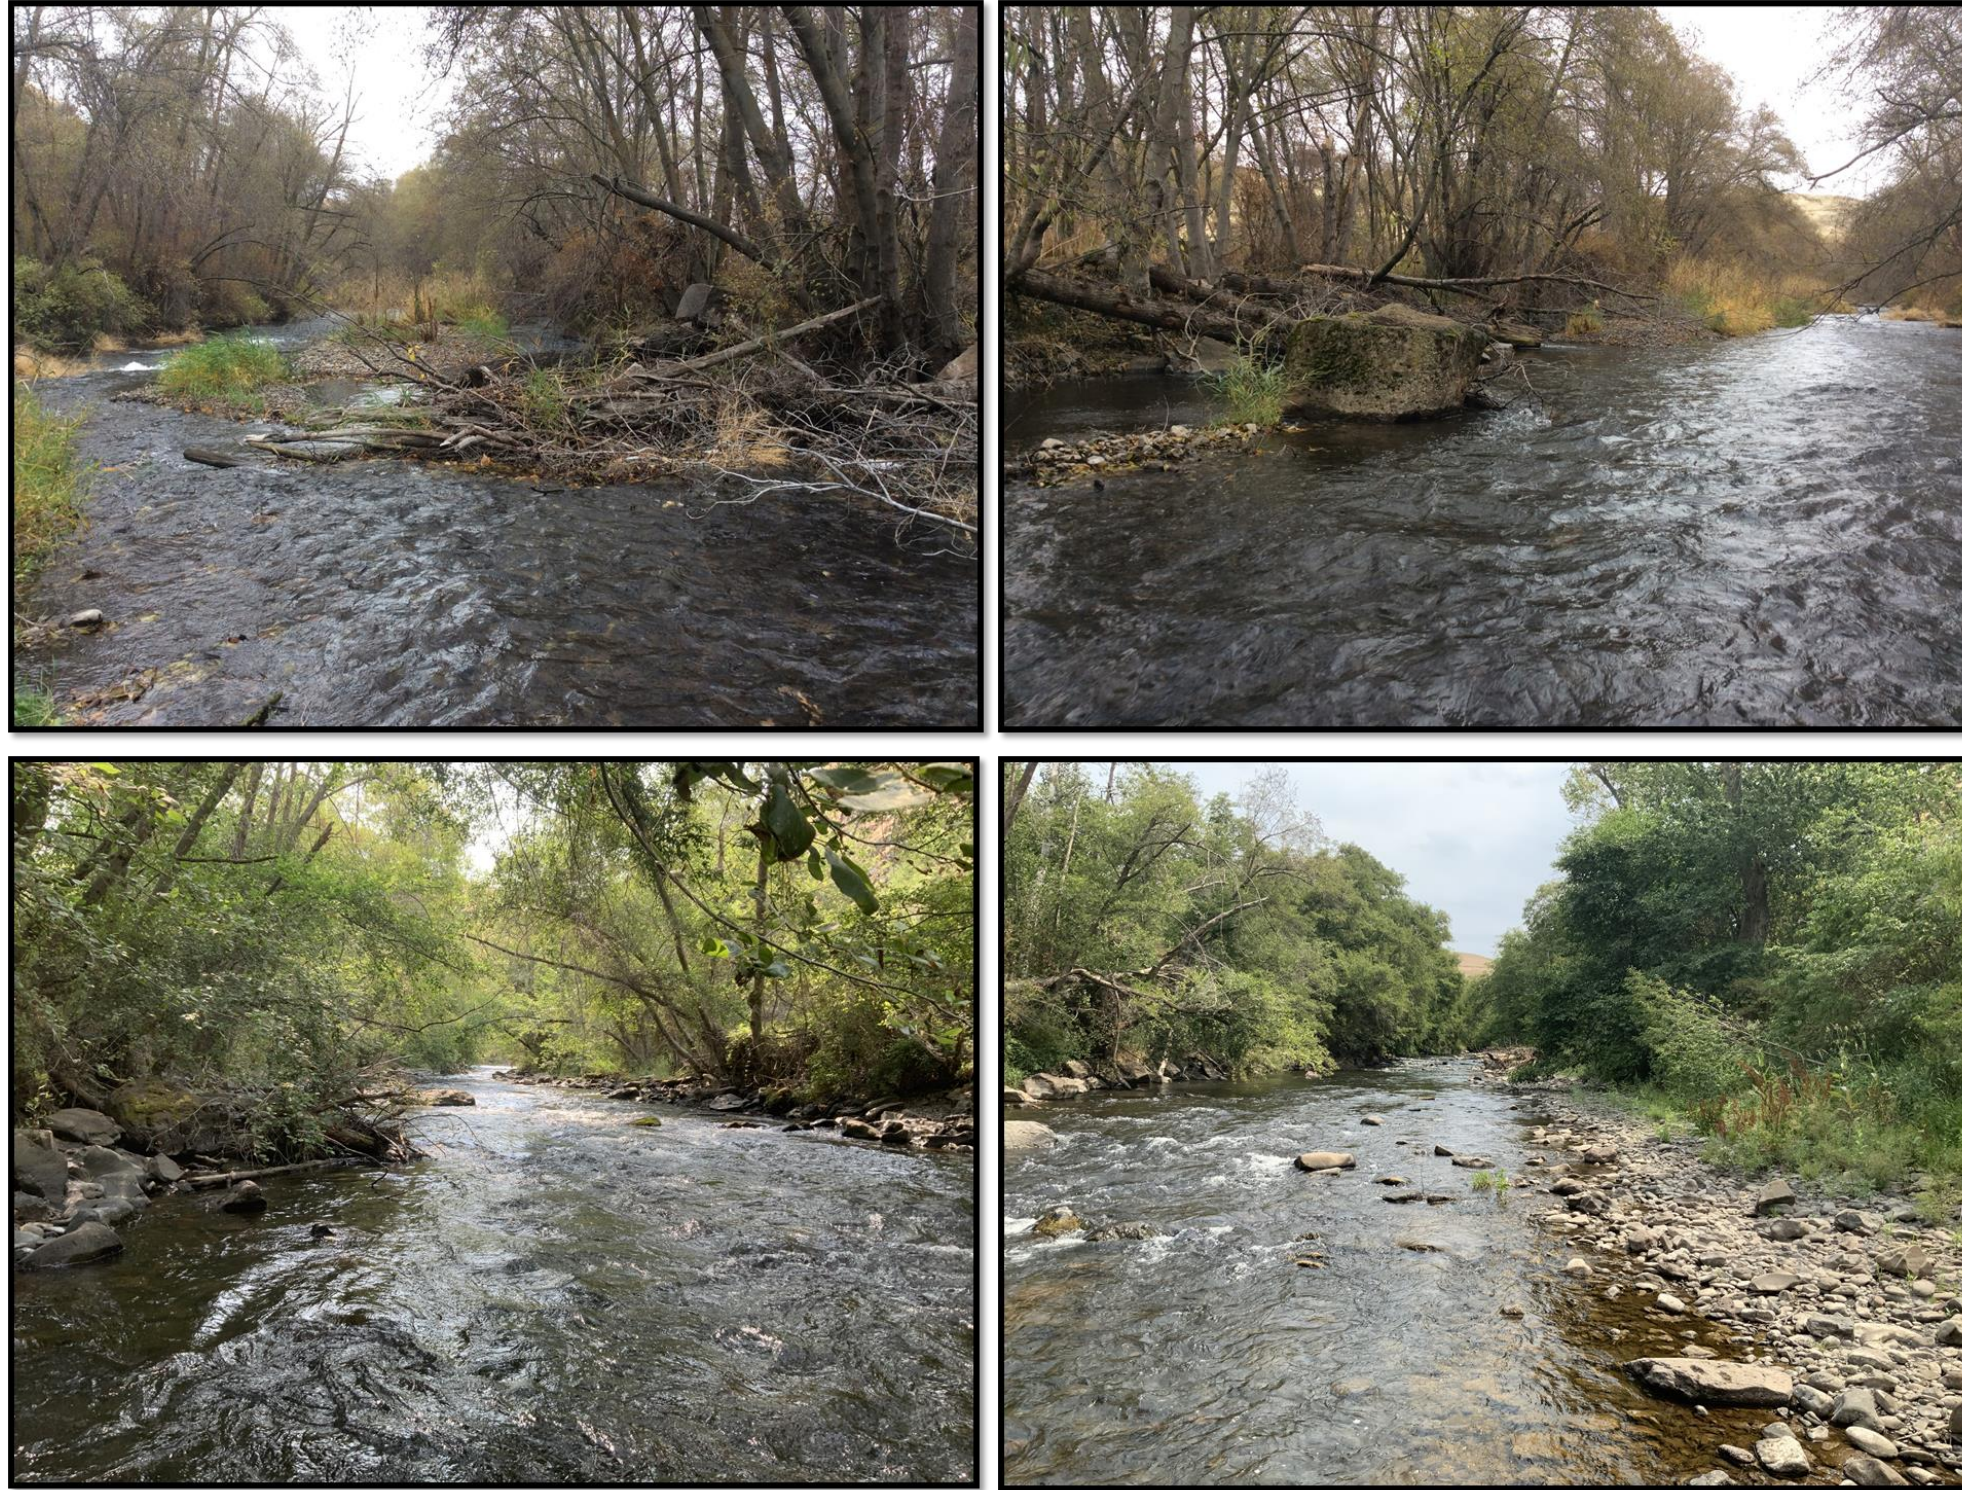
Figure 26-4: Changes in bed deposition and bed scour during the 2020 flooding event within the Phase II reach of PA 26. Upper images show pre-project conditions in 2015 captured during the 2015 RHS. The lower two images illustrate the change in conditions at the same locations following severe flooding event and prior to implementation in 2021.

in 2012, and none between 2013 & 2017. The CHaMP program recommended additional LWD structure placement to sort and retain gravel bars to encourage lateral channel migration and increased floodplain inundation frequency and duration (Hill 2017). In 2020, the flood (Figure 3) led to fairly significant export of bed load throughout the reach (Figure 26-4) including the few log jams that were observed in 2015 RHS (Table 26-1).

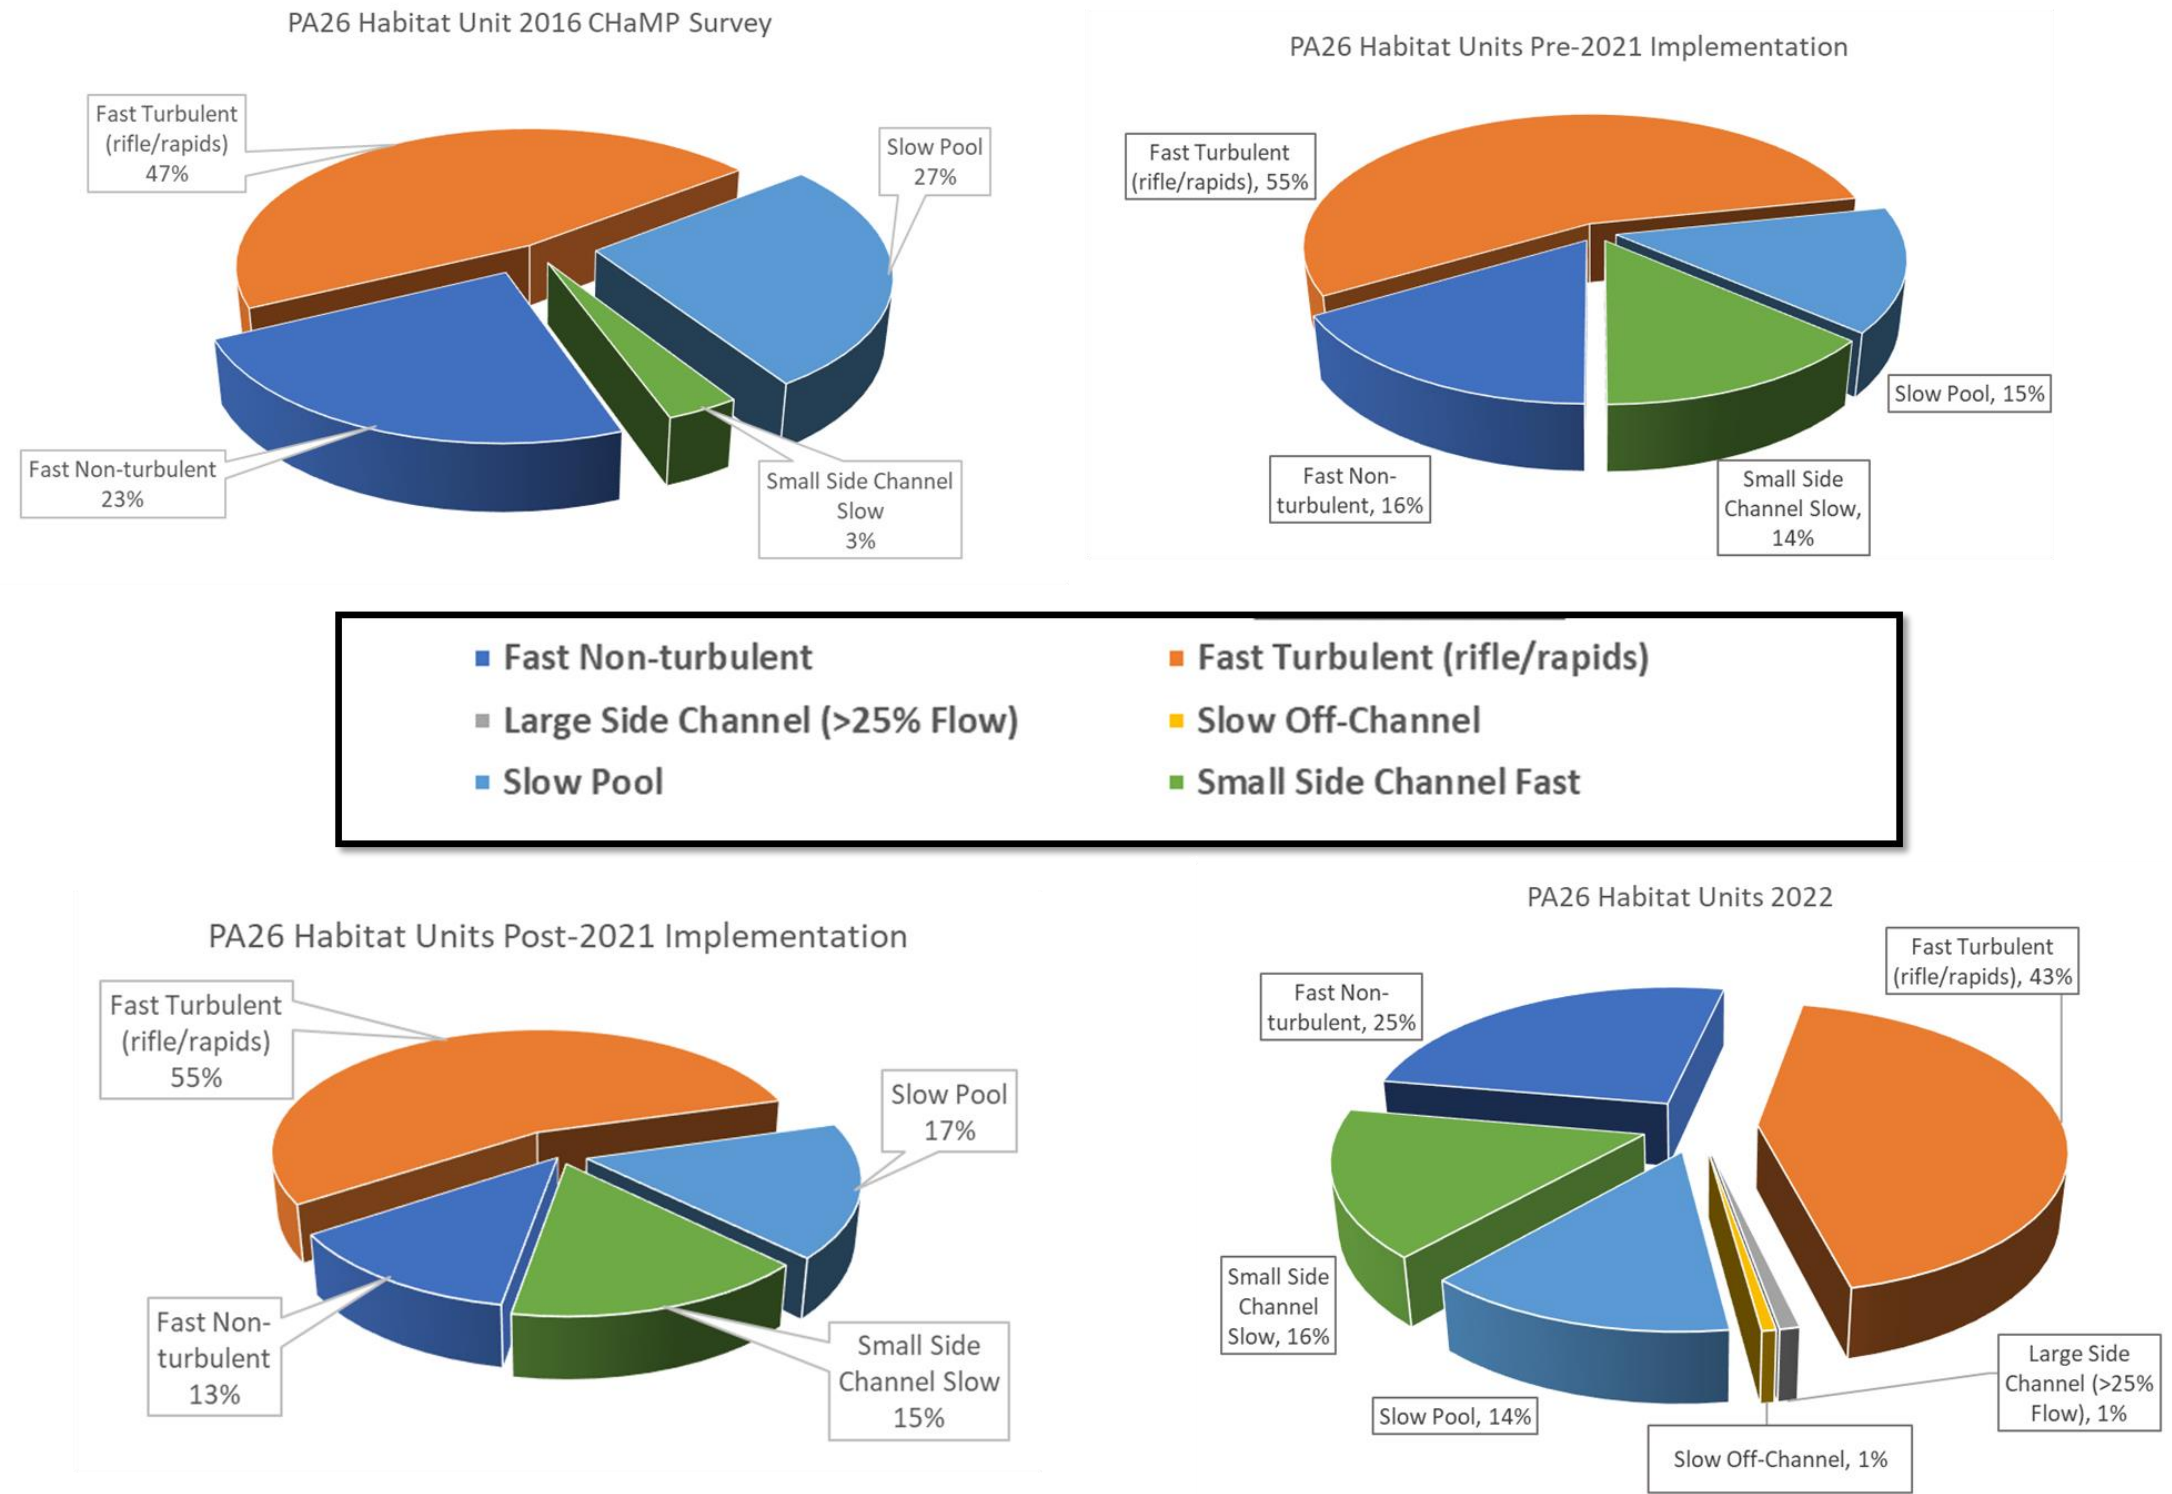
Figure 26-7: Project 26 Phase II channel habitat units summed across the two CHaMP sites measure in 2016 (upper left) compared to channel units measured in 2021 (upper right) prior to implementation and post project (lower left) and again in the summer of 2022 (lower right) for the purpose of comparison over time. The next survey period for this project will be in 2024 or following a significant flow event >2yr flow. Note: Channel units collected for the CHaMP sites (CBW05583-465355 and CBW05583-072139) reflect a sub-reach of the Phase II project captured by the RHSs in 2021 & 2022. The goals of the project are to increase floodplain connectivity and reduce stream power through greater inundation during flooding event increasing channel complexity for rearing spring Chinook. Prior to construction this project site experiences significant fluctuation in channel units over time, minimizing unit diversity. This was particularly evident for slow off channel and side channel units between 2016 and 2022.

Habitat units and channel complexity both exhibit increasing trends post project with a conversion of fast turbulent habitats to non-turbulent glides, side channels and pools (Table 26-1, Figure 26-7). The 2016 CHaMP site assessment provides a glimpse back to pre-flood conditions and the relationship of pool habitat and channel bed load. Many reaches in the Tucannon river exhibit greater pool frequency in reaches experiencing aggradation rather than degradation. This is likely due to legacy bed armor left as an artifact of past floods of record and confining features which have kept the river static. The layer of large material left on the bed is too large to be scoured and resist pool development. Excavation through this layer has revealed

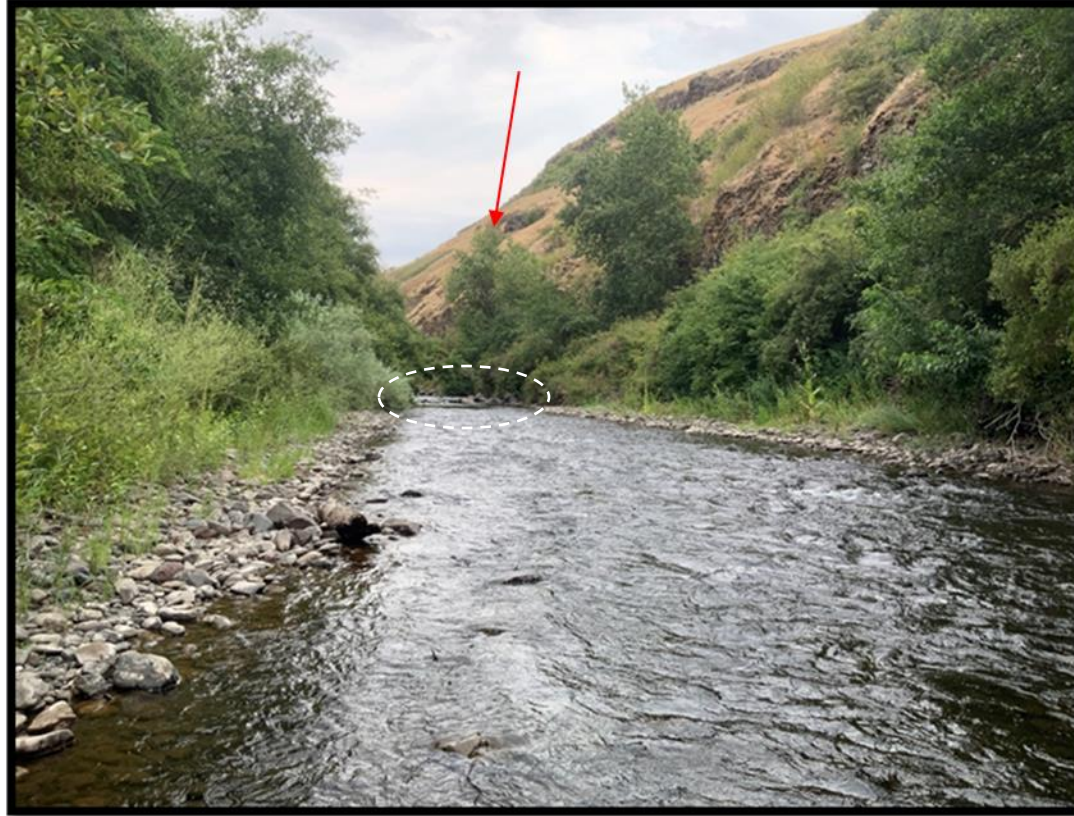
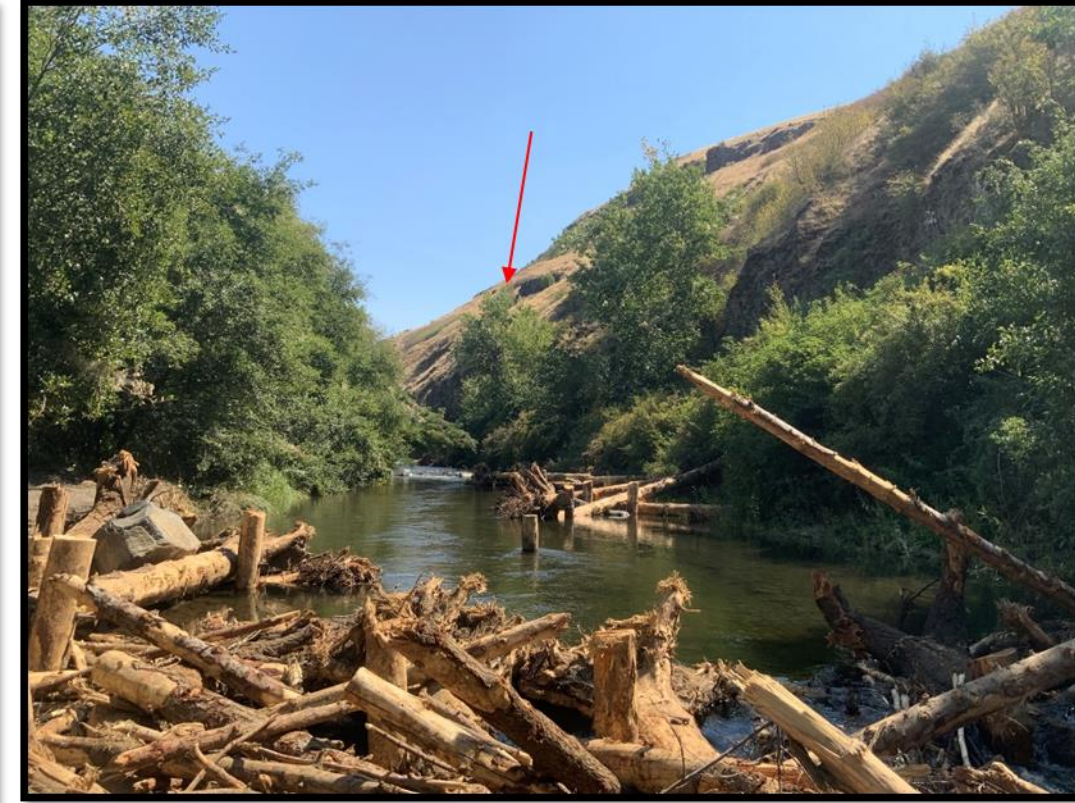
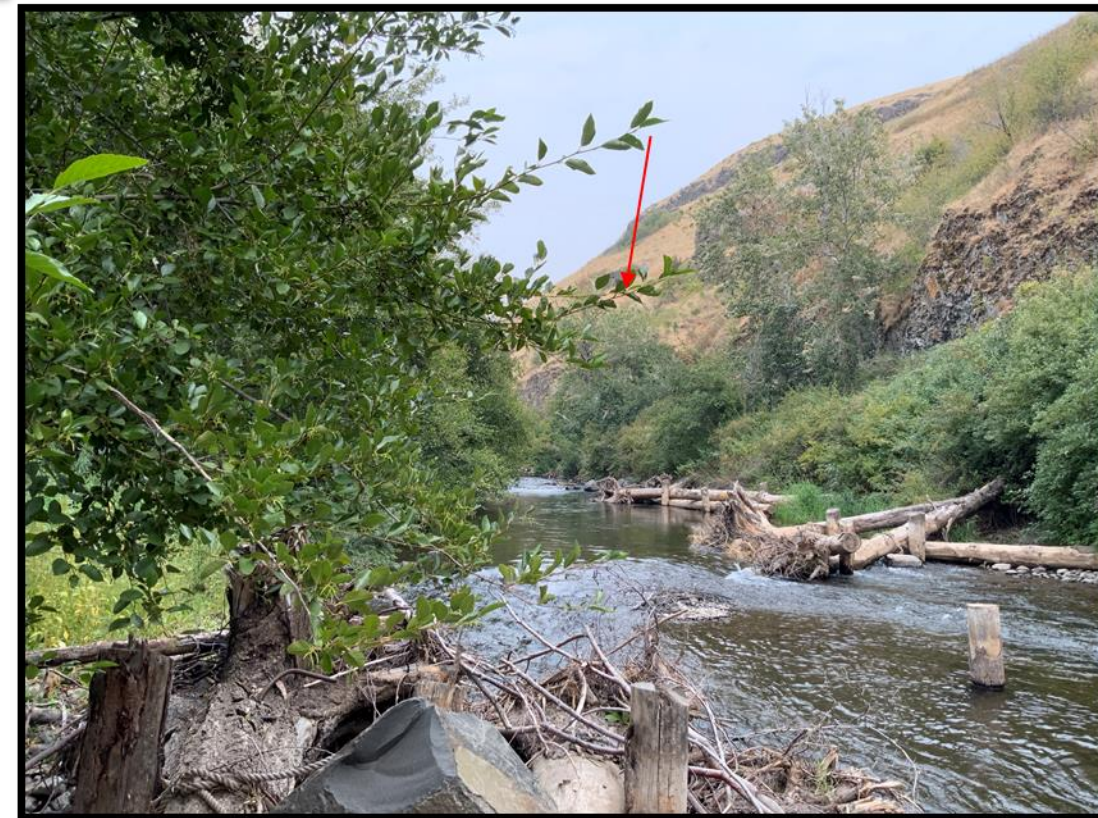
Figure 26-10: Project Area 26 Phase II pre (upper left) post project 2021 (upper right) and 2022 (lower right) above a channel spanning structure designed to aggrade the channel bed and increase floodplain inundation. The white dashed oval indicates the location of one rock weir structure placed post 1996-97 flood to control grade (upper left).

however the total number of LWD key pieces and number of jams observed in the reach were considerably below the Program goals and objectives for restoration in 2015. All other metric in 2015 were also below restoration objective (Table 26-1) including those for floodplain connectivity and channel complexity. Looking to the pre-project surveys in 2020 (Table 26-1) LWD key pieces and log jam totals further declined between the 2015 & 2020 RHS. This is likely a result of limited natural LWD recruitment over that time period and the winter flood event in 2020 (Figure 3). Following the >25 yr flood event, RHS showed a decline in pool frequency, although the number of pools >1 m deep increased over that same time period (Table 26-1). This was largely attributed to the loss LWD structures, decreased channel roughness, and mobilization of bars and previous depositional deposits during the event (Figure 26-4) precipitating bed scour, exposing a number of rock veins/weirs placed following the 1996-97 floods to control grade (Figure 26-10).
