Tucannon Habitat Programmatic

Annual Summary Report

(January 2022– December 2022)

BPA Project #2010-077-00

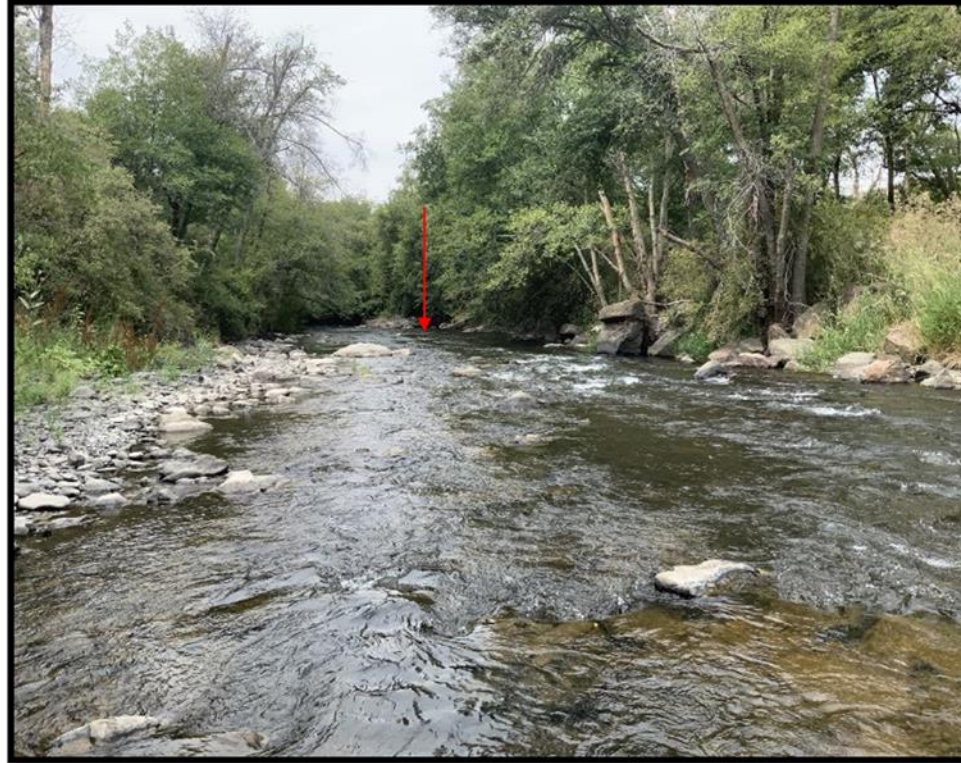
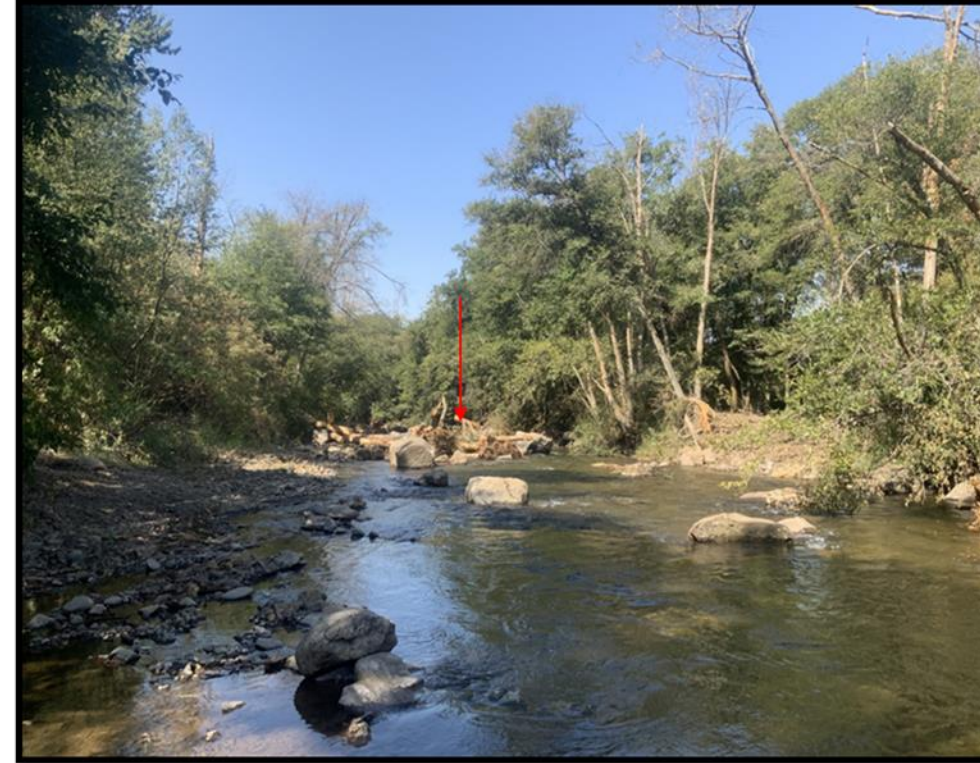
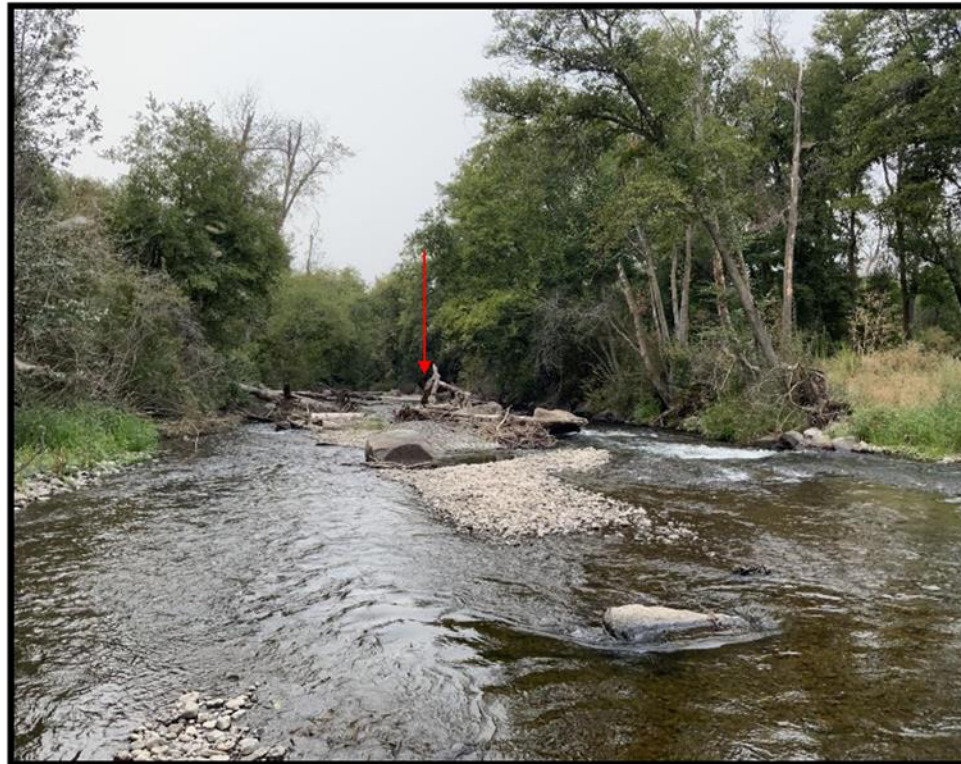
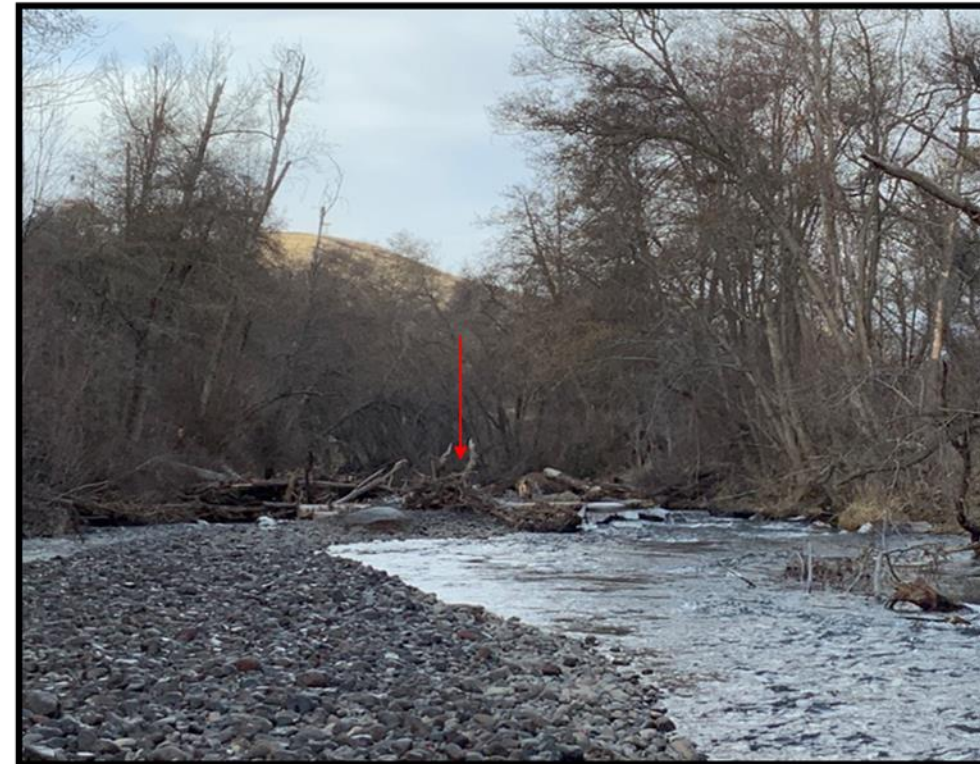
Figure 26-11: Project Area 26 Phase II pre (upper left) post project 2021 (upper right), post 1 flow summer 2022 (lower left) and post two flow events winter 2023 (lower right) above a apex spanning structure designed to aggrade the channel bed and increase channel meander and floodplain inundation over time. During the 2021-22 winter/spring flows which were moderate the structure was largely buried in gravel (lower right) and channel migration to river left began undercutting the left bank.

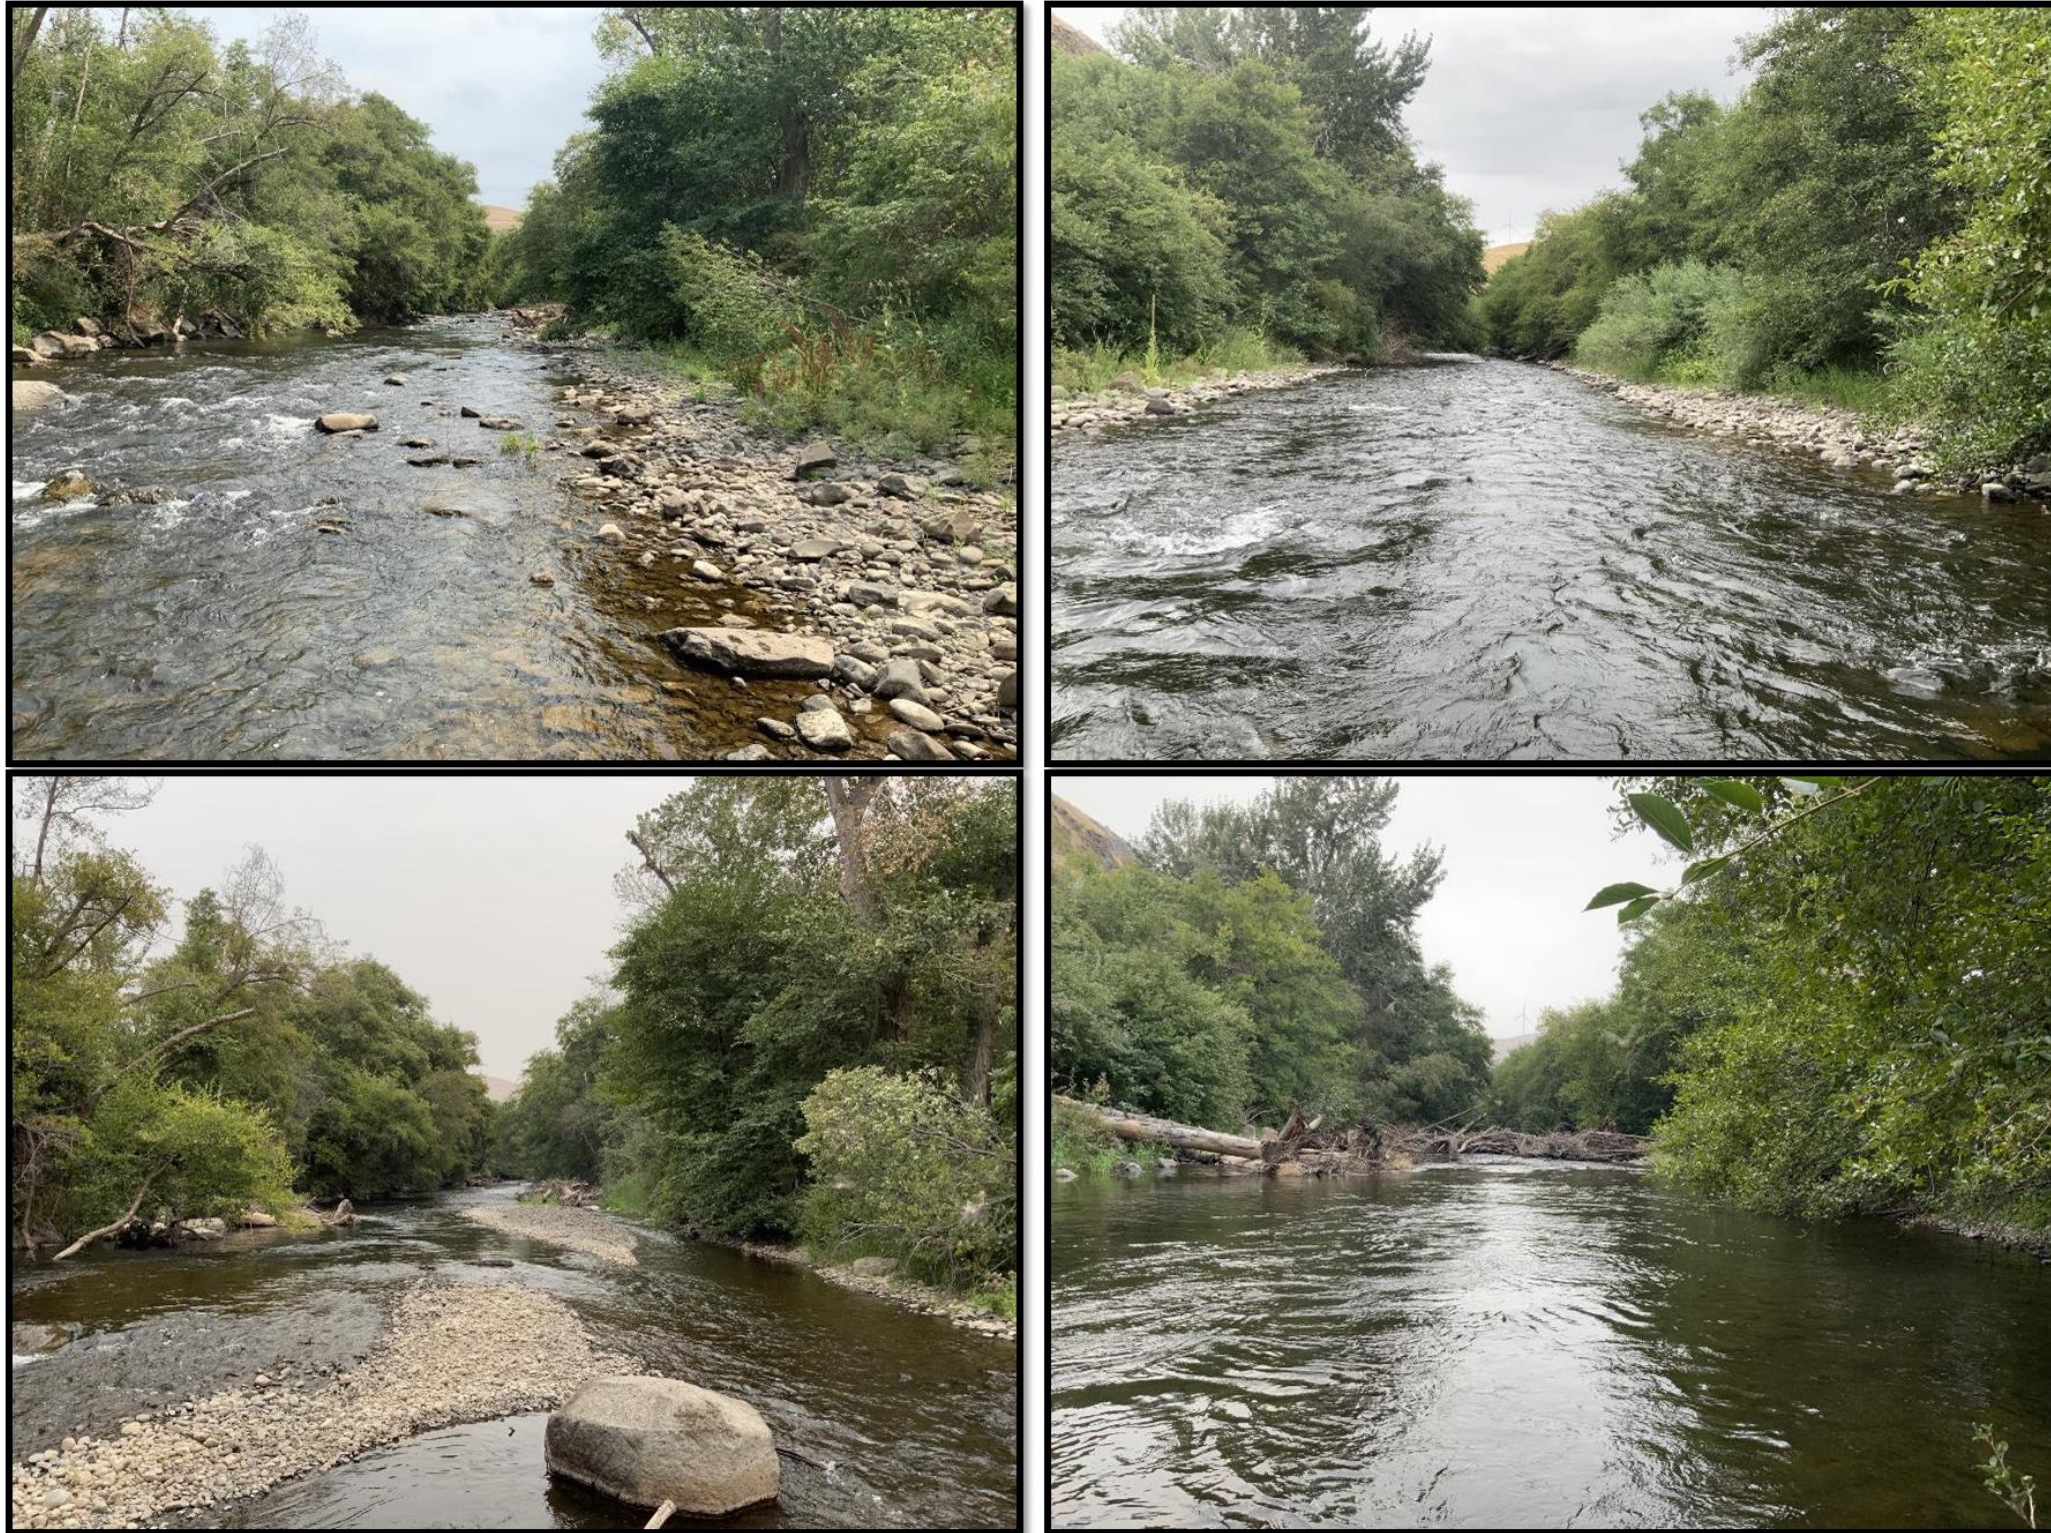
Figure 26-12: Project Area 26 Phase II pre (upper right & left) and post (lower right & left) plain bed reaches treated LWD structures to improve gravel deposition bar formation and habitat unit complexity. The two upper reaches were treated in 2021 and the lower two images are the result of a single year of moderate seasonal flow (~1Yr return interval).

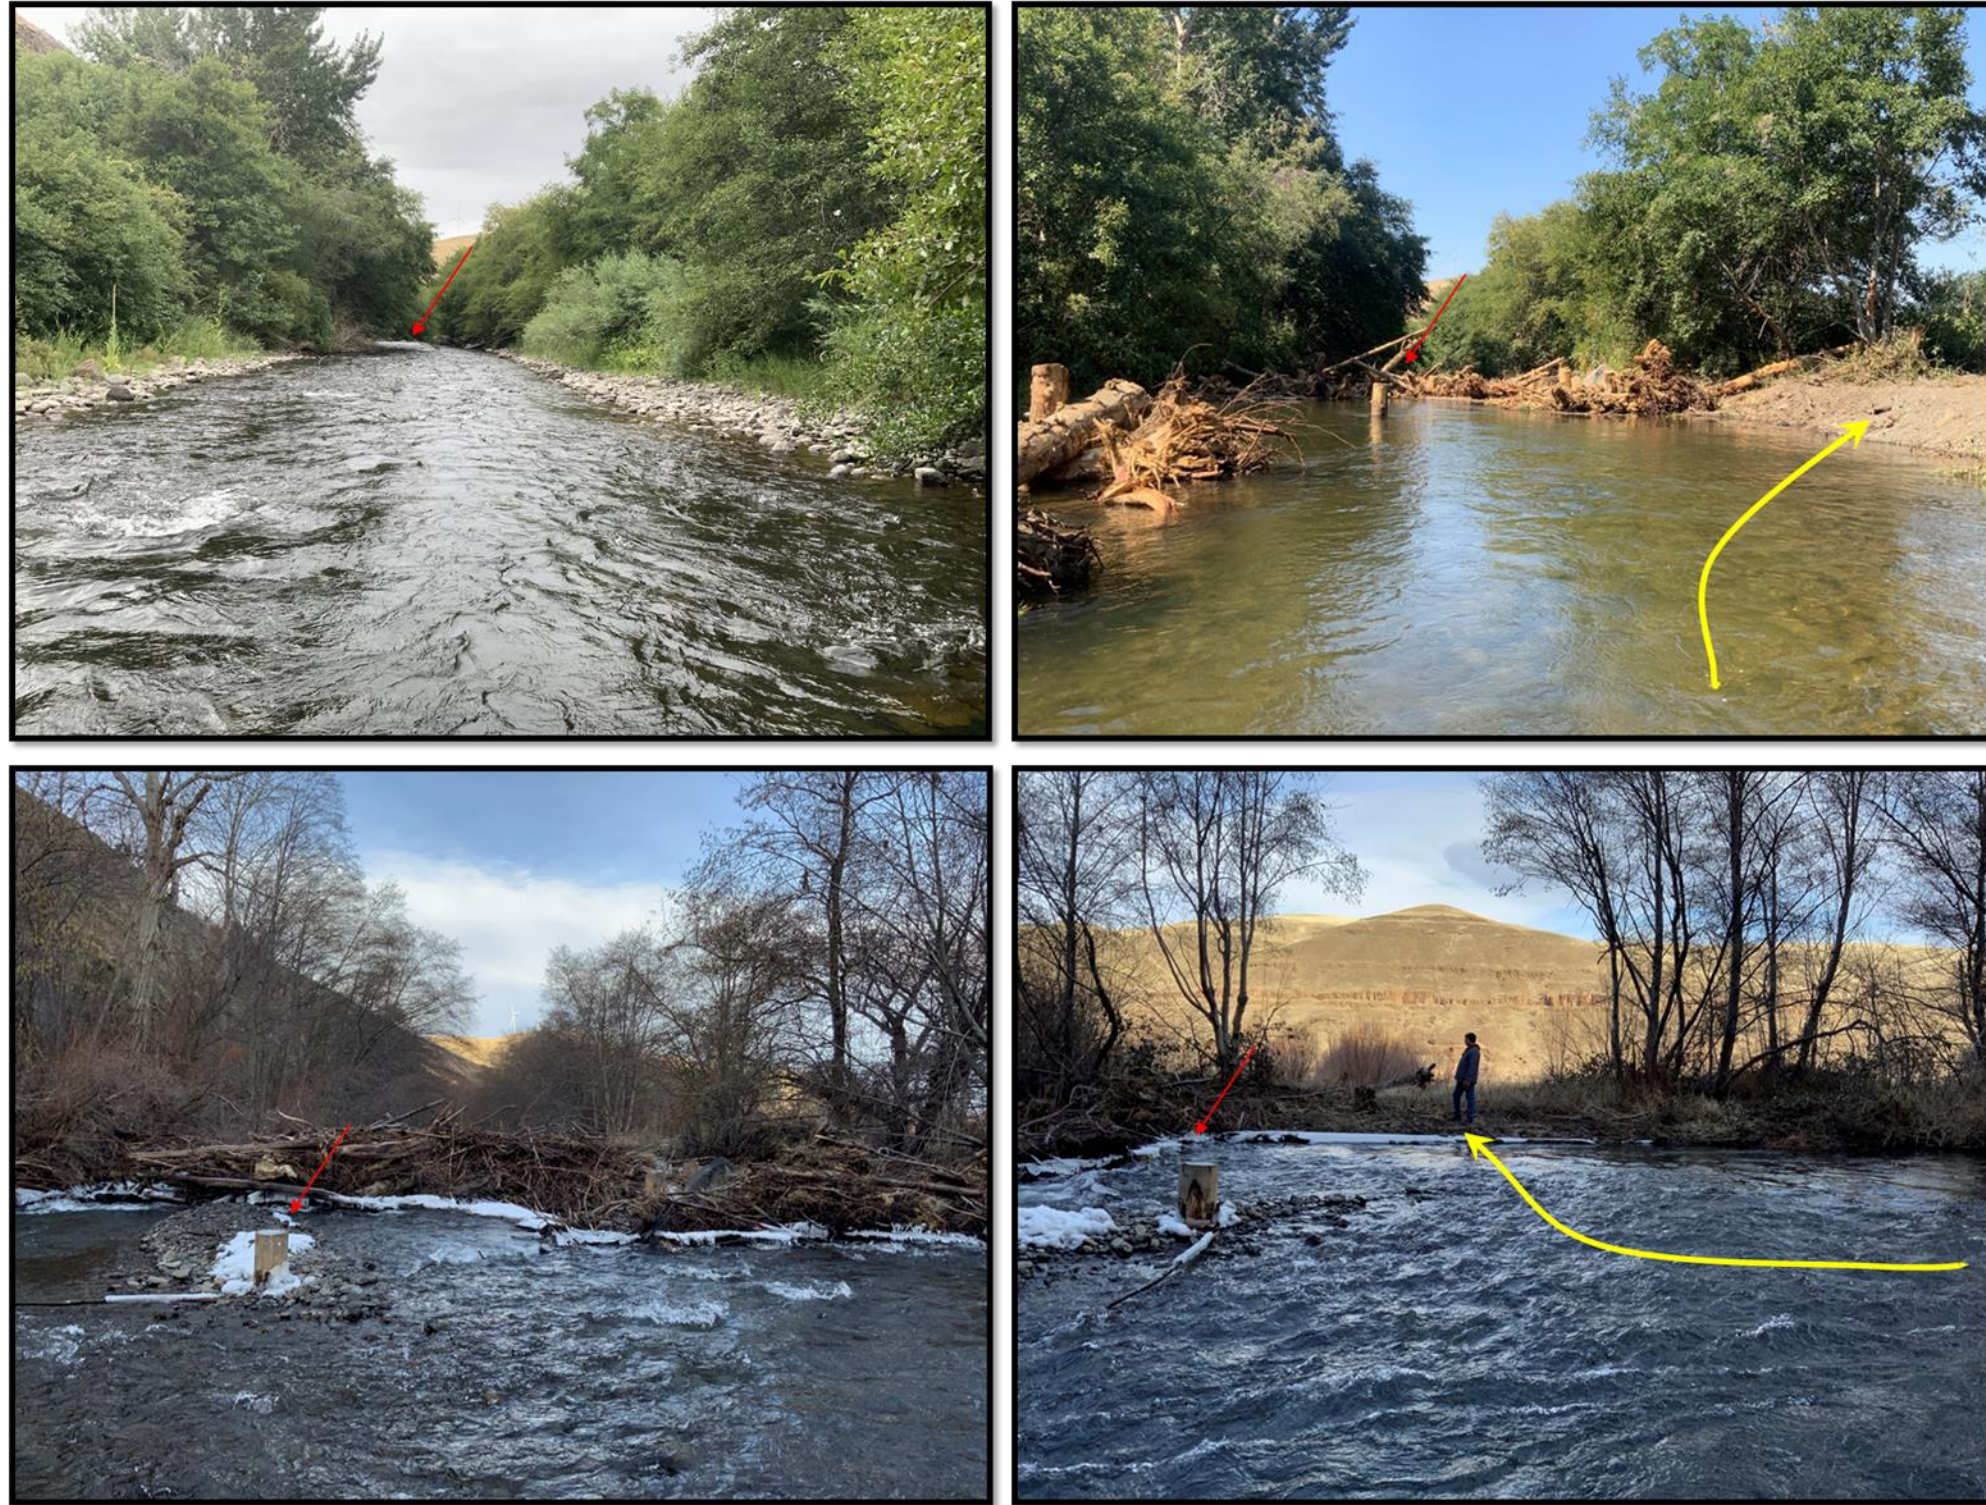
Figure 26-13: Project photo point for channel spanning a structure designed to aggrade the river channel and increase floodplain connectivity, pre-project (upper left) as-built (upper right) and following two high flow events (lower left). The red arrow indicated a reference point pile placed during construction as a test pile and left in position for reference. During the high flow event in December 2022 (Figure 3) channel spanning structures captured significant gravel bed material resulting in an over bank event at less than the 2 yr flow interval indicated by the yellow arrow. Note: The pile when placed was measured to make future observation on bed elevation, which at as-built was measured to emerge 1.4 m out of the stream bed with 0.82 m of it sticking out of the water (upper right). Following two relatively low season low event the bed elevation has aggraded (~1 m) above the original water height with only 0.4 m above the river bed.

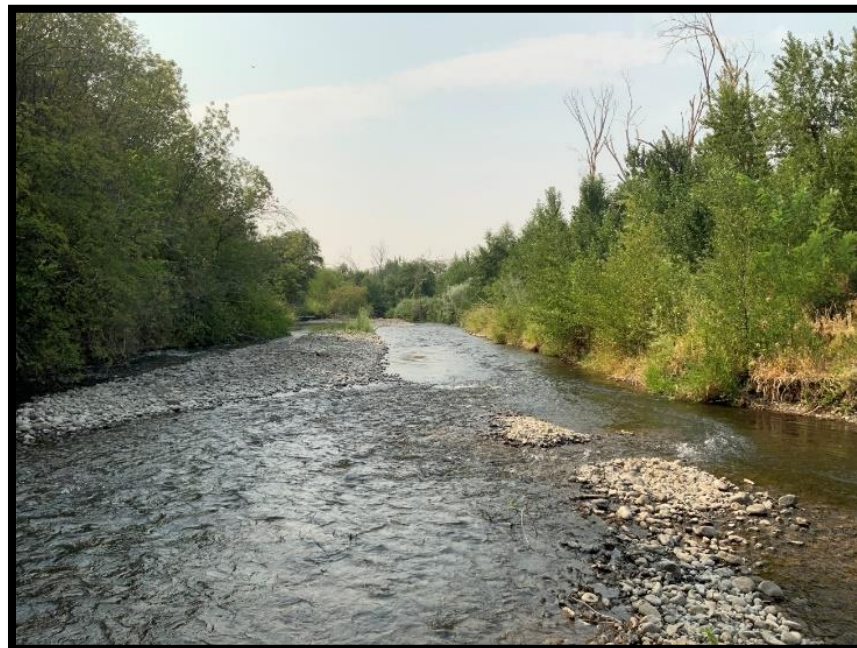
Example of degraded habitat being targeted for increased complexity and connectivity

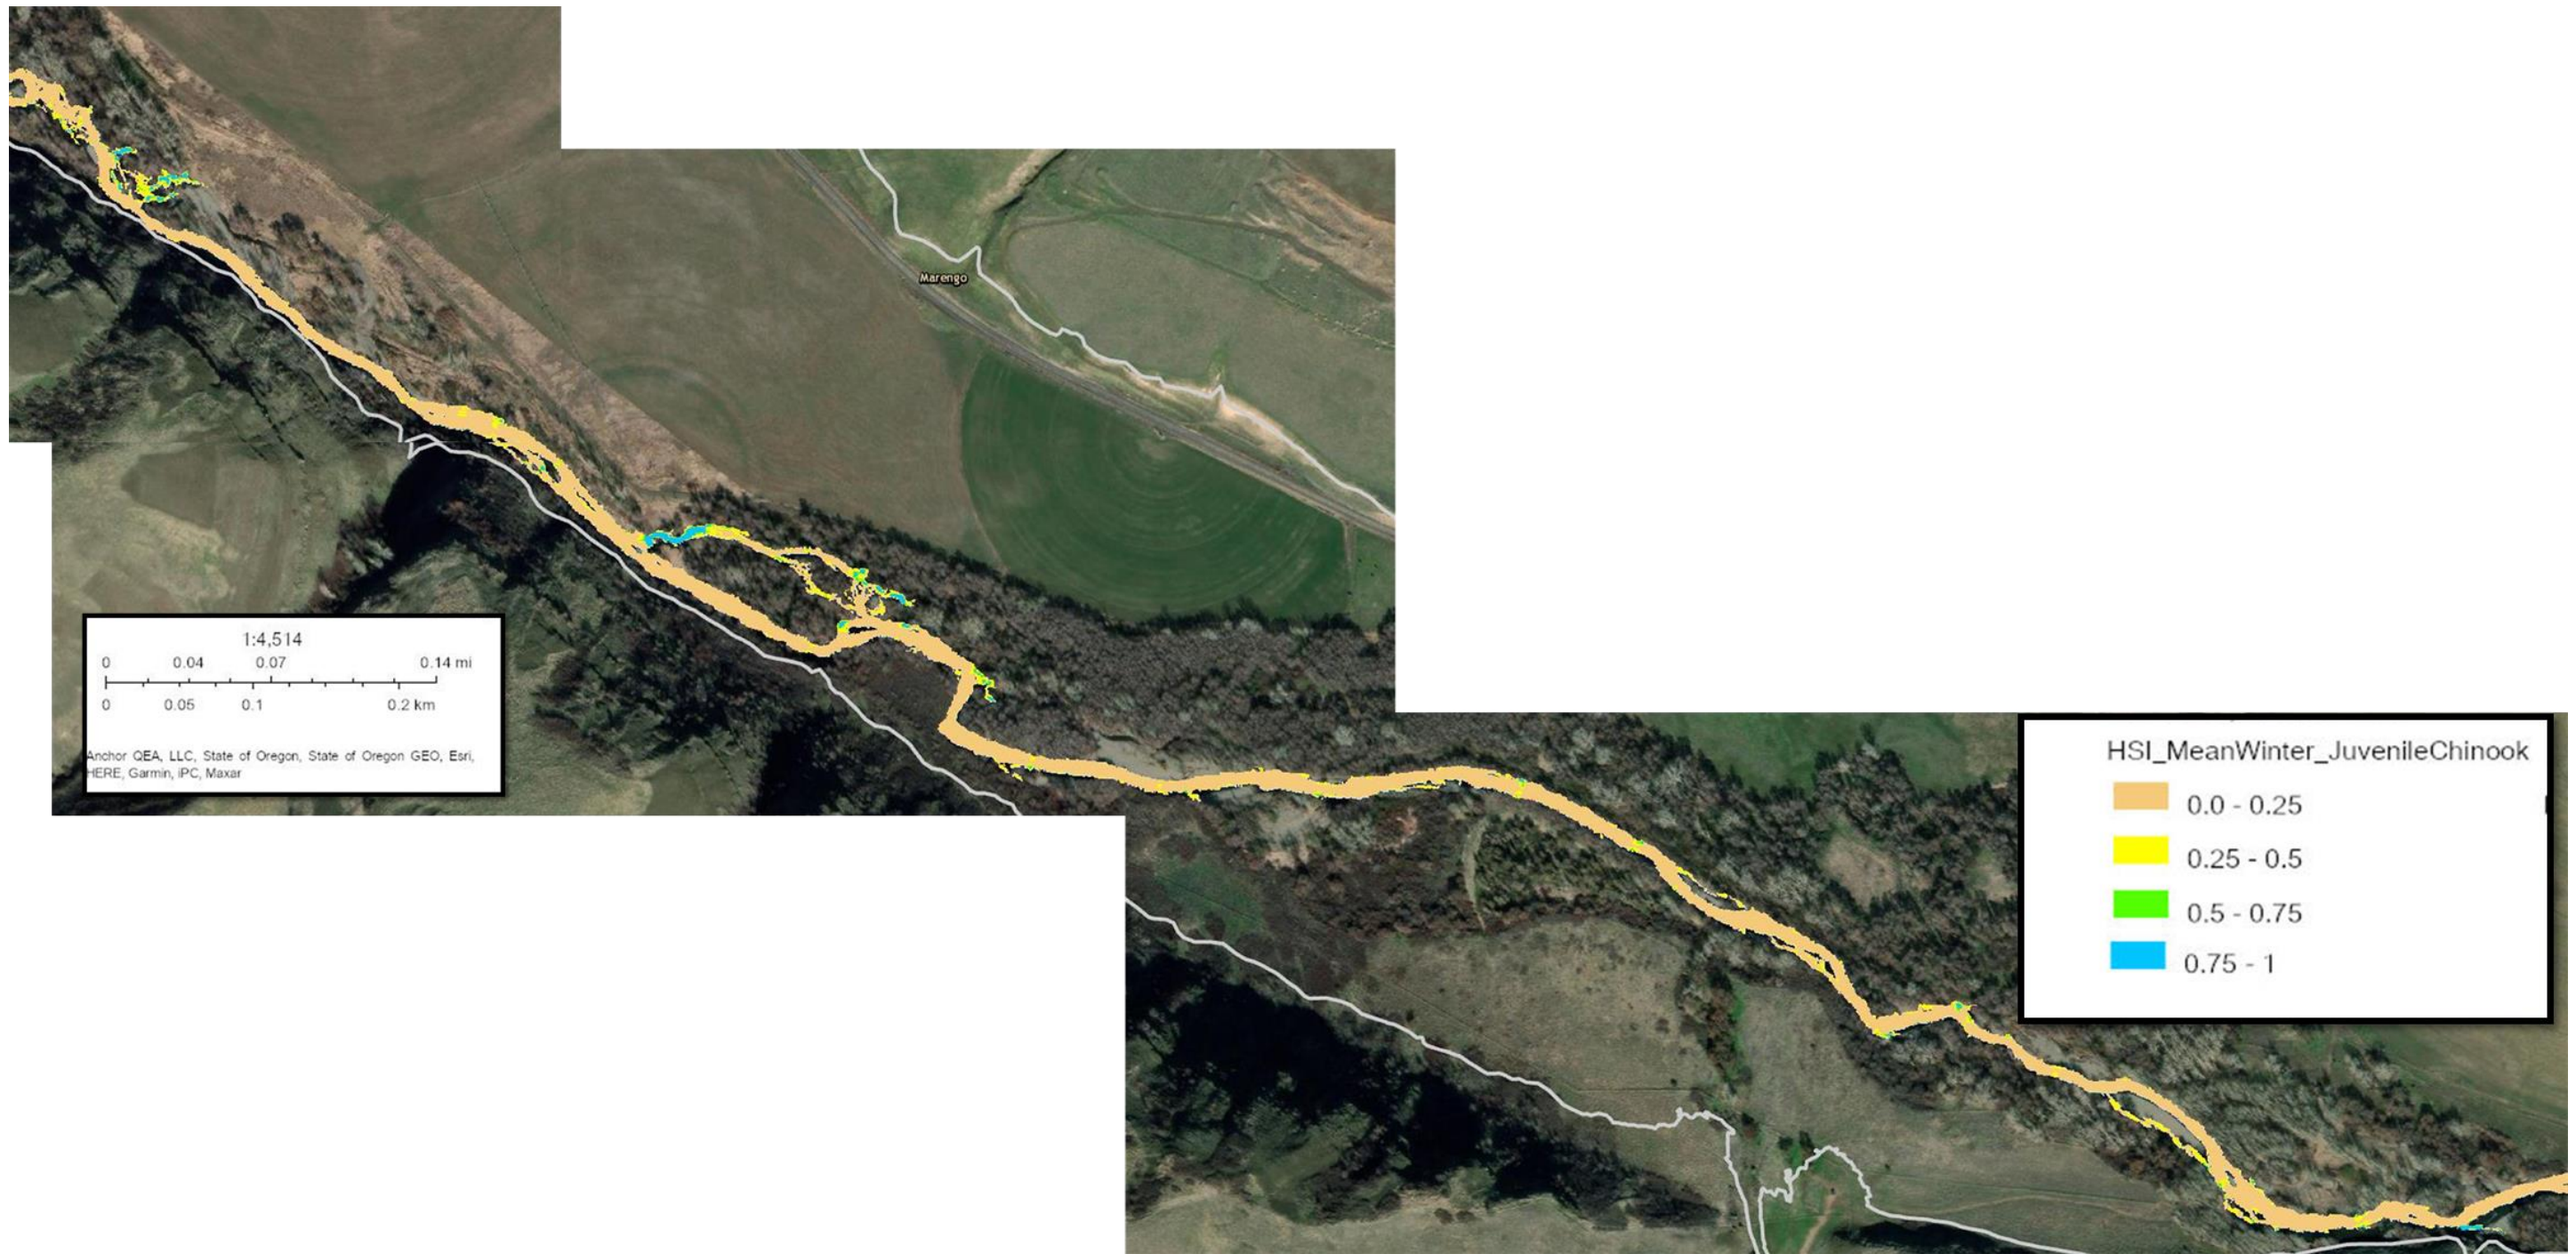
Figure-26-16: Habitat suitability index (HSI) model for juvenile spring Chinook at mean winter flows based on 2020 LiDAR and modeled velocities (Anchor QEA 2022). The model is indicating that HSI relatively low (<0.25) throughout most of the reach, with the exception to the lower middle of the project area where a large off-channel side channel feature exists creating a number of low velocity deep habitats with high HSI values (>0.5).

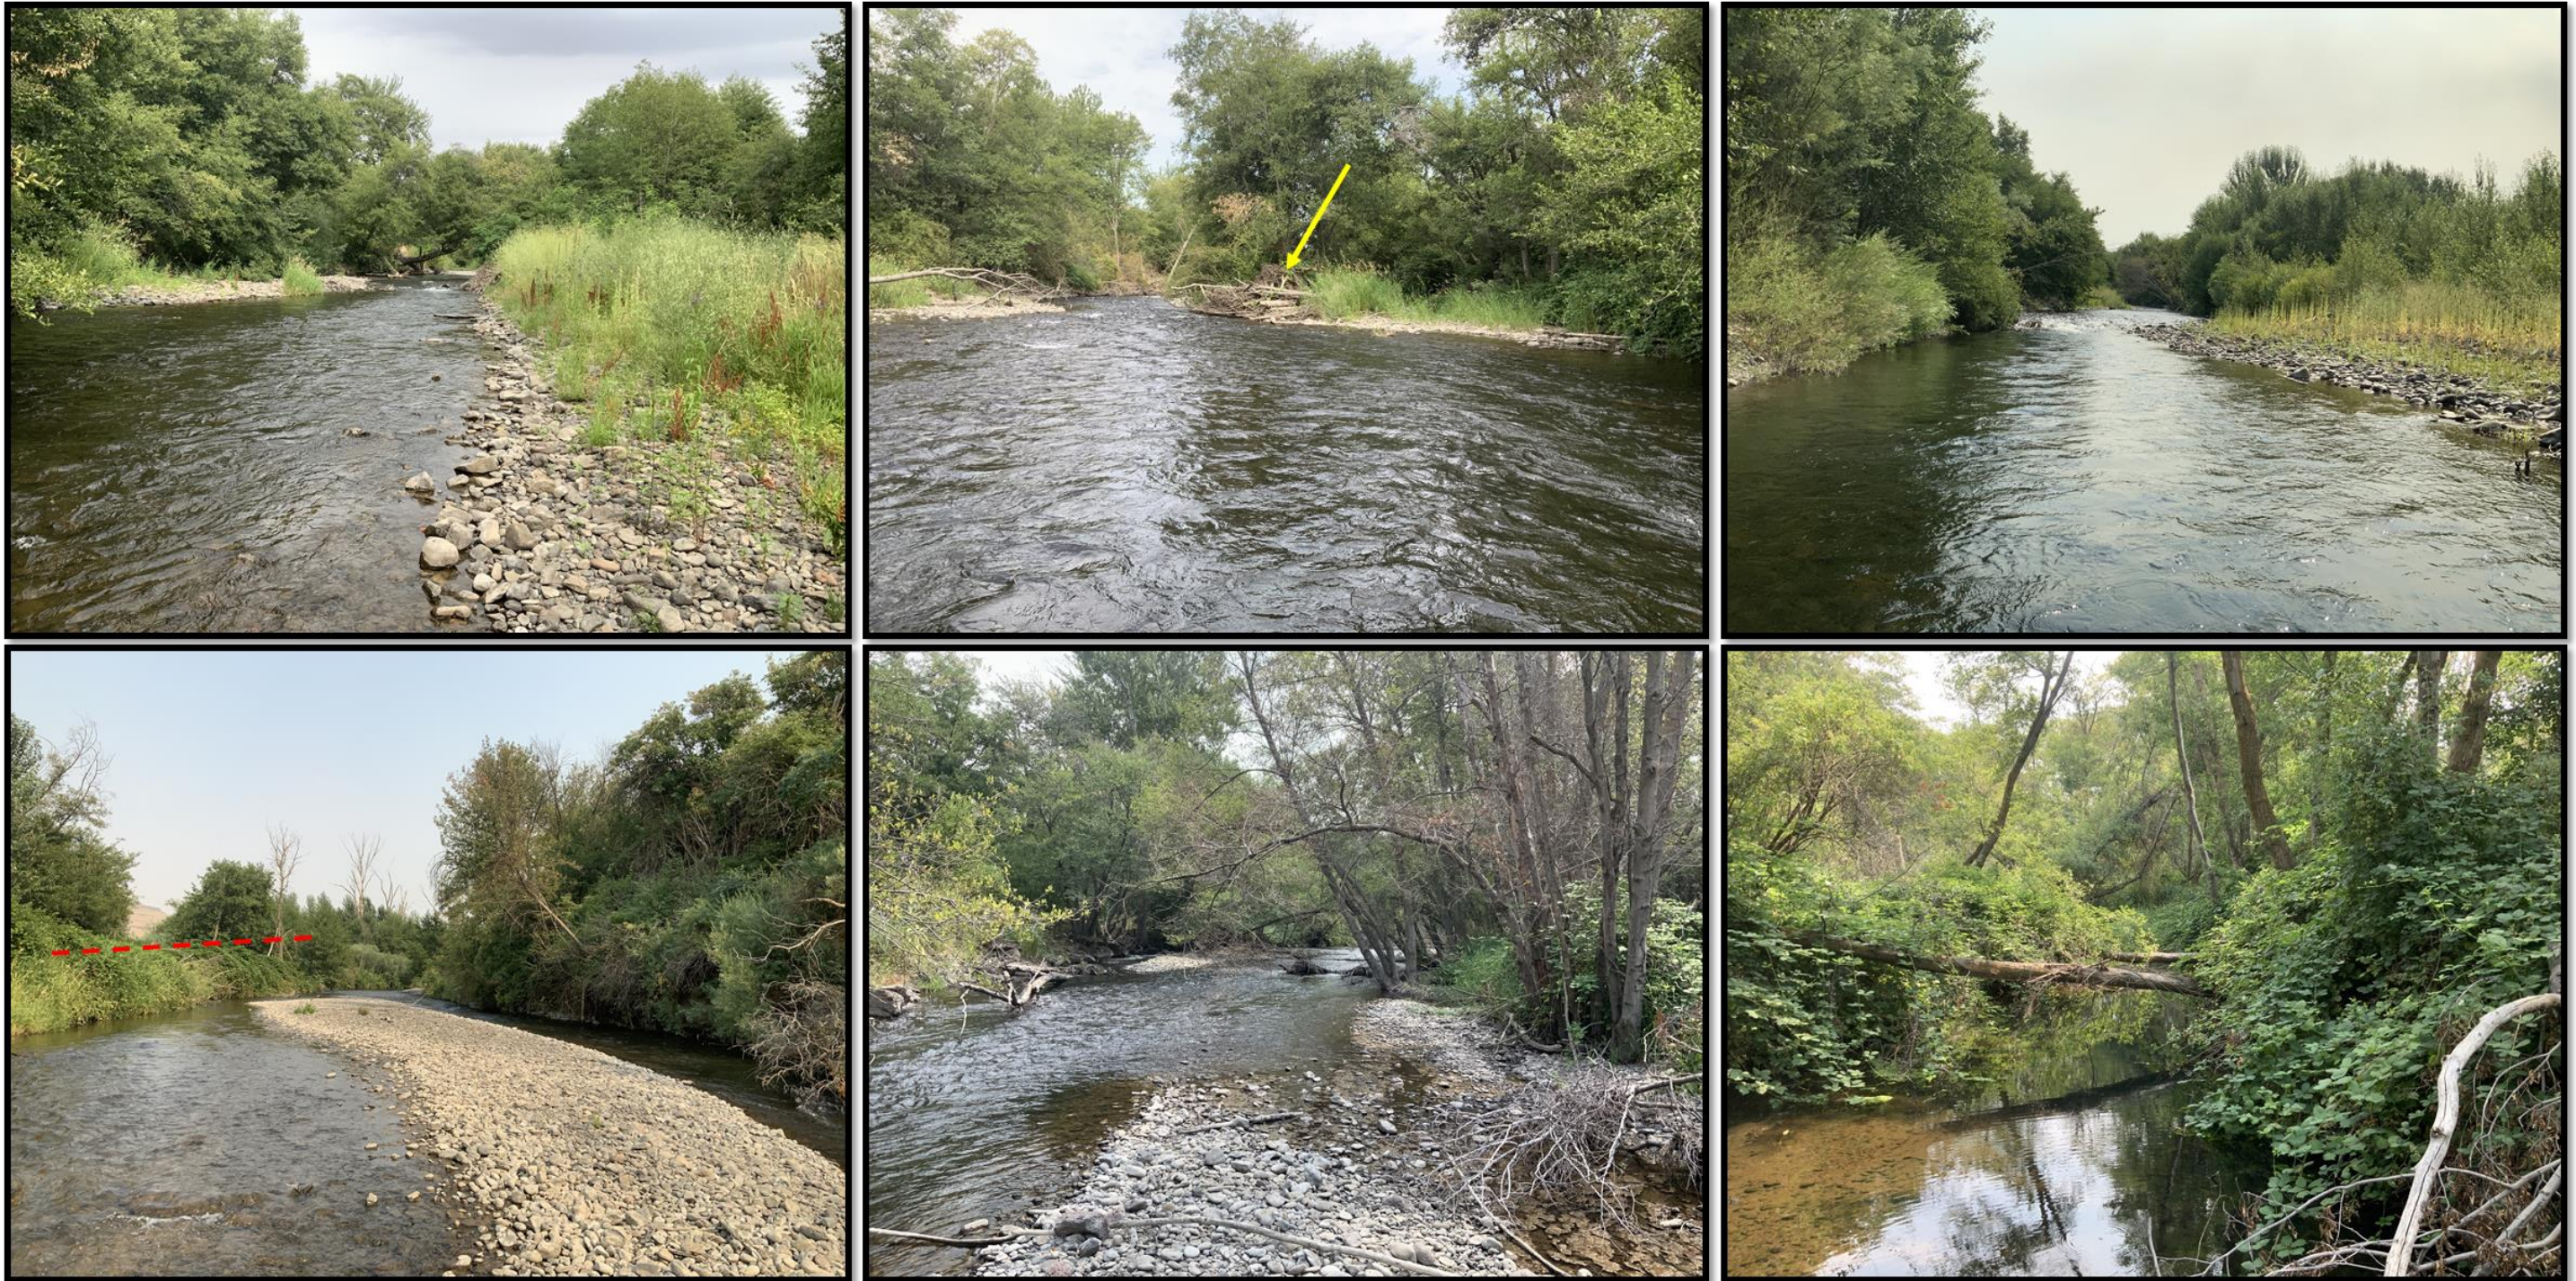
Figure 26-17: Project Area 26 Phase III-IV images showing existing conditions in 2022. The upper third of the reach is characterized by long wide reaches with simple plan bed riffles (upper left). Existing LWD jams create isolated bars (upper center) and long glides (Upper right) however few pools exist. The middle third of the reach is characterized by deposition with numerous side channels, pools and generally function habitat conditions (lower center and right), where no actions are identified in Phase III or IV. The lower third of the project reach is characterized by channel deposition with significant bar formation (lower left) but has been confined by channel confinement (red dashed line) by levees and riprap identified for removal.

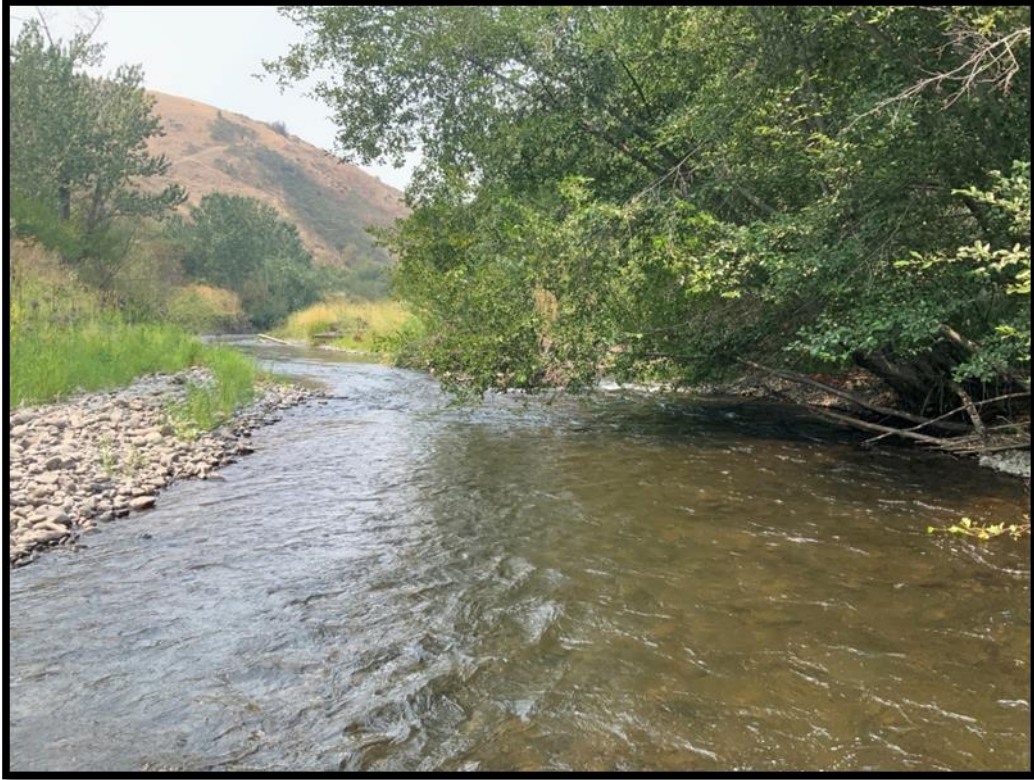
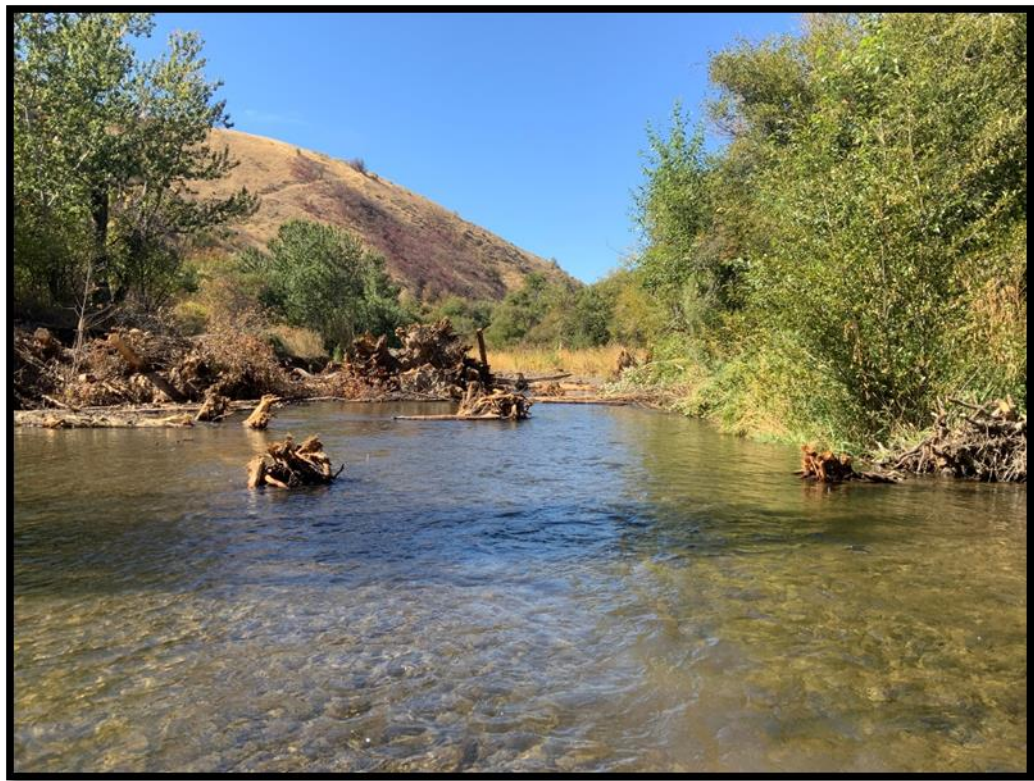
Figure 27/28.1-2: PA28.1 Pre/post Photo Point 2021 illustrating a channel fill reach where thalweg elevation was increased, with LWD secured within the bed matrix.

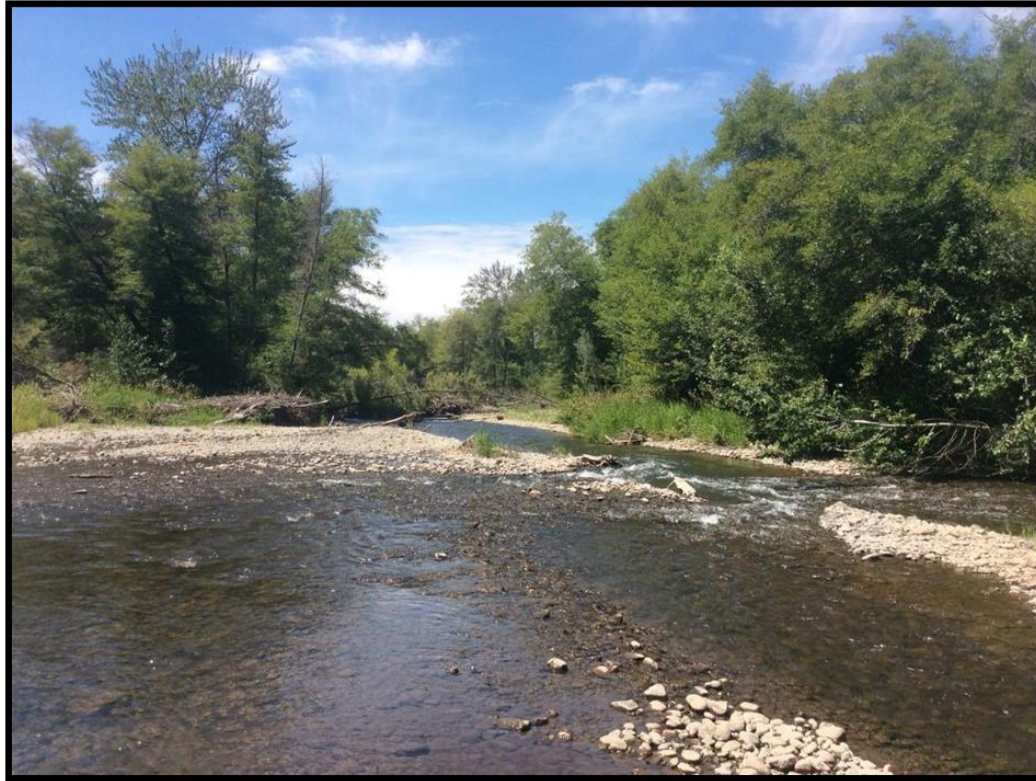
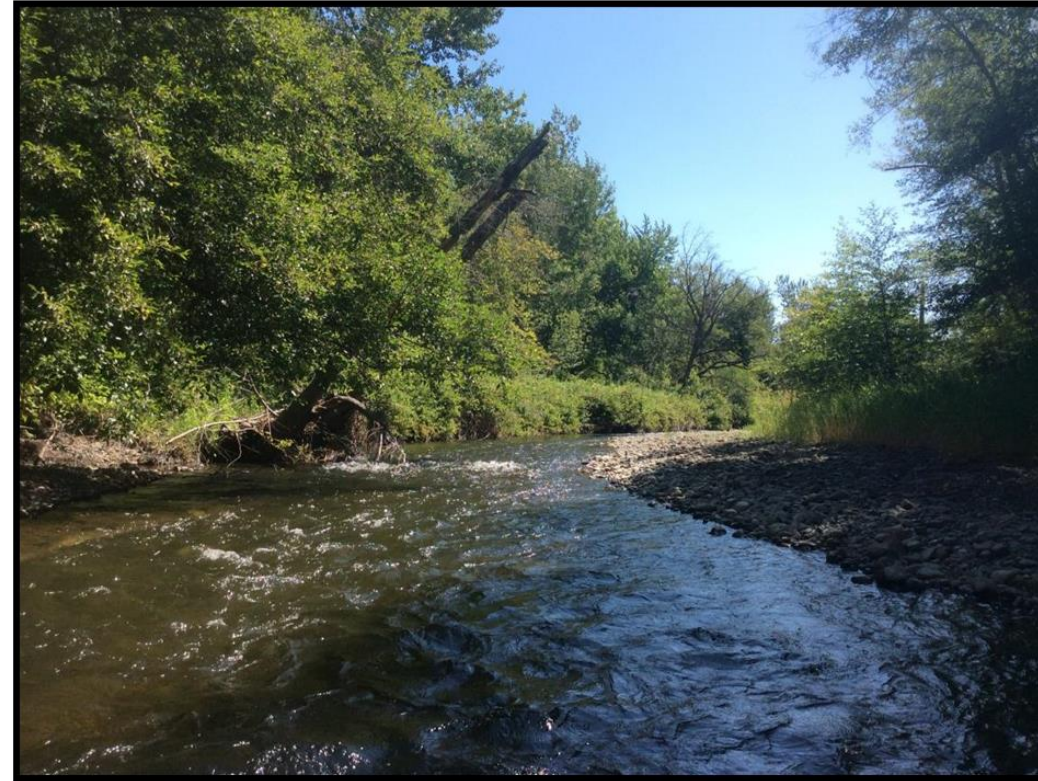
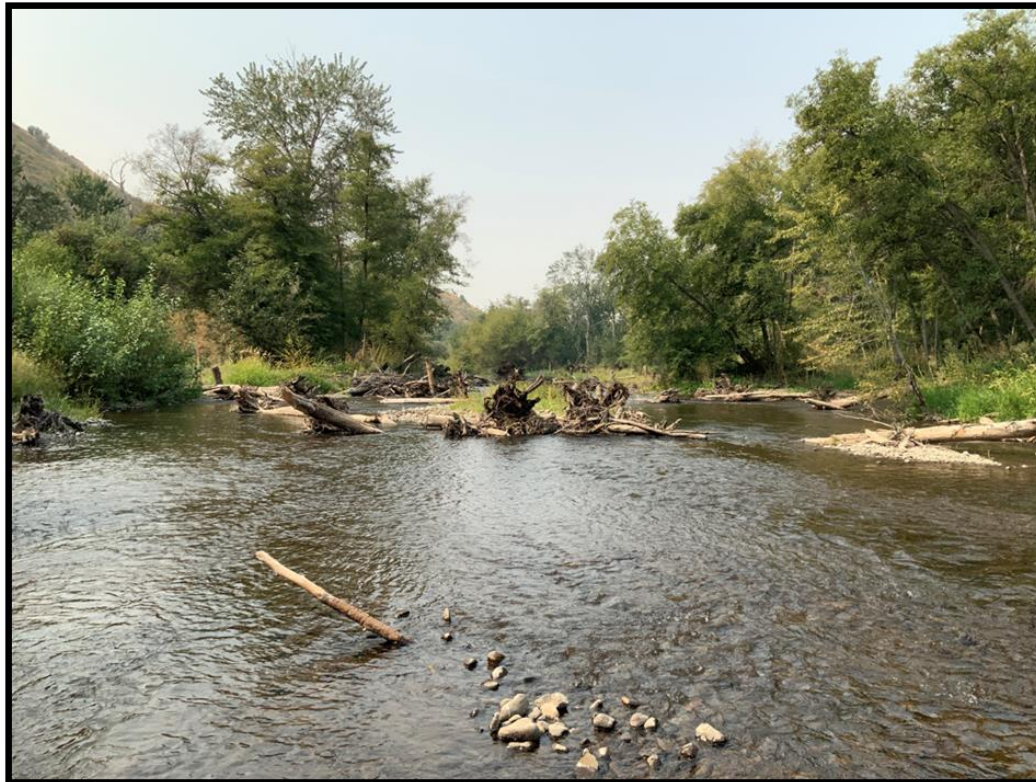
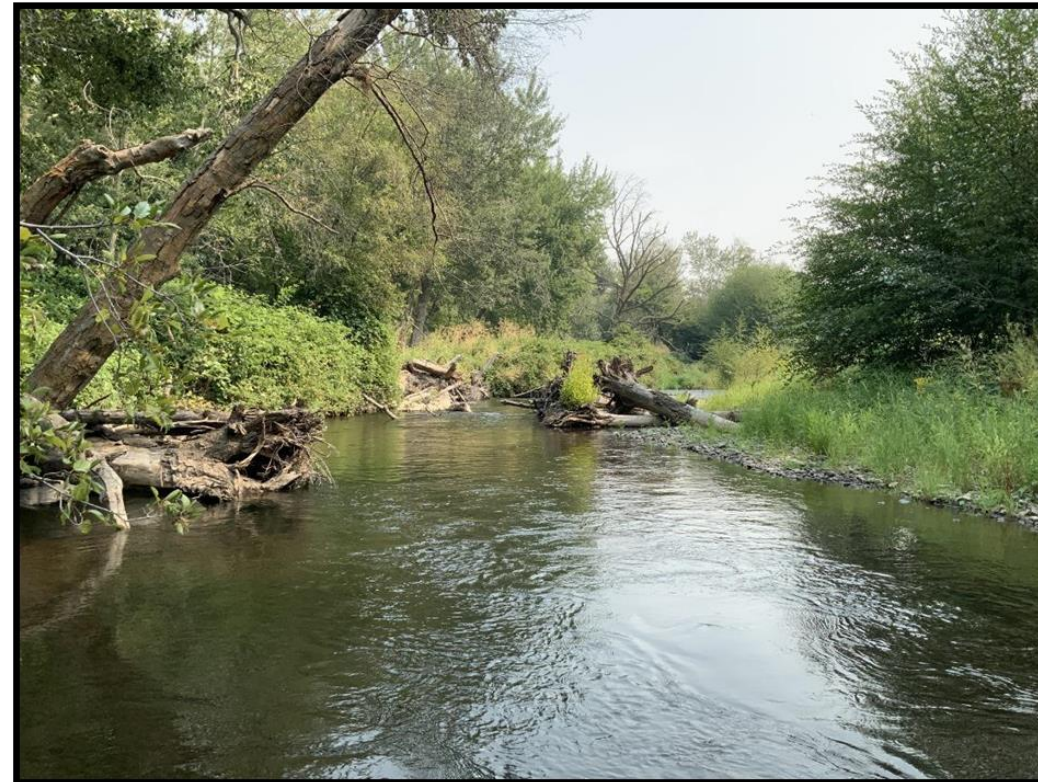
Figure 27/28.1-7: Project 28.1 pre and post implementation photo points 2020 (upper) and 2021 (lower). Both photo points illustrate conversion of riffle habitats to less gradient broadly floodplain connected low energy reaches.

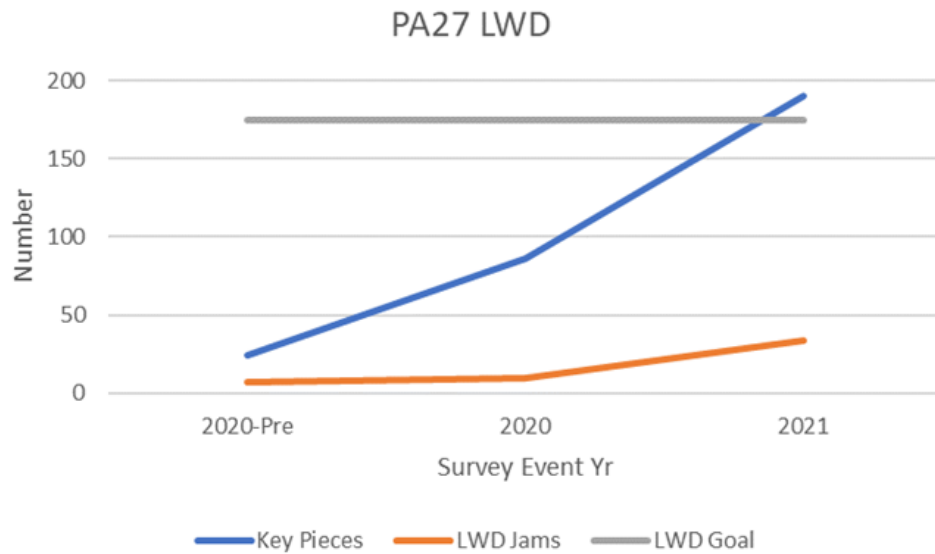
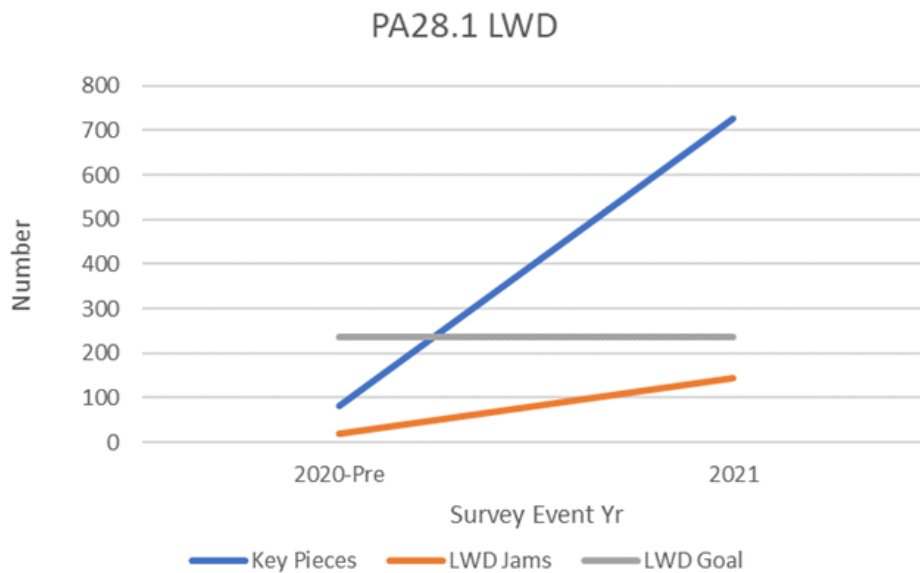
Figure 27/28.1-9: Project Area 27/28.1 large woody debris key pieces (>6 m long & 0.3 m dia.) and number of multi key piece log jams during pre-project and post-project rapid habitat surveys for PA 27 (upper) and PA28.1 (lower). The grey horizontal line represents the project goal base on 2 key pieces per bank full width. There has not been a goal for the number of log jams.
