Tucannon Habitat Programmatic

Annual Summary Report

(January 2022– December 2022)

BPA Project #2010-077-00

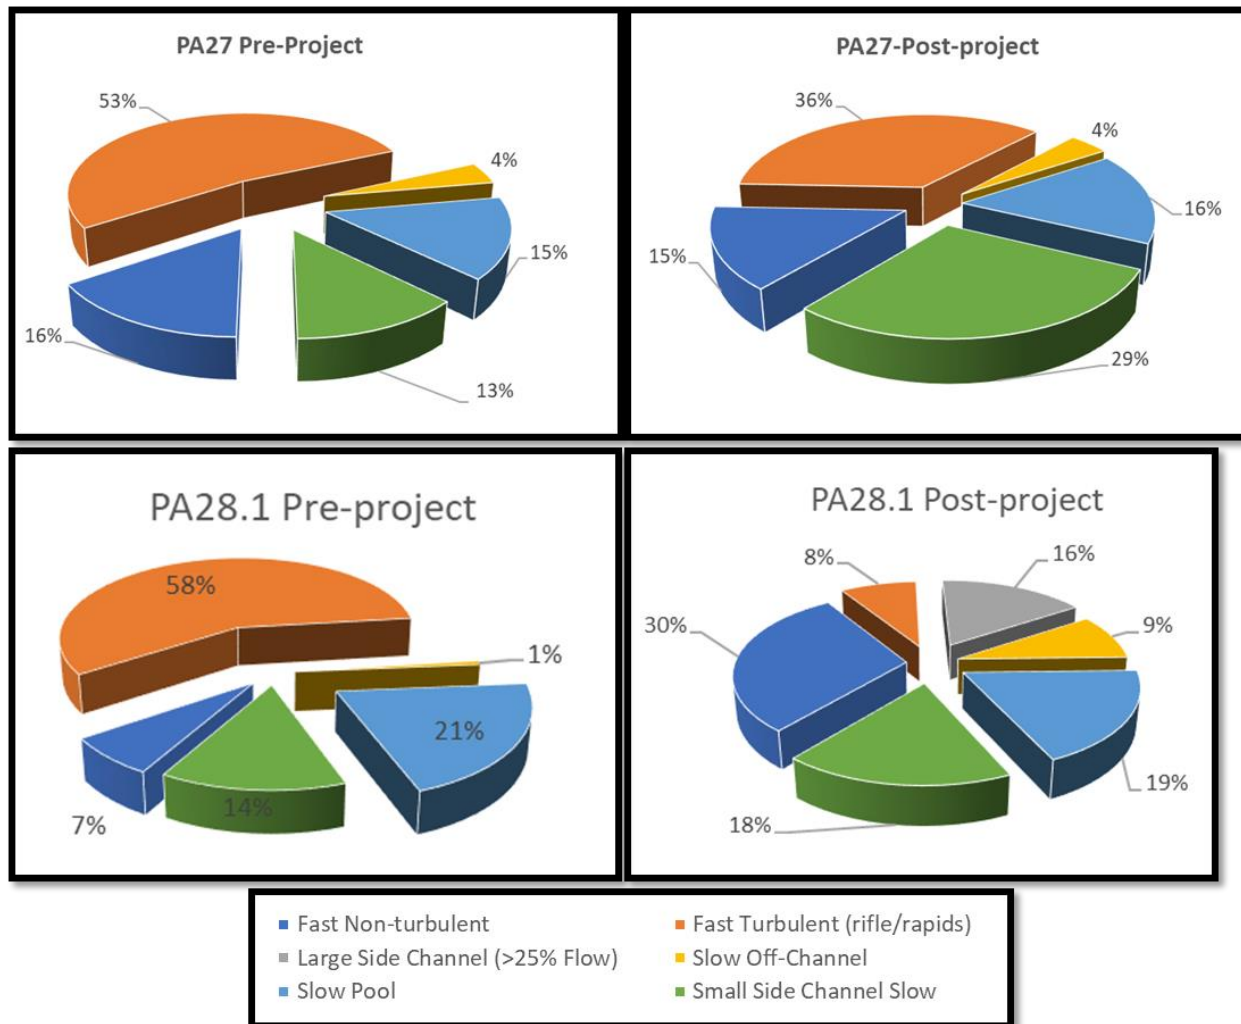
Figure 27/28.1-13: Project Area 27/28.1 channel habitat units measured in the field during the pre-project and post-project rapid habitat surveys for PA 27 (upper) and PA28.1 (lower). The largest change in the channel unit type and diversity involves the conversion of riffle type units to glide unit types and the creation of large side channels.

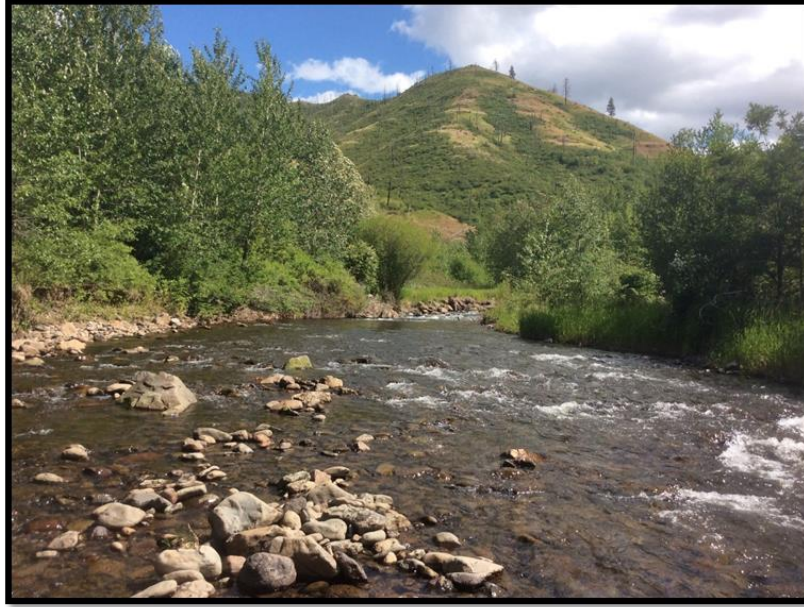
Figure 16: River condition 2020 flooding looking upstream to Beaver Watson diversion point

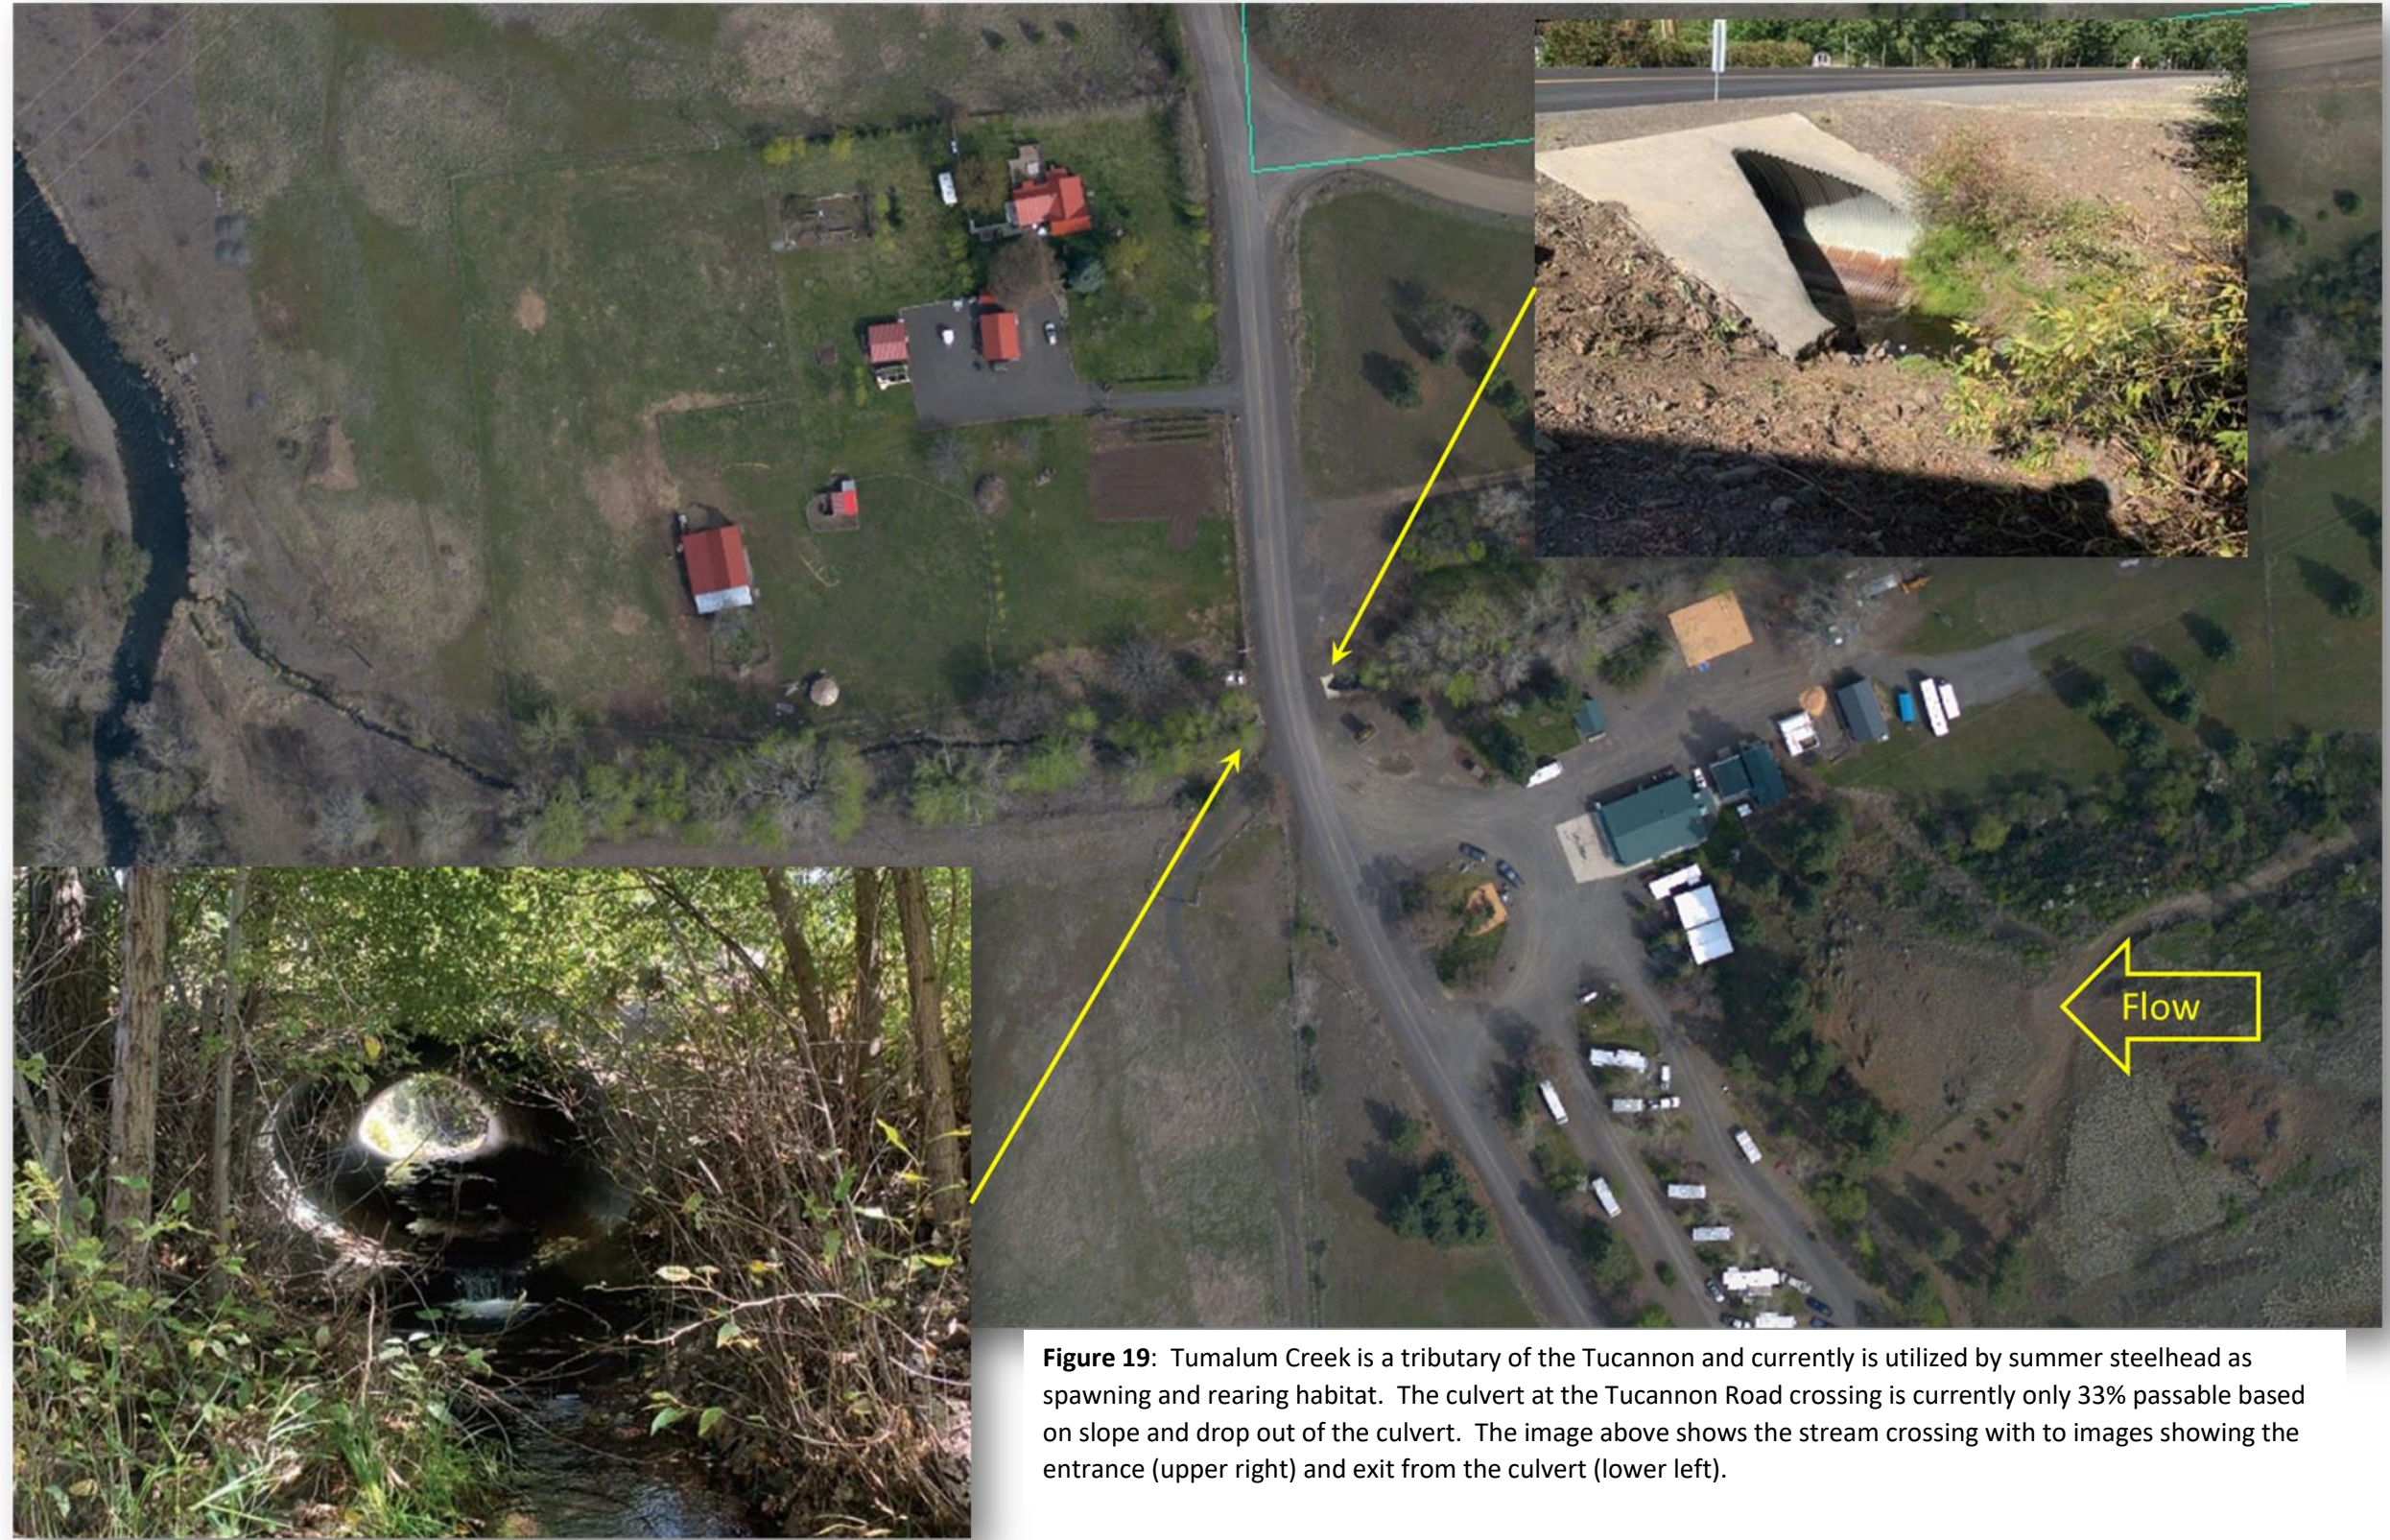
Figure 19: Tumulum Creek is a tributary of the Tucannon and currently is utilized by summer steelhead as spawning and rearing habitat. The culvert at the Tucannon Road crossing is currently only 33% passable based on slope and drop out of the culvert. The image above shows the stream crossing with two images showing the entrance (upper right) and exit from the culvert (lower left).

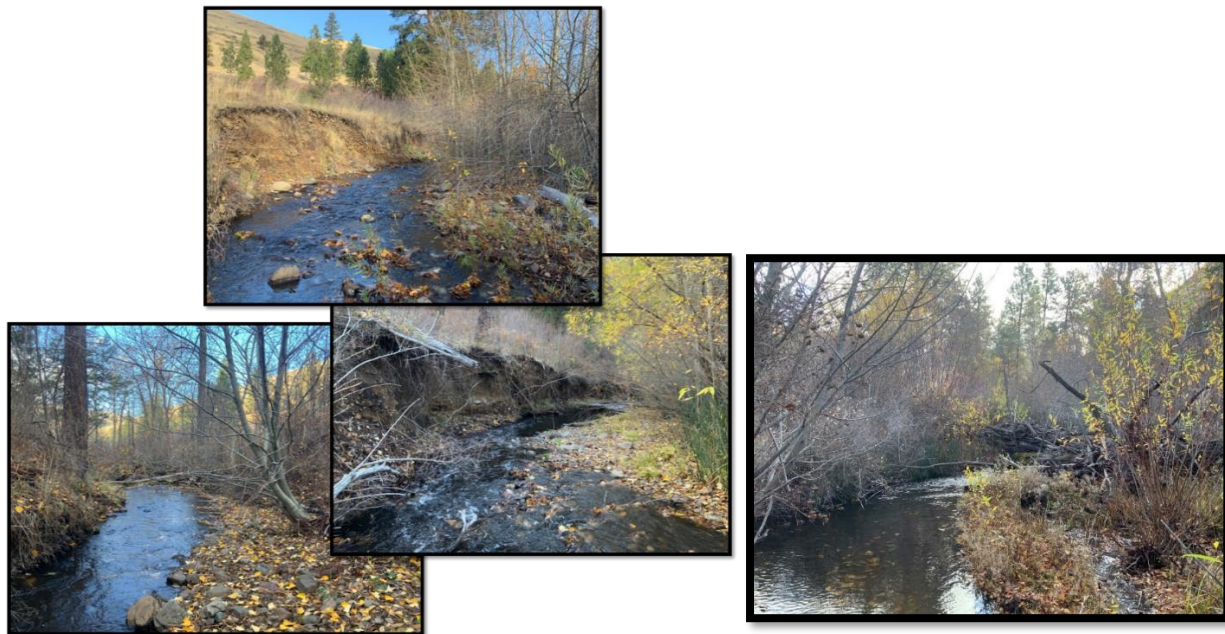
Figure 21: Cummings Creek photo points established in November 2021 during a rapid habitat survey conducted for reach observation and concept design development. The left three images indicate typical condition of channel habitat, which the right (4th) image illustrating habitat potential observed at the upper most part of the project area.

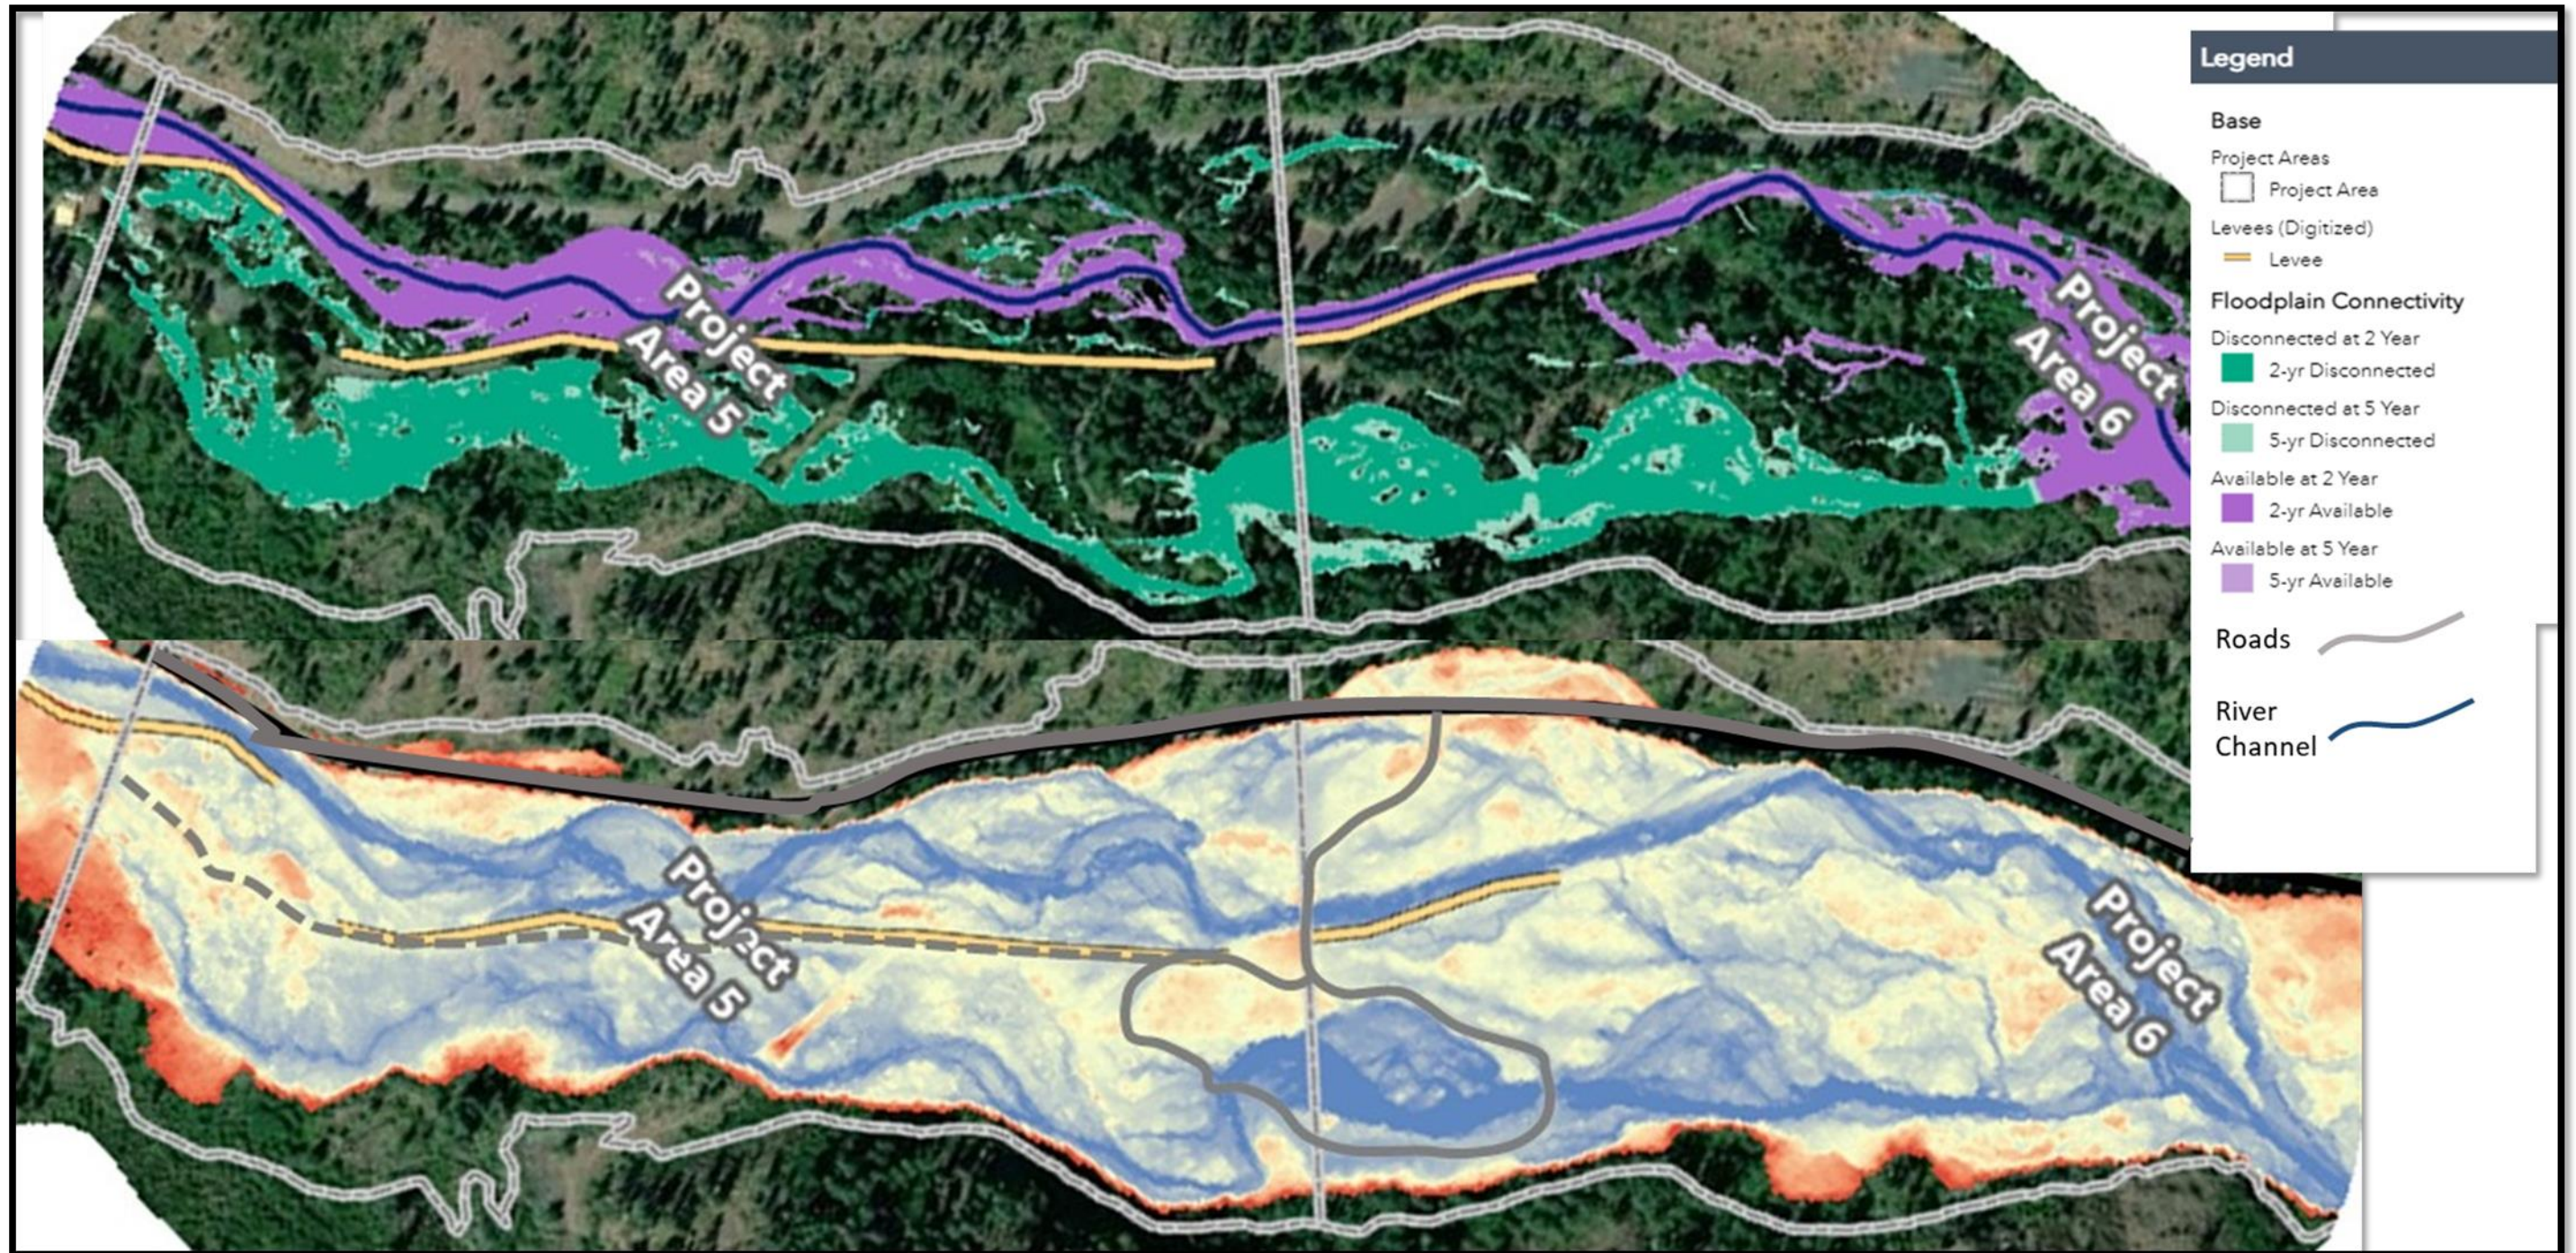
Figure 23: Project Area 5 & 6 just downstream from WA State Parks Camp Wooten. The upper map illustrates low-lying floodplain across both project areas with the lower map showing the relative elevation model based on 2017 LiDAR (<https://ctuirgis.maps.arcgis.com/apps/MapSeries/index.html?appid=7961a9f233684f0daf87970b37d8dc1c>). The upper map illustrated connected 5yr floodplain in purple with the disconnected floodplain in green. In total >19 acres of green shaded floodplain are disconnected by the road and associated gravel berms protecting the road.

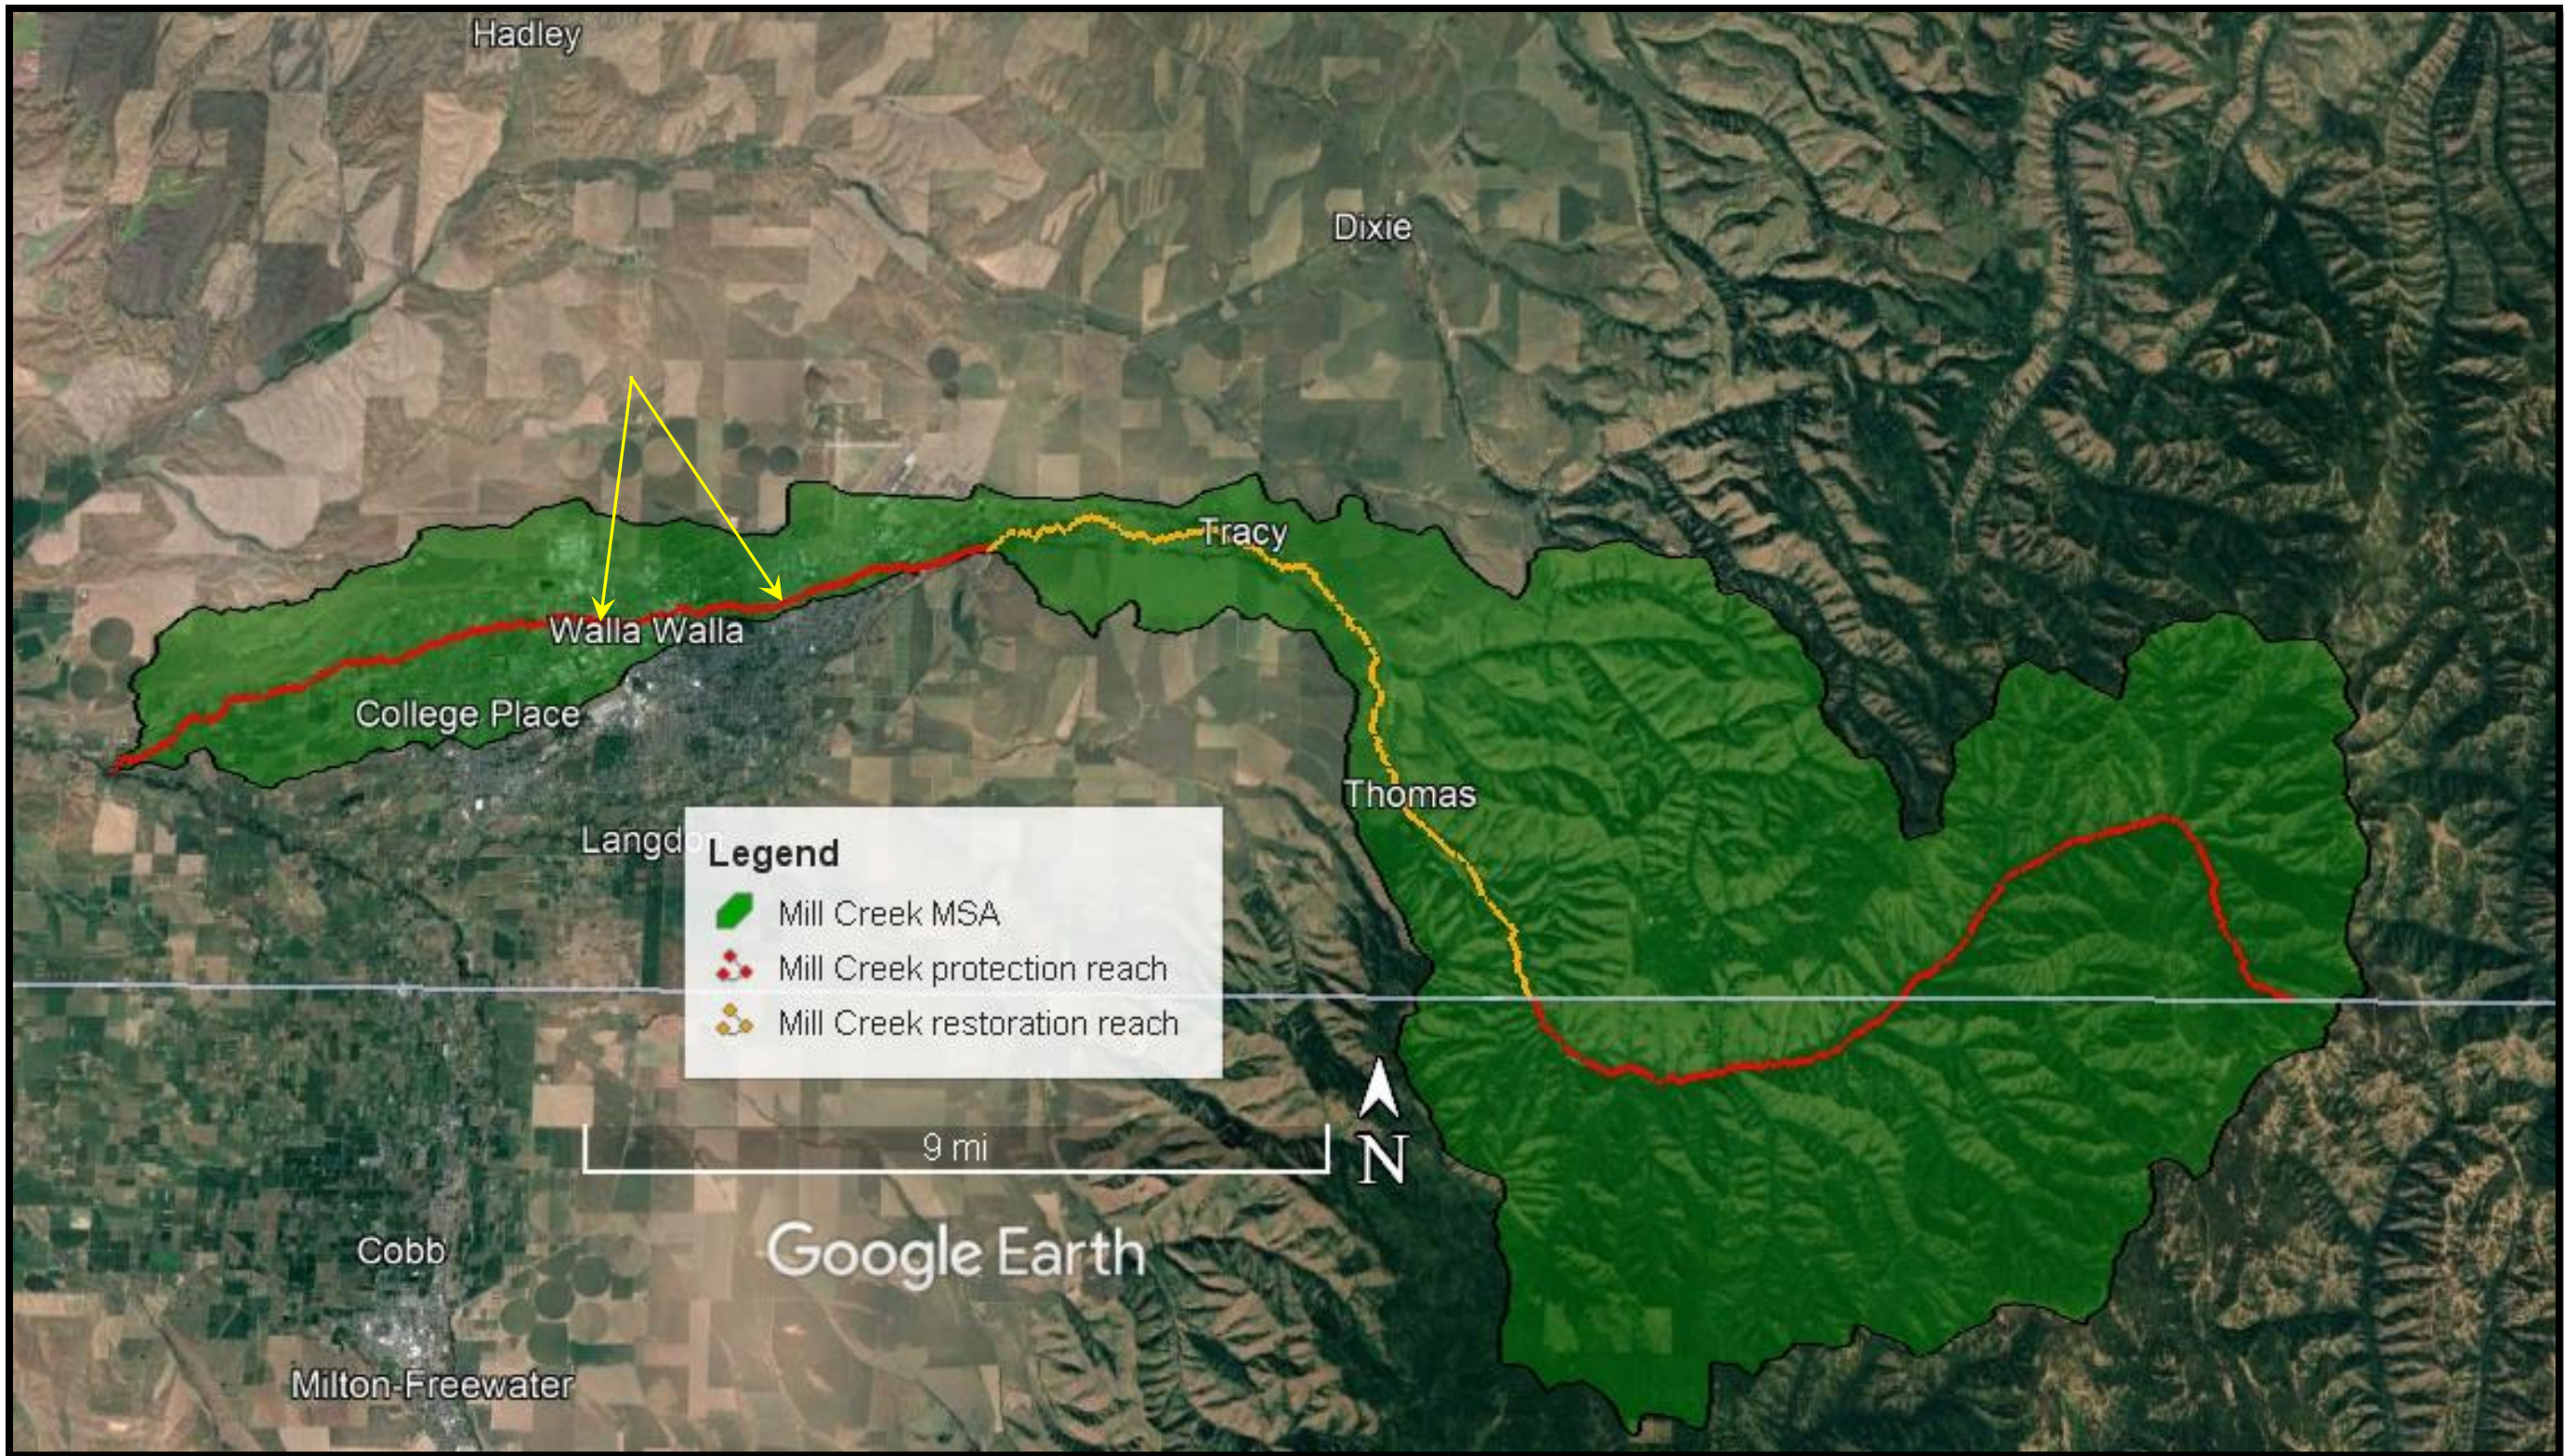
Figure 24: Mill Creek floodway fish passage project general location within the priority watershed. The yellow arrows indicated reach where panels were built for.

Location: Panels were purchased used these funds and delivered to Mill Creek using other funds in 2022 and 2023; Lat/Long 46.066910 / -118.344333 (Figure 24).

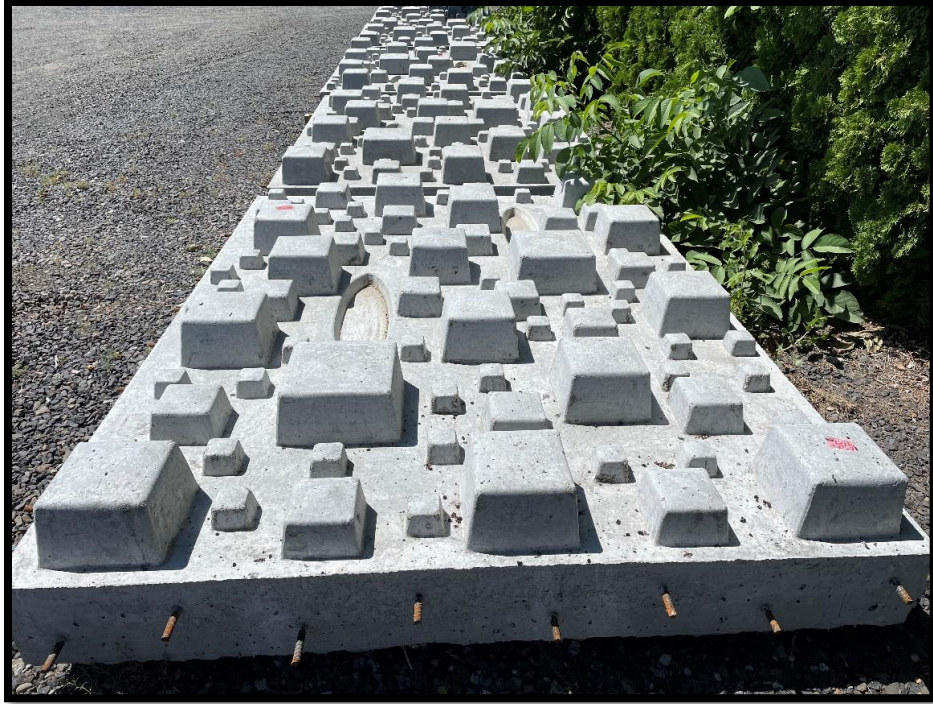
Figure 25: Fish way roughness panel purchased with BPA contract (#86820) in 2022.

Current Status 2022: In 2022, the TSS used this contract to purchase materials (Figure 25) totaling 104 concrete panels which were provided for passage of 1,200 feet of the fishway from Division St. to Blue St. in the upper channel flume in downtown Walla Walla (Figure 26).

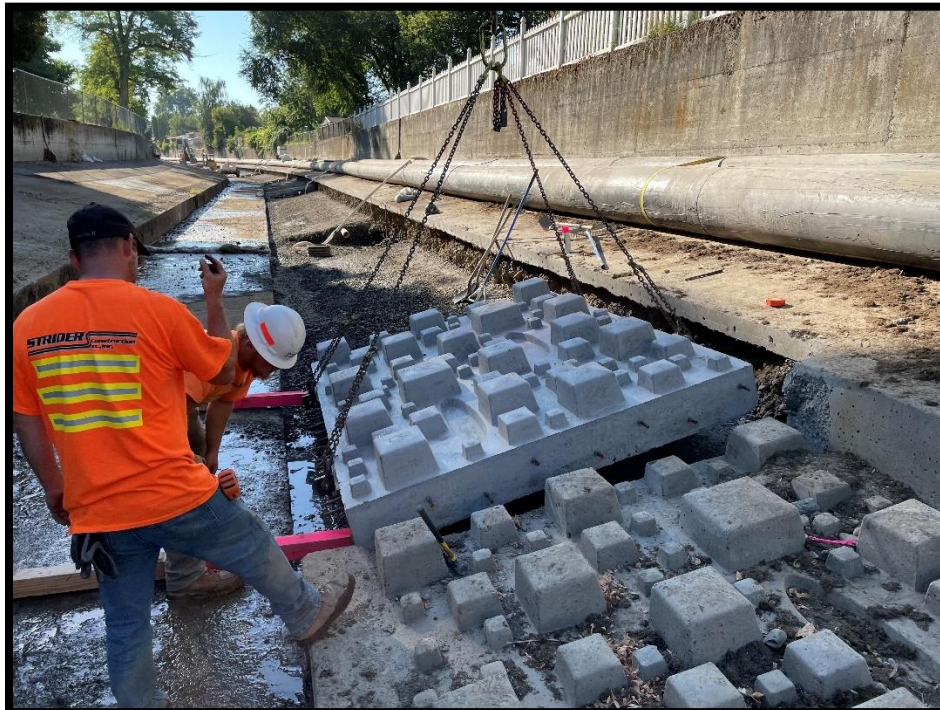
Figure 26: Panels being installed using non-BPA funding in through the State of Washington.

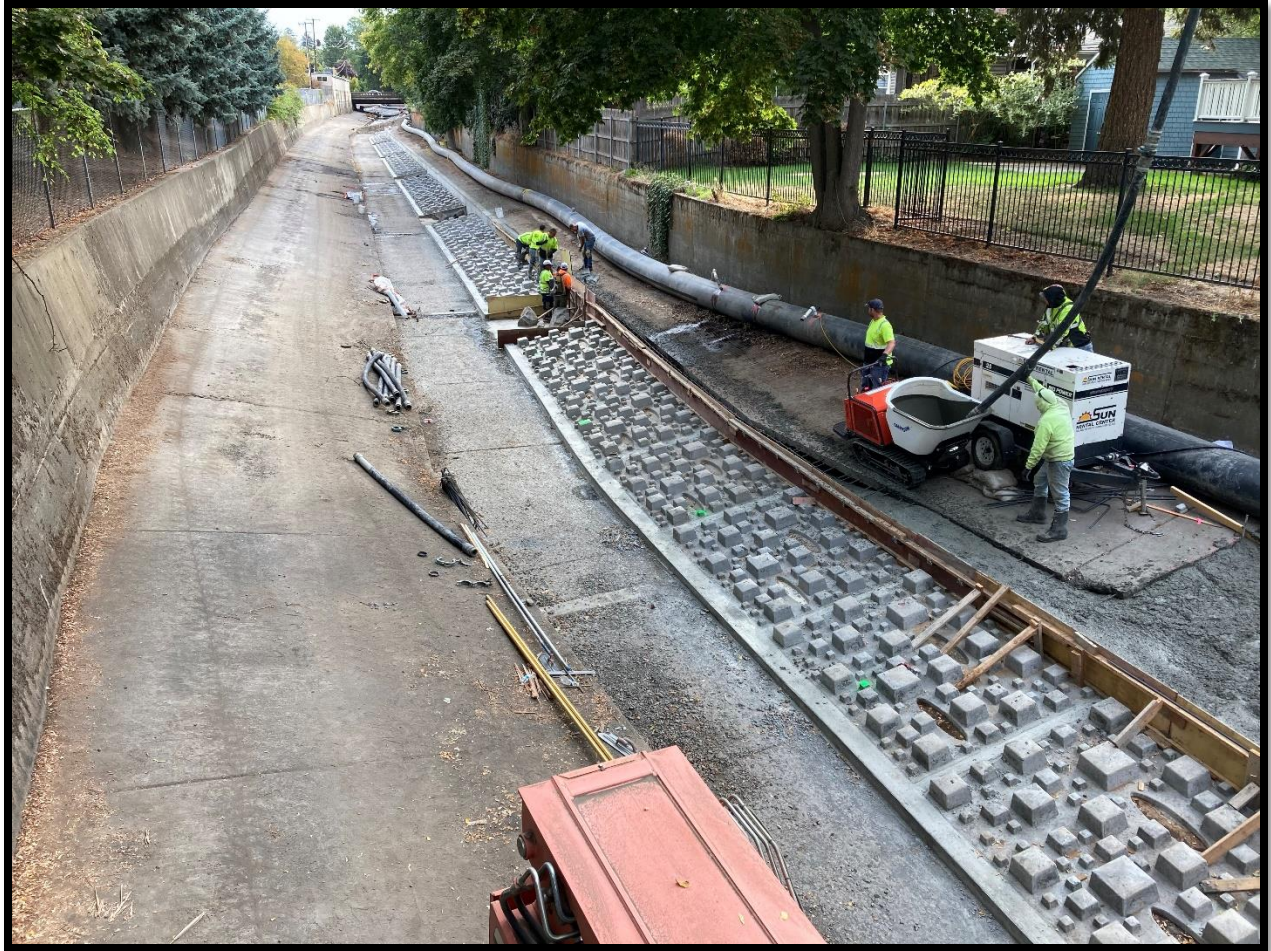
Figure 27: Mill Creek floodway fish passage construction showing the concrete roughness panels while flows are diverted.
