## LIST OF PRIORITIZED REACHES

### Lower Mainstem Touchet

*Prescott to Coppei Creek*

**Project Areas: MS-1 to MS-6**

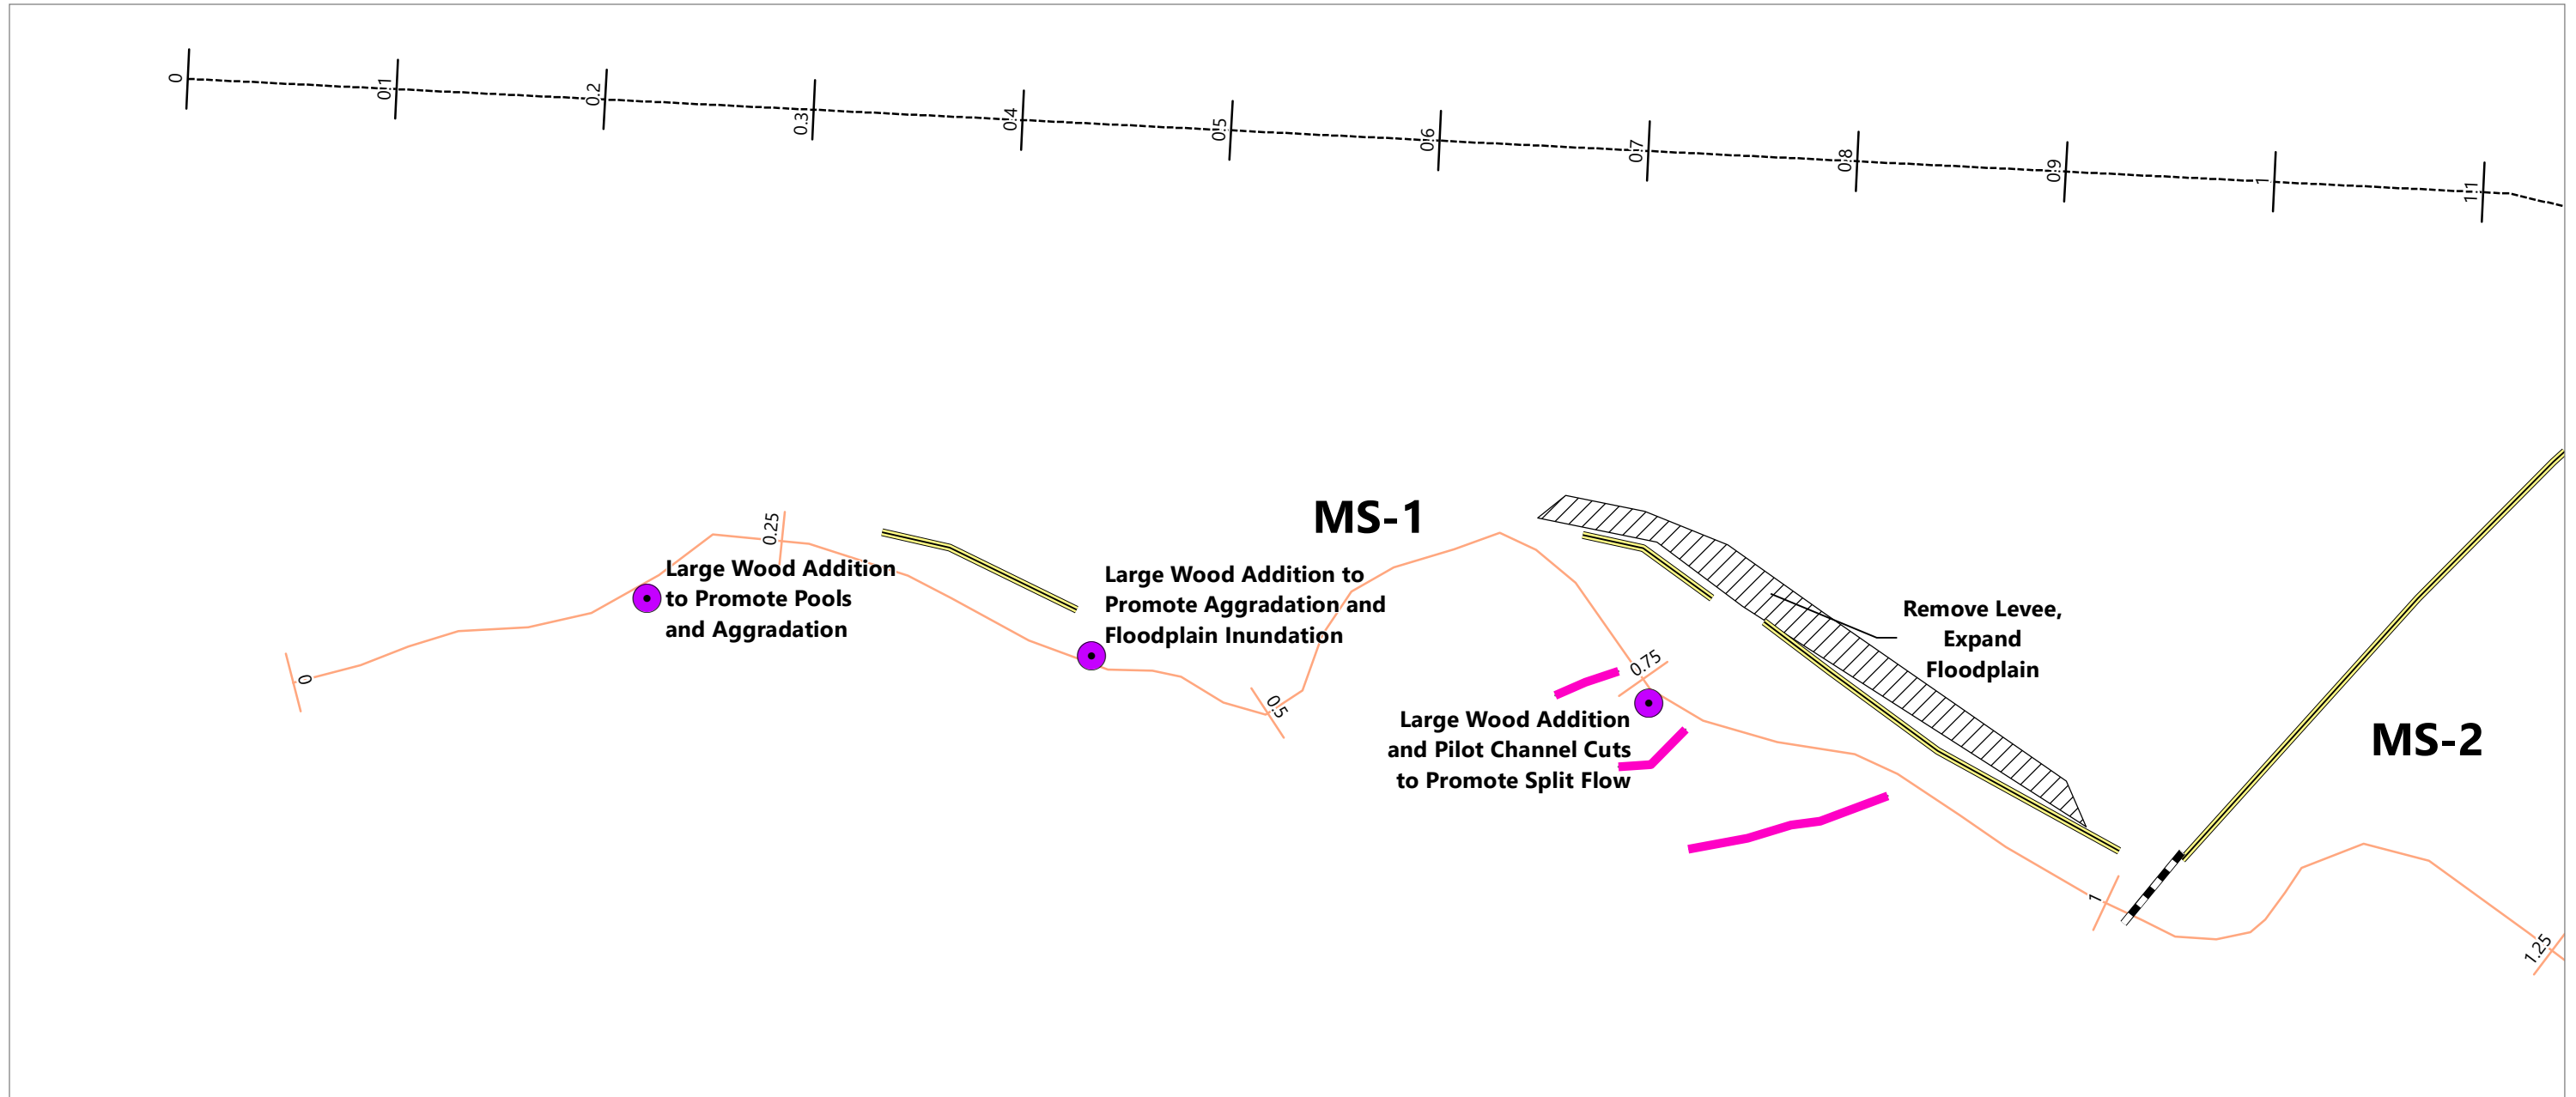
- ELJs to promote aggradation and sinuosity in straight bedrock reaches
- Remove or breach levees through VM 0.7 to VM 0.9
- Pilot channel cuts to activate side channels
