Túuši Wána Design Project

Touchet River - Mile 14 – 17

90% Level Basis of Design Report

November 2024

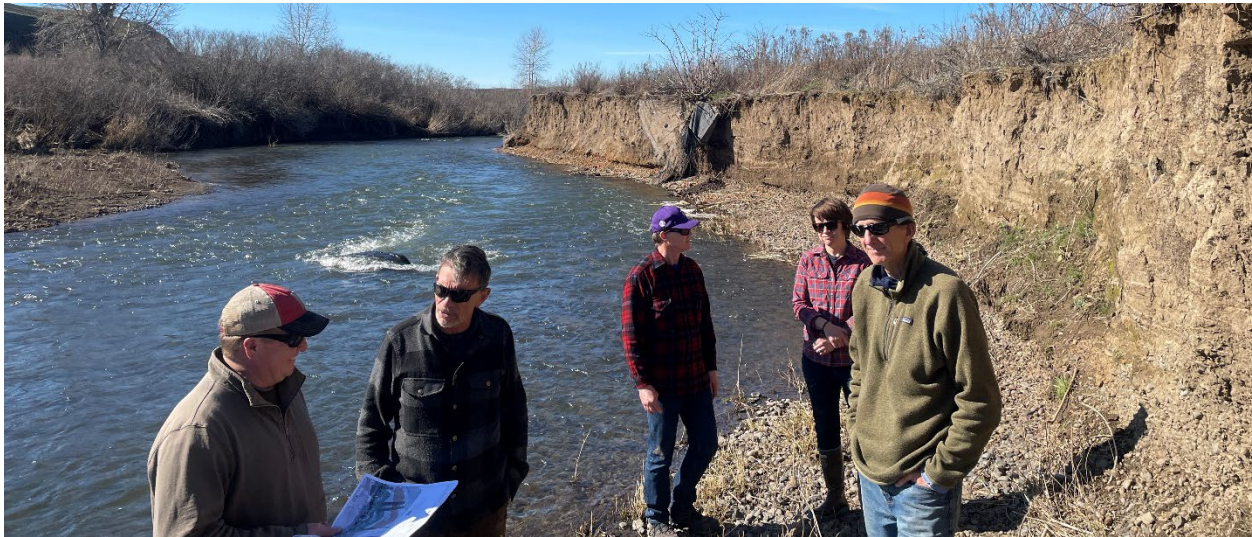
Figure 2: Photo looking down river near RM 16.1. | February 2024

Photo shows the tall right bank composed of fine sediments over a consistent layer of gravels.

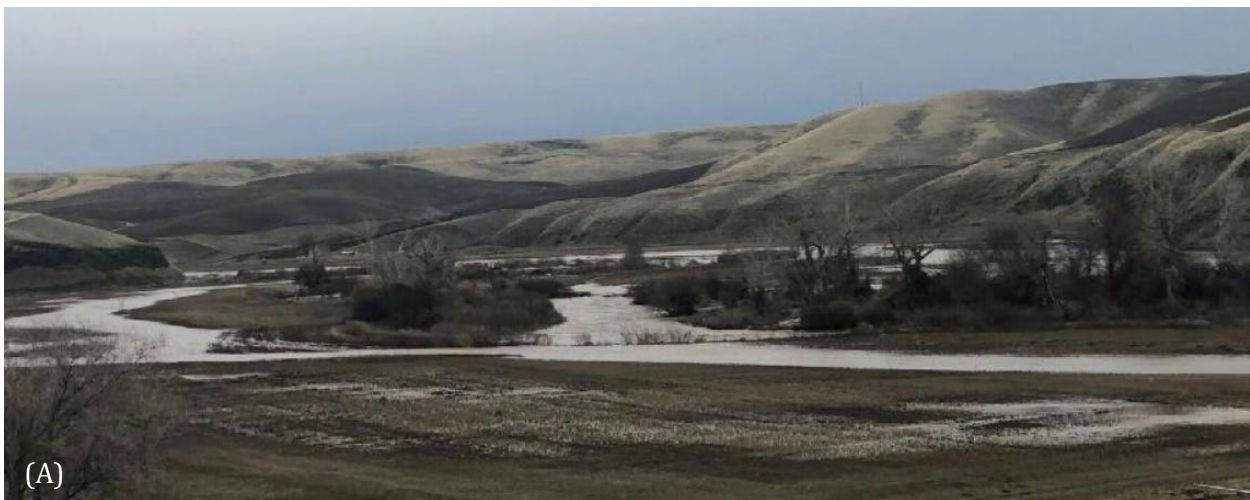
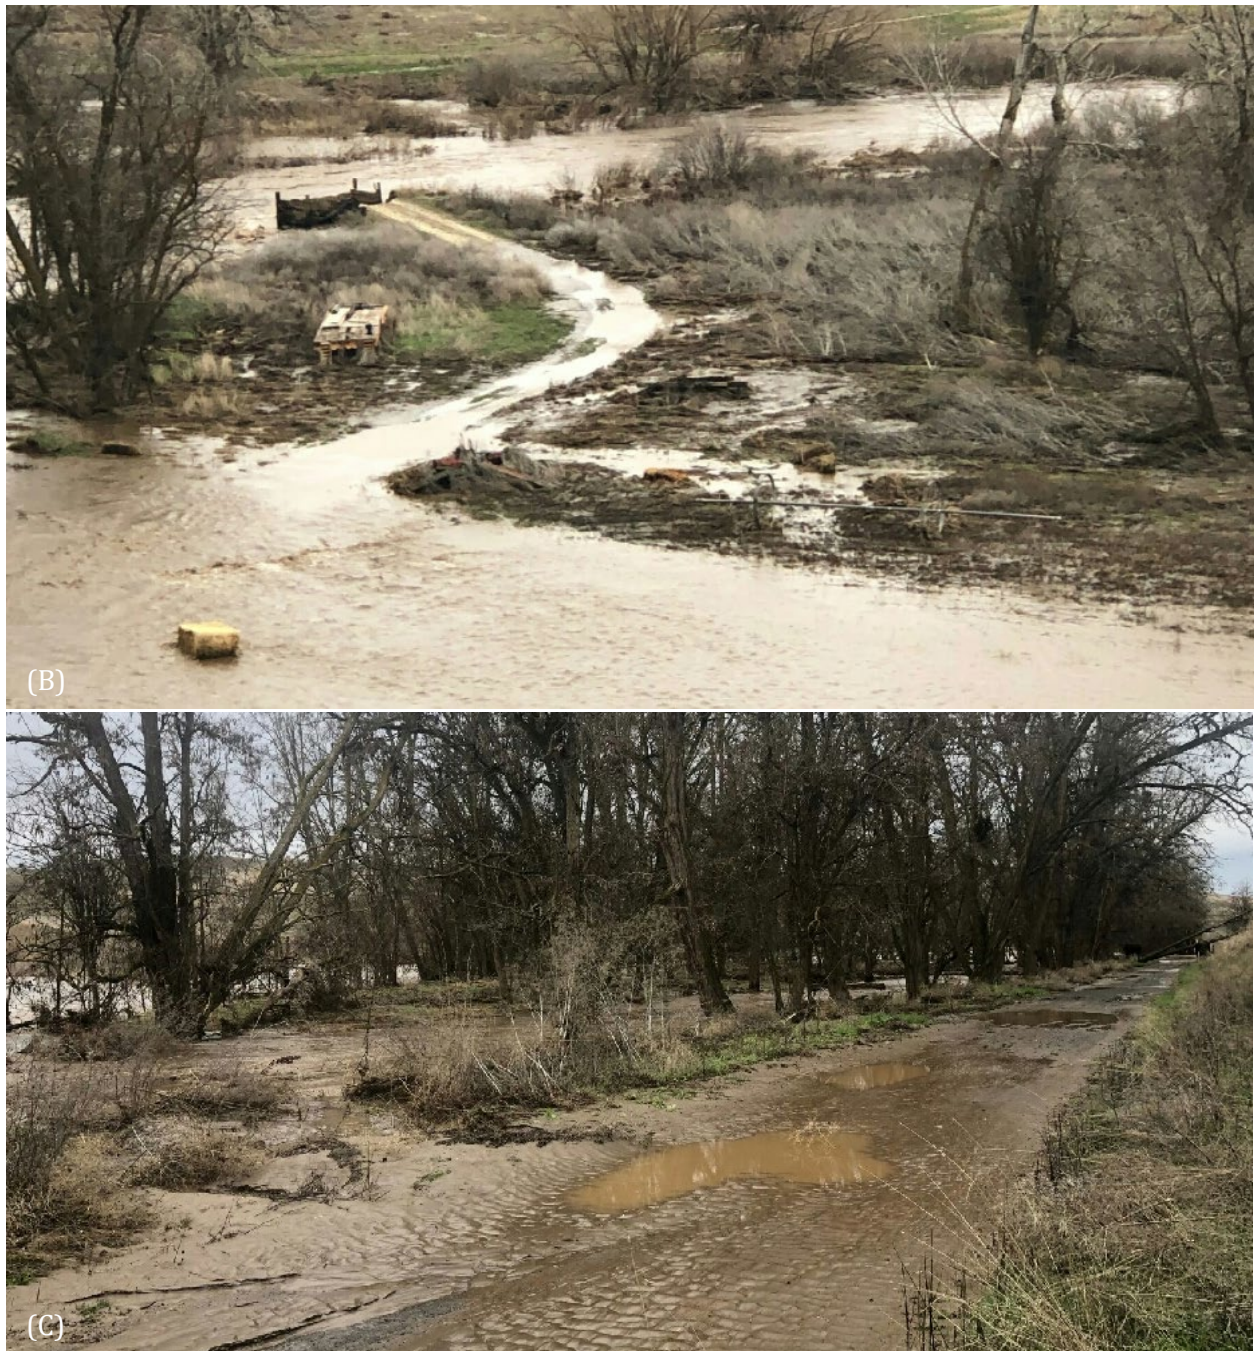
Figure 3: Photos of 2020 Flooding

Note inundation of large areas of the valley bottom (A), appearance of sediment laden water (B), and fine sediment deposition on the order of inches (C) visible as the flood water receded.

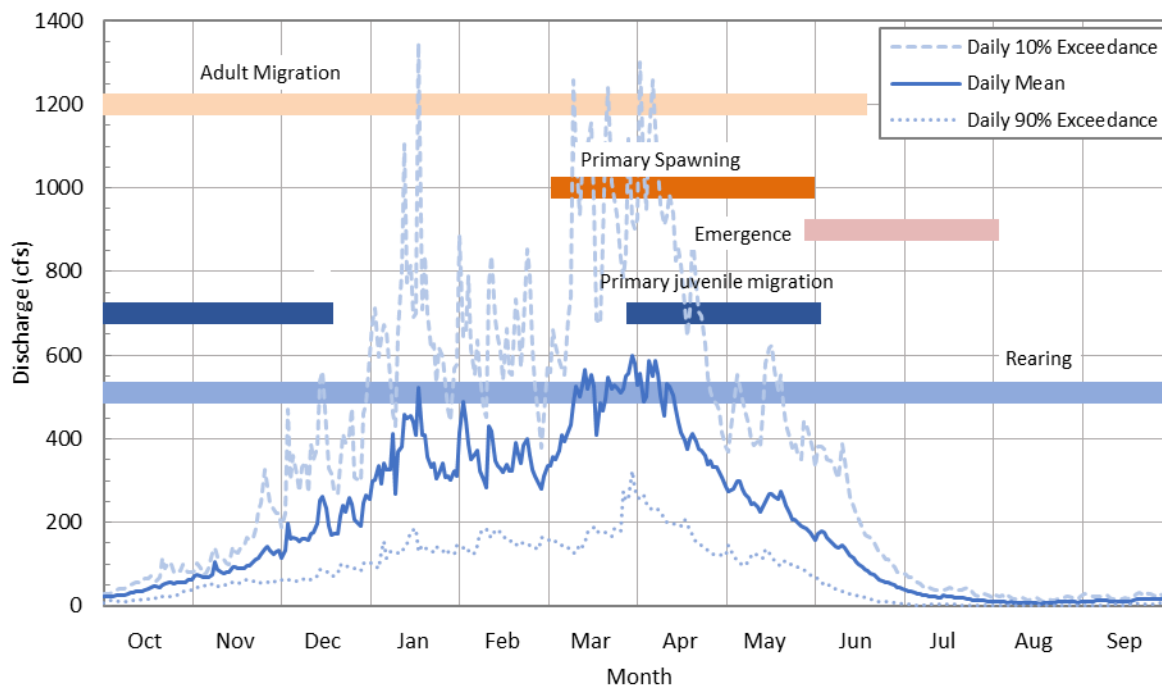
Figure 5: Steelhead (*Oncorhynchus mykiss*) life history timing in the Touchet River and Walla Walla River watersheds overlaid on discharge in the Túuši Wána project area.

Discharge data is adjusted from the WADOE Cummins Rd gage (~RM 3, period of record Water Year 2003-2021) using a direct basin area correction. Fish use timing is approximate and reflects typical life history stages (WDFW 2014, Steve Martin 2016) for fish using the Touchet River. Upstream adult and downstream juvenile migration are the primary life history stages assumed to be present in the Túuši Wána project area.

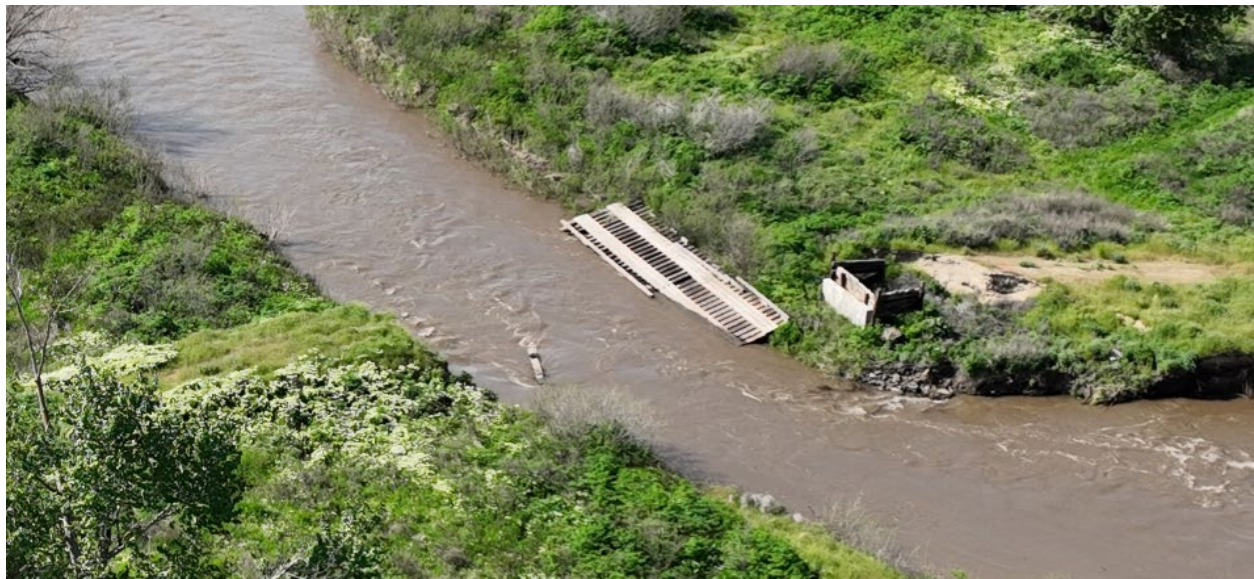
Figure 8: Photo of derelict bridge and abutments to be removed near River Mile 16.5.

Removal of riprap and derelict items. Existing riprap, other types of bank armoring, a farm bridge deck and abutments (Figure 8), and other derelict agricultural items (pipes, fences, poles, equipment, etc.) will be removed throughout the project area. Removal of the riprap and bank armoring will allow for natural bank erosion rates and remobilization of floodplain sediments with the project reach. The overhead electric powerlines serving the irrigation pumps with the project area will remain in-place until they are no longer needed to provide irrigation water to help establish the riparian plantings. This plant establishment period is expected to take around five years. The larger power transmission lines that cross the valley near River Mile 16.5 will remain, including the two sets of poles in the valley bottom. There will be a 300-foot buffer on each side of the transmission lines with no excavation, fills, or LWS within it.

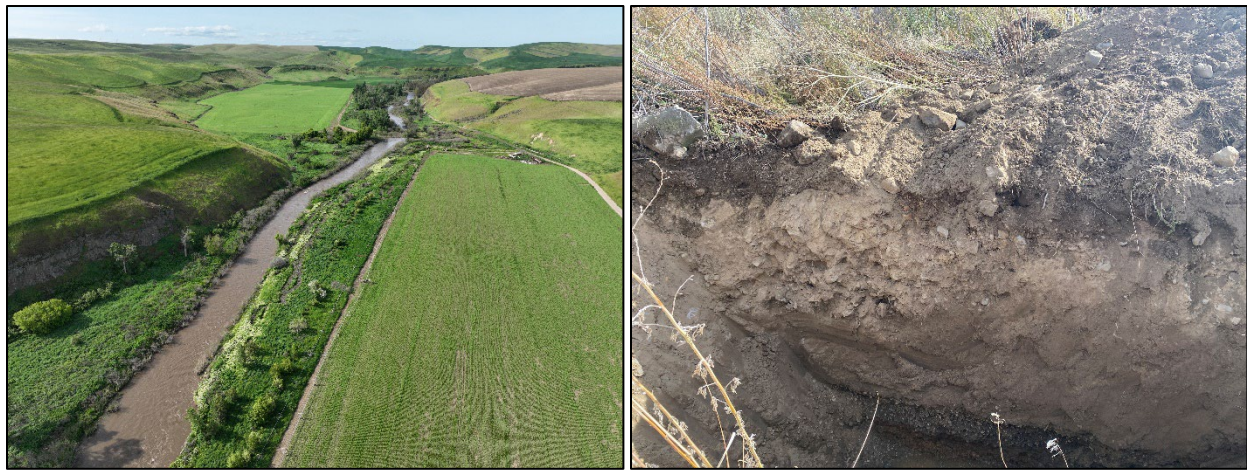
Figure 9: Photo of straightened channel segment at the project site (left). Photo of test pit excavated along the right bank of the photo at left showing substantial coarse, angular non-alluvial material likely placed during the channelization process.

- *Channelization and bank stabilization.* Observations of aerial imagery and LiDAR suggest the current channel has been straightened in several locations throughout the project site, and the channel may have been forced to the valley margins in places (Figure 9). Several straightened channel segments bounded by pushup berms and/or bank armoring are present at the site, and a test pit excavated along these straightened reaches (Figure 28) revealed coarse non-alluvial material in the subsurface, which was likely placed during the channelization process (Figure 9). Riprap was found in multiple locations throughout the project site, both related to discrete infrastructure protection (pumps, road crossings, etc.) and in continuous placements along sections of the bank.

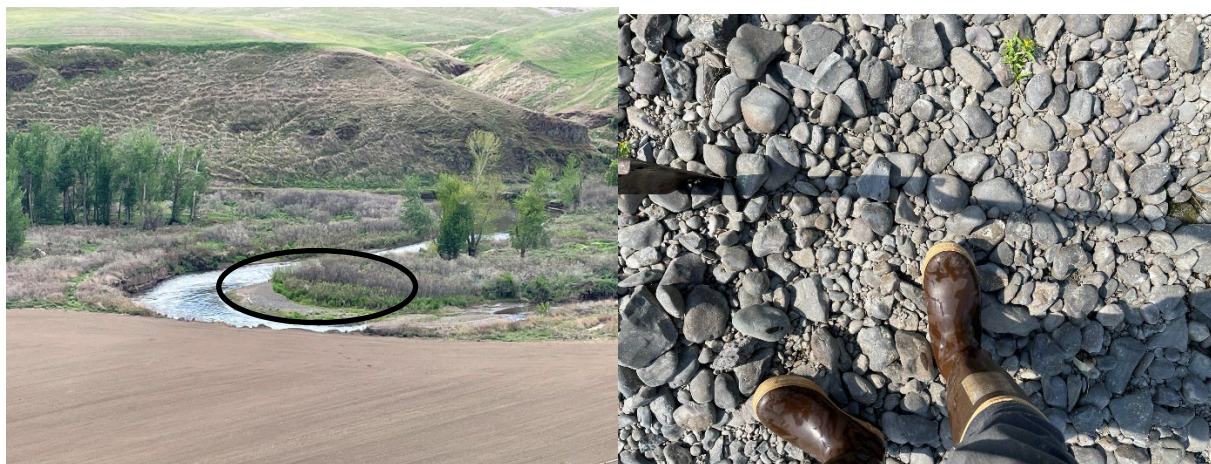
Figure 21 : Active contemporary (modern) alluvial surface (left) and material on active point bar (right).
 This surface correlates with channel traces and signatures visible on LiDAR (Figure 21).

The most recently formed alluvial surface (Figure 21) at the project site is a connected floodplain inset to elevated valley bottom surface. This contemporary floodplain has formed in response to lateral channel changes and active fluvial reworking of sediments in the channel bed and banks. This surface is approximately 2-4 feet above the modern channel bed, displays substantial local topographic variability, shows evidence of fluvial reworking, and is mostly found in areas where the channel has occupied since approximately 1950 and since migrated away from that location (Figure 22). This surface is connected to the channel at semi-regularly occurring flows (~2-year return period), and woody riparian species densely cover this surface along the channel margins in most locations.

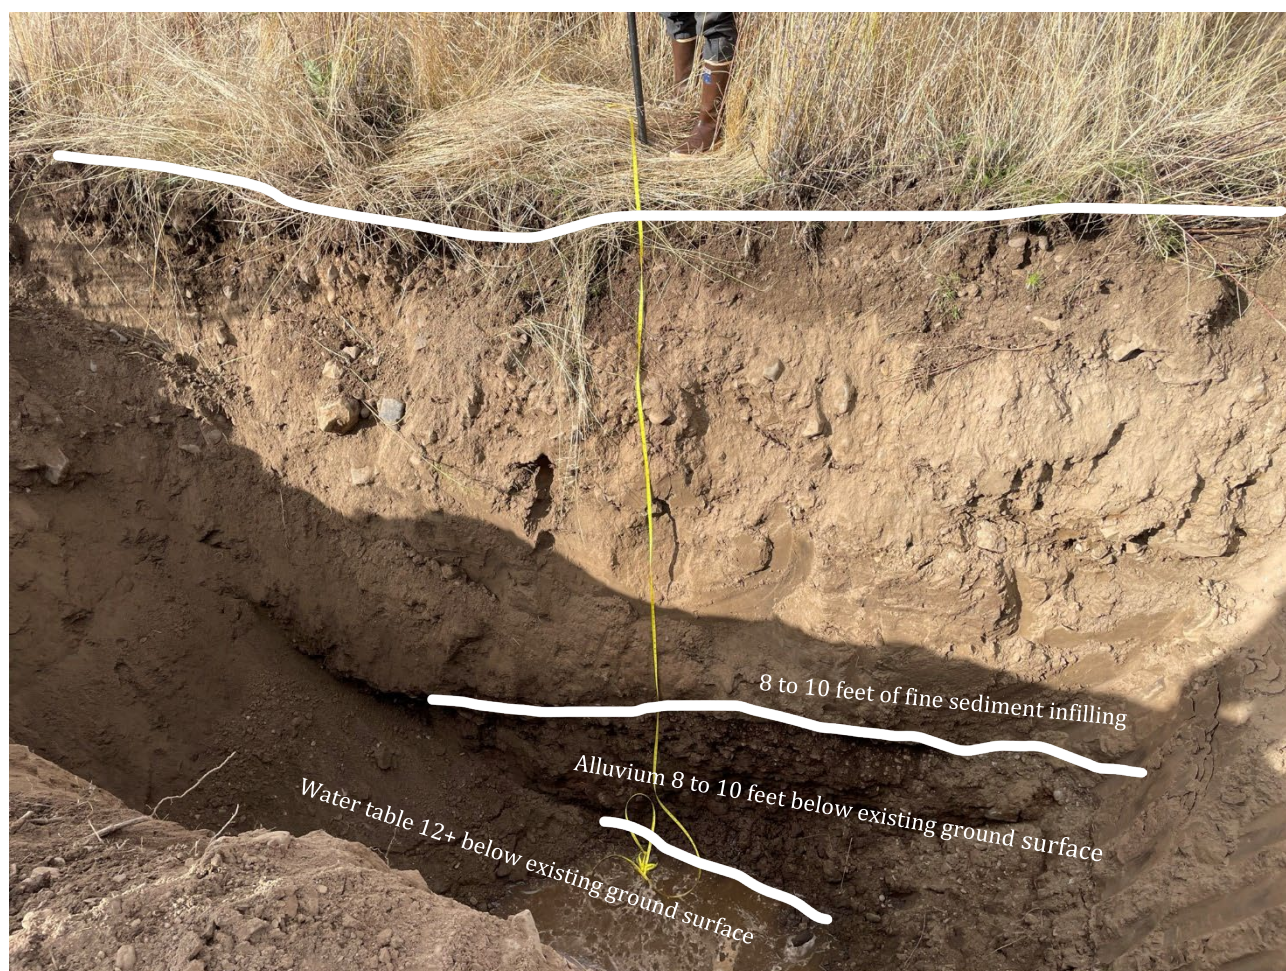
Figure 23: Annotated example of a test pit dug at Túuši Wána project area.

Lack of discernable stratification along channel banks and within test pits (Figure 23) suggests the surface comprising the majority of the valley bottom was formed by large scale floodplain aggradation during one or multiple large floods. This is primarily evidenced by an unstratified layer of sandy silt eight to ten feet above gravel alluvium observed along channel banks and within test pits as well as an absence of discernable alluvial stratigraphy and/or substates associated with in-channel or channel margin deposition and a lack of buried soil horizons in the valley bottom stratigraphy. It is acknowledged that there is uncertainty regarding this hypothesis and that test pits were limited to the river right side of the project area due to channel crossing limitations. Of note, planned additional test pits for the Spring of 2024 requested by the SRFB were unable to occur due to equipment challenges. A ground penetrating radar (GPR) evaluation of valley bottom sediment and groundwater characteristics was attempted in summer 2024 to inform design efforts, but these investigations were not successful due to an equipment malfunction which limited the depth of radar imaging to roughly 1-2 feet. The data collected as a part of this investigation is not suitable to evaluate the sedimentological and stratigraphic properties of valley bottom sediments to the degree required to satisfy review comments and substantively change the design approach at this time. Further investigation by test pits and trenches was attempted, but access constraints and technical issues provided only limited data insufficient to fill the data gap.

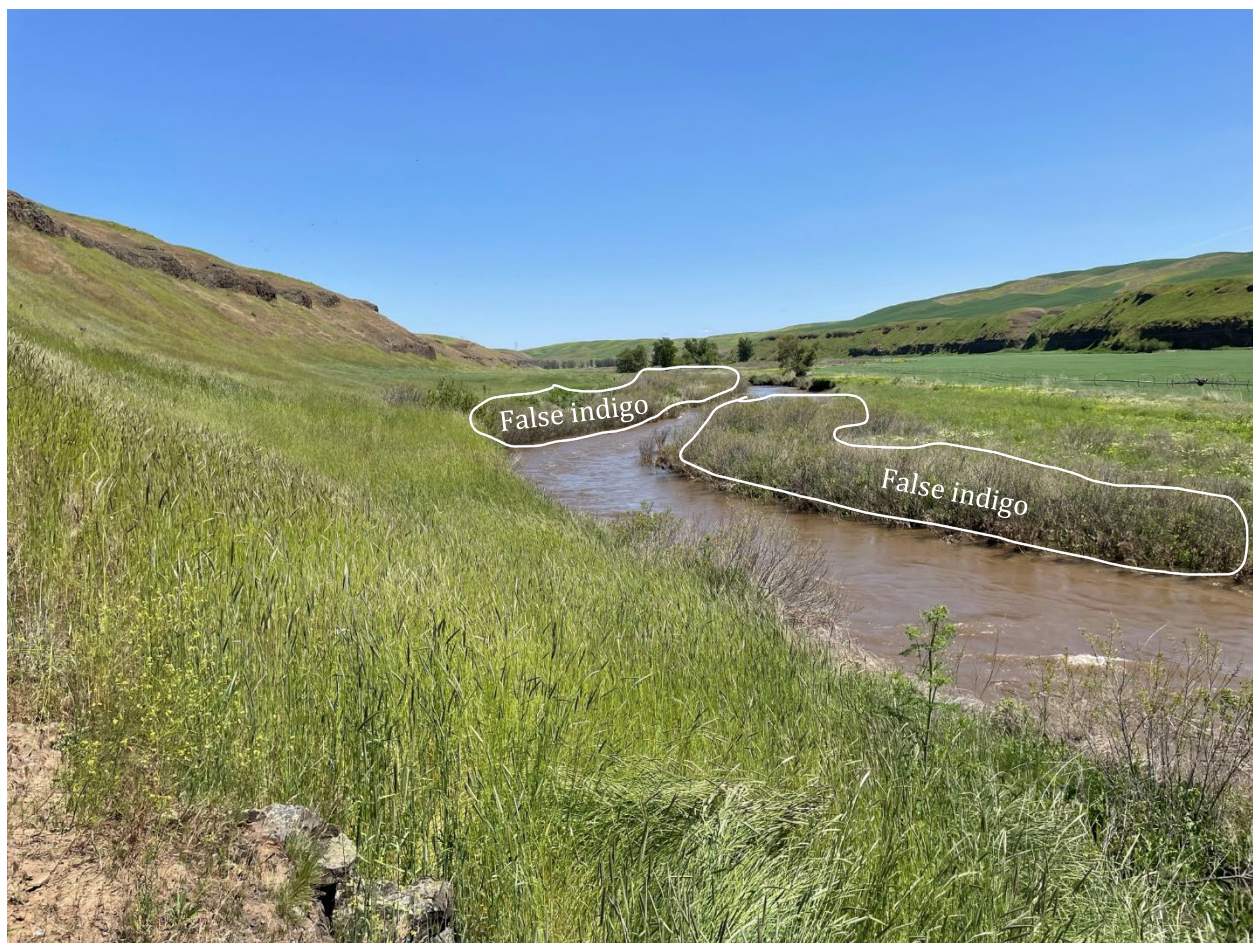
Figure 24: Representative image of False indigo likely occupying the historical niche of shrub willow (e.g., *Salix exigua*)

substantial portions of the valley bottom from intermediate flood events (e.g., 2-year, 5-year). This, combined with agricultural clearing and grading and assertion by non-native riparian species (e.g., False Indigo), has resulted in a valley bottom largely devoid of floodplain vegetation assemblages that would be typical of the region's intermediate floodplain surfaces (e.g., cottonwood). Field observation and examination of the aerial photo record suggest surfaces were cleared of the remainder of vegetation by the 1970s and consequently contain primarily pasture grasses with few remnant cottonwoods visible from historical flood events. In recent decades, as the smaller inset point bars and floodplains have developed along the actively migrating channel corridor, riparian plant assemblages have occupied these surfaces. Many of these surfaces have been occupied by False Indigo (*Amorpha fruticosa*), which was planted by the Civilian Conservation Corps in an effort to halt stream erosion (J. Gailey, personal communication, May 5, 2022). False indigo now occupies the habitat niche that historically was likely occupied by shrub-type willows (Figure 24). Notably, a project in the early 2000s was completed to remove the False Indigo completely. However, a flood event following the False Indigo removal led to reoccupation of the project area by False Indigo.

Given the absence of shrub-type willows within the project area, False Indigo growth conditions were assessed as a proxy for shrub willow. This assessment was completed to inform the

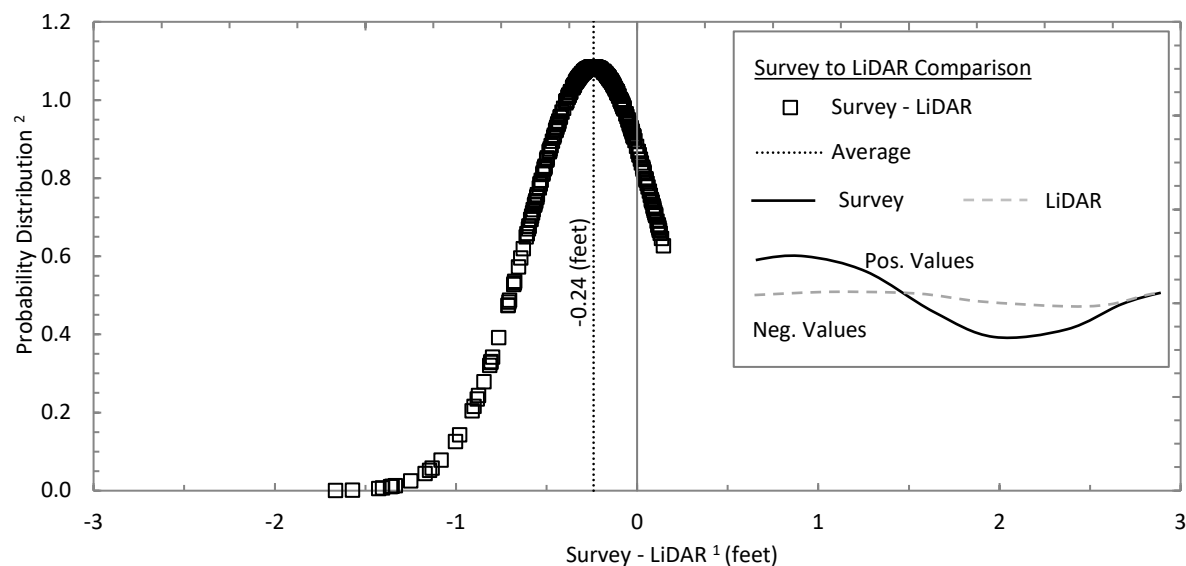
Figure 26: Survey comparison to LiDAR ground elevations.

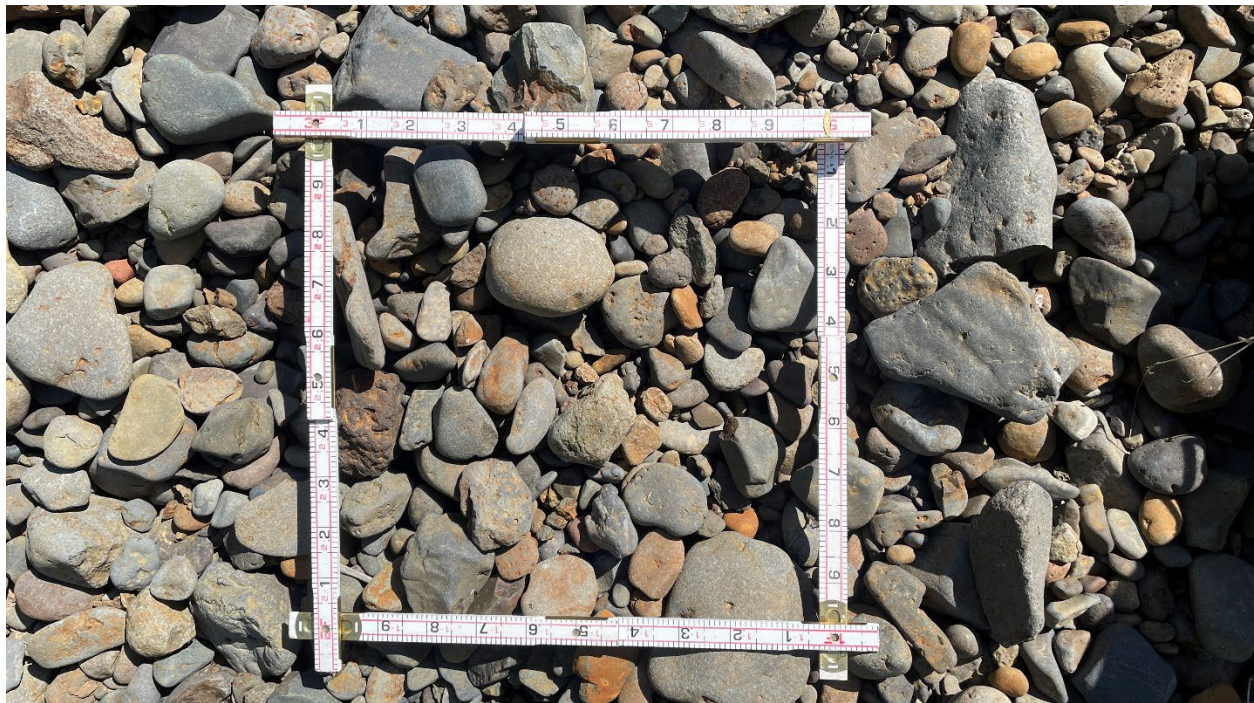
Figure 27: Representative photo of gravel bar substrate in the project area.

The Touchet River is a gravel bed river system (e.g., Church 2010) in the vicinity of the project site. The channel readily transports gravel-sized sediment as bedload at regularly occurring flows (annual peak flows, or less, based on field observations), and the deposition of gravel-sized sediment creates bed and bar forms which drive the morphology of the river channel. Much of the gravel which is transported to the site likely is generated in the headwaters, but local, secondary sources of gravel include colluvial inputs and gravel eroded from channel banks. Figure 27 provides a representative example of bar substrate at the site.

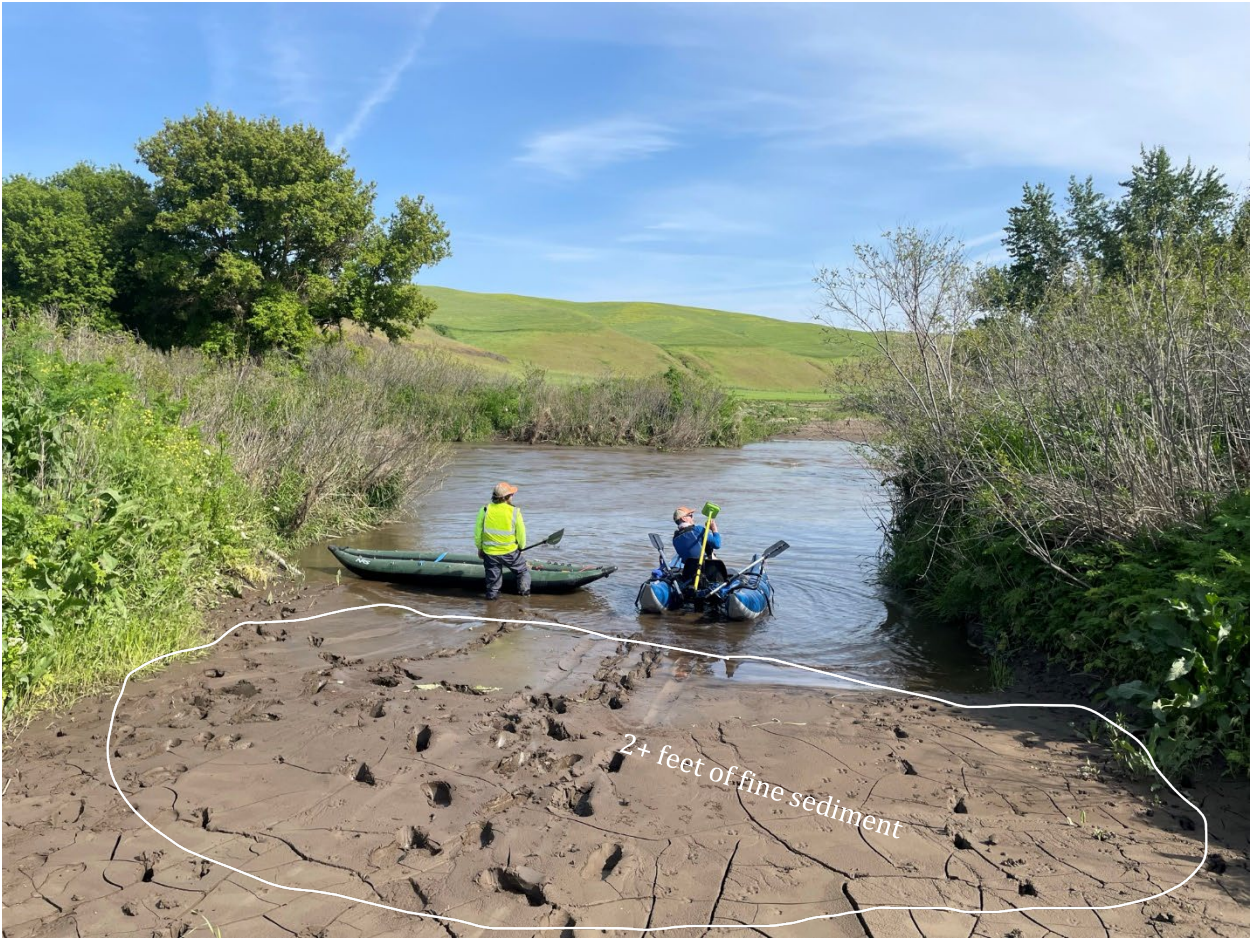
Figure 31: Fine sediment along the banks near RM 15.7. Deposit was from a single year of spring runoff flows.
