**NORTH FORK JOHN DAY RIVER BASIN ANADROMOUS FISH HABITAT
ENHANCEMENT PROJECT Annual Report for February 2018 – January 2019**

Project No. 2000-031-00

April 2020

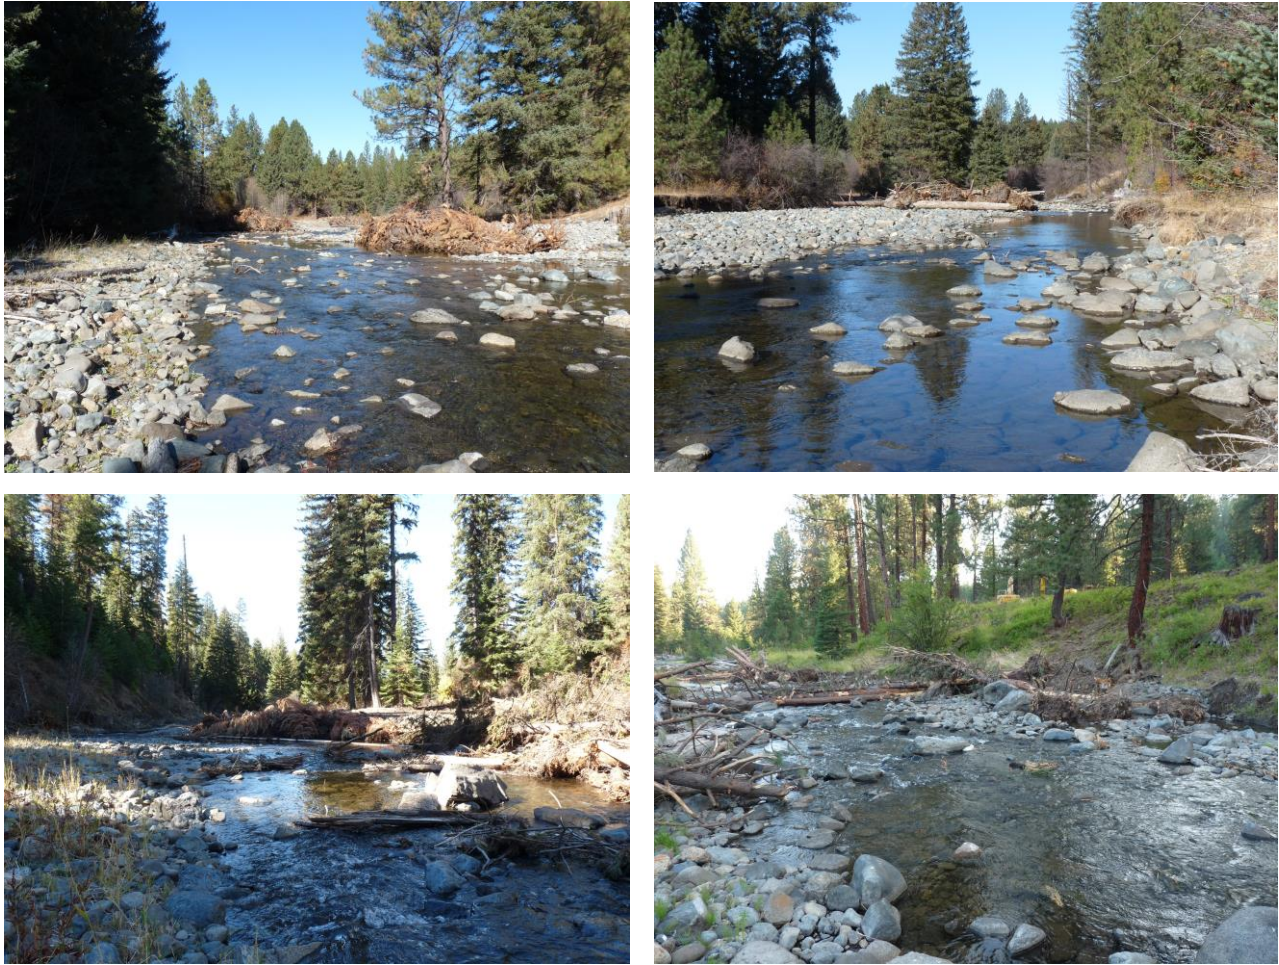
Figure 5. Large wood structures developed in Desolation Creek's primary channel.

During the instream work window 18 large wood structures (Figure 5) and associated willow cuttings were developed as designed. However, the alcove and associated structures were not developed to avoid disturbing sensitive wetland habitat. We determined that incorporating the treatment into the Lower Reach 6 Implementation at a later date would allow for more effective implementation as the 10 Road is obliterated. Implementation occurred in an upstream direction where completed areas were not re-entered with heavy equipment once completed. The only complication not foreseen was the need for extra overburden required to stabilize the largest wood jam structures, however, we were able to locate said material within permit constraints. Native vegetation beyond cuttings associated with individual structures or in specific locations on gravel bars were put off. Plantings will occur once the site has had some time to adjust to implemented treatments.

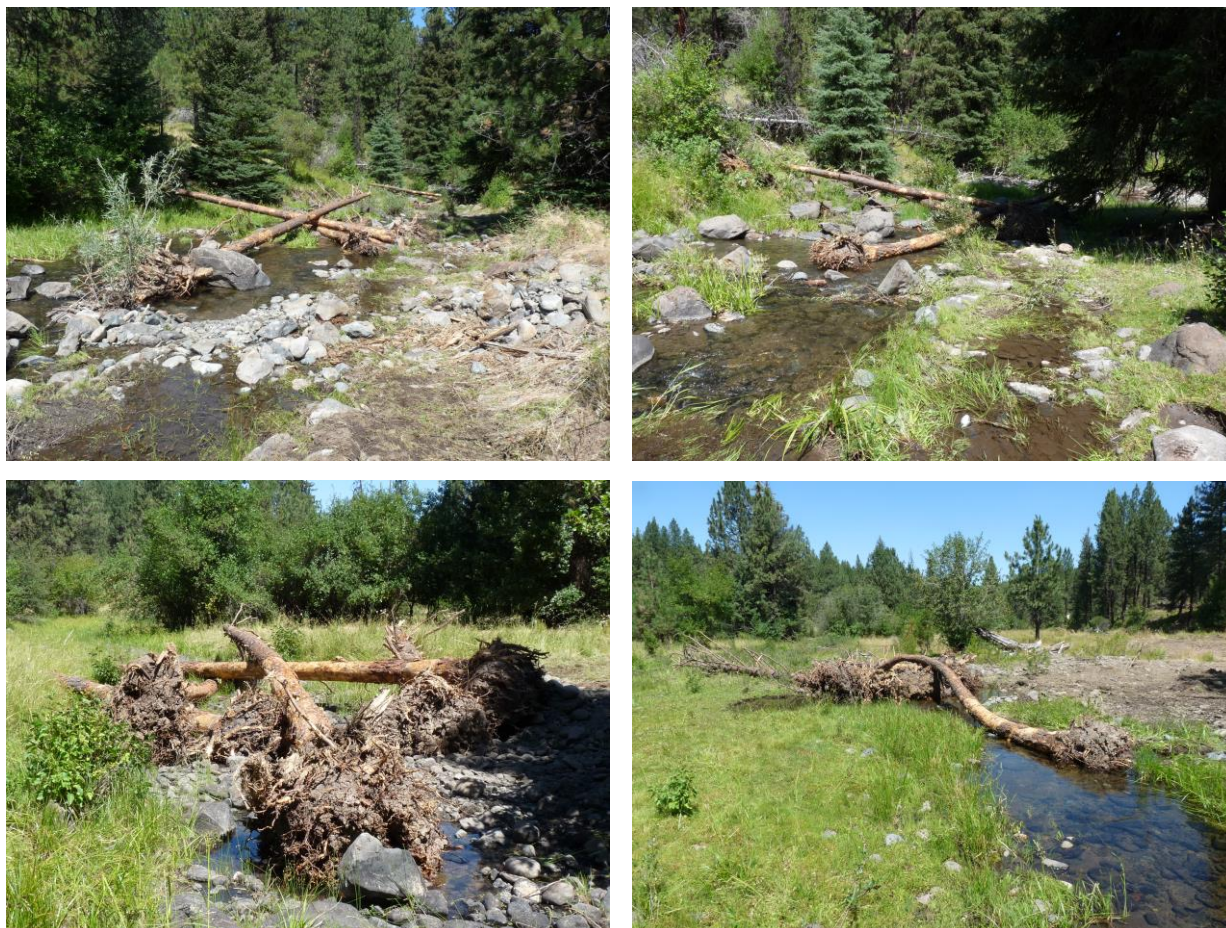
Figure 6. Large wood features developed in reactivated side channels.

Approximately 500 feet of excavated plug reintroduced flows to 4,000 feet of side channel disconnected as a result of human floodplain manipulation (3,500 feet), natural process influenced by human activity (500 feet), or a combination thereof (1,500 feet). Within the reconnected side-channel 17 large wood structures (Figure 6) were developed to increase complexity and provide habitat for juvenile aquatic life stages. An additional three structures were developed in what was once Desolation Creek's thalweg until a log jam forced channel avulsion. Although this channel is minimally or not active throughout the year decomposing logs will likely allow flows within five to ten years at least during spring run-off. Side-channels contained active flows within several hours once plugs were removed and spring Chinook salmon were seen spawning in the lower portion on one immediately after implementation.

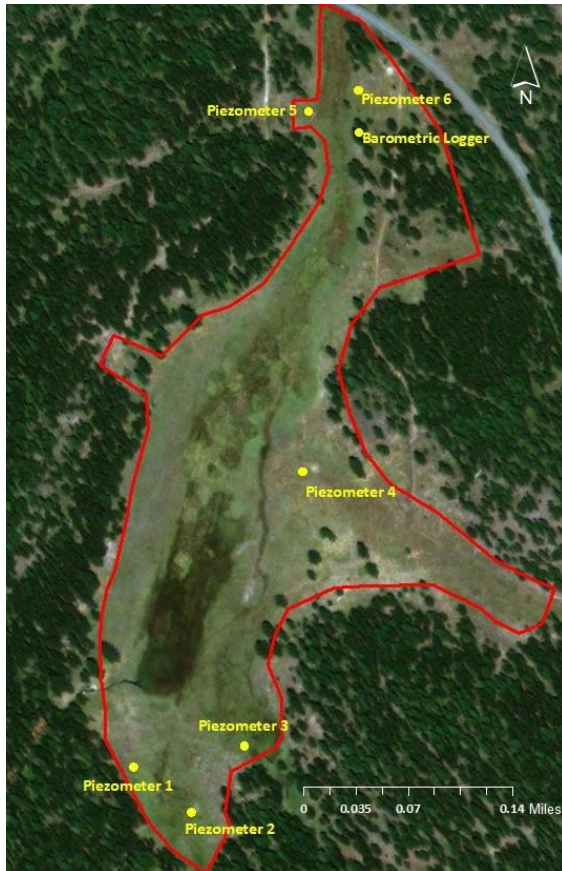
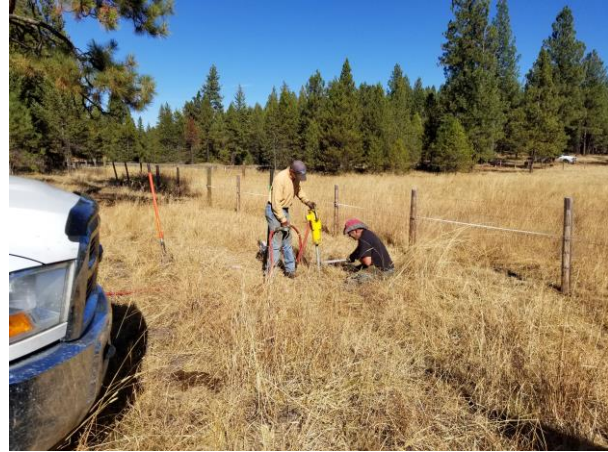
Figure 7. Location of piezometers installed to monitor water levels in Wassen Meadows (left) and piezometer installation using hand held vibrators (above).

Six piezometers (Figure 7) 1.25" in diameter were installed in Wassen Meadows to a depth of approximately 8' between 15 and 19 October of 2018 although several were installed to slightly deeper. Installation depth reflected design expectations and the need to chase water levels if they did not conform to an 8' depth. Hand held vibrators were used to install the piezometers after an initial shallow excavation by mini excavator. Loggers were placed several inches above the bottom of the piezometer. Bulk density of soils were collected at the time of piezometer installation with

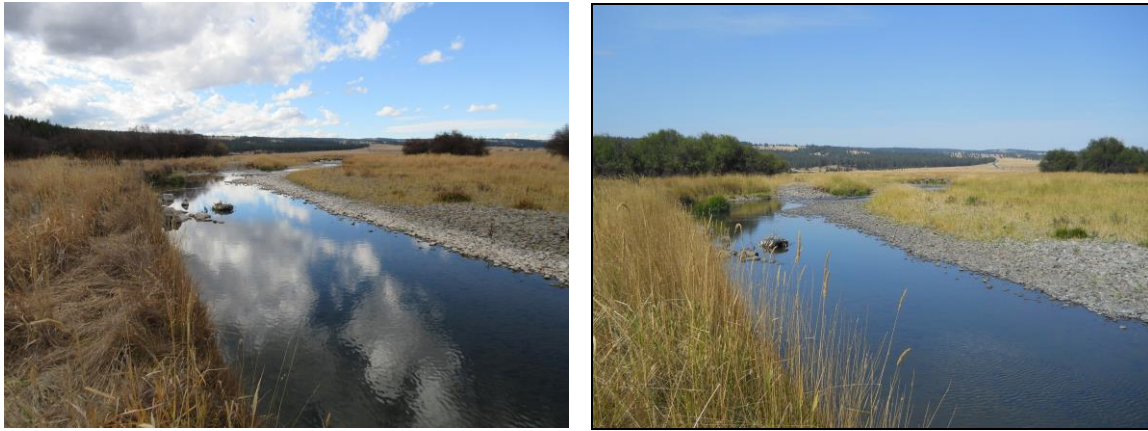
Figure 8. Photo point collected for the Lower Camas Creek site 2007 (right) a year after levee removal looking downstream with the lowest two J-hook structures visible. During 2018 (left) looking downstream from the middle of the reach where the lowest two J-hook structures are visible.

Photo points (Figure 8) continue to show streambank erosion and the isolation of J-hooks placed in 2006 as stream sinuosity increases over time. A larger more comprehensive restoration effort would address process to a significant degree and improve in-stream habitat complexity. Unfortunately, we are unable to supplement previous in-stream efforts due to restrictions imposed by the landowner's CREP contract. Noxious weed control efforts will continue throughout the conservation agreement's term.

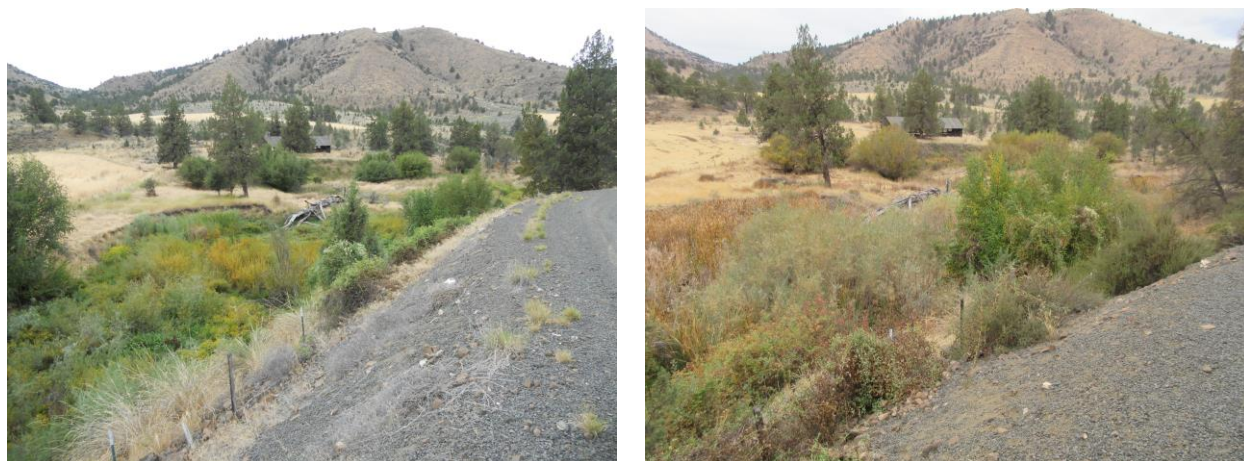
Figure 11. Photo points for the Deer Creek site collected in 2010 (left) and 2016 (right).

Native hardwood vegetative recovery over the conservation agreement's term as suggested by photo points (Figure 11) may in time minimize the influence of air temperatures. Raw streambanks visible in 2004 are now not evident and Deer Creek's floodplain continue to be colonized by cattails (*Typha* genus) and willow (*Salix* genus). Water temperature will likely continue to improve as beaver have re-inhabited the site and continue to develop wetland complexes.

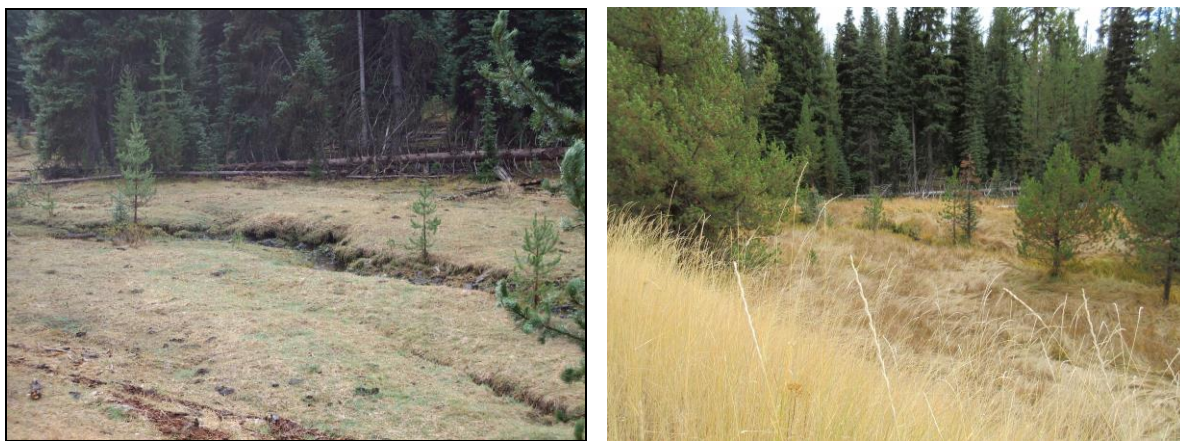
Figure 12. Photo points from 2008 (left) and 2015 (right) collected at the downstream end of the Kelsay Creek site.

Photo point data (Figure 12) suggests that cattle exclusion allowed native vegetation to recover and streambanks are not being disturbed to the level they once were. Elk and deer still have access to the site and likely influence hardwood vegetative recovery to an unknown extent. Plantings will likely repopulate the site in time as they have in the previously constructed downstream enclosure. A useful exercise would be to place wood in Kelsay Creek to improve channel complexity and sediment retention which may occur as part of the UNF's meadow enhancements identified in the Desolation Creek GAAP (WE L).

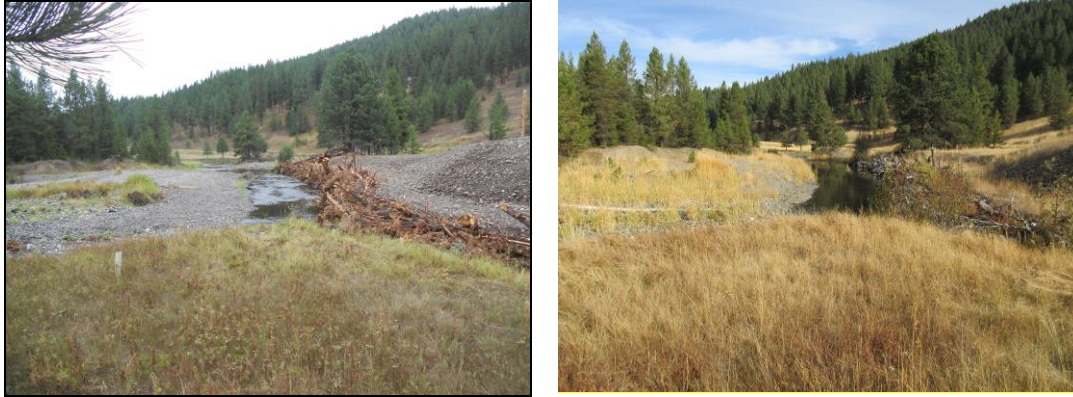
Figure 14. Photo points collected at the Granite Creek site during 2013 (left) and 2016 (right).

During 2013 four large wood structures were developed to protect an existing trailer pad located atop placer mine tailings and create low and high flow channel margin habitat. Thus far the structures have maintained their stability and native vegetation is recovering. Willow cuttings can be seen in the 2016 photo point (Figure 14) along with a naturally occurring mountain alder. A second effort to be implemented in 2020 will improve stream channel and side channel attributes, increase stream channel complexity for aquatic species, increase available side channel habitats, and include a more comprehensive native vegetation component.

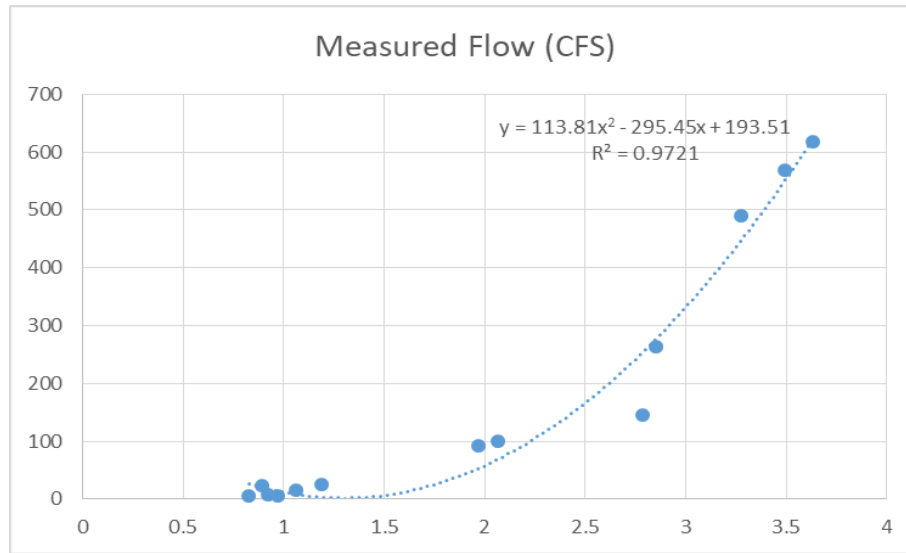
Figure 16. Ratings curve for correlating measured flow with sensor depth for extrapolated flow estimates.

In total, five discharges were collected during this performance period (Table 7). A ratings curve was applied to estimate discharge in correlation with a Hobo Level Logger which was also installed at the site (Figures 16 and 17). Staff will install a staff gauge during 2020 to further enhance data collection and facilitate the development of a ratings curve.

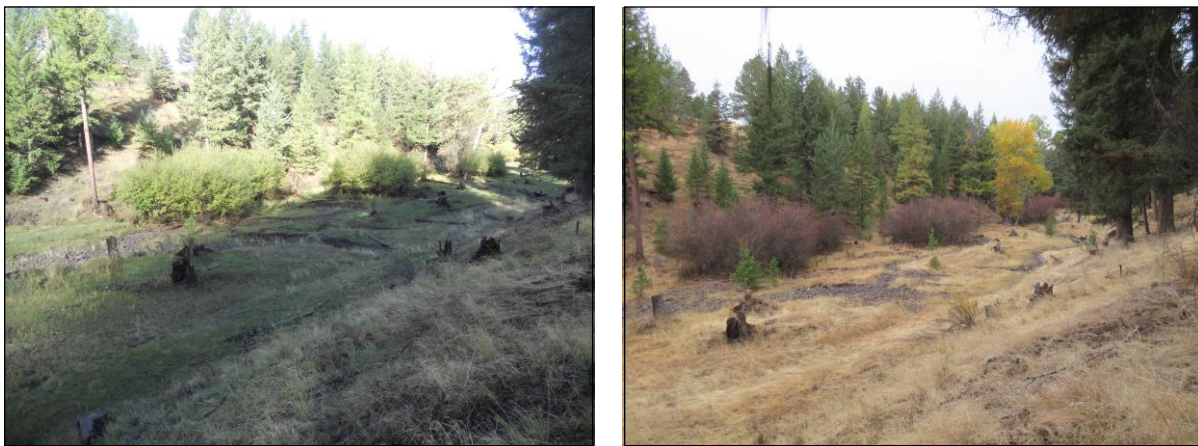
Figure 18. Photo points collected in 2013 (left) and 2018 (right).

Photo points taken at Mud Creek (Figure 18) in 2018 do not suggest significant vegetative recovery within the floodplain. However, given that this site typically is dry throughout the summer save within its lowest extent grass recovery constitutes modest floodplain improvement. Hardwood recovery, while occurring, will be much slower.
