Bull Run Creek RM 0.5 Fish Habitat
Enhancement
15 Percent Basis of Design

Grant County, Oregon

December 13, 2024

15 Percent Basis of Design

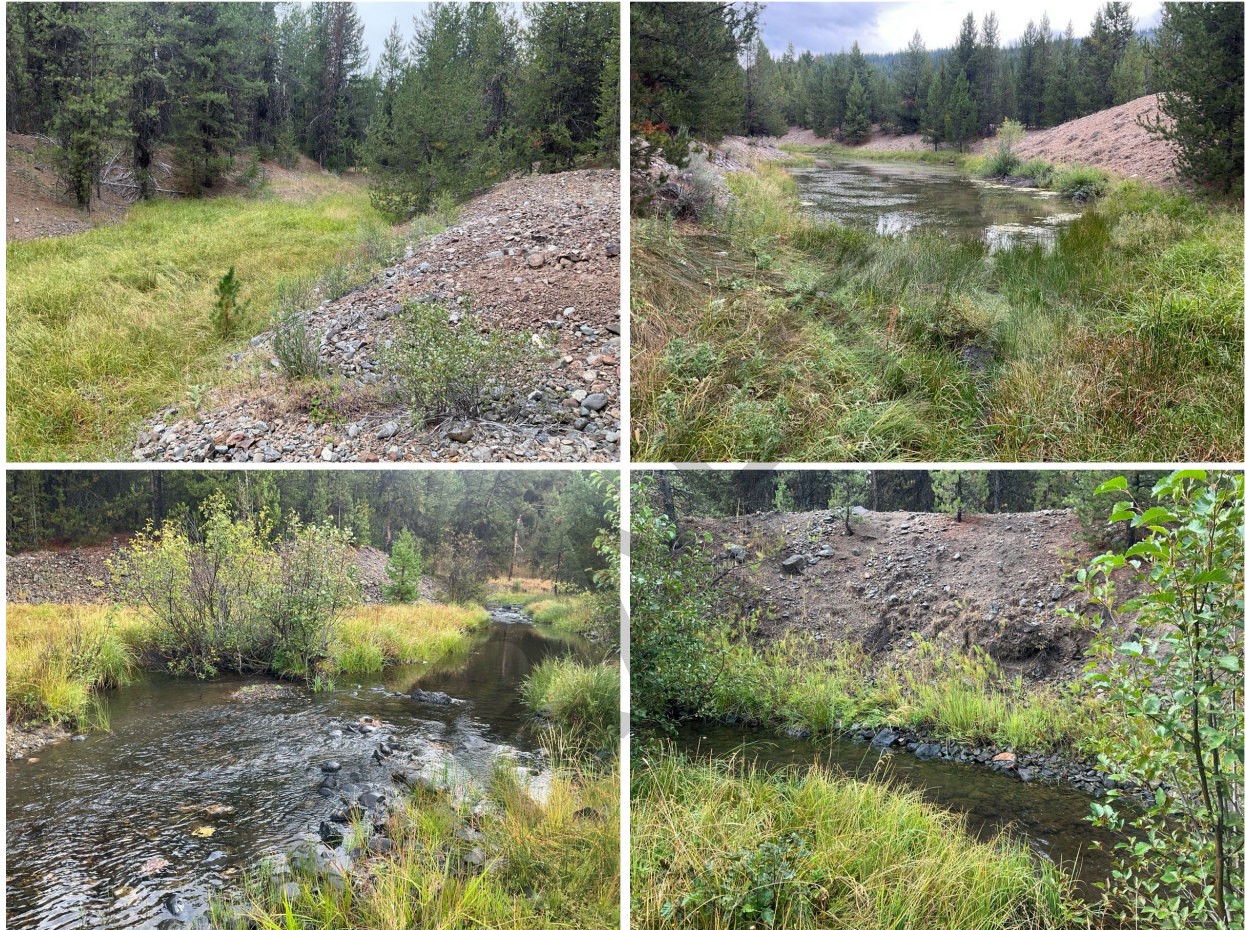
Figure 5. Images of mine tailing piles along Bull Run Creek. The tailings piles confine Bull Run Creek channel and prevent riparian vegetation establishment throughout the valley bottom, limiting much of the riparian vegetation to grass and forbs species.

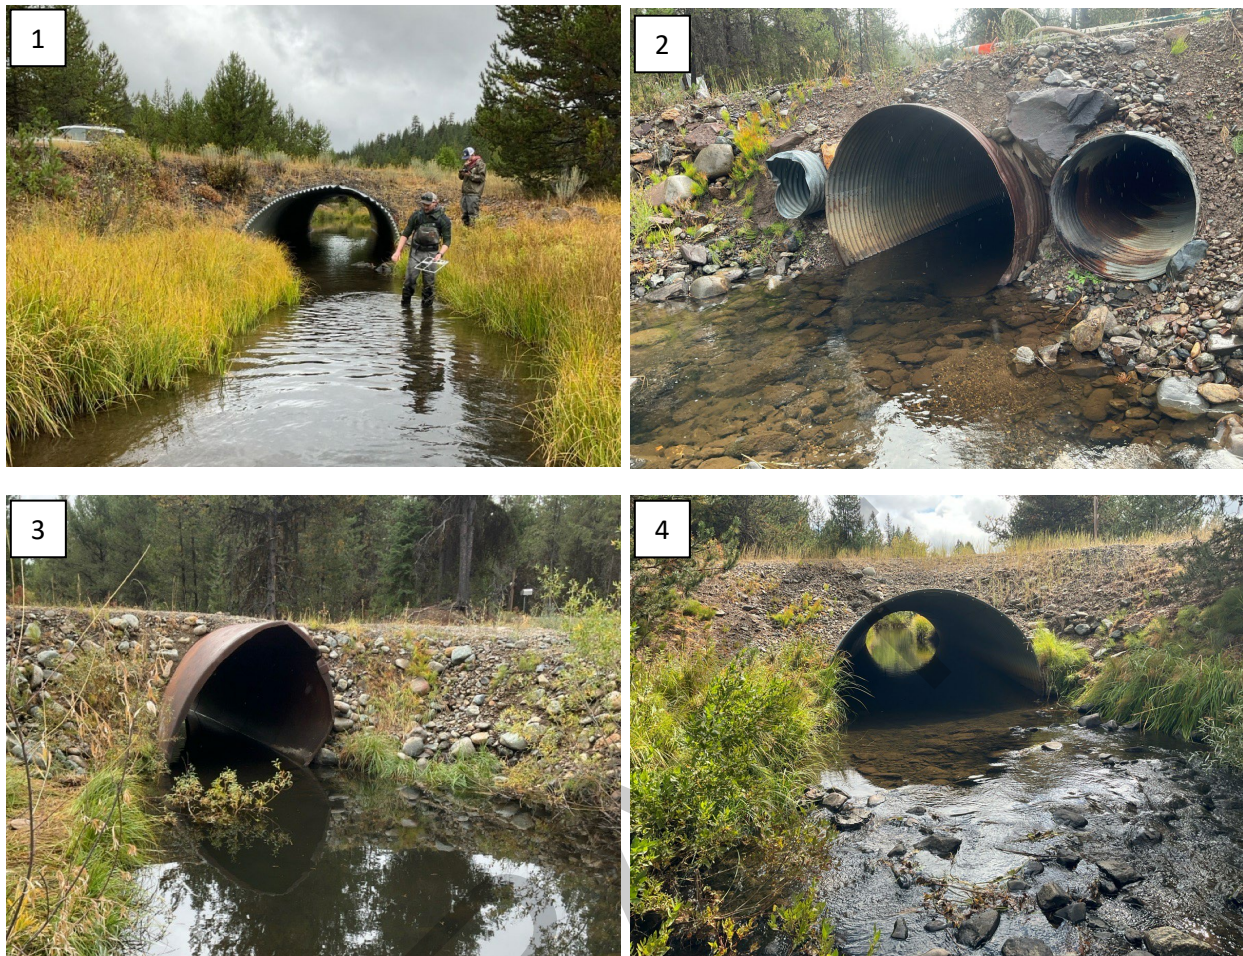
Figure 7. Images of culverts located along Bull Run Creek project area (1 through 4).

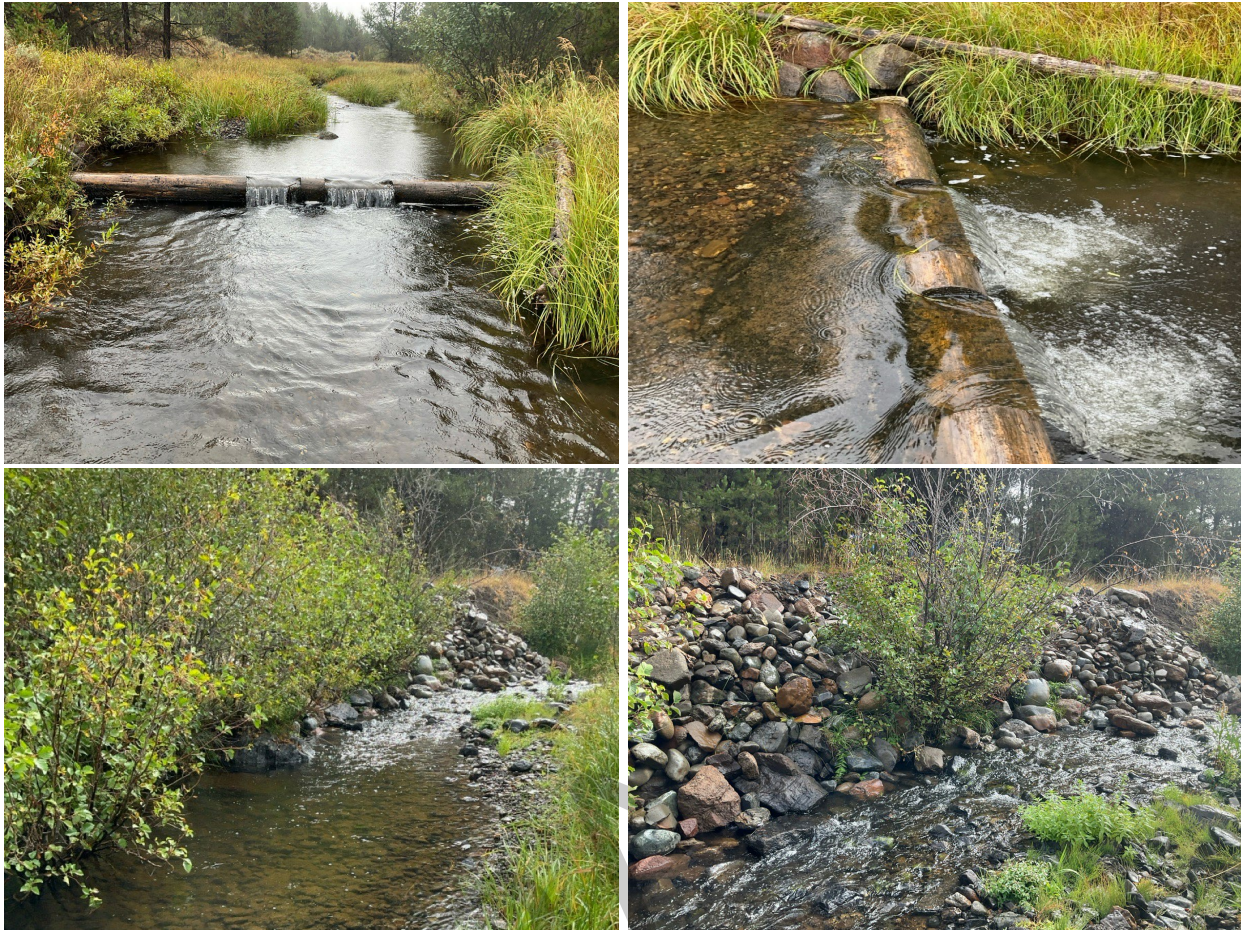
Figure 8. Images of placed wood and an armored bank located on Bull Run Creek.

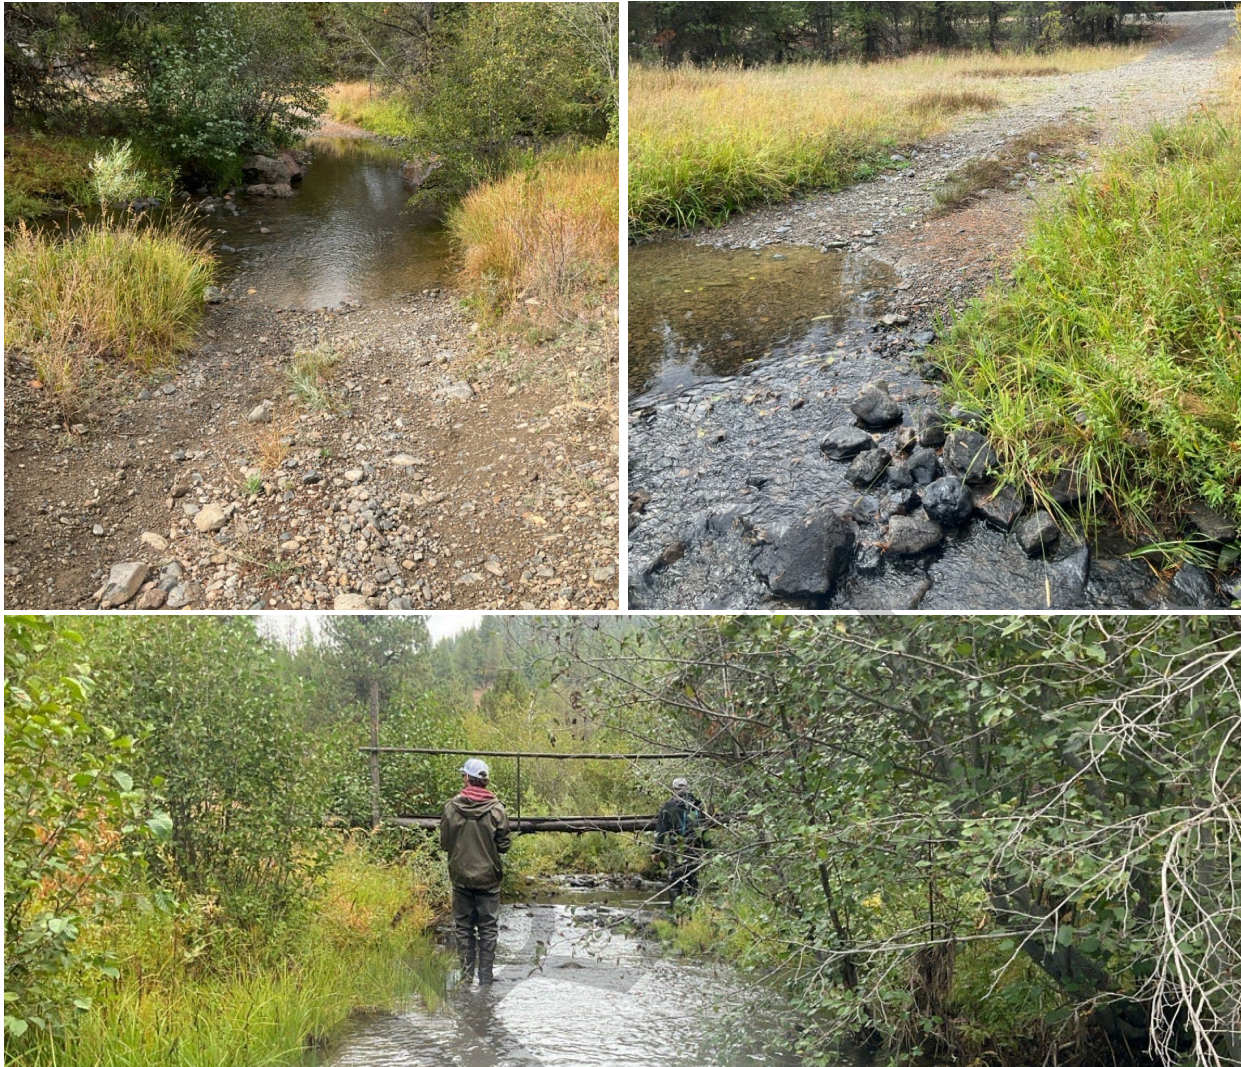
Figure 9. Images of a ford crossing and walking bridge located on Bull Run Creek.

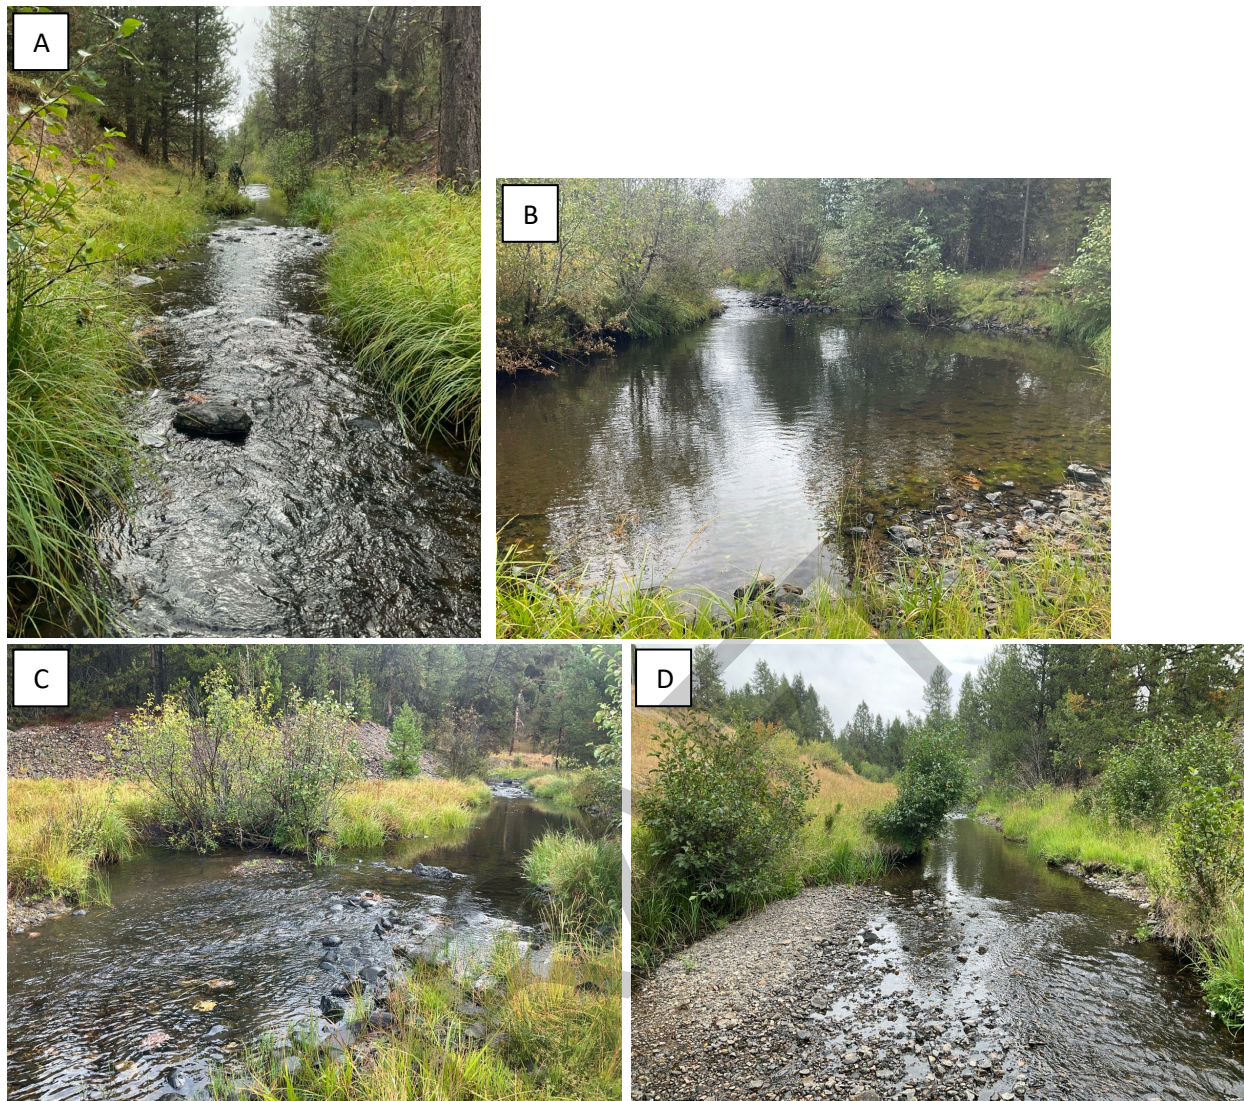
Figure 12. Photos showing available habitat along Bull Run Creek project area, including riffle-pool complexes (A), deeper pools along meander bends (B), small backchannels (C), and small gravel bars (D).

The simplified-straightened channel of Bull Run Creek has evident effects on the in-channel habitat (Figure 12 and Figure 13). Most of Bull Run Creek consists of shallow riffle-pool complexes comprised of gravel and cobble substrate. There are a few meander bends throughout the reach where the stream was able to create deeper scour pools with simplified morphologies and limited fish cover. Although there were a few small backchannels, gravel bars and vegetated islands that created quality habitat, they were rare due to the channel's confinement by the mine tailings.

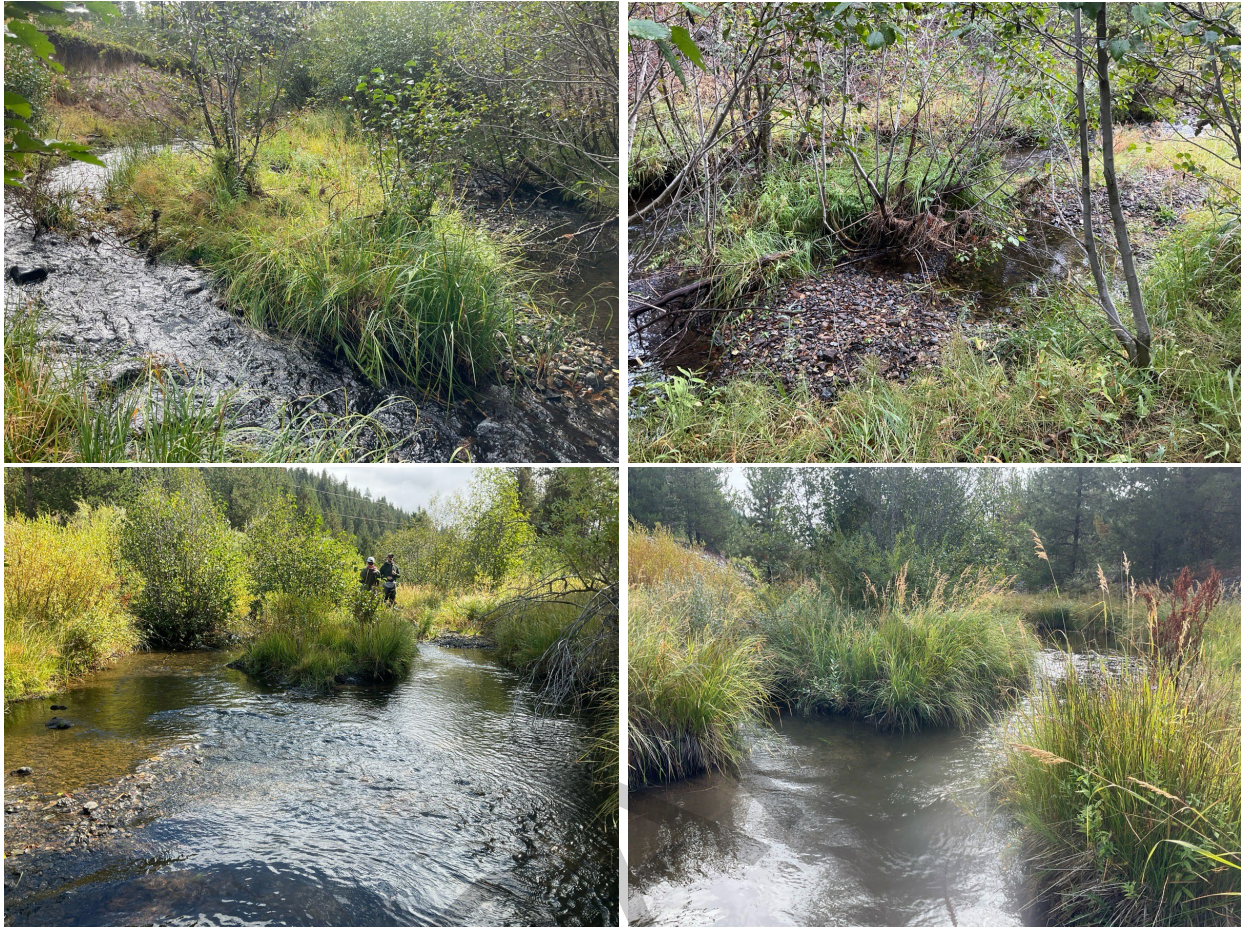
Figure 13. Example of vegetated gravel bars that create split flow channels on Bull Run Creek.

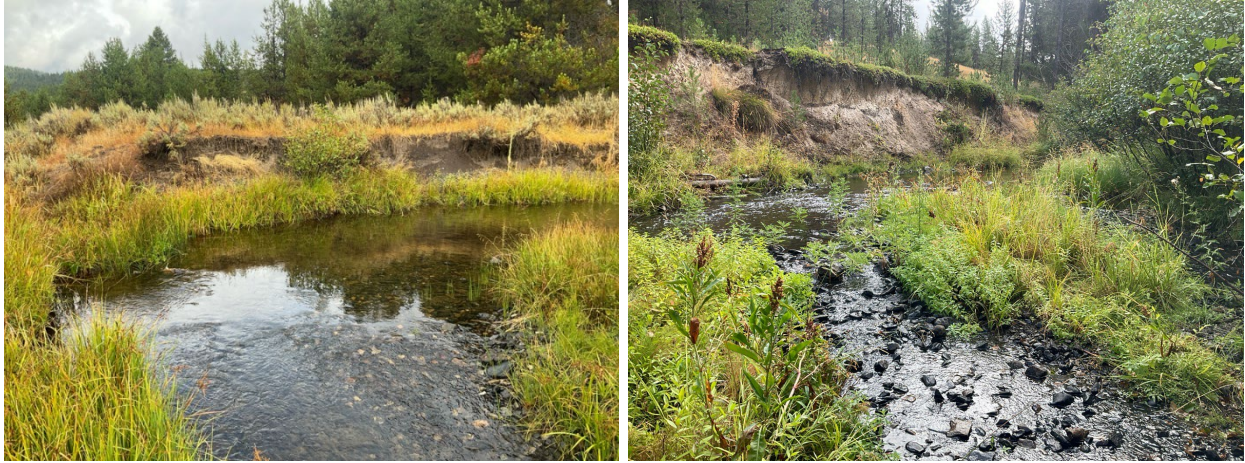
Figure 15. Example of eroding banks leading into relict floodplain deposits and ancient terraces on Bull Run Creek that are greater than 4 ft in height.

There are various levels of horizontal erosion occurring along Bull Run Creek in the project area (Figure 11 through Figure 17). Some sections have cutbanks that were less than 1 foot in height occurring along the meadow habitats and along low-lying floodplain habitat. There were sections of the creek that were eroding into mine tailings piles that were between 1 and 3 ft in height. There were also sections where the creek was eroding into terraces creating cutbanks in excess of 4 ft in height.

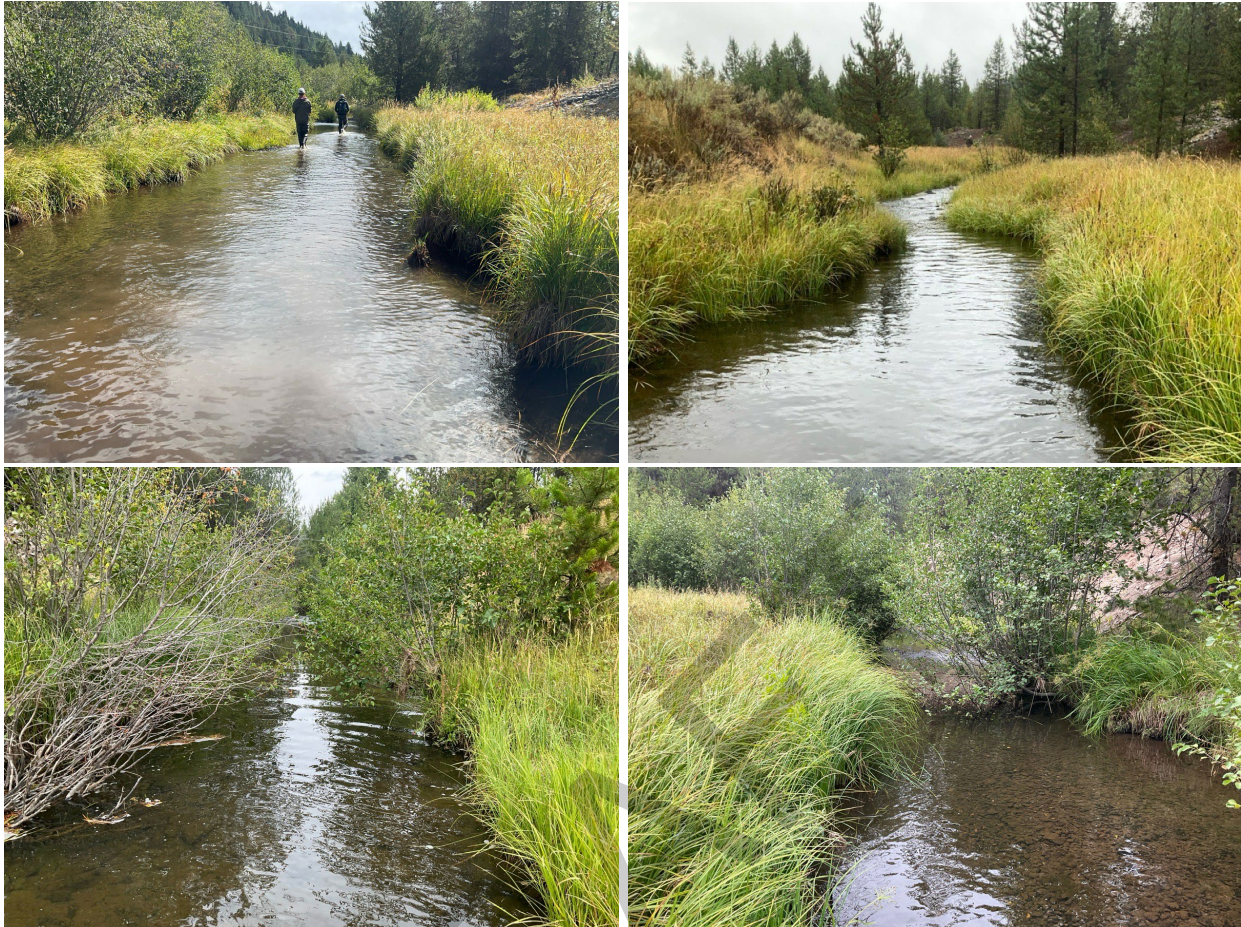
Figure 16. Example of stream structure, cover and shading along Bull Run Creek.

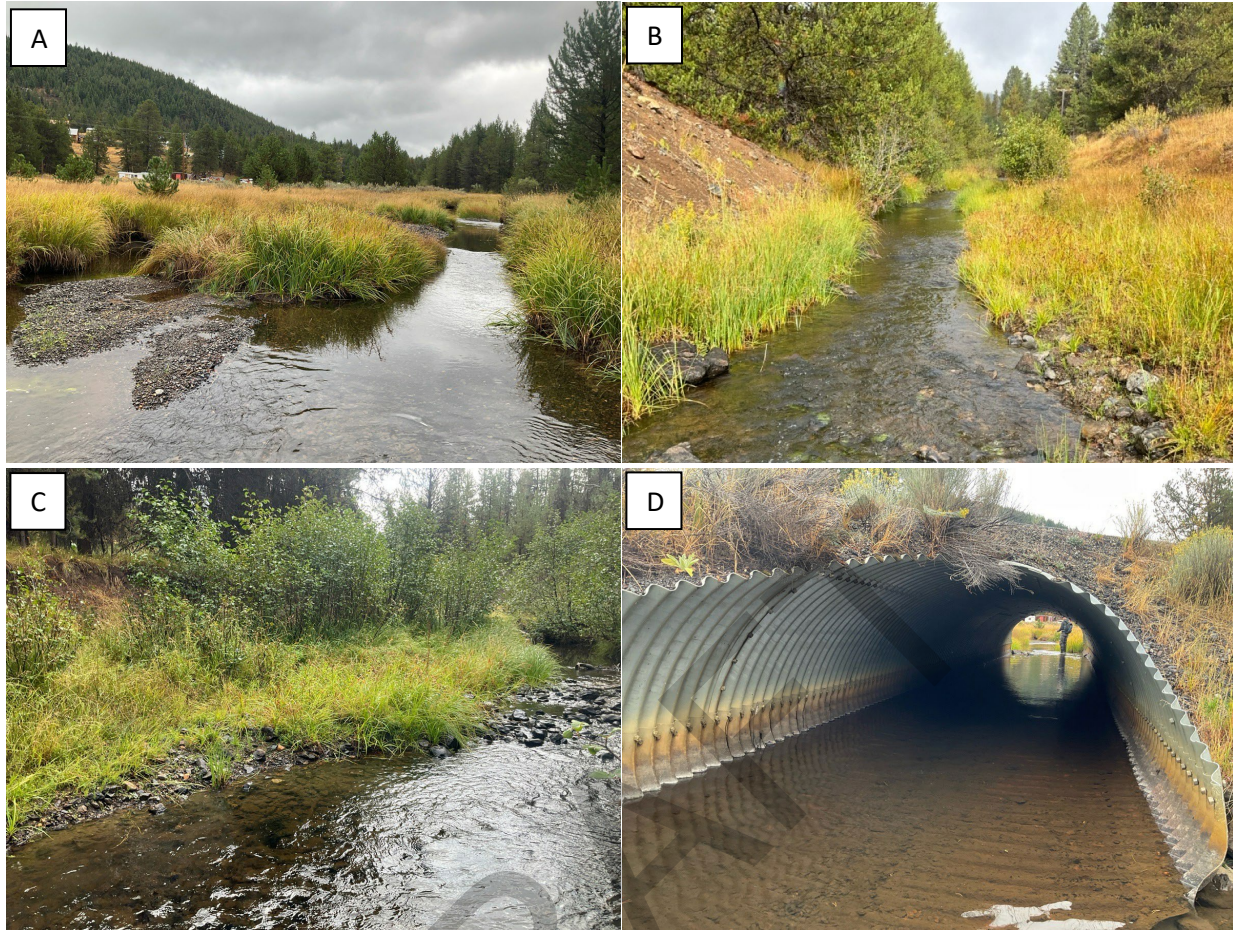
Figure 17. Examples of meadow habitat (A), confined reach (B), small floodplain pocket (C) and confining infrastructure (D) along Bull Run Creek project area.

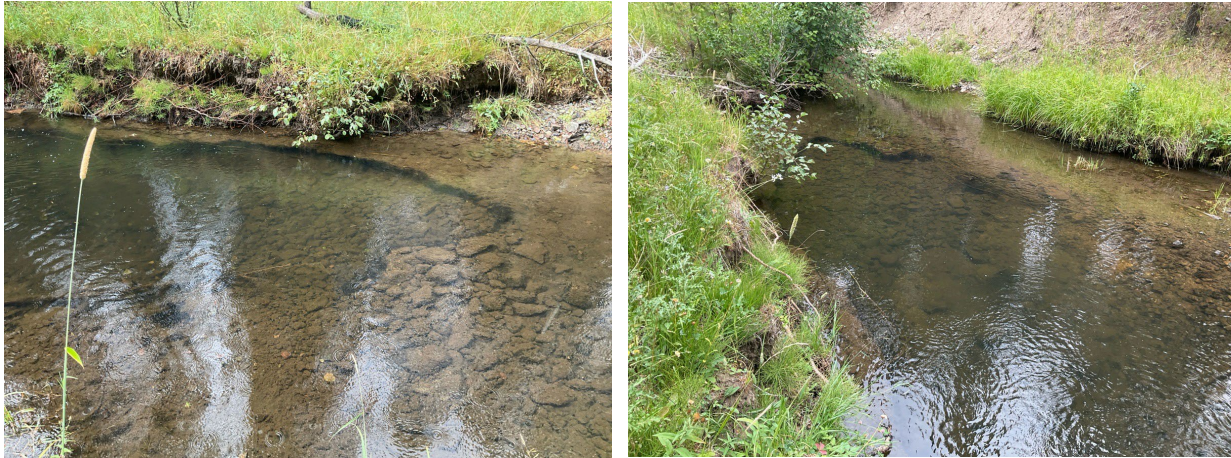
Figure 25. Exposed alluvial base on Bull Run Creek.

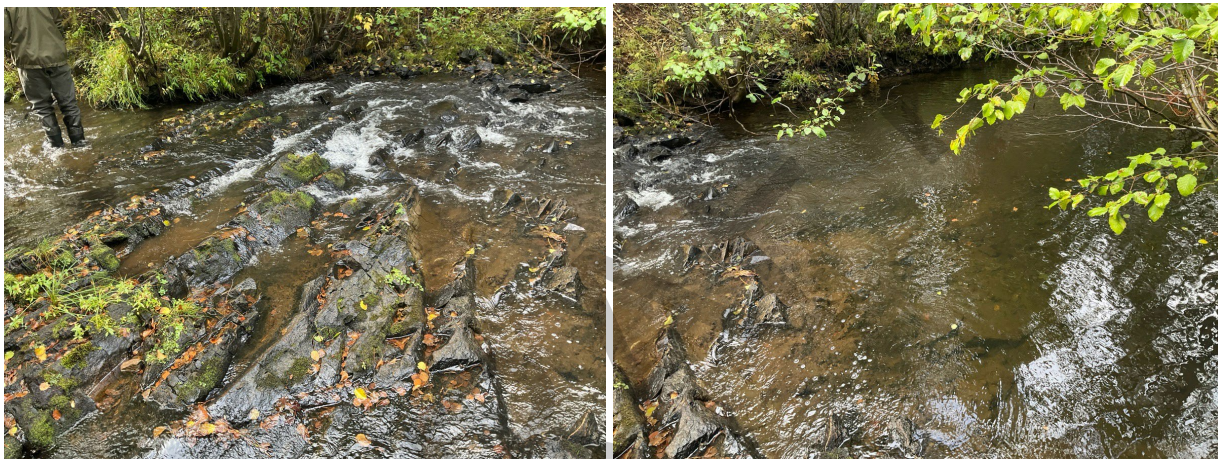
Figure 26. Bedrock dominated reach of Bull Run Creek.
