**NORTH FORK JOHN DAY RIVER BASIN ANADROMOUS FISH HABITAT
ENHANCEMENT PROJECT**

Annual Report for April 2010 – January 2011

Project No. 2000-031-00

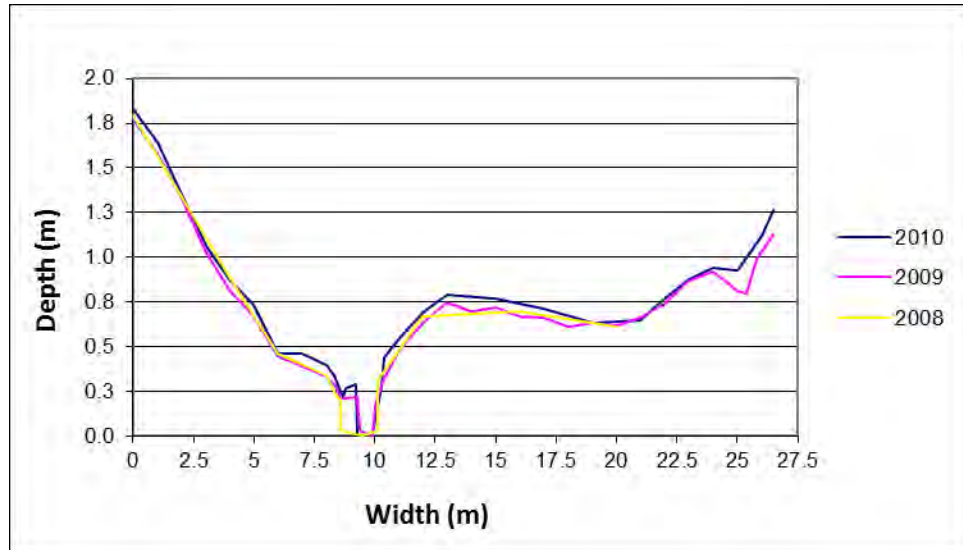
A single cross-section with associated vegetation and longitudinal data was selected to represent the upper reach on the property. Figure V indicates the channel has maintained the same general form from 2008 through 2010 with the exception of differences due to different sampling points. Predetermined distances along the cross-section are not identified for any of

our cross-sections; instead, data points reflect on-site topography which may lead to differences between individual years. Additionally, the disparity between the 2008 channel width and 2009/10 cannot be explained unless the difference lies in a slightly different location. During 2009 pins were placed at both ends of the cross-sections to reduce potential discrepancies between years.

Figure V. Cross-section selected for the Upper Snipe Creek project reach.

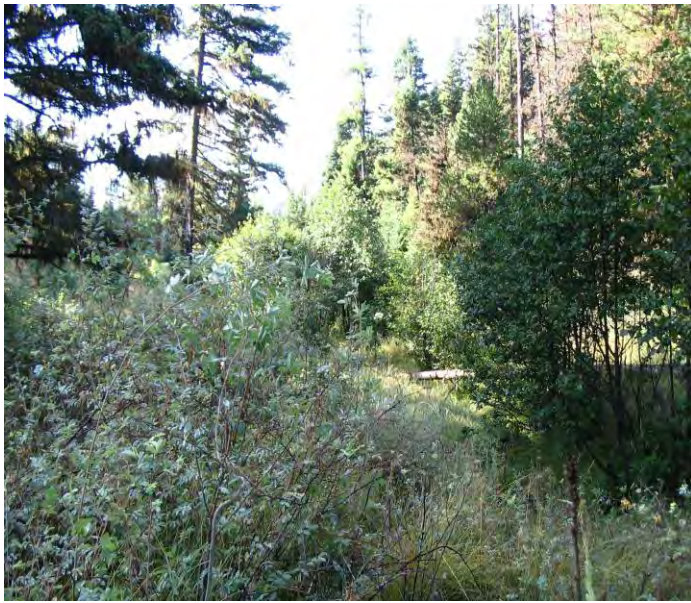
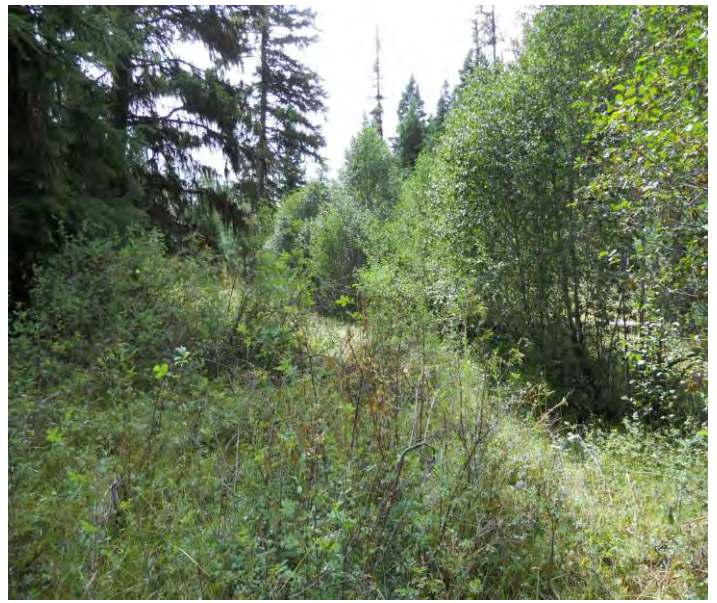
Figure VI. Photopoints taken in 2004 (left) and 2010 (right) at the lower end of cross-section I.

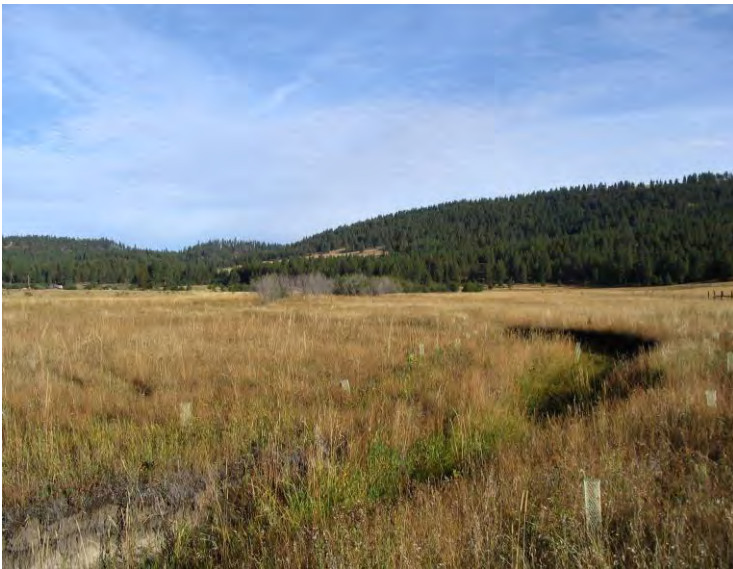
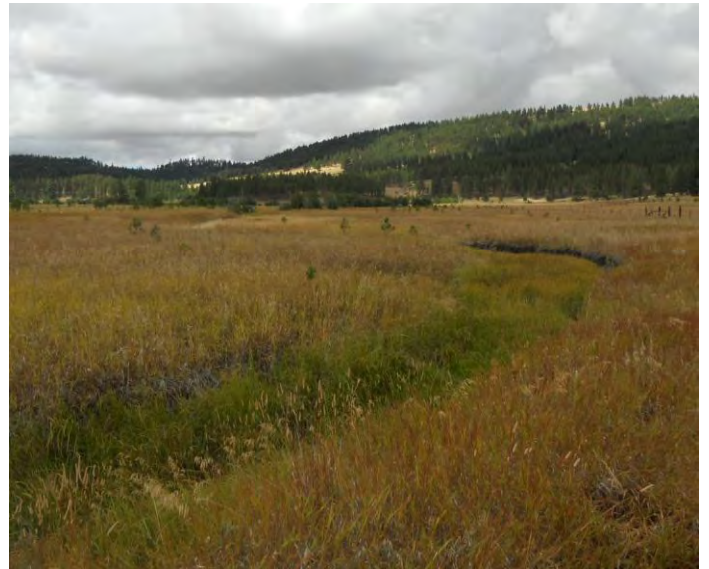
Figure IX. Photopoints on Lower Snipe Creek taken in 2004 (left) and 2010 (right) looking upstream from the middle of the reach looking upstream (north).

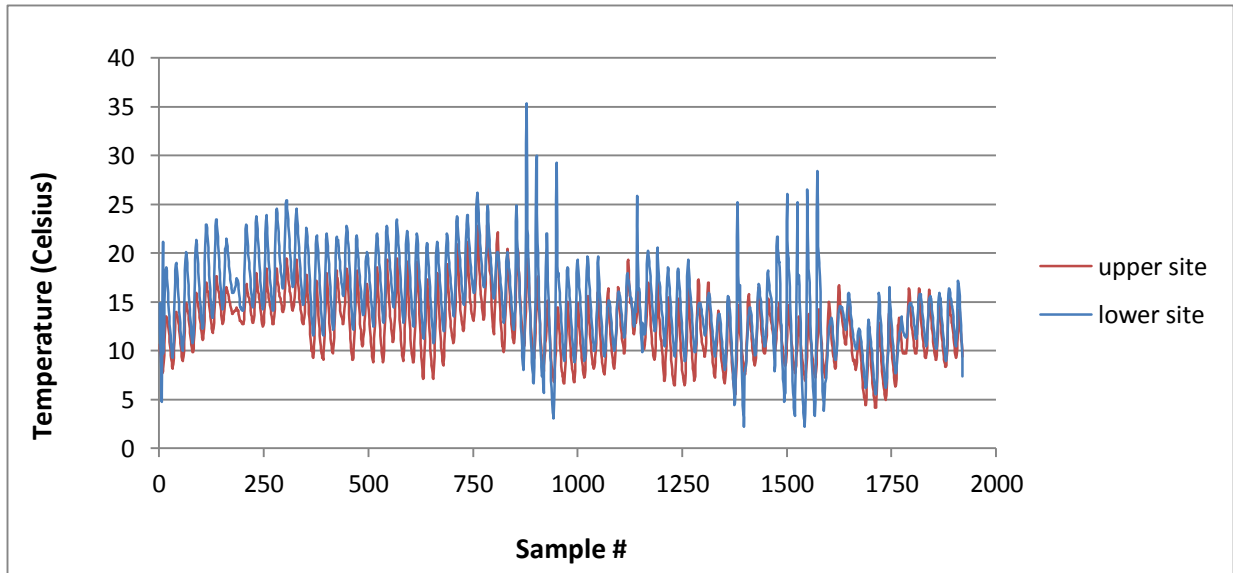
The signals character shown in Figure X confirmed by a Paired 'T' tests (α 0.05) suggests there is a difference in the mean values of data collected at the upper and lower boundaries of the lower project site for both 2006 and 2010. Descriptive statistics support the appearance of higher mean temperatures, wider data ranges, and greater variance in the lower sites (Table IX). Unfortunately this is contrary to attempts to improve site stability and channel characteristics along with water quality. Stream temperatures do however maintain mean temperatures at or close to those for both Bull and Steelhead trout and with adequate streamflows may provide refuge from higher temperatures in Camas Creek.

Figure X. Stream temperature data collected on Snipe Creek on the Lower project site from 22 June 2006 through 9 September 2006 (top) at one hour intervals and 22 June 2010 through 9 September 2010 (bottom) at one hour intervals. Note disturbances in the temperature signal in both graphs such as points 1394 – 2679 in the bottom graph.

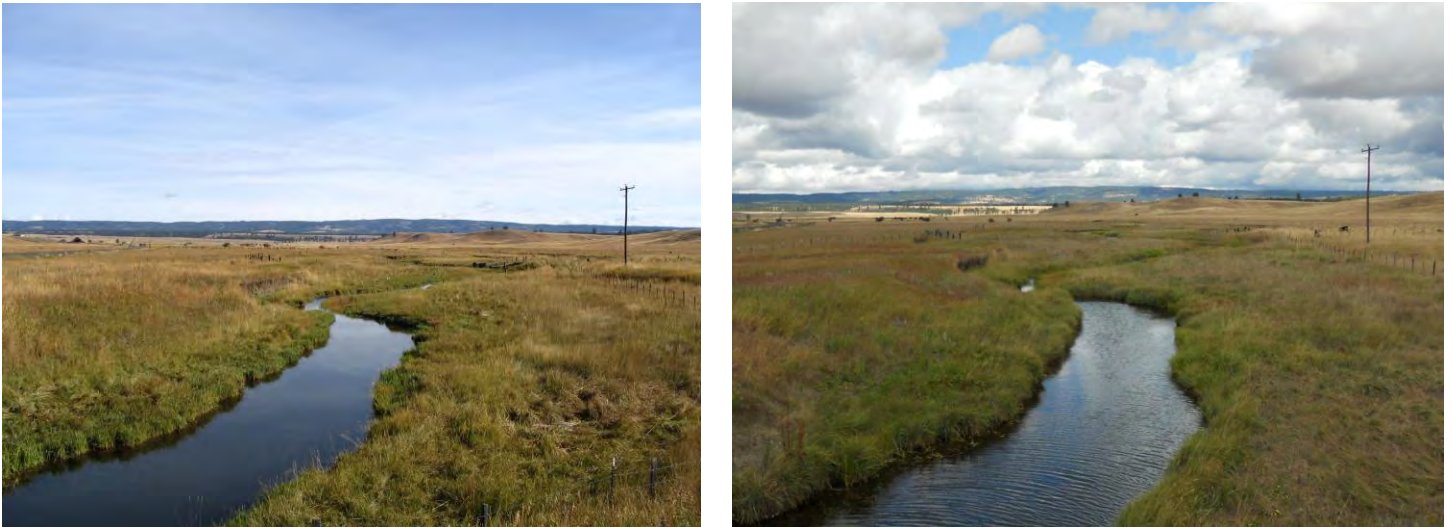
Figure XII. Photopoints taken in 2004 (left) and 2010 (right) from SR 244 looking upstream. Note the cut-bank present in both photographs.

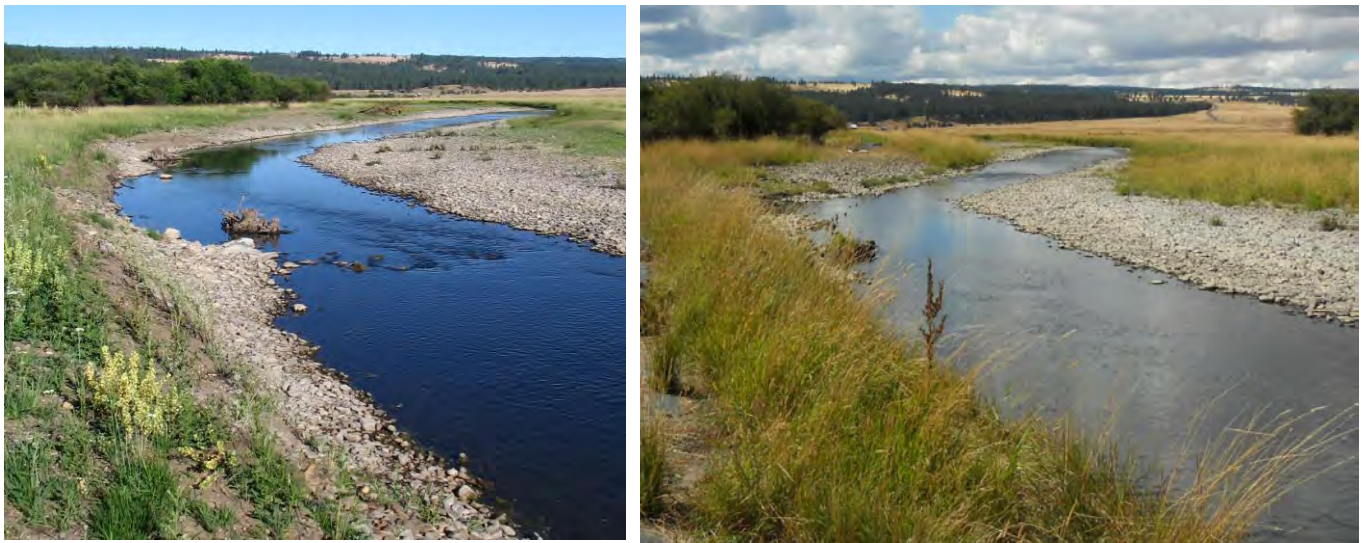
Figure XV. Photopoints collected for the Camas Creek site from 2007 (left) and 2010 (right). Photographs were taken mid-way through the levee removal area looking down stream (west).

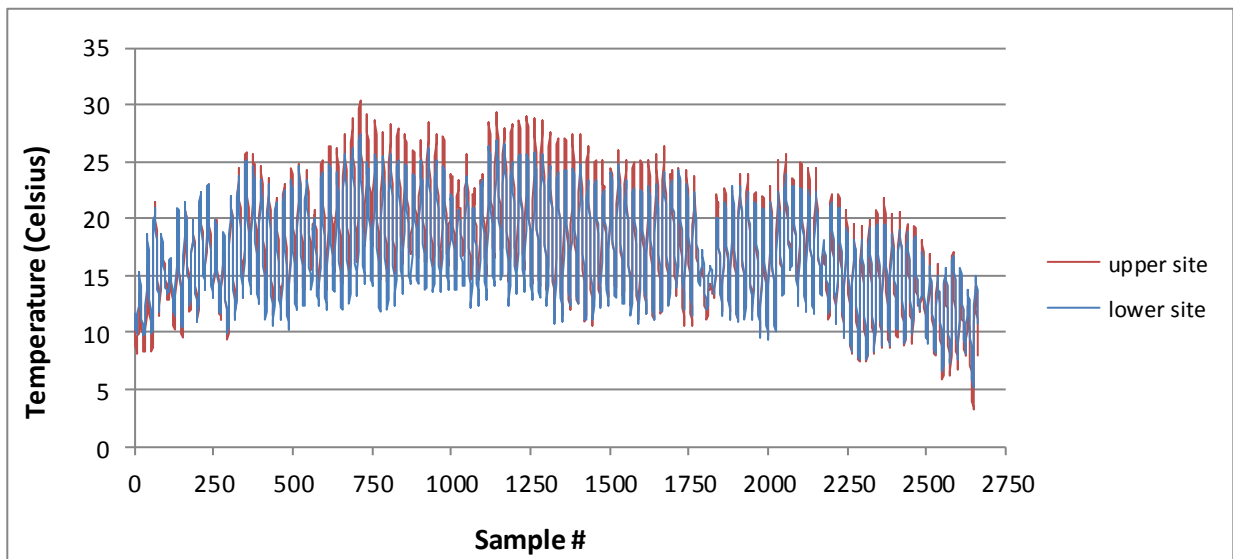
Figure XVI. Stream temperature data collected on Camas Creek from 6 June 2006 through 24 September 2006 (top) at one hour intervals and 6 June 2010 through 24 September 2010 (bottom) at one hour intervals.

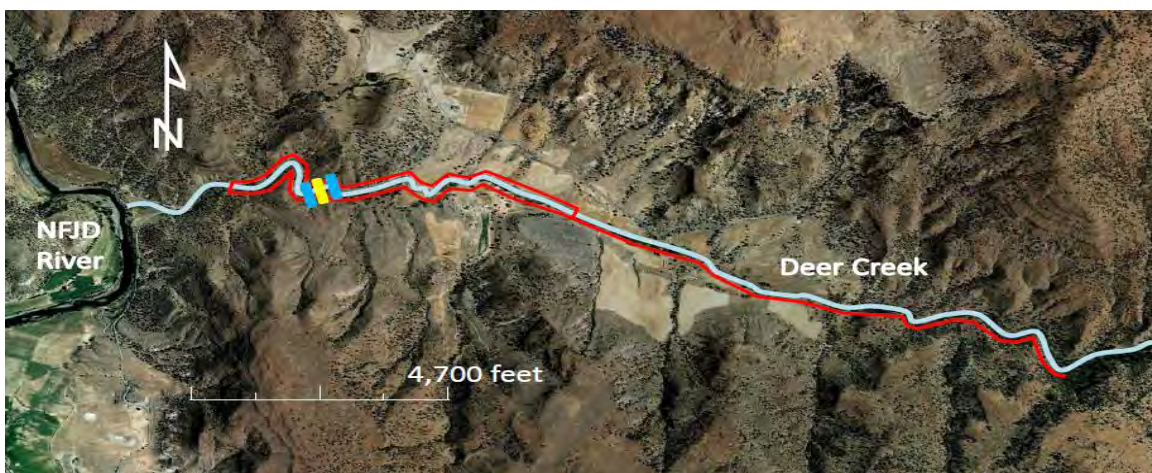
Figure XVII. The monitored portion of the Deer Creek Project site in red showing the approximate location of cross-sections in blue and water gaps in yellow noted in the report's body.

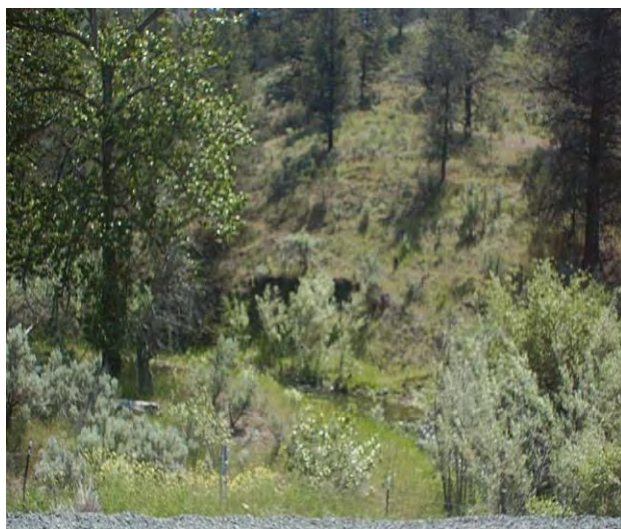
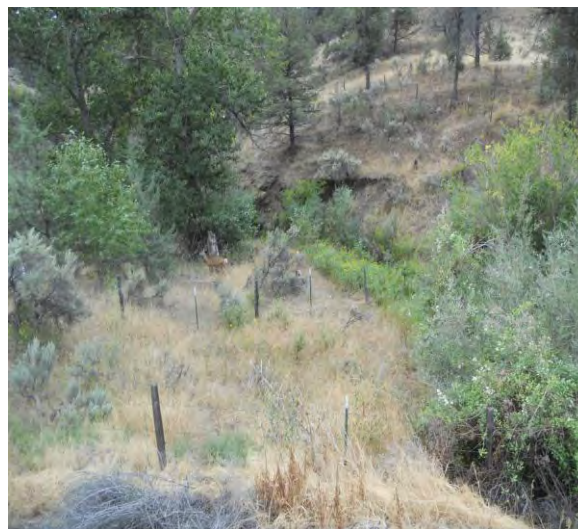
Figure XIX. Photopoints collected for the Deer Creek site during 2003 (left) and 2010 (right).

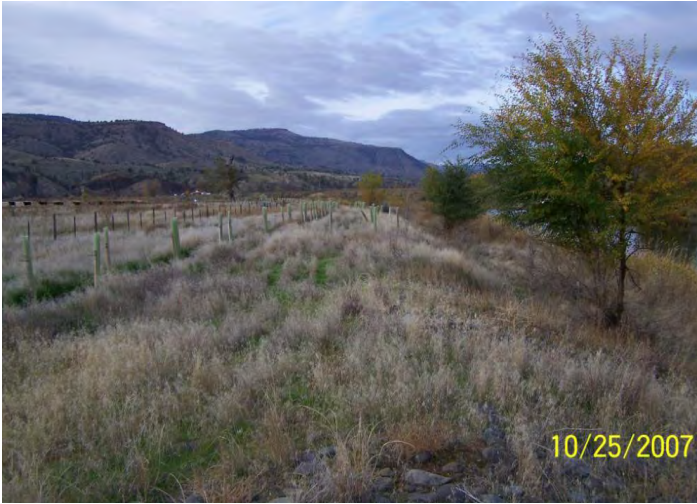
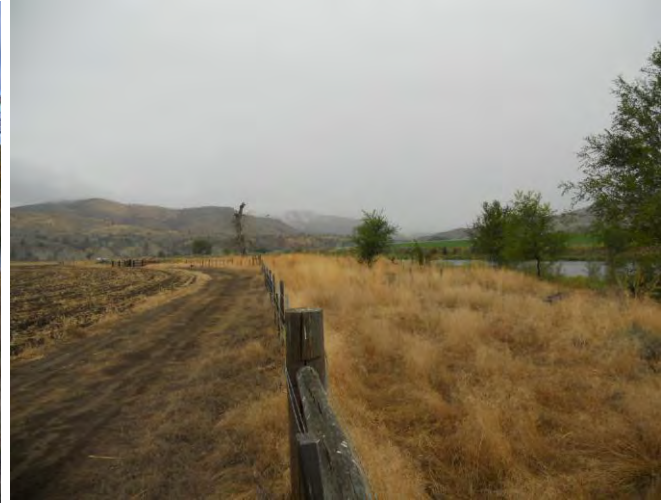
Figure XXII. Photographs taken of the implementation site in 2007 (left) and 2010 (right).
