**NORTH FORK JOHN DAY RIVER BASIN ANADROMOUS FISH HABITAT
ENHANCEMENT PROJECT**

Annual Report for February 2011 – January 2012

Project No. 2000-031-00

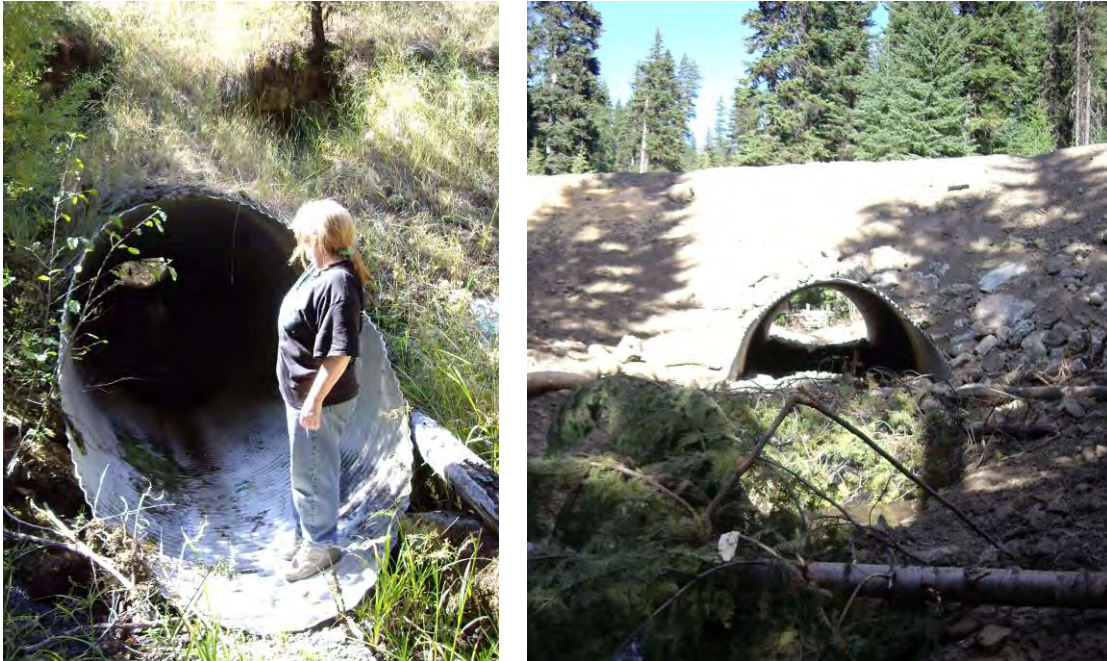
Over the past three years the road prism about the Bruin Creek culvert (Figure IV) had been eroding causing the old culvert to split at the first upstream seam. During spring runoff the culvert plugged resulting in a significant loss of prism material; fortunately,

implementation had been planned for 2011. Increased estimated costs resulted in diverting funding from the Sponge Creek culvert replacement to this one which was taken care of in early 2011. Implementation began and ended within the in-stream work window resulting in a smaller road prism in part due to the loss of eroded material. There were no complications or cost overruns and cost share included \$17,000 (UNF) and \$82,086 (NFJWC/Ecotrust Grant Funding) (\$99,086 (CTUIR)). The UNF secured and administered a contract for this effort, the NFJWC provided funding though and EcoTrust Grant, and CTUIR provided funds for implementation.

Figure IV. The Bruin Creek culvert before (left) and after (right) replacement. Note erosion above and around the old culvert and streamflows entering the culvert at the first seam.

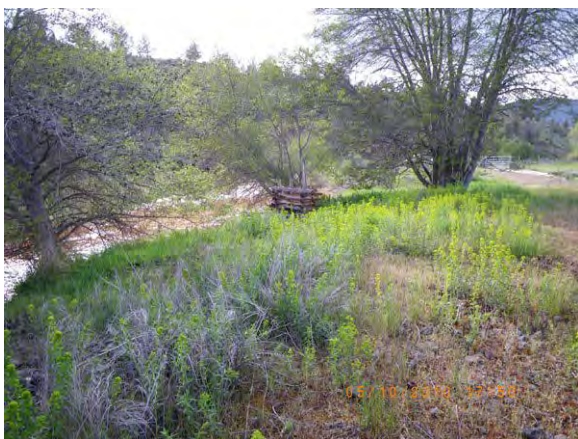
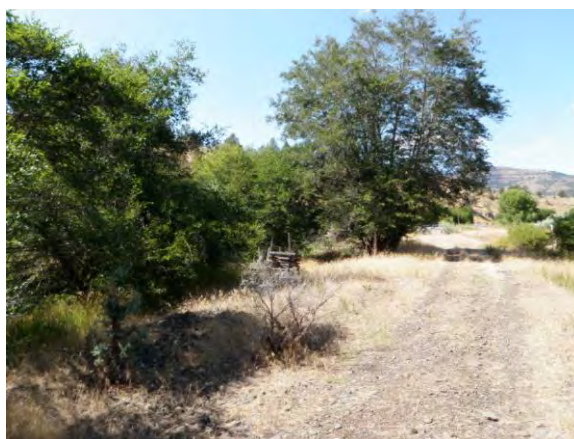
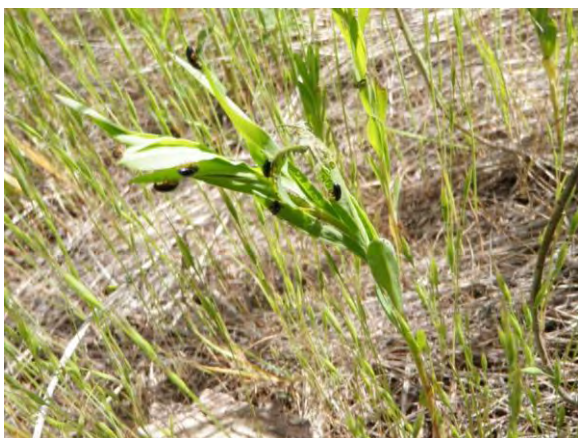
During 2011 targeted areas along 41 miles of Fox Creek were mapped. These efforts indicated that leafy spurge remained widely distributed in the areas where targeted mapping was conducted. The 2011 survey suggested that infestations are likely due to remote sites infestations and not a lack of treatment efficacy as 2010 herbicide treatments showed substantial improvement (Figure V). A total of 59 acres were treated with herbicides. Funding for this effort included \$4,660 from the NFJWC and \$14,065 from CTUIR. The NFJWC secured and administered a contract with a certified sprayer and CTUIR provided funding for labor.

Figure V. Treated area in 2010 (upper left), the same area during 2011 (upper right), and successful biological controls from 2010 noted in 2012 (lower left).

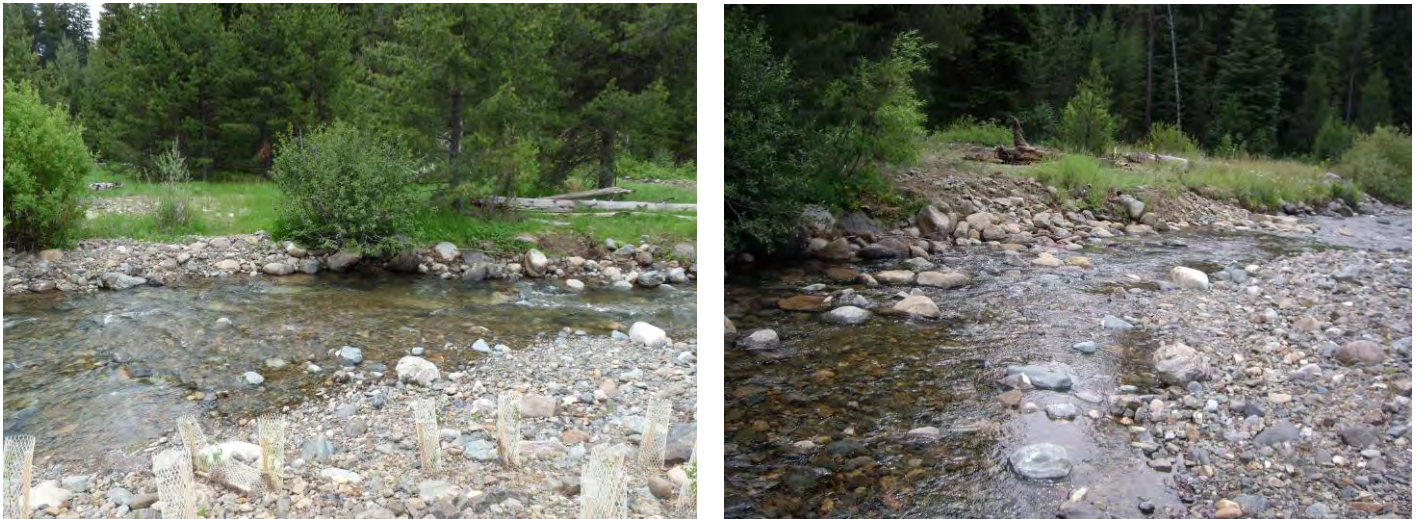
The 2010 effort to return late summer flows to Beaver creeks channel was successful although scour in one location needed attention in 2011 to provide for long term stability. While most of the stream channel stabilized during high flows scour along a meander bend exposed a small portion of the Bentonite blanket used to prevent flows from leaving the channel through the substrate. In cooperation with the contractor who completed the 2010 effort and a local resident with appropriate equipment larger rock was placed to protect the streambank and create localized turbulence to decrease water velocities (Figure VI). The treatment proved effective in 2012 and CTUIR will continue to monitor site stability.

Figure VI. Scoured streambank in June of 2011 (left) and larger material placed during August of 2011 (right).
