**NORTH FORK JOHN DAY RIVER BASIN ANADROMOUS FISH HABITAT  
ENHANCEMENT PROJECT**

**Annual Report for February 2014 – January 2015**

Project No. 2000-031-00

Contract Number 64736

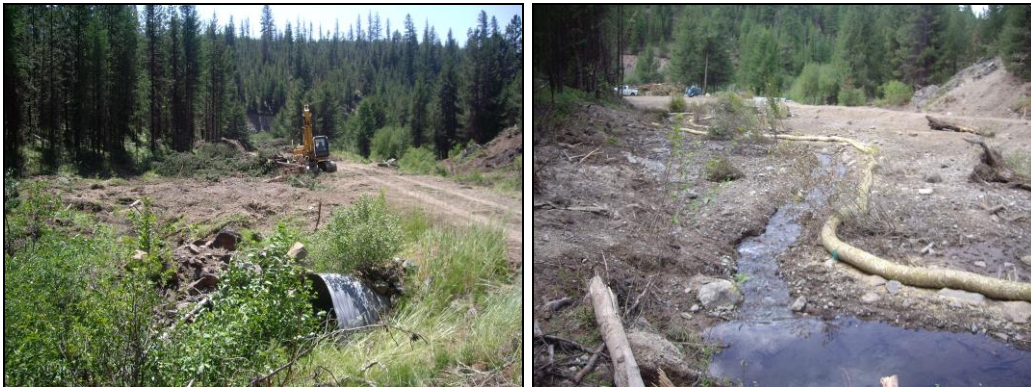
Figure 5. Photographs of the Deep Creek culvert looking downstream before replacement (left) and after replacement (right). Note the ‘after’ photograph was taken from where the old culvert was located showing the meanders created and the new Deep Creek Culverts relative location (60 meters downstream of the old culvert).

This Work Element replaced two culverts (Figure 5 & 6) creating partial barriers with pre-cast concrete bridges in Deep Creek and Bull Run Creek through a cooperative effort in cooperation with the Wallowa-Whitman National Forest and the NFJWC. This action returned access to approximately 10 miles of stream channel for all life stages of steelhead and bull trout. Additionally, U.S.F.S. Rd 7370 was realigned to eliminate two 90 degree turns in Deep Creek where the culvert passed flows under the road and allowed for the reestablishment of several stream meanders in Deep Creek while eliminating the potential for erosion of the road prism. These actions used natural channel design practices and will effectively pass sediment and debris during high flows. The engineer’s estimate (\$450,000) for these replacements was accurate and all funds allocated for this effort by The Project were spent.

These culverts were identified in the Wallowa-Whitman National Forest’s Bull Run Creek Action Plan (USFS, 2012) and follows a previous culvert replacement by the cooperators in 2013 on Bull Run Creek and has been deemed successful, an effective use of resources, and will provide a long term benefit to aquatic species while reducing infrastructure maintenance costs. Native planting which haven’t survived being replanted will be supplemented with plantings by the Wallowa-Whitman National Forest. Other restoration actions completed in the Bull Run Creek subbasin will be implemented in 2015 and consecutive years.

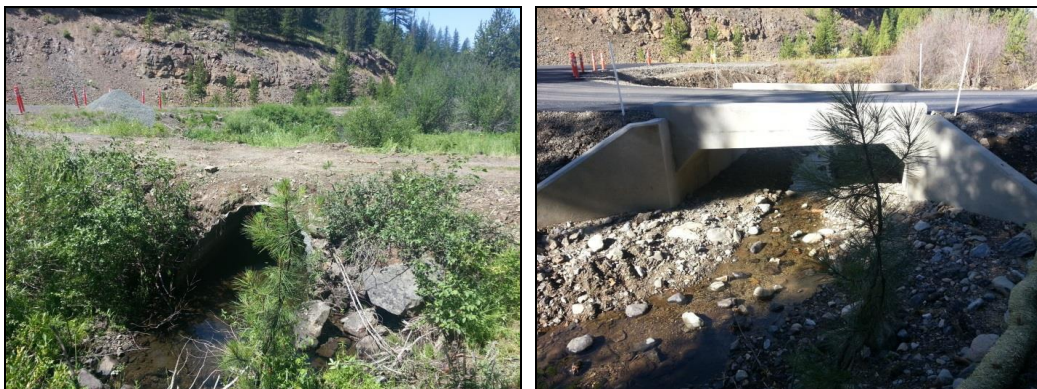
Figure 6. The Bull Run Culvert before replacement (left) and after replacement (right).

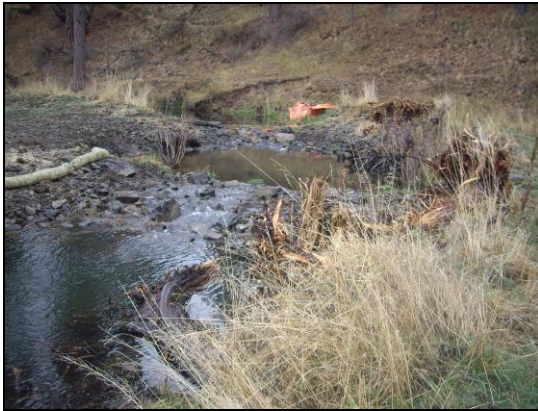
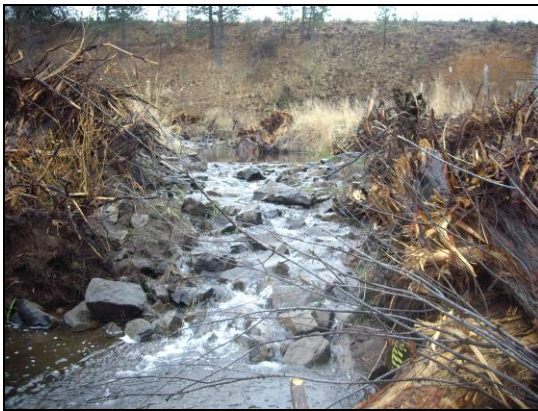
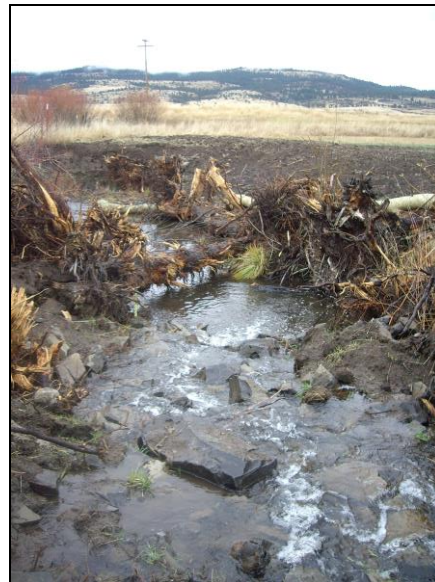
Figure 7. Finished top and middle structures (top left), bottom structure looking upstream (bottom left) and bottom structure looking upstream (below).

A considerable amount of time by the NFJDCW, BPA, permitting entities, and The Project was spent in early 2014 to identify a suitable approach to treat concerns rising from the 2013 implementation effort. Concerns included drop heights greater than six inches across rock structures and bank cutting around the upper most of three structures. In the end BPA, the NFJDCW, and The Project improved three rock structures through the incorporation of 30 junipers and 30 yards of rock (Figure 7). As a result of these actions the landowner has noticed improved hay production in an adjacent field.

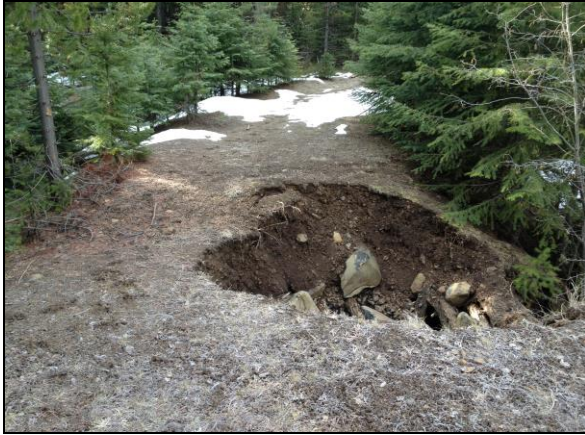
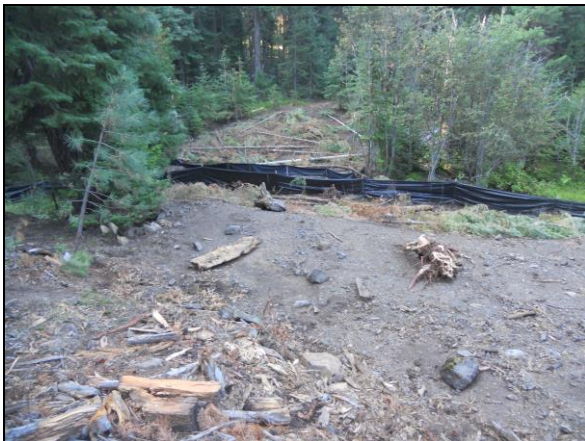
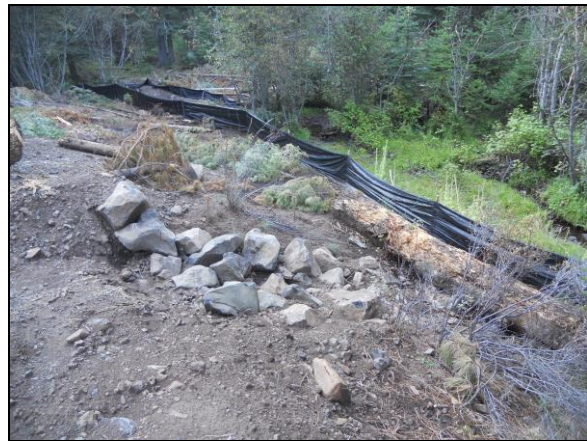
Figure 8. Little Indian Creek culvert looking across the stream from river right before removal (top), after removal (middle and bottom). Rocks in the lower right of the bottom picture were placed to prevent excessive erosion from water flowing down a decommissioned road. The sediment barrier replaced with straw waddles in late 2014.

The Project provided design specifications and input to complete NEPA permitting requirements to the Umatilla National Forest who also provided implementation oversight. The Project rented equipment and provided operators for the implantation which occurred over one week during the 15 July to 15 August in-stream work window. During this time suspended sediment monitoring did not result in any delays and the final product was approved by the Umatilla National Forest. The Project planted native alder during the following fall and will be collecting photopoint data in the future.

This proved to be an effective use of cooperator resources for both entities and juvenile salmonids were identified in 2015 above the barrier. The site is thus far stable with grasses and alder plantings growing and sediment loading from the culvert eliminated. Similar actions may occur in the future if a similar opportunity arises.

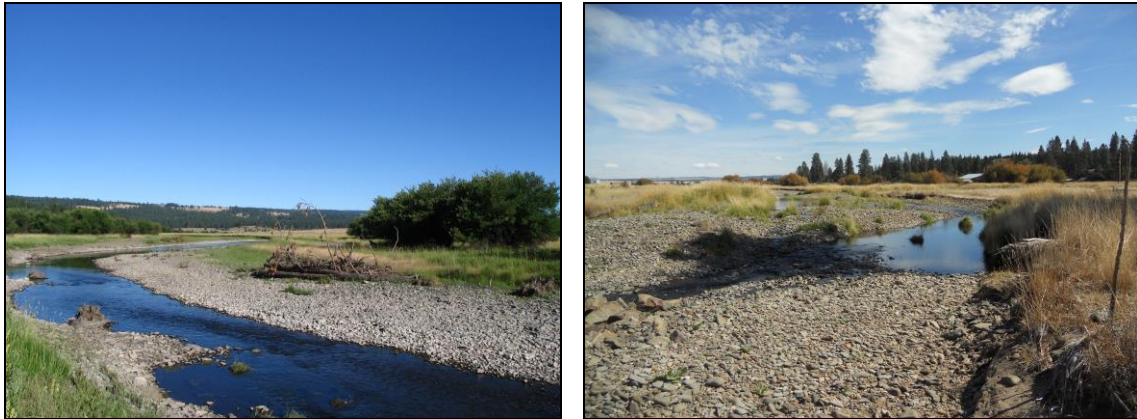
Figure 9. Photopoint collected for the Snipe Creek site during 2014 (right) looking upstream from the middle of the reach. The left photo was collected in 2007 a year after levee removal looking downstream upon the 2014 photopoint located on river left just below the lowest J-hook structure.

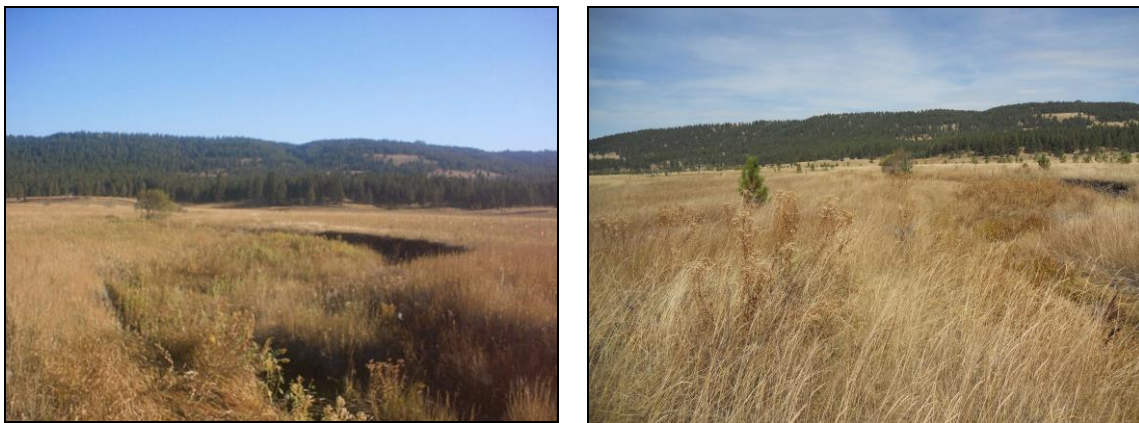
Figure 15. Photopoints collected for the Snipe Creek site during 2002 (left) and 2014 (right) from the lower end of the lower enclosure looking upstream.

Due the channel’s incision native plantings were largely unsuccessful even with watering. Native Ponderosa Pine (Figure 15) is however colonizing the surrounding floodplain within the enclosure which in and of itself suggests a significant change in the sites ability to buffer snowmelt and provide high quality streamflows during the summer. Without an extensive effort to treat the head cut below this site additional restoration efforts on the landowner’s property will not produce a satisfactory result.

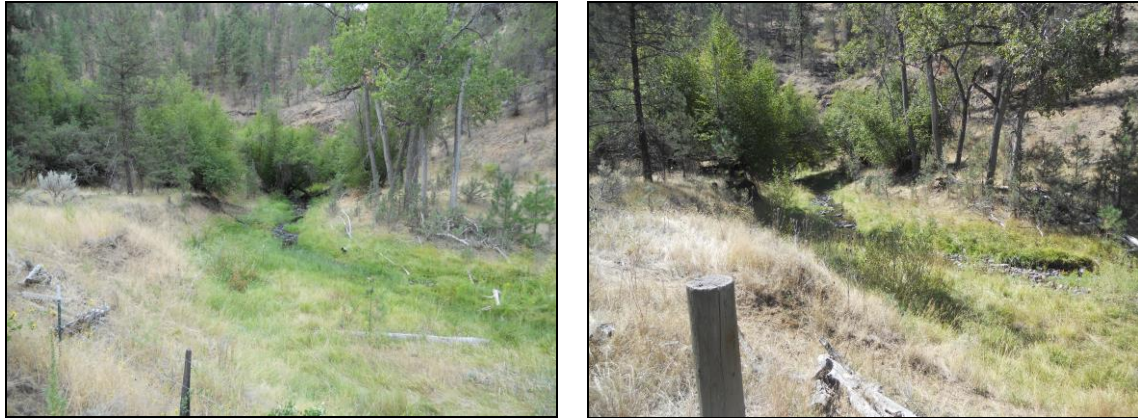
Figure 16. Photopoints collected for the Deer Creek site during 2010 (left) and 2014 (right) and the upper logger location. Note the 2004 picture was taken in early summer and while the 2014 picture was collected in late summer.

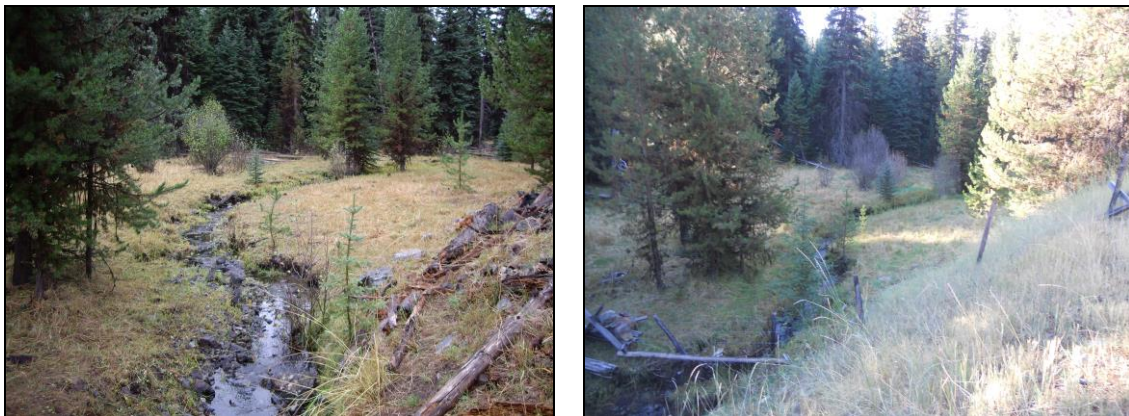
Figure 21. Photopoints collected for the Kelsay Creek site during 2008 (left) and 2014 (right) and the upper logger location.

Photopoint data (Figure 21) does however suggest that the exclusion of cattle has allowed native vegetation to recover over time and streambanks are not being disturbed to the level they once were. Elk and deer still have access to the site and therefore retard vegetative recovery though browse to an unknown extent. Without the requisite data we cannot determine the influence of nearby springs in moderating Kelsay Creek's water temperatures.
