**NORTH FORK JOHN DAY RIVER BASIN ANADROMOUS FISH HABITAT  
ENHANCEMENT PROJECT Annual Report for February 2016 – January 2017**

Project No. 2000-031-00

January 2018

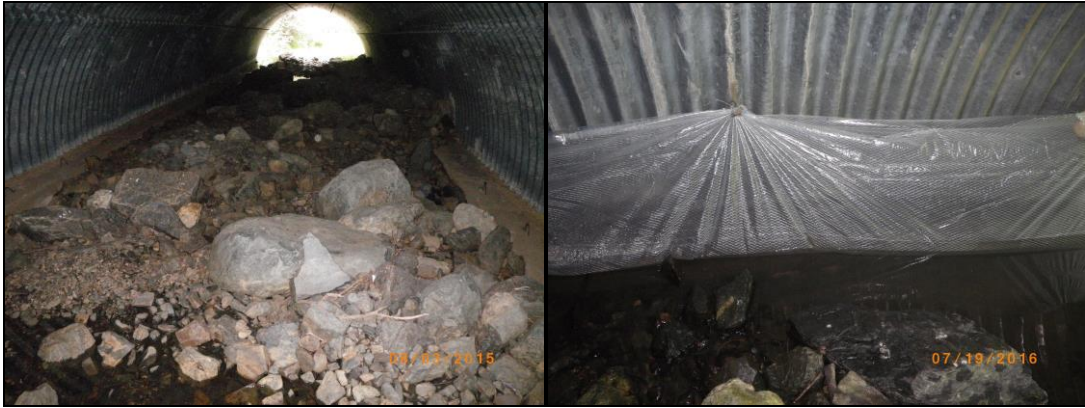
Figure 5. Resorted stream simulation material prohibiting passage through the Battle Creek Culvert (left) and plastic sheeting 'purse' passing stream flows during implementation.

During the spring of 2011 high flows resorted large and small stream simulation materials within the Battle Creek culvert resulting in an estimated 100 yd<sup>3</sup> loss of channel substrate and discontinuous flows during baseflow (Figure 5). The UNF, NFJDWC, ODFW, and CTUIR discussed several options to restore passage through the culvert since a contractors bid exceeded available funds in 2015. The agreed upon low impact treatment entailed washing in fines and creating a low flow channel. While our ability to wash in fines was minimized by an insufficient amount of available fine material the treatment combined with the low flow channel proved adequate. Flows and passage were reestablished and the treatment was stable through spring flows in 2017.

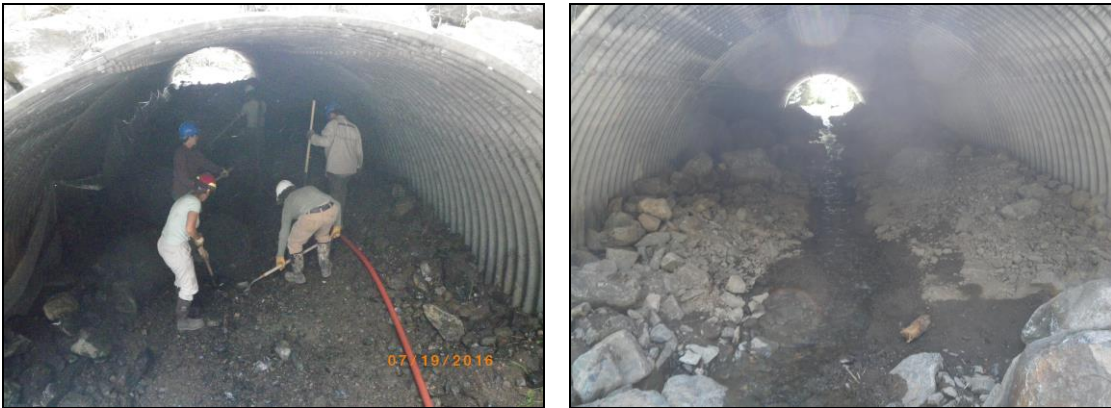
Figure 6. Youth crew excavating the low flow channel within the inset floodplain (left) and the finished inset floodplain and low flow channel.

In support of the effort the UNF provided permitting and oversight, ODFW provided a truck and backhoe with two of their staff, and the NFJWC provided a technical crew (Figure 6) funded by the CTUIR who also secured a skid steer. Passage for both water and fish were realized through the use of a plastic sheeting purse (Figure 5) along the culvert's footer and the inset floodplain was created with the skid steer pushing larger material aside to protect culvert footers. The technical team then created a low flow channel and washed in fine material by hand.

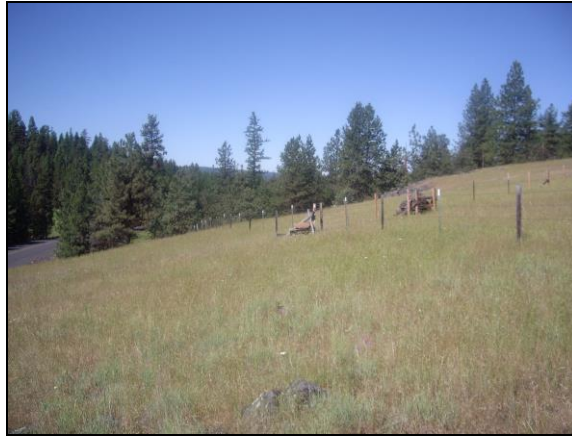
Figure 7. New fence constructed on a hillslope above Camas Creek and its floodplain.

and CTUIR collaborated to replace 0.5 miles of four stand barbed wire fence with 0.75 miles of fence located well above the floodplain (Figure 7). WWNF cost share consisted of fence materials and the CTUIR supported WWNF construction staff time. Fence construction occurred during May of 2016 with the action being carried out as planned.

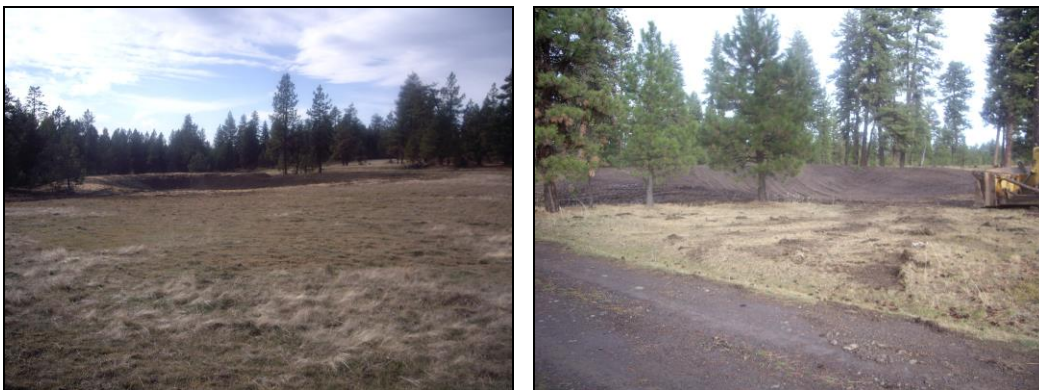
Figure 8. The pond developed through this action to improve stock watering opportunities (left) and the improved pond which was deepened and widened (right).

With the fence construction of WE O stock watering opportunities from Camas Creek were limited. To offset this loss an existing pond was improved and a second was developed (Figure 8). These ponds capture and hold runoff from rain and snow events. For this action the WWNF contracted with a qualified company to develop and improve the ponds. Construction occurred during November of 2016.

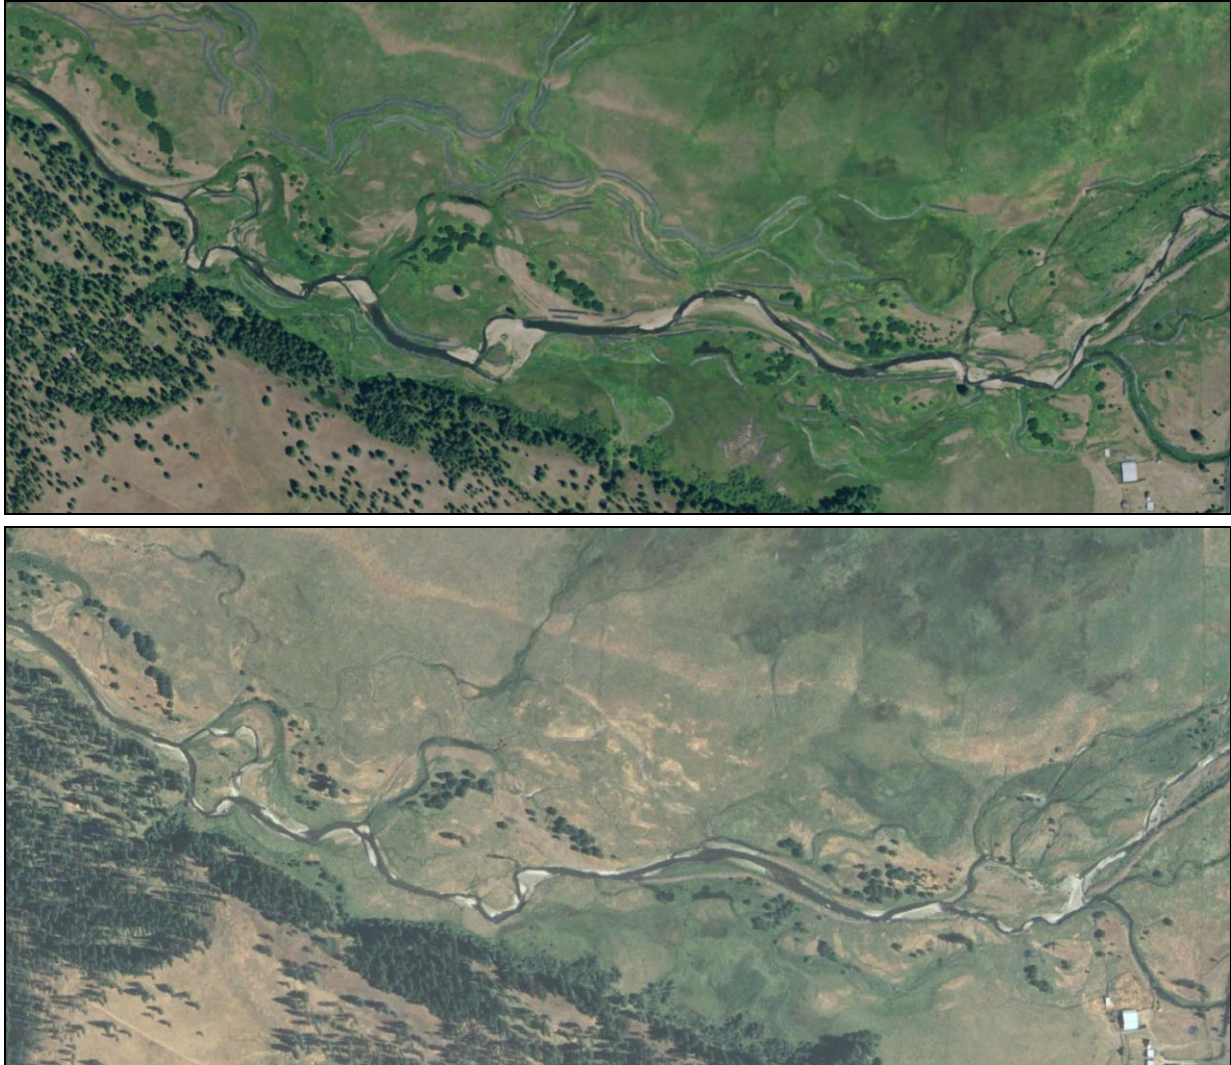
Figure 12. Aerial NAIP imagery from 2005 (bottom) and 2016 (middle) for the Lower Camas Creek site.

Another potential influencing factor based upon qualitative observations suggests that sediments are being mobilized from or more likely passed through Camas Creek within and adjacent to the City of Ukiah and deposited in the project area. Floodplain connectivity appears to have increased since 2005 while channel depths appear to have decreased, especially at the upper end of the project area. Although difficult to quantify, aerial imagery (Figure 12) for 2005 and 2016 suggests that gravel bars are much more robust then they were in the past. If gravels are in fact being deposited more frequently one could expect an increase in hyporheic exchange even without hard structures to create and maintain more localized scour which could be reflected in the temperature record. The role deposited sediments potentially creating shallower and a narrower channel hasn't been quantified either.

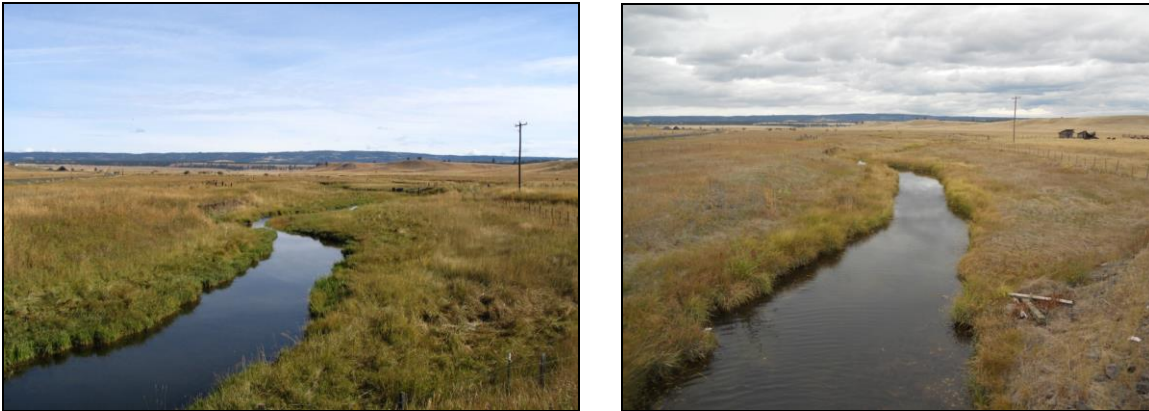
Figure 13. Photo points collected in 2004 (left) and 2015 (right) at the Owens Creek site.

Photo point data isn't available to document the site's condition at the onset of the conservation agreement. Photo points collected in 2004 and 2015 (Figure 13) suggest that streambanks maintained stable grass, sedge, and forb coverage. Unfortunately, woody vegetation hasn't prospered, the reason

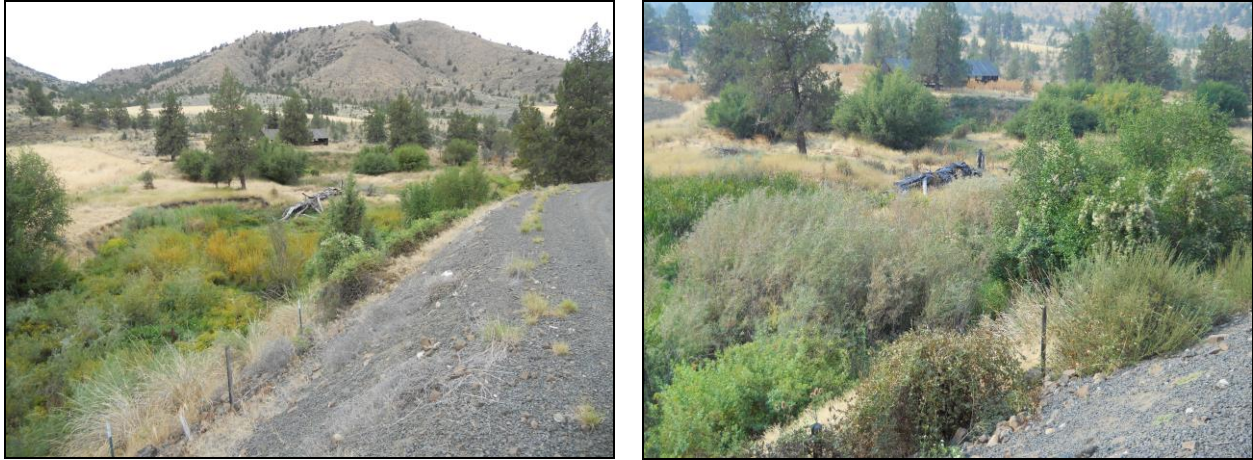
Figure 16. Photo points for the Deer Creek site collected in 2010 (left) and 2016 (right).

streambanks visible in 2004 and Deer Creek's floodplain continue to be colonized by cattails (*Typha* genus) and willow (*Salix* genus). Water temperature may also continue to improve in response to beaver colonization of the project site.

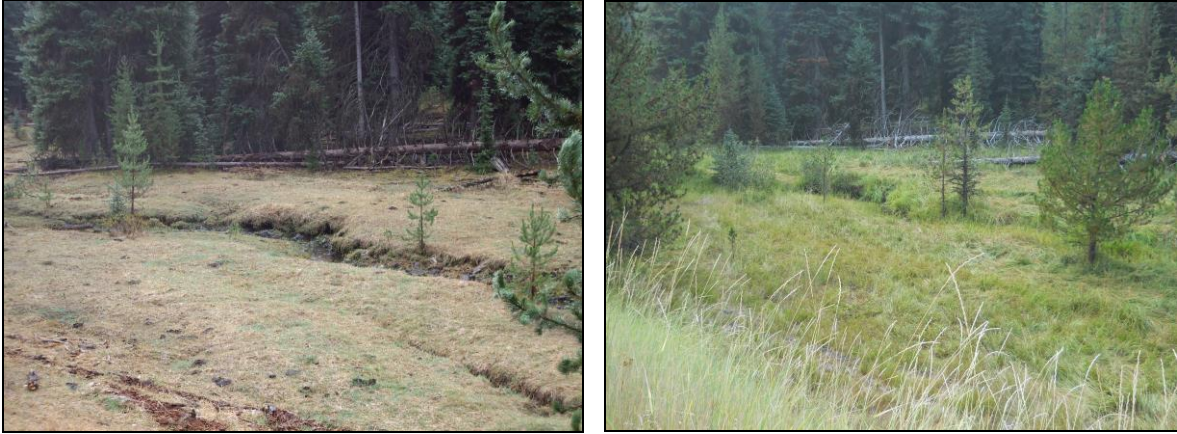
Figure 17. Photo points from 2008 (left) and 2015 (right) collected at the downstream end of the Kelsay Creek site.

Photo point data (Figure 17) suggests that cattle exclusion allowed native vegetation to recover and streambanks are not being disturbed to the level they once were. Elk and deer still have access to the site and likely influence hardwood vegetative recovery to an unknown extent. Plantings will likely repopulate the site in time as they have in the previously constructed downstream enclosure. A useful exercise would be to place wood in Kelsay Creek to improve channel complexity and sediment retention which may occur as part of the UNF's meadow enhancements identified in the Desolation Creek GAAP (WE L).

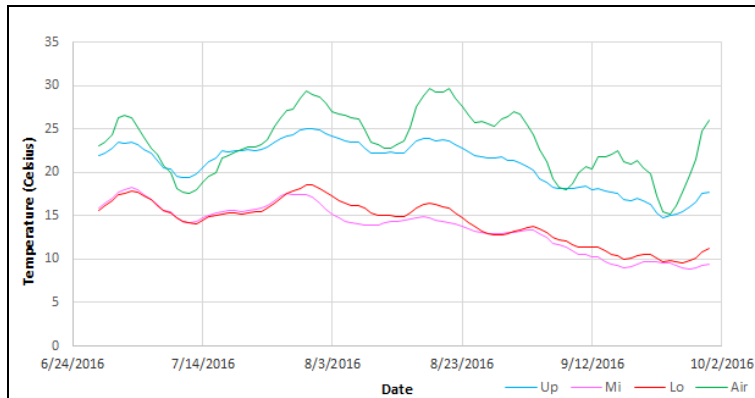
Figure 19. Seven day maximum temperature moving window average for data collected at the Kelsay Creek site between 6 June 2016 and 30 September 2016.
