# **CTUIR GRANDE RONDE SUBBASIN RESTORATION PROJECT ANNUAL REPORT**

## **A Columbia River Basin Fish Habitat Project**

**Northwest Power Planning Council Project # 199608300**

Report covers work performed under BPA contract # 72551  
Report was completed under BPA contract #72551  
Report covers work performed from: May 1, 2017 to April 30, 2018

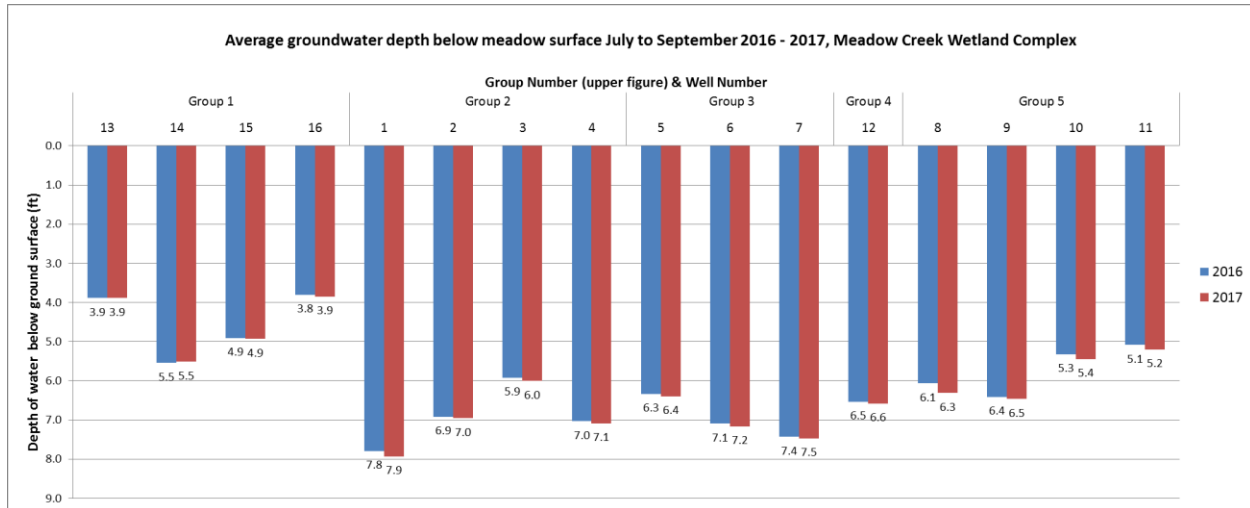
**FIGURE 7 AVERAGE GROUNDWATER ELEVATIONS ALONG MEADOW CREEK WITHIN THE MCCOY MEADOWS RANCH.**

compared to their corresponding wells measured during the same months the previous year. The remaining 13 wells measured in summer 2017 each show a decrease in groundwater elevation of approximately 0.1 ft. compared to the previous year.

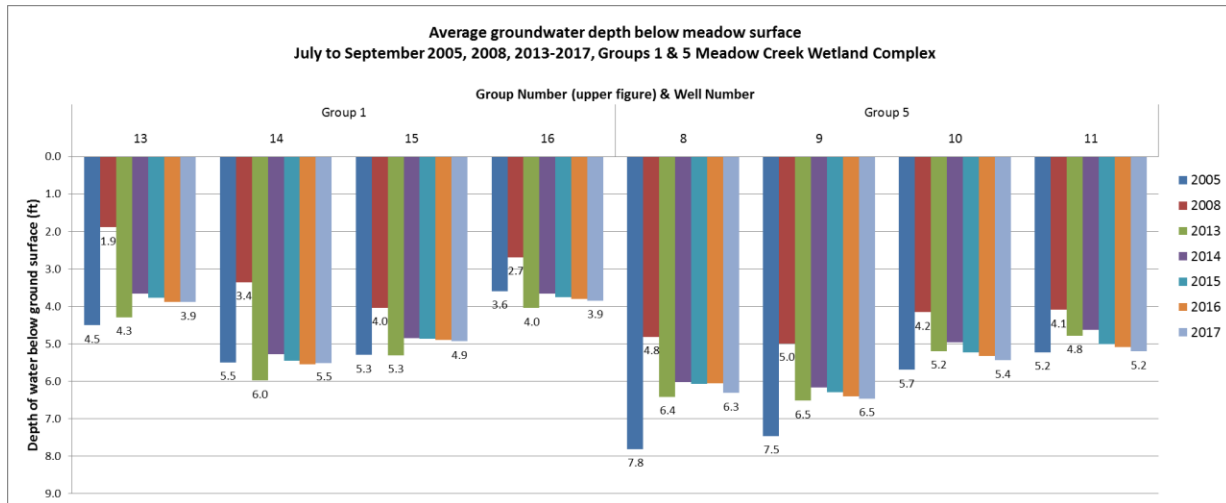
**FIGURE 8 2005 (PRE-PROJECT), 2008, 2013 - 2017 AVERAGE GROUNDWATER ELEVATIONS ALONG MEADOW CREEK WITHIN THE MCCOY MEADOWS RANCH.**

Average summer groundwater depths within the Meadow Creek Wetland Complex from months July to September 2008, 2013- 2017 for the most upstream wells (Group 1) and most downstream wells (Group 5) were graphed (Figure 8). In addition, pre-project measurements taken in 2005 during the same months are also shown for comparison. There is a six-year trend in decreasing groundwater elevation from 2008 to 2013. Groundwater records from 2013 are the furthest below meadow surface since 2005 pre-project levels for nearly all wells, with the exception of wells 10 and 11 where 2017 groundwater measurements were furthest from the meadow surface since pre-project conditions. It is possible that sediment build up at the Meadow Wetland Intake prevented desired flows from main channel Meadow Creek to access the wetland channel and contributed to this drop in groundwater elevation. A possible down-cutting of Meadow Creek, and coinciding dropping of the water table, may also have been a factor in these groundwater differences. The lower than average snowpack during winter 2012/2013 could also have contributed to lower than average summer flows in the Meadow Creek drainage, resulting in a lowered water table.

Groundwater depth measurements taken in 2014 indicate a consistent increase in groundwater elevation when comparing to summer seasonal average depths recorded from 2013 for Group 1 and Group 5 wells. The average increase in groundwater elevation in 2014 for these eight well sites was +0.4 feet. A possible explanation for the increase in groundwater elevation could be that mainstream Meadow Creek flows were allowed more access to floodplain and side channels, or that high flow diversion from the main channel persisted longer in these areas. All but one of the 8 wells (well #16) from Groups 1 and 5 showed groundwater elevations higher than pre-project levels in 2014. The average increase in groundwater elevation in 2014 compared to 2005 pre-project levels was +0.7 feet, which could be the result from seasonal high flows accessing the constructed Meadow Creek Wetland side channel. From 2014 to 2017 there has been a slight,

but consistent, decline in average summertime groundwater elevation. The combined average drop in groundwater elevation between 2014 and 2017 among all wells from Group 1 is 0.2 feet. For Group 5 wells the combined average decline in groundwater elevation is 0.4 feet. One well (well #16) had an average summer 2016 groundwater depth 0.3 feet below that of the 2005 pre-project level, and well #14 and #11 were measured in 2017 to be at the same groundwater elevation as pre-project records.

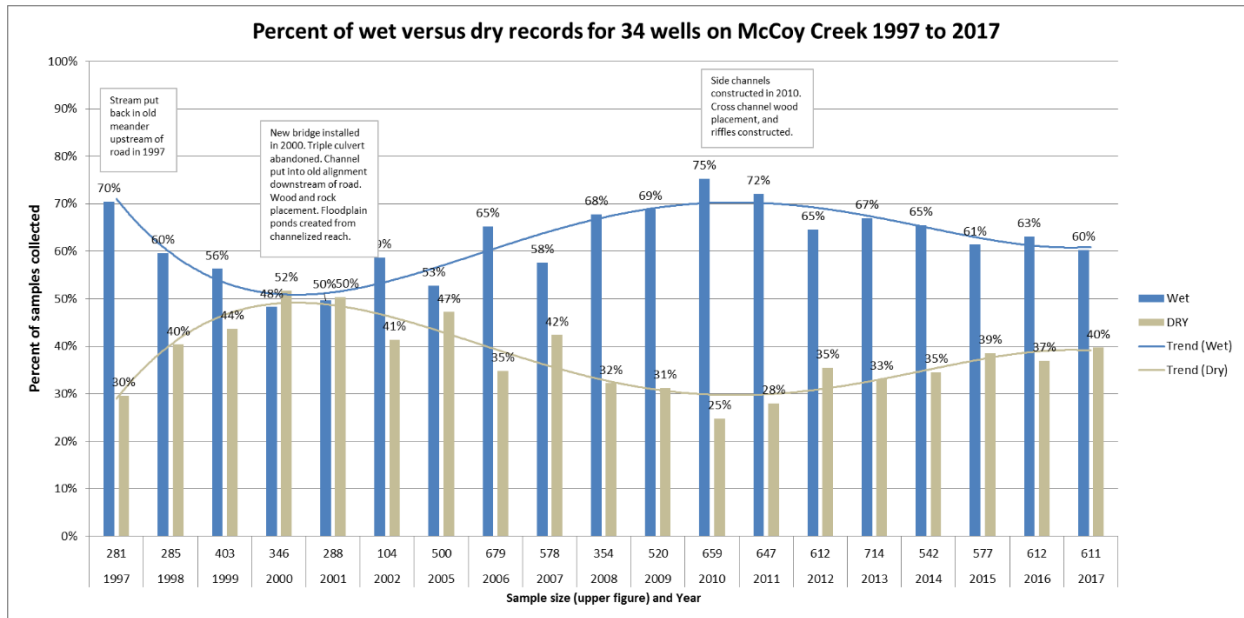
**FIGURE 9 PLOT OF WET VERSUS DRY WELL MEASUREMENTS ALONG MCCOY CREEK 1997 TO 2016.**

Groundwater well data was collected once every two weeks beginning March 28, 2017 and ending November 22, 2017. A total of 18 surveys were conducted to measure the groundwater depth below meadow surface during these months. There were 34 groundwater wells monitored along the McCoy Creek restoration project in 2017. The percent of well measurements when wet versus when dry were recorded and plotted (Figure 9) and shows a trend in increased groundwater elevation within the project area from 2007 to 2011, a decrease from 2011 to 2012, and no significant change from 2012 through 2014. Records from 2015 show a 4% decrease in wet well measurements compared to the previous year, but measurements from 2016 show a 2% increase in wet wells versus dry. There were 3% fewer wet wells measurements taken in 2017 compared to the previous year, which puts the current Wet vs. Dry ratio (60-40) at the lowest since 2007 (58-42).

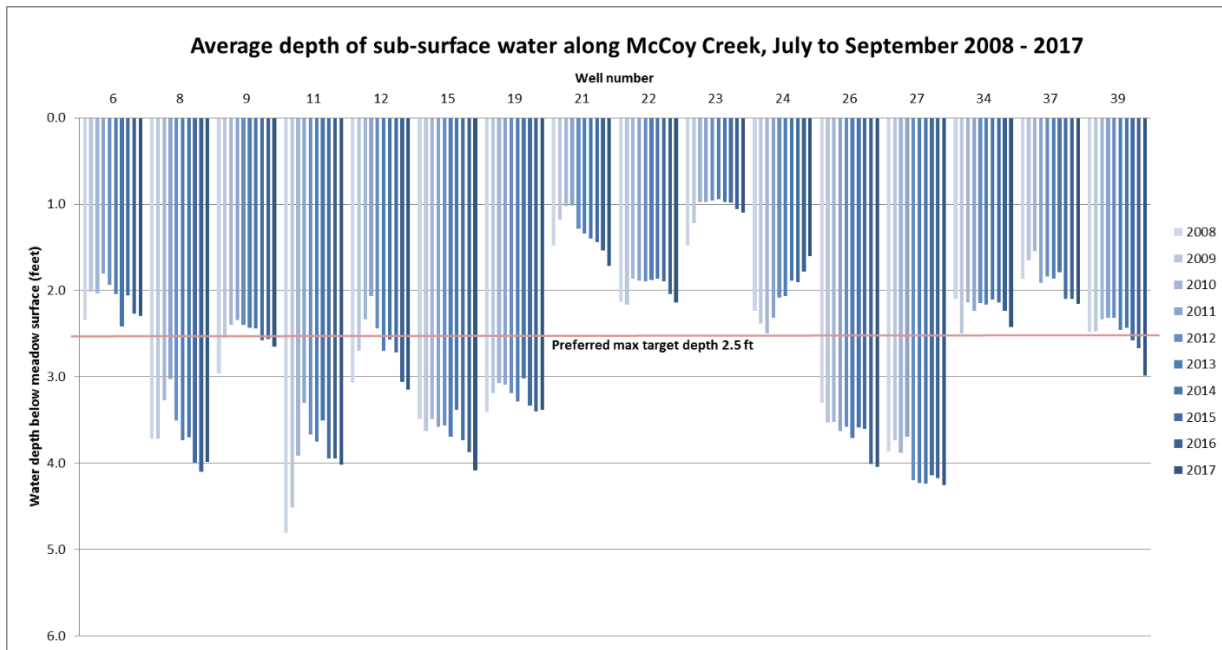
**FIGURE 10 PLOT OF AVERAGE SUB-SURFACE WATER ELEVATIONS JULY TO SEPTEMBER 2008 - 2017 ALONG MCCOY CREEK.**

Figure 10 shows 16 wells that remained wet for at least 3 surveys during the summer months July through September for the last 10 years since 2008. Wells located where water table levels dropped below the bottom of the well during July through September were not considered for annual comparison. 9 of the 16 wells sampled for these years contained average summer groundwater at a level that never dropped below 3 feet of the meadow surface, and 7 of these wells did not get below the preferred max target depth of 2.5 feet below the meadow surface during the months July through September for the last 10 years. Only two of these wells measured in 2017 recorded an average summer groundwater depth of below 4 feet from the meadow surface. For most of these wells, a similar trend in average summer groundwater elevation change can be seen. The general pattern that exists is a rising of groundwater elevation toward the meadow surface beginning in 2008 and topping out around 2011, followed by a decline away from meadow surface elevation. Records collected in 2017 show that, in most cases, summer groundwater was the furthest away from the meadow surface since 2008. The most peculiar exception is seen in well 24 where average summer groundwater elevation declined from 2008 to 2010, and has been steadily rising towards the meadow surface since. Records from 2017 show that groundwater elevations at well 24 are the closest to the meadow surface than they have been since the early 2000's (not shown on graph), which contrasts with the declining groundwater elevation trend seen in most other wells.

Following the restoration efforts there appears to be some increase in the average sub-surface water elevation within the project area. Increased groundwater elevations are most evident near the upstream log structure (above the McIntyre road bridge), but is also evident within all the wells. There is a widespread increase in sub-surface water and the rising trend seen after 2000 is continuing. This trend of a sudden increase in sub-surface water followed by a gradual ‘settling’ has also been recorded along Meadow Creek. It is anticipated that with the activation of the McCoy Creek side channels, greater floodplain access at high flows, and the backing up of water within proximity to the log and riffle structures the sub-surface water within the well network will continue to be at a level greater than the lows of 2000 and 2001.

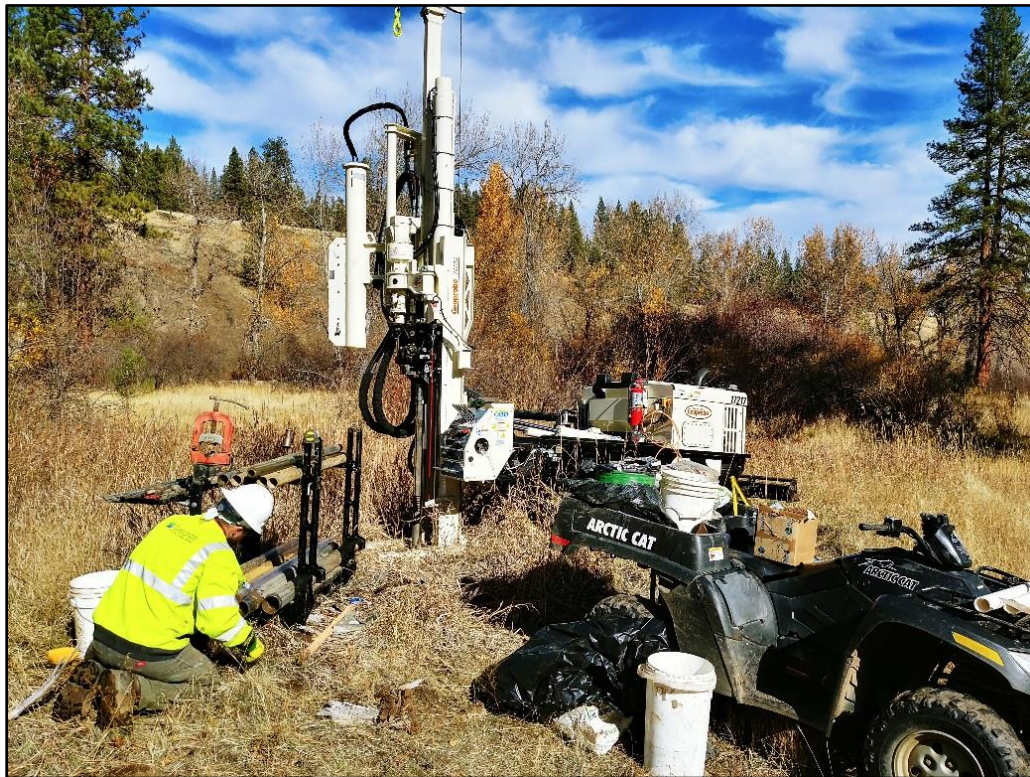
**FIGURE 13 INSTALLATION OF GROUNDWATER WELL #21**

Each well hole was approximately 2 inches in diameter and were advanced by a drill rig which was approximately the size of a personally operated vehicle (Figure 13). The work area for well installation was approximately 20 feet long by 10 feet wide for each hole. Spill prevention included absorbent mats and booms maintained onsite to collect any potential leakage/spillage that would occur due to the unlikely chance of a spill, hydraulic line failure or refueling accident. Wells were installed in the floodplain both to the north and south of the existing channel alignment and were installed using a drill auguring method in which core samples were collected. The locations were placed outside of the anticipated channel realignment to allow for pre and post project implementation monitoring.

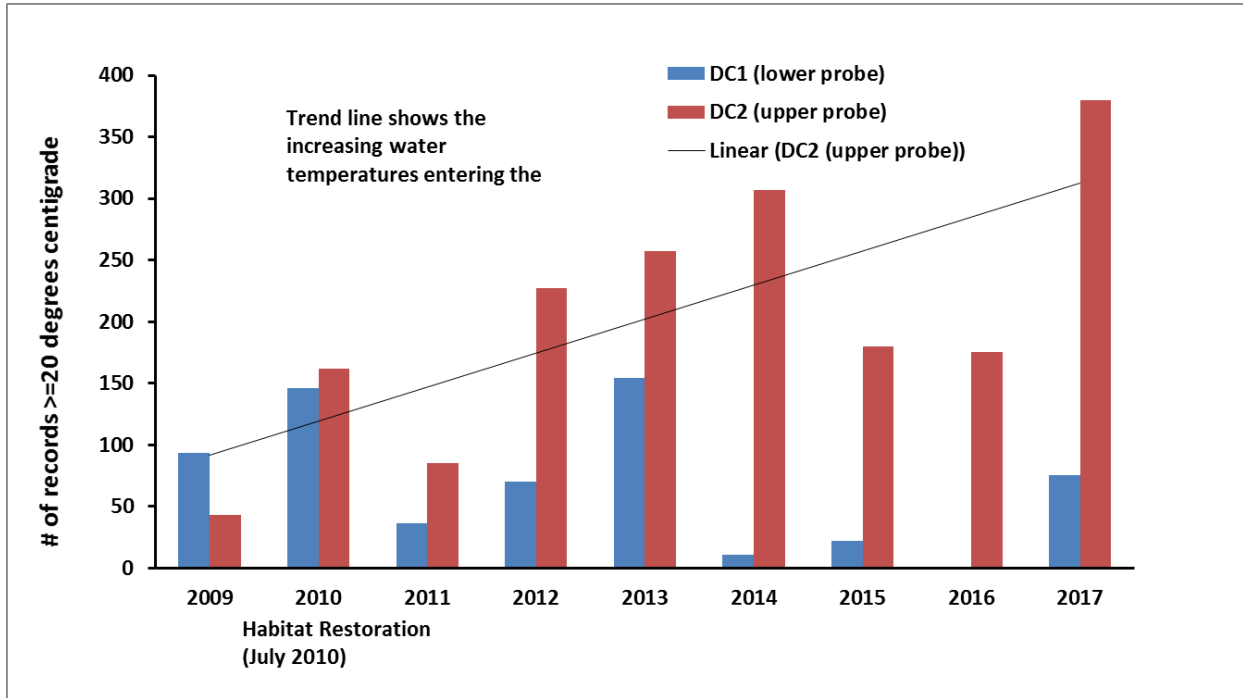
**FIGURE 21** PLOT OF THE NUMBER OF WATER TEMPERATURES  $\geq 20^{\circ}\text{C}$  ON DARK CANYON CREEK. PLOTTED TREND LINE DEMONSTRATES THAT OVERALL WARMER WATERS ARE ENTERING THE PROJECT AREA EACH YEAR (RED BARS), BUT THIS WATER IS COOLING AS IT MOVES THROUGH THE PROJECT AREA TO THE LOWER PROBE SITE (BLUE BARS).

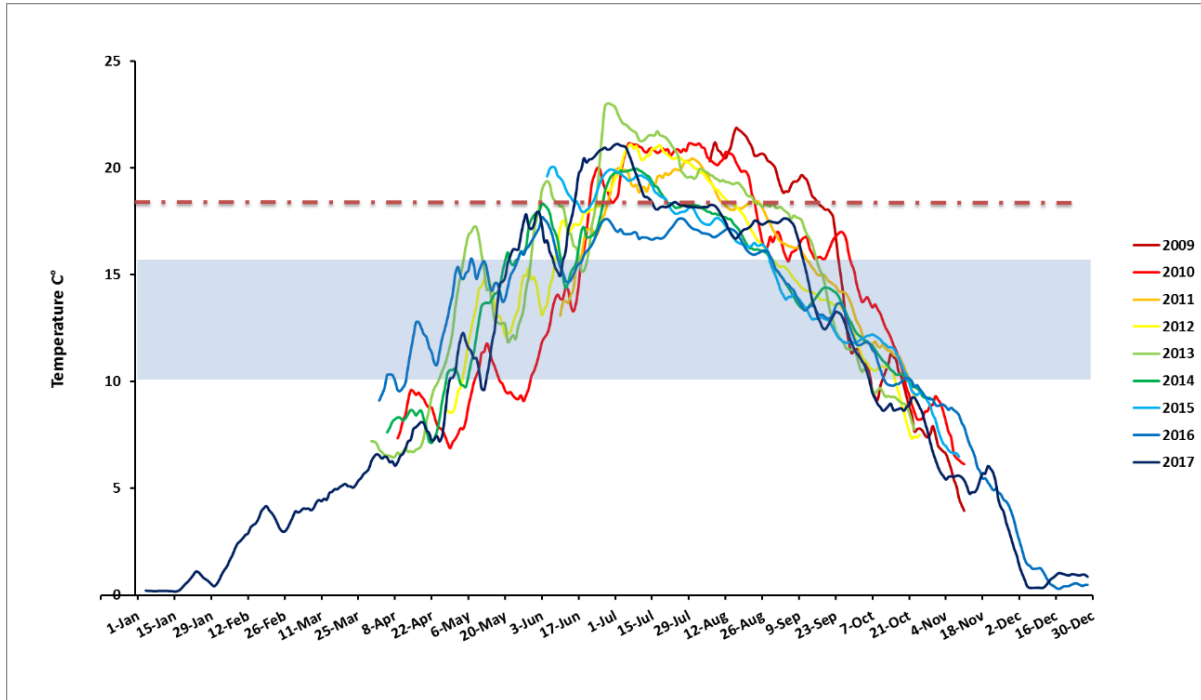
**FIGURE 22 7 DAY AVERAGE DAILY MAXIMUM TEMPERATURES (7DADM) FOR DARK CANYON (LOWER), YEARS 2009 TO 2017. COLOR GRADIENT INDICATES PRE-PROJECT (2009-2010; RED) TO POST PROJECT CONDITIONS (2010-2017; BLUE). BLUE BOX IS IDEAL TEMPERATURES FOR JUVENILE CHINOOK (10-15.6°C) AND RED DASHED LINE IS UPPER LIMIT FOR JUVENILE REARING AND MIGRATION (18°C).**

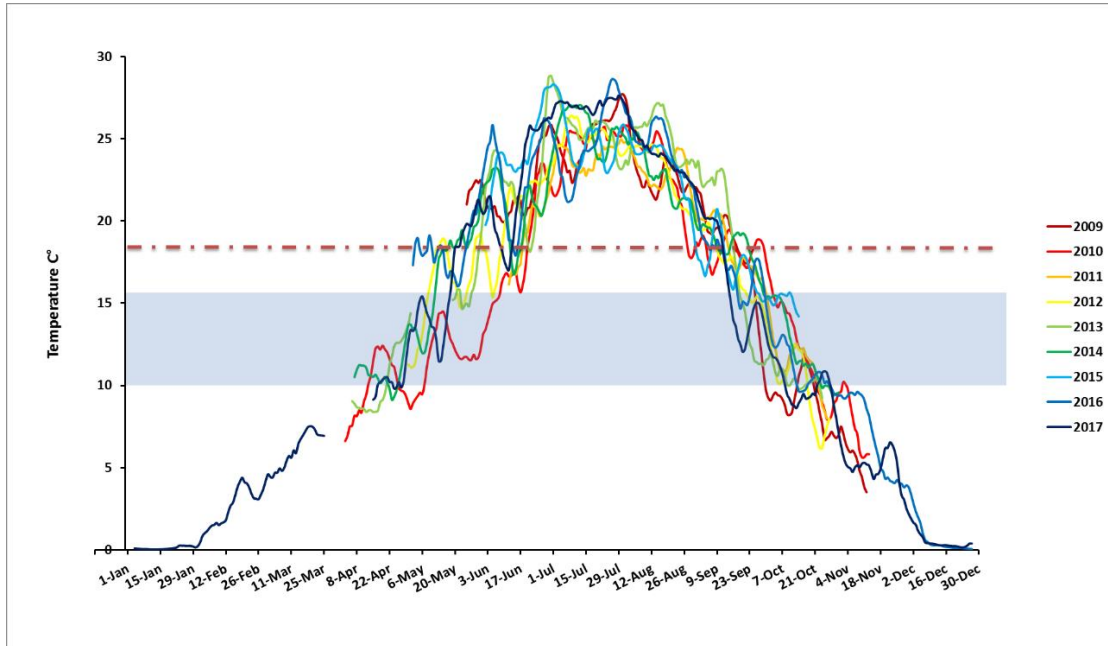
**FIGURE 24** 7 DAY AVERAGE DAILY MAXIMUM TEMPERATURES (7DADM) FOR MCCOY CREEK (RIVER MILE 0.1), YEARS 2009 TO 2016.. COLOR GRADIENT INDICATES PRE-PROJECT (2009-2010; RED) TO POST PROJECT CONDITIONS (2010-2017; BLUE). BLUE BOX IS IDEAL TEMPERATURES FOR JUVENILE CHINOOK (10-15.6°C) AND RED DASHED LINE IS UPPER LIMIT FOR JUVENILE REARING AND MIGRATION.
