CTUIR GRANDE RONDE SUBBASIN RESTORATION PROJECT ANNUAL REPORT

A Columbia River Basin Fish Habitat Project

Northwest Power Planning Council Project # 199608300

Report covers work performed under BPA contract # 72551
Report was completed under BPA contract #72551
Report covers work performed from: May 1, 2018 to April 30, 2019

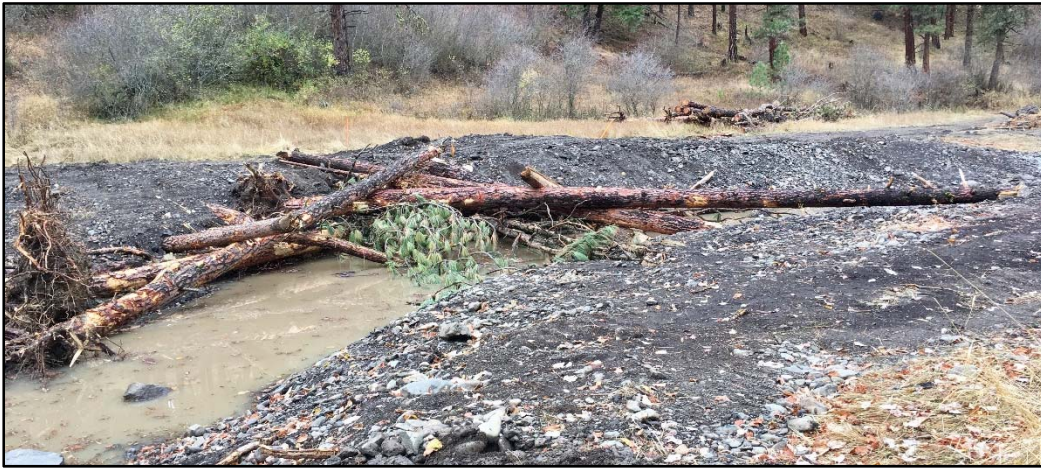
- **Install Large Wood Complexes along Rock Creek:** Approximately 54 large wood complexes were installed along project area main channel and side channels to recreate complex and diverse habitat components within the project reach (Figure 7). Typical instream wood placement configurations mimicked natural debris accumulations, and were designed to stabilize stream banks, provide overhead cover, and facilitate backwatering activation of alcoves, side channels, and floodplain swales. These structures will provide shade for fish species, hiding cover from predators, velocity refuge, bank stability, and a food source (insects).

FIGURE 7 ROCK CREEK TYPE 2 LARGE WOOD COMPLEX

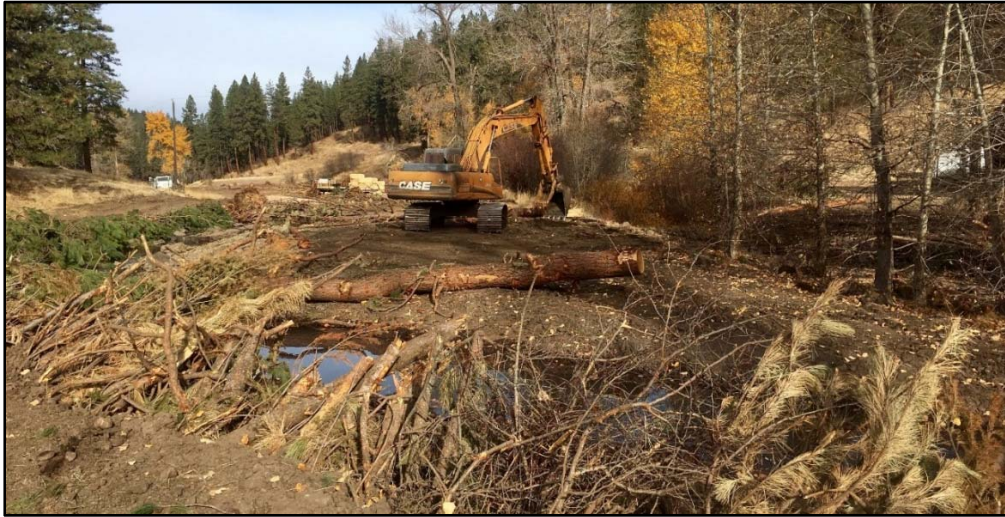
FIGURE 8 BIOENGINEERED BANK TREATMENT – WILLOW/BRUSH MATTRESS

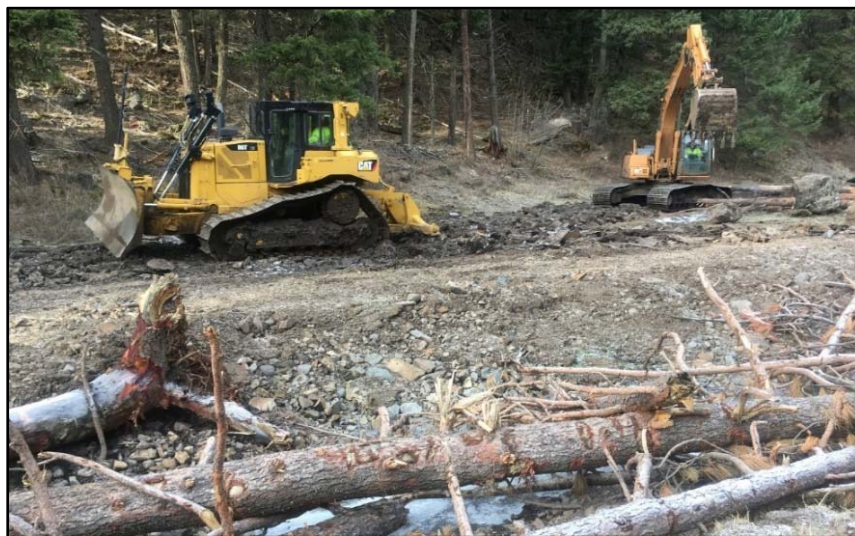
Approximately 5,248 feet of draw bottom road that ran parallel to Rock Creek on the southwest side (river left) of the channel was decommissioned (Figure 9). Once vehicles and equipment no longer needed access, the road was de-compacted and fractured to a depth of 24 inches. This will result in the rehabilitation of floodplain vegetation, and hydraulic reconnection of cold water hillside springs with Rock Creek.

FIGURE 9 DRAW-BOTTOM ROAD DECOMMISSIONING

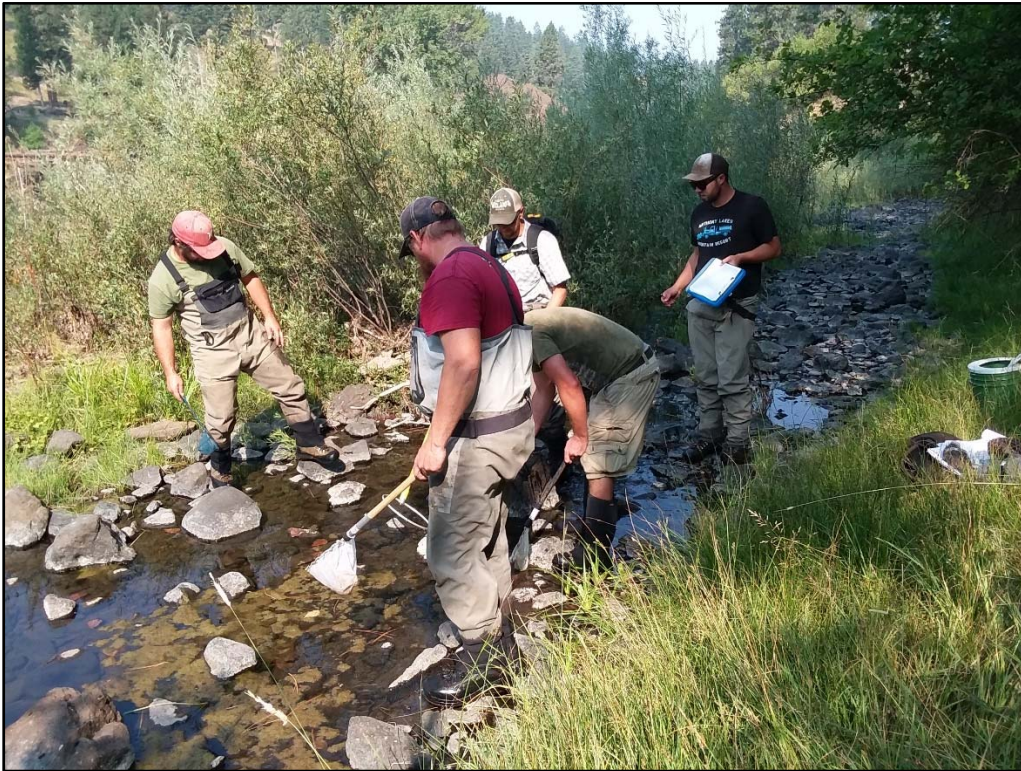
FIGURE 10 CTUIR STAFF CONDUCTING FISH SALVAGE ON ROCK CREEK

Overall, the Rock Creek Phase III salvage operation was successful in depleting construction sites and relocating 57 ESA listed juvenile *O. mykiss* without observing any salmonid mortalities. However, salmonids were only 2% of total fish caught, with 1,384 non-salmonids making up the majority of fish salvaged from the project area. Of these 23 mortalities were recorded, giving a mortality rate of less than 2% for non-ESA listed species. Non-salmonids species were recorded as “Other” on salvage data sheets, and consisted of northern pikeminnow, dace, redbreast shiner, sculpin, sucker, and chisel mouth. In addition, crayfish, frogs, and freshwater mussels were recorded and relocated outside of the Phase III project area (Figure 10).

Site 67+00 was previously identified as being occupied by a colony of freshwater mussels (*M. falcate*). CTUIR Freshwater Mussel Project staff assisted in the collection and relocation of 60 mussels from this site during fish salvage operations.

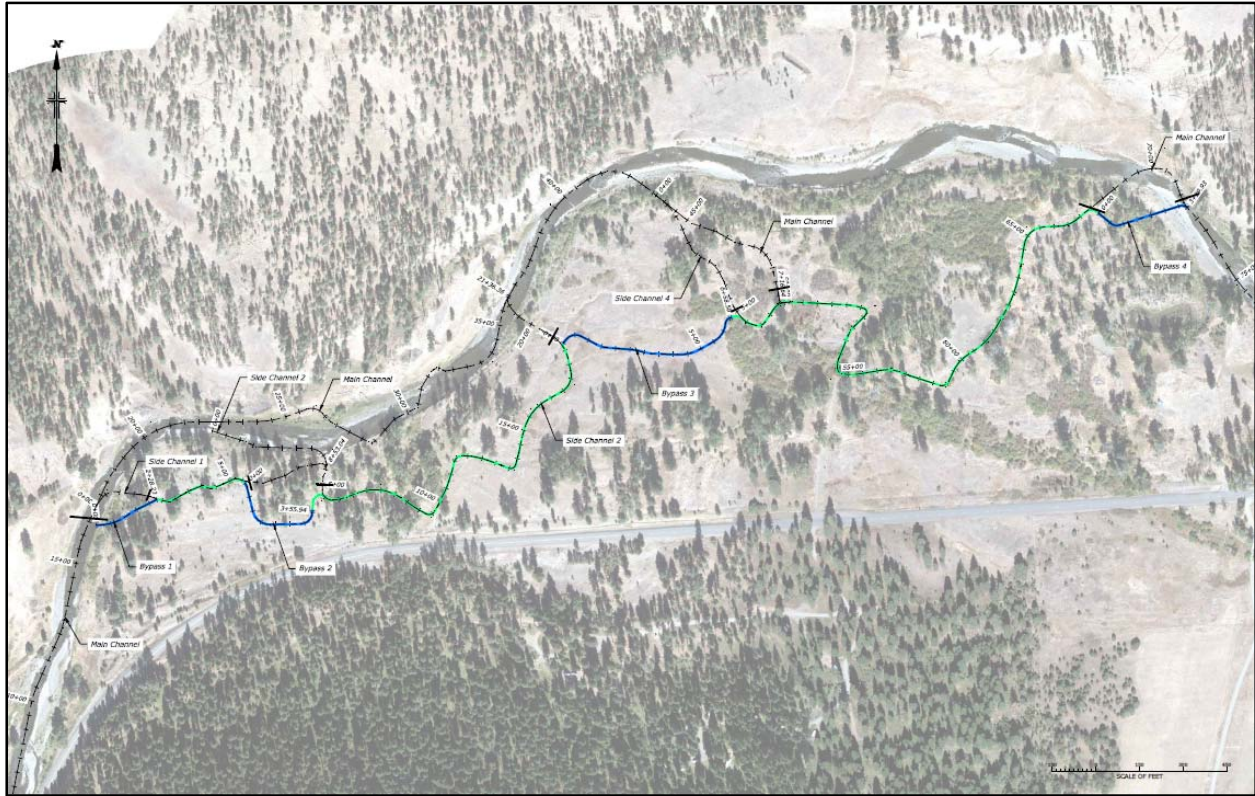
FIGURE 11 BTS 2019 TEMPORARY BYPASS OVERVIEW.

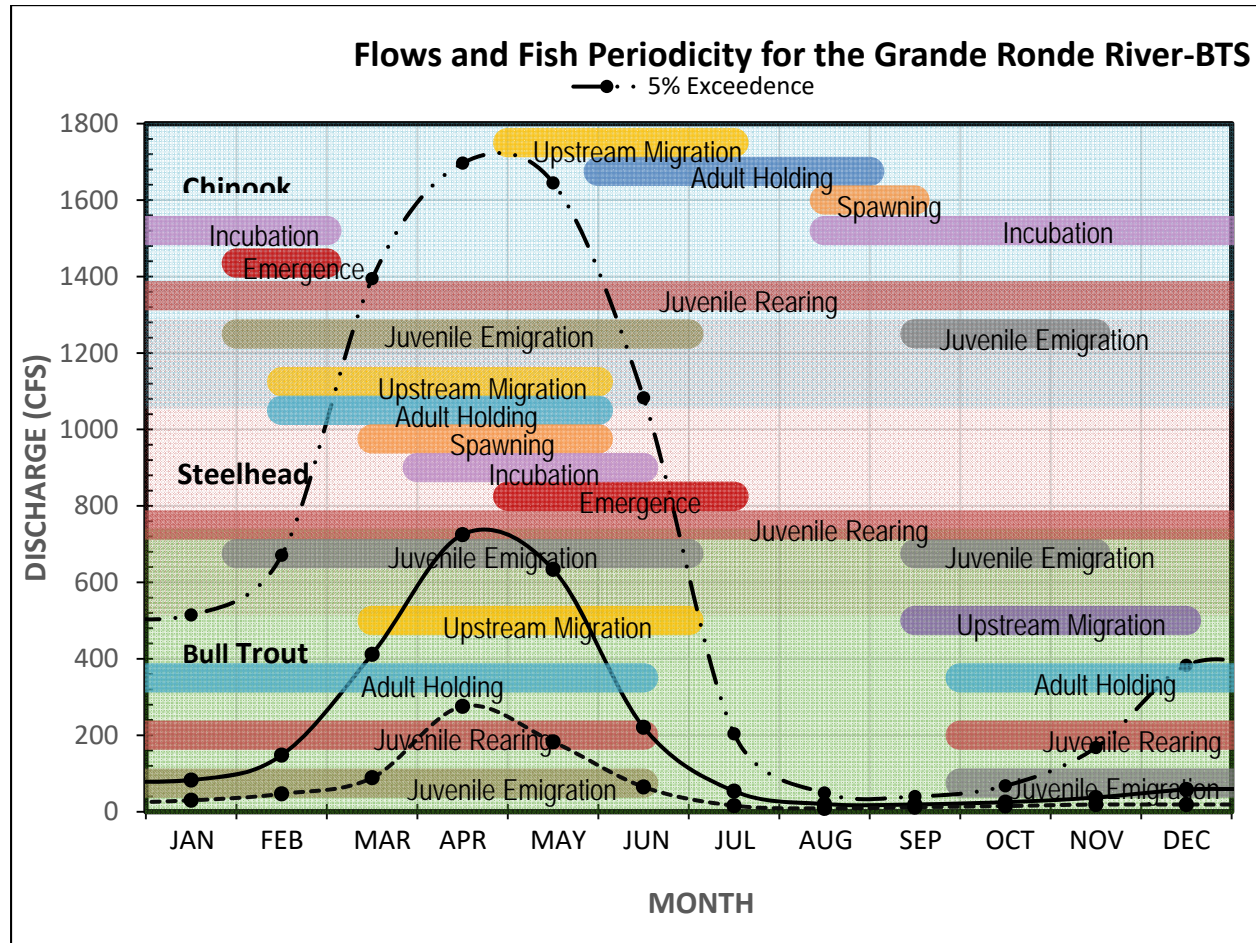
FIGURE 12 ANNUAL HYDROGRAPH AT THE UPSTREAM END OF THE PROJECT REACH (RM 146.1). SALMONID DATA GENERATED IN THE ATLAS PROCESS ARE SHOWN. DARKER PORTIONS OF FISH PERIODICITY BANDS SHOW THE CRITICAL PERIOD AND LIGHTER BANDS SHOW SECONDARY PERIODS OF A GIVEN LIFE STAGE.

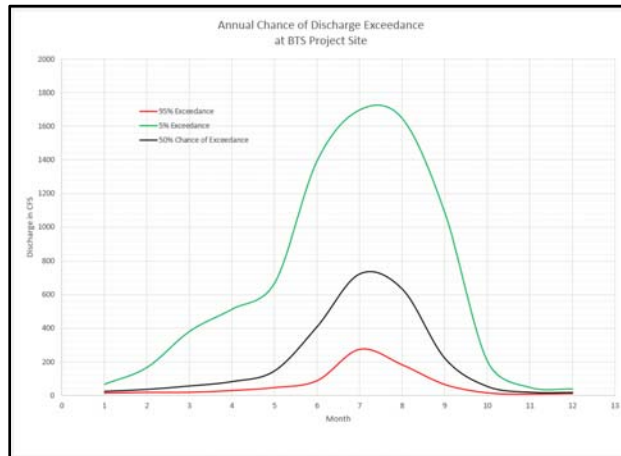
For this project, the exponent was solved for algebraically using a historic USGS gage within the project reach that had overlapping data (Grande Ronde near Hilgard, USGS Gauge 13318500, 1937-1956). Transformation of gauge data from the La Grande gauge to the project site was completed using a resulting exponent ('a') of 1.14. The following figures depict the annual chance of exceedance for the 95%, 50% and 5% conditions at the project site for the annual period of record followed by the in-water work period.

FIGURE 13 GRANDE RONDE RIVER 5%, 50% AND 95% ANNUAL CHANCE OF EXCEEDANCE AT BTS PROJECT SITE.

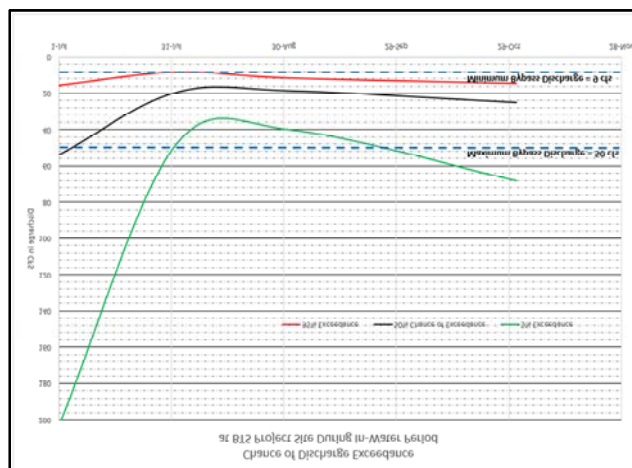
FIGURE 14 GRANDE RONDE RIVER 5%, 50% AND 95% ANNUAL CHANCE OF EXCEEDANCE AT BTS PROJECT SITE DURING THE UPPER GRANDE RONDE IN-WATER WORK PERIOD (JULY 1ST THROUGH OCTOBER 15TH).

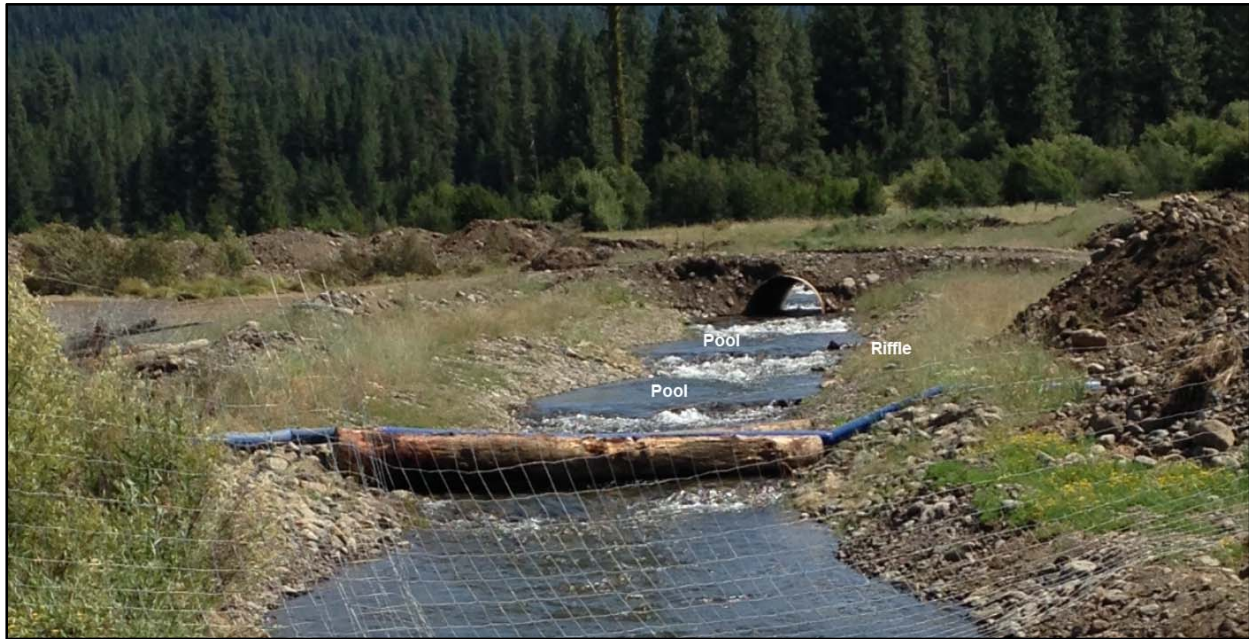
FIGURE 16 2017 TEMPORARY BYPASS CHANNEL AT MFJD OXBOW PROJECT JULY 2017. DISCHARGE OF APPROXIMATELY 35 CFS. CHANNEL SLOPE OF 2%, RIFFLE HEIGHTS OF 2-FEET. NOTE – LOG AND PIPE WERE BRIEFLY PLACED AND REMOVED.

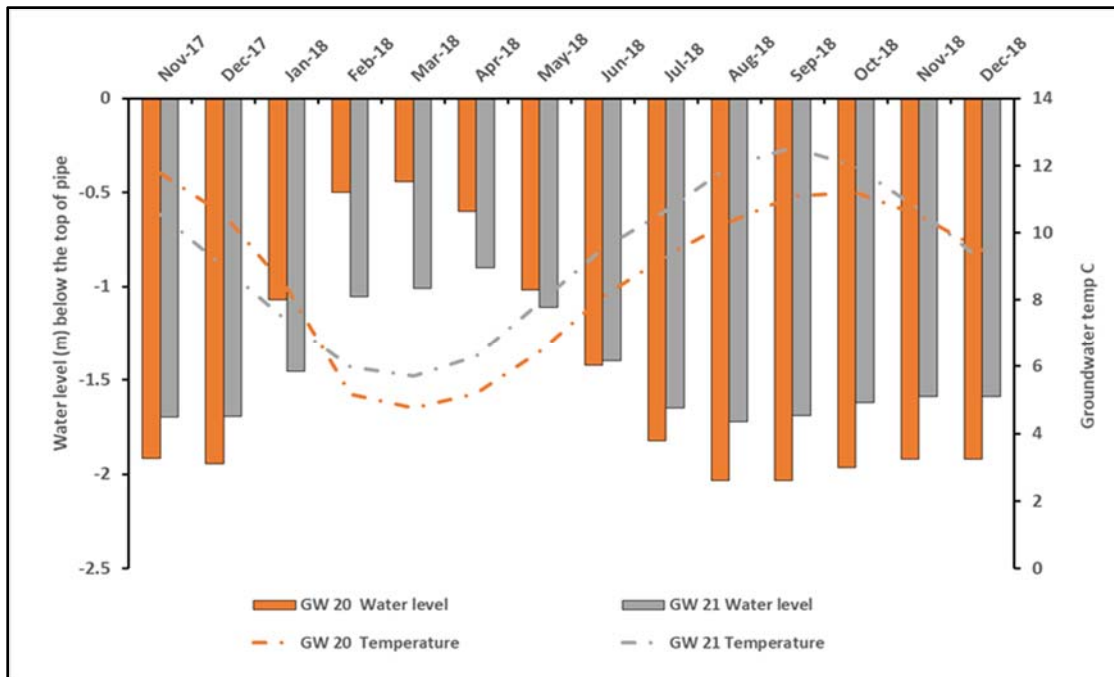
FIGURE 33 MONTHLY AVERAGE GROUNDWATER LEVELS FOR WELLS 20-21 AT LONGLEY MEADOWS AND CORRESPONDING GROUNDWATER TEMPERATURES, NOVEMBER-17 TO DECEMBER-18. COLORS FOR GROUNDWATER TEMPERATURES AND LEVELS ARE MATCHING.

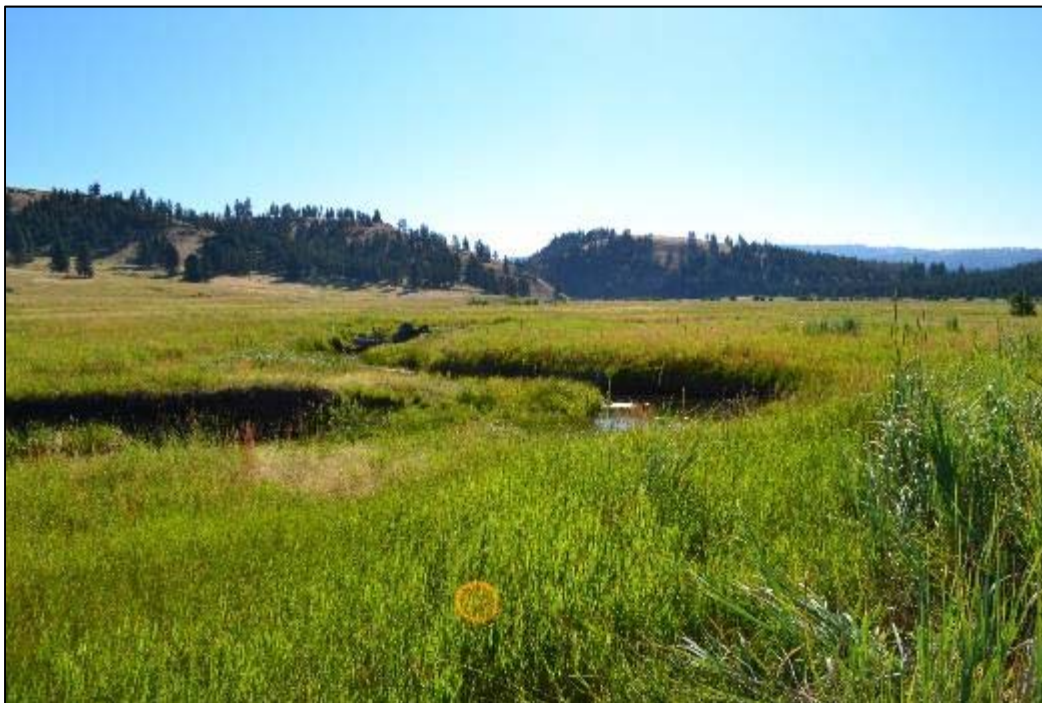
FIGURE 34 UNPROTECTED REACH ON MCCOY CREEK, JULY 2017.

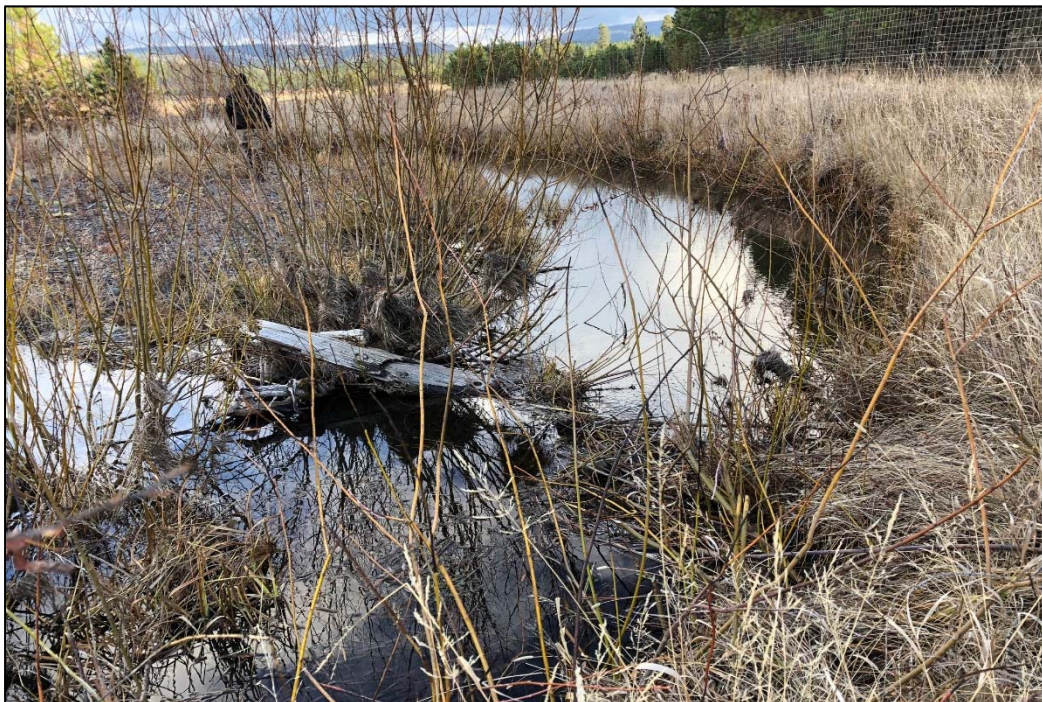
FIGURE 35 PROTECTED ELK ENCLOSURE ON MCCOY CREEK AND RECENT BEAVER ACTIVITY, DECEMBER, 2018.

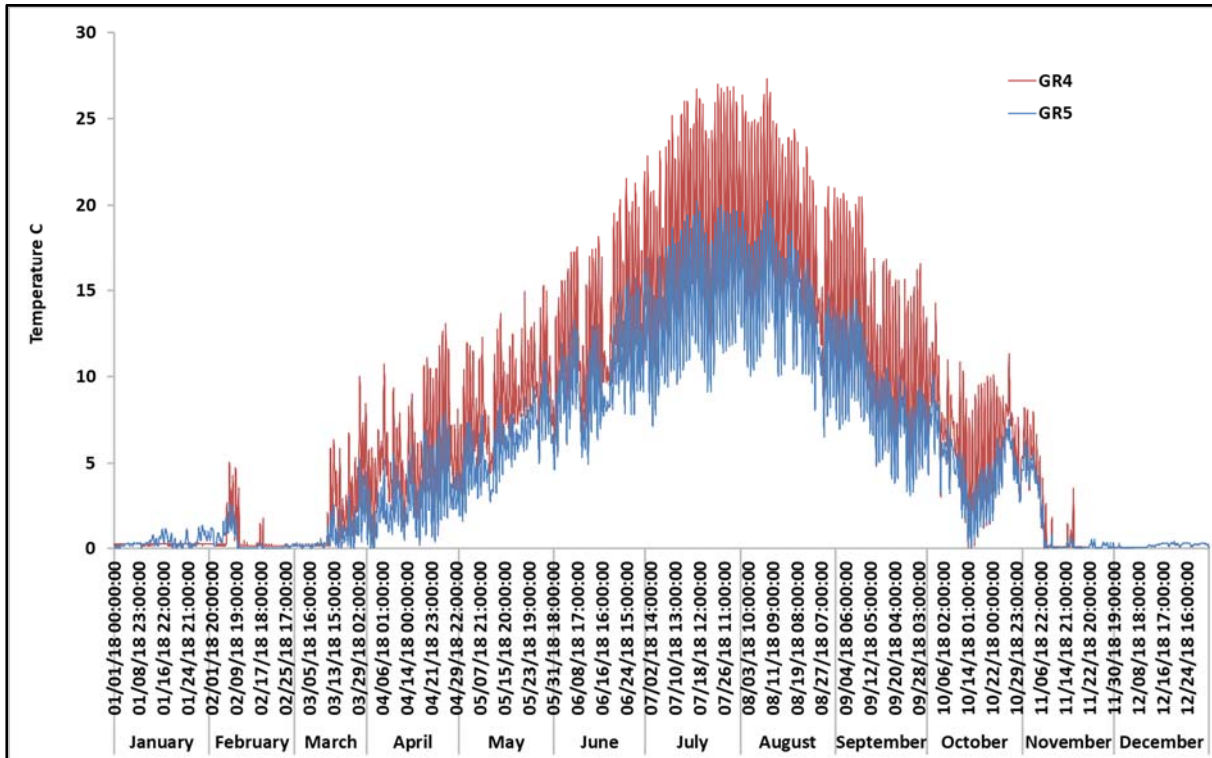
FIGURE 37 DIURNAL FLUCTUATIONS IN WATER TEMPERATURE ALONG THE GRANDE RONDE RIVER DURING 2018.

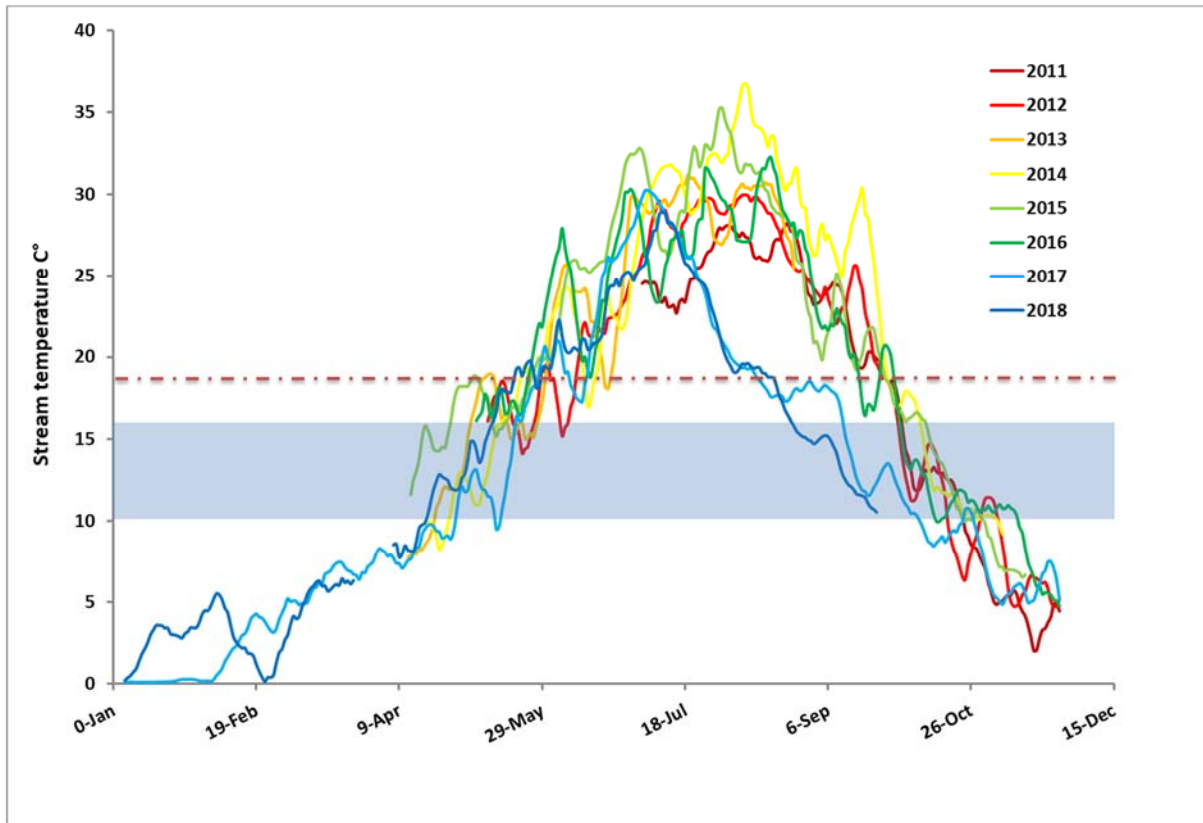
FIGURE 48 7 DAY AVERAGE DAILY MAXIMUM TEMPERATURES (7DADM) FOR ROCK CREEK (LOWER), YEARS 2011 TO 2018. COLOR GRADIENT INDICATES PRE-PROJECT (2011-2012; RED) TO POST PROJECT CONDITIONS (2017-2018; BLUE). BLUE BOX IS IDEAL FEEDING TEMPERATURES FOR JUVENILE CHINOOK (10-15.6°C) AND RED DASHED LINE IS UPPER LIMIT FOR JUVENILE REARING (18°C).

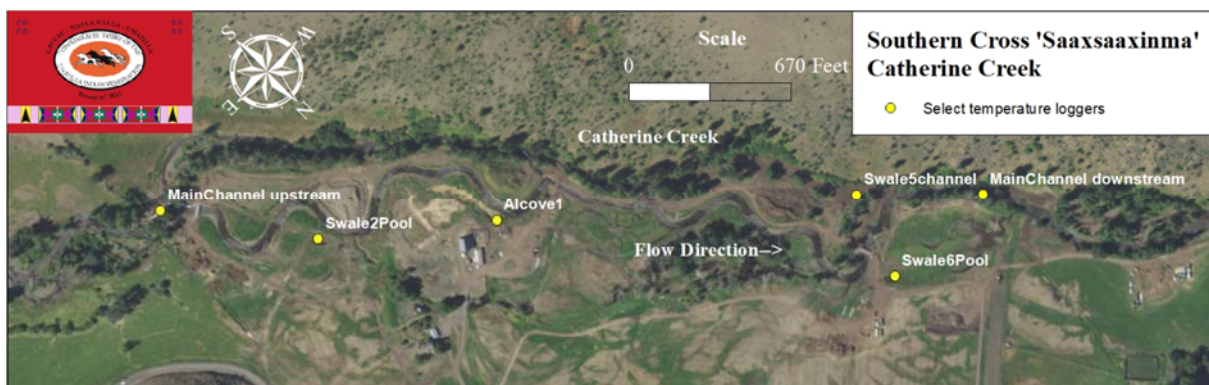
FIGURE 50 MAP OF SELECTED TEMPERATURE LOGGERS MONITORED ON CATHERINE CREEK FISH HABITAT ENHANCEMENT PROJECT 2016-2018.
