CTUIR GRANDE RONDE SUBBASIN RESTORATION PROJECT ANNUAL REPORT

Northwest Power Planning Council Project # 199608300

Report covers work performed under BPA Contract 73982 REL 75

Report covers work performed from: May 1, 2019 to April 30, 2020

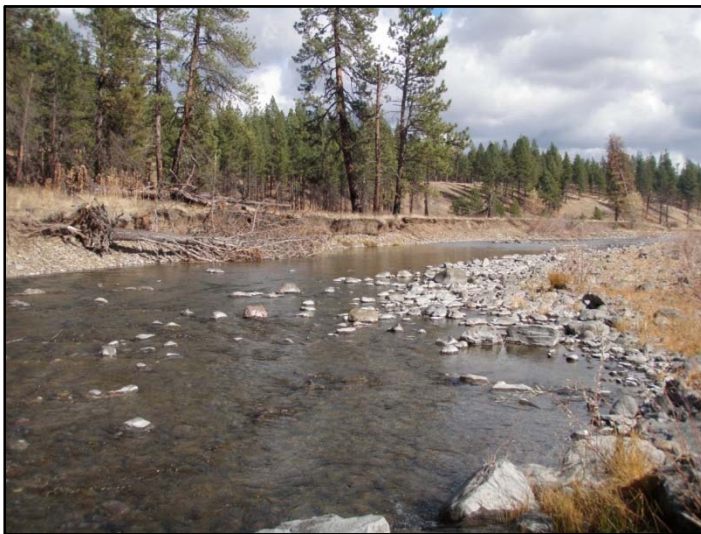
FIGURE 8 PRE-PROJECT CHANNEL CONDITIONS

The pre-project condition of the Grande Ronde River in the Bird Track Springs reach was an unconfined, free-formed alluvial channel that had a straight planform with a plane-bed, and lower degree of channel-floodplain interactions compared to historic conditions (Figure 8). Artificial channel constrictions and disconnected floodplains due to railroad grades, road grades and levees had changed the channel geometry and floodplain cross-sectional area which increases flow depths, flow velocities and shear stresses during high water events.

This condition translated into increased sediment mobilization and transport resulting in a wider, shallower channel with an armor layer that inhibited pool development when flows were not sufficient to mobilize the armoring particles, or in the absence of channel-spanning structures or significant channel constrictions.

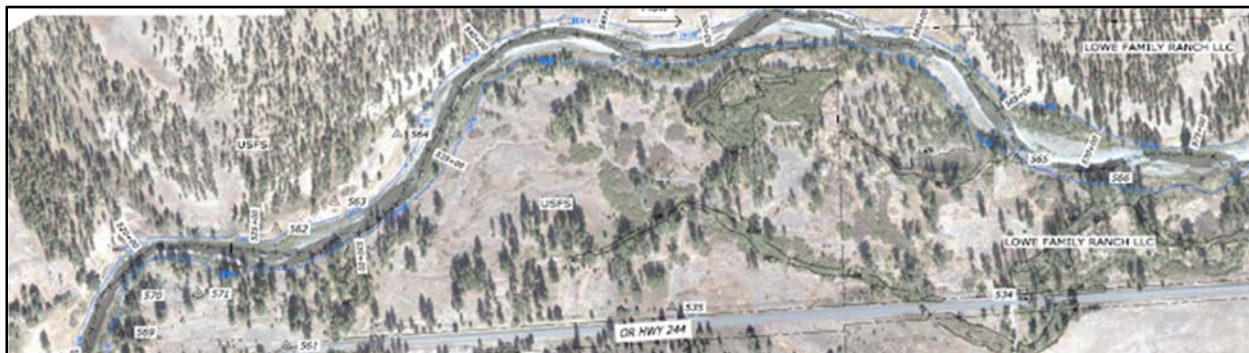
FIGURE 9 PRE-PROJECT CONDITIONS OF BIRD TRACK SPRINGS PROJECT REACH

Icing is a significant process affecting habitat condition in the basin during low flows in the winter months due to the wider, shallower channel geometry in the project area. Trees with ice scars have been identified in the upper .5 miles of the channel in the Bird Track Springs project area and provide an indication of longitudinal ice scour extent. These trees show height of scour occurring consistently above the 100-year water surface elevation. Surface ice accumulation can be significant during winter months to the point of creating large ice dams. Salmonids overwintering in rivers such as the Grande Ronde are vulnerable to numerous threats to their survival as a result of highly variable environmental conditions due to fluctuations in water temperatures, discharge and ice conditions (Brown et al. 2011).

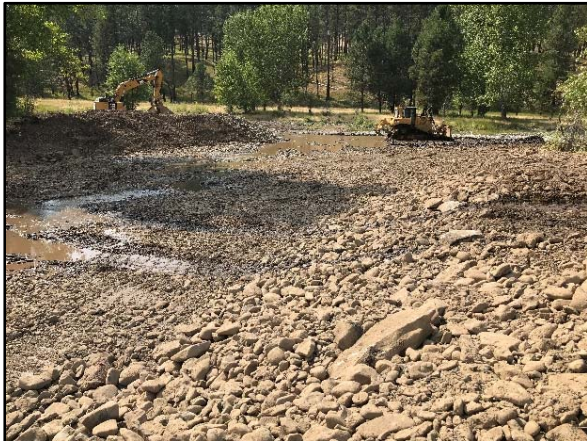
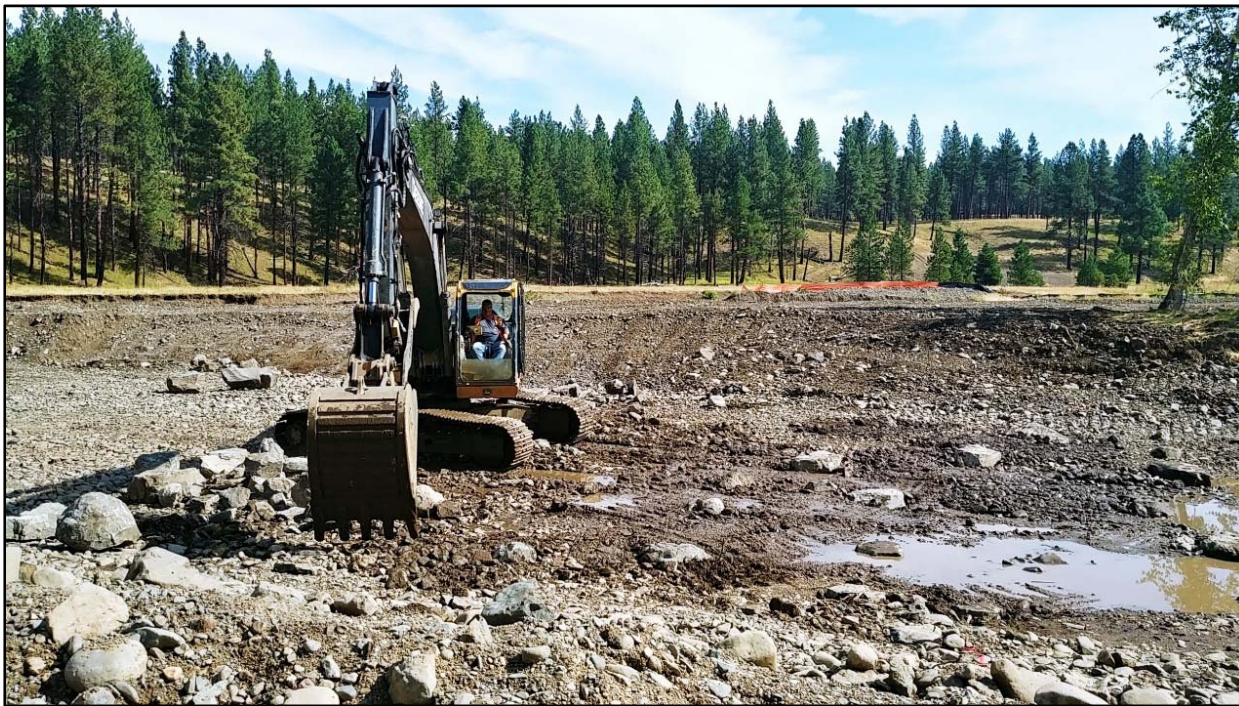
FIGURE 20 MAIN CHANNEL AND SIDE CHANNEL CONSTRUCTION

A total of 16 main channel riffles and 48 side channel riffles were constructed using approximately 9,973 cubic yards of riffle matrix mix, and will aid in maintaining floodplain connection and preventing potential head cuts or channel degradation. A total of 1,389 individual boulders were embedded as clusters into each of the riffle locations to increase channel bottom roughness, provide habitat diversity and velocity refuge, and assist in maintaining vertical grades.

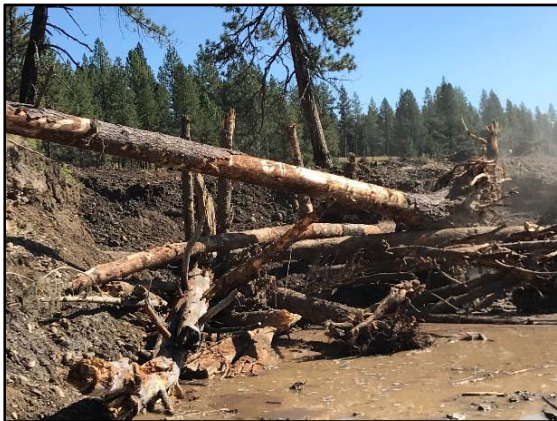
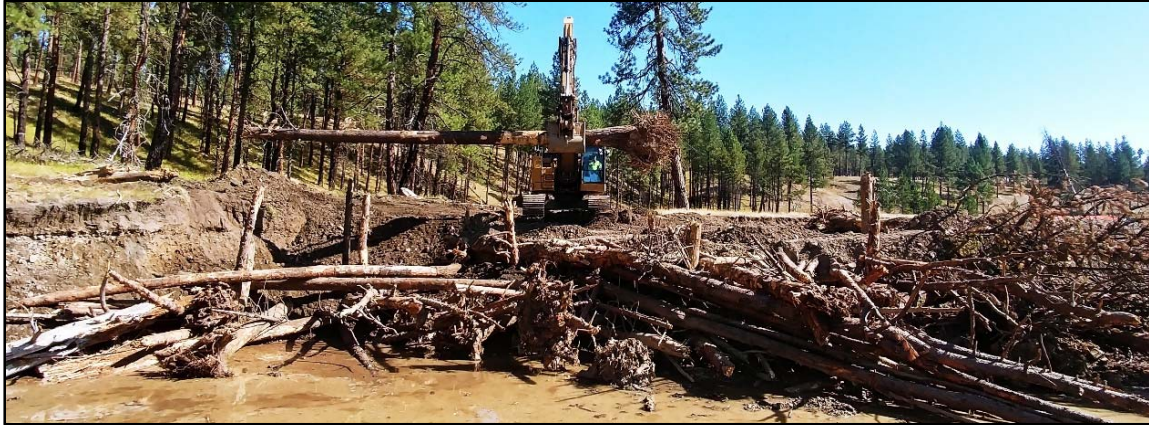
FIGURE 22 LARGE WOOD STRUCTURE CONSTRUCTION

A total of 293 large wood structures and complexes were installed along the main channel and side channels to provide complex and diverse habitat components within the project reach. Purposes of large wood structures included creating hydraulic conditions that maintain deep pool habitat, complexity and diversity, providing temporary streambank protection by redirecting flow and shear stress from near bank and stable bank conditions for establishing riparian vegetation, and providing overhead cover, velocity refuge, and organic nutrients that support food web process and complex rearing and holding habitat.

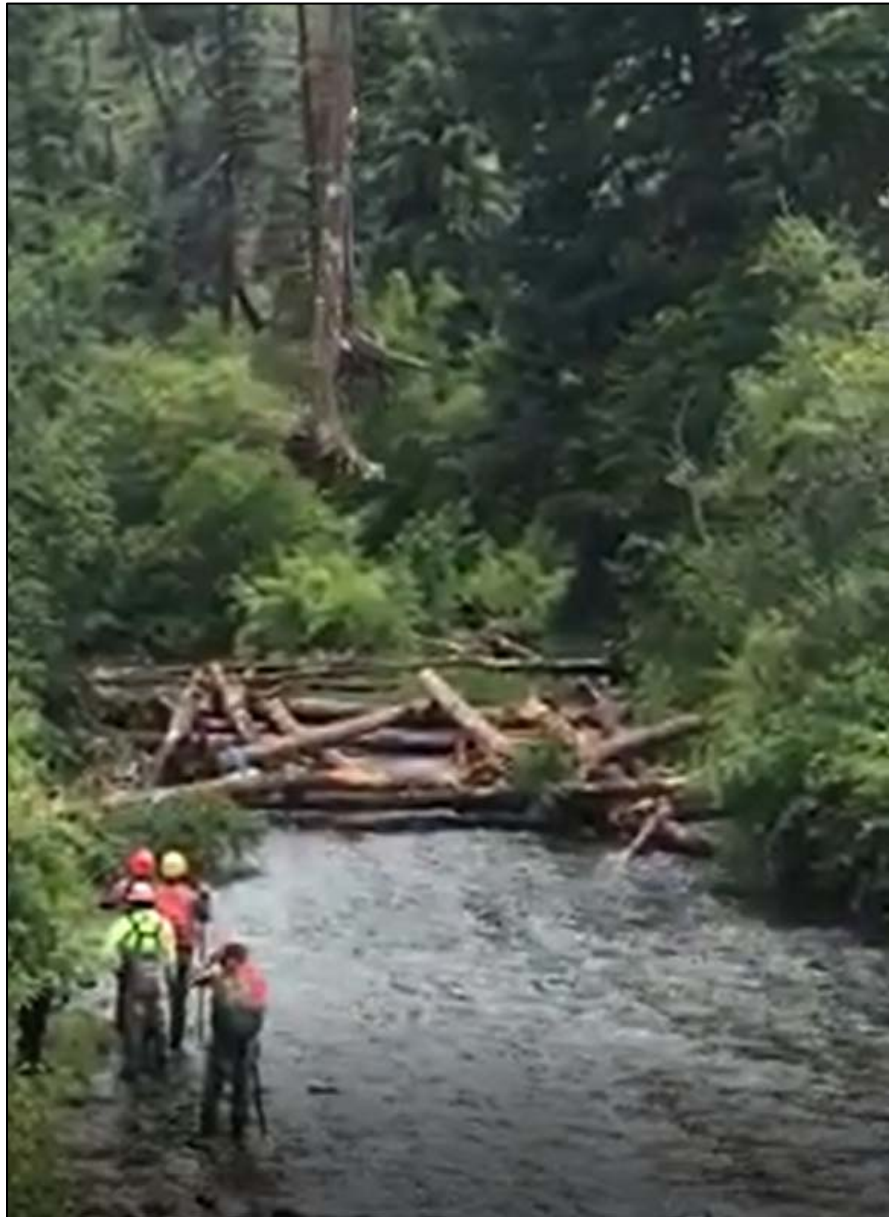
FIGURE 30 HELICOPTER LARGE WOOD PLACEMENT

CTUIR staff provided all site layout and construction detail for the project. Individual wood sites were staked and flagged. Station stakes along the project reach were staked out to provide reference for the entire project. The project included installation of 39 large wood structures and placement of an additional 574 wood pieces in complexes along the main Grande Ronde River channel, side channels and on the floodplain. The project encompassed approximately 2 miles of the Grande Ronde River and 0.30 miles of lower Fly Creek.
