**ANNUAL REPORT
CTUIR GRANDE RONDE WATERSHED
RESTORATION PROJECT
A Columbia River Basin Fish Habitat Project**

Northwest Power Planning Council Project # 1996-08-300

Report covers work performed under BPA Contract 73982 REL 101
May 1, 2020 to April 30, 2021

Confederated Tribes Umatilla Indian Reservation
Department Natural Resources Fish & Wildlife Program
Pendleton, Oregon
Report Created: April, 2021

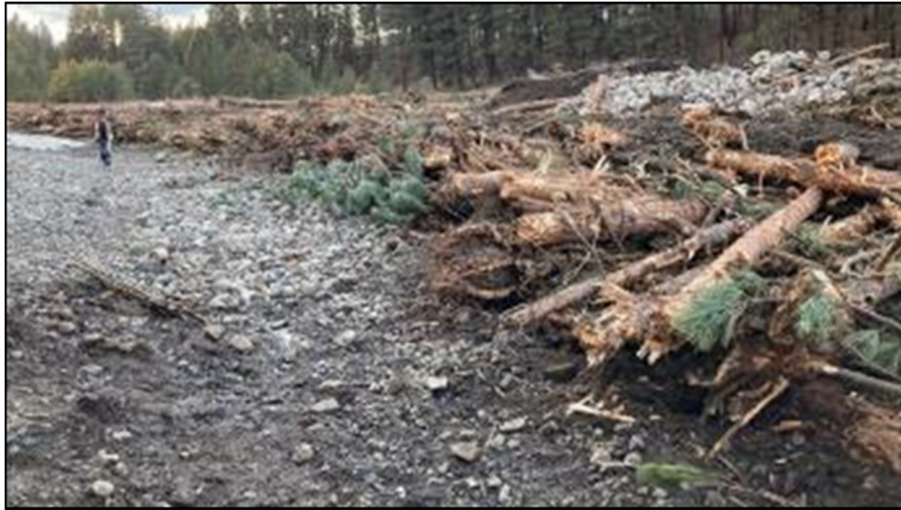
FIGURE 6 ROUGHENED EDGE BANK TREATMENT IN SIDE CHANNEL 5

- Construction of network of side channels and connections to existing off-channel features including swales, remnant channel scars, and low areas to create side channels and ponds;
- ELJs (e.g., meander jams, channel-spanning jams, apex jams, small wood placement acting similarly to beaver dams, channel margin jams, and deflector jams);
- Individual large wood habitat pieces (e.g., sweepers, floodplain roughness);
- Bioengineered bank treatments; and
- Creation and enhancement of alcoves and oxbows.

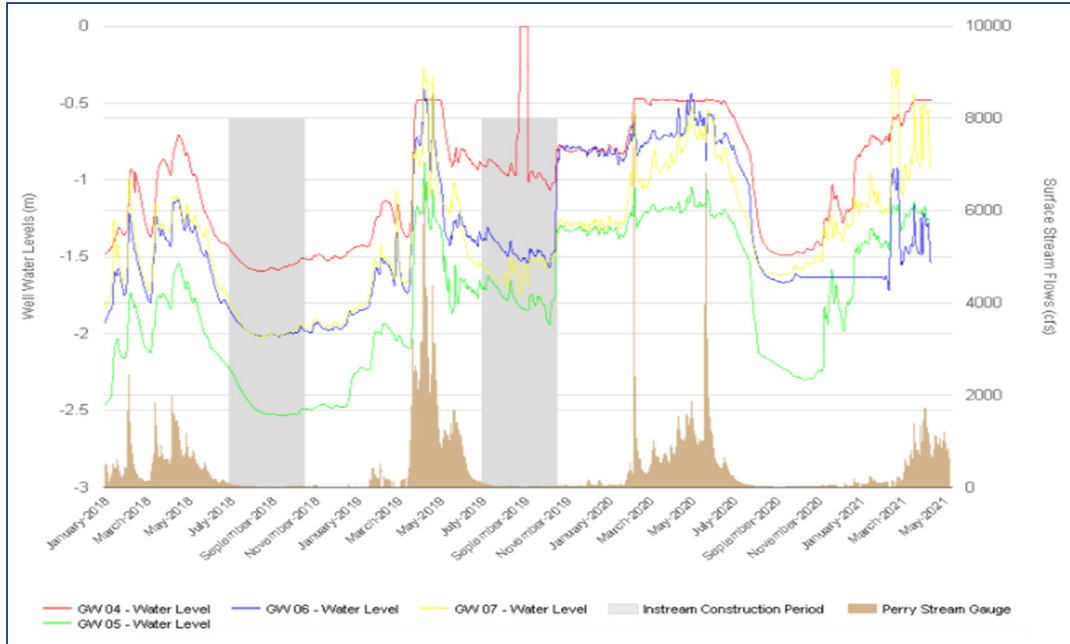
FIGURE 17 AVERAGE DAILY GROUND WATER LEVELS FOR WELLS 4-7 AT BIRD TRACK SPRINGS AND DISCHARGE AT THE PERRY GAUGE, JANUARY-18 TO MARCH-21.

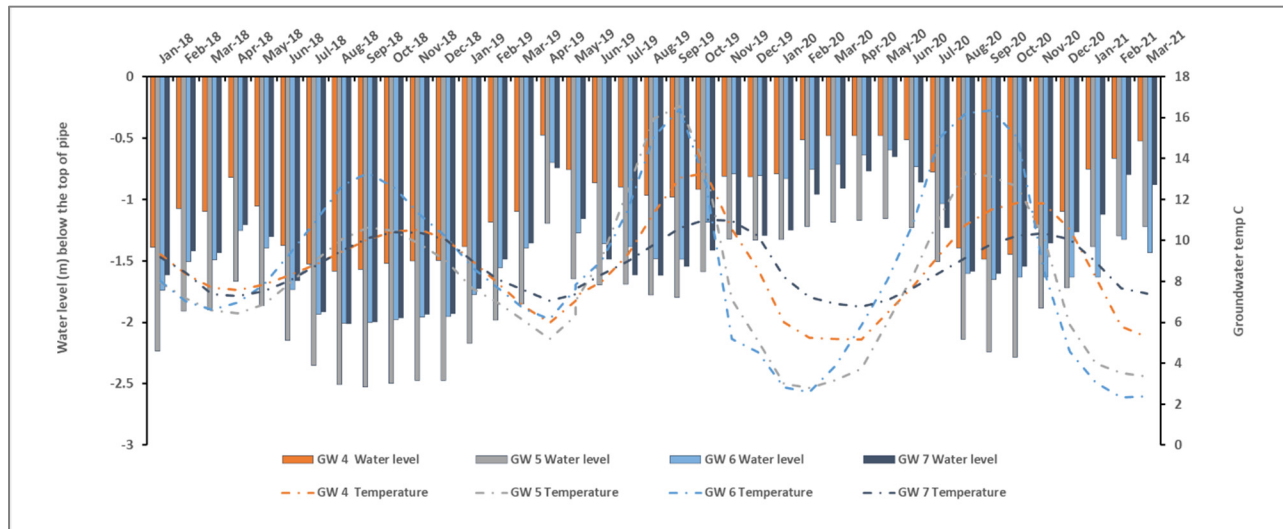
FIGURE 18 MONTHLY AVERAGE GROUNDWATER LEVELS FOR WELLS 4-7 AT BIRD TRACK SPRINGS AND CORRESPONDING GROUNDWATER TEMPERATURES, JANUARY-18 TO MARCH-21. COLORS FOR GROUNDWATER TEMPERATURES AND LEVELS ARE MATCHING

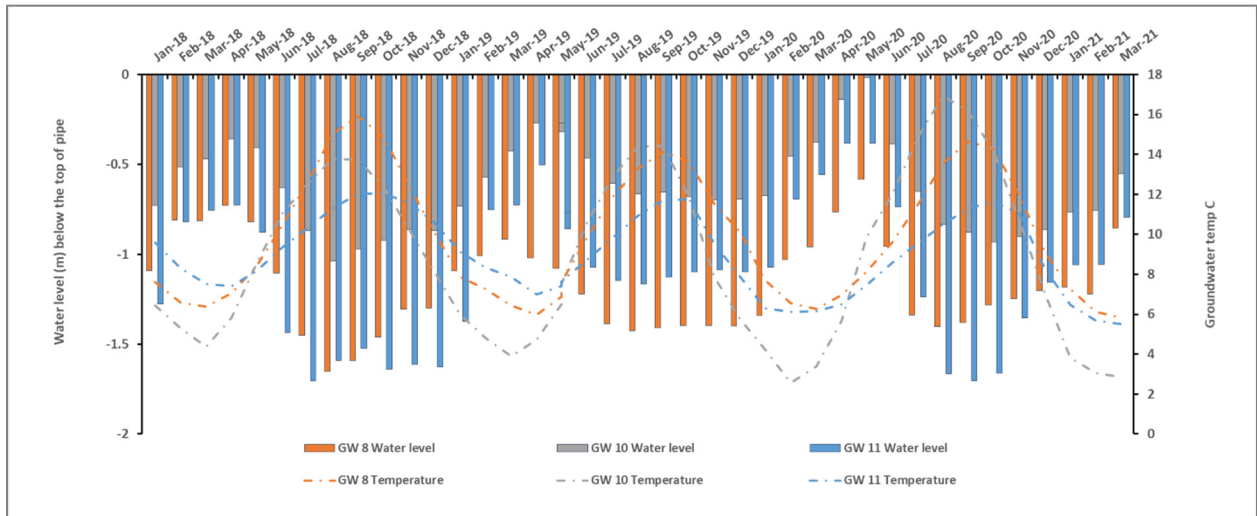
FIGURE 20 MONTHLY AVERAGE GROUNDWATER LEVELS FOR WELLS 8-10 AT BIRD TRACK SPRINGS AND CORRESPONDING GROUNDWATER TEMPERATURES, JANUARY-18 TO MARCH-21. COLORS FOR GROUNDWATER TEMPERATURES AND LEVELS ARE MATCHING

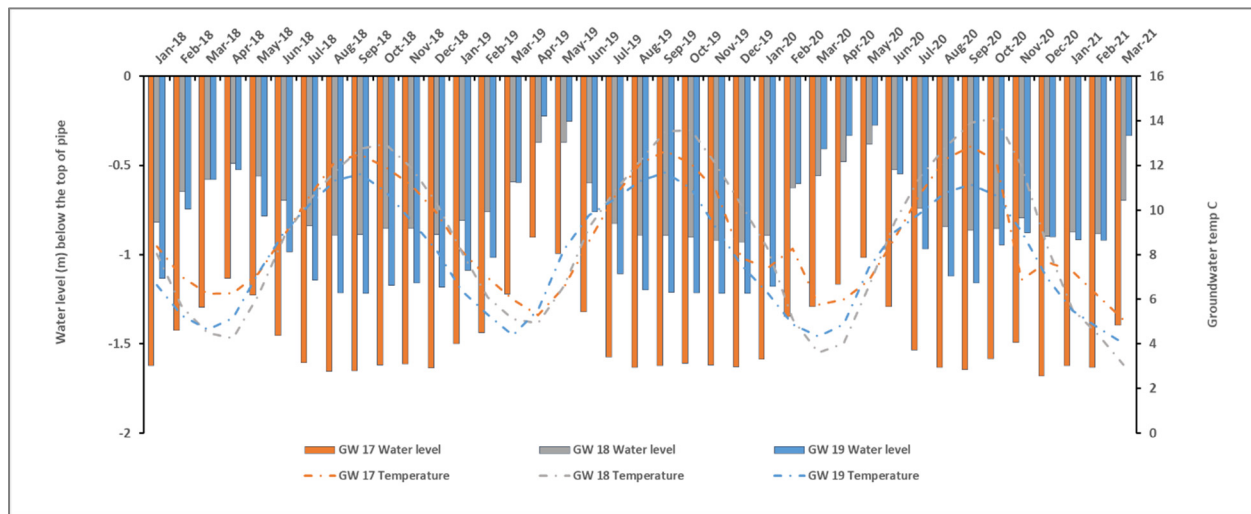
FIGURE 22 MONTHLY AVERAGE GROUNDWATER LEVELS FOR WELLS 17-19 AT LONGLEY MEADOWS AND CORRESPONDING GROUNDWATER TEMPERATURES, JANUARY-18 TO MARCH-21. COLORS FOR GROUNDWATER TEMPERATURES AND LEVELS ARE MATCHING

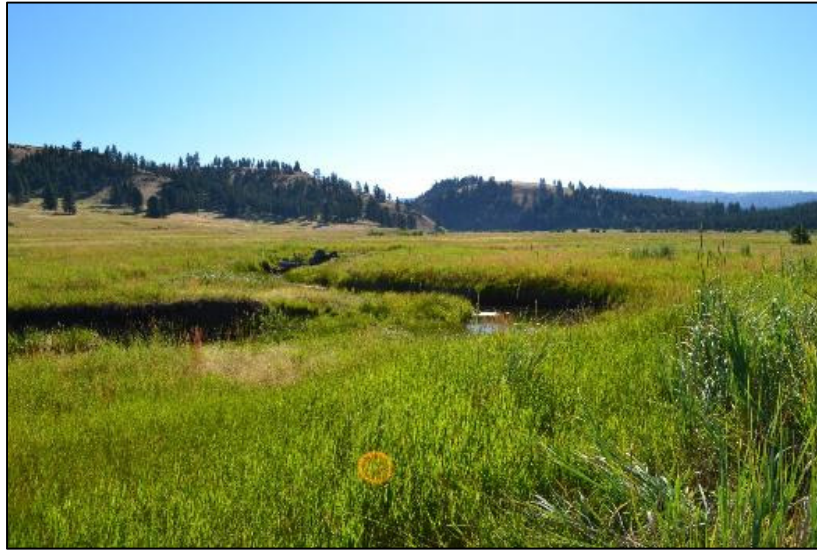
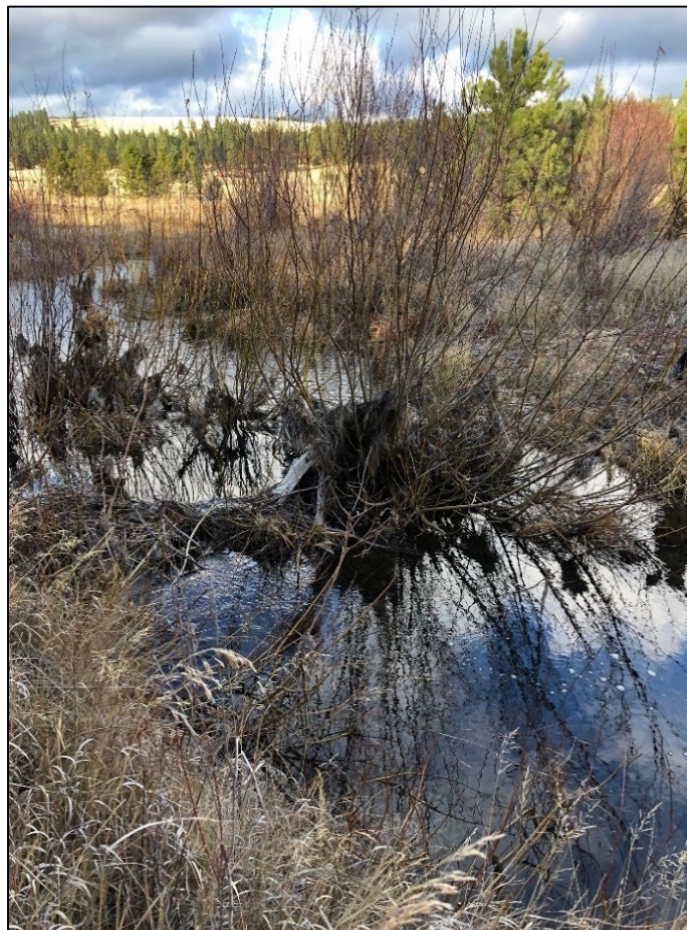
FIGURE 32 UNPROTECTED REACH ON MCCOY CREEK, JULY 2017

FIGURE 33 PROTECTED ELK ENCLOSURE ON MCCOY CREEK AND RECENT BEAVER ACTIVITY, DECEMBER, 2018

Representative samples are provided below. Of particular note are stark differences in recruitment of riparian vegetation between enclosed and exposed areas in the McCoy Creek/Meadow Creek complex. This project is subject to intense browsing pressure from wild ungulates resulting in extremely limited release of riparian vegetation in untreated areas. This contrast is readily seen when comparing photo points of protected and unprotected areas of the project (Figures 29 and 30).

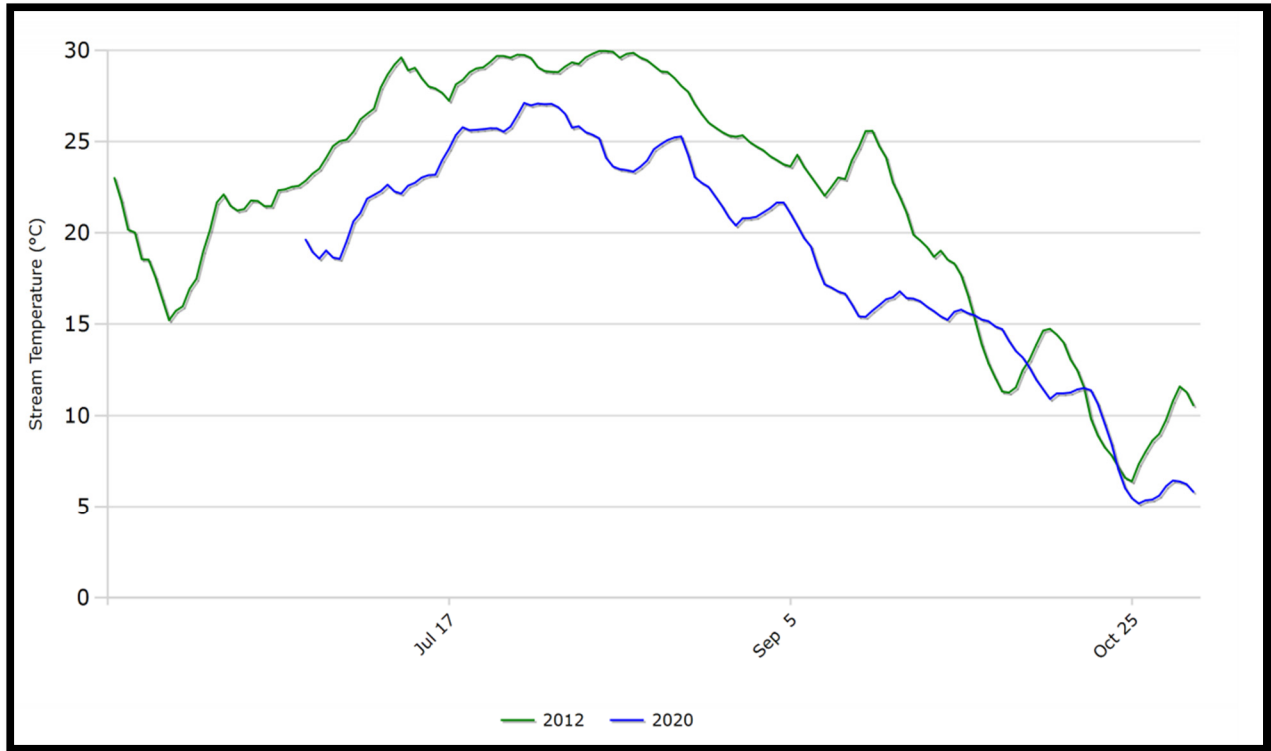
FIGURE 56 MIDPOINT 7DADM FOR ROCK CREEK LOWER PROBE (ROCK_RM0.23)

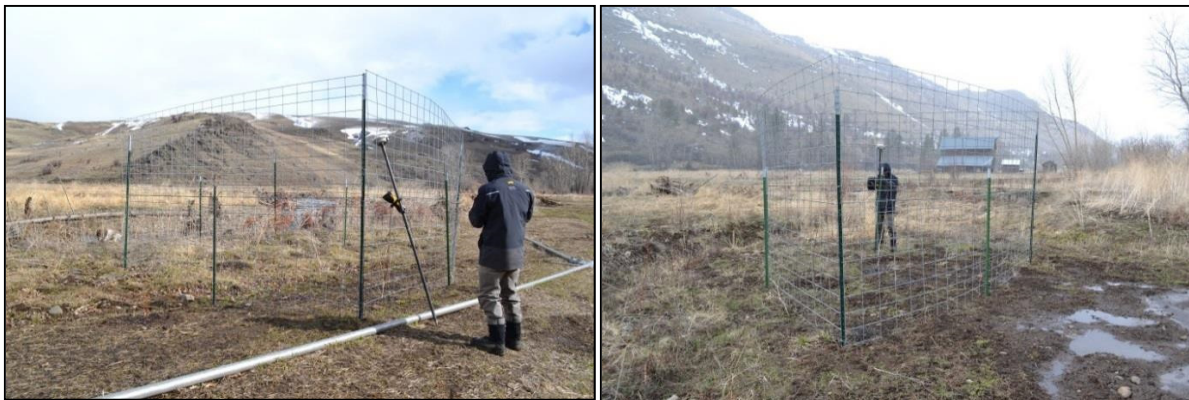
FIGURE 64 DIFFERENT ENCLOSURES TYPES-8’X8’ SQUARE ON LEFT AND 8’X8’X8’ TRIANGLE ON RIGHT.

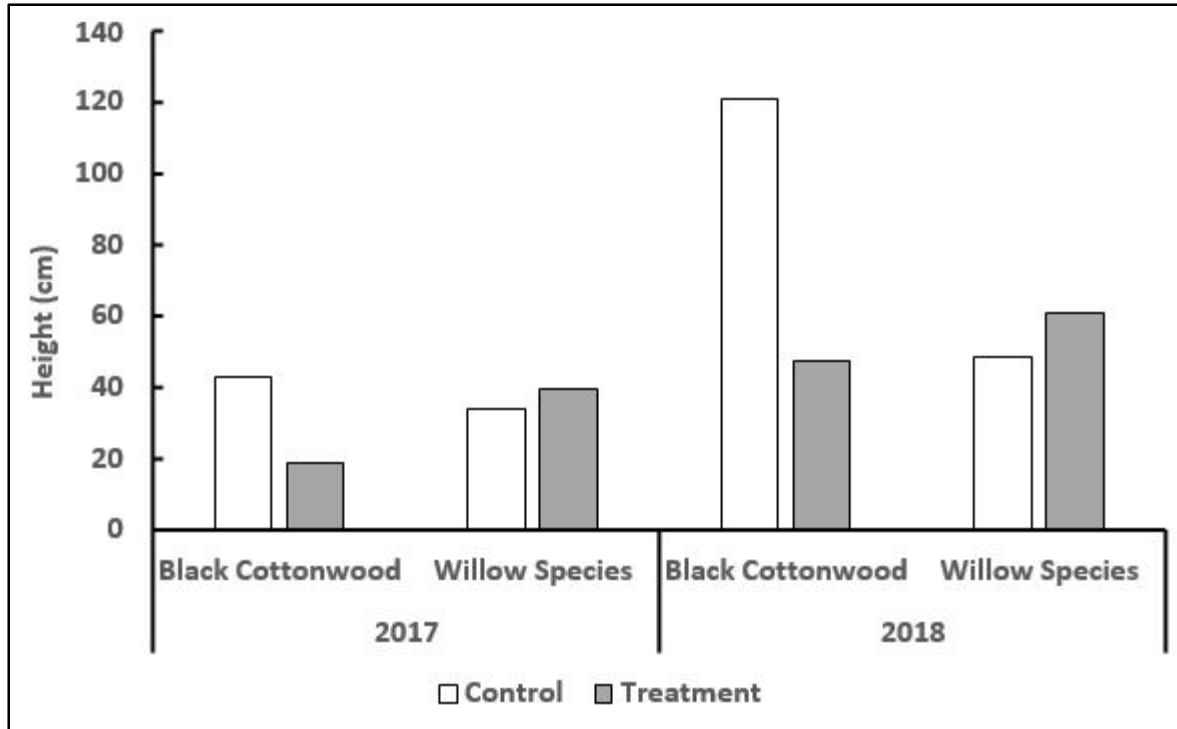
FIGURE 66 DIFFERENCE IN AVERAGE HEIGHTS (I.E. GROWTH) OF BLACK COTTONWOOD AND SALIX SPP. FOR TREATMENT AND CONTROL GROUPS DURING 2017 AND 2018 GROWING SEASON. THE CONTROL PLOTS DID NOT INCLUDE ENCLOSURES.
