Restoring Functional, Sustainable Floodplain and Watershed Processes: Grande Ronde Subbasin Bird Track Springs Project

CTUIR Department of Natural Resources, Grande Ronde Habitat Project, La Grande, OR

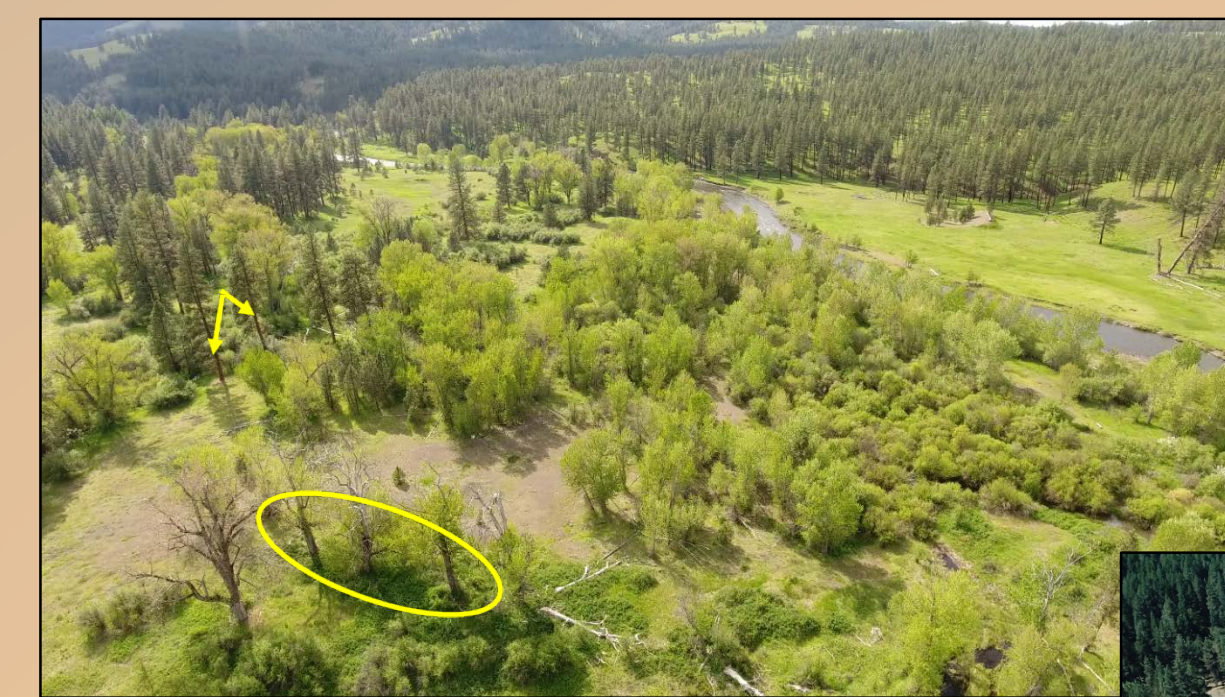
Main channel pre-project, looking upstream

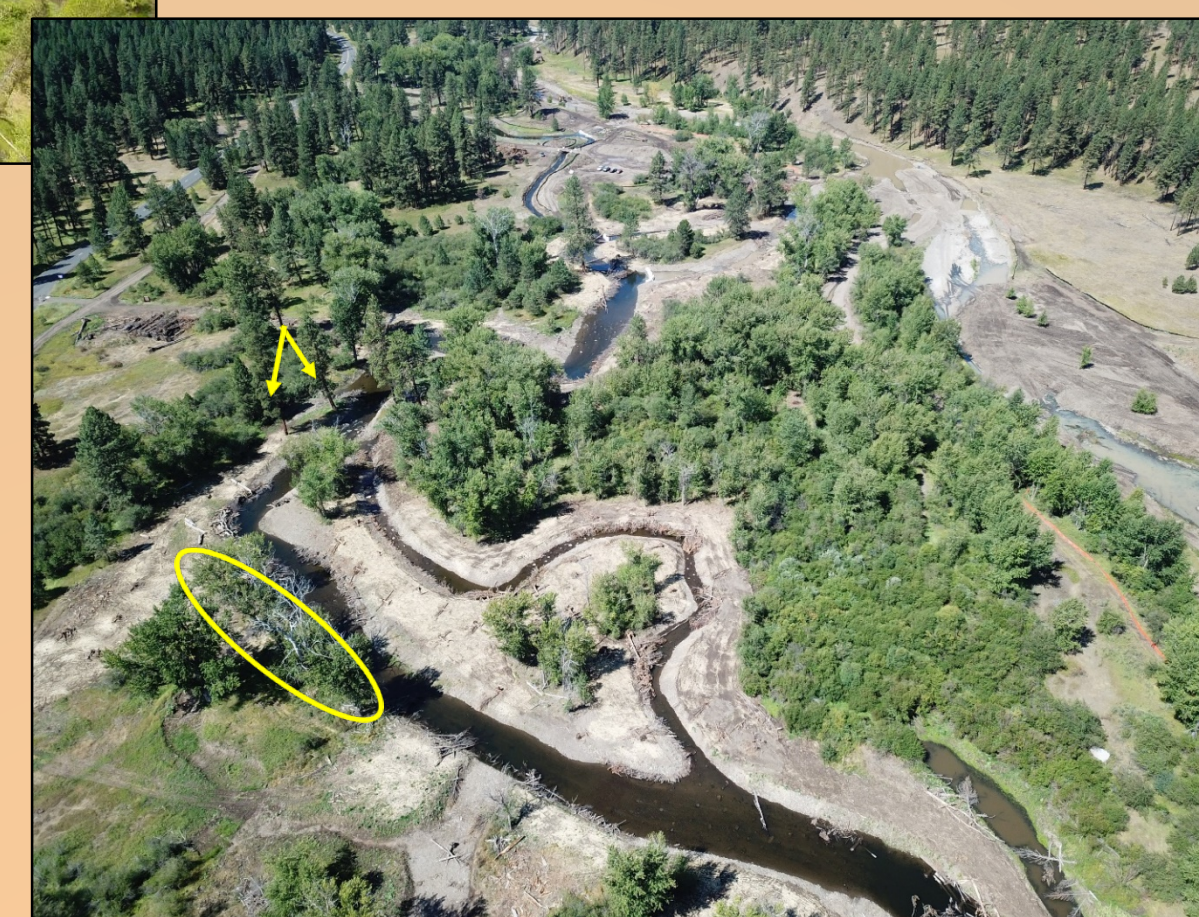
Main channel and side channel 5 post-project, looking upstream

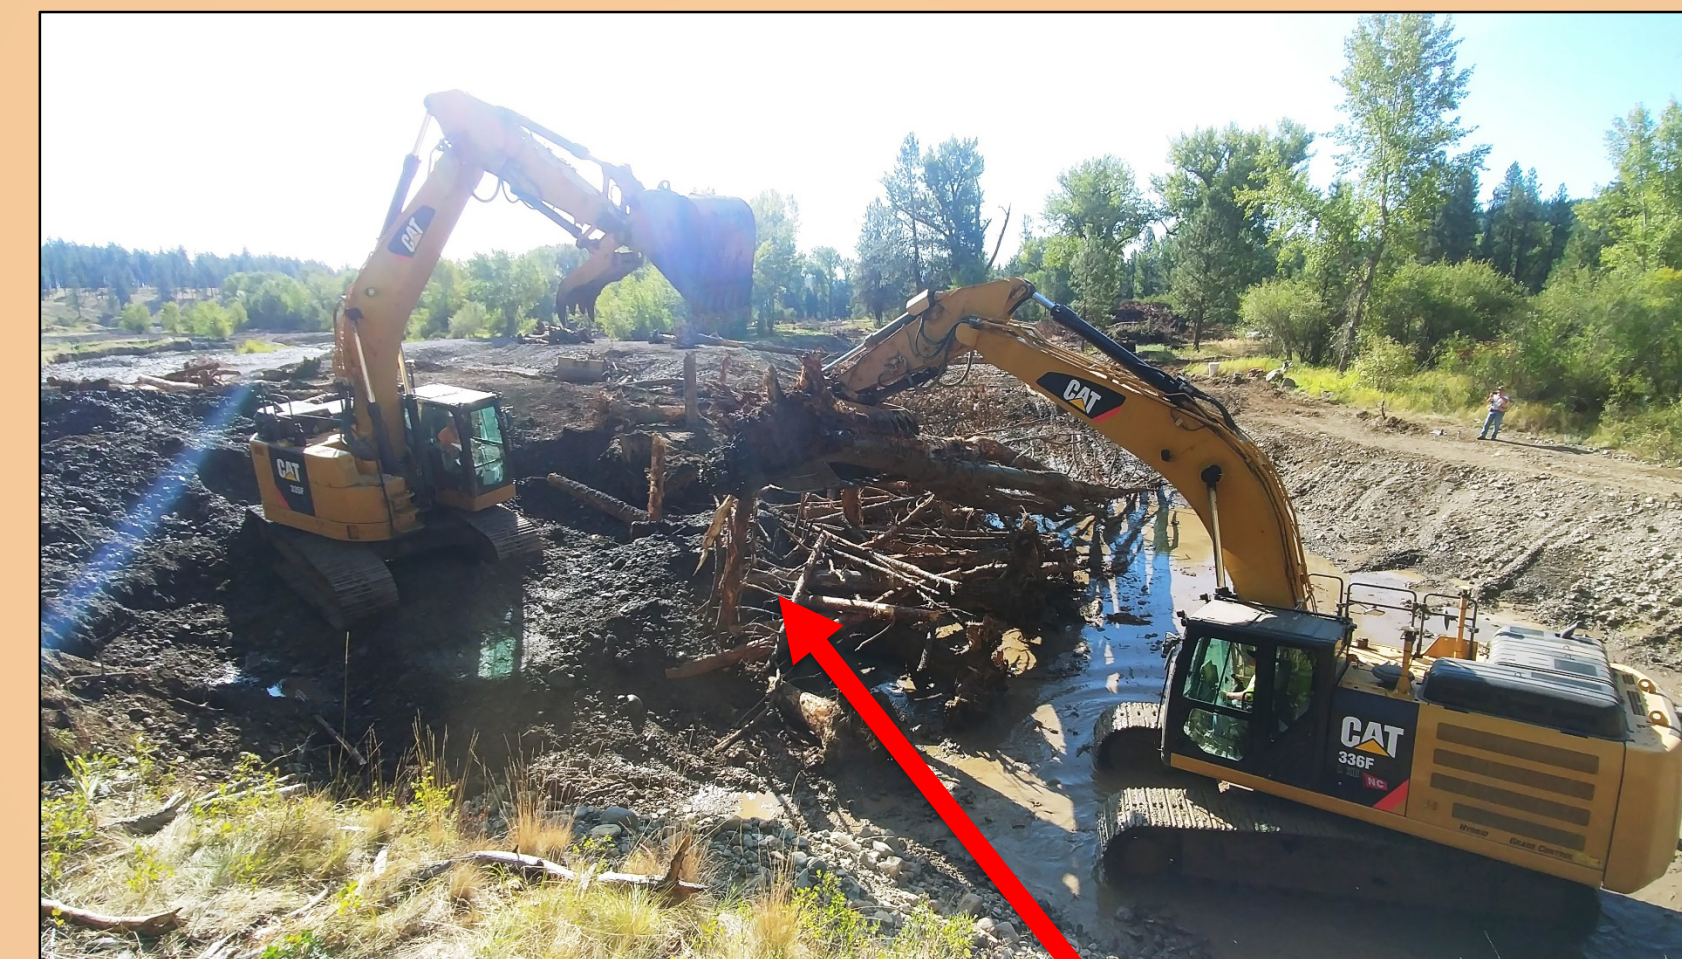
Large wood structure construction at station 42+00, August 23, 2019 (looking downstream).

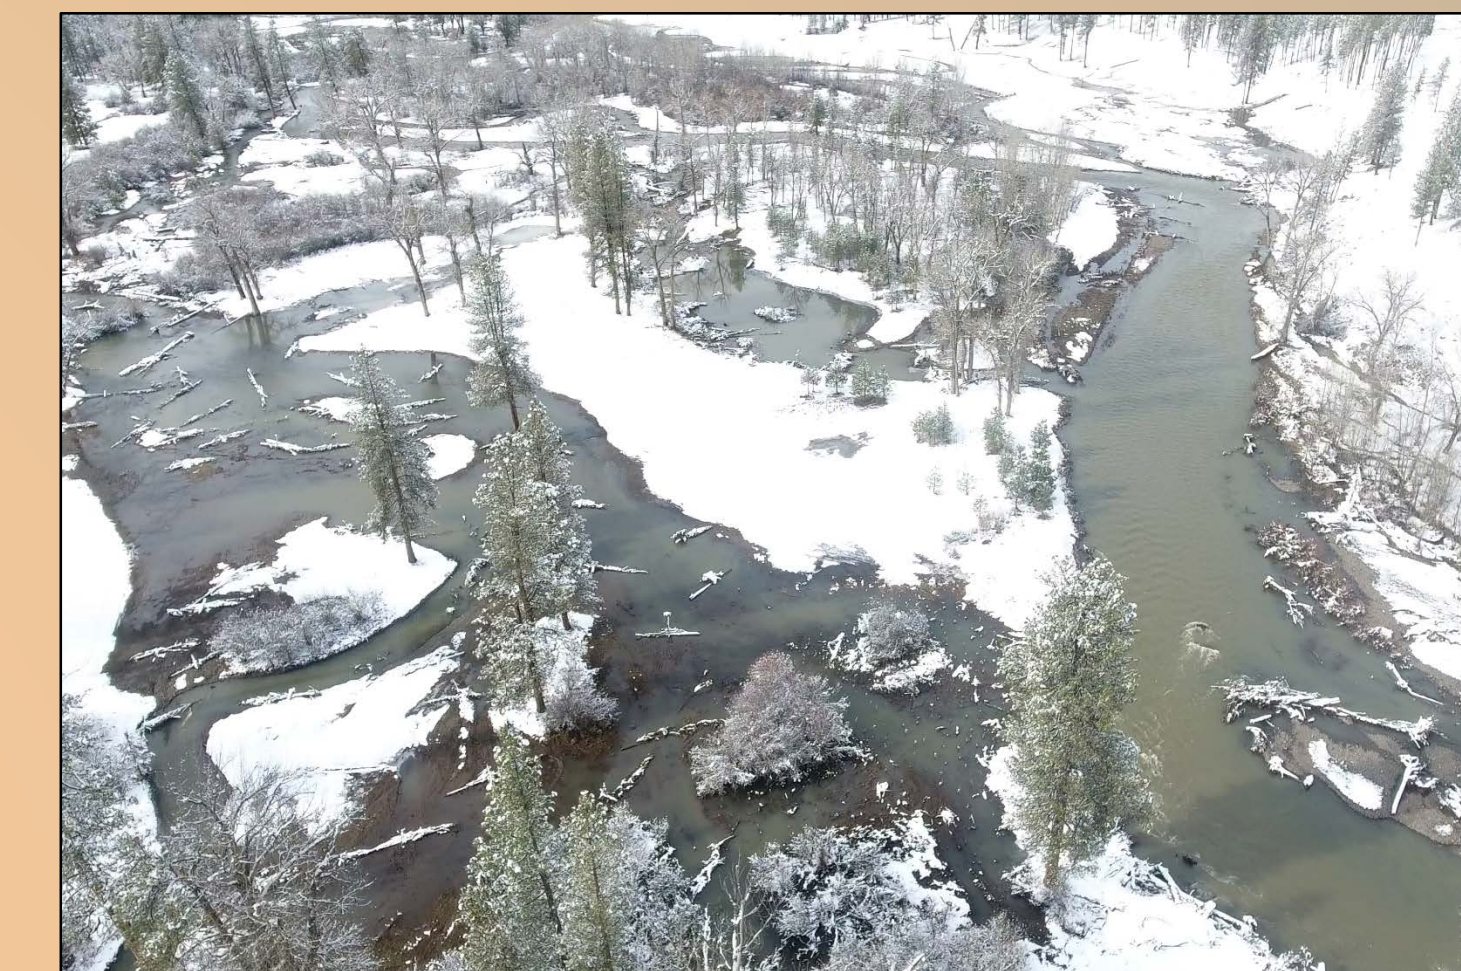
Floodplain activation at station ~80+00

The Grande Ronde River through the Bird Track Springs Project sustained a 50-year (approximate) flood event on February 6, 2020. Recently constructed channels, swales, large wood structures, bank treatments, and floodplain structures withstood the high flows remarkably well, with minimal damage to constructed project components. Below are images of the event:

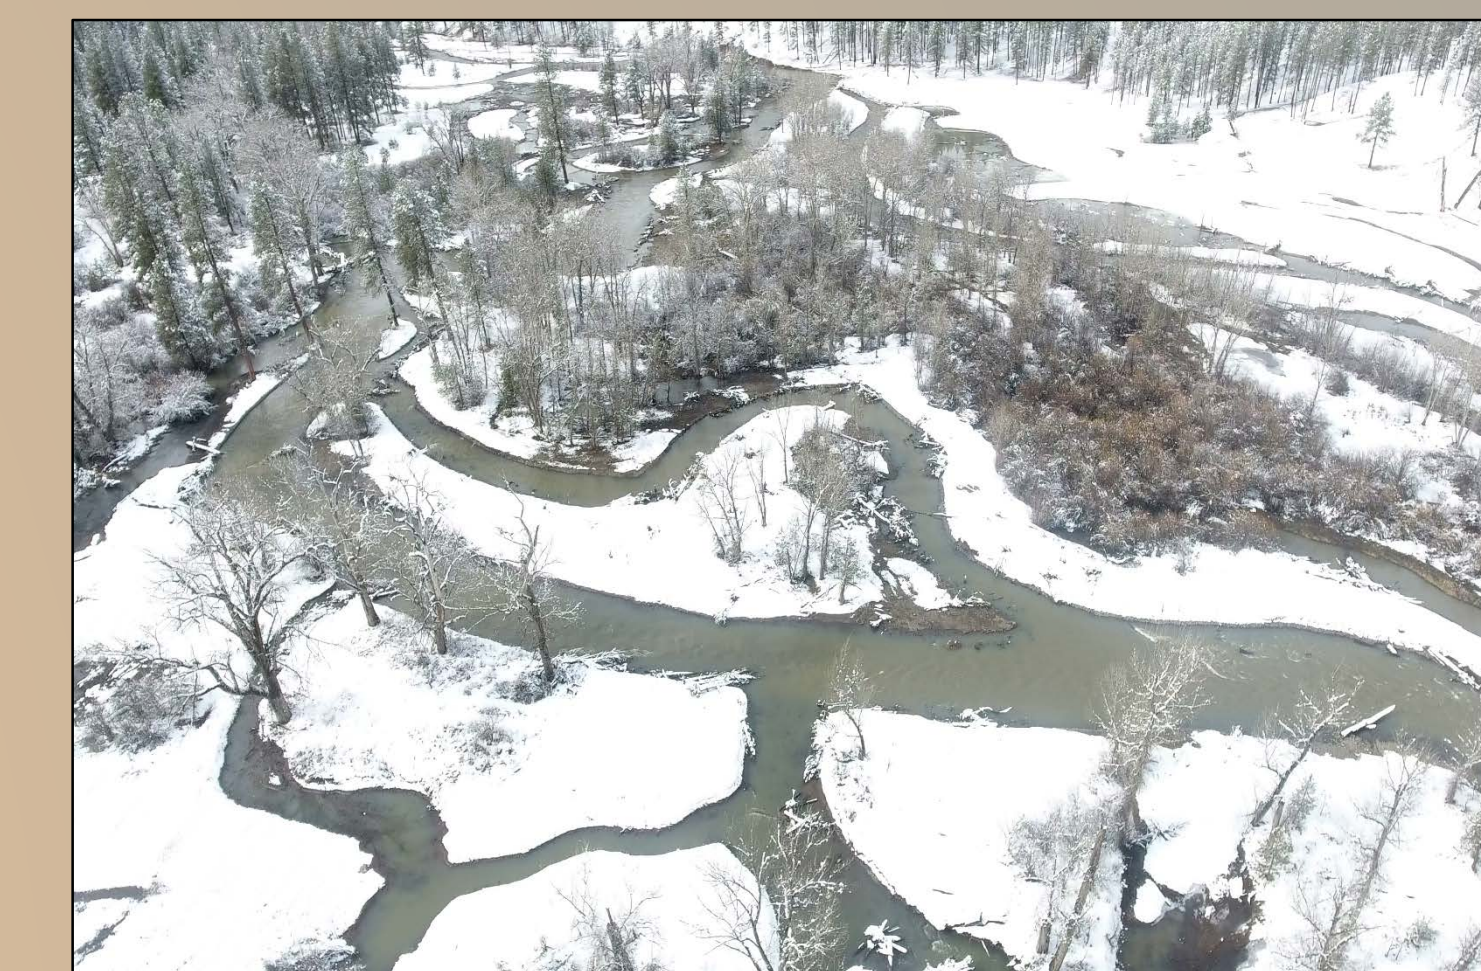
Floodplain activation at station ~65+00

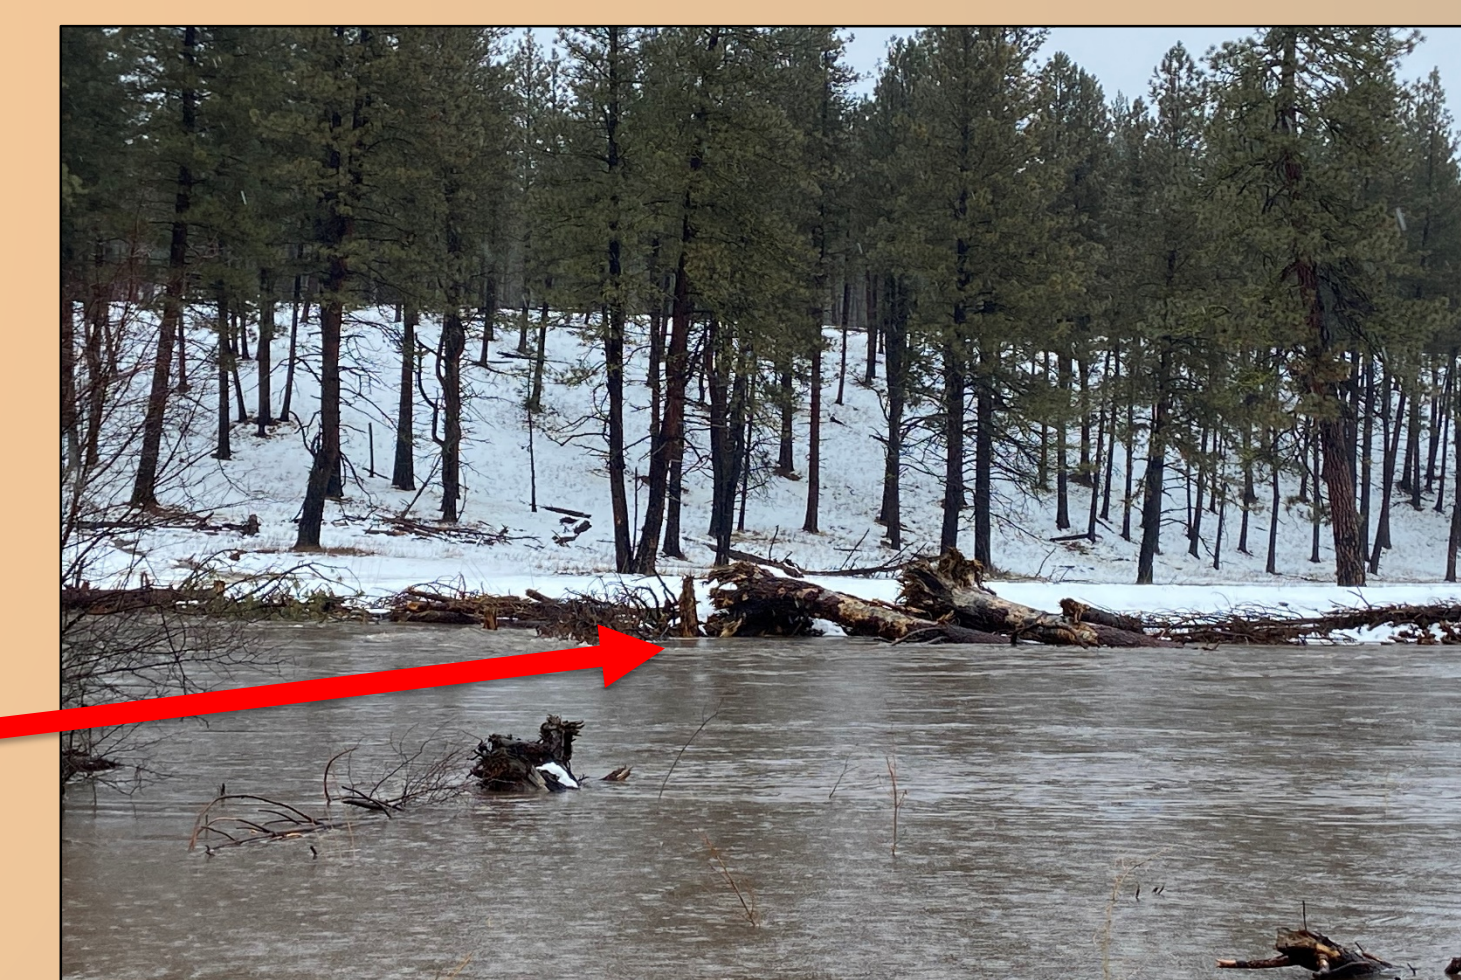
Large wood structures at station 42+00

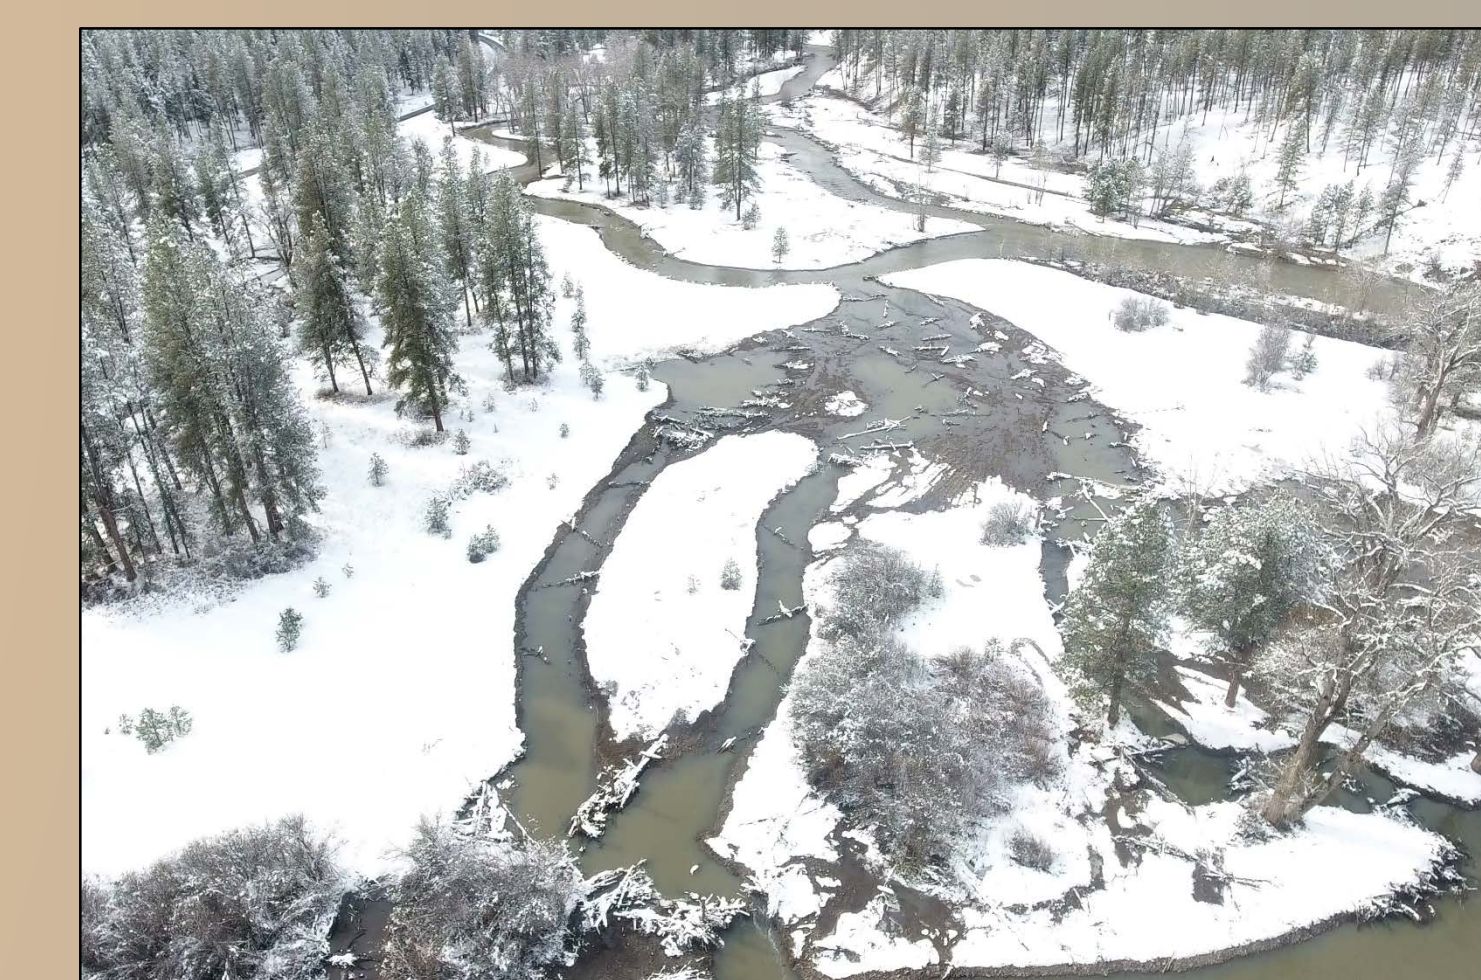
Floodplain activation at station ~52+00

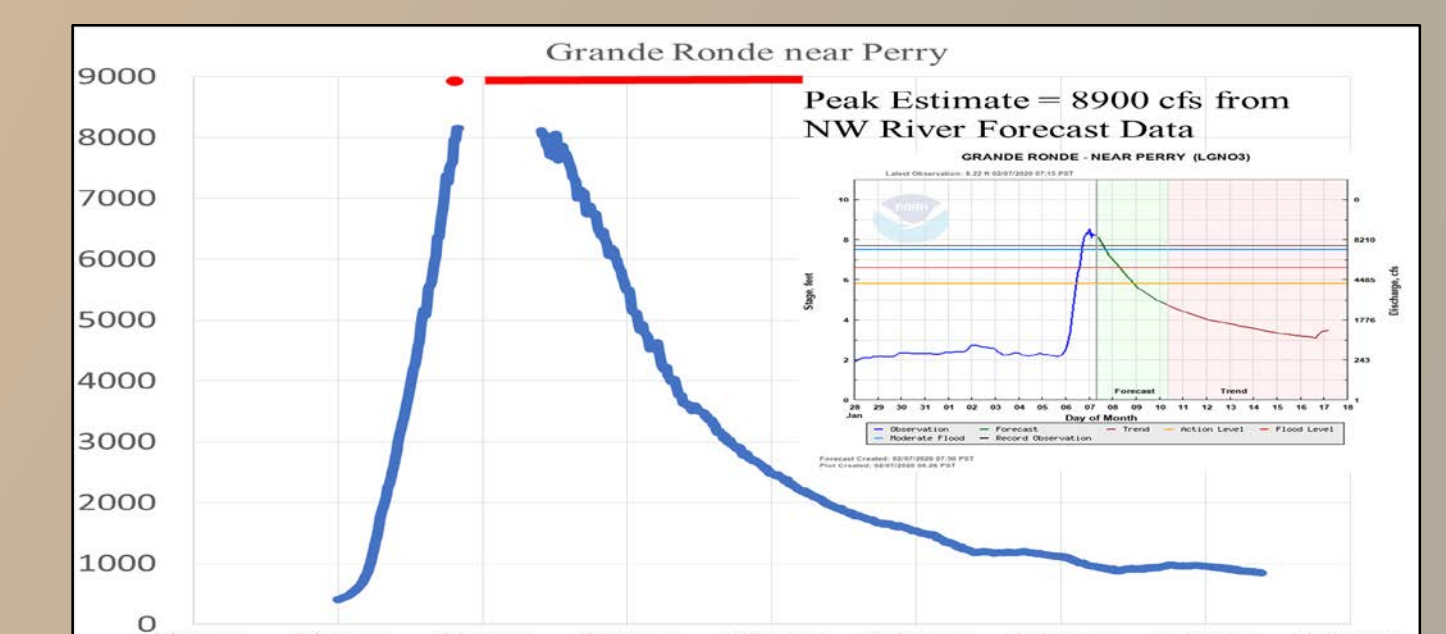
The Grande Ronde River at Perry sustained a record flow event of ~8,900 cfs. From hydrology data, it appears the project sustained ~5,500 cfs.
