## Catherine Creek Tributary Assessment Hydraulics Appendix

Grande Ronde Project, OR  
Pacific Northwest Region  
SRH Report 2012-05

# Catherine Creek Tributary Assessment Hydraulics Appendix

**Grande Ronde Project, OR  
Pacific Northwest Region  
SRH Report 2012-05**

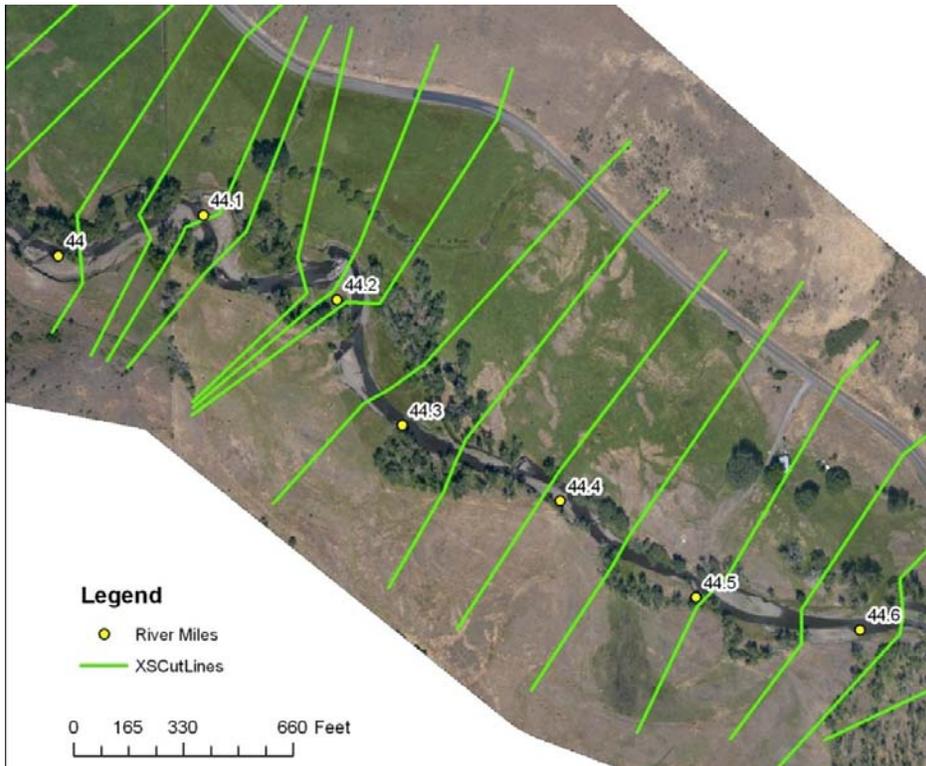
Figure 3. Example portion of upper Catherine Creek with delineated cross sections.

across the three streams. Figure 3 shows a portion of the cross sections delineated upstream of Union, OR near RM 44. Figure 4 shows a portion of the cross sections delineated on Catherine Creek near RM 10. A module within HEC-GeoRas was then utilized to convert all of the delineated line work and topographic information into a HEC-RAS format. The stream channel is extremely sinuous and the dominant flow paths may be different at bankfull and flood flows. There was an attempt to represent the main channel flow paths and overbank flow paths as accurately as possible. However, because of the complex stream channel alignment, this is difficult and it may be necessary to alter the over bank representation to better represent flood flows.

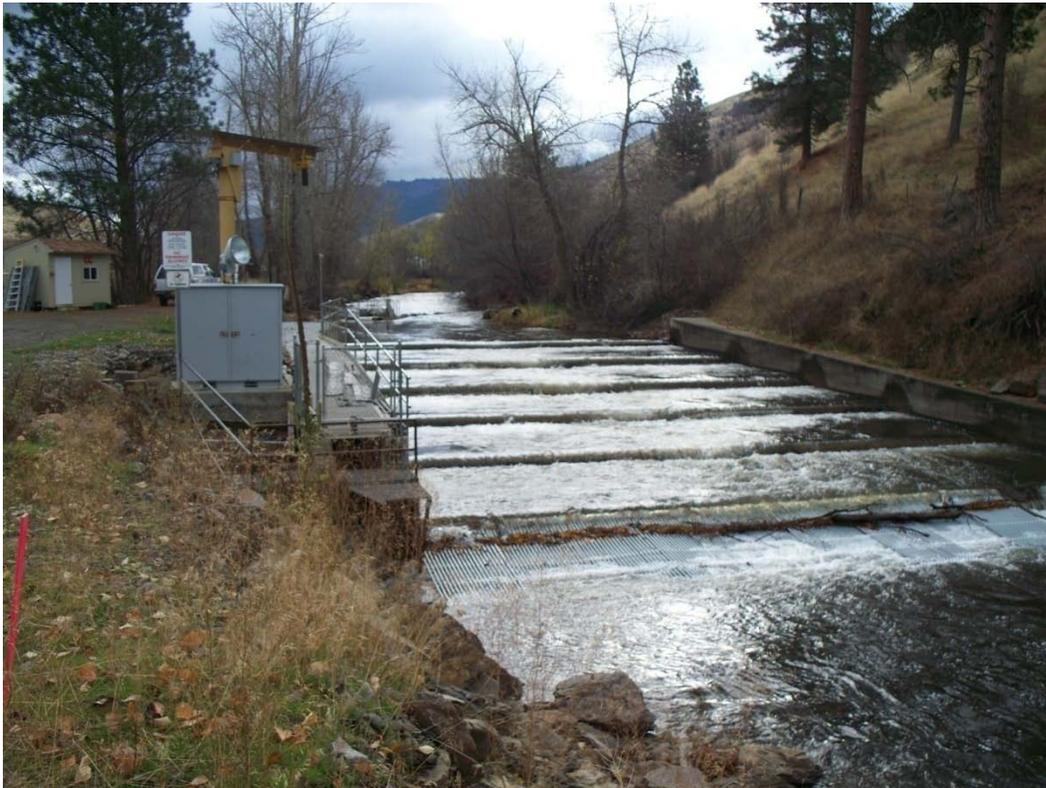
Figure 6. Medical Springs #D2 Diversion (aka Catherine Creek Adult Collection facility, CCACF) looking upstream. Photo courtesy of AP, taken on November 16, 2010.

Nine diversion dams were included in the HEC-RAS model. Only the grade control portion of a diversion dam was included. For example, Medical Springs Diversion #D2 is a series of notched weirs (shown in Figure 6). To include this structure, the four adjacent cross sections were adjusted in a similar manner to the bridge cross sections. Then, the highest weir (typically the most upstream) elevations, width, and dimensions were input as an inline weir structure in HEC-RAS. The highest weir acts as a water surface control and the other weirs would have only a small local effect on the hydraulics.
