Tucannon River Programmatic Habitat Annual Report

Project #: 2010-077-00

Annual Progress Report

(Reporting Period January 2018 to December 2018)

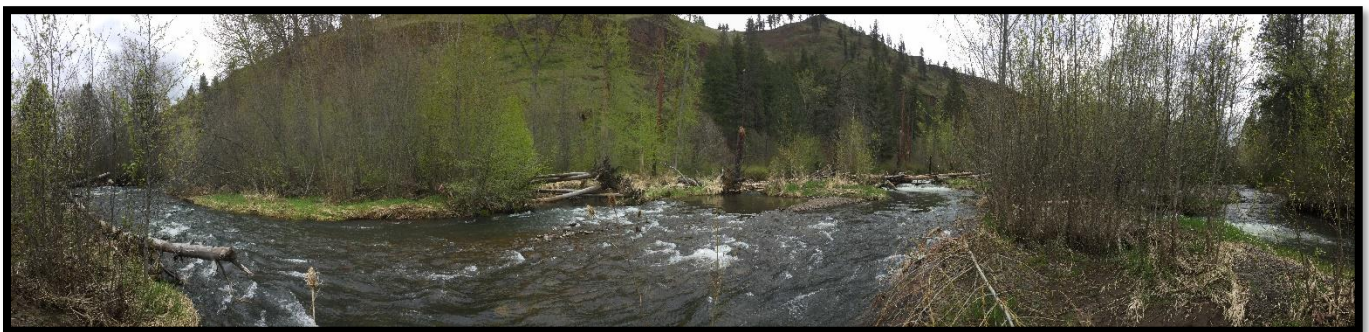
Floodplain connectivity created in a previously incised reach of the Tucannon River in PA-10, during an estimated 120 cfs flow.

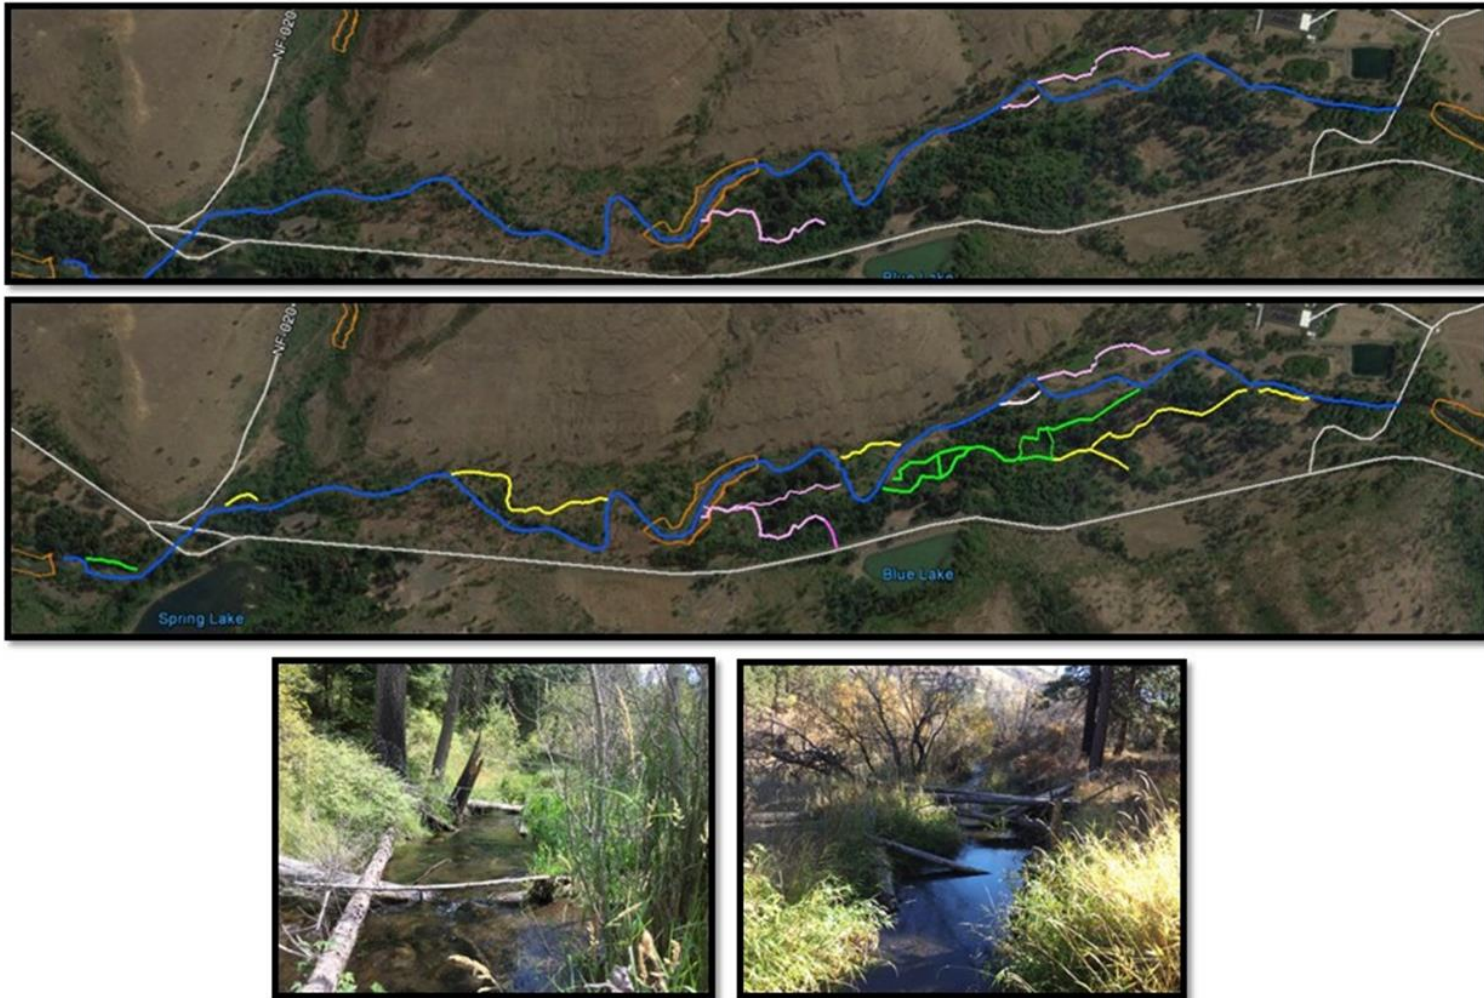
Figure 6: The program partners within the Tucannon have used side channel re-connection actions to reconnect floodplain and increase River Complexity. The upper map illustrates side channel reconnection in one project reach in the Tucannon (upper pre-project and lower post project, with the green lines being perennial, yellow being ephemeral and pink being reconnected tributaries). The lower pictures illustrate channel conditions within reconnected side channel reaches.

The restoration approach enacted by the Program and its partners has focused on restoring stream channel complexity and floodplain connectivity to the extent possible give landownership and public support. Where possible restoration actions target full reconnection of floodplain at flows >1.5 year flood. In 2017, the Program adapted some of the more widely used channel evolution models (Cluer 2013, Brierly 2005) for forested wandering gravel bed, to best fit the Tucannon River (Figure 2, Figure 3). The floodplain model illustrates the ecological process targeted for habitat restoration in the Tucannon and helps to communicate the benefits of connected floodplain to practitioners and the public. The model illustrates that as floodplain roughness is lost, the river channel devolves to a wider shallow channel traveling unabated over the floodplain as exhibited in our model stage B (Figure 2 & 3). In the Tucannon, this lead to land management activity, which have trained the river to be straighter and steeper, and in some place trapped the river behind levees illustrated in our stage C (Figure 2 & 3). Once this has occurred, channel evolution stalls leaving the channel in a relatively stable condition best described as arrested degradation (Clure, Thorne 2013), poor conditions can persist until the stream is forced from the stage. In 2018, one additional stage was added to our Tucannon model though it has not at the time of this report been illustrated which would include a transition from stage B (Figure 2&3) to an incised state which required no levees to maintain, but remains in an arrested degradation state as well through entrenchment and legacy armored river cobble. The Program approaches floodplain connectivity from three angles, the removal of river levees or gravel berms/fill that blocks overbank flow or disconnected channels from being inundated (Figure 4). In many project reaches simple removal of blockages is not, the single action required to reconnect floodplain in the Tucannon. These reaches also require the placement of LWD in some structural form, but for the purpose of reducing channel capacity and increasing streambed roughness raising flood stage (Figure 5). Wood structures placed in the Tucannon for the purpose of reconnecting incised channels, which exhibit plane bed condition and are stuck in arrested degradation (Figure 2-3 C). The third is to cut or reconnect side channels, an approach to spreading flows and proving winter refuge for juvenile Chinook (Figure 6).

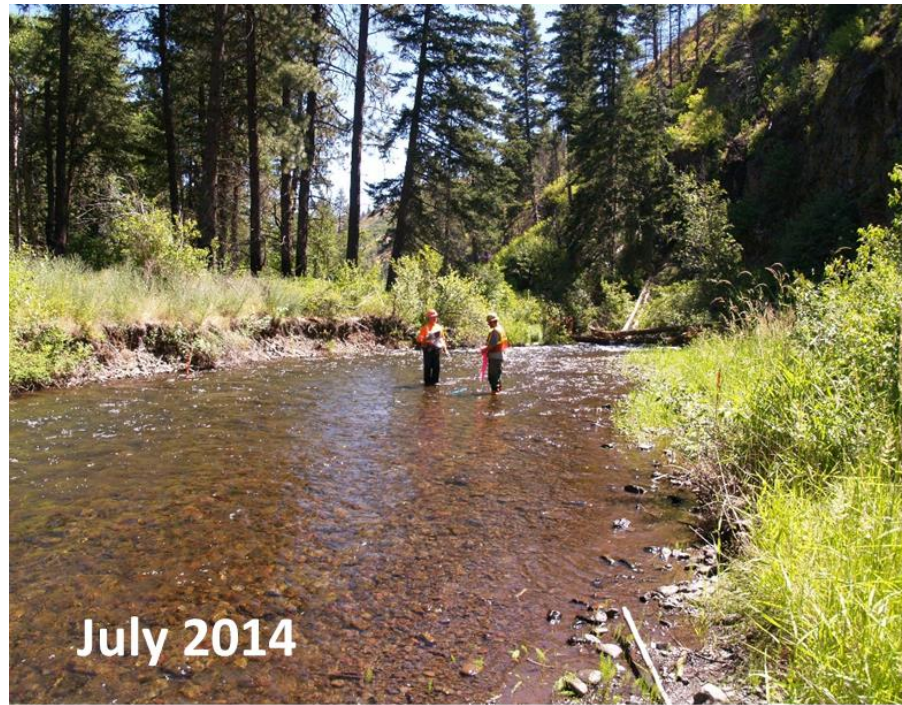
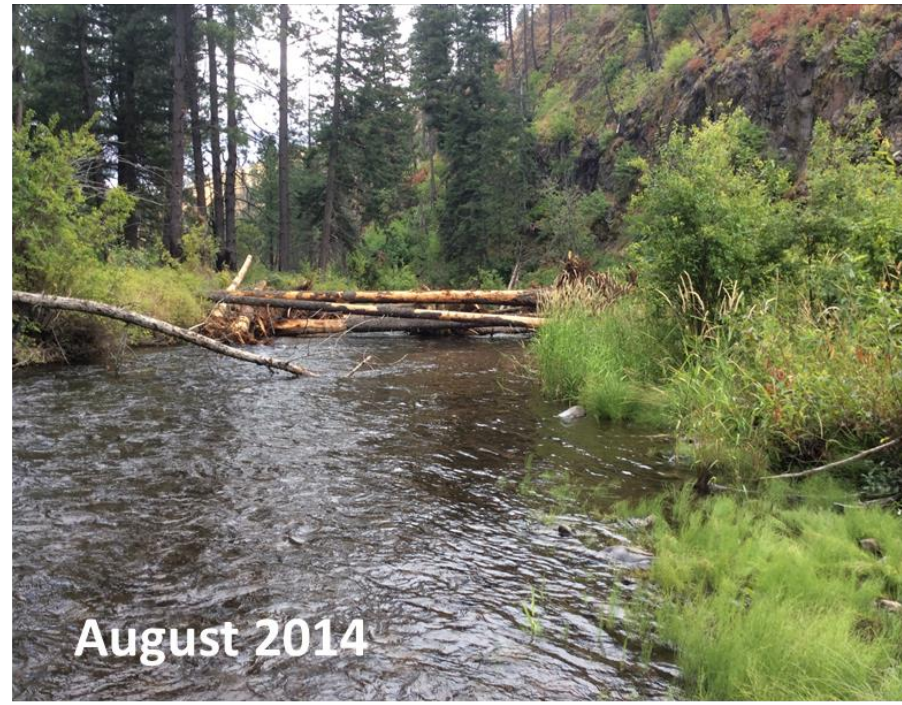
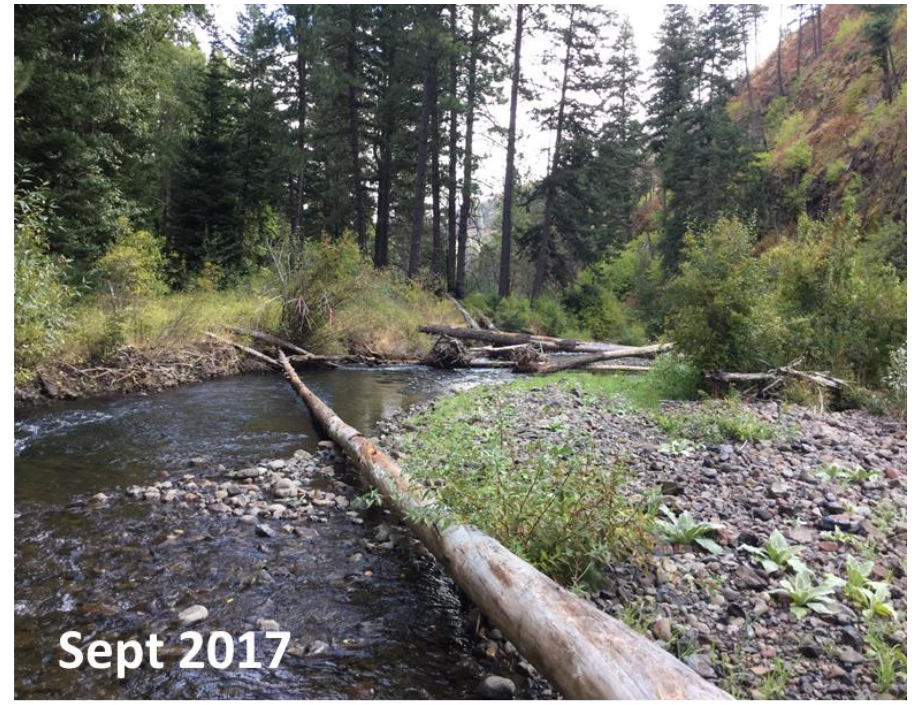
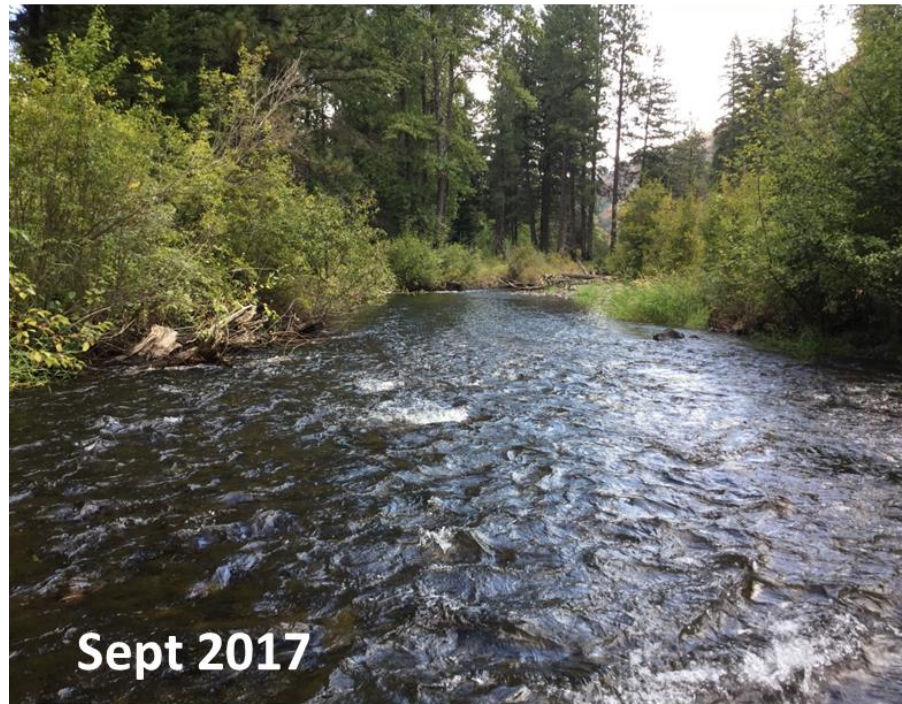
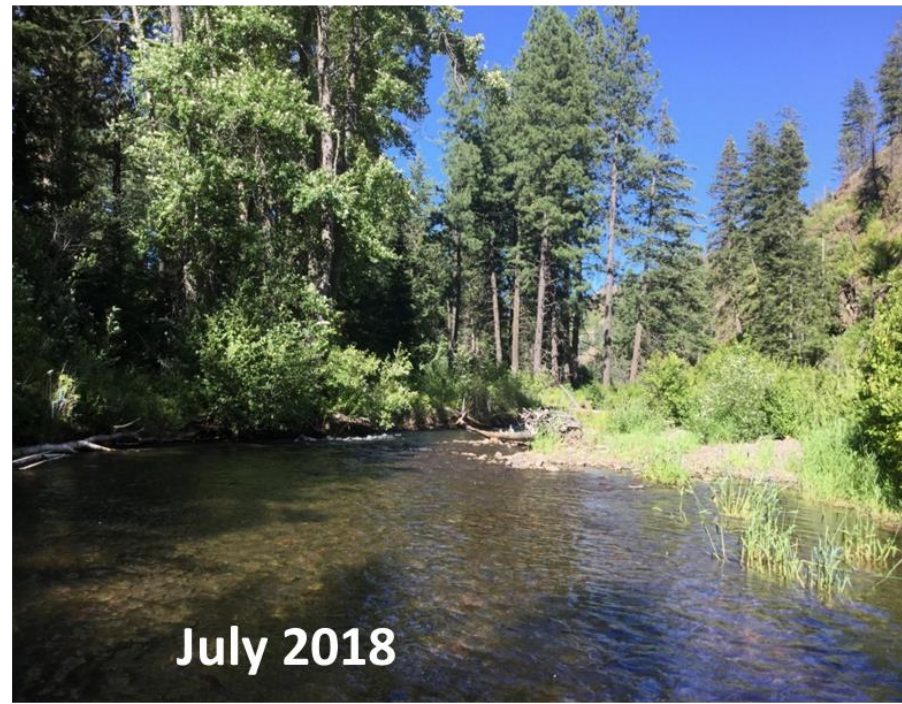
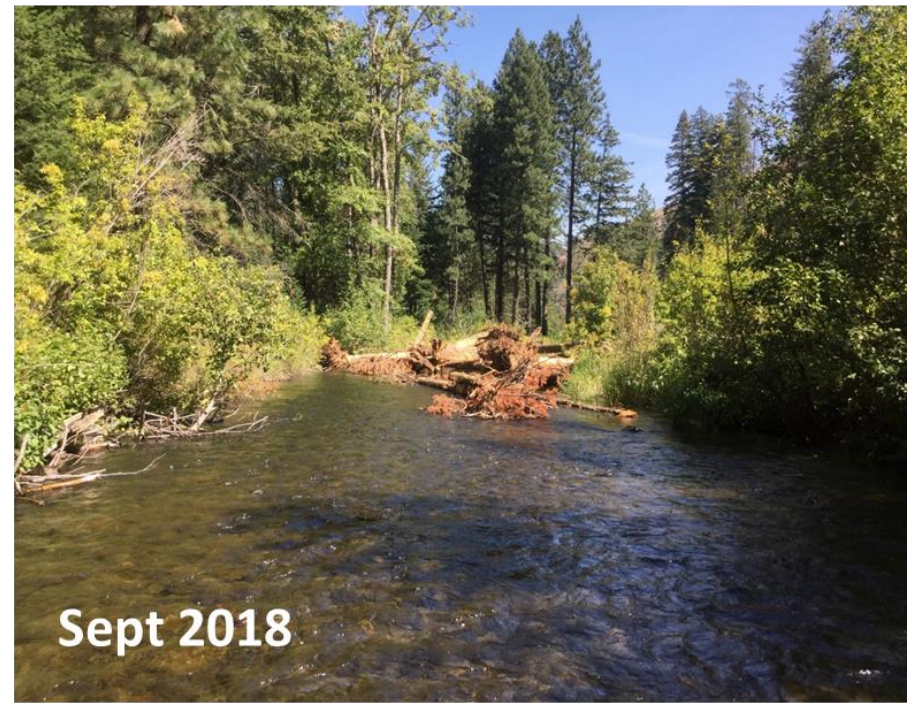
Figure 11: PA3 photo time series illustrating changes in entrenchment and channel shape preceding 2014 restoration treatment, through four winter freshets with one of them being a significant bed load mobilizing event~1,400 cfs (March 2017). The upper left image shows the pre-treatment plain bed channel, and to its right the 2014 treatment. The upper right and lower left images show a change in channel shape and some aggradation of the river bed. The lower middle and lower right images illustrate the 2018 restoration treatment designed to maintain and increase river bed aggradation occurring at this location, with the long term goal of capturing the left bank floodplain significantly increasing habitat river complexity within the reach.

The 2017 flow event mobilize bed load in the project area leading to localized bed aggradation (Figure 11), reducing channel entrenchment and increasing channel complexity to an extent not anticipated by the 2014 design. As a result of the floodplain expansion and reclaiming of disconnected flow paths, side channel length double, increasing from 0.34 miles in 2014 to 0.68 miles in 2017 (Figure 10). Using a method of measuring river complexity described by Brown (2002), we observed the river complexity index (RCI) values increased from RCI =8.88 (pre-project) in 2014 to a RCI = 35.09. Field observations indicated additional LWD loading may offer an opportunity to maintain and increase the reach RCI value by as much as an additional 50-100%. In 2017, the Regional Technical Team based on field investigation and an interest in maintaining and improving the existing 2017 condition, recommended a management action on PA 3 in which additional wood loading with the goals of connecting additional floodplain and increasing river complexity. CTUIR and WDFW worked to prepare a design with the primary objectives of placing 350 root wad trees in a various configurations to increase channel roughness and floodplain connectivity, to reconnect between 1,175' to 4460' of new side channels and high flow paths (Figure 13). Following an intermediate flow (~2 yr flow) in late winter 2018 and prior to the 2018 restoration action, a slight decline from 2017 condition, was observed in pool frequency and side channel length during the pre-construction survey (Figure 10 & 14).

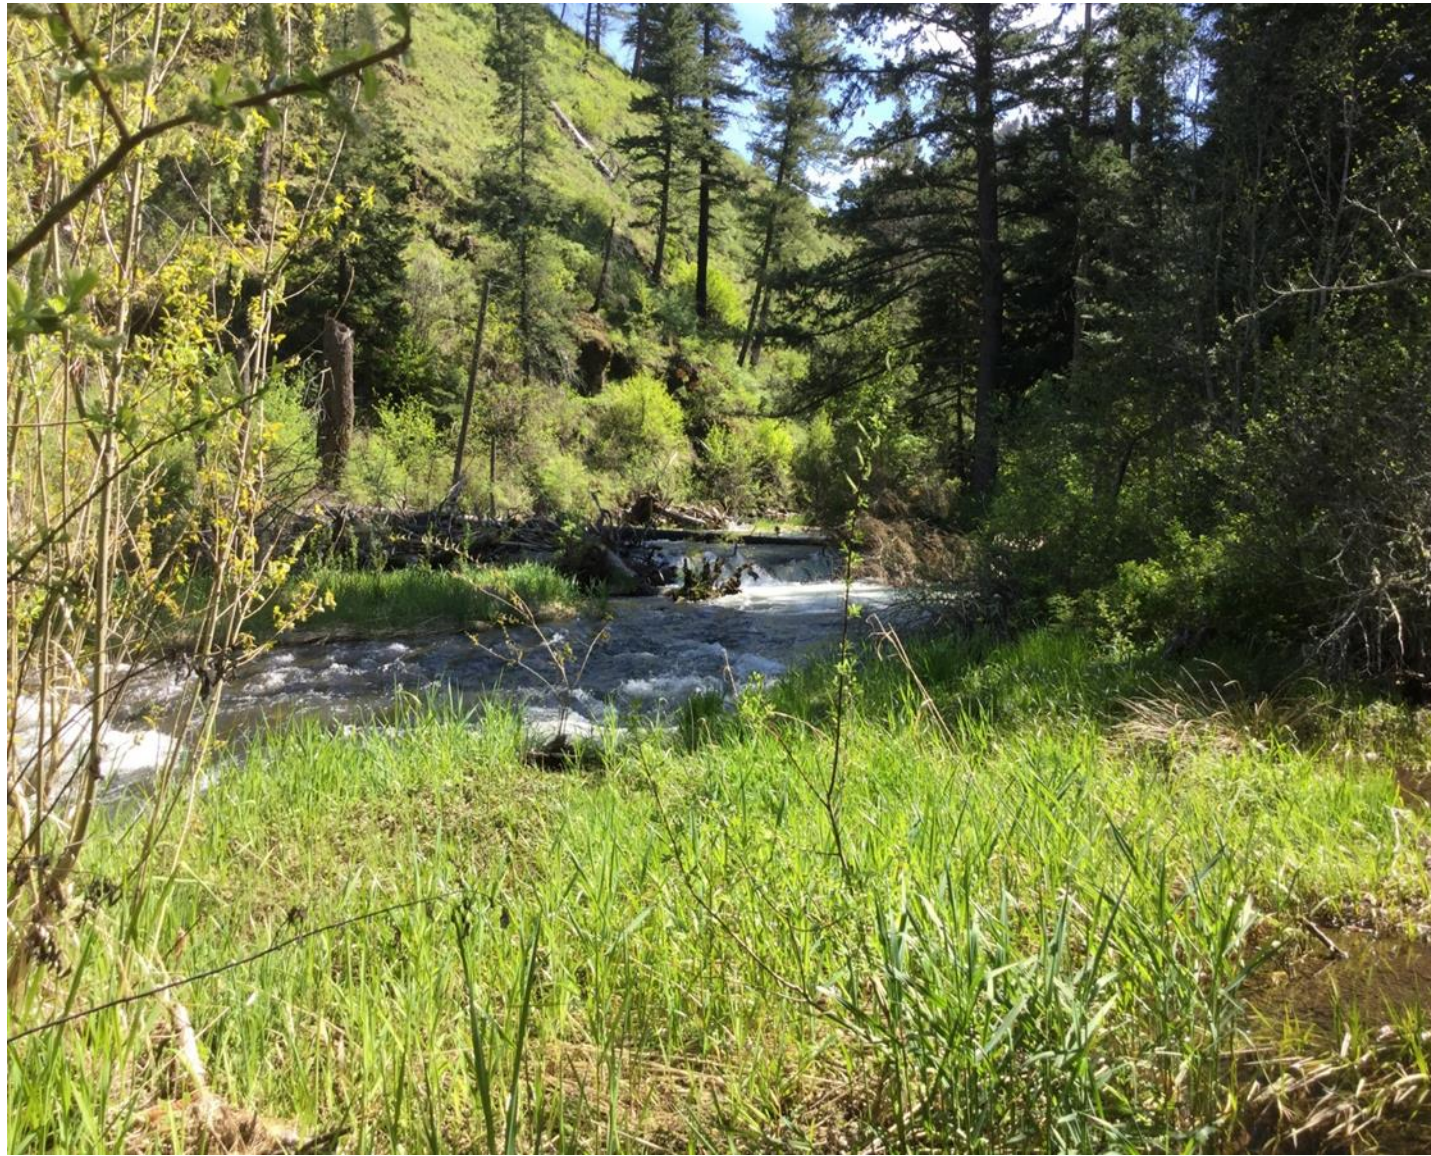
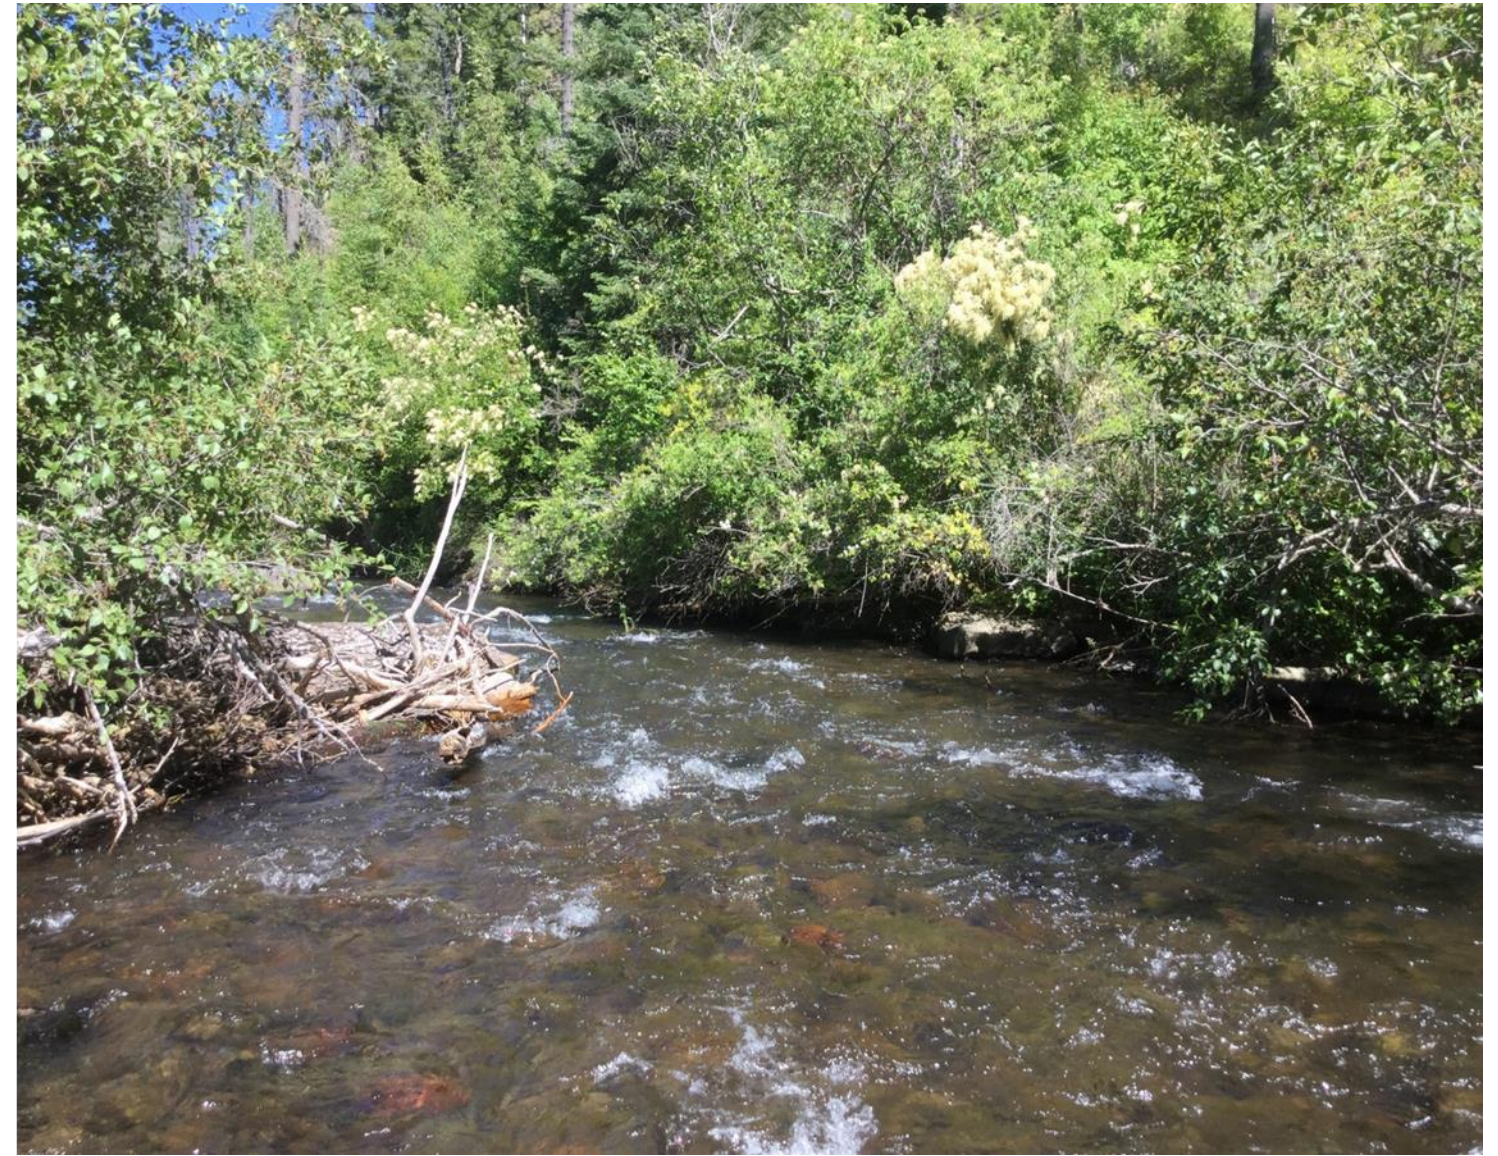
Figure 12: Natural channel spanning log jam located on the Tucannon River within Project Area 3. A channel spanning log jam has persisted at this location for >20 yrs (USFS personnel communication) and has been sustained by a number of very large ponderosa pines and Douglas fir trees estimated to be >30" in diameter. The trees have been buried in river cobble and are maintaining grade preserved in a wet environment. The log jam has been used as model for reference condition incorporated into the design of projects throughout the Tucannon (Upper right). The left image illustrates remains of a natural spanning jam which failed due to the failure of the main key piece in 2010, which can still be seen in the left side of the right image. The loss of the jam reduced habitat complexity and increased entrenchment within the reach.

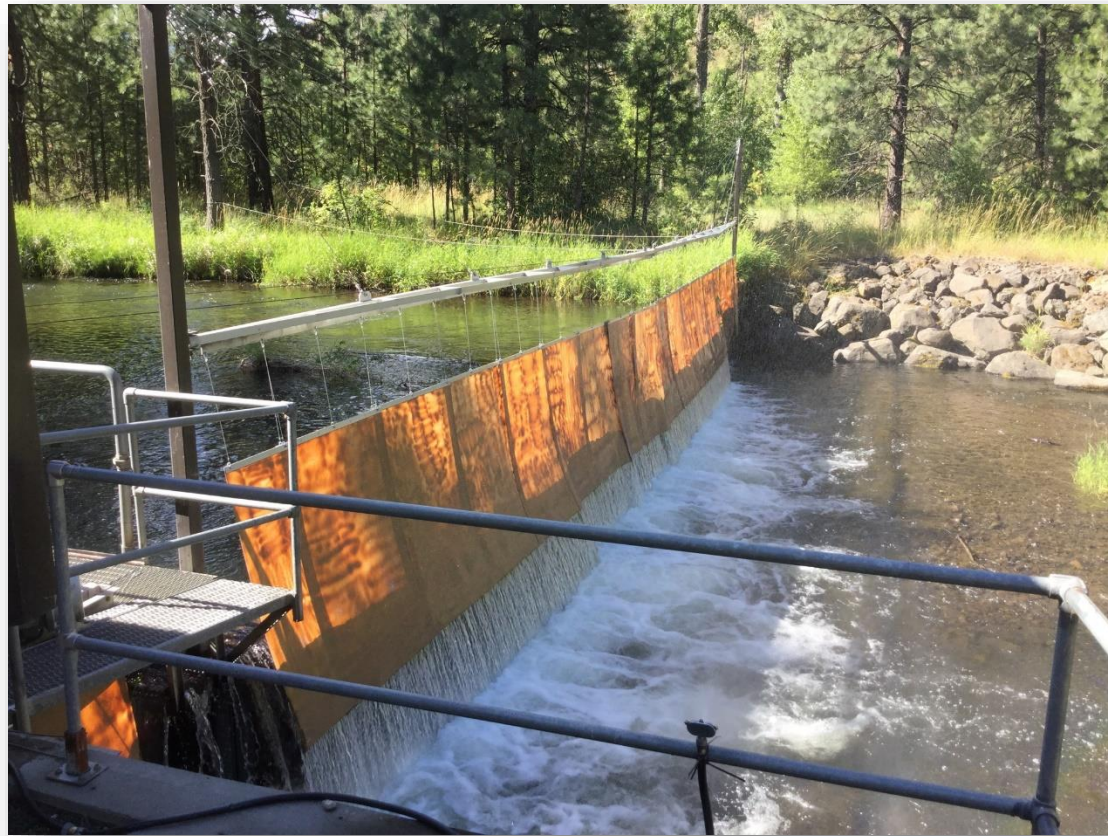
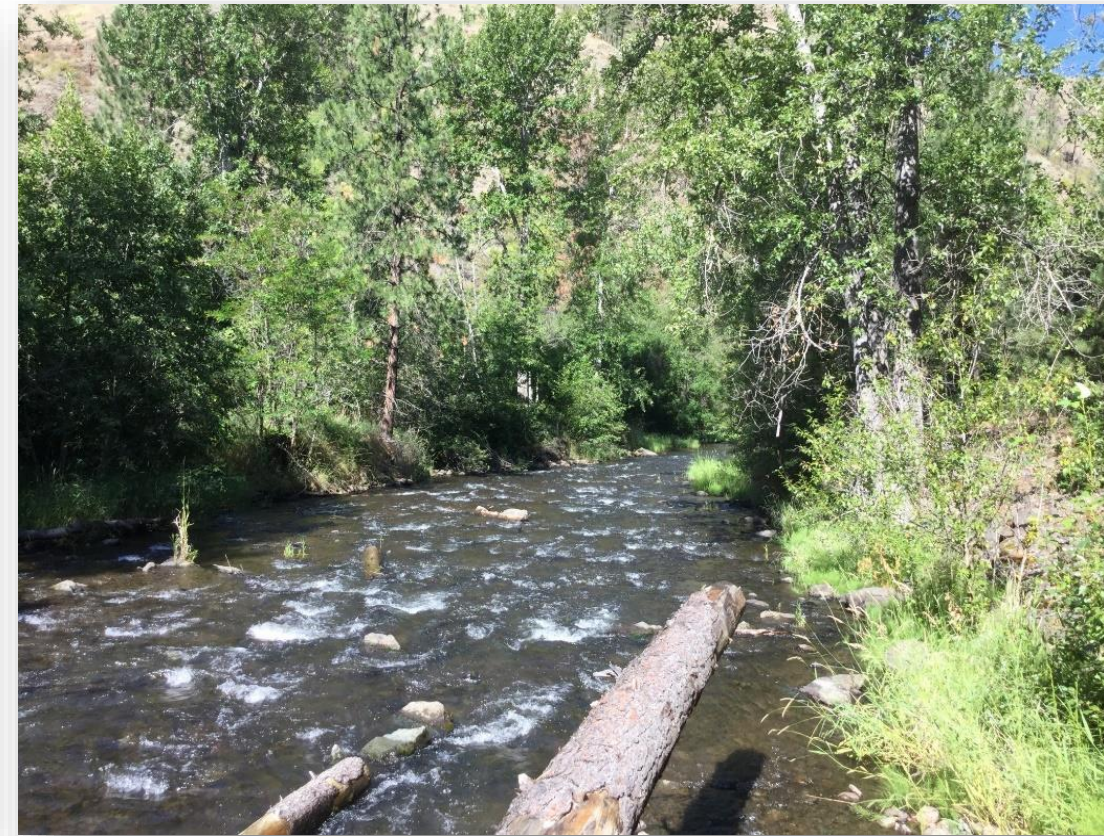
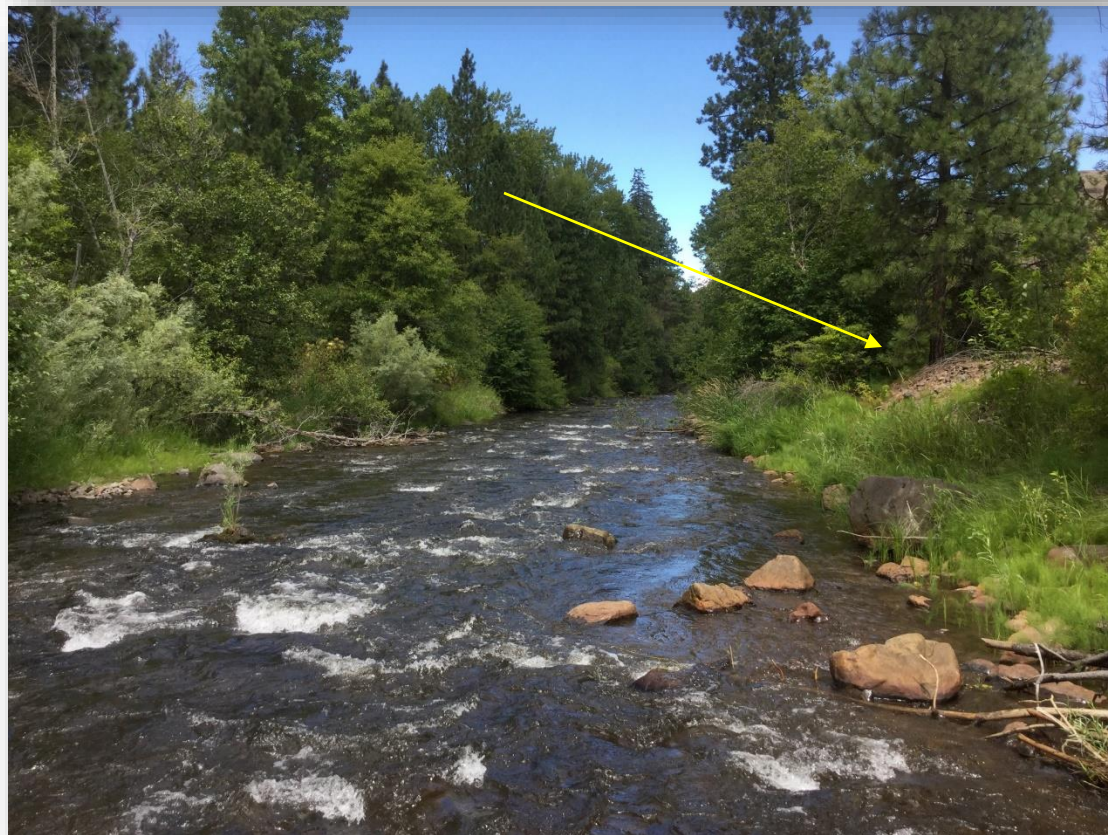
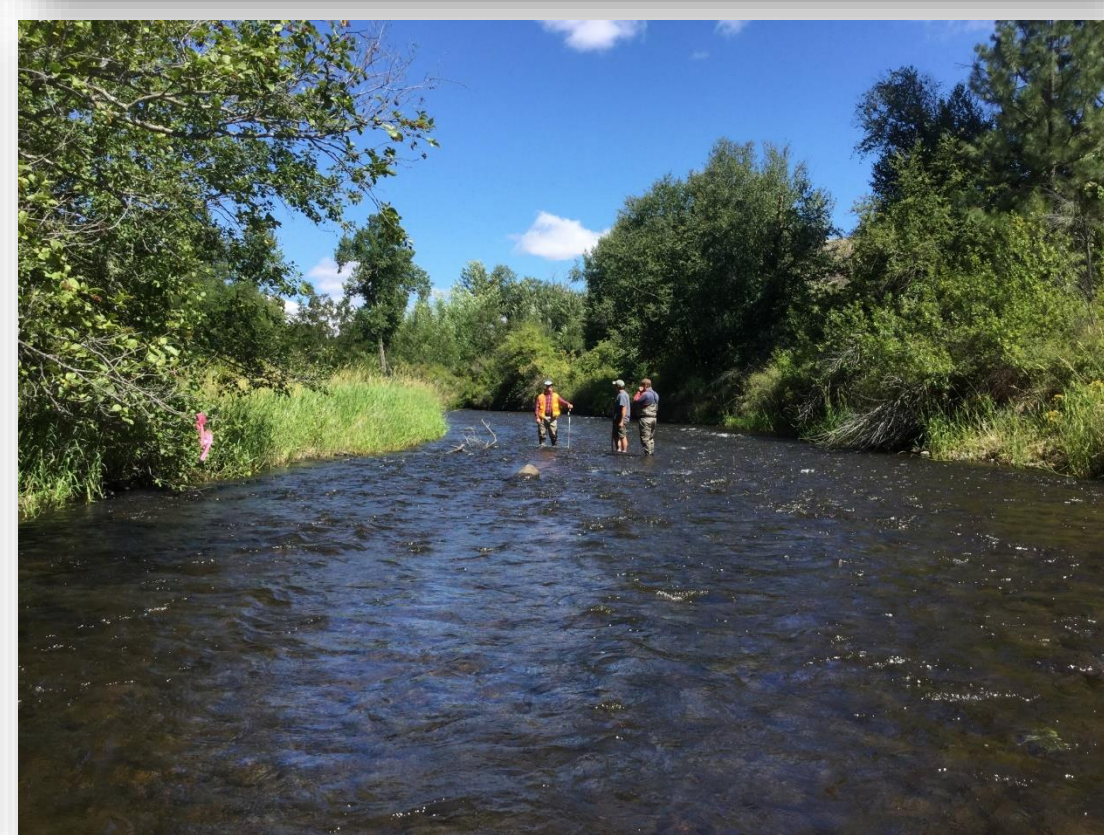
Figure 17: Tucannon River Project Area 13 pre-project conditions in 2018. The upper left image is the Tucannon Fish Hatchery weir and fish trap located at the upper most end of the project area. The project reach is described as a combination of plain bed riffle and rapids (lower left and right images) caused and maintained by river levees and riprap. The lower left image shows one of the river levees being removed (yellow arrow) in 2020 as part of the restoration project design for this reach.

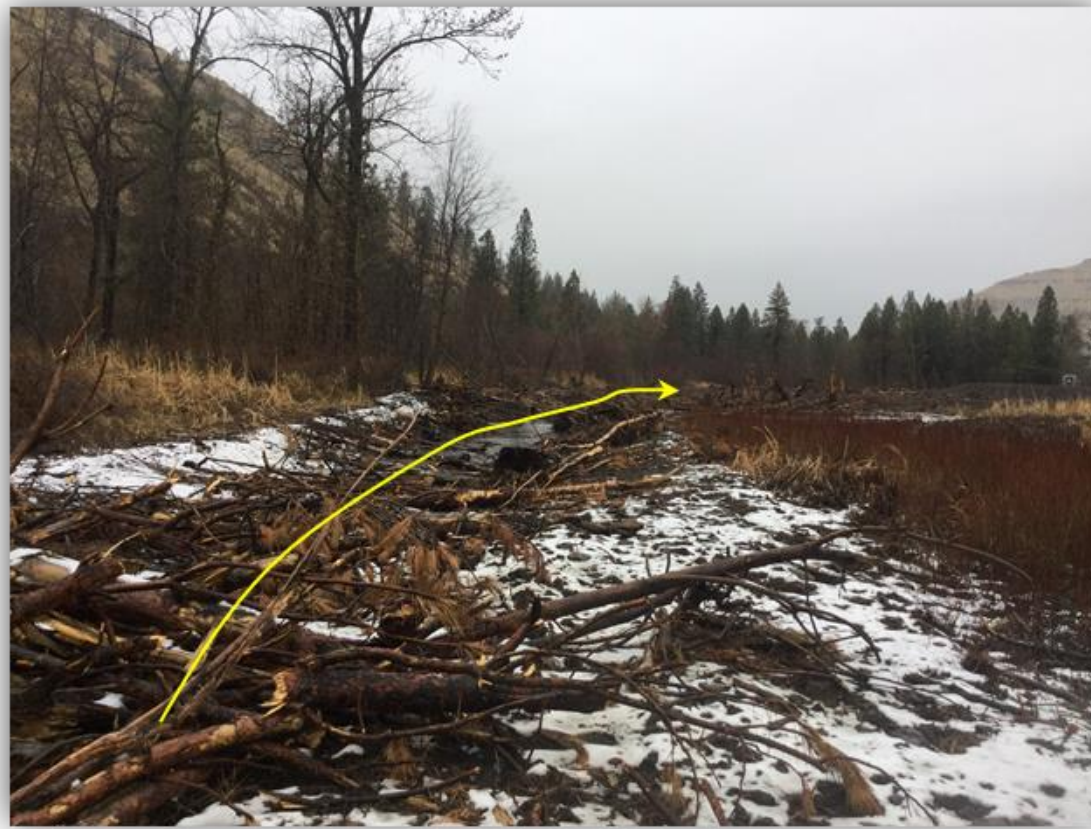
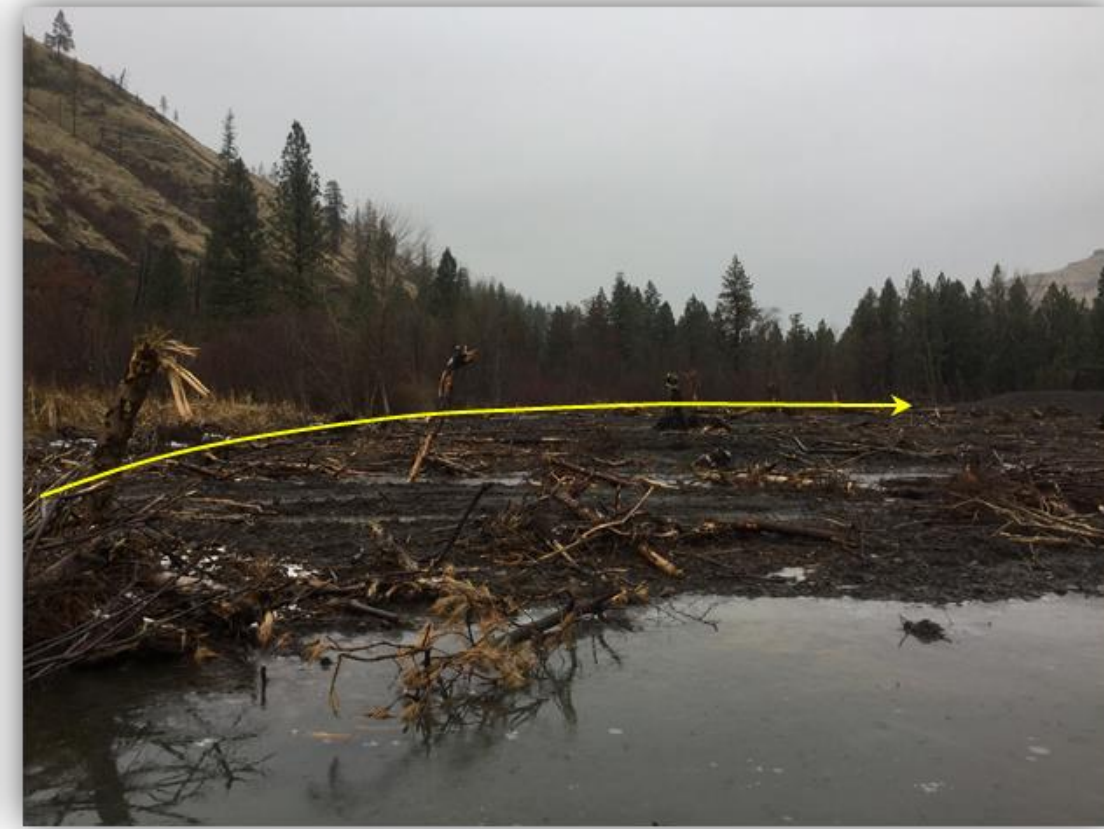
Figure 18: The upper left image was taken in March 2019 and illustrates the upstream extent of the Rainbow Lake dam removal that took place in 2018 as part of the WDFW lead Floodplain Management Plan. The yellow arrow indicates the previous position of the dam/levee that was removed. Following the removal of the dam the area that was previously lake bed was roughened with LWD and will be planted with wetland plants in the spring 2019. A flow path was developed through the previously inundated area (upper right) however this area remains disconnected from the river by levees which will be addressed during the implantation of PA13 in 2020. The lower right image shows the downstream end of the treated area.

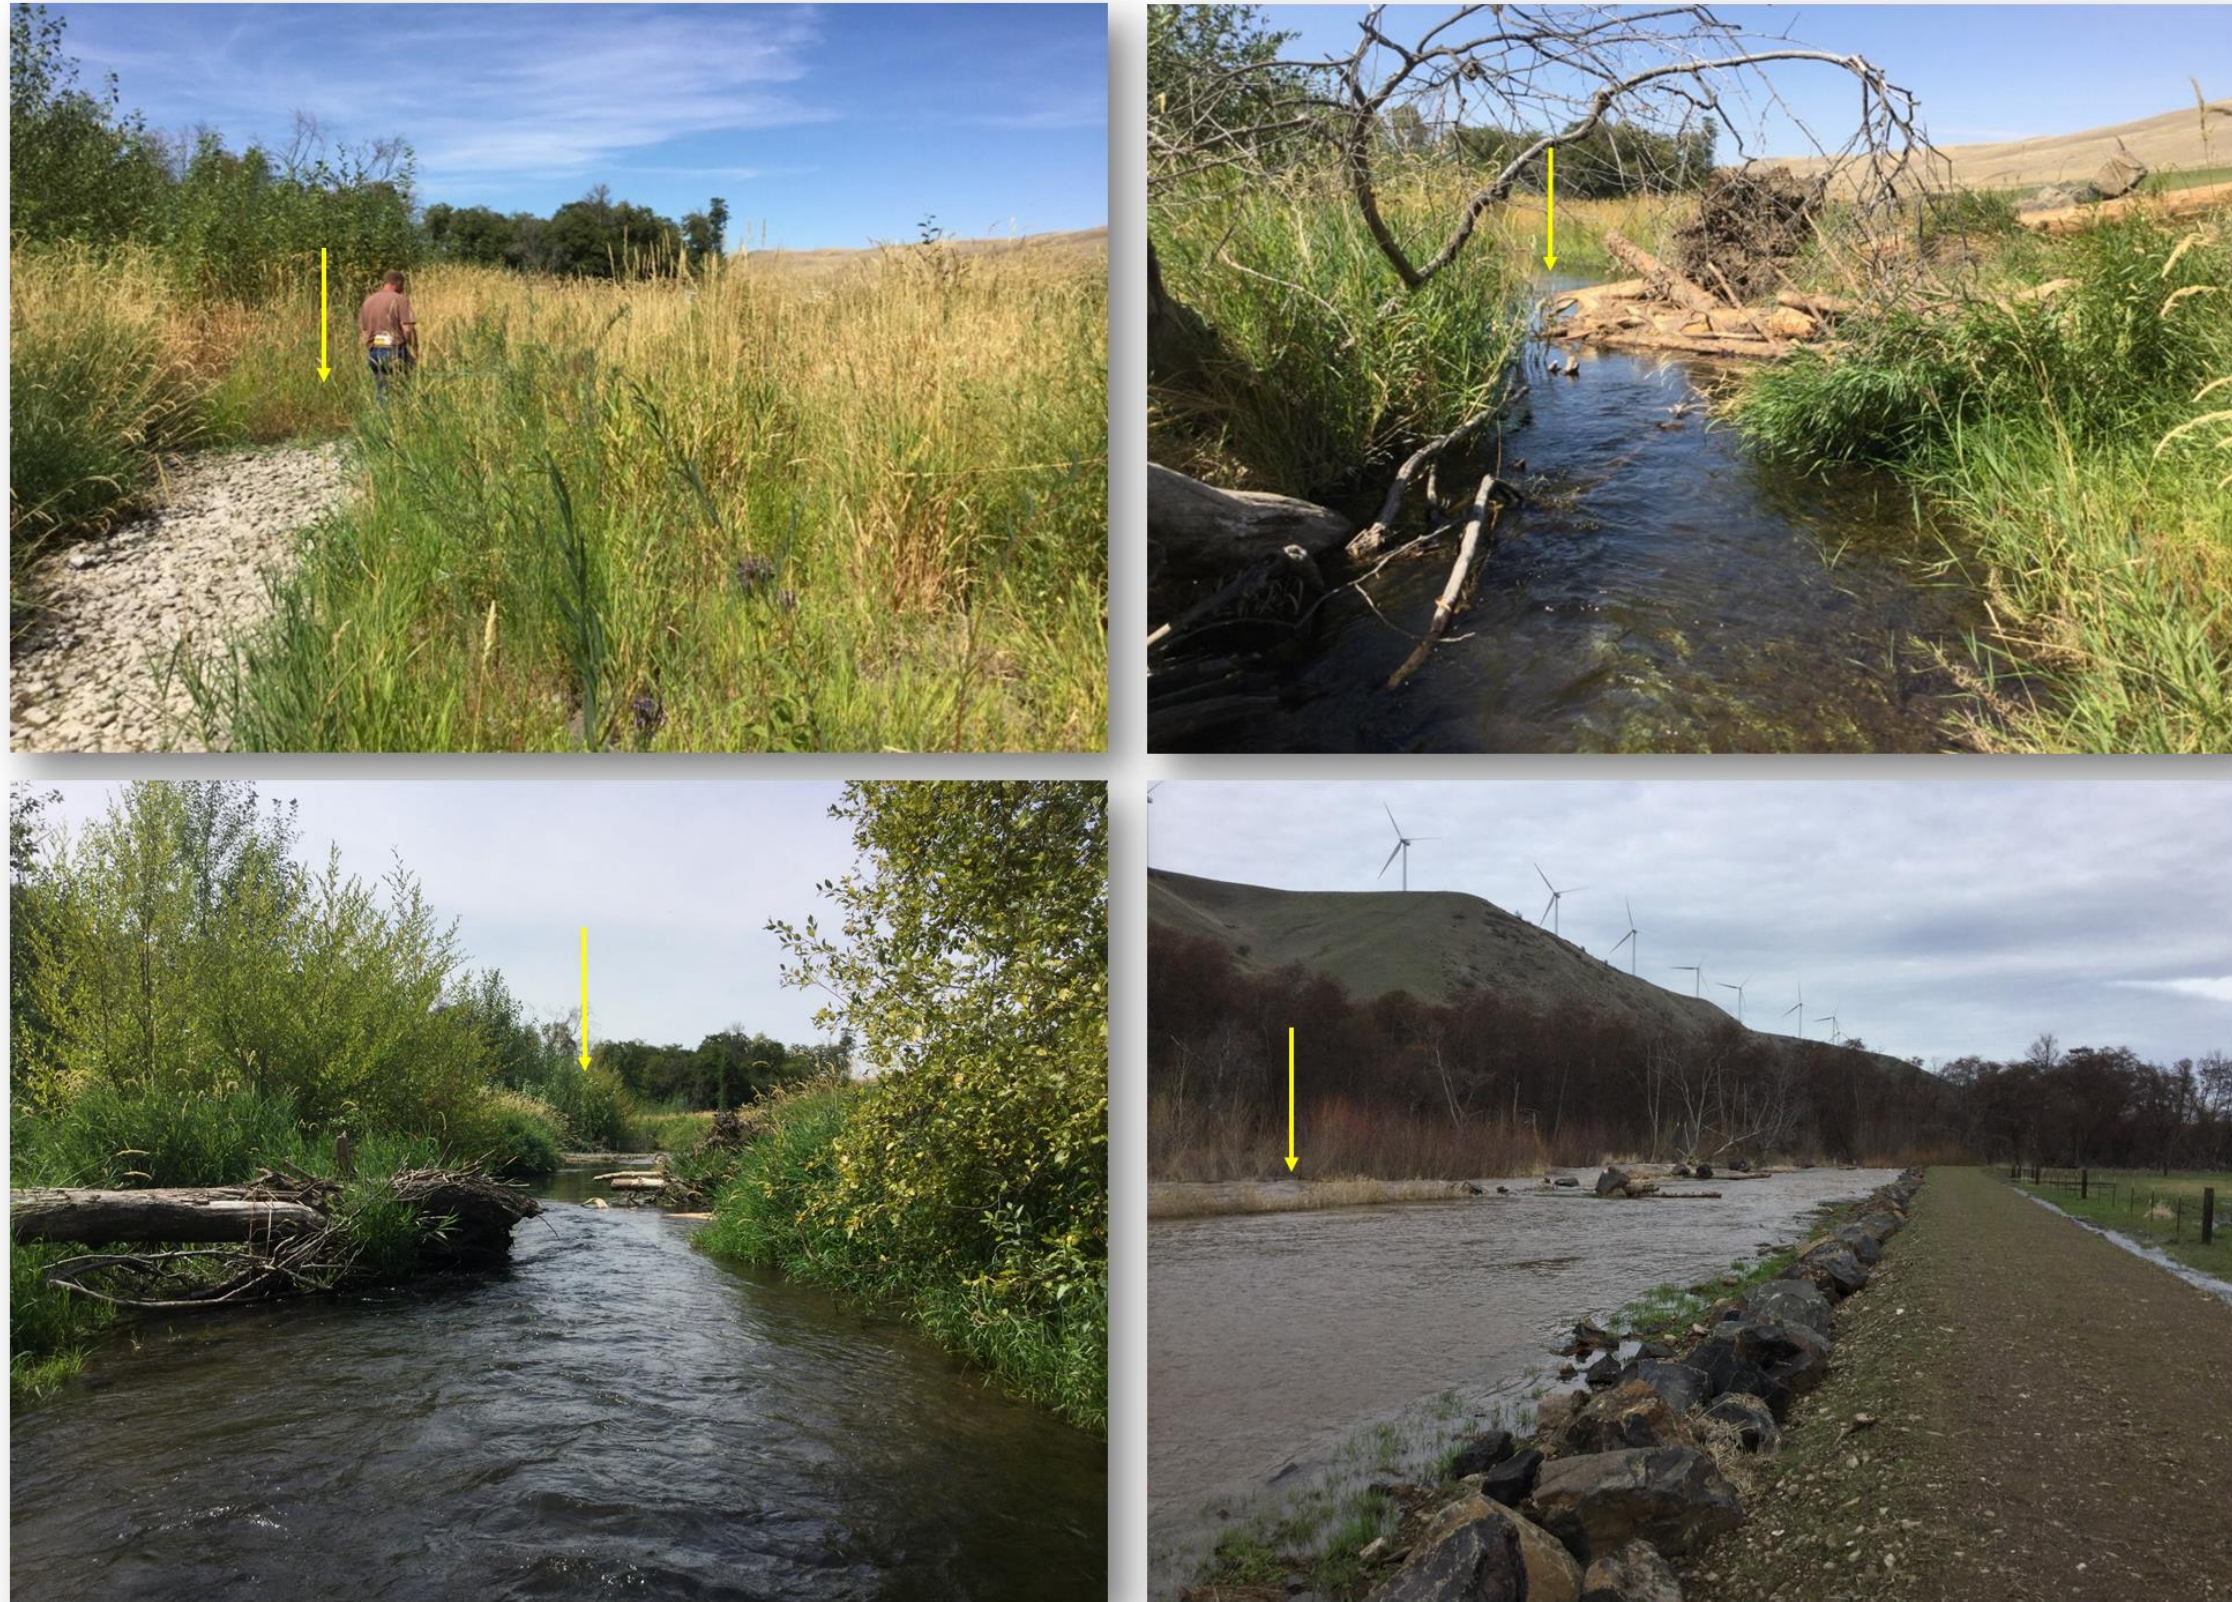
Figure 21: Phase I side channel pre project (upper left) immediate post project (upper right) and post high flow 2017 (lower left). The lower left photo shows the level of the flow in March 2017 and ~1,100 cfs. Flows during the flood extended across the entire floodplain and exhibited relatively shallow depth and low velocities. Flowing the flood very little scour was observed on the floodplain, however some areas had >2" of fine sediment deposition and residual pools depths within the channel exceed 1.5 m in some areas. The yellow arrow indicates the same general location through the time series.
